Static and Seismic Performance of California Levees

Michelle Jennifer Shriro

Doctor of Philosophy

Engineering - Civil and Environmental Engineering

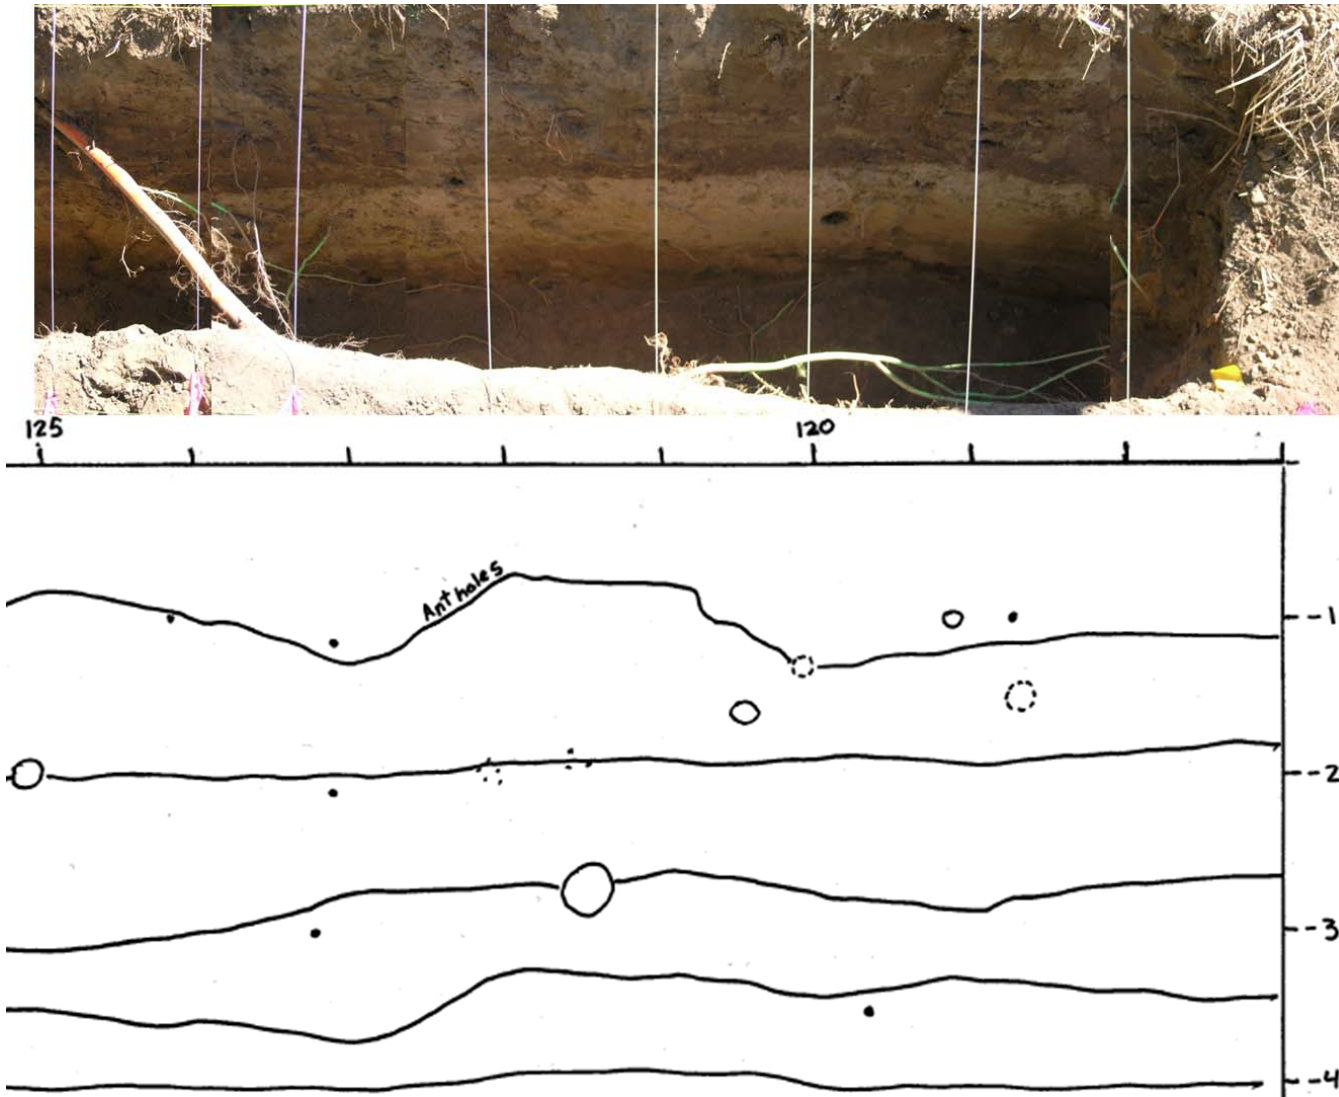
2C-25

Figure 2C- 25. Spliced photos looking south (top) and analogous uphill wall log (bottom) of lower control trench Stations 117-125.

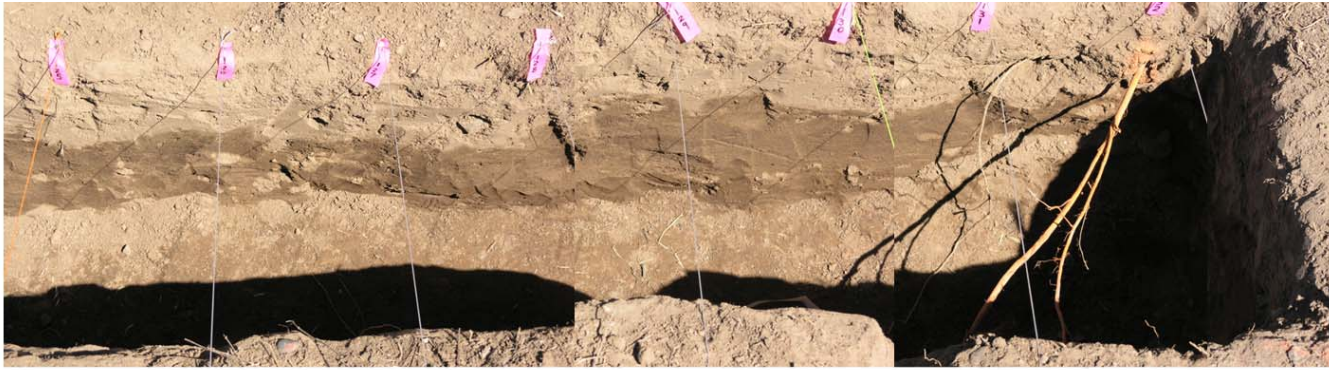
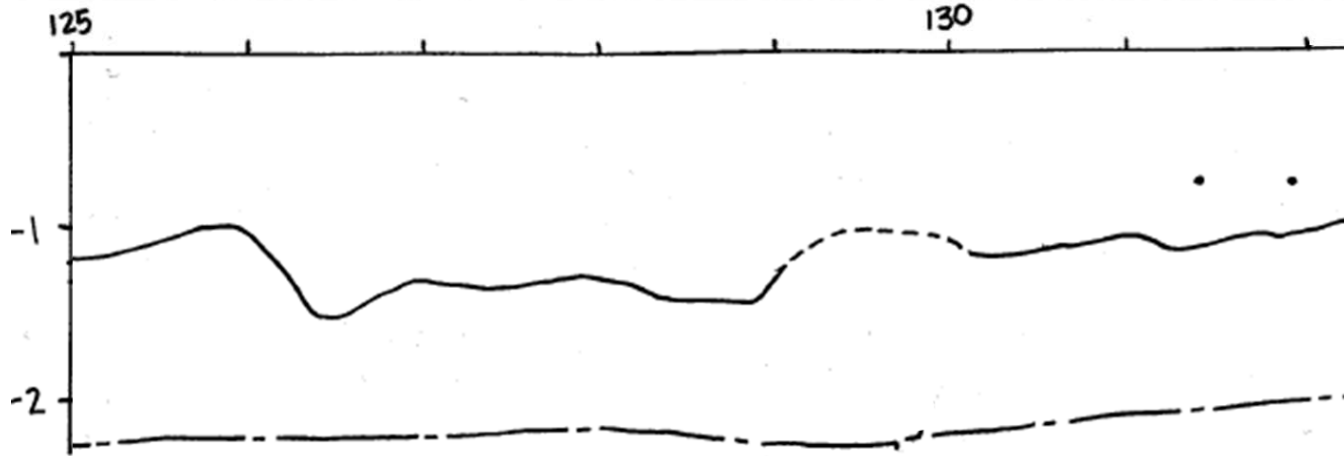
2C-26

Figure 2C- 26. Spliced photos looking north (top) and analogous downhill wall log (bottom) of upper control trench Stations 125 to 132. Photos were taken prior to excavation completion.

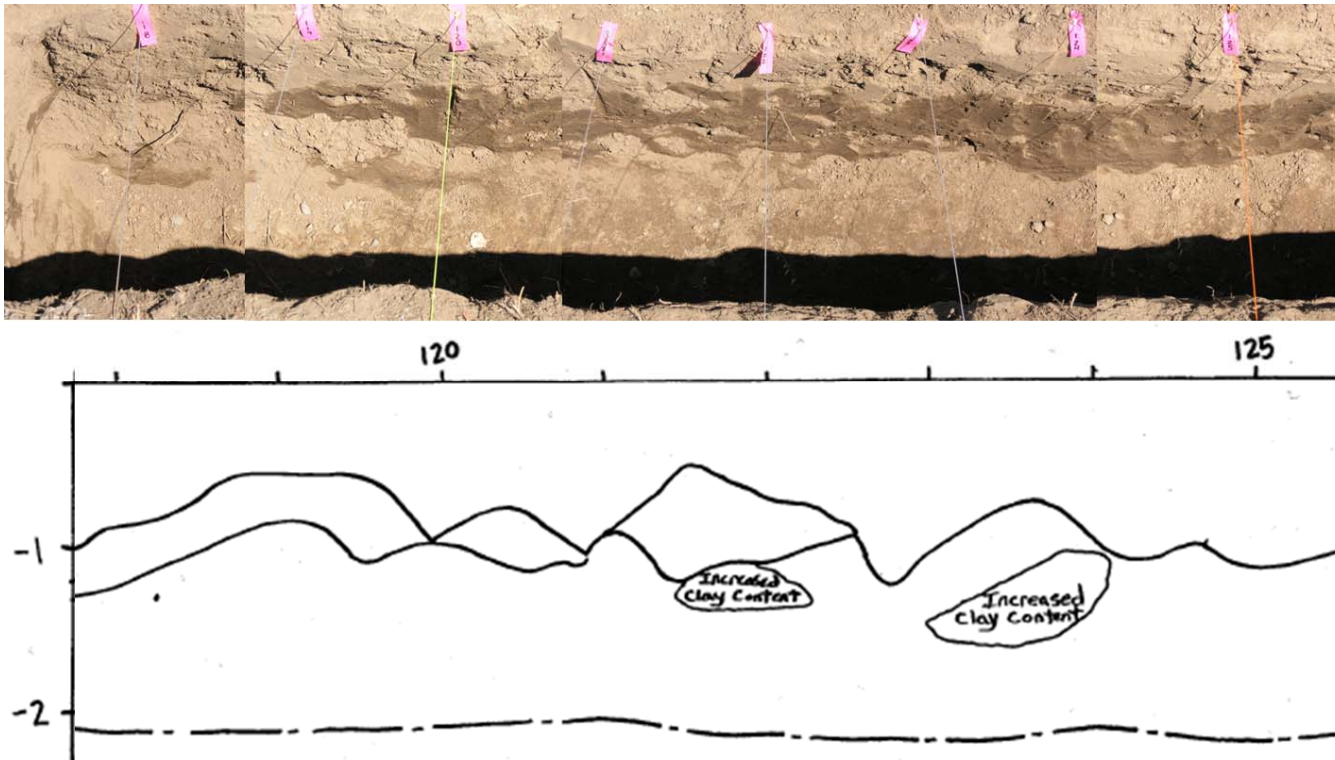
2C-27

Figure 2C- 27. Spliced photos looking north (top) and analogous downhill wall log (bottom) of upper control trench Stations 118 to 125. Photos were taken prior to excavation completion.

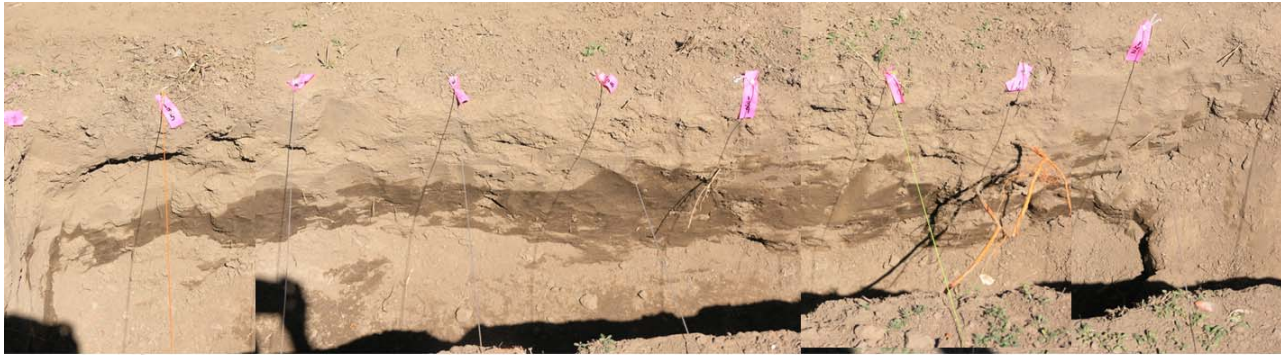
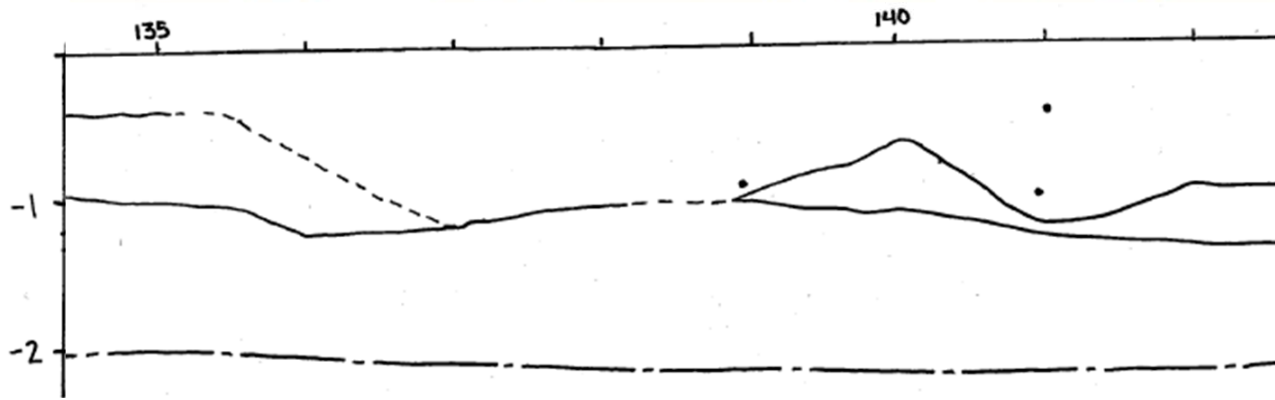
2C-28

Figure 2C- 28. Spliced photos looking north (top) and analogous downhill wall log (bottom) of upper stump trench Stations 134 to 142. Photos were taken prior to excavation completion.

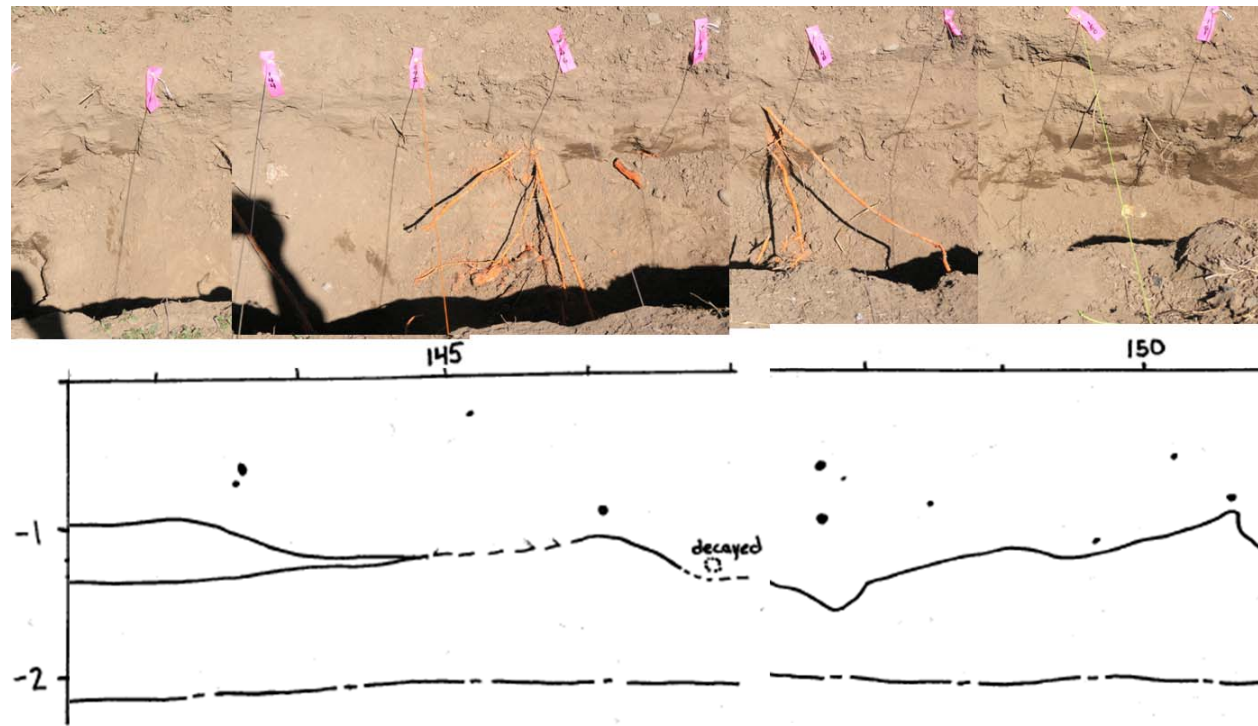
2C-29

Figure 2C- 29. Spliced photos looking north (top) and analogous downhill wall log (bottom) of upper stump trench Stations 142.5 to 151. Photos were taken prior to excavation completion.

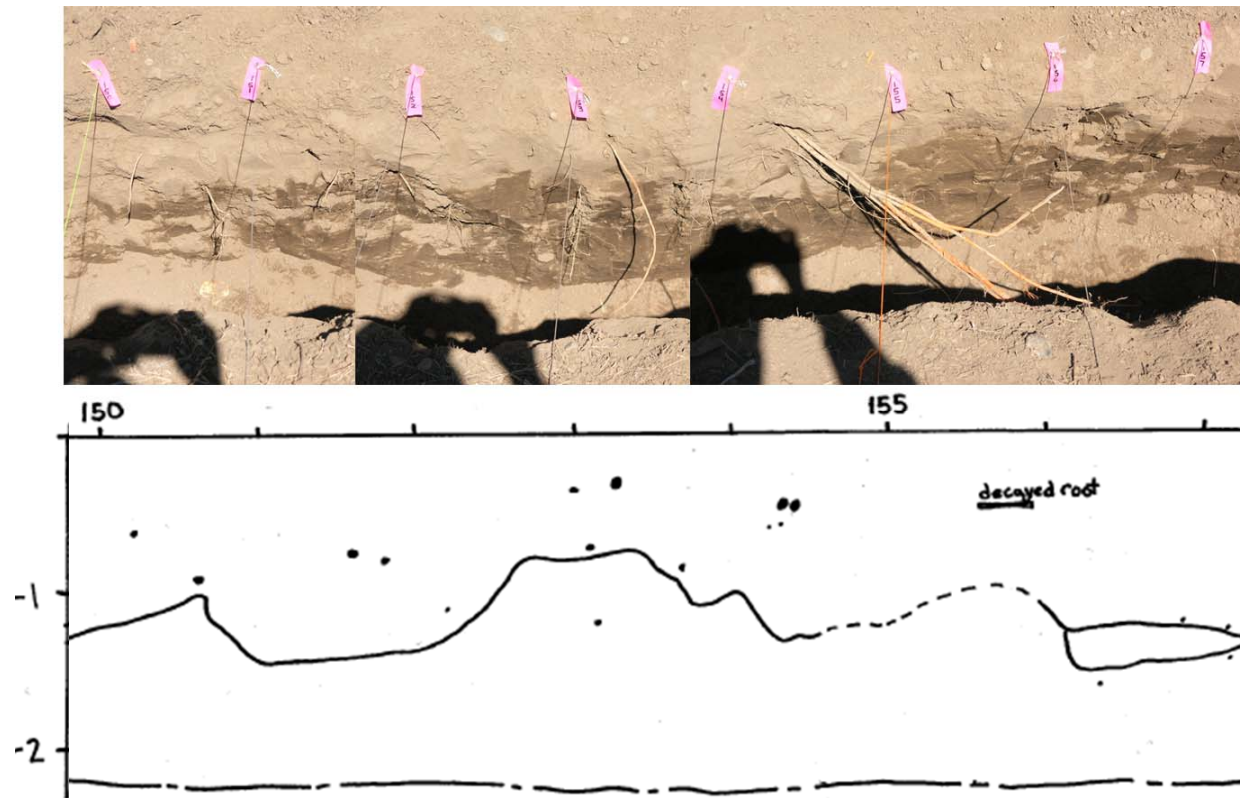
2C-30

Figure 2C- 30. Spliced photos looking north (top) and analogous downhill wall log (bottom) of upper stump trench Stations 150 to 157. Photos were taken prior to excavation completion.

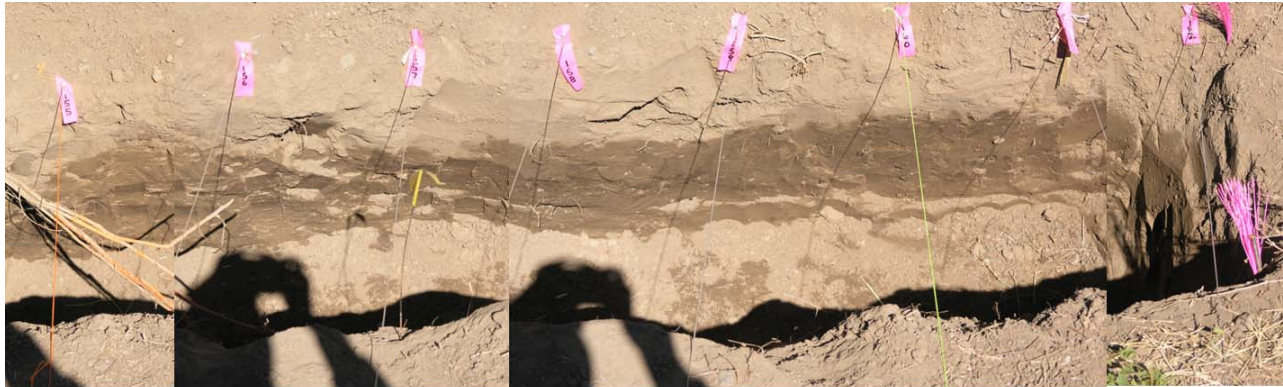
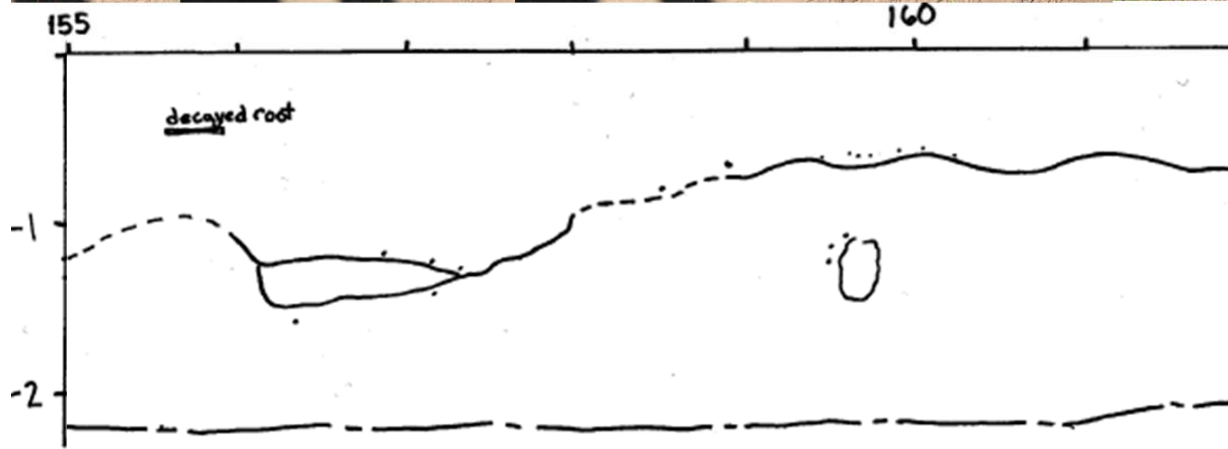
2C-31

Figure 2C- 31. Spliced photos looking north (top) and analogous downhill wall log (bottom) of upper stump trench Stations 155 to 162. Photos were taken prior to excavation completion.

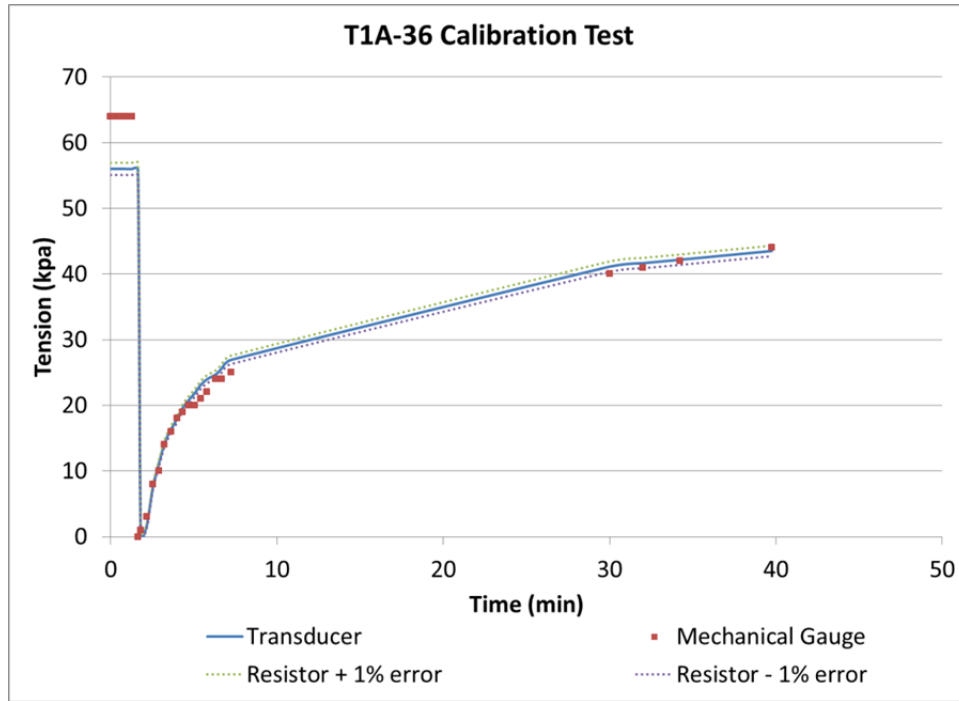
Figure 2D- 3. Calibration test correlating readings from mechanical vacuum gauge with transducer readings for tensiometer T1A-36.

Figure 2D- 2 shows the locations of instruments installed at the site. Tensiometers T4B-18, and T3C-36 and piezometer P2B-84 were not functional. Tensiometers were connected to the datalogger during the days leading up to the flow test to check functionality. Tensiometer T1A-36 was selected for a calibration test. The instrument was installed in the ground, and allowed to develop tensions that seemed relatively constant based on readings of the mechanical gauge. The datalogger was observed in real time while the mechanical gauge was read periodically. Mechanical gauge suction values were compared with corresponding readings from the transducer. The results are shown on Figure 2D- 3. At high suction values, the mechanical gauge yielded higher values of soil suction than the transducer. The instrument was opened during the test, water added, and the instrument re-sealed. After 40 minutes, tension had not increased to the level prior to opening the instrument. The mechanical gauge and the transducer were generally in good agreement for much of the test. Error of the resistor is shown on the plot and does not explain the discrepancy between the gauge and the transducer at high suction values.

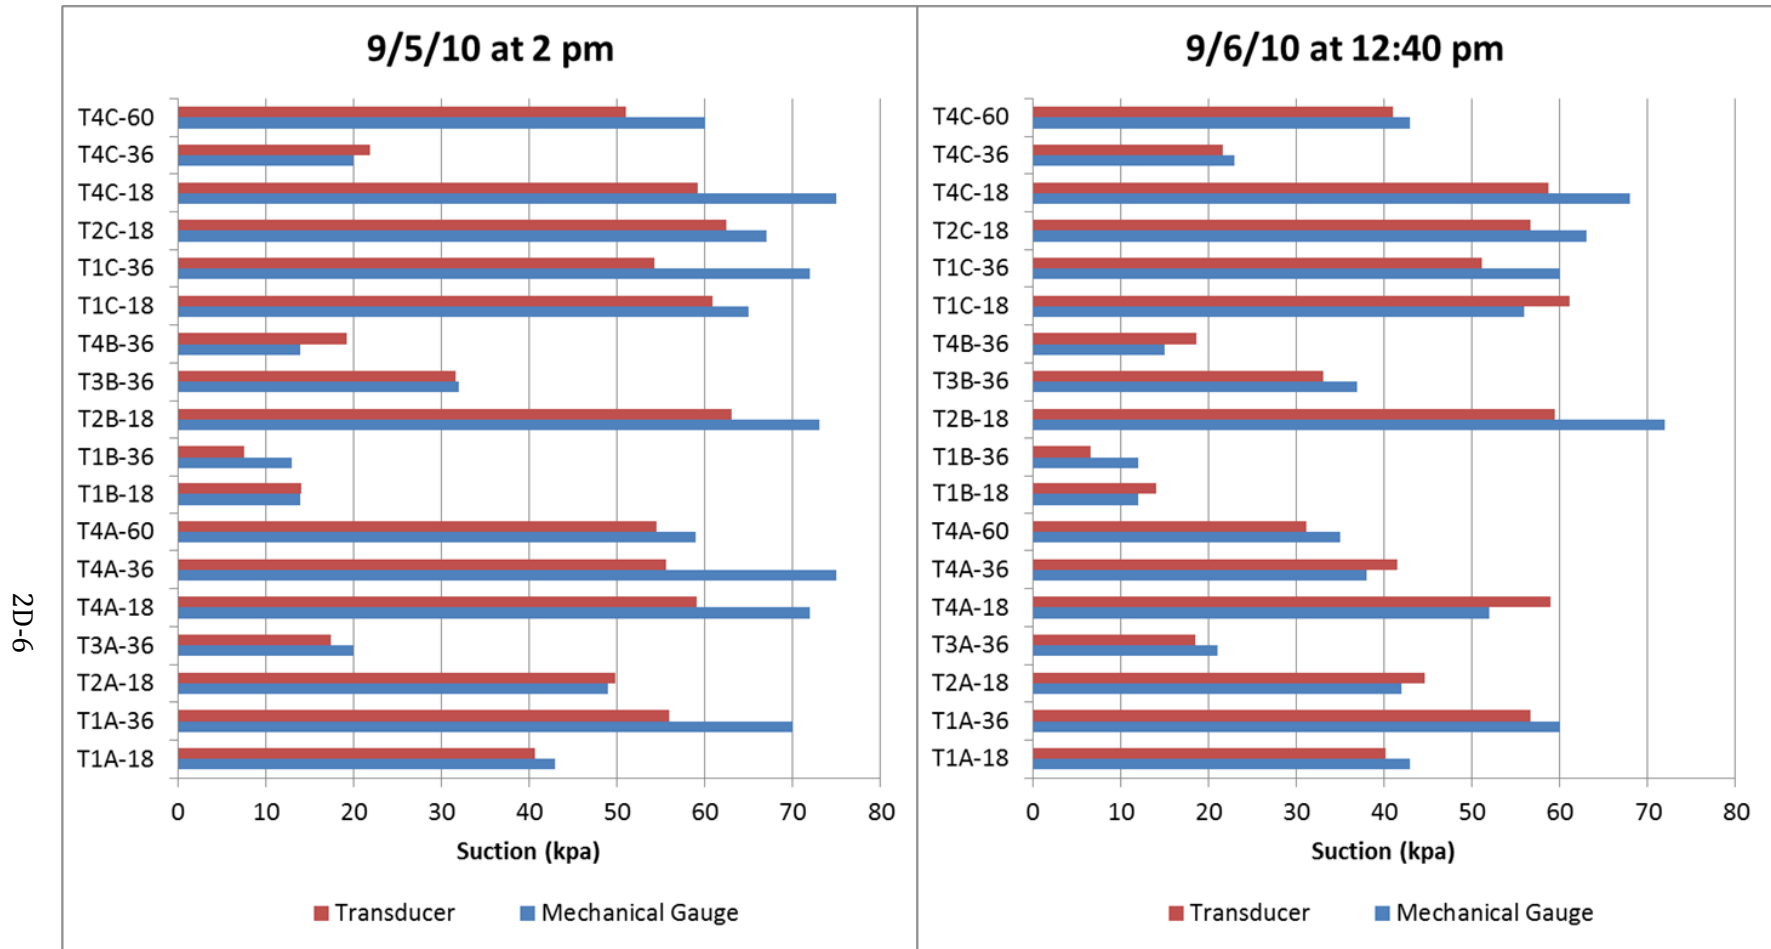
Figure 2D- 4. Comparison of mechanical vacuum gauge readings with transducer results for all instruments.

Figure 2D- 4 compares mechanical gauge readings with those measured by current transducers. All instruments are shown for two time intervals on the two days just before the flow test. The flow test began on September 7, 2010 at 11:57am and comparisons between mechanical gauges and transducers were performed on September 5<sup>th</sup> and 6<sup>th</sup>. Mechanical gauge readings predicted higher values of suction than transducers in 14 of 18 tensiometers on September 5<sup>th</sup> and in 12 of 18 tensiometers on September 6<sup>th</sup>. The mean percent difference between gauge readings and transducers was 14.9 percent with a standard deviation of 11.5 percent on September 5<sup>th</sup> whereas it dropped to 13.1 percent with a 9.14 percent standard deviation the next day. Air bubbles can become trapped in the gauges and at high suction values can enter through the high air entry value ceramic cups at the base. Air content in the fill water, though minimized by boiling water in the field or bringing de-aired water from the lab prior to filling the instruments, can introduce higher errors at high suction values (approaching cavitation) as air bubbles are formed inside the instrument. Soilmoisture Equipment Corporation ceramic cups have an air entry value of about -100 kPa, however increasing this value would not improve accuracy of the instruments as the water in the tube will cavitate when the water pressure reaches -90 kPa (Fredlund and Rahardjo, 1993). Given that the height of the water column adds to the suction, the maximum value of matric suction that can be achieved with this system is 84 kPa, 78 kPa, and 75 kPa for 24 inch, 48 inch, and 60 inch instruments, respectively. Longer instruments are therefore less capable of measuring high values of matric suction.

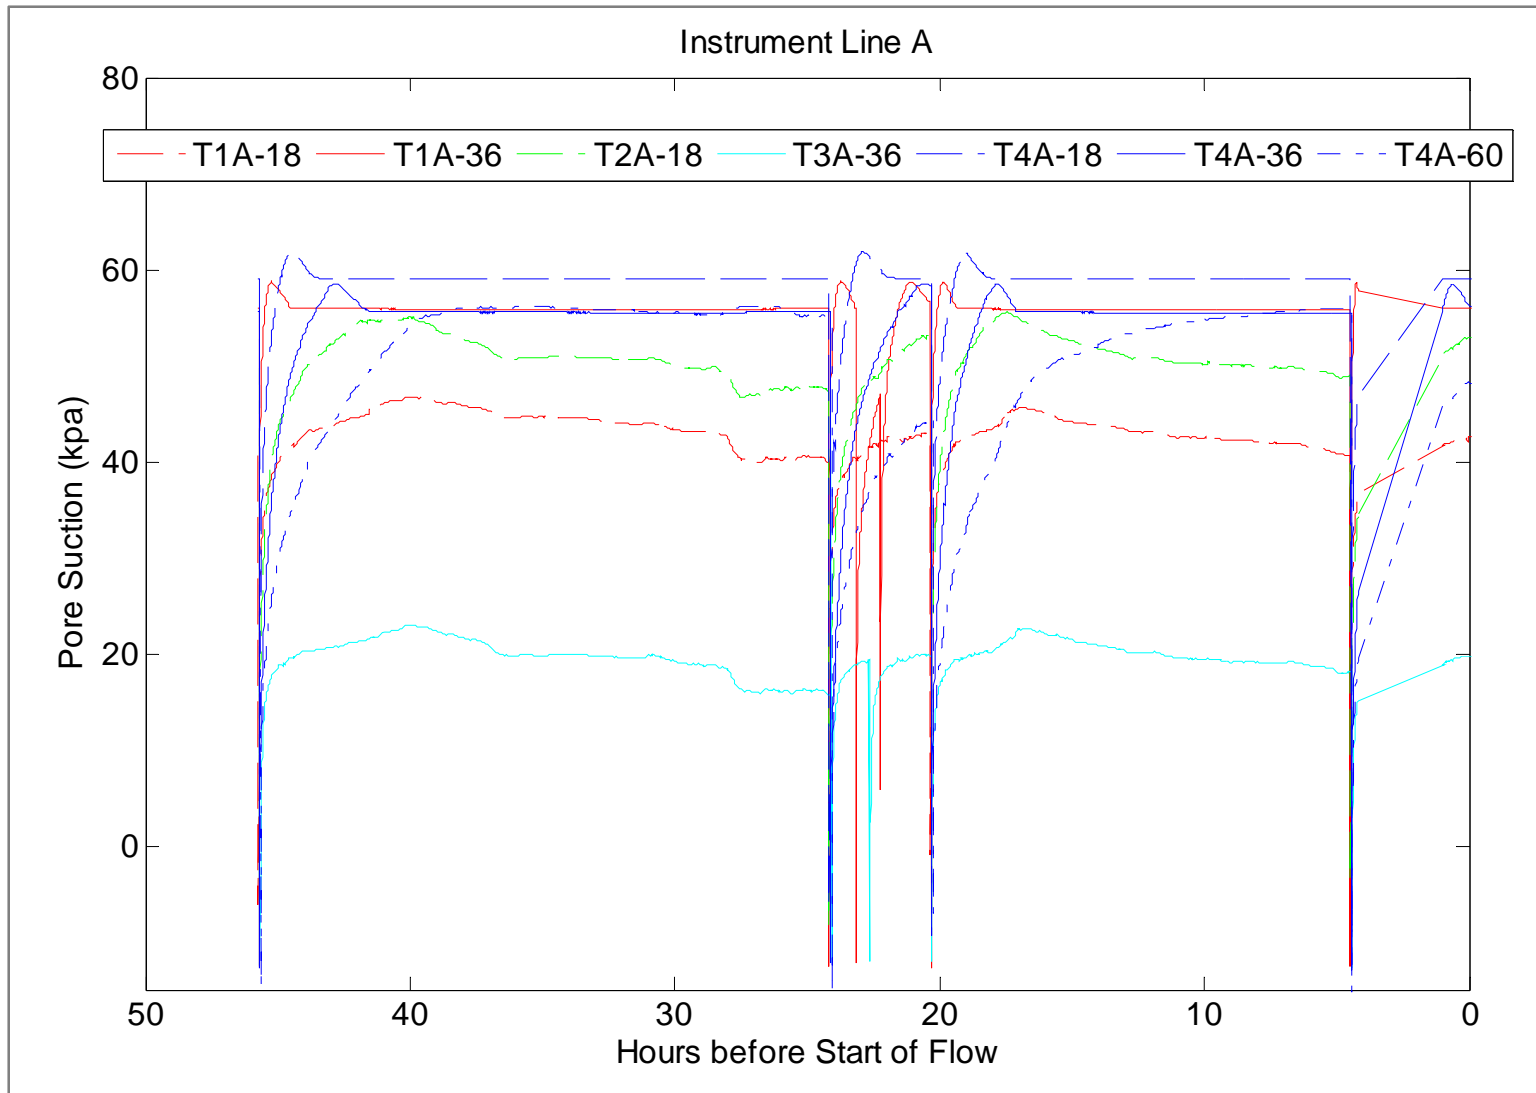
Figure 2D- 5. Matric suction values read from transducers at Line A tensiometers prior to the flow test.

Two days prior to the flow test, the datalogger was connected and a continuous record of soil suction was recorded for instrument lines A (Figure 2D- 5), B (Figure 2D- 6), and C (Figure 2D- 7). Water was added frequently prior to the flow test as soils were unsaturated. If air bubbles are allowed to accumulate inside the instrument, matric suctions read on the instruments can falsely trend toward zero, or atmospheric pressure (Fredlund and Rahardjo, 2005). Tensiometers T3A-36, T4A-36, T1B-18, T1B-36, T2B-18, T3B-36, T4B-36, and T4C-36 generally required more water than other instruments. These instruments show matric suction values that tend to have the lowest peak values of suction as compared to other nearby instruments or comparable depth instruments in other instrument lines. Further, curve shapes tend to be irregular, always dropping, while instruments that did not require addition of water as often developed regular curves with relatively constant values of matric suction prior to the arrival of the wetting front. It is possible that air was slowly entering the system in these instruments, either through a poor seal at the ceramic cup or through air entering through the porous ceramic cup. The results from these instruments was removed from the falling head test results as the test was conducted over a period of time when no one was onsite daily to maintain water in the instruments. Peak values of suction for these instruments are unlikely to be accurate, however a distinct drop in suction was achieved in each of the instruments indicating the arrival of the wetting front. We believe that the data is accurate for the purpose of understanding the timing of the wetting front arrival, but untrustworthy for peak values of matric suction prior to, during, and after the flow test.

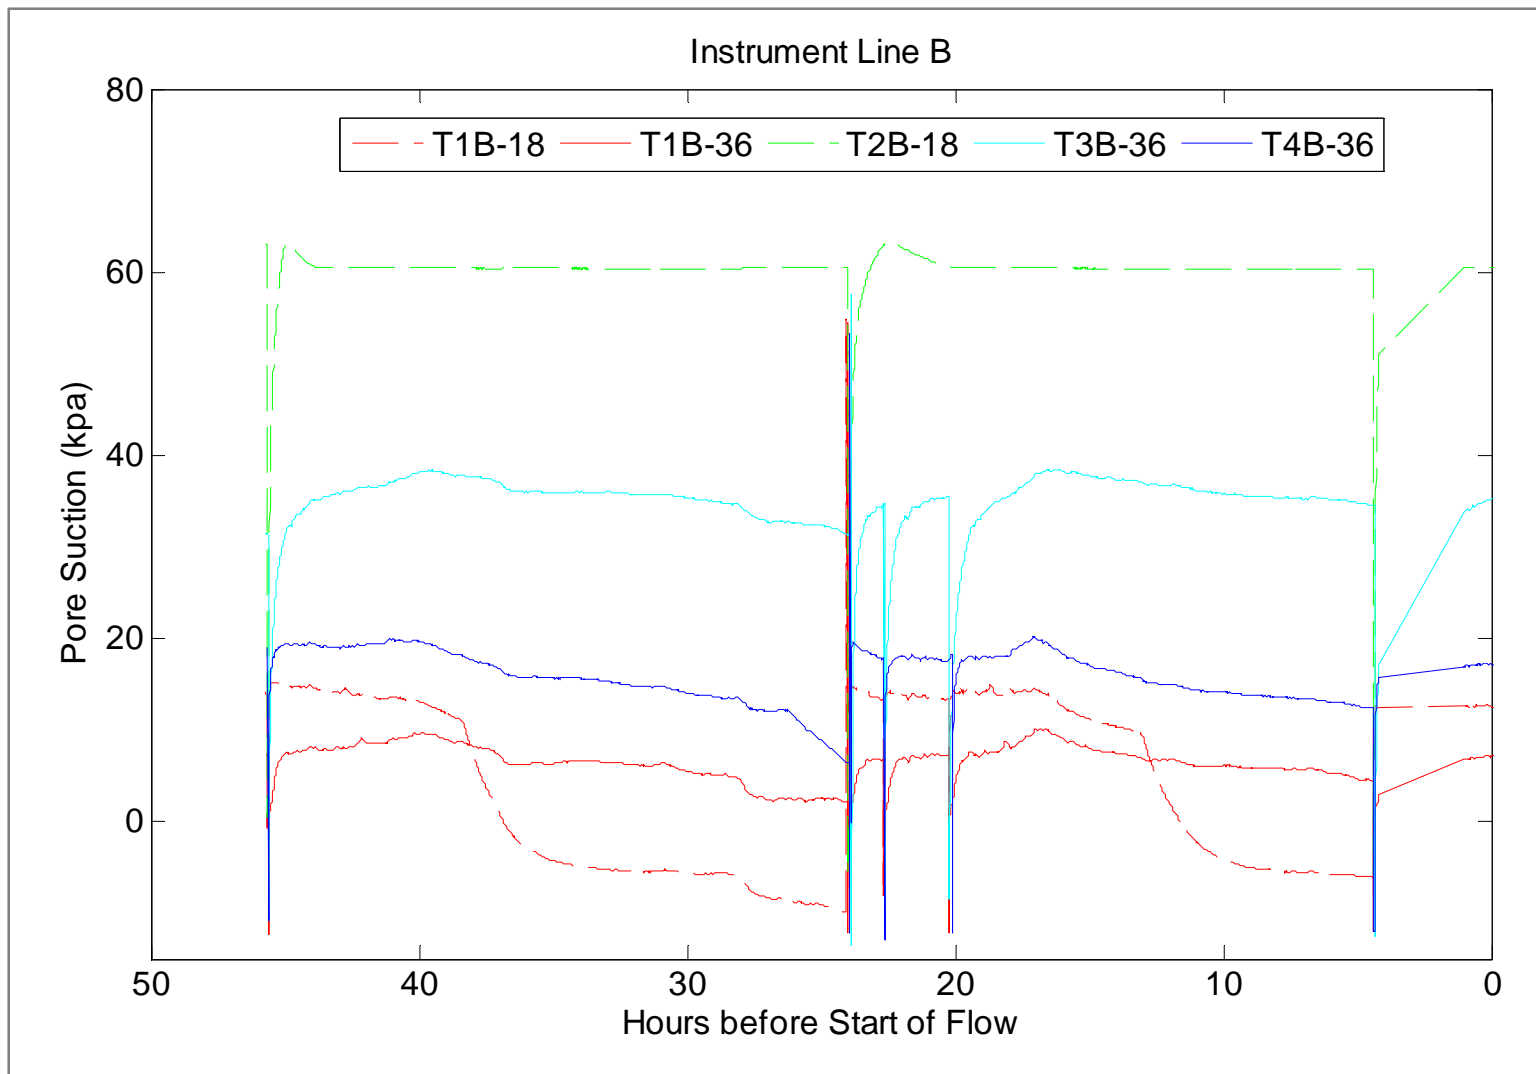
Figure 2D- 6. Matric suction values read from transducers at Line B tensiometers prior to the flow test.

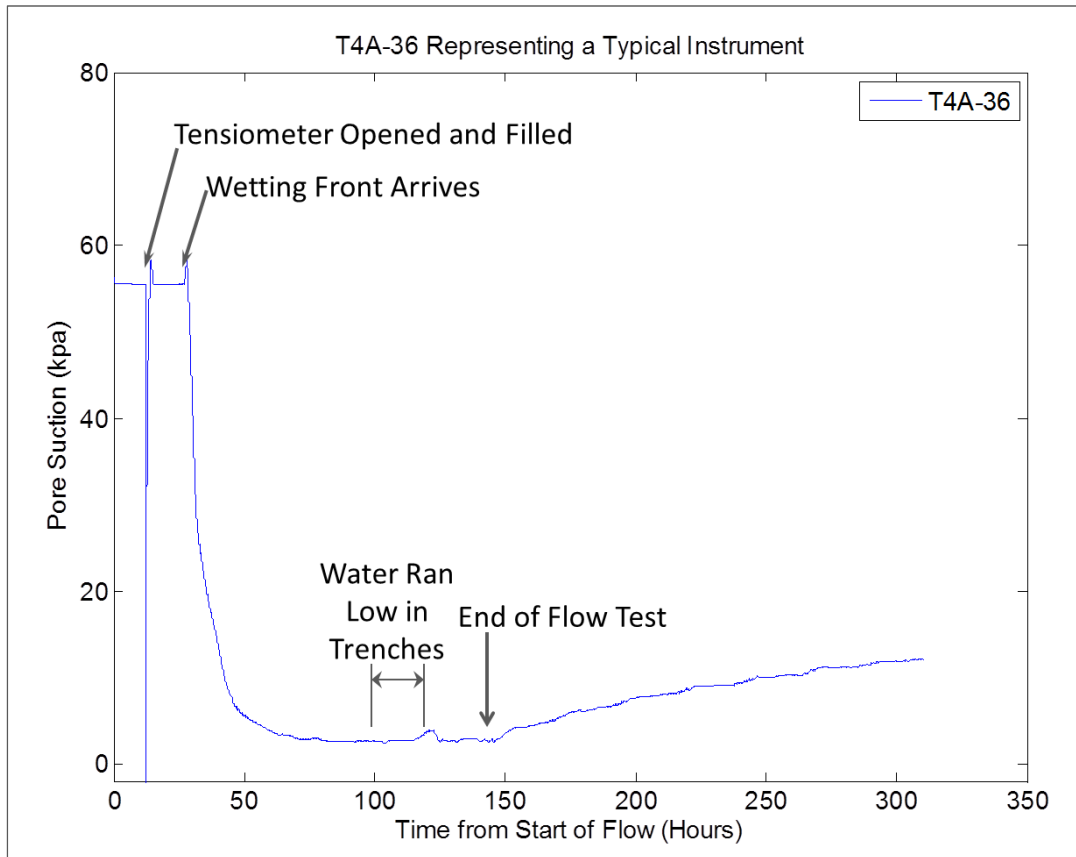
Figure 2D- 8. A typical tensiometer result for the flow test the drying period that followed.

Figure 2D- 8 shows a typical profile of suction with time during the flow test and the days following the test as the soil began to dry out. The plot shows the drop in tension that is expected when the instrument is opened and filled, the drop in tension associated with the arrival of the wetting front, the slight rise in soil suction when water ran low in the trenches, and the re-establishment of matric suction in the soils as drying began following the flow test.

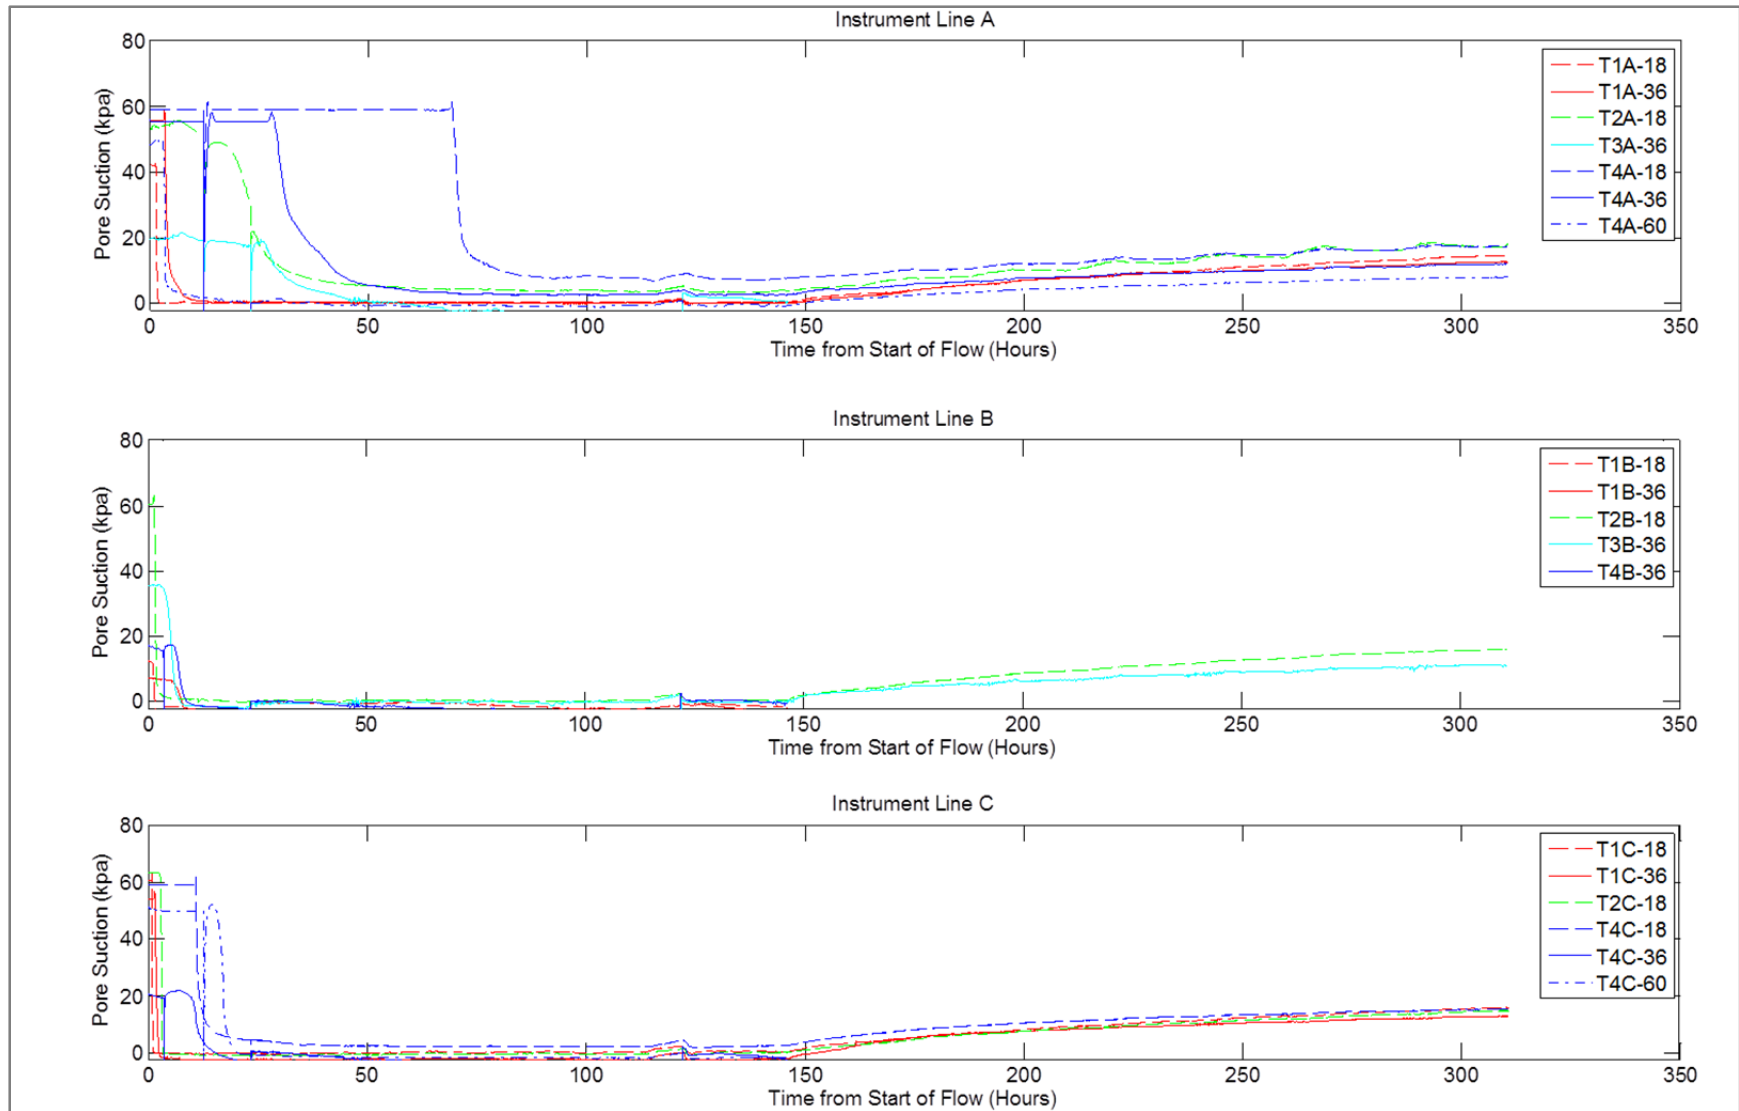
Figure 2D- 9. Tensiometer data for instrument lines A, B, and C for the duration of the flow test (146.25 hours or 6 days) and the falling head and drying phase that followed.

Figure 2D- 9 provides a summary of all instrument data gathered during the flow test. Similar patterns to those of Figure 2D- 8 are seen with each instrument, however the arrival of the wetting front and the rate of decrease in suction values varies from almost immediately arriving to arriving after a period of nearly 3 days. Table E-1 provides a summary of wetting front and saturation front arrivals as well as steady state suction values for tensiometers. Table E-2 provides a summary of the saturation front arrival and buildup of pore pressures for piezometers. A discussion of instrument results in the context of the flow test observations is provided in Section 3.6.4.

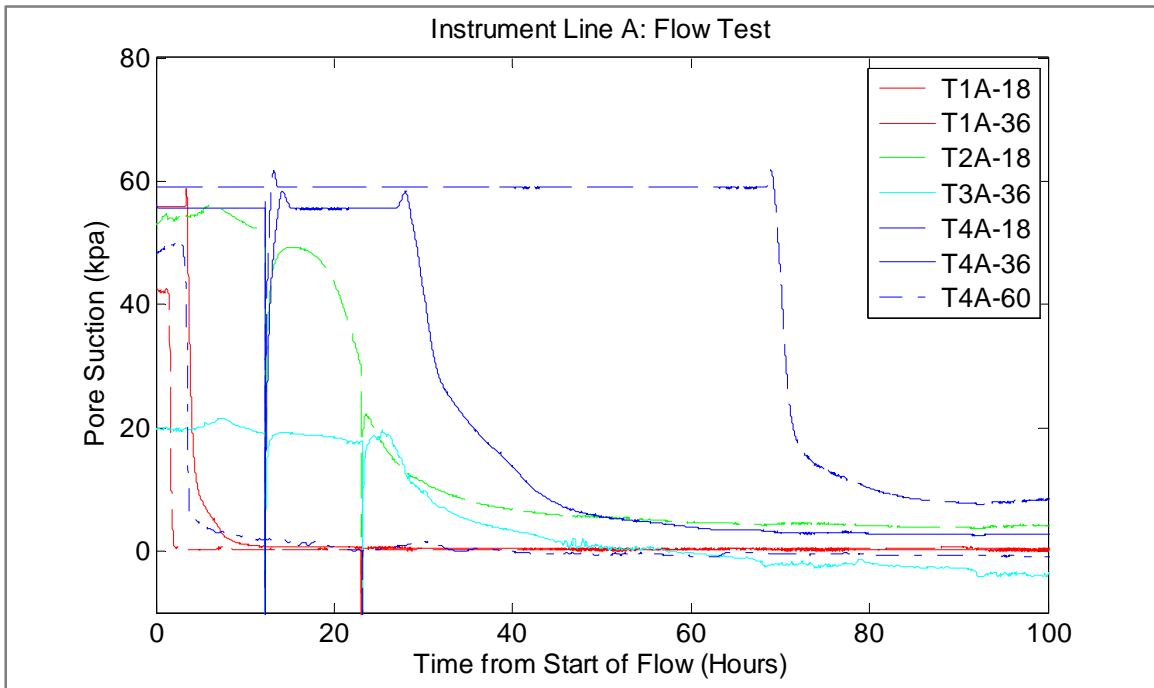
Figure 2D- 10. Summary of Tensiometer Data for Instrument Line A

Tensiometer data during the first 4 days of the flow test are provided by instrument line as Figure 2D- 10 through Figure 2D- 12. Tensiometer data are then displaced for like instruments across all three instrument lines with results presented on Figure 2D- 13 through Figure 2D- 19.

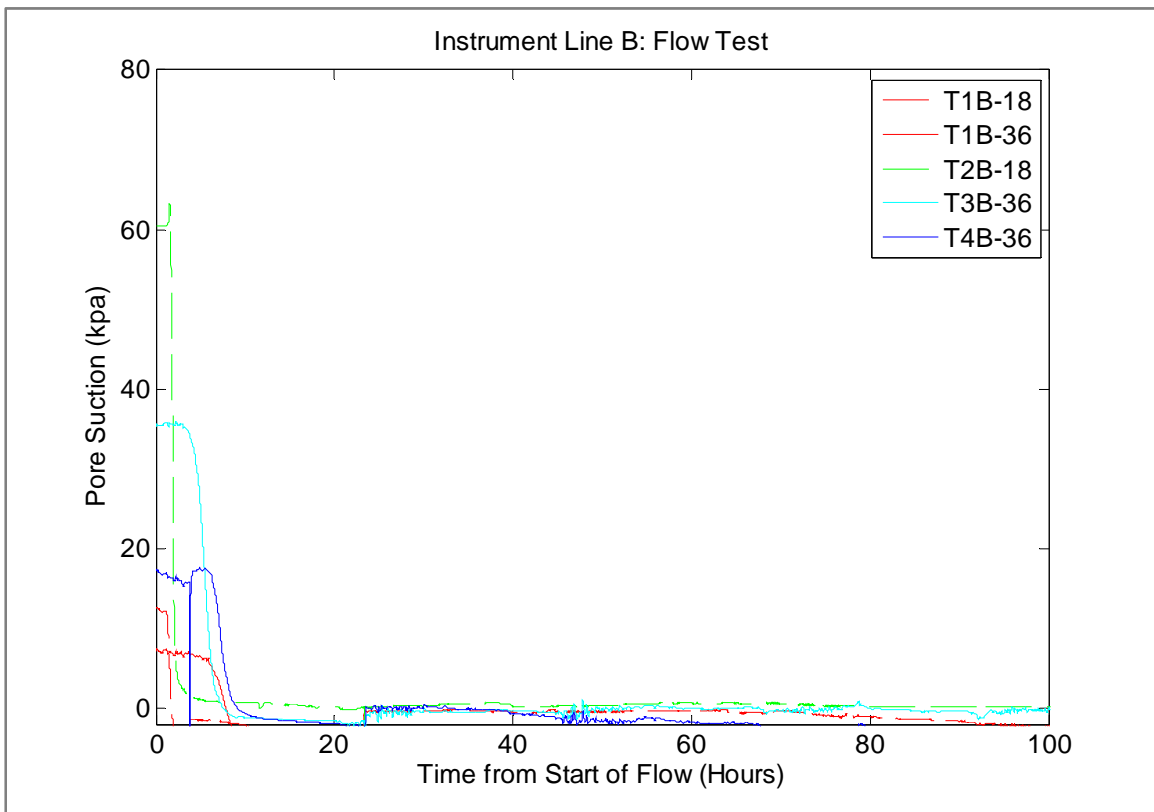
Figure 2D- 11. Summary of Tensiometer Data for Instrument Line B

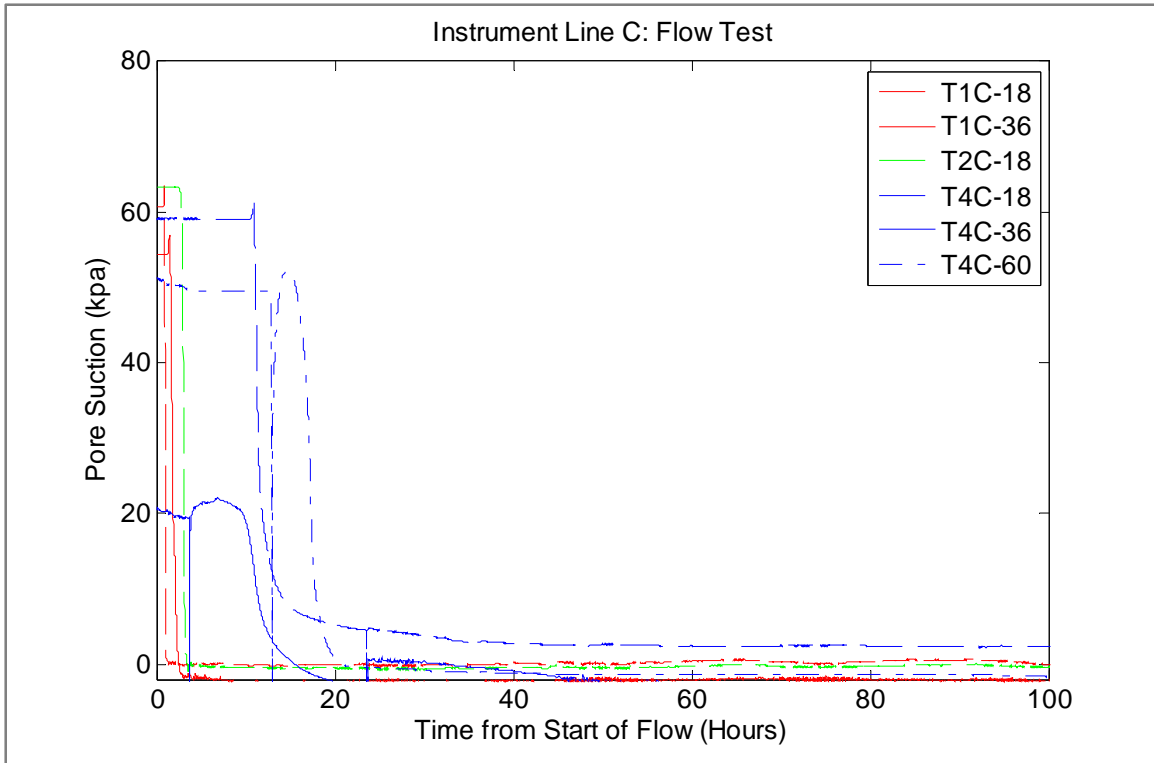
Figure 2D- 12. Summary of Tensiometer Data for Instrument Line C

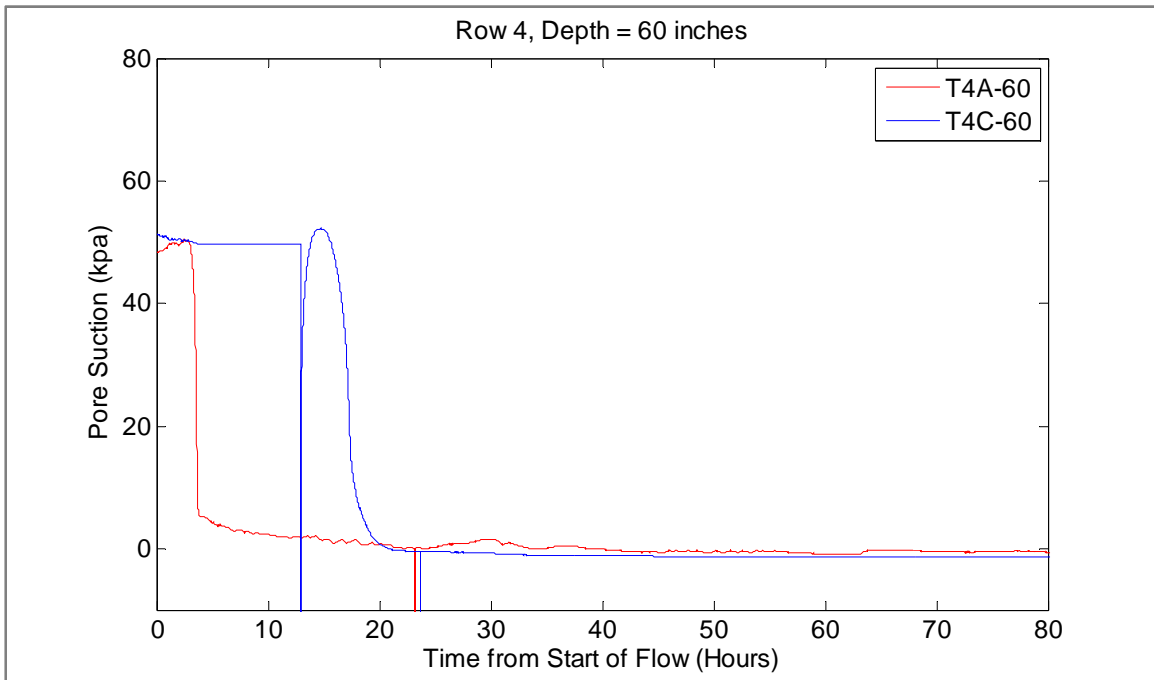
Figure 2D- 13. Comparison of Row 4 (below the stump) Lines A and C at 60 inch depth. Note the early saturation of the 60 inch tensiometer at Line A likely due to saturation flowing down from lower trench which was filling with water from the mammal burrow at Line B.

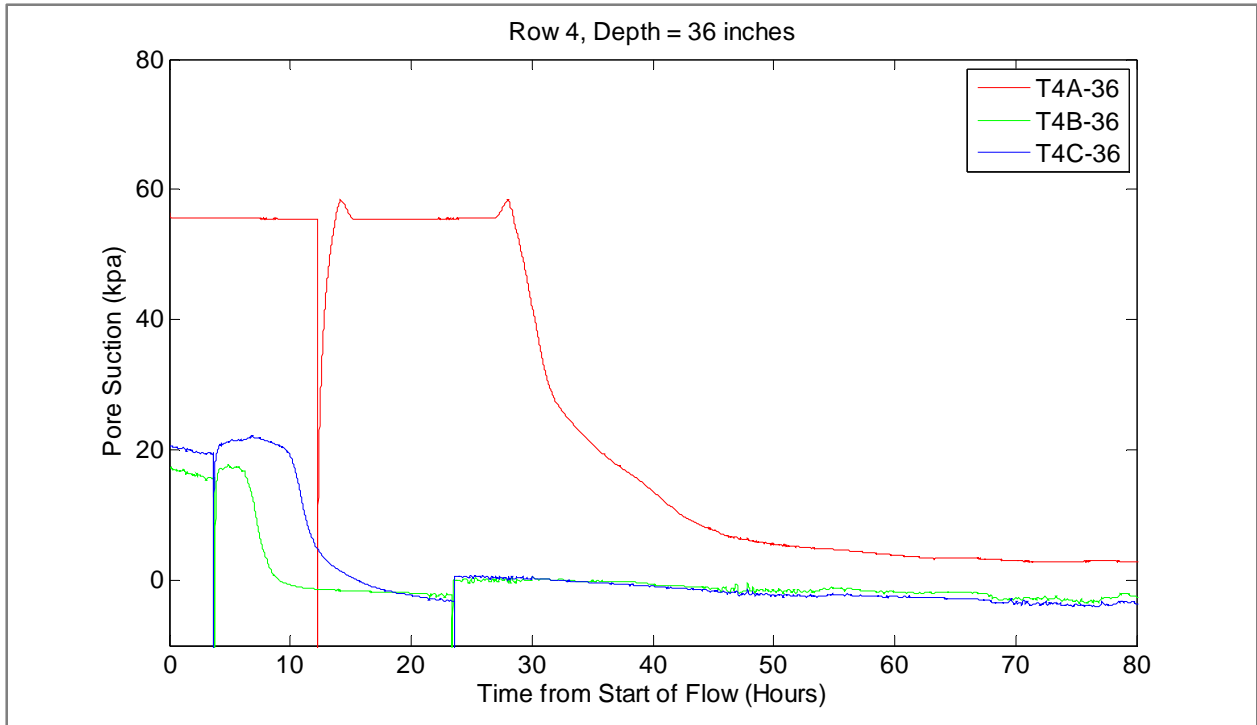
Figure 2D- 14. Comparison of Row 4 (below the stump) Lines A, B and C at 36 inch depth. Note that tensiometer T4A-36, below the stump, is the last to saturate-
