Static and Seismic Performance of California Levees

Michelle Jennifer Shriro

Doctor of Philosophy

Engineering - Civil and Environmental Engineering

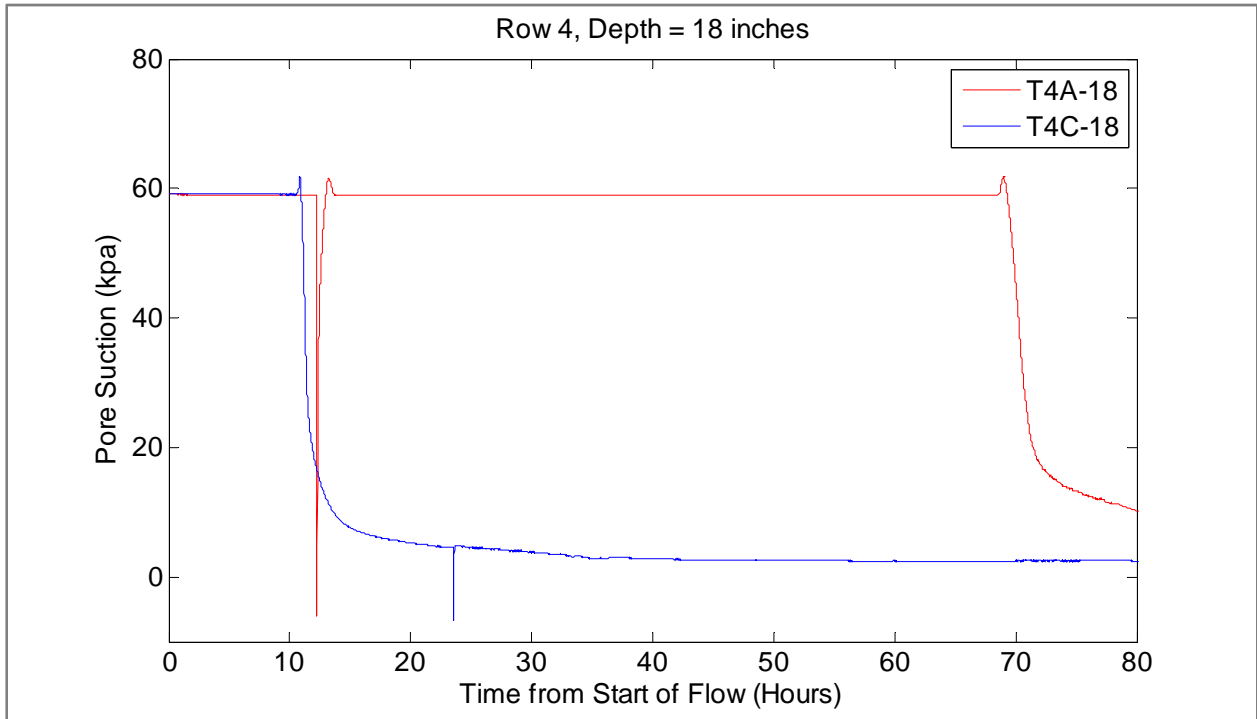
Figure 2D- 15. Comparison of Row 4 (below the stump) Lines A, B and C at 18 inch depth. Note that tensiometer T4A-18, below the stump, is the last to saturate-

Tensiometer data during the first 4 days of the flow test are provided by instrument line as Figure 2D- 10 through Figure 2D- 12. Tensiometer data are then displaced for like instruments across all three instrument lines with results presented on Figure 2D- 13 through Figure 2D- 19.

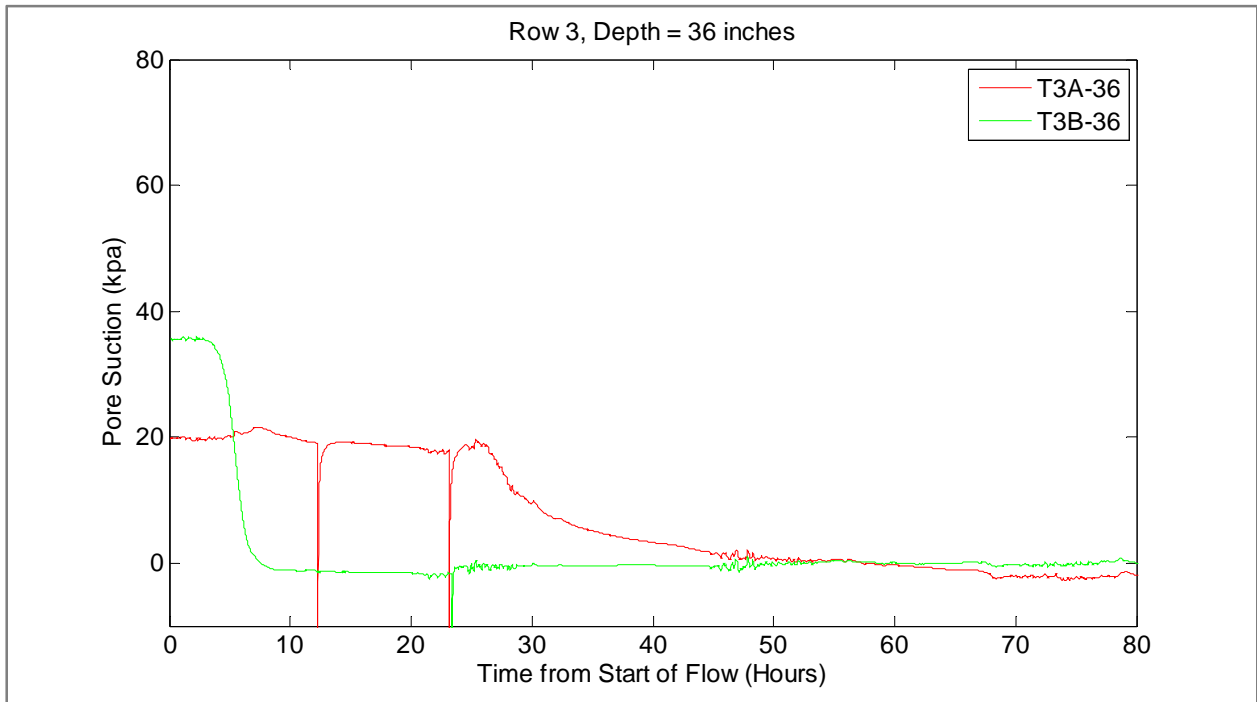
Figure 2D- 16. Comparison of Row 3 at Instrument Lines A and B at a depth of 36 inches. The analogous instrument at Line C was found to be non-functional during the test.

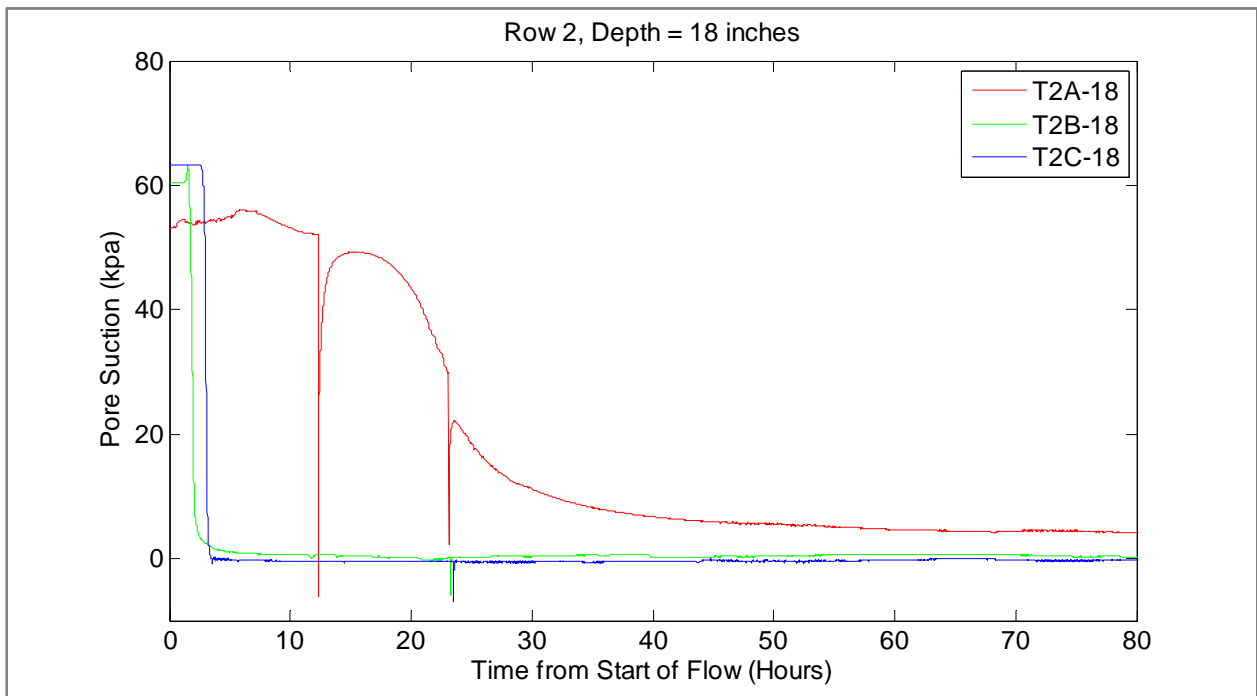
Figure 2D- 17. Comparison of Row 2 at Instrument Lines A, B and C at a depth of 18 inches. Note that instrument lines B and C saturate before Line A at the stump.

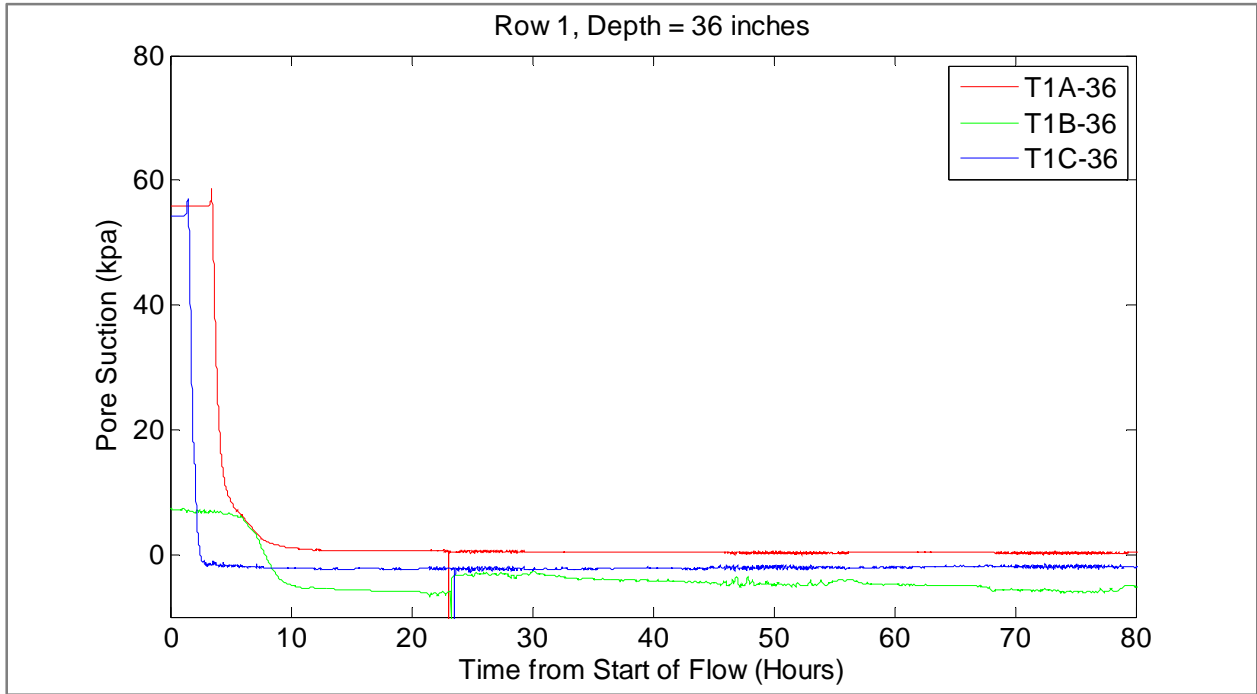
Figure 2D- 18. Comparison of Row 1 at Instrument Lines A, B and C at a depth of 36 inches

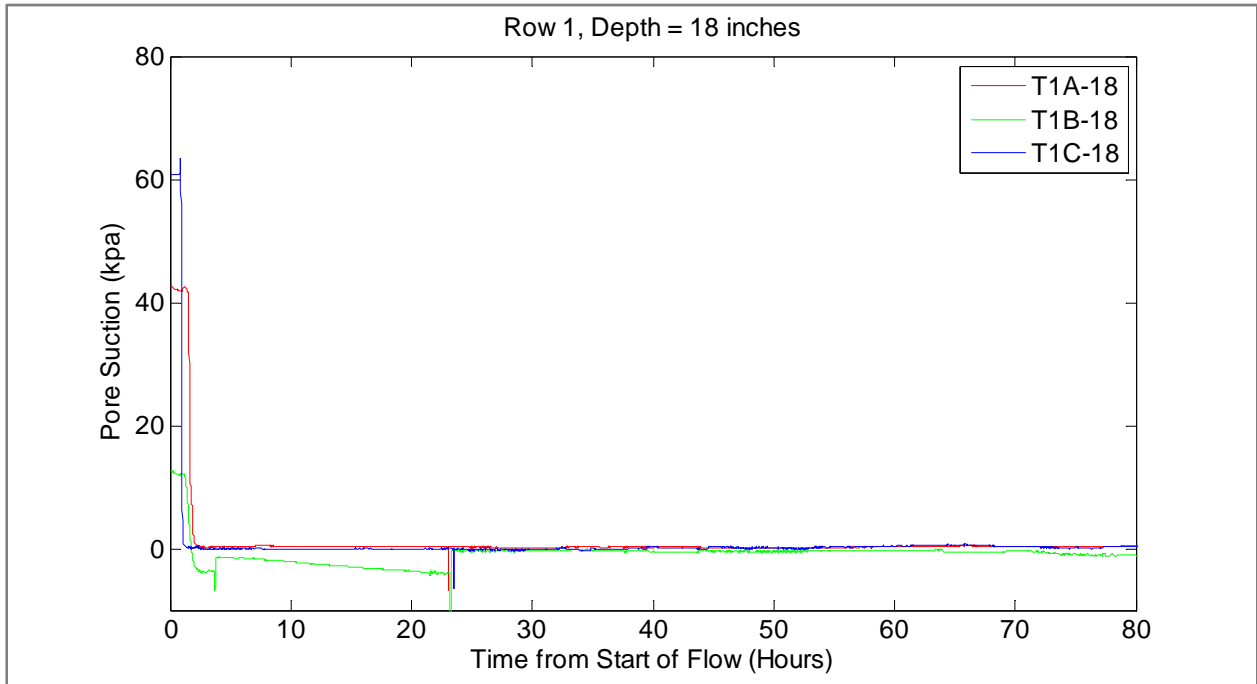
Figure 2D- 19. Comparison of Row 1 at Instrument Lines A, B, and C at a depth of 18 inches

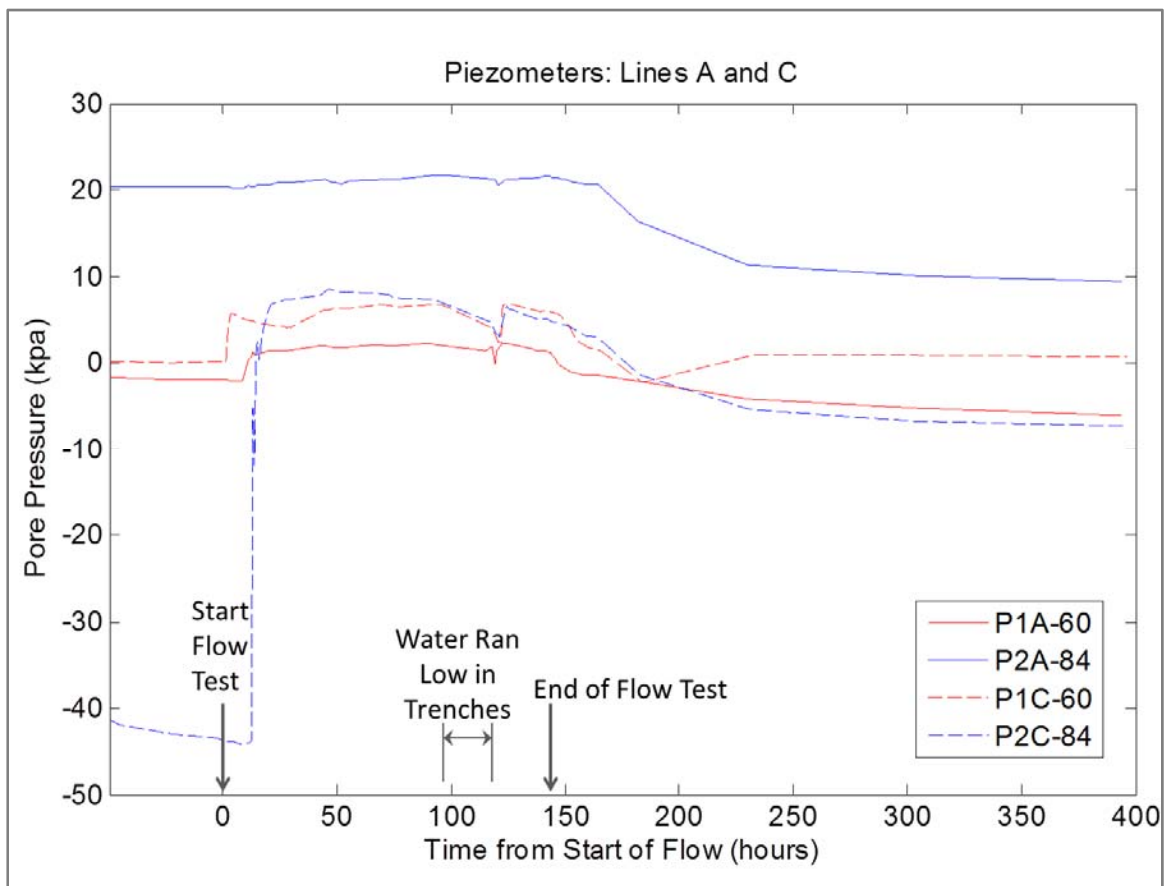
Vibrating wire piezometers were pre-saturated and were grouted into place upside down to prevent desaturation of the porous stone in accordance with the recommendations of the manufacturer, onsite consultation with Eric Mikkelsen, and available literature (Mikkelsen 2002; Mikkelsen and Green, 2003; McKenna, 1995; Vaughan, 1969; Contreras et al. 2008). Piezometers were not read continuously, but at regular intervals with a Model GK-403 vibrating wire piezometer readout box. Frequency of readings was determined based on the observed rates of change in recorded pore pressures. Figure E-11 provides a summary of recorded piezometer data at instrument lines A and C. Data results are discussed in Section 3.6.4 of the report and instrument installation is detailed in Section 3.5.3.

Figure 2D- 20. Pore pressures as measured during flow test through Instrument Lines A and C

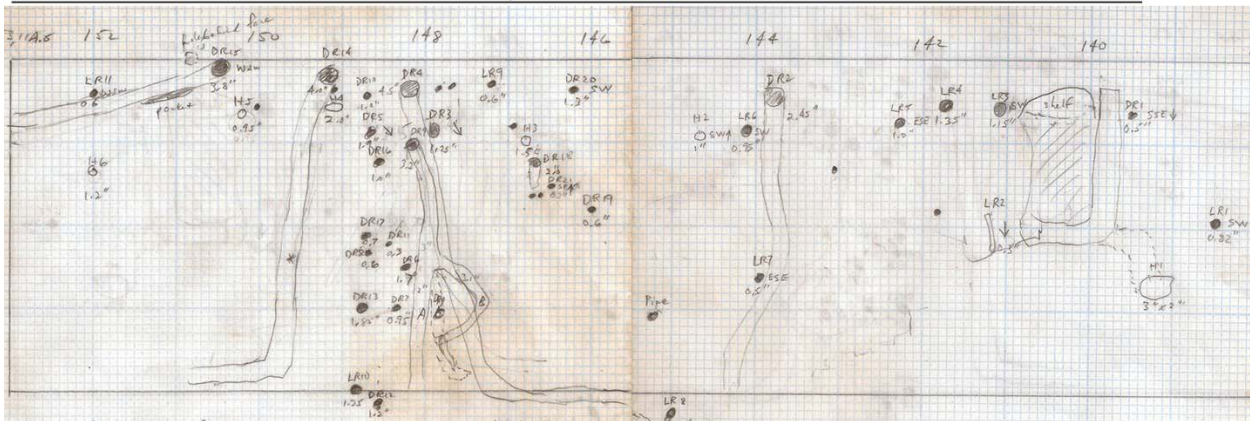
Figure 2E- 2. Log of wall face of Slice 1 (see Section 3.7.1). Logged by John Lichter of Tree Associates and Richard Evans of UC Davis

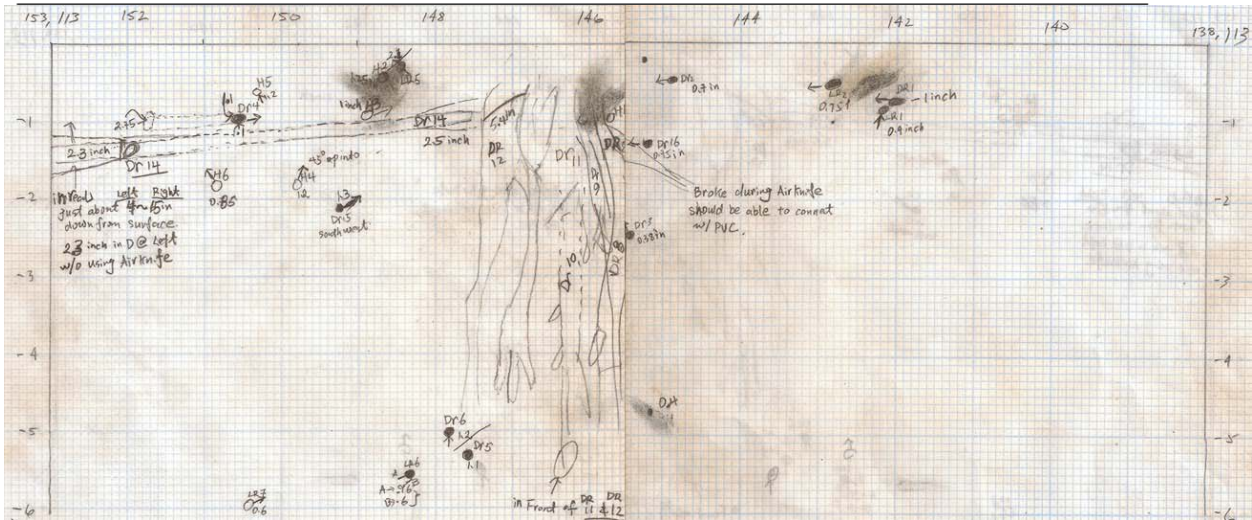
Figure 2E- 3. Log of wall face of Slice 2 (see Section 3.7.1). Logged by John Lichter of Tree Associates and Richard Evans of UC Davis.

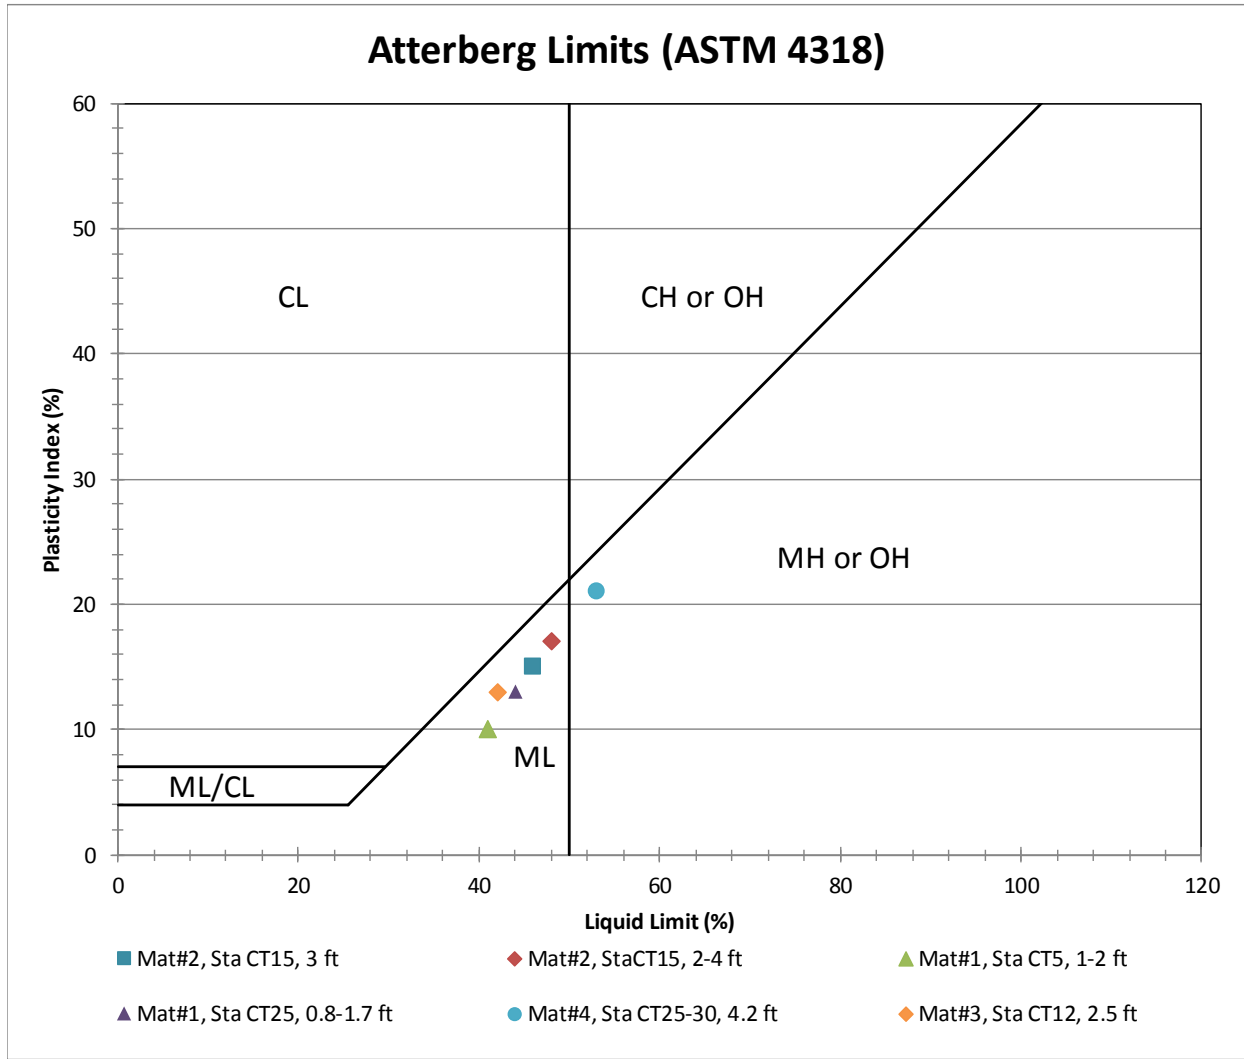
Figure 3B- 1. Atterberg limits (ASTM 4318) test results for commonly occurring onsite materials

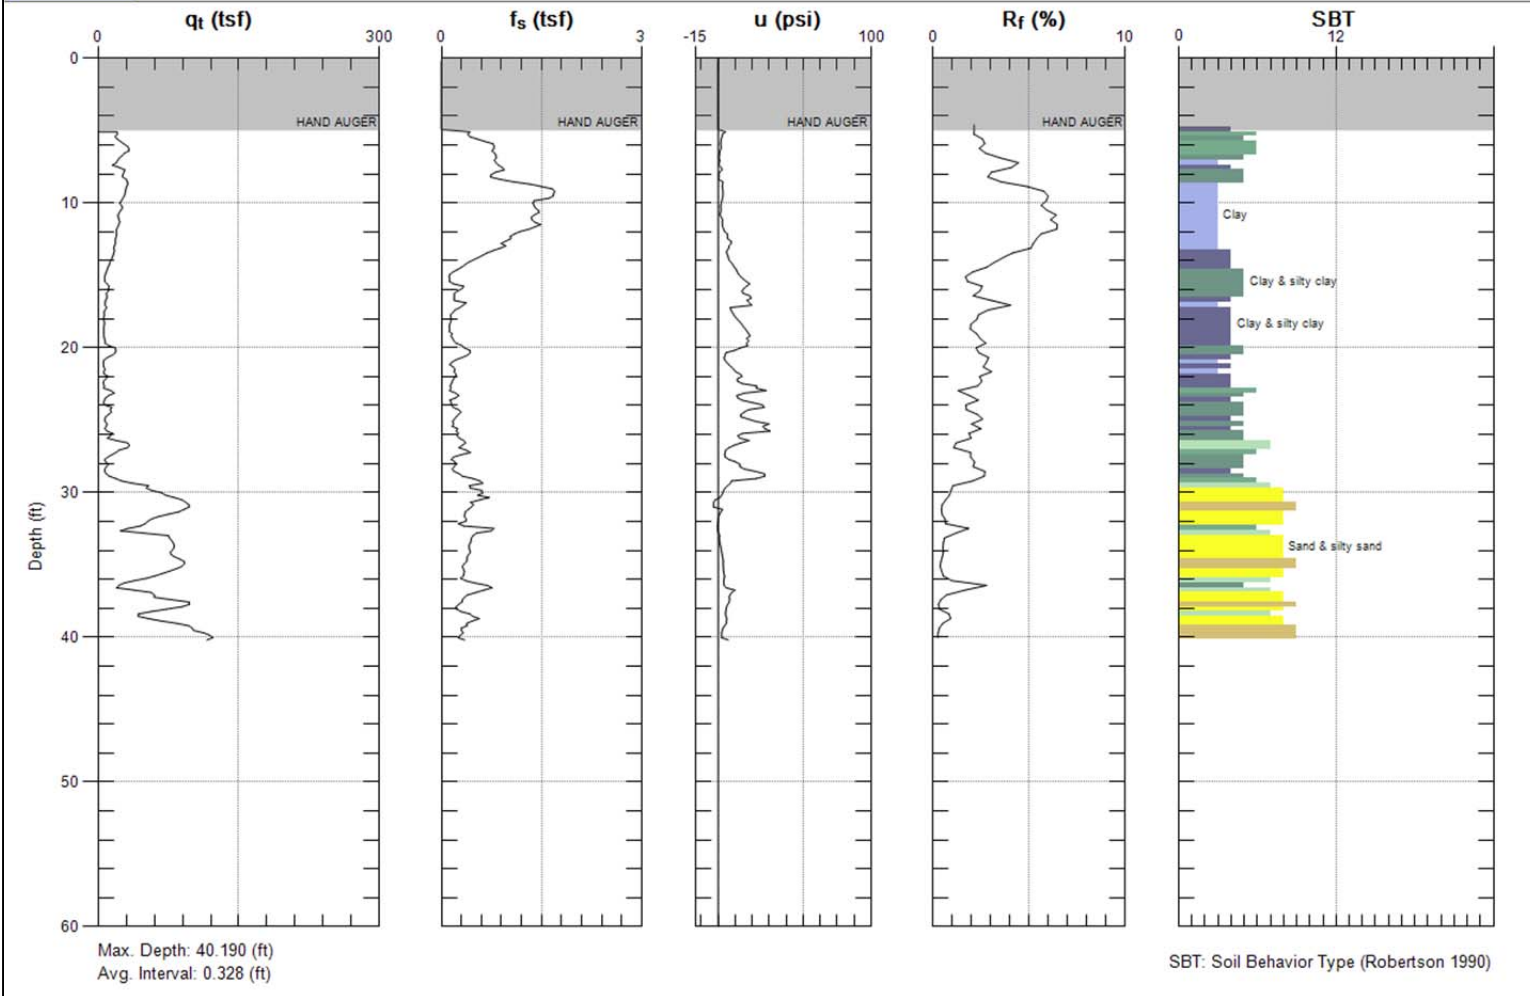
3C-8

Figure 3C- 7. Cone Penetration Test Log at CPT location C3 at the waterside of the access road at instrument line C. Sheet 2 of 2.

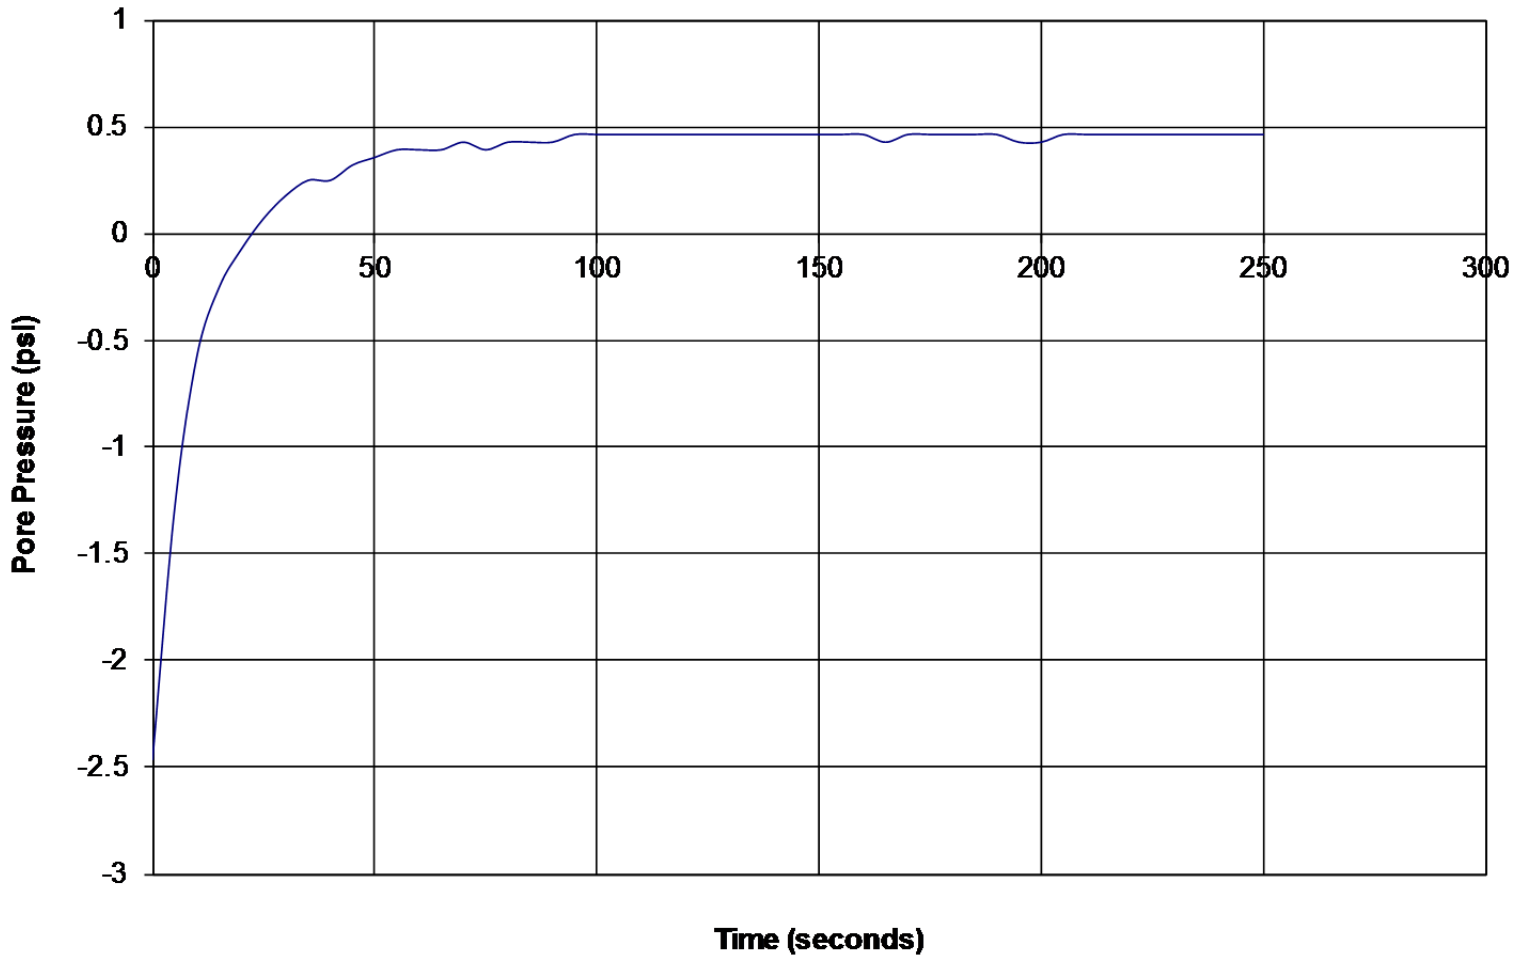
3C-9

Figure 3C- 8. Pore pressure dissipation test at CPT location C1 at instrument line A, depth = 25ft

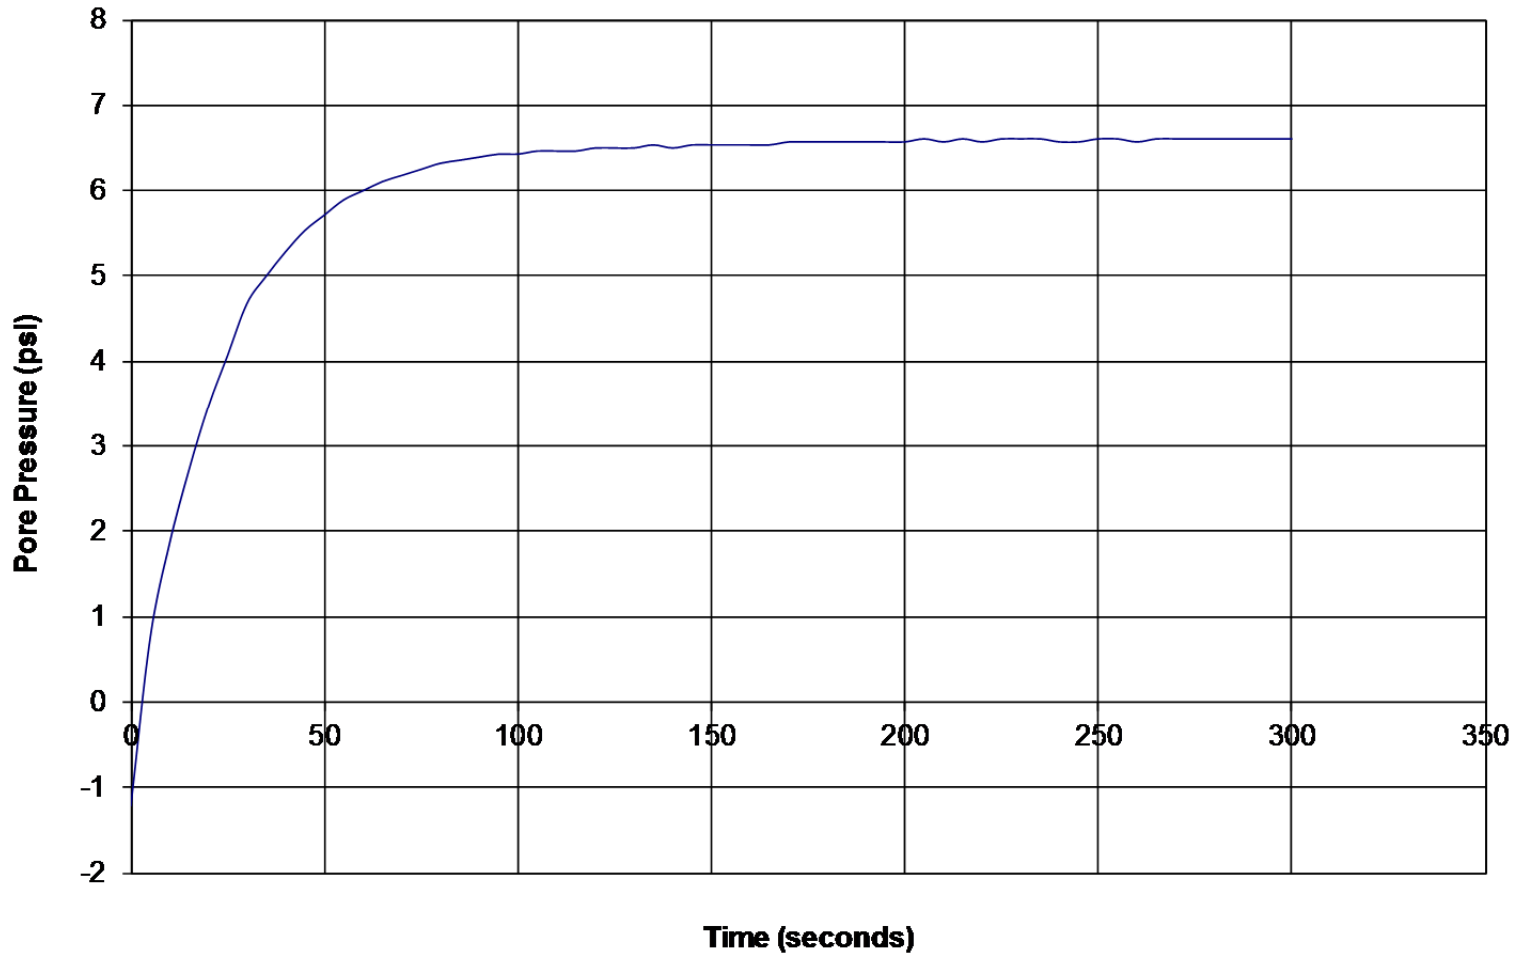
3C-10

Figure 3C- 9. Pore pressure dissipation test at CPT location C1 at instrument line A, depth = 40ft

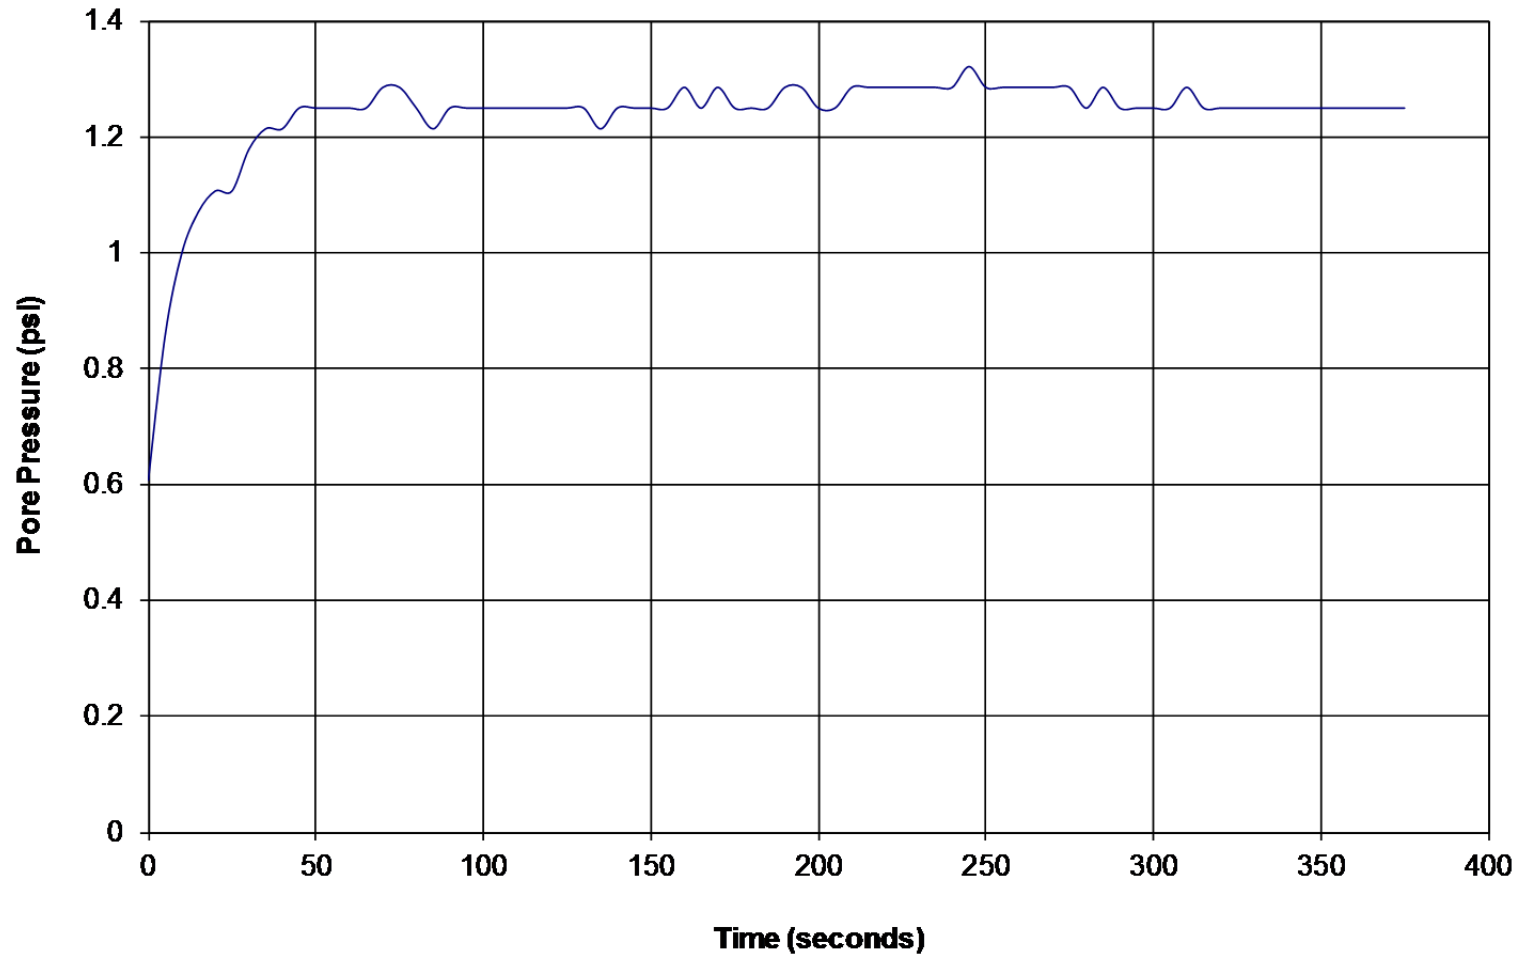
3C-11

Figure 3C- 10. Pore pressure dissipation test at CPT location C2 at instrument line B, depth = 24ft

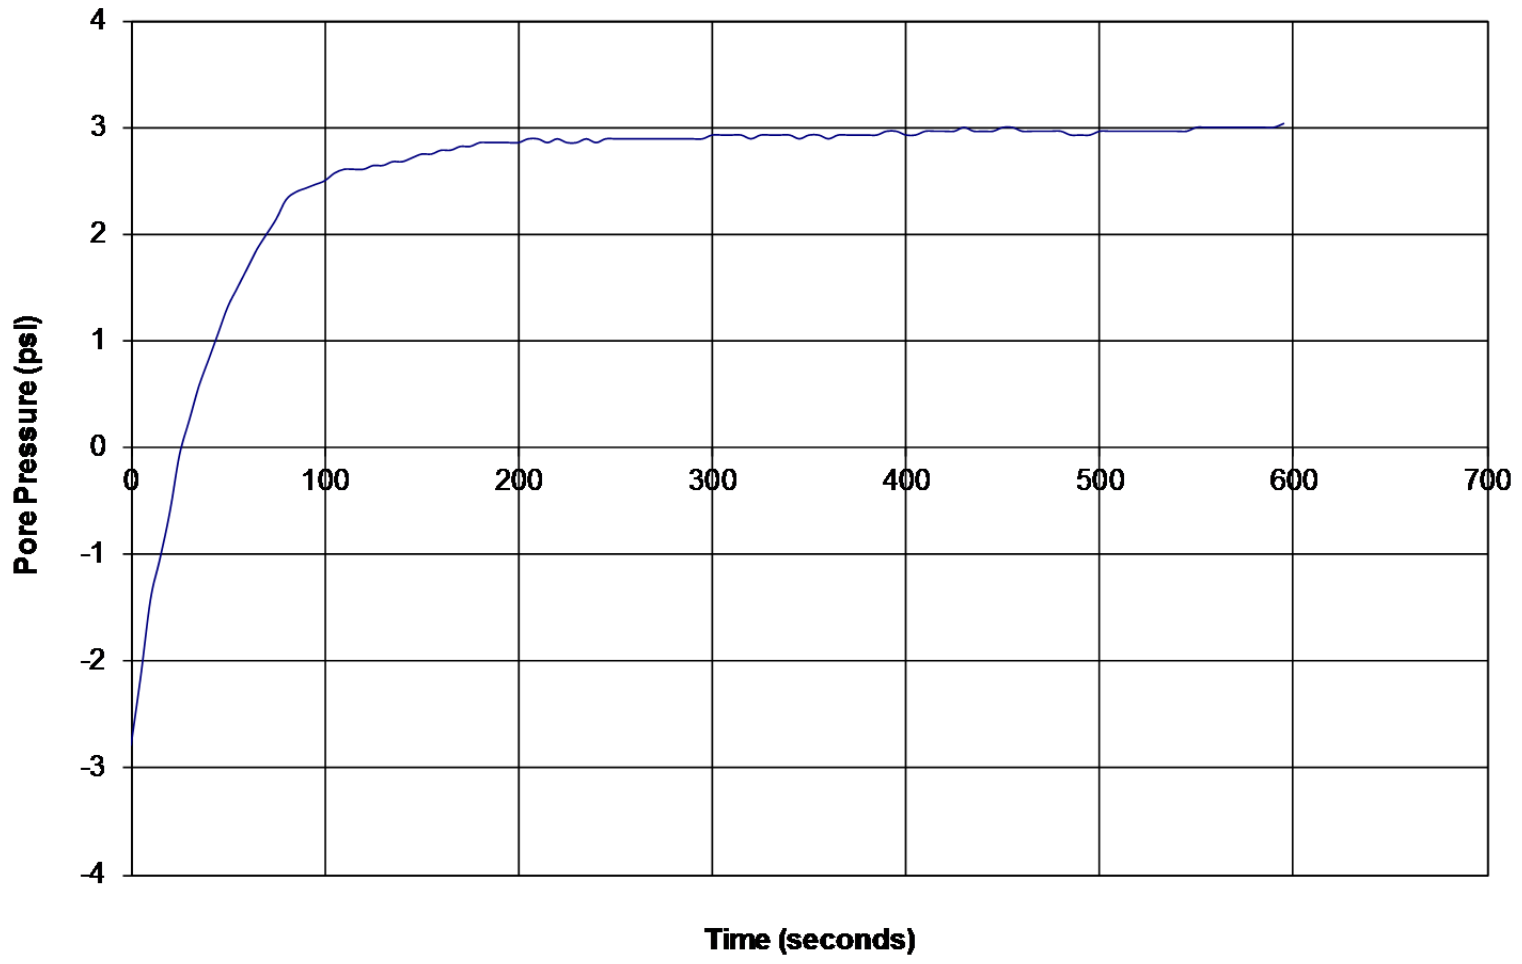
3C-12

Figure 3C- 11. Pore pressure dissipation test at CPT location C2 at instrument line B, depth = 31ft

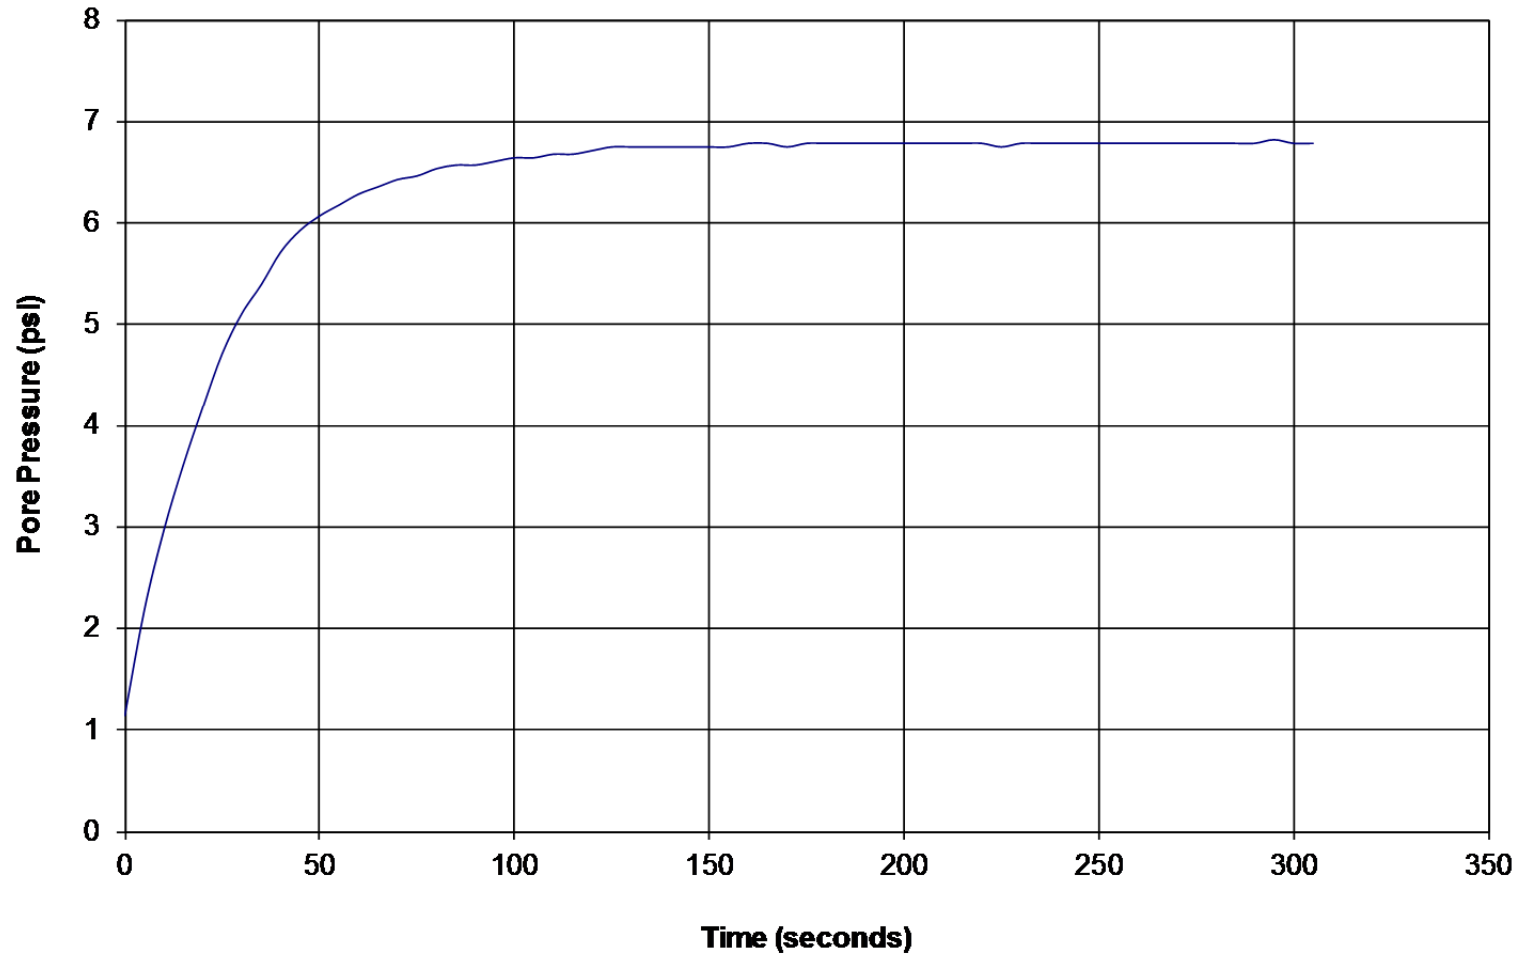
3C-13

Figure 3C- 12. Pore pressure dissipation test at CPT location C2 at instrument line B, depth = 40ft

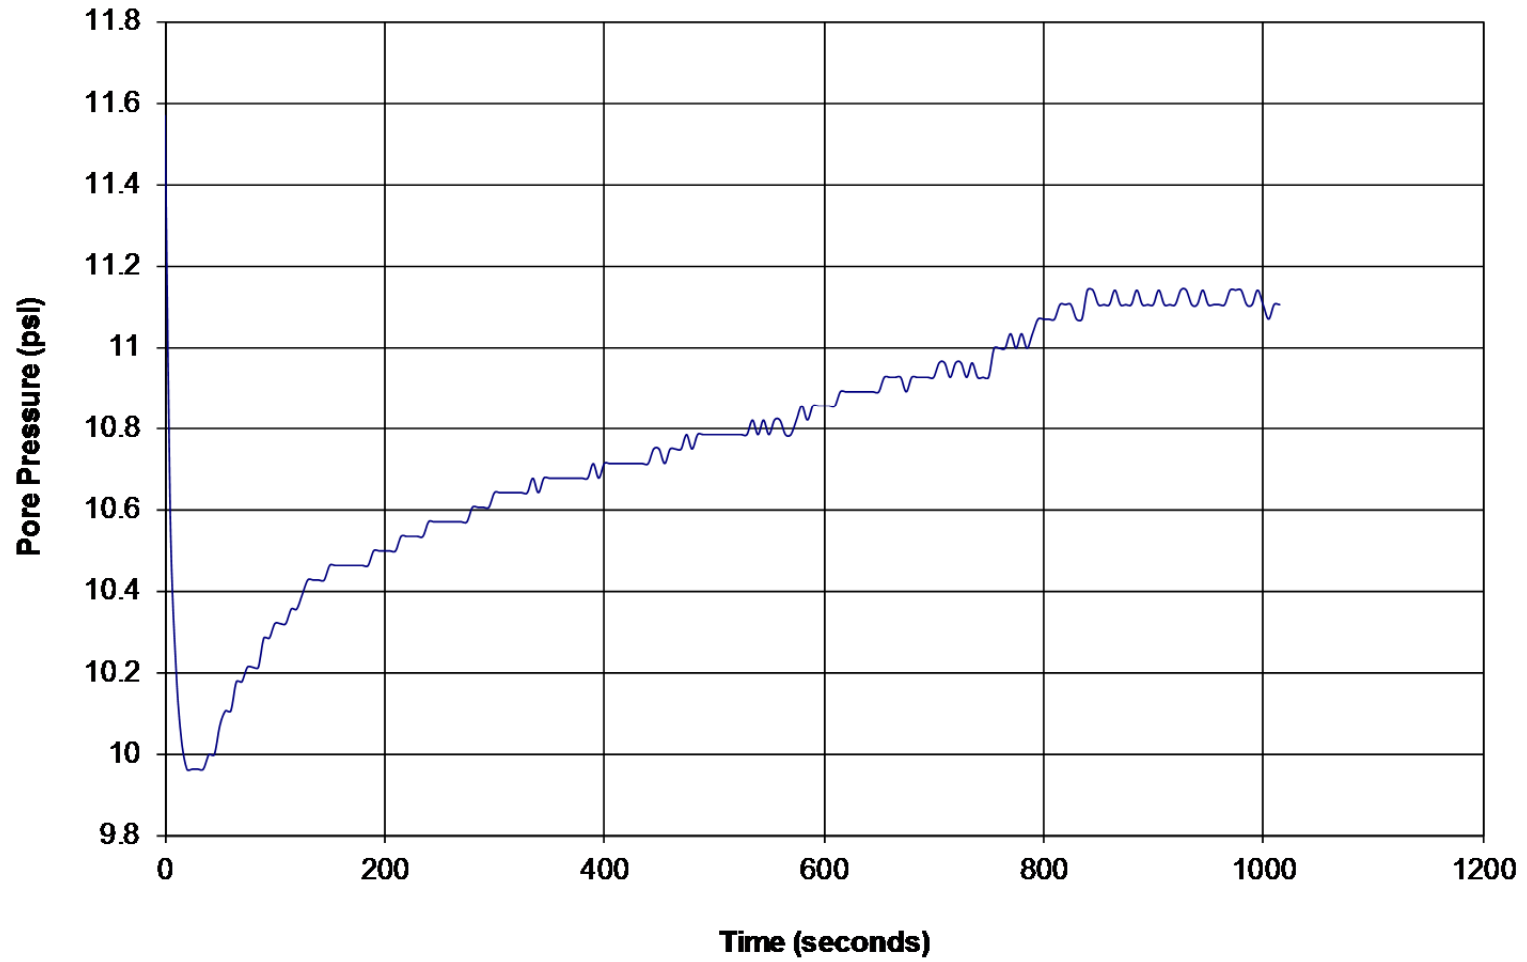
3C-14

Figure 3C- 13. Pore pressure dissipation test at CPT location C2 at instrument line B, depth = 49ft

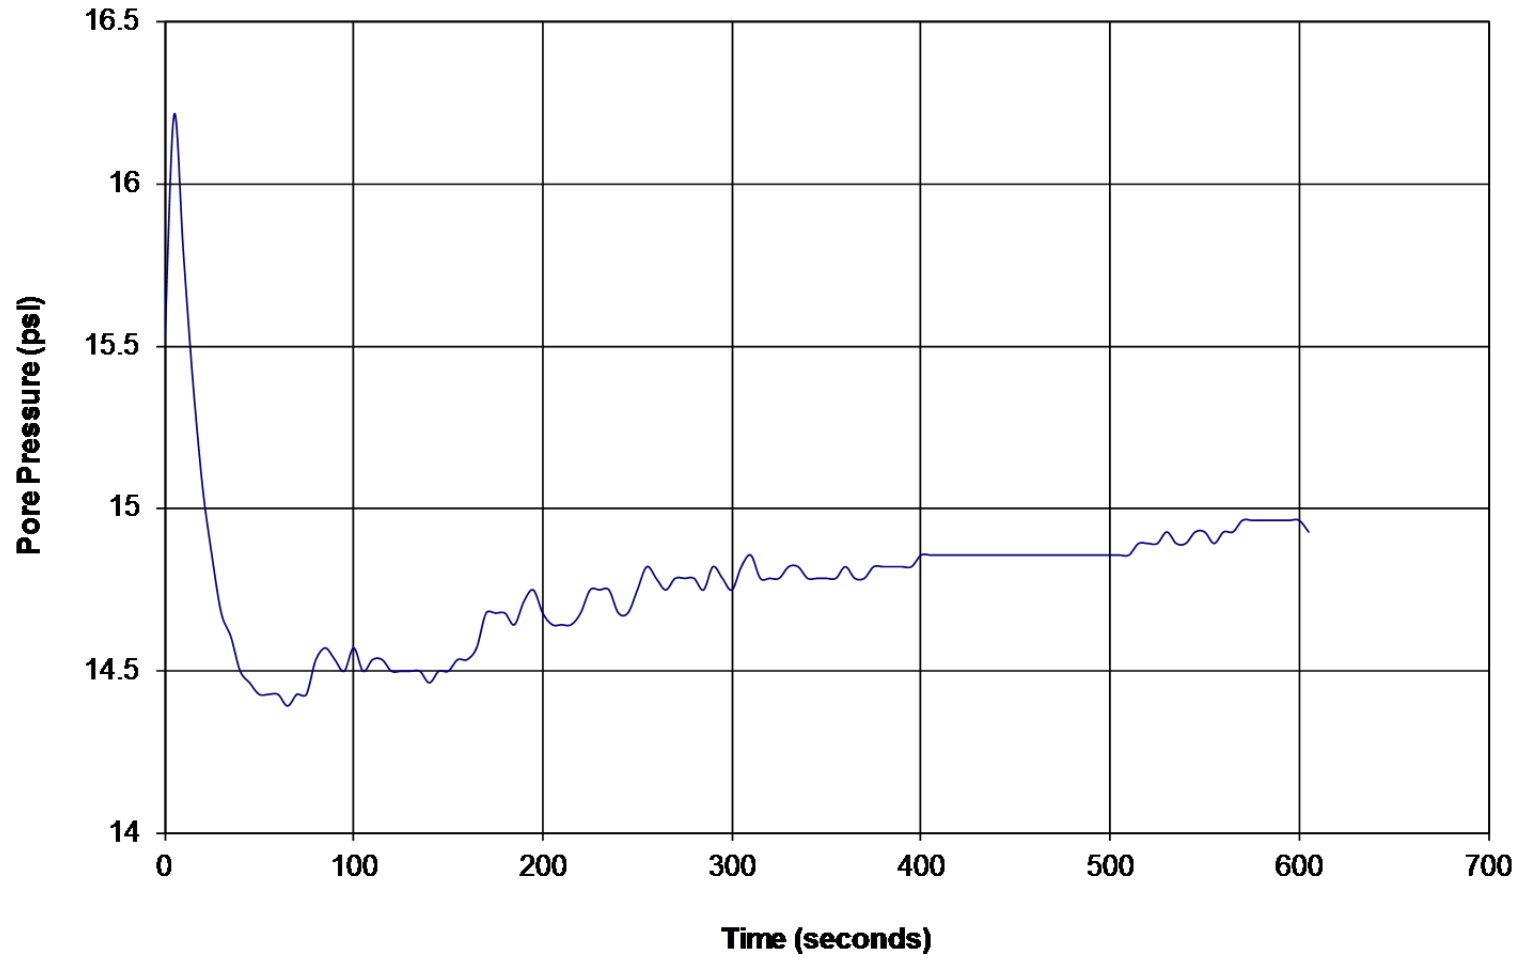
3C-15

Figure 3C- 14. Pore pressure dissipation test at CPT location C2 at instrument line B, depth = 59ft

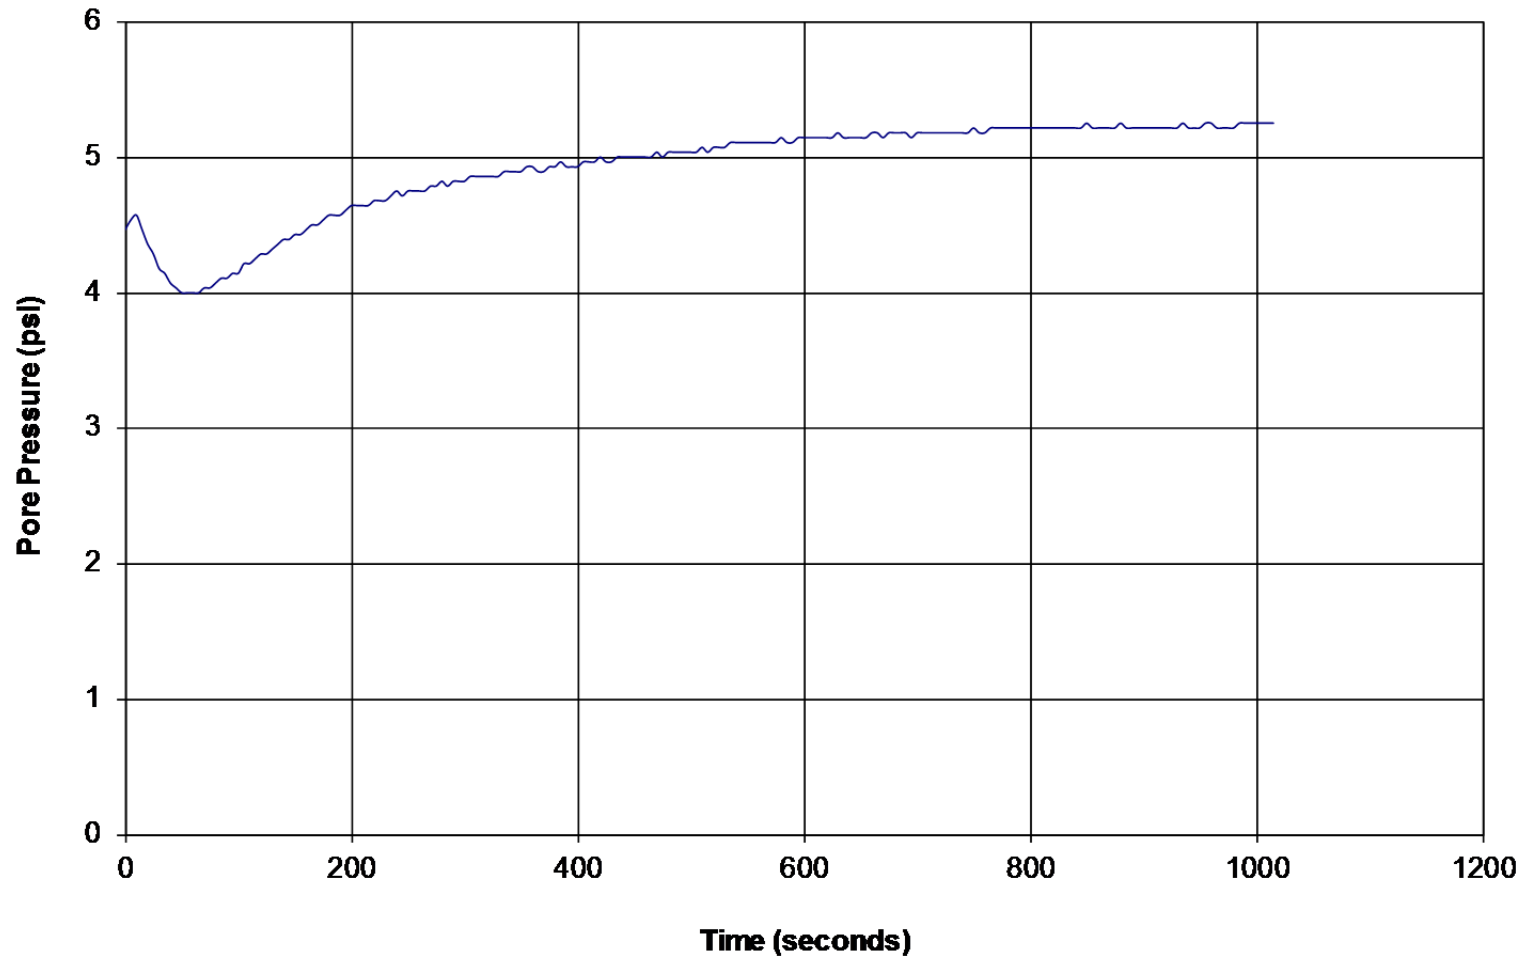
Figure 3C- 15. Pore pressure dissipation test at CPT location C3 at instrument line C, depth = 27ft
