Static and Seismic Performance of California Levees

Michelle Jennifer Shriro

Doctor of Philosophy

Engineering - Civil and Environmental Engineering

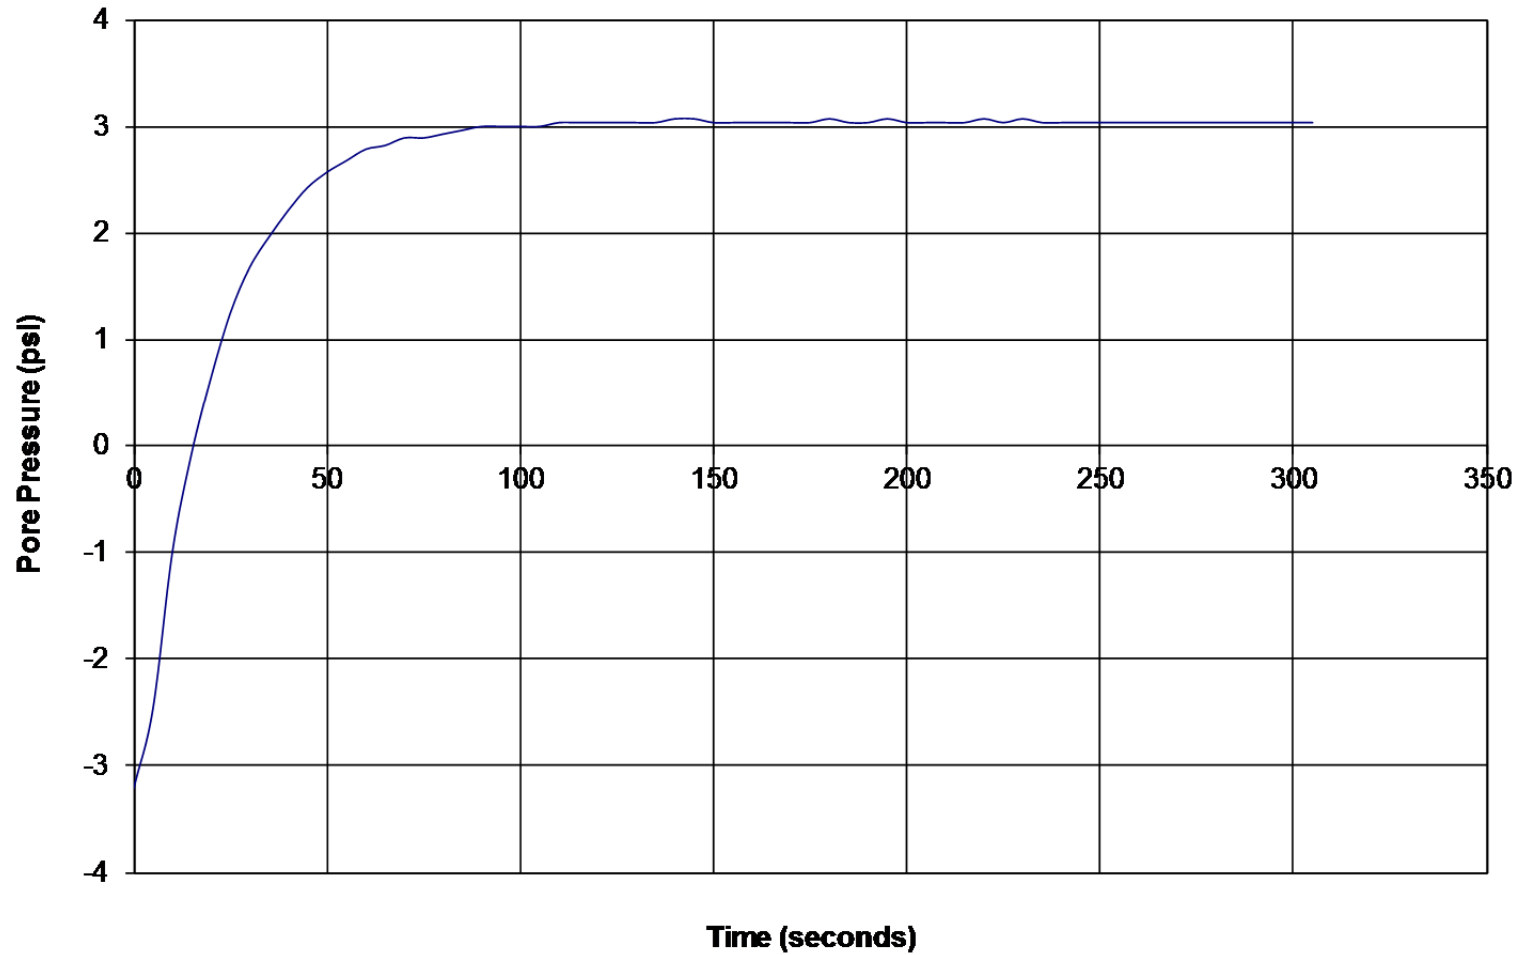
3C-17

Figure 3C- 16. Pore pressure dissipation test at CPT location C3 at instrument line C, depth = 31ft

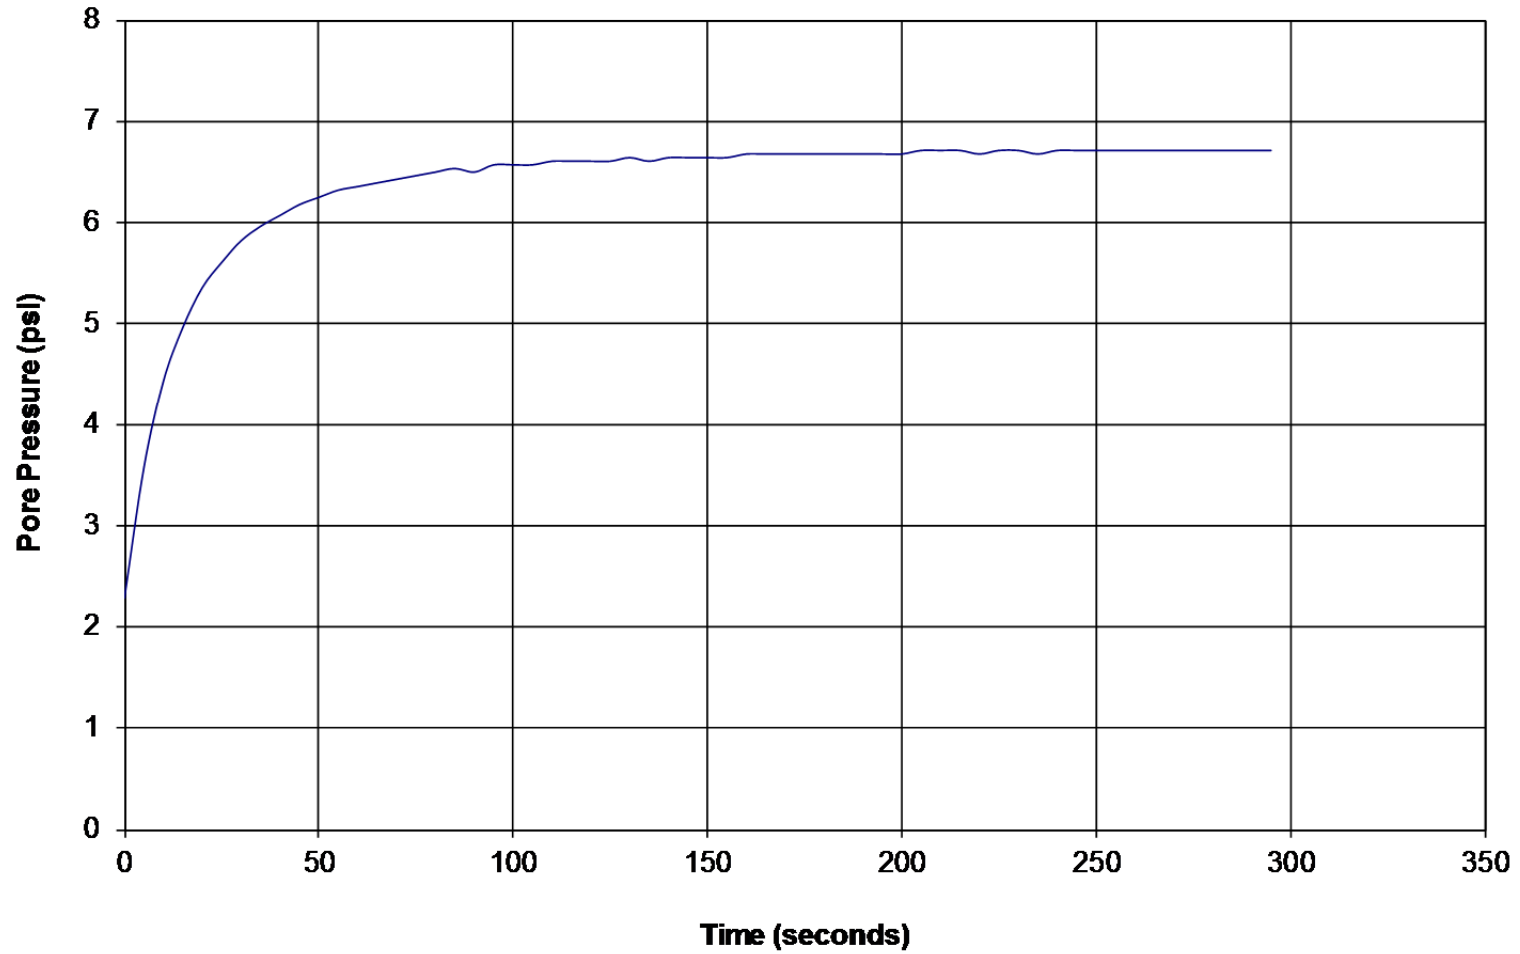
3C-18

Figure 3C- 17. Pore pressure dissipation test at CPT location C3 at instrument line C, depth = 40ft

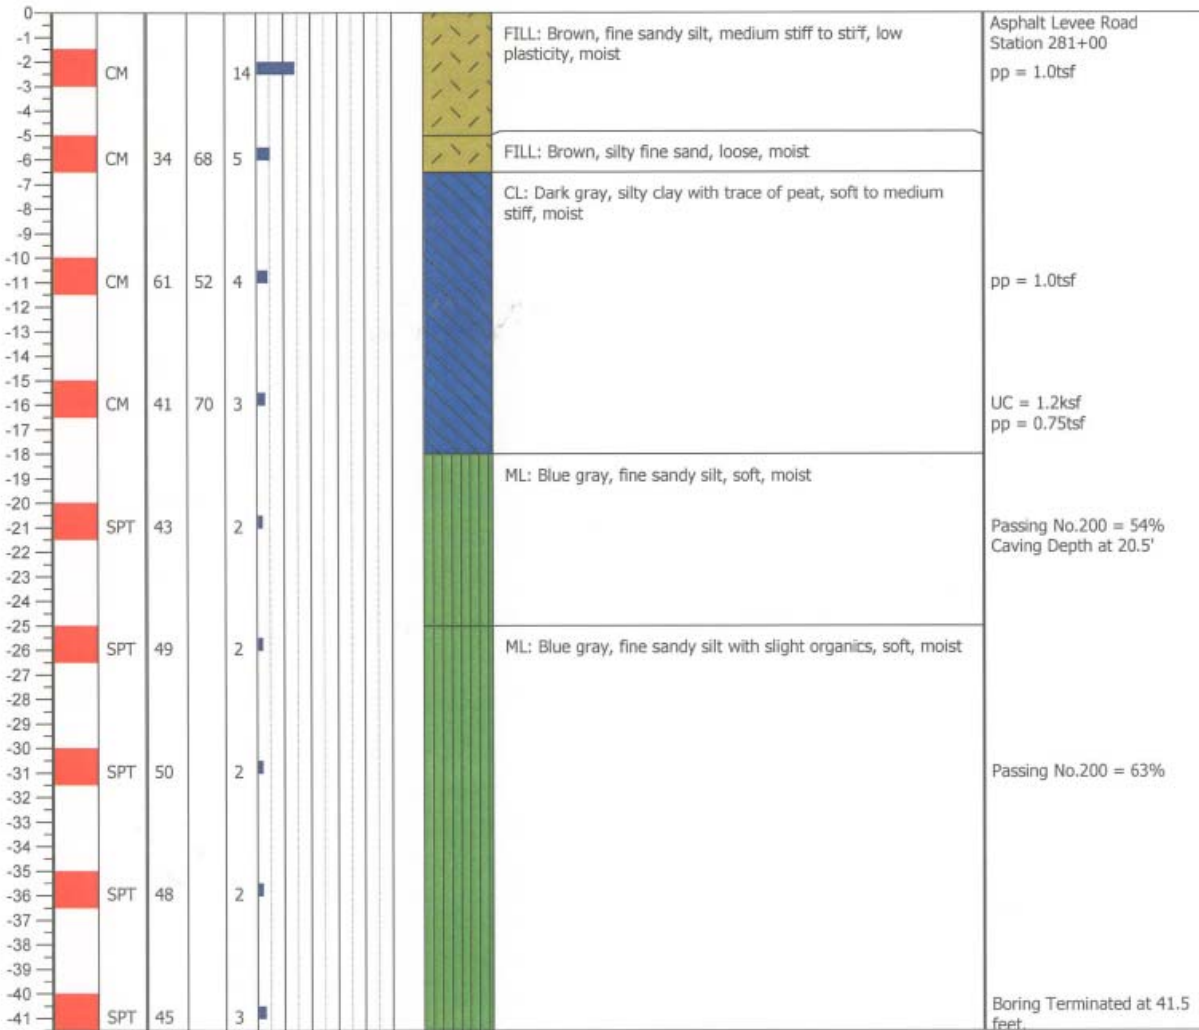
<b>Neil O. Anderson &amp; Assoc., Inc.</b> 902 Industrial Way, Lodi, CA 95240 (209)367-3701 Fax (209)333-8303		<h1>LOG OF TEST BORING</h1>		<b>BOREHOLE NUMBER</b> <h2>B6</h2>						
PROJECT NUMBER: <b>LFG-0229</b>		DATE DRILLED: <b>3-14-07</b>		GROUND SURFACE ELEVATION: <b>0.0</b> Feet						
PROJECT NAME: <b>Seven Mile Slough Site 1, 2, &amp; 3 Levee</b>		LOCATION: <b>Sacramento County, CA</b>		<b>PLATE NO. 7</b>						
DRILLING EQUIP.: <b>Mobile B53 Explorer Mud Rotary</b>										
Depth, ft.	Sample	Sampling Method	Moisture, %	Dry Density, pcf	Blow Counts	Blow Count Histogram	Ground Water	Soil Lithology	Soil Lithology Description	Notes

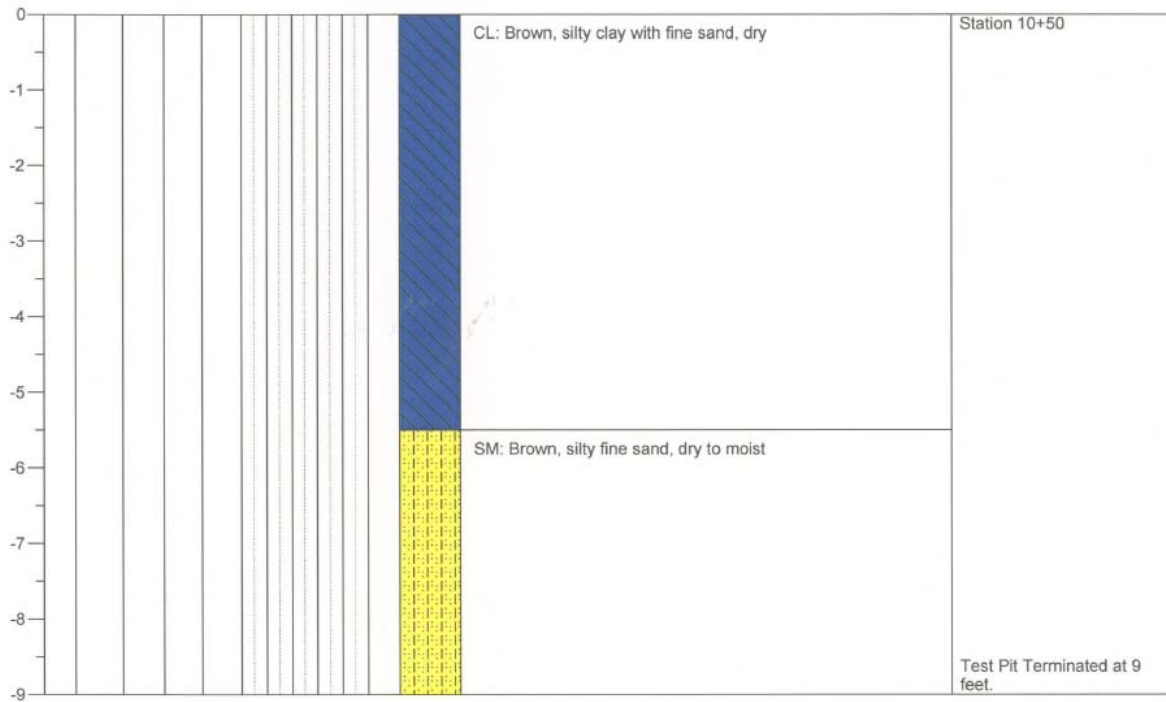
<b>Neil O. Anderson &amp; Assoc., Inc.</b> 902 Industrial Way, Lodi, CA 95240 (209)367-3701 Fax (209)333-8303		<b>LOG OF TEST PIT</b>		<b>TEST PIT NUMBER</b> <b>TP-3</b>						
PROJECT NUMBER: <b>LFG-0229</b>		DATE EXCAVATED: <b>8-8-07</b>								
PROJECT NAME: <b>Twitchell Island</b>		GROUND SURFACE ELEVATION: <b>0.0</b> Feet								
LOCATION: <b>Sacramento County, CA</b>		<b>PLATE NO. 4</b>								
DRILLING EQUIP.: <b>Case Backhoe with 30 inch Bucket</b>										
Depth, ft.	Sample	Sampling Method	Moisture, %	Dry Density, pcf	Blow Counts	Blow Count Histogram	Ground Water	Soil Lithology	Soil Lithology Description	Notes

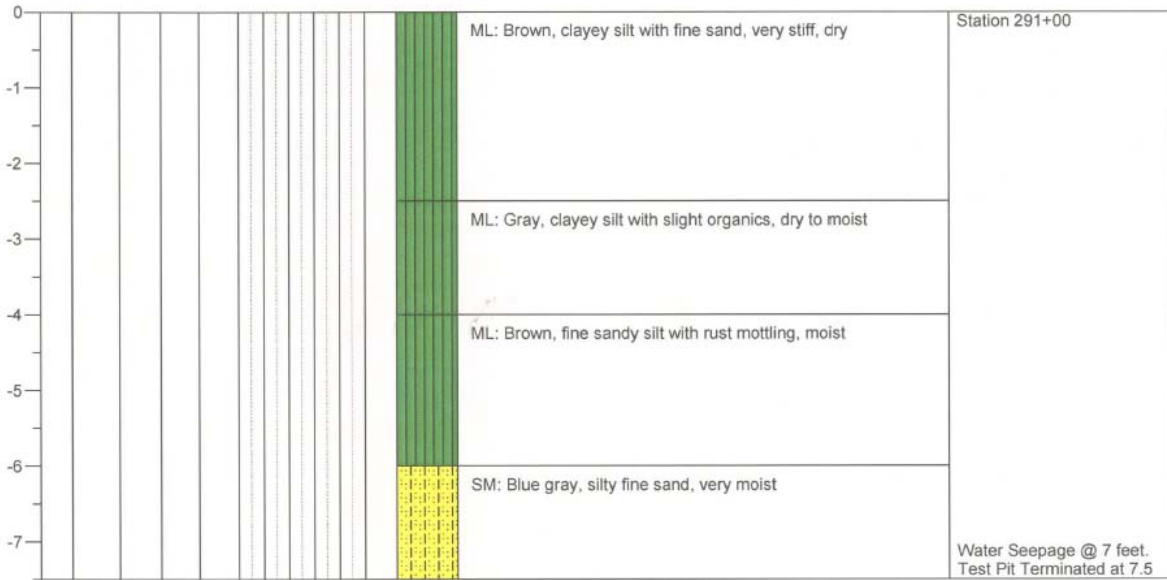
<b>Neil O. Anderson &amp; Assoc., Inc.</b> 902 Industrial Way, Lodi, CA 95240 (209)367-3701 Fax (209)333-8303		<h1>LOG OF TEST PIT</h1>		<b>TEST PIT NUMBER</b> <h2>TP-4</h2>						
PROJECT NUMBER: <b>LFG-0229</b>		DATE EXCAVATED: <b>8-8-07</b>								
PROJECT NAME: <b>Twitchell Island</b>		GROUND SURFACE ELEVATION: <b>0.0</b> Feet								
LOCATION: <b>Sacramento County, CA</b>		<b>PLATE NO. 5</b>								
DRILLING EQUIP.: <b>Case Backhoe with 30 inch Bucket</b>										
Depth, ft.	Sample	Sampling Method	Moisture, %	Dry Density, pcf	Blow Counts	Blow Count Histogram	Ground Water	Soil Lithology	Soil Lithology Description	Notes

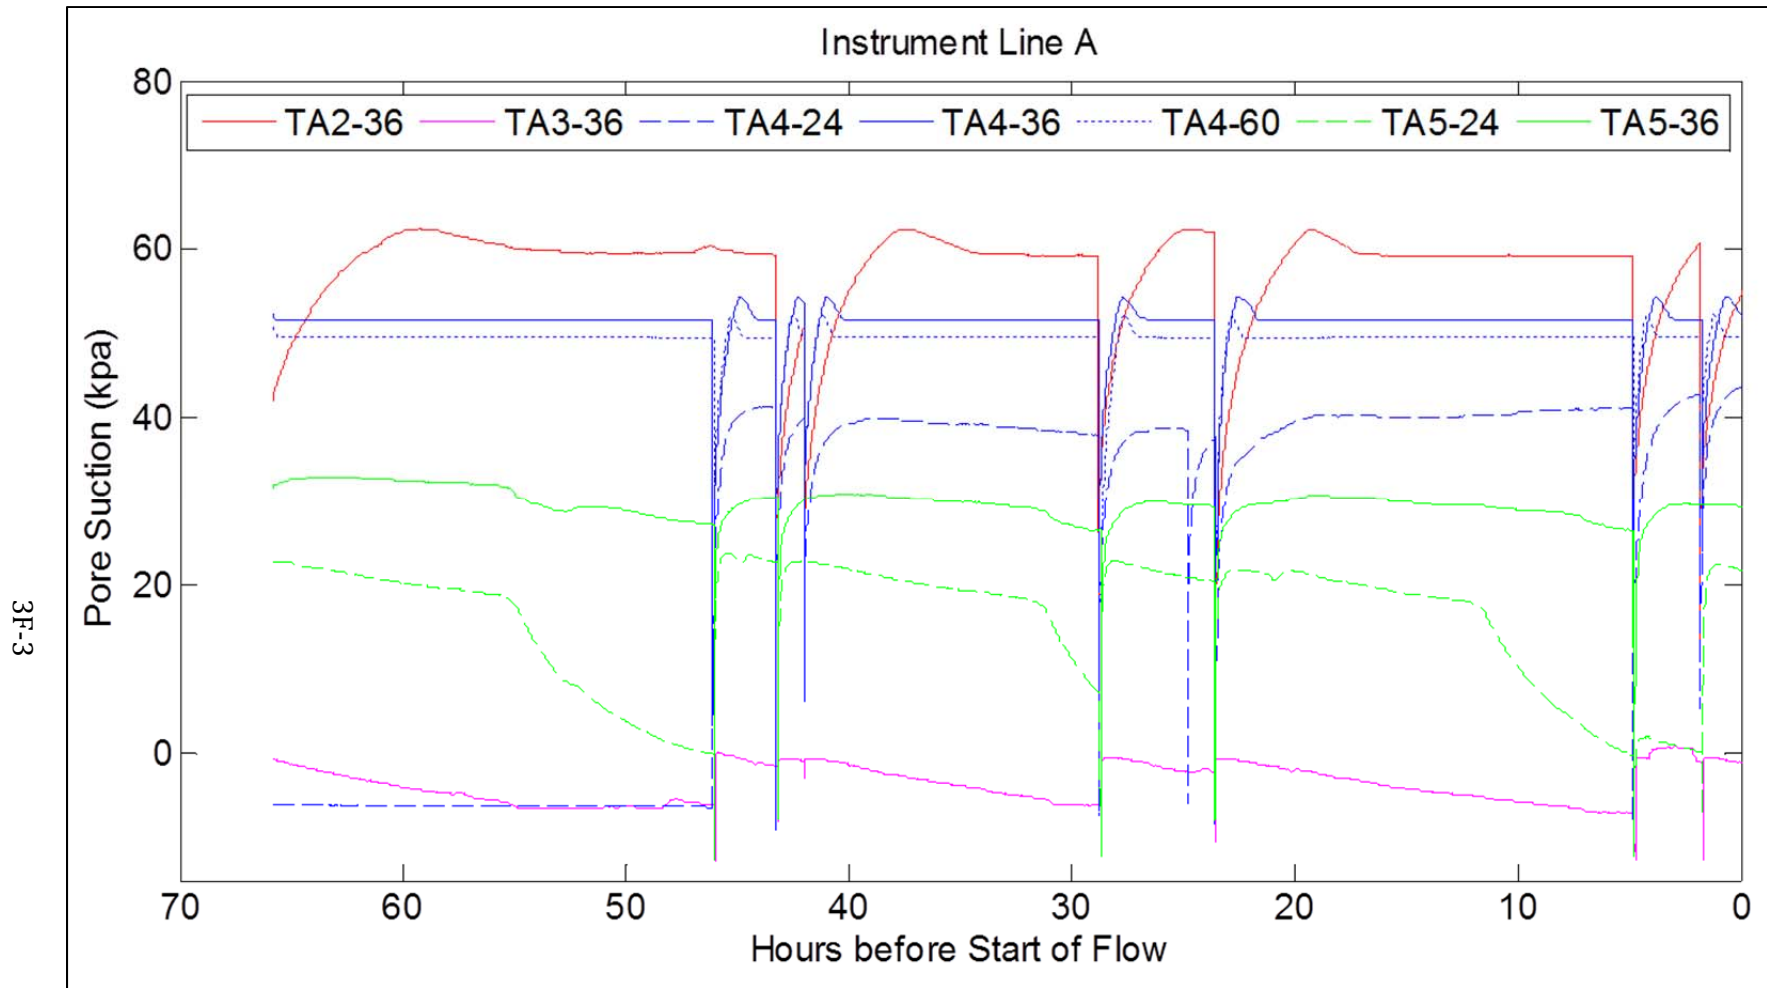
Figure 3F -2. Initial values of soil suction at instrument line A, measured in the days just prior to the flow test

Tensiometer data is presented first, followed by piezometer data. Tensiometer data collection began with a dry run equilibration phase. During the dry run equilibration phase, tensiometers were assembled, leak checked, and installed in the ground. Soil Moisture tensiometers of 24, 48, and 60 inches in length were installed to depths of 24, 36 and 60 inches, respectively (). The instruments were assembled with brass “T” adaptors to allow for connection of both a mechanical gauge and a Model 5301 current transducer by Soil Moisture. The current transducer was wired to a Campbell Scientific CR3000 datalogger in order to continuously read the instruments. The current output from each transducer was converted to voltage using a 249 ohm resistor with a resistor error of 1 percent. Based on manufacturer’s specifications, currents of 4 and 20 mA correspond to soil suction values of 0 and 100 kpa, respectively. The values can be scaled linearly between these values. With a resistance of 249 ohms, using Ohms Law (which states that voltage is equal to current multiplied by resistance) voltages of 996 ohms and 4980 ohms correspond to soil suction values of 0 and 100 kpa, respectively, sharing the same linear relationship.

Tensiometers were installed ahead of the flow test and were connected to a continuously reading datalogger for a few days prior to the inundation of the trenches to establish baseline values in the instruments and to check functionality. Initial moisture contents of surficial soils are presented in Appendix B and results of initial testing are presented in Figure 3F -2 through Figure 3F -6. These moisture contents resulted in observed initial suction values of approximately 0 to 64 kPa. Results during the flow test are presented in Section 2.6.4. Values reported are not corrected for barometric pressure, though this parameter was recorded at the surface and values are presented on Figure 3F -7.

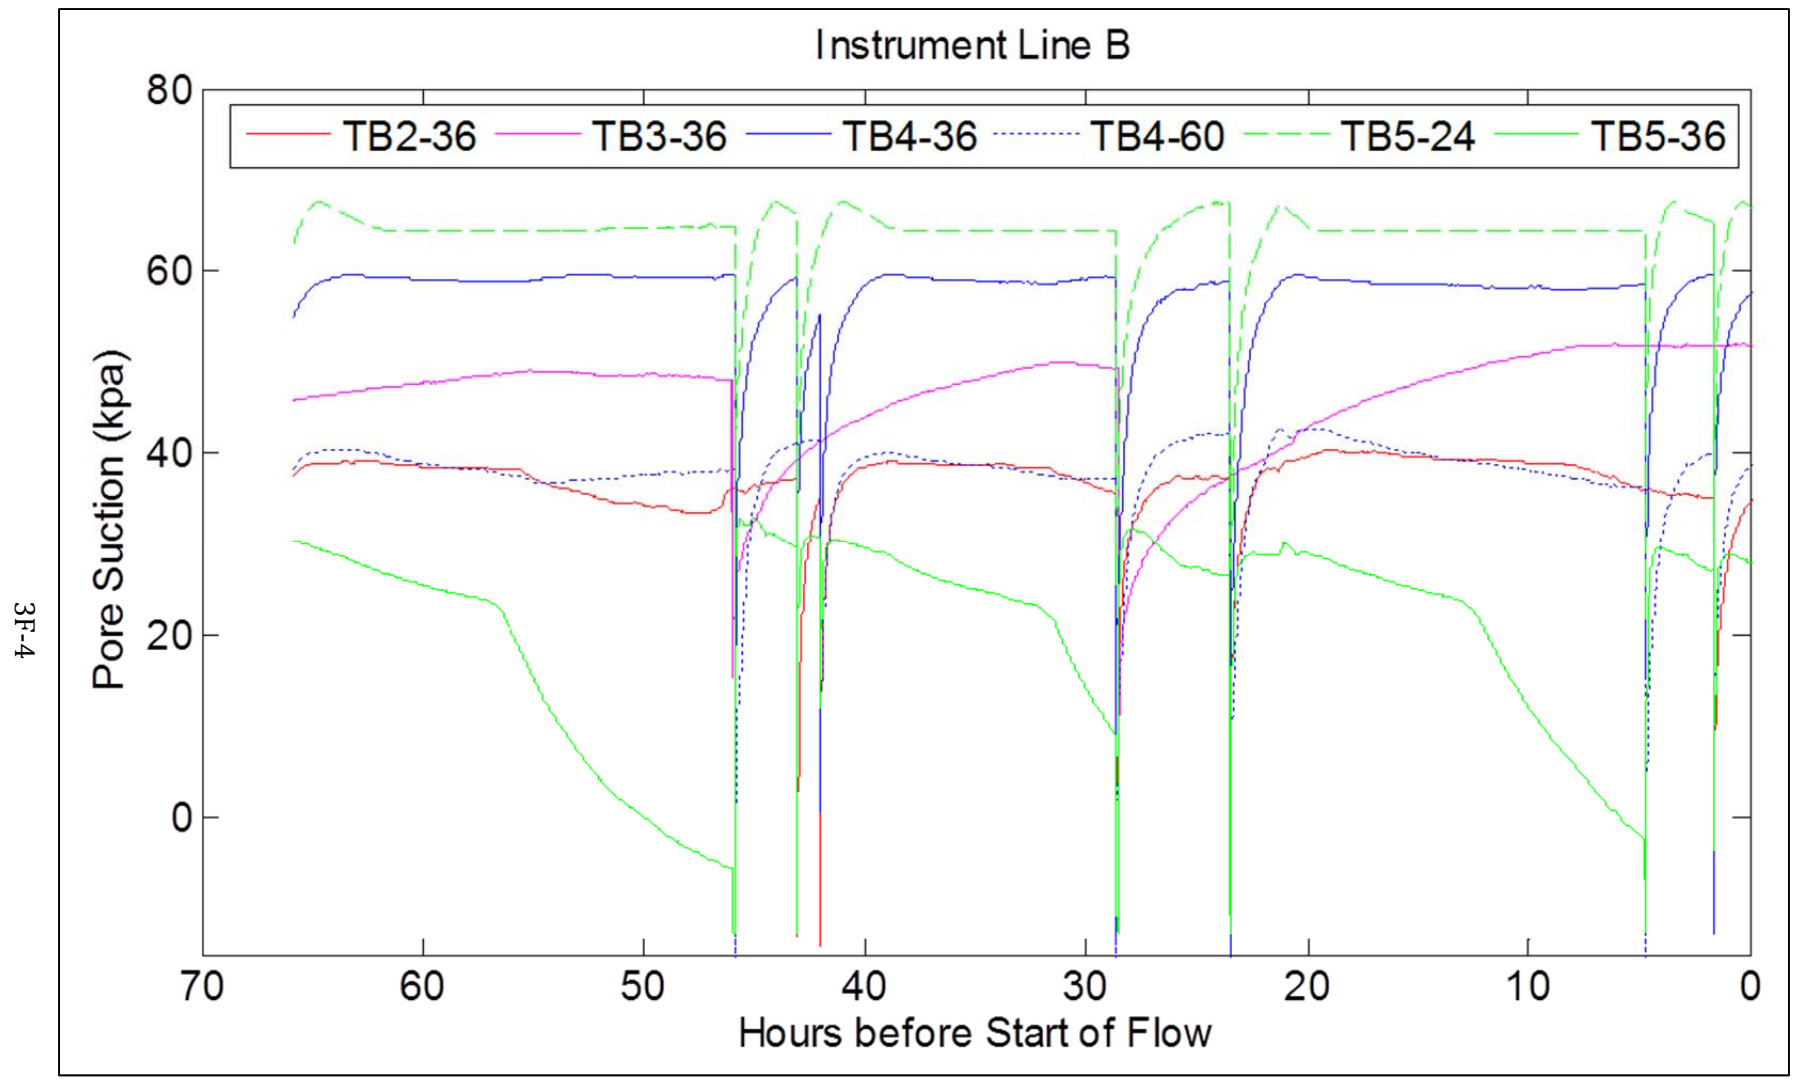
Figure 3F -3. Initial values of soil suction at instrument line B, measured in the days just prior to the flow test

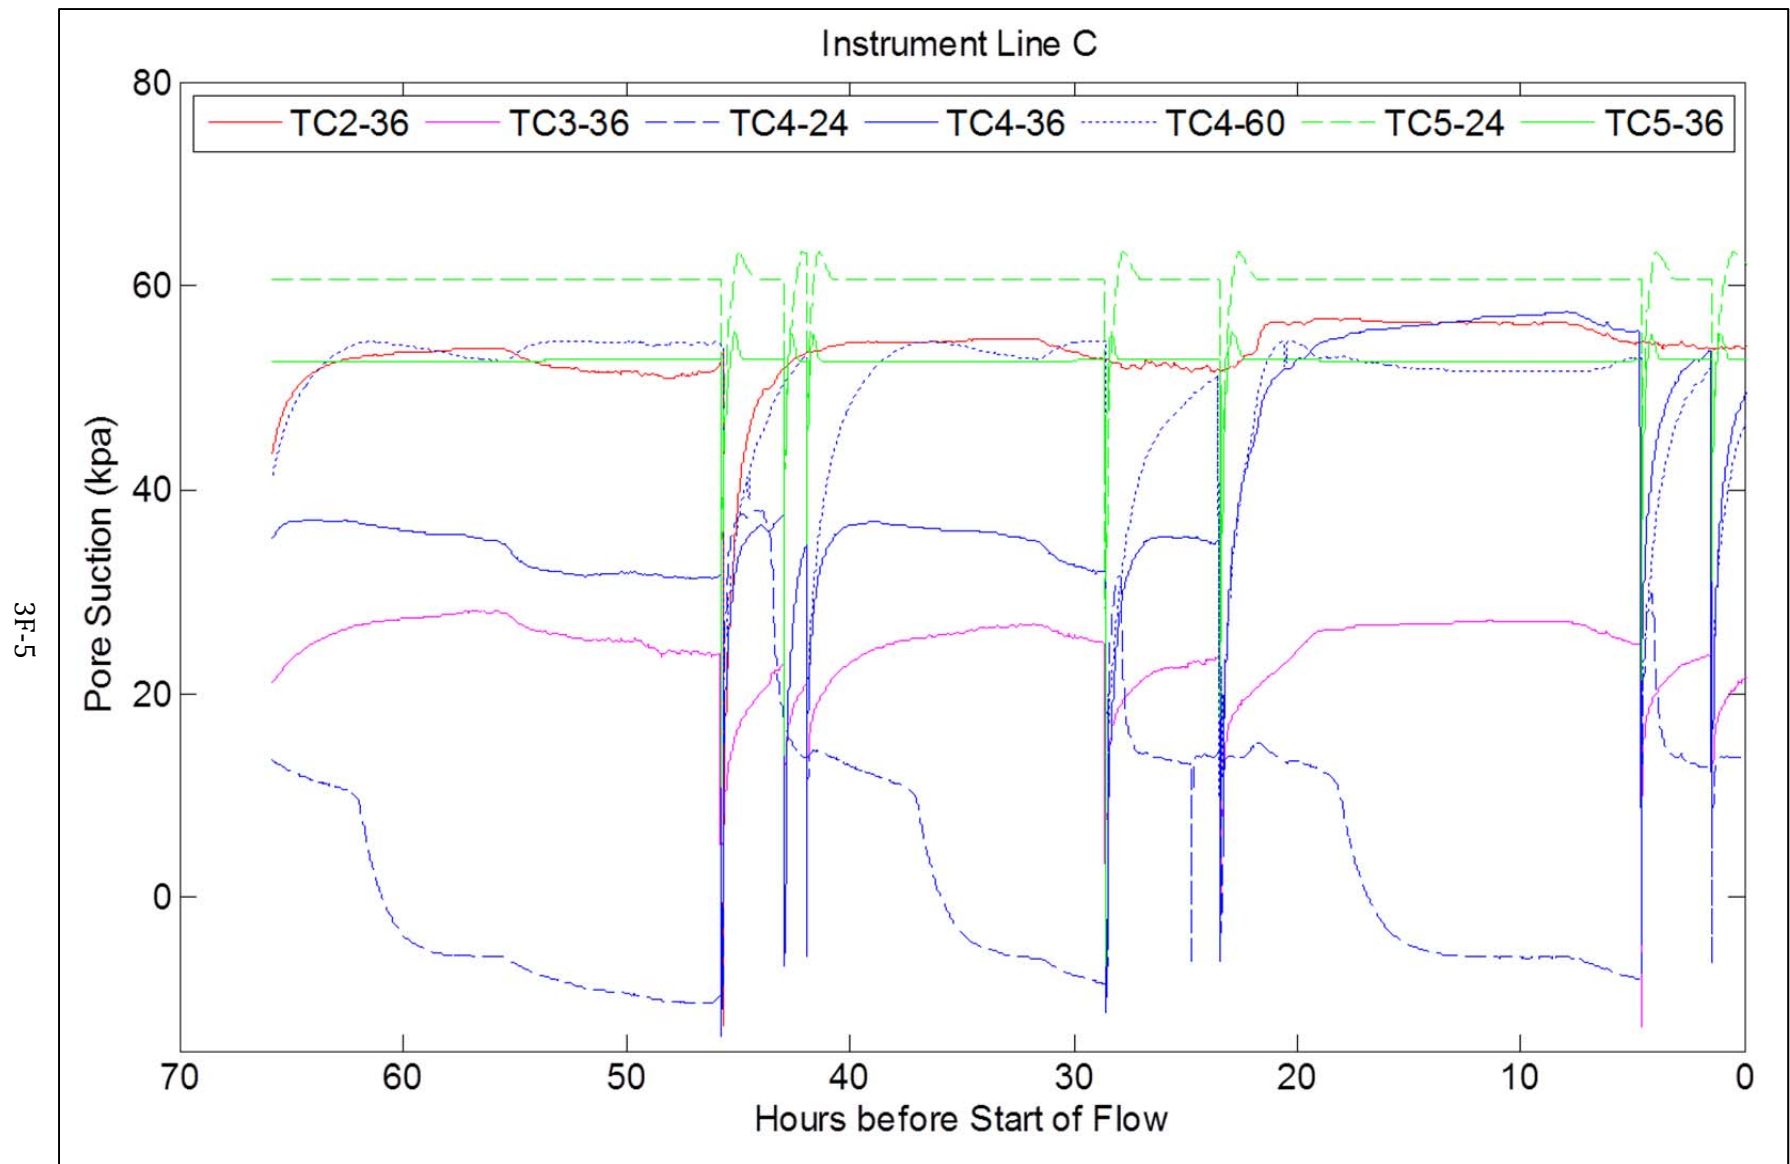
Figure 3F -4. Initial values of soil suction at instrument line C, measured in the days just prior to the flow test

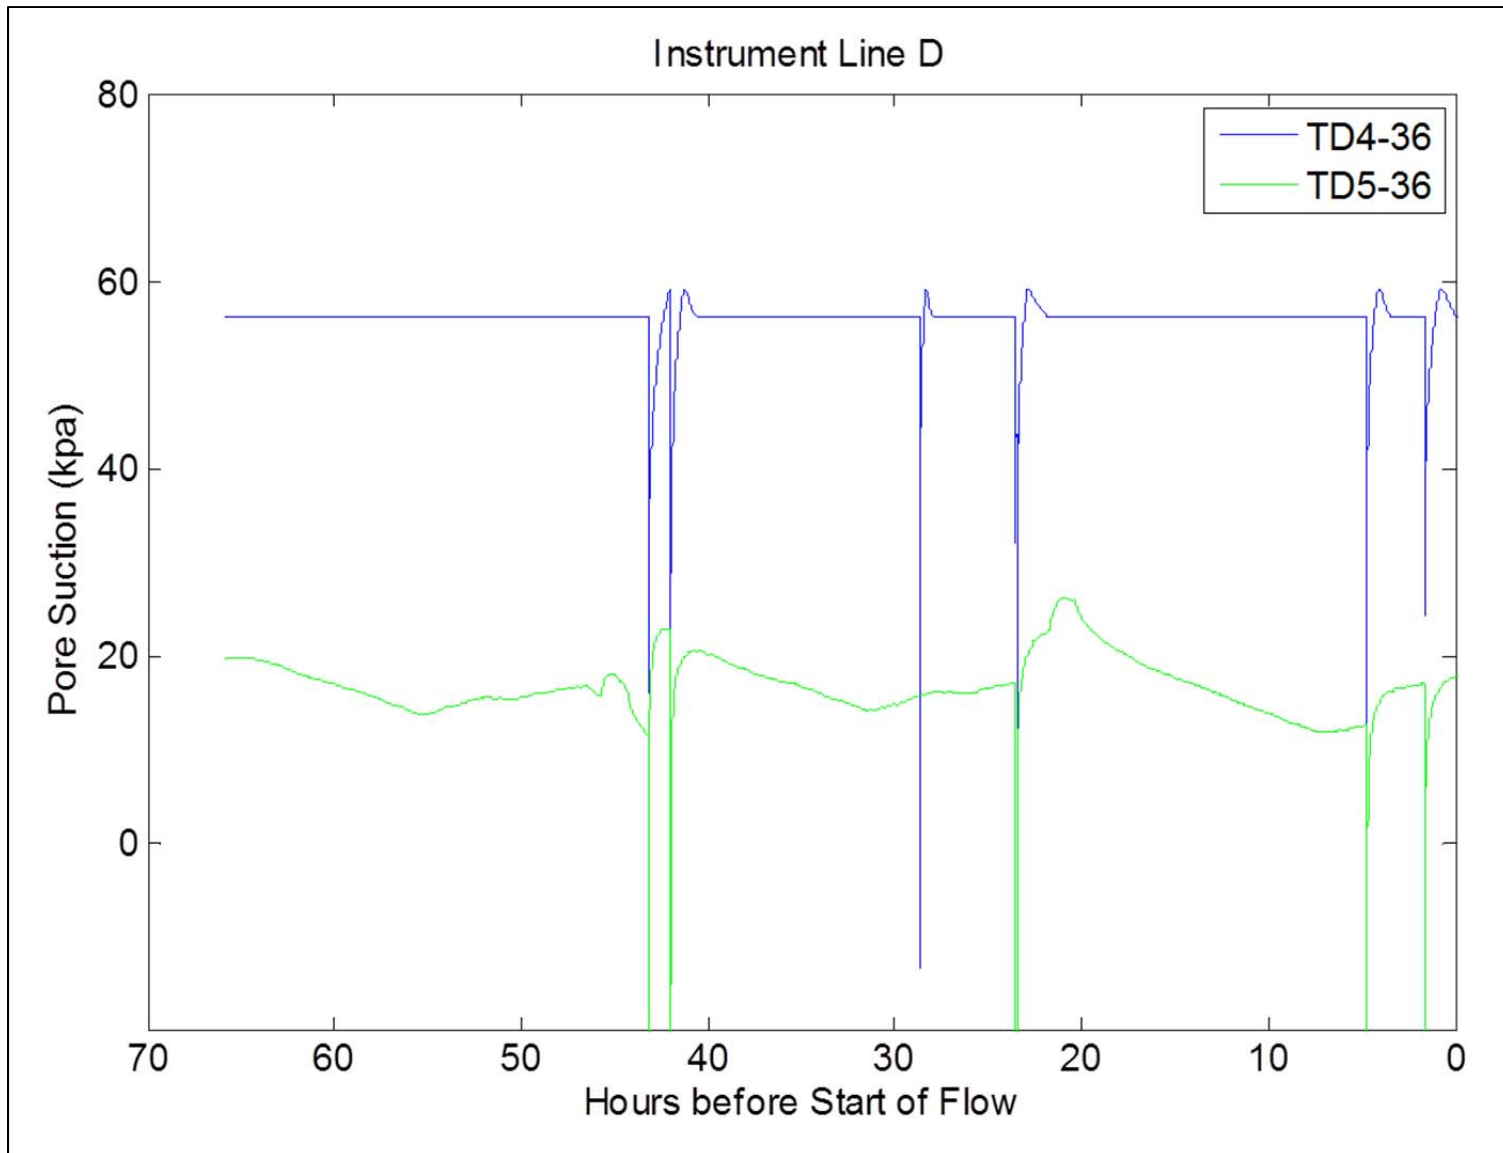
Figure 3F -5. Initial values of soil suction at instrument line D, measured in the days just prior to the flow test

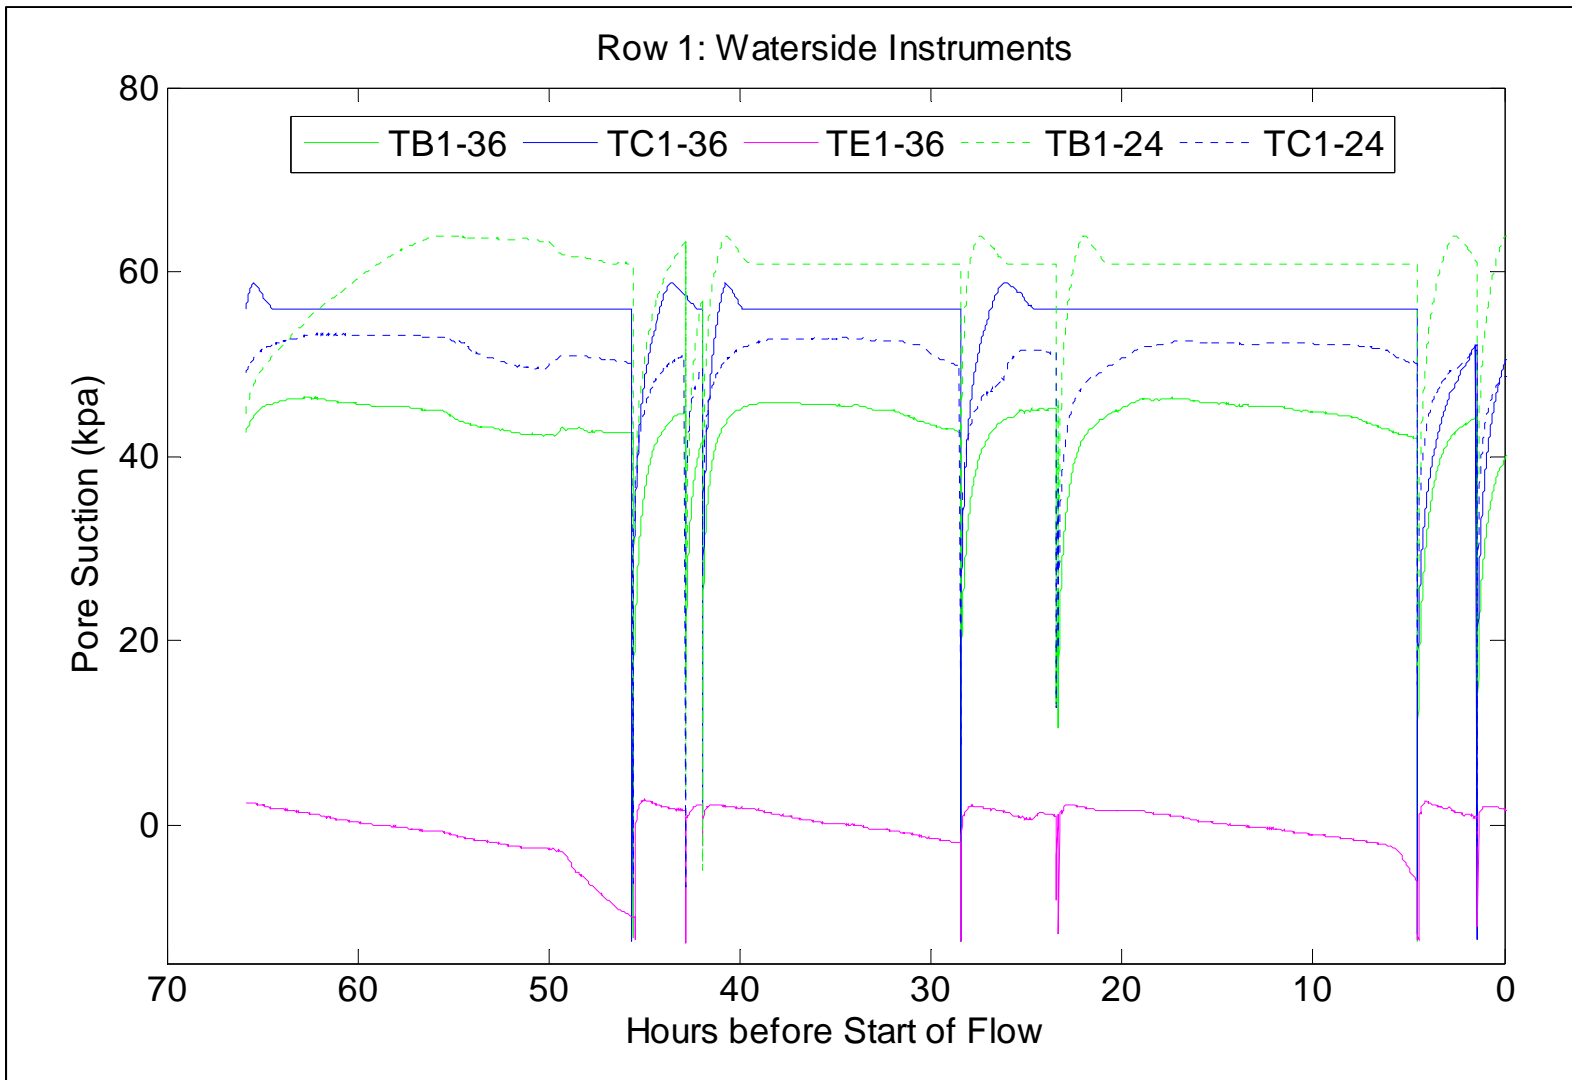
Figure 3F -6. Initial values of soil suction at waterside instruments (Row 1), measured in the days just prior to the flow test

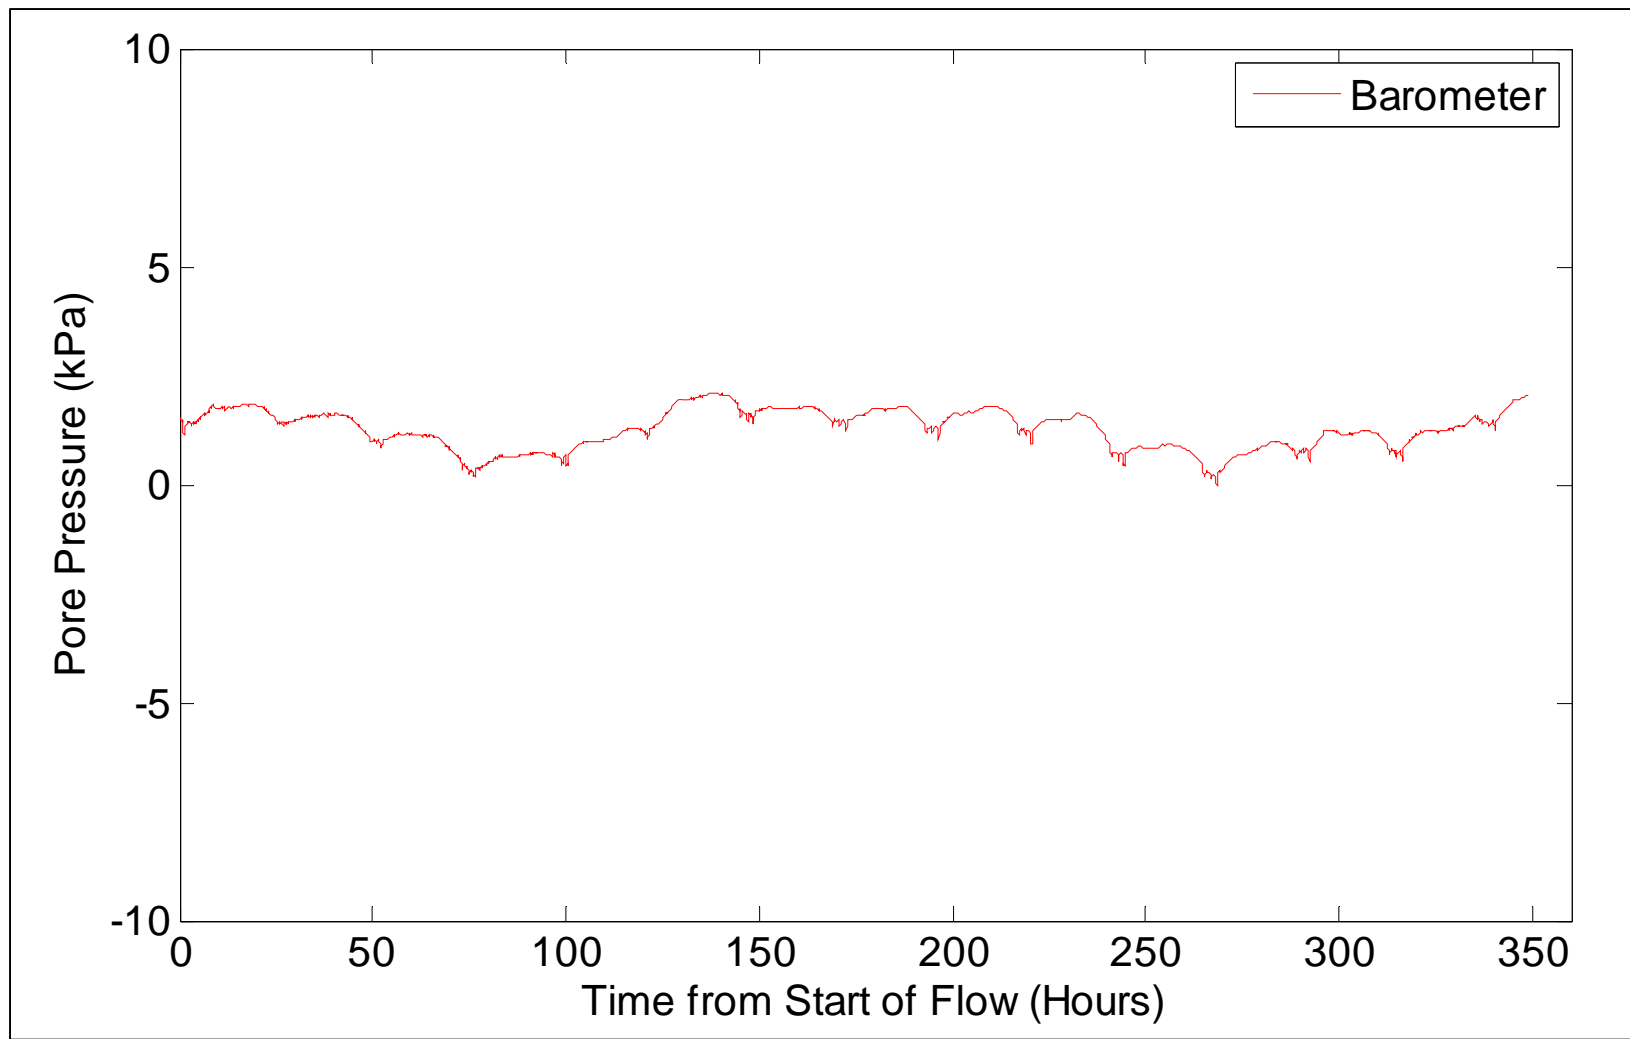
Figure 3F -7. Barometric pressures at the surface of the levee during the 10 day flow test and for 5 days afterward

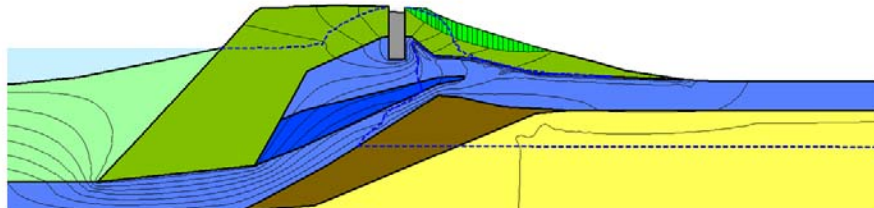
Section C1

**Landside C, Steady State Test Conditions**

FS = 1.94

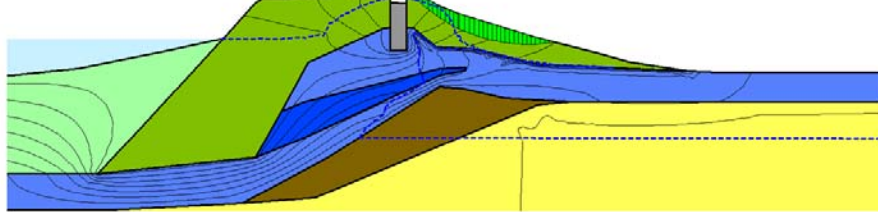
Section C3

FS = 2.03

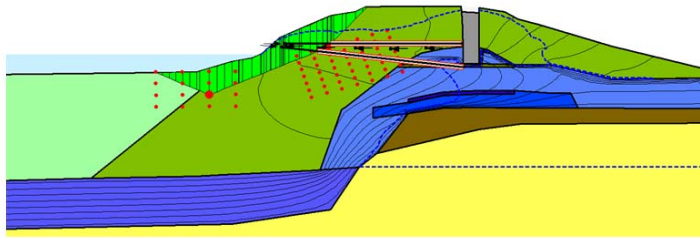
**Waterside B1 - - 39 hr Transient Test Conditions, with Tree**

Section B1 FS = 0.96

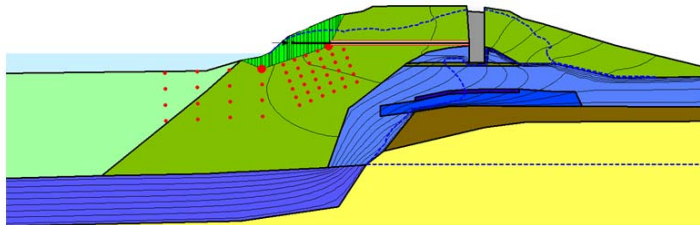
Section B3 FS = 1.50

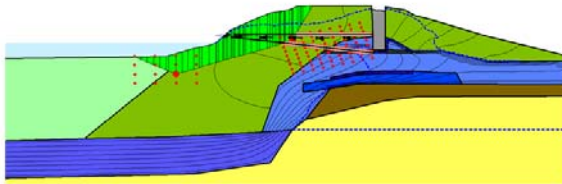
**Waterside B2 - - 39 hr Transient Test Conditions, with Tree**

Section B1 FS = 1.05

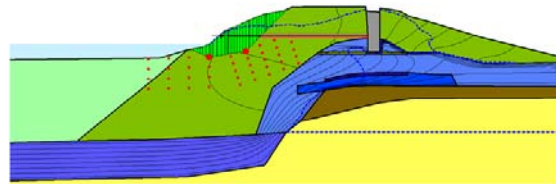
Section B2 FS = 1.28

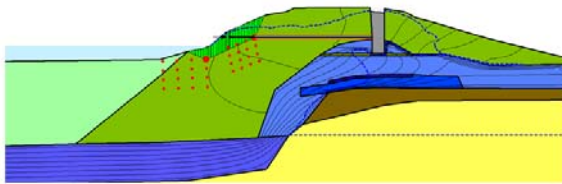
Section B3a FS = 1.35

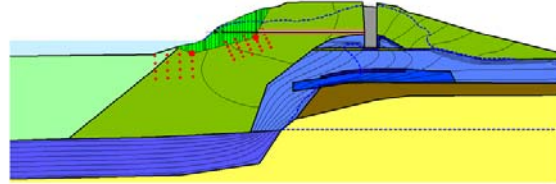
Section B3b FS = 1.44

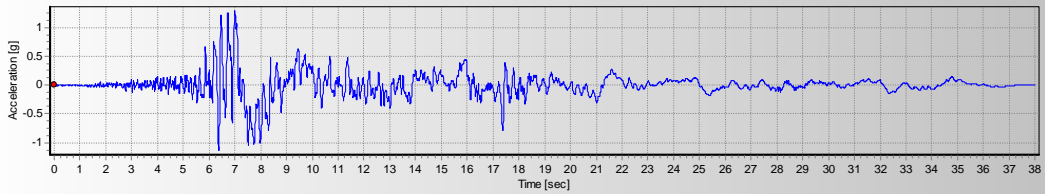
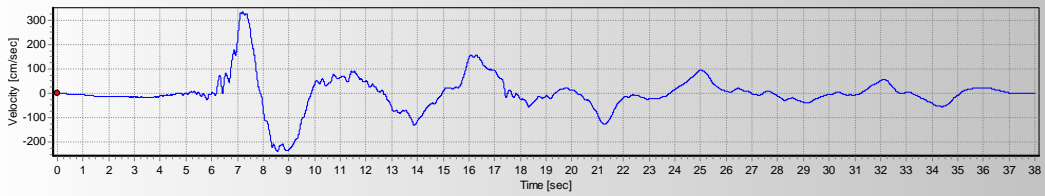
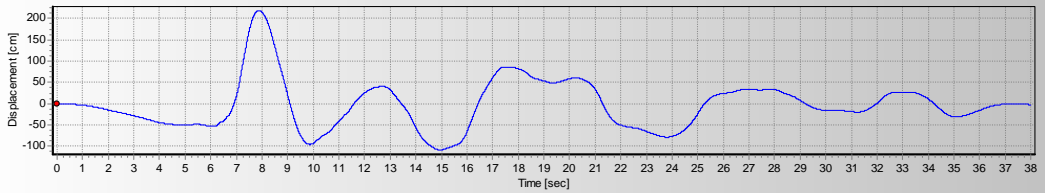
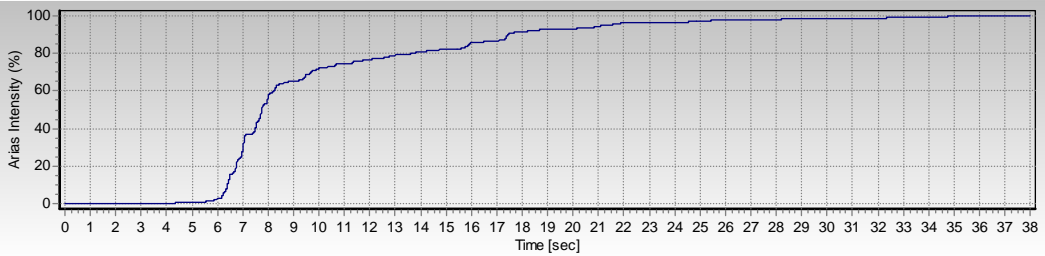
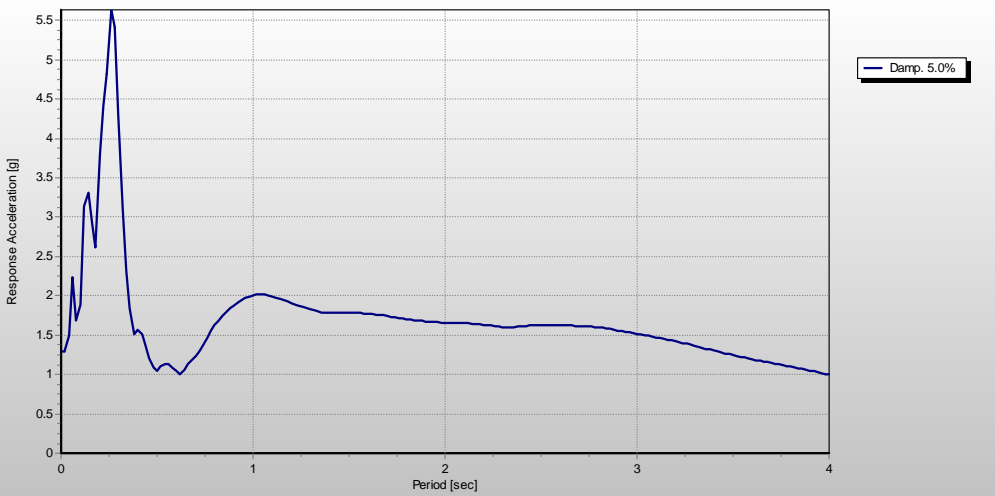
1979 Imperial Valley, Brawley Airport 225

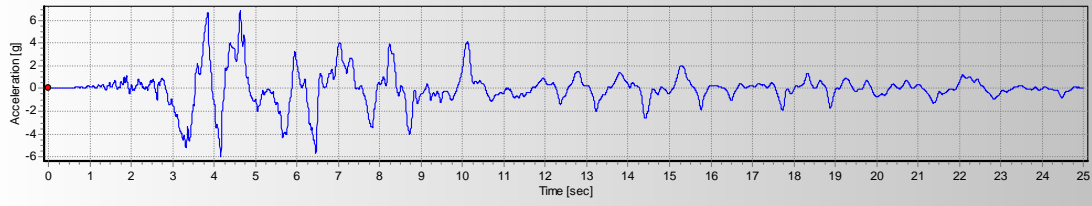
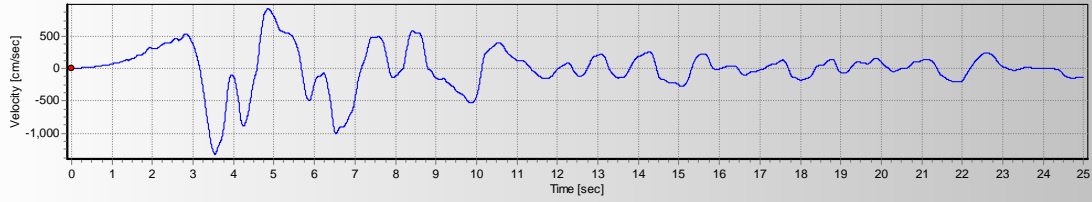
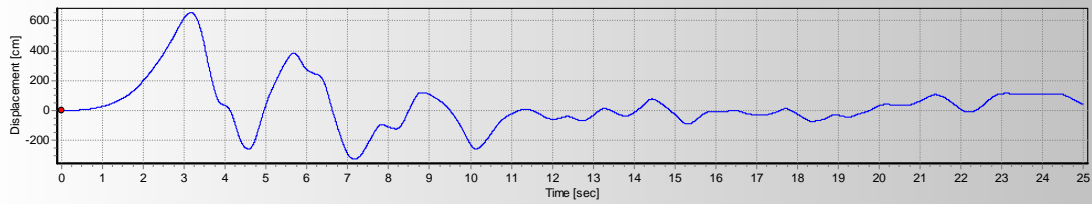
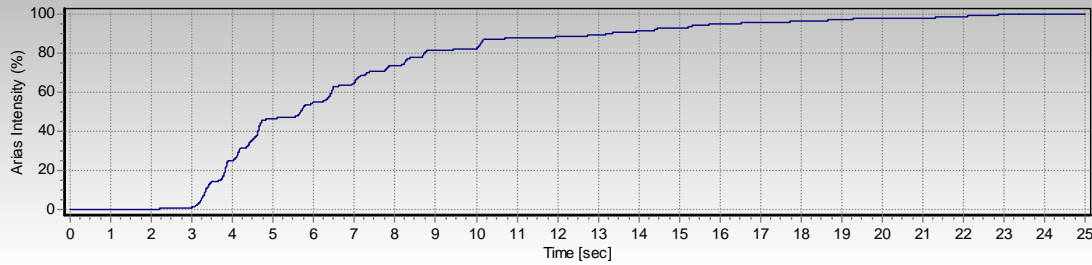
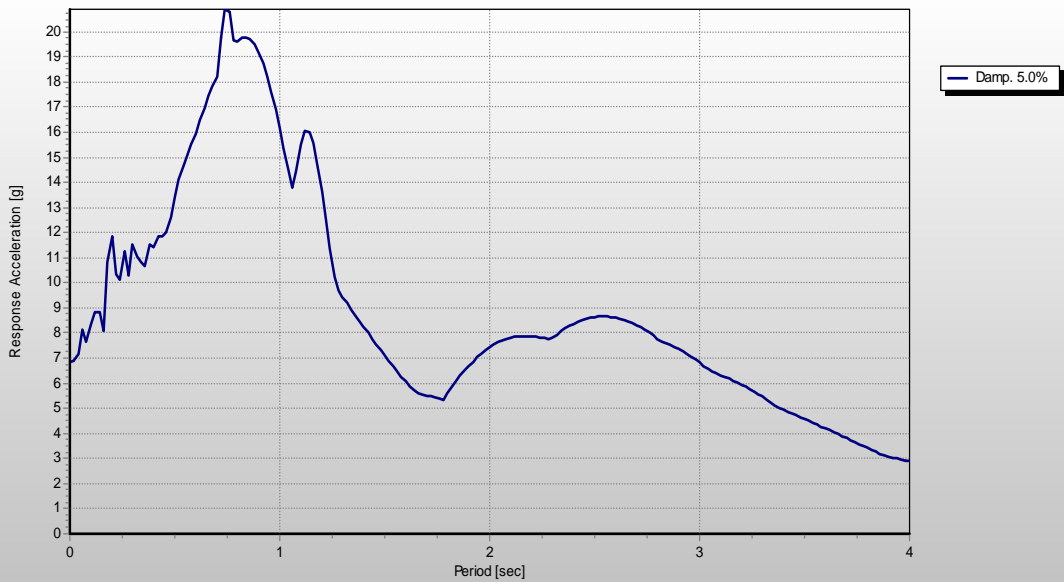
# 1994 Northridge, Sylmar – Conv Sta 052 scaled to 1.25x
