Static and Seismic Performance of California Levees

Michelle Jennifer Shriro

Doctor of Philosophy

Engineering - Civil and Environmental Engineering

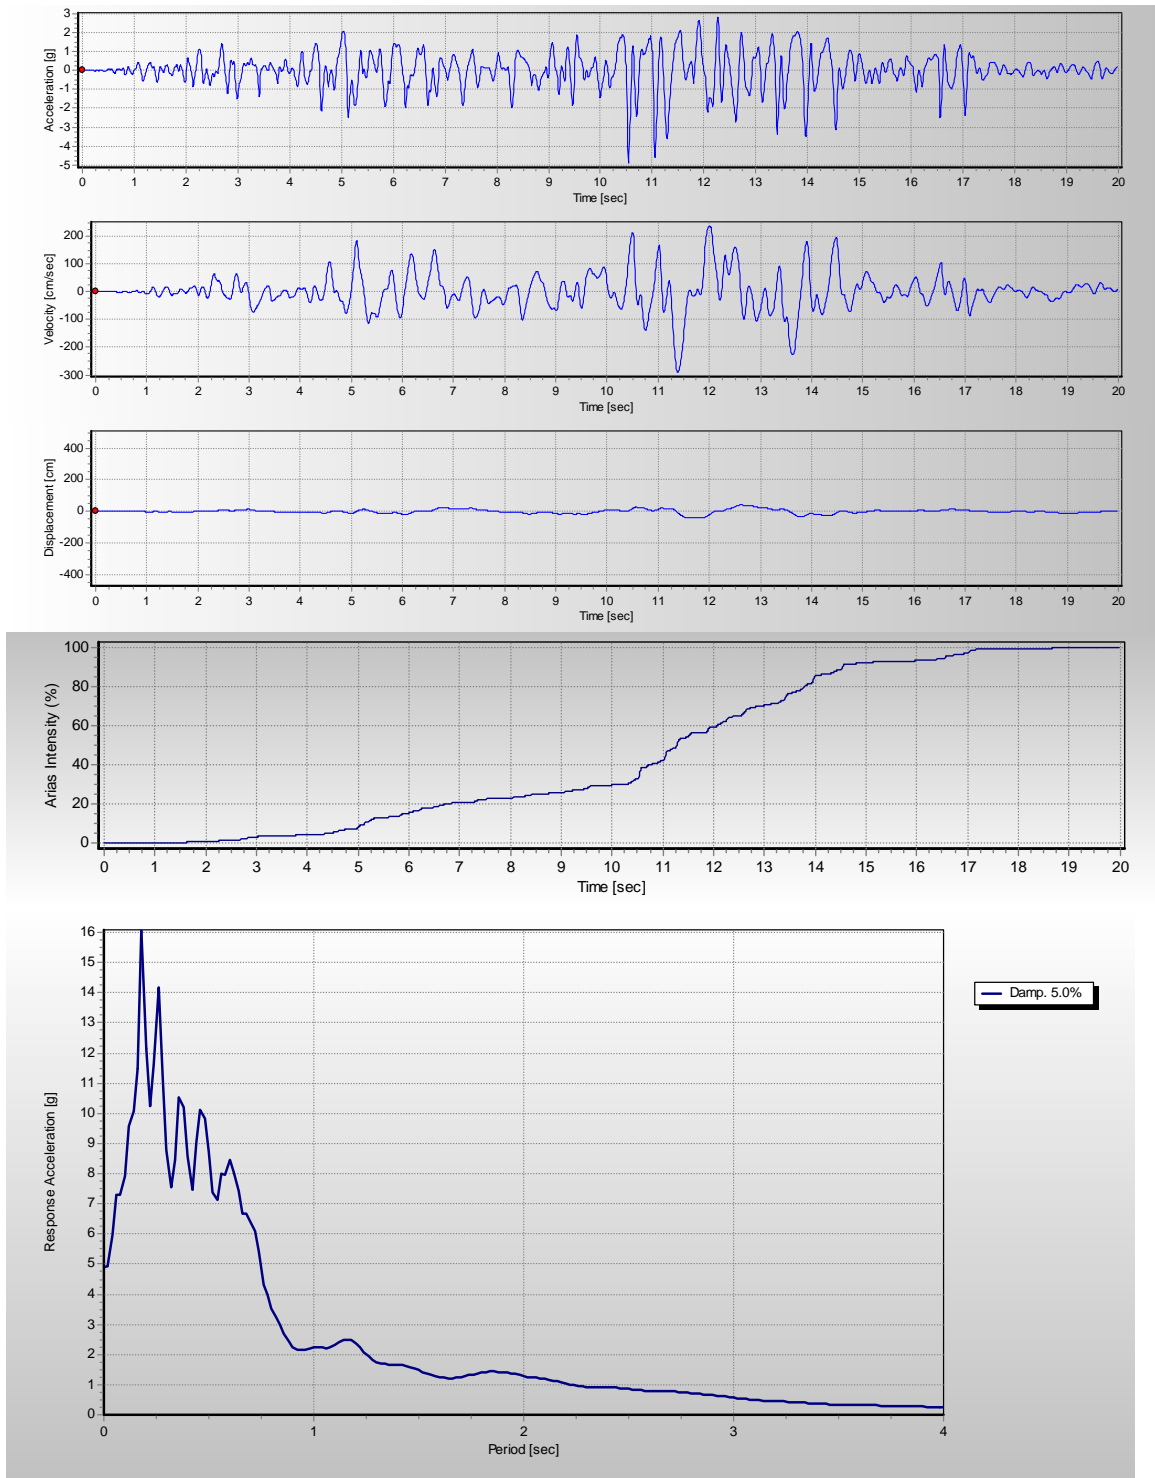
# 1987 Superstition Hills, Superstition Mountain Camera 045

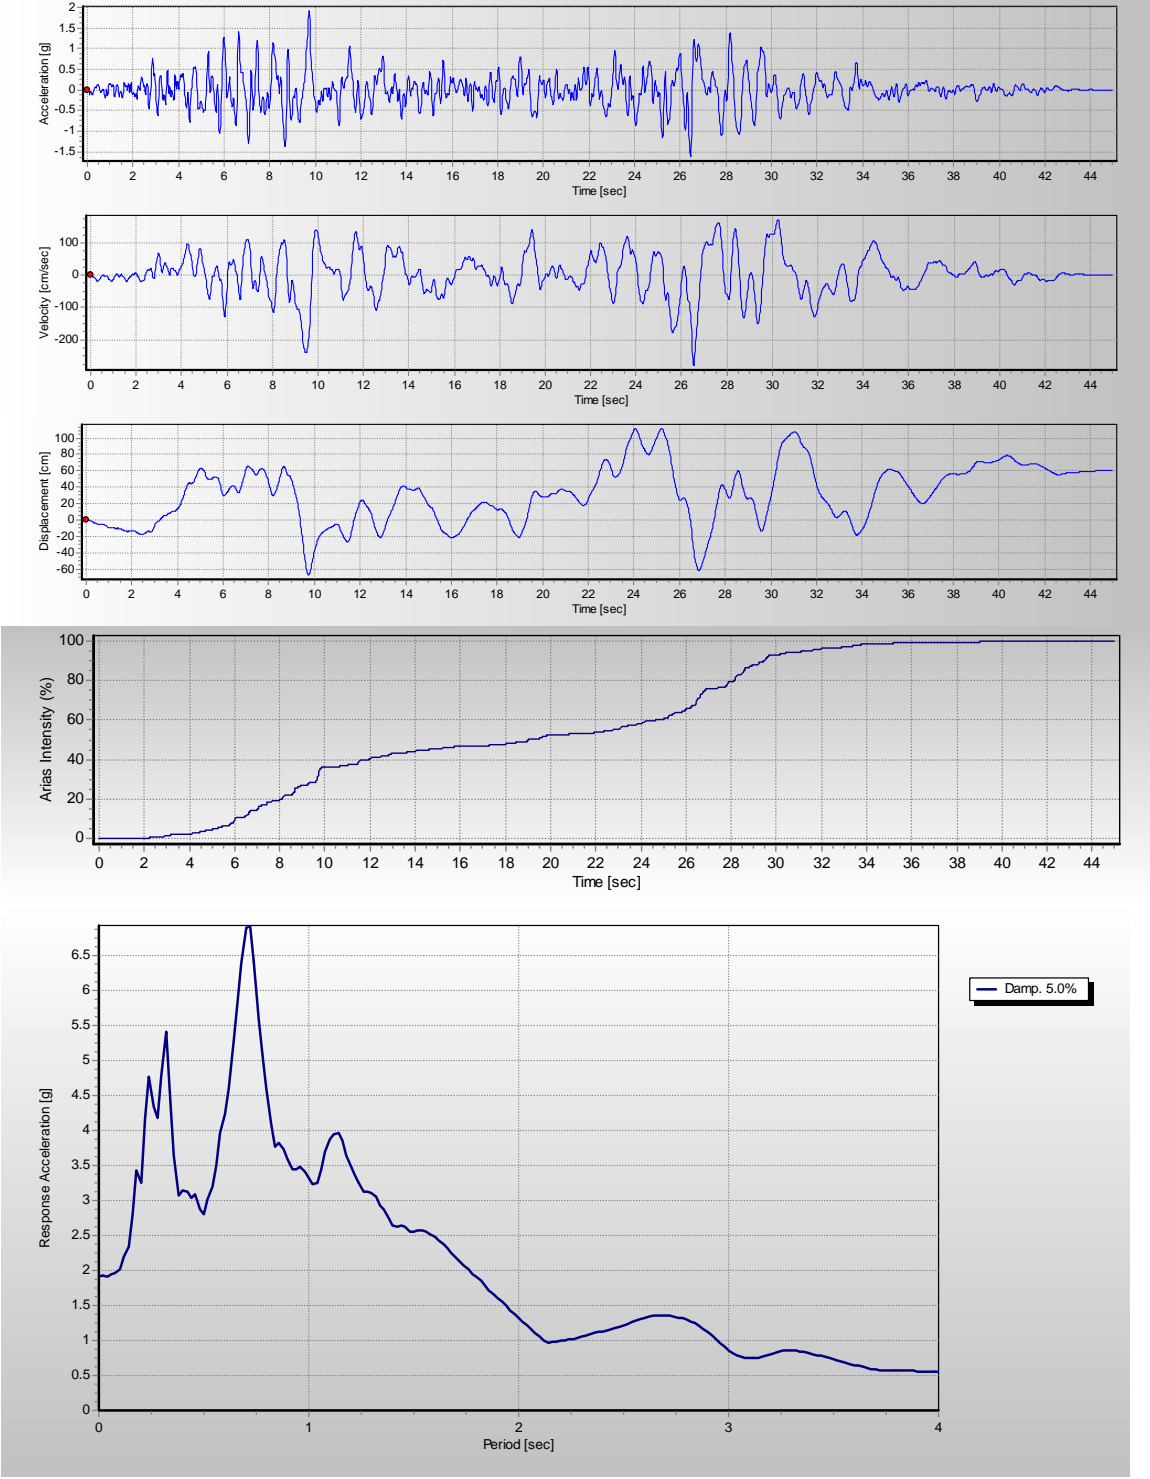
# 92 Landers, Joshua Tree 090 – Scaled by 0.75x

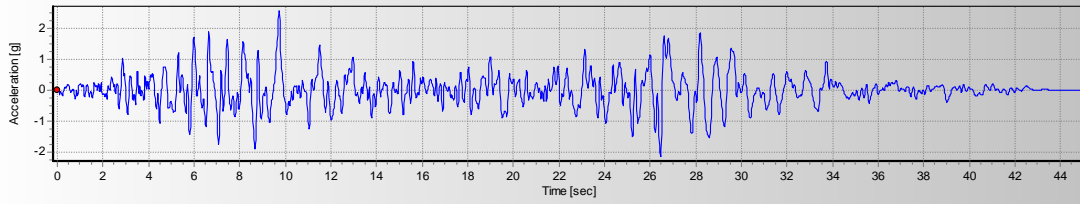
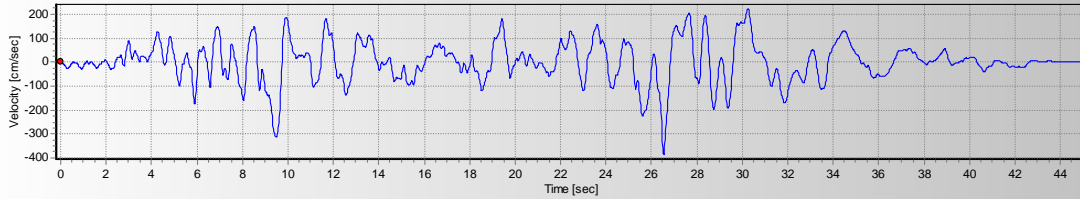
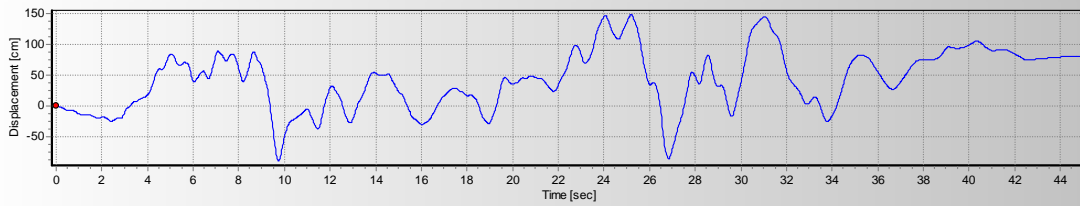
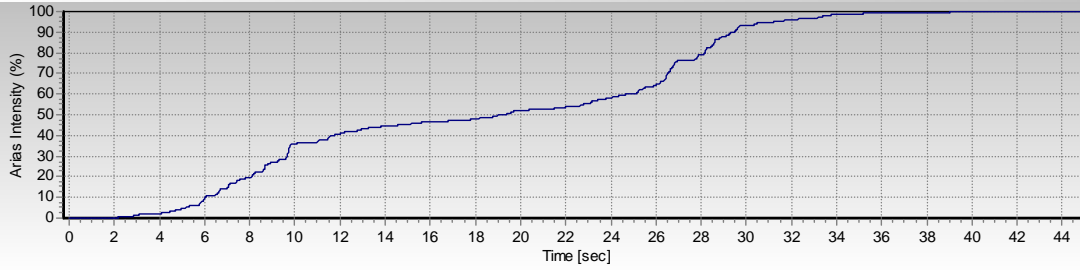
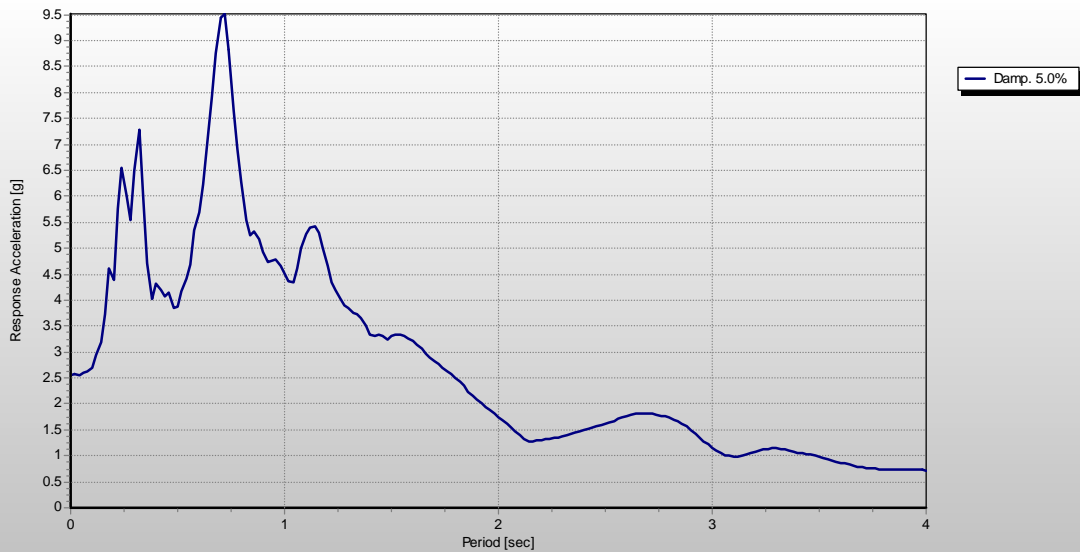
# 92 Landers, Joshua Tree 090 – Scaled by 1.0x

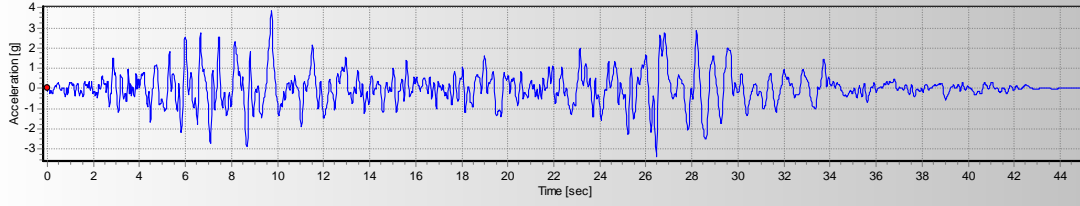
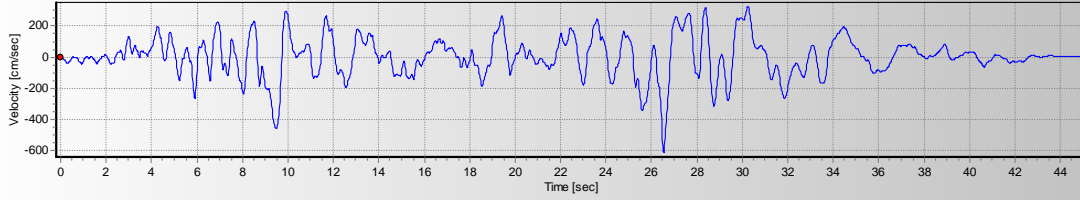
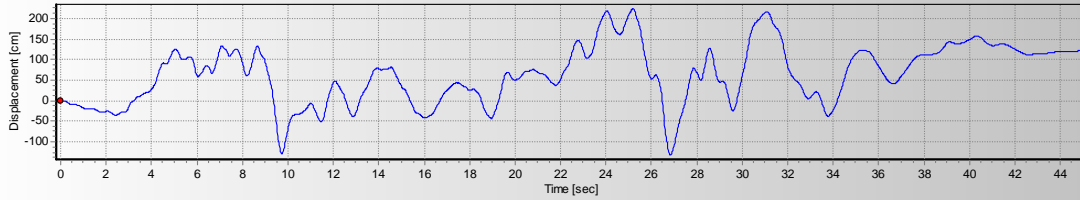
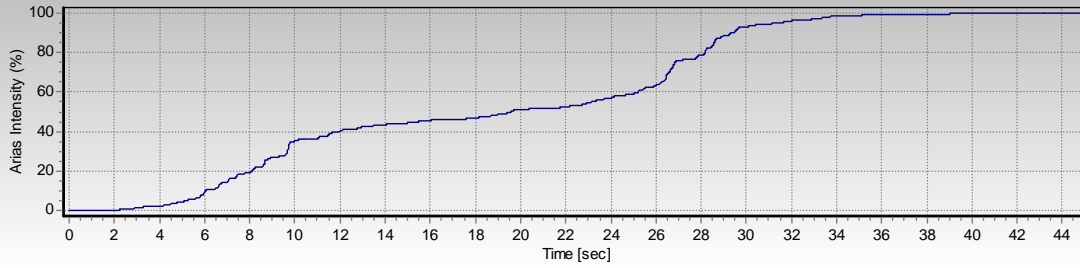
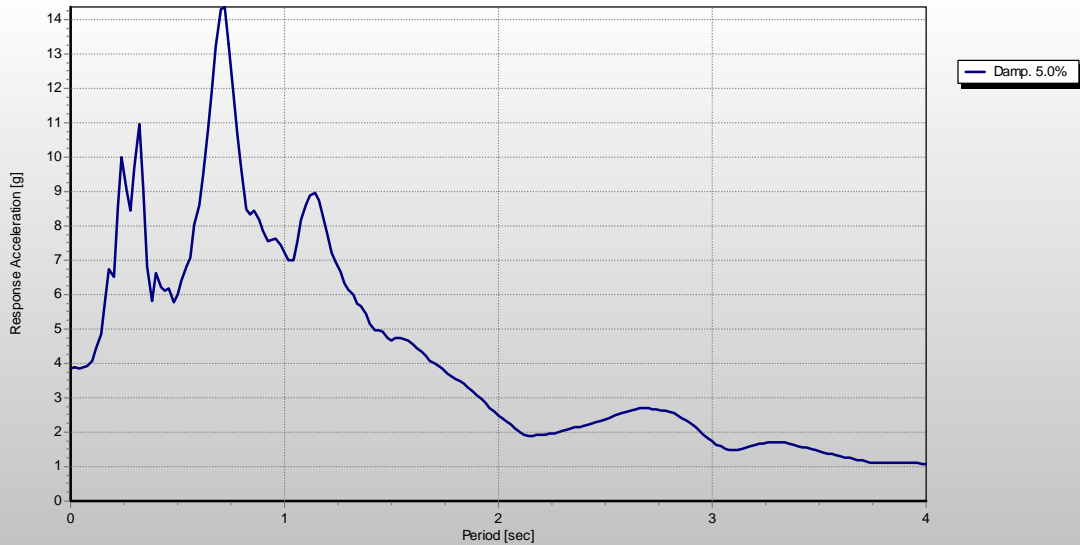
# 92 Landers, Joshua Tree 090 – Scaled by 1.5x

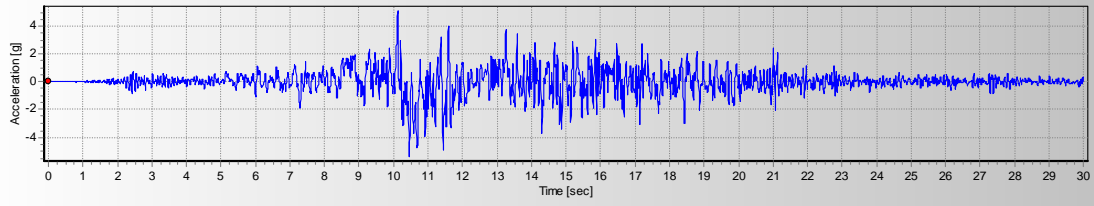
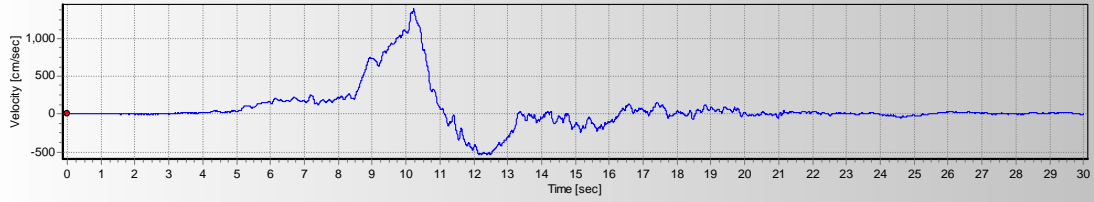
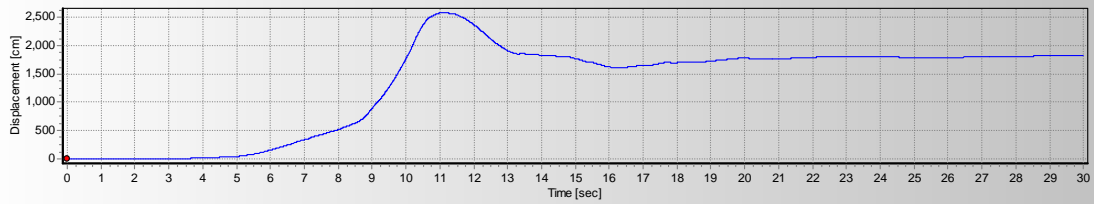
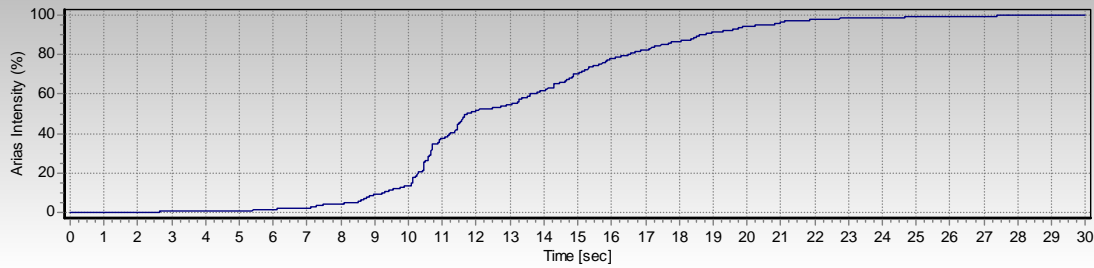
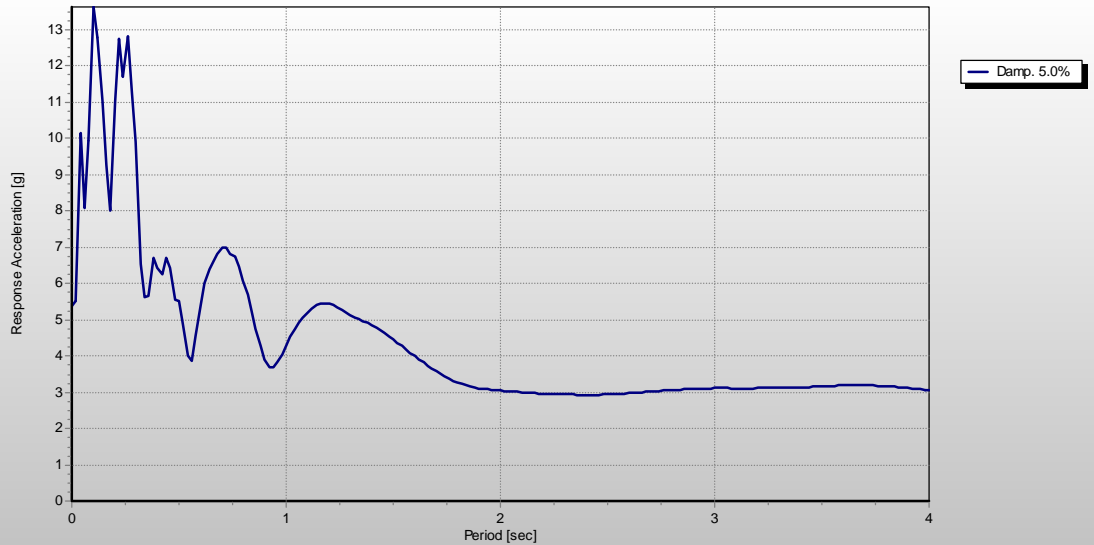
# 1992 Landers, Lucerne 260

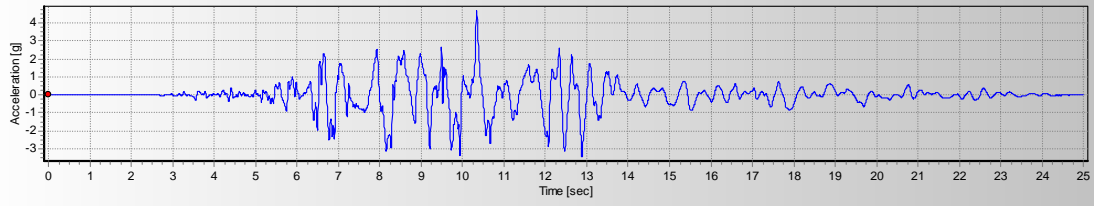
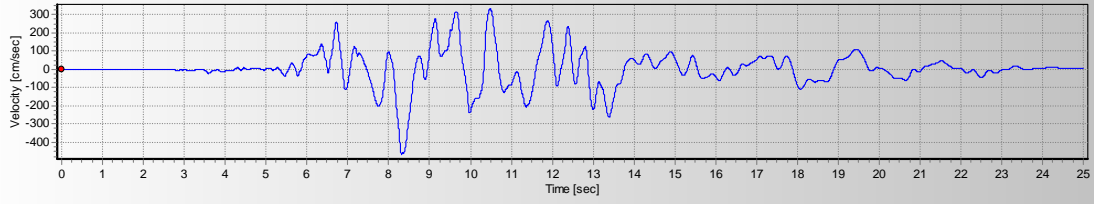
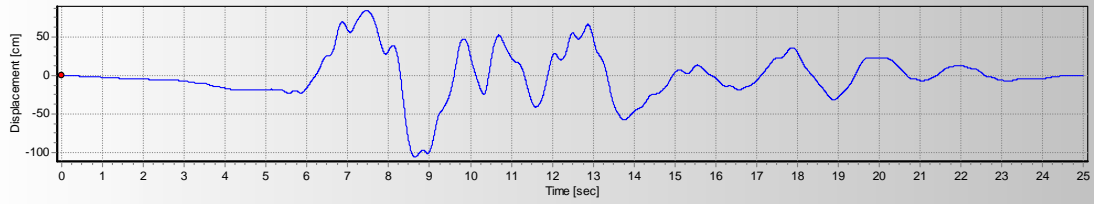
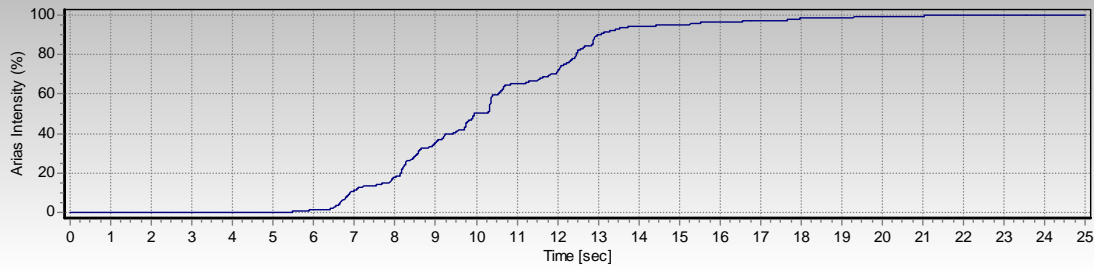
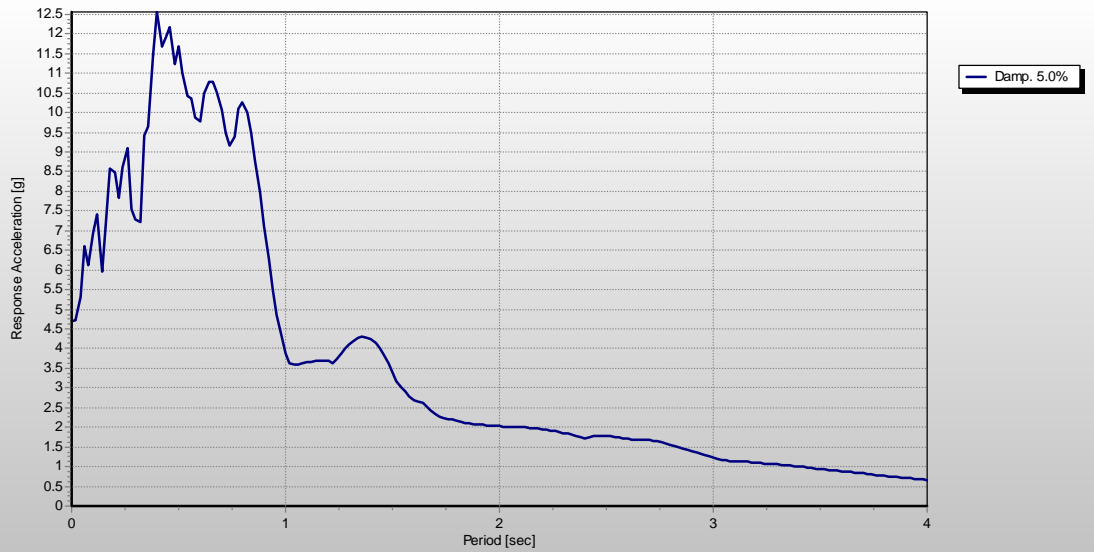
# 1989 Loma Prieta EQ, LGP

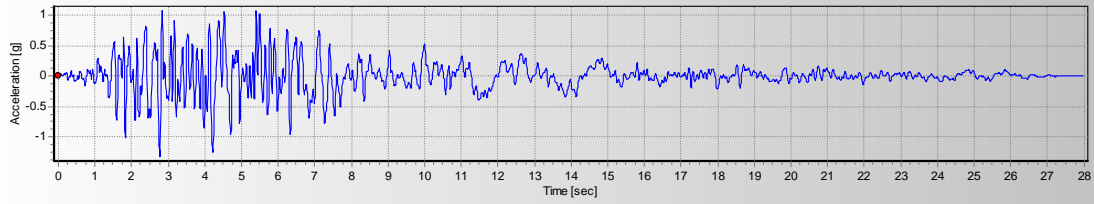
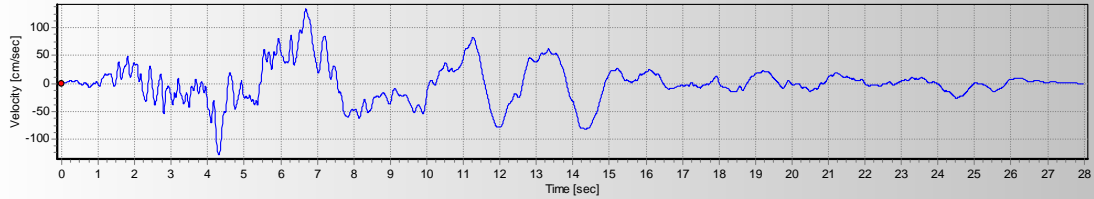
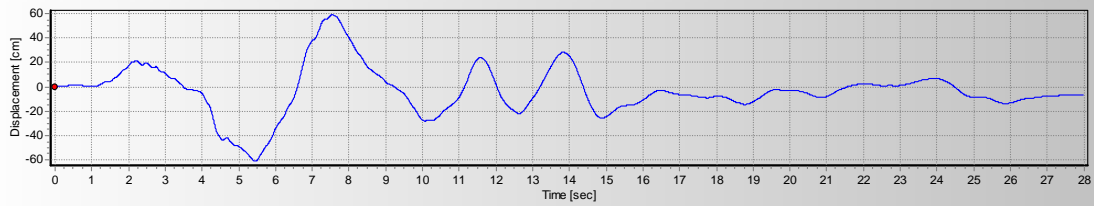
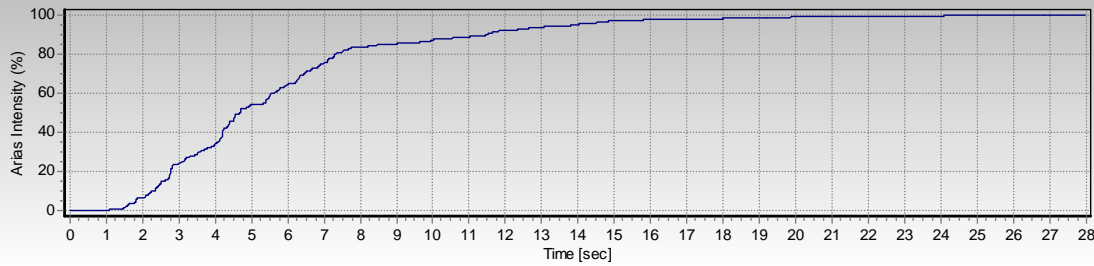
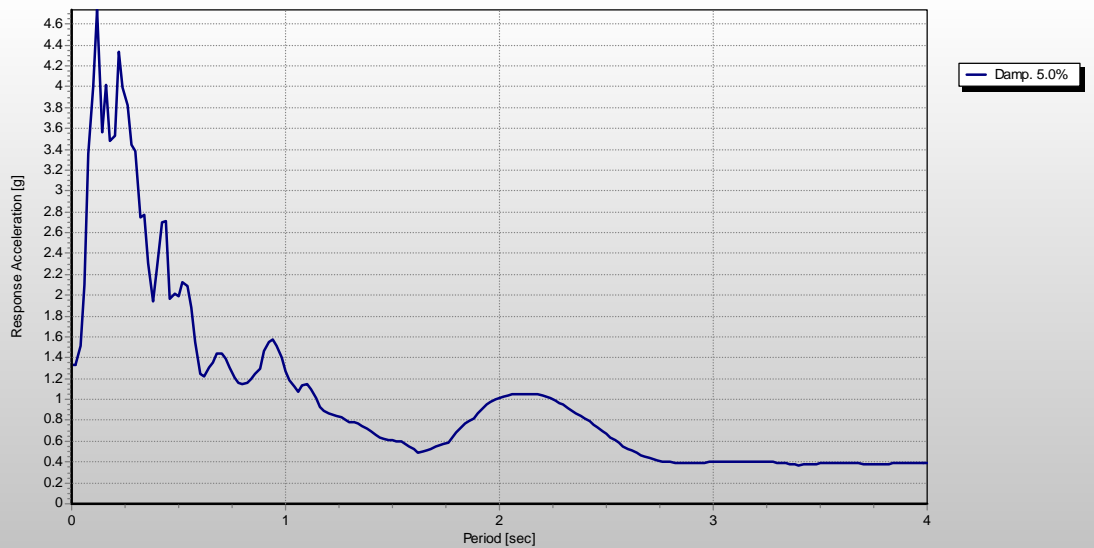
# 1971 San Fernando EQ, Hollywood Storage Facility,

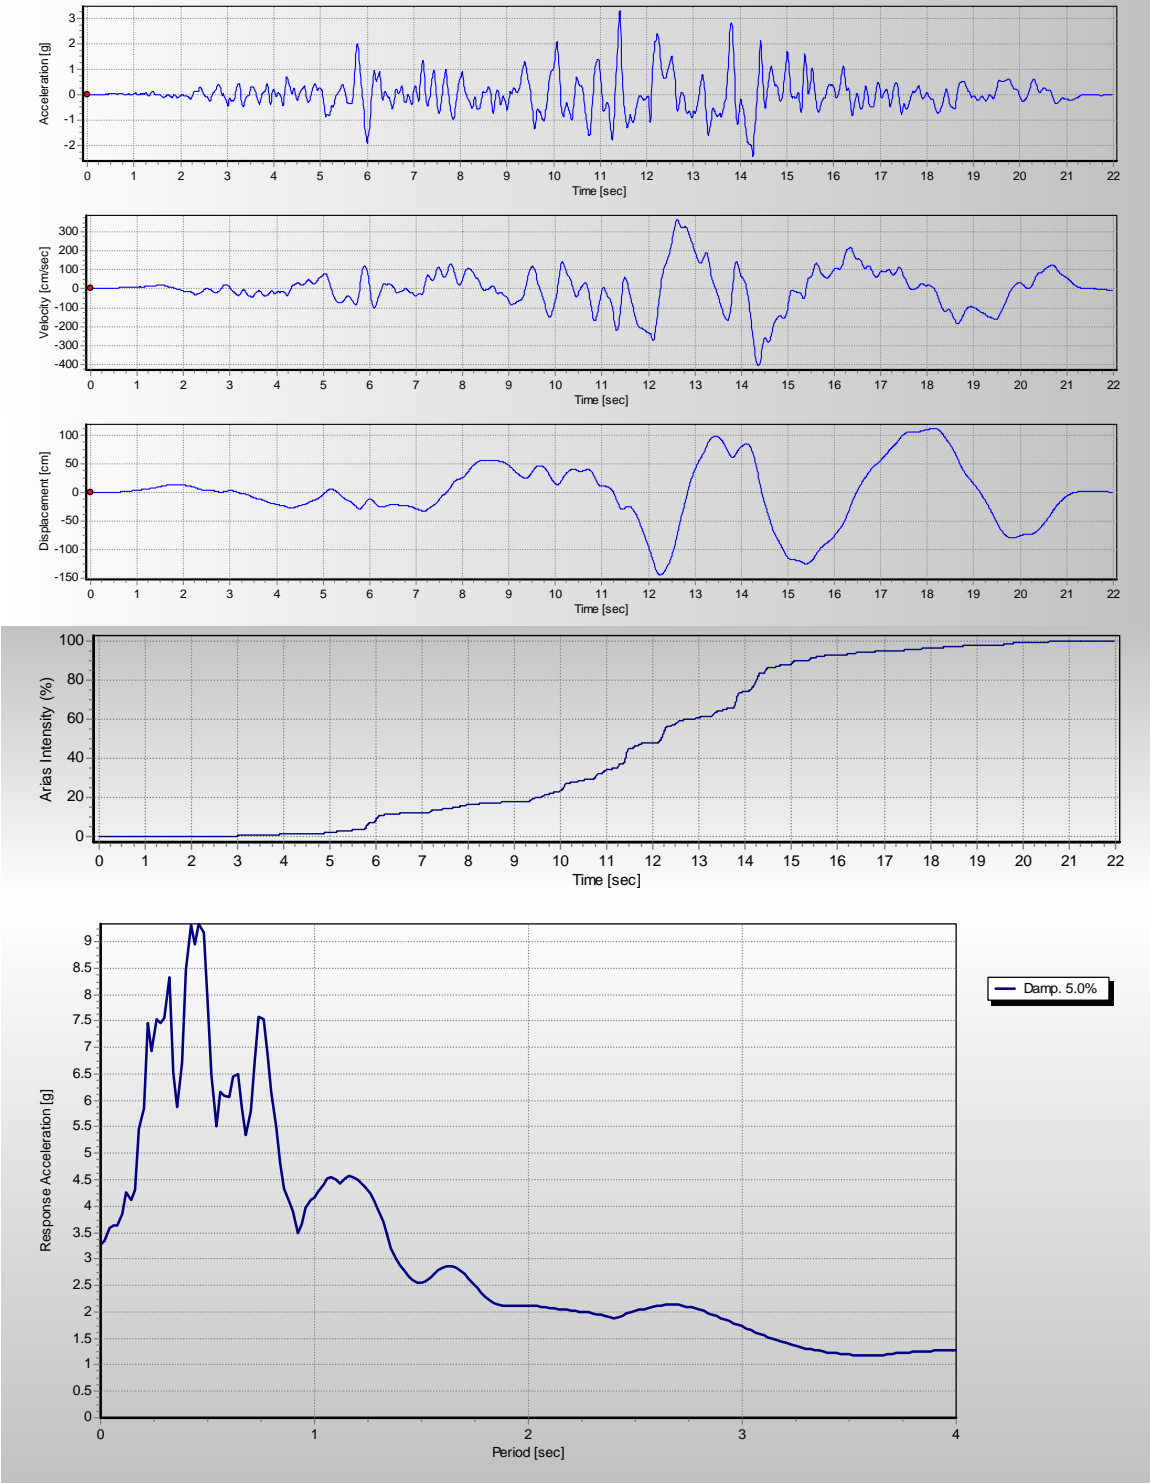
# Superstition Hills, Parachute T S

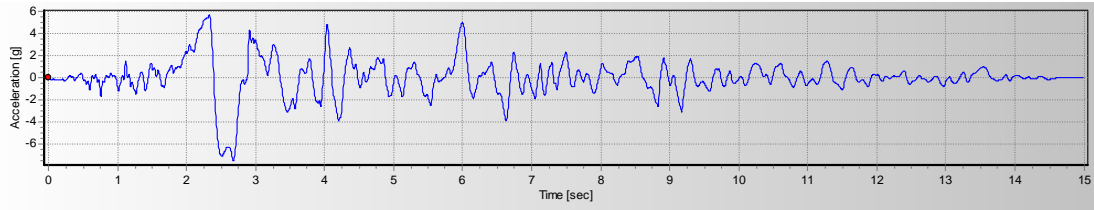
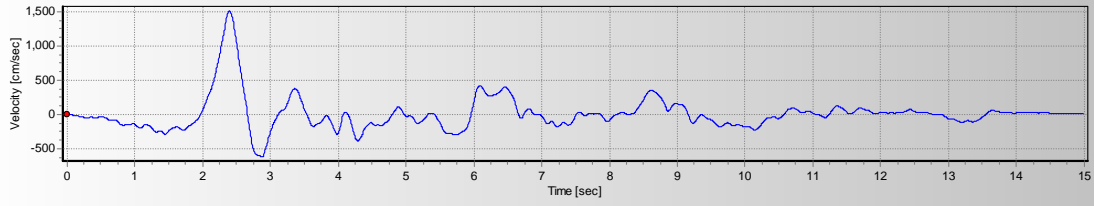
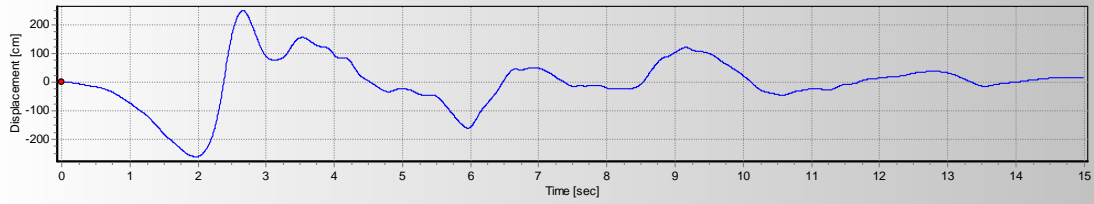
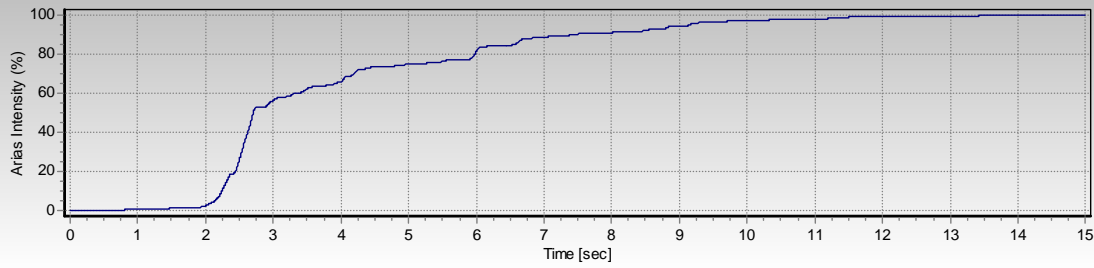
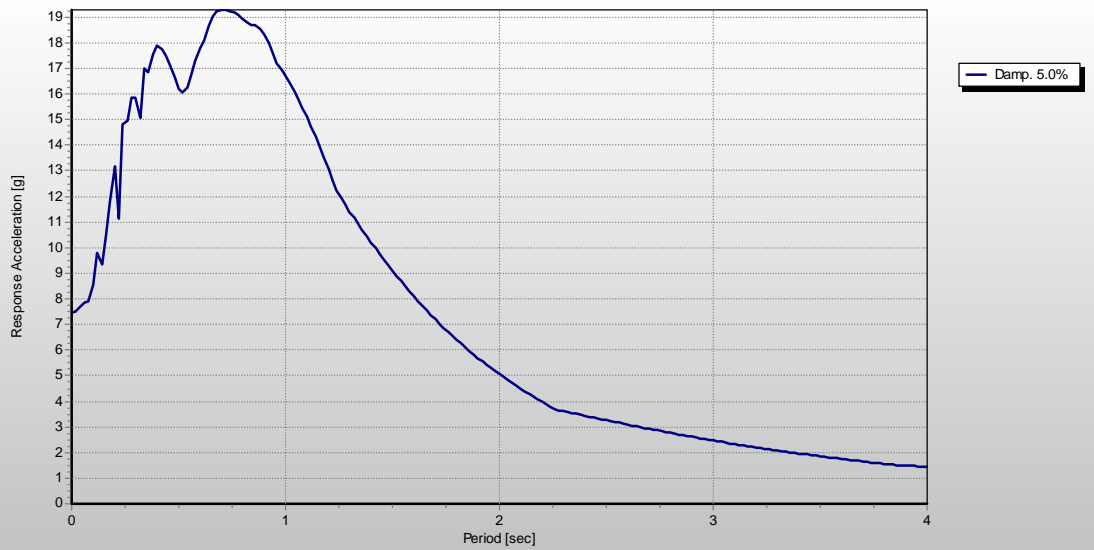
# 1994 Northridge, Rinaldi R Sta 228

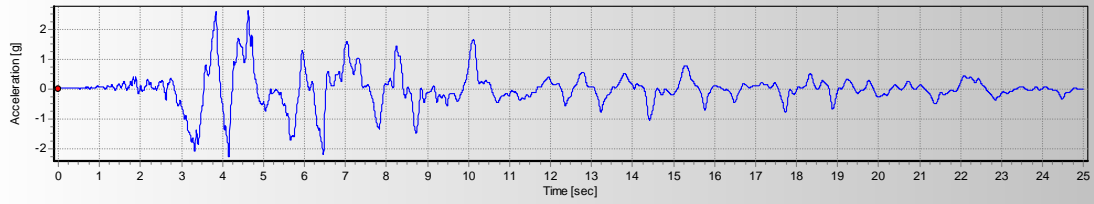
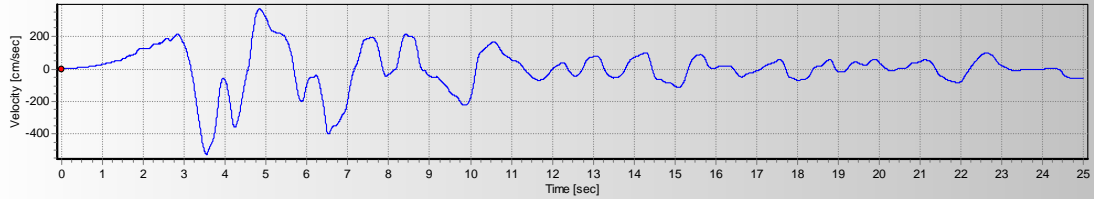
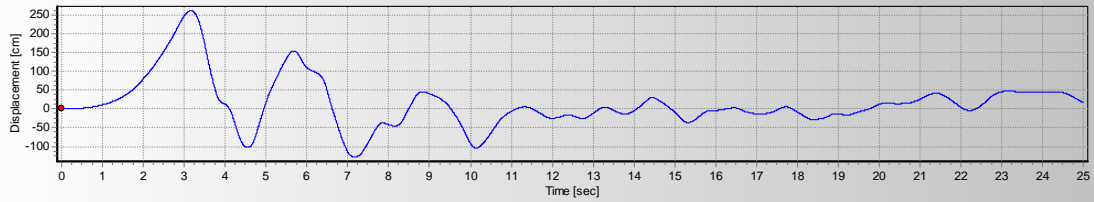
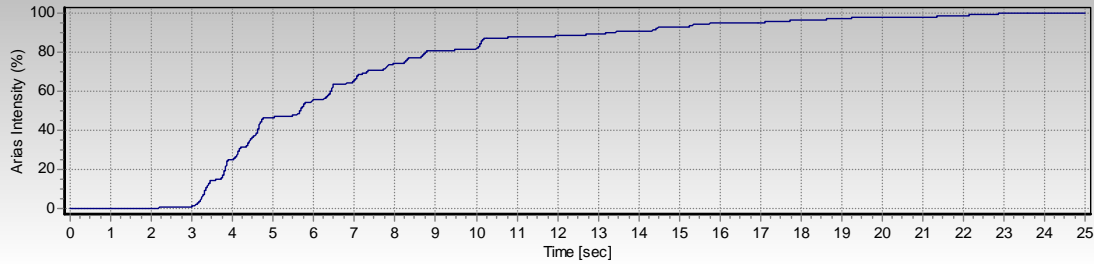
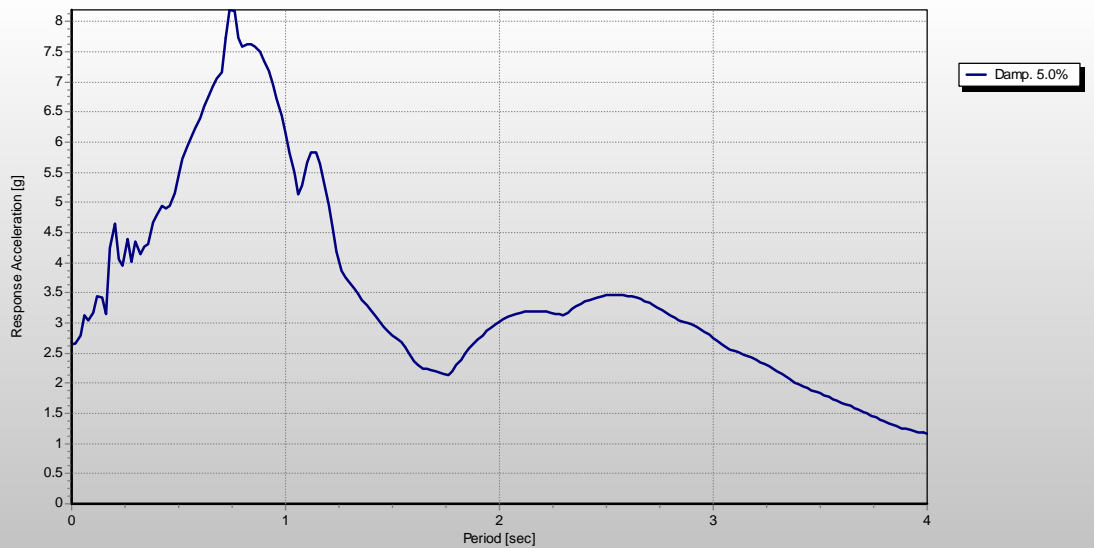
# 1994 Northridge, Sylmar – Conv Sta 052 scaled to 0.5x

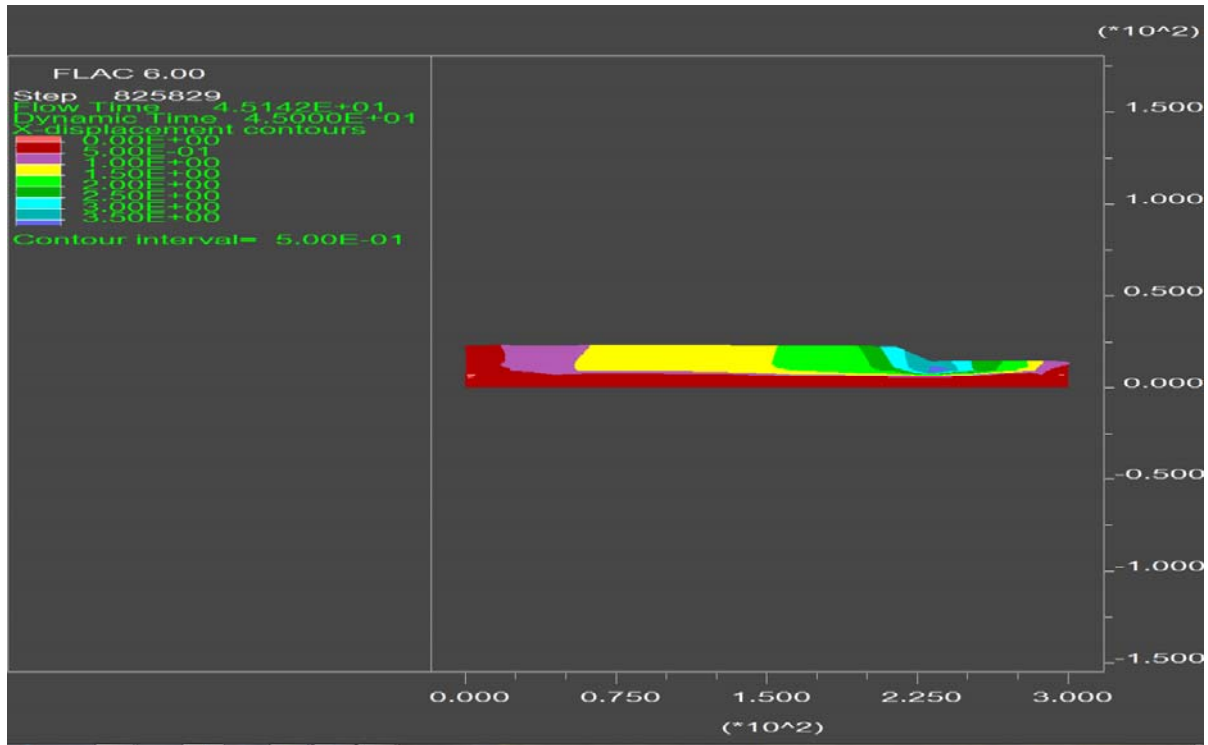
Figure 6B-1. Contours of calculated lateral displacement (9 m embankment height, 8 meter liquefiable silt layer, clean sand corrected  $(N_1)_{60-cs}$  blowcount of 8, ground motion = 92 Landers Joshua Tree 090 Scale 1.0x).

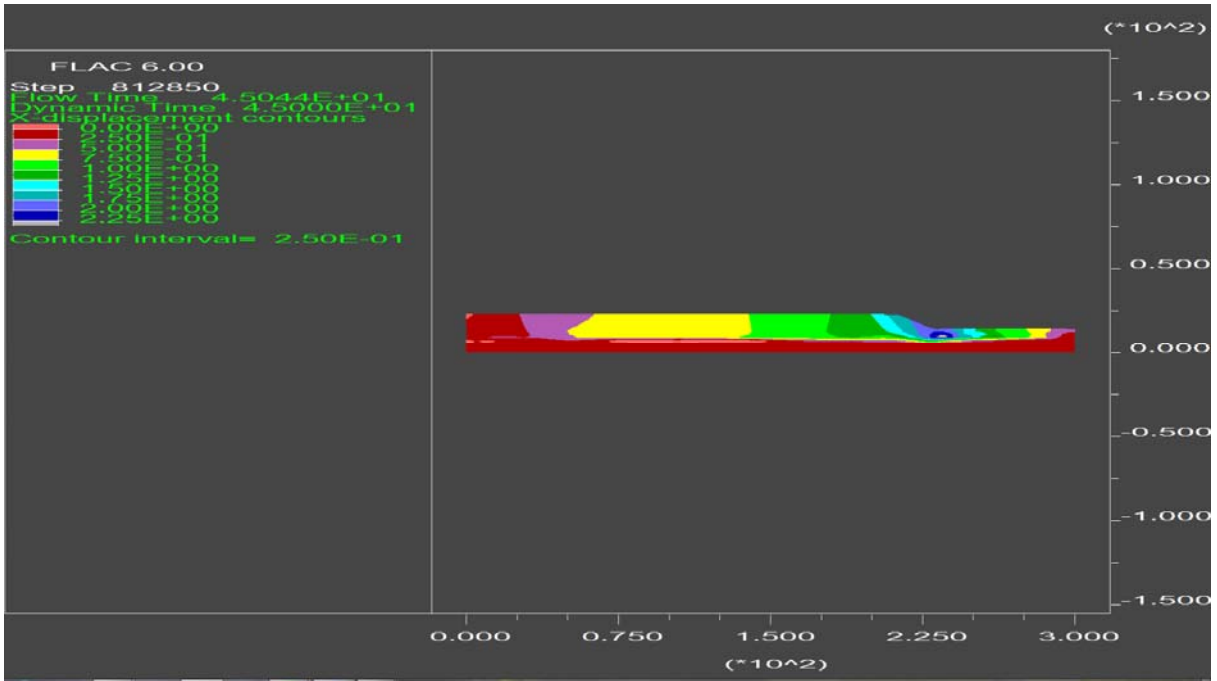
Figure 6B-2. Contours of calculated lateral displacement (9 m embankment height, 8 meter liquefiable silt layer, clean sand corrected  $(N_1)_{60-cs}$  blowcount of 15, ground motion = 92 Landers Joshua Tree 090 Scale 1.0x).

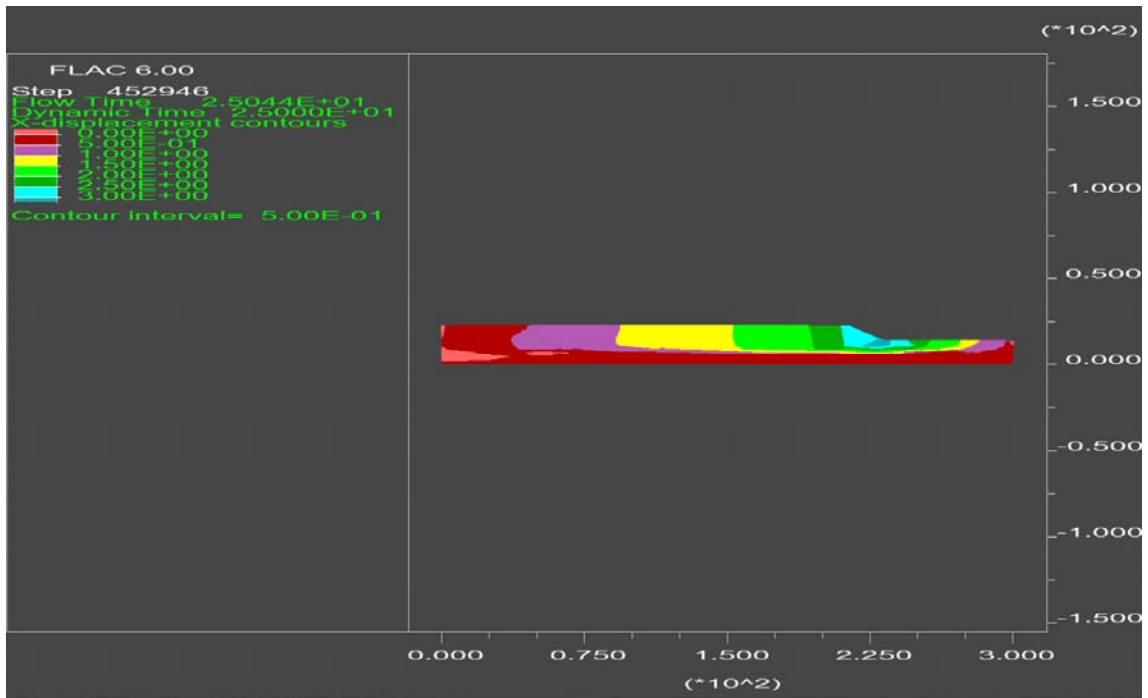
Figure 6B-3. Contours of calculated lateral displacement (9 m embankment height, 8 meter liquefiable silt layer, clean sand corrected  $(N_1)_{60-cs}$  blowcount of 15, ground motion = 94 Northridge Sylmar - Conv Sta 052 Scale 1.0x).

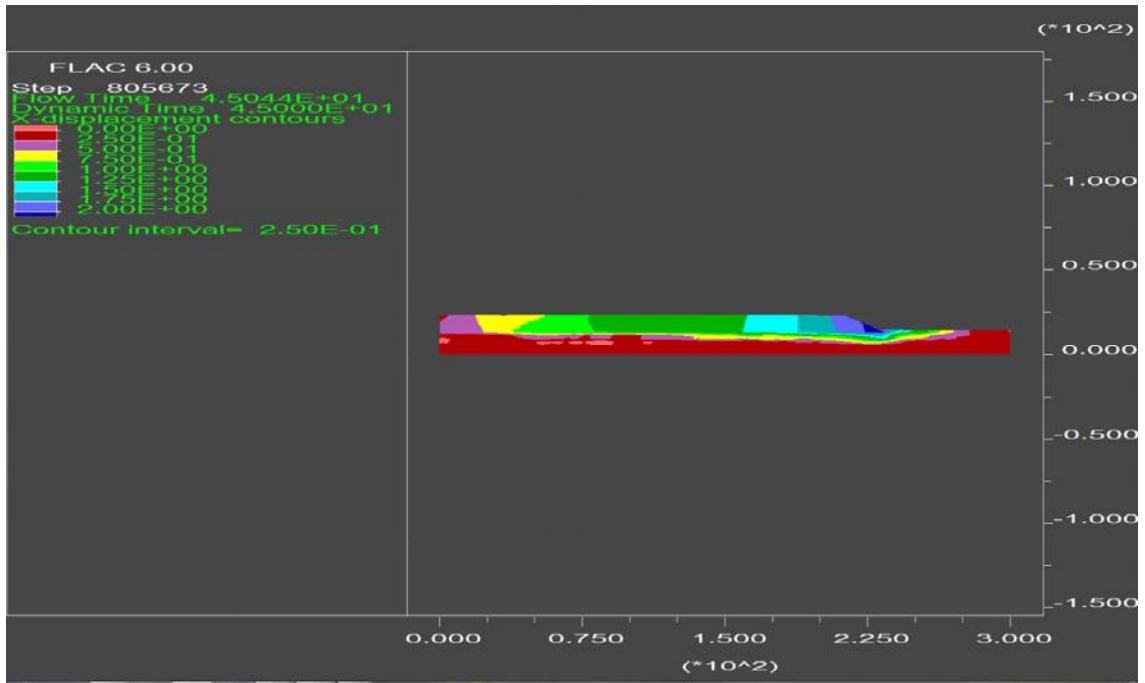
Figure 6B-4. Contours of calculated lateral displacement (9 m embankment height, 8 meter liquefiable sand layer, corrected  $(N_1)_{60}$  blowcount of 12, ground motion = 92 Landers Joshua Tree 090 Scale 1.0x).

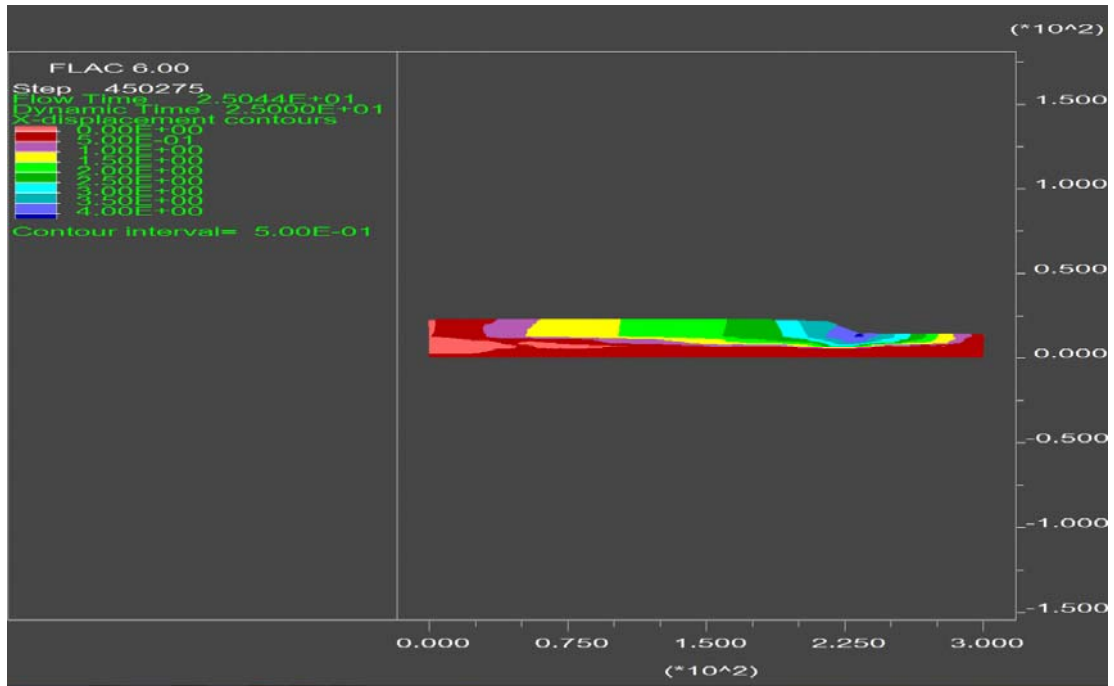
Figure 6B-5. Contours of calculated lateral displacement (9 m embankment height, 8 meter liquefiable sand layer, corrected  $(N_1)_{60}$  blowcount of 12, ground motion = 94 Northridge Sylmar - Conv Sta 052 Scale 1.0x).

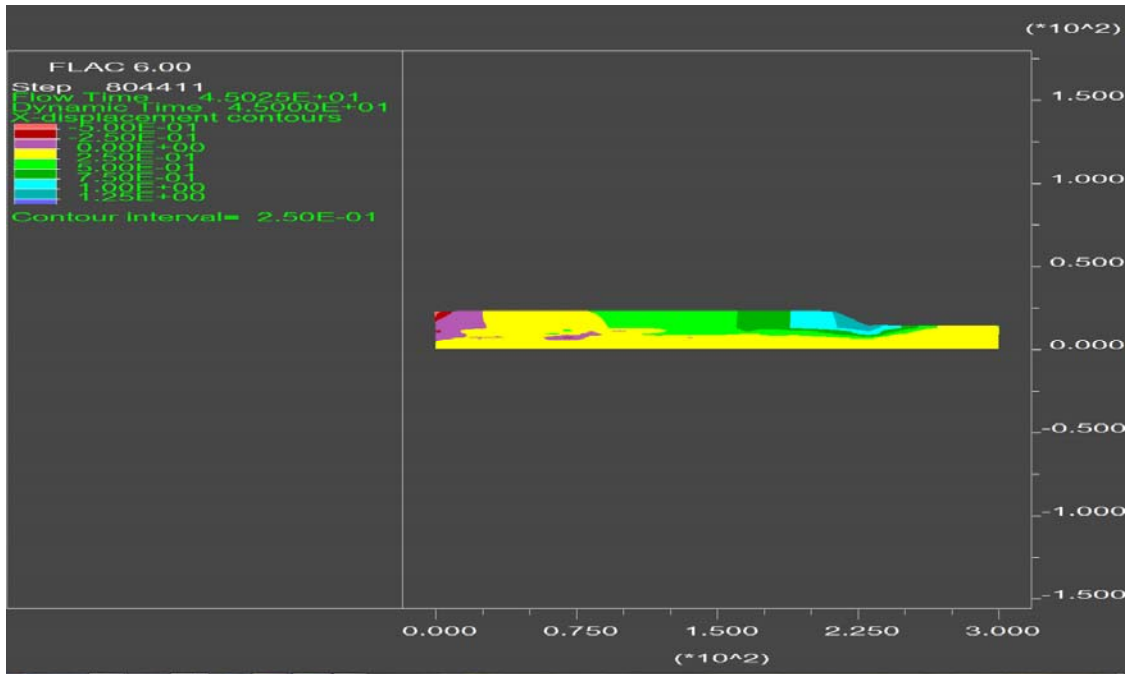
Figure 6B-6. Contours of calculated lateral displacement (9 m embankment height, 8 meter liquefiable sand layer, corrected  $(N_1)_{60}$  blowcount of 20, ground motion = 92 Landers Joshua Tree 090 Scale 1.0x).

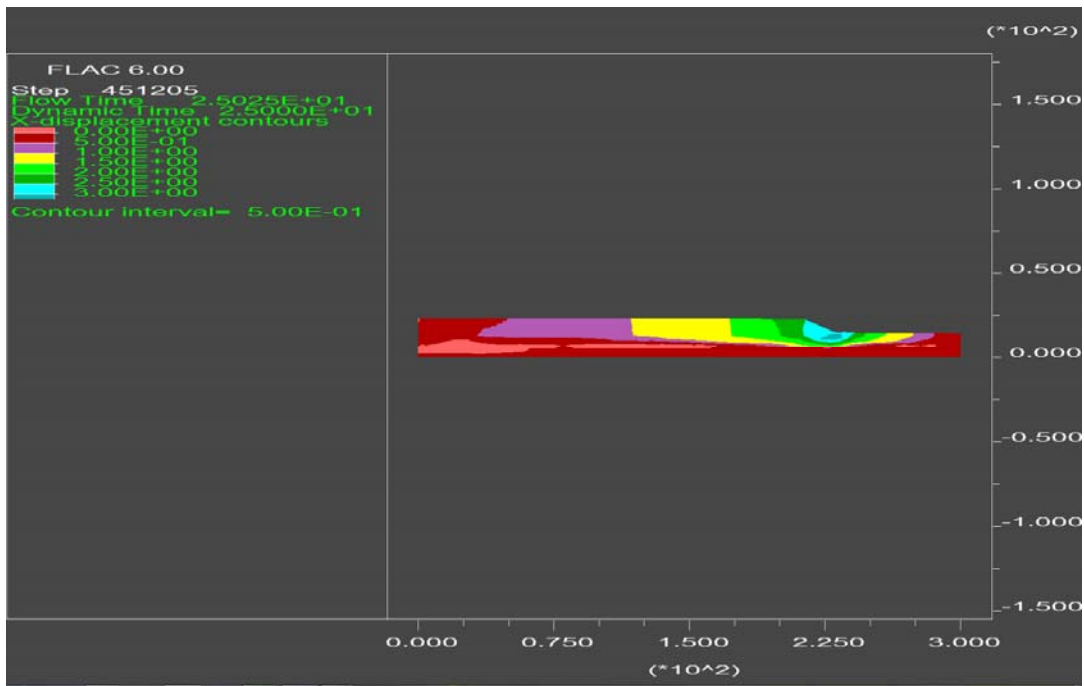
Figure 6B-7. Contours of calculated lateral displacement (9 m embankment height, 8 meter liquefiable sand layer, corrected  $(N_1)_{60}$  blowcount of 20, ground motion = 94 Northridge Sylmar - Conv Sta 052 Scale 1.0x).

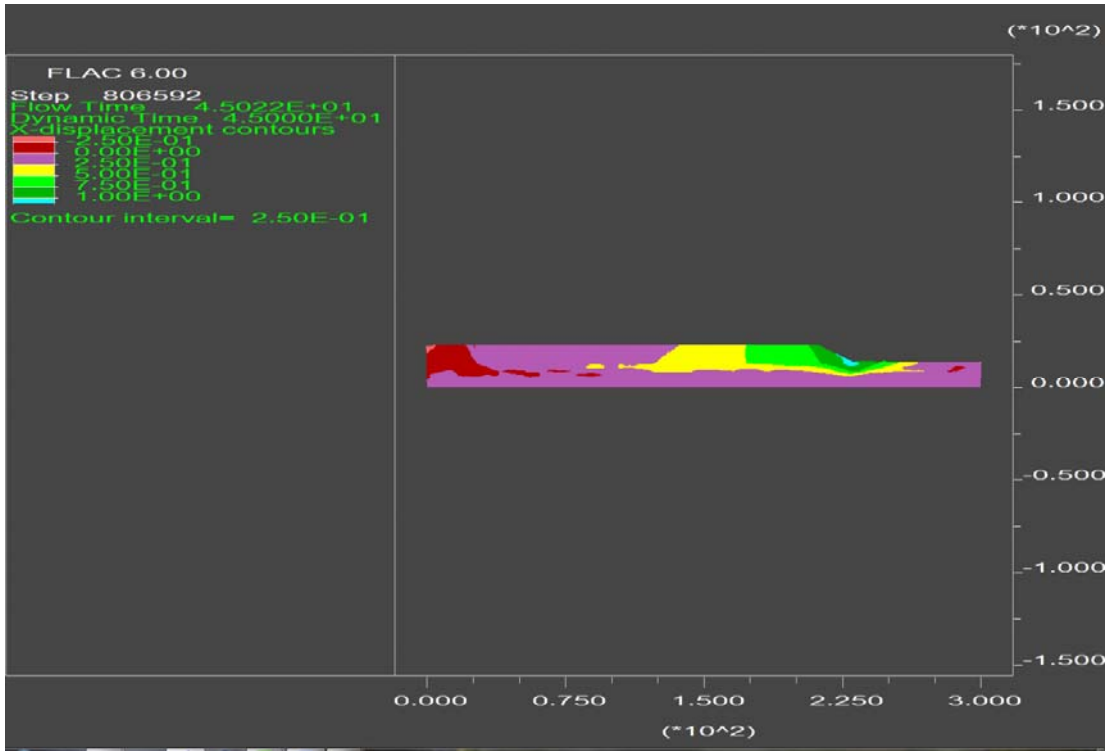
Figure 6B-8. Contours of calculated lateral displacement (9 m embankment height, 8 meter liquefiable sand layer, corrected  $(N_1)_{60}$  blowcount of 25, ground motion = 92 Landers Joshua Tree 090 Scale 1.0x).
