Static and Seismic Performance of California Levees

Michelle Jennifer Shriro

Doctor of Philosophy

Engineering - Civil and Environmental Engineering

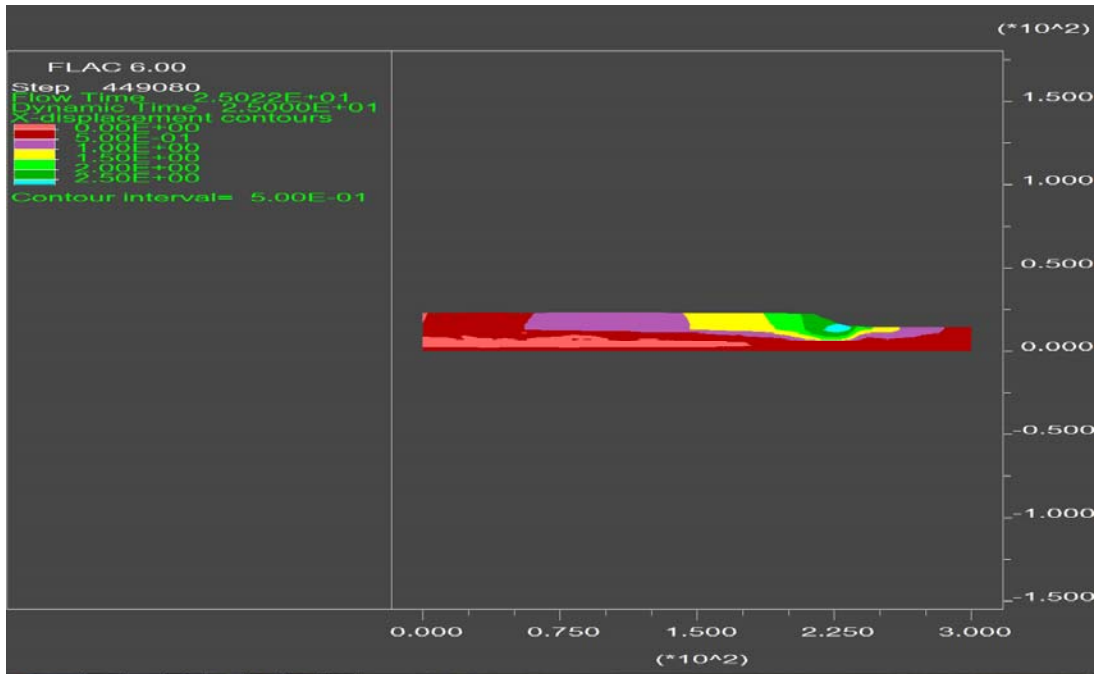
Figure 6B-9. Contours of calculated lateral displacement (9 m embankment height, 8 meter liquefiable sand layer, corrected  $(N_1)_{60}$  blowcount of 25, ground motion = 94 Northridge Sylmar - Conv Sta 052 Scale 1.0x).

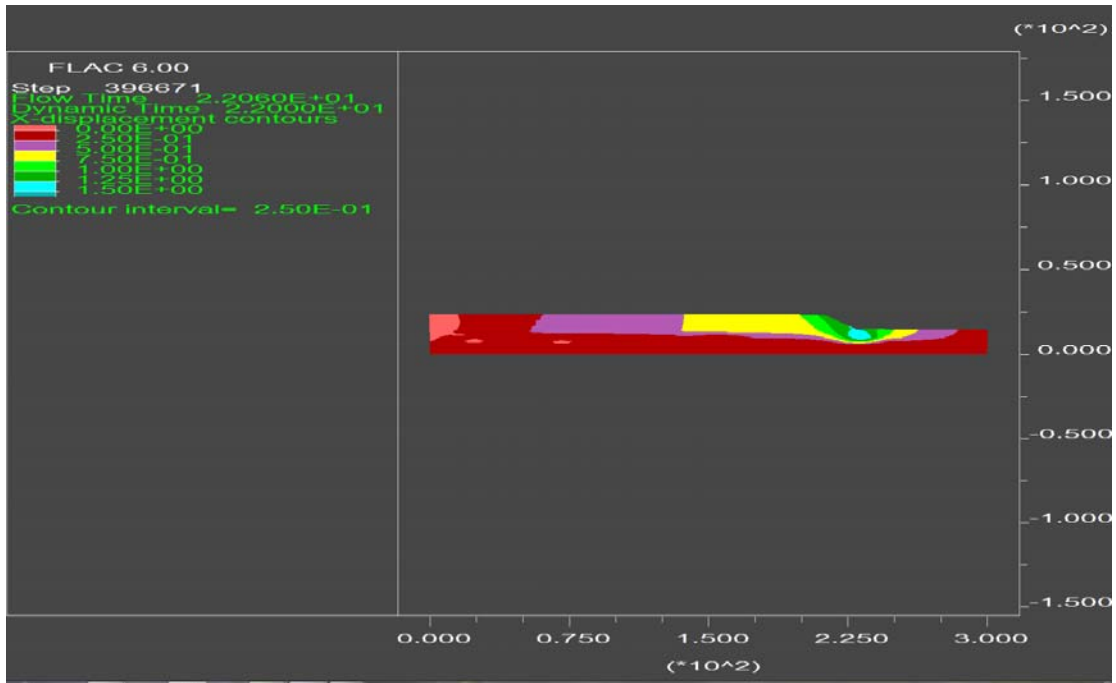
Figure 6B-10. Contours of calculated lateral displacement (9 m embankment height, 8 meter liquefiable sand layer, corrected  $(N_1)_{60}$  blowcount of 8, ground motion = 87 Superstition Hills Superstition Mtn Cam 045)

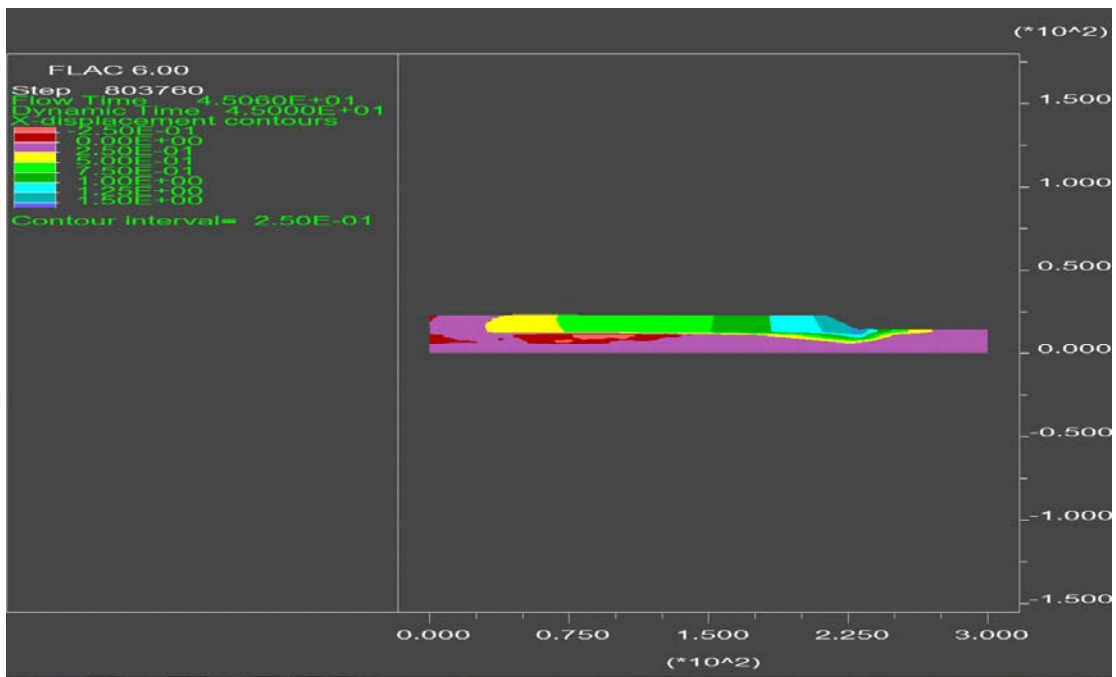
Figure 6B-11. Contours of calculated lateral displacement (9 m embankment height, 8 meter liquefiable sand layer, corrected  $(N_1)_{60}$  blowcount of 8, ground motion = 92 Landers Joshua Tree 090 Scale 0.75x).

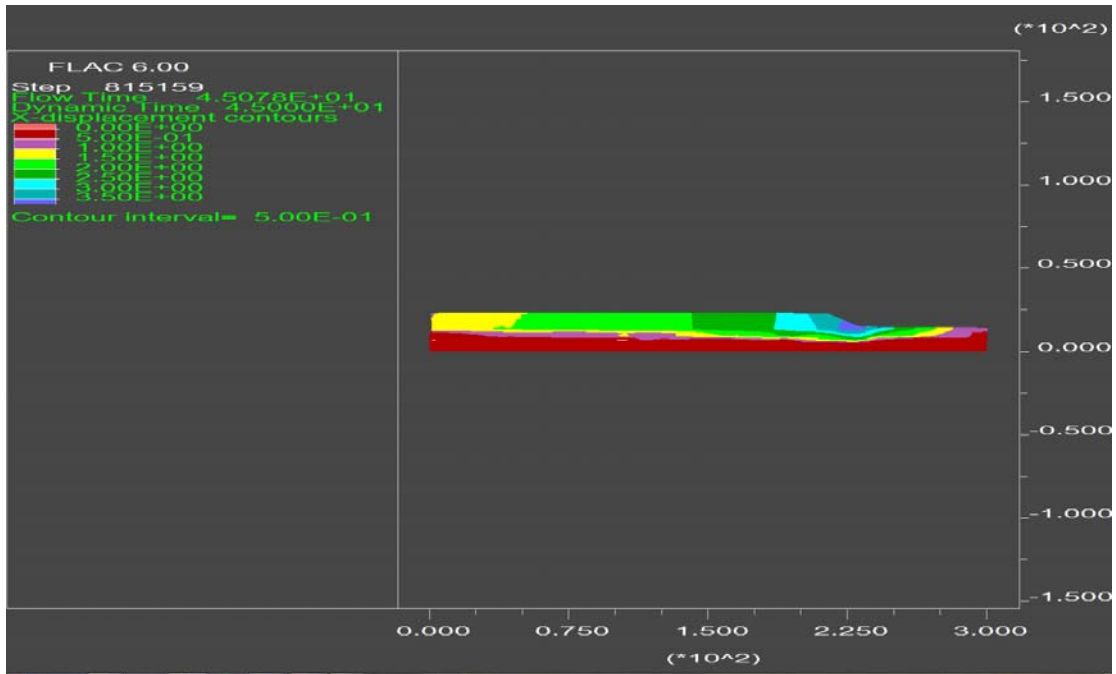
Figure 6B-12. Contours of calculated lateral displacement (9 m embankment height, 8 meter liquefiable sand layer, corrected  $(N_1)_{60}$  blowcount of 8, ground motion = 92 Landers Joshua Tree 090 Scale 1.5x).

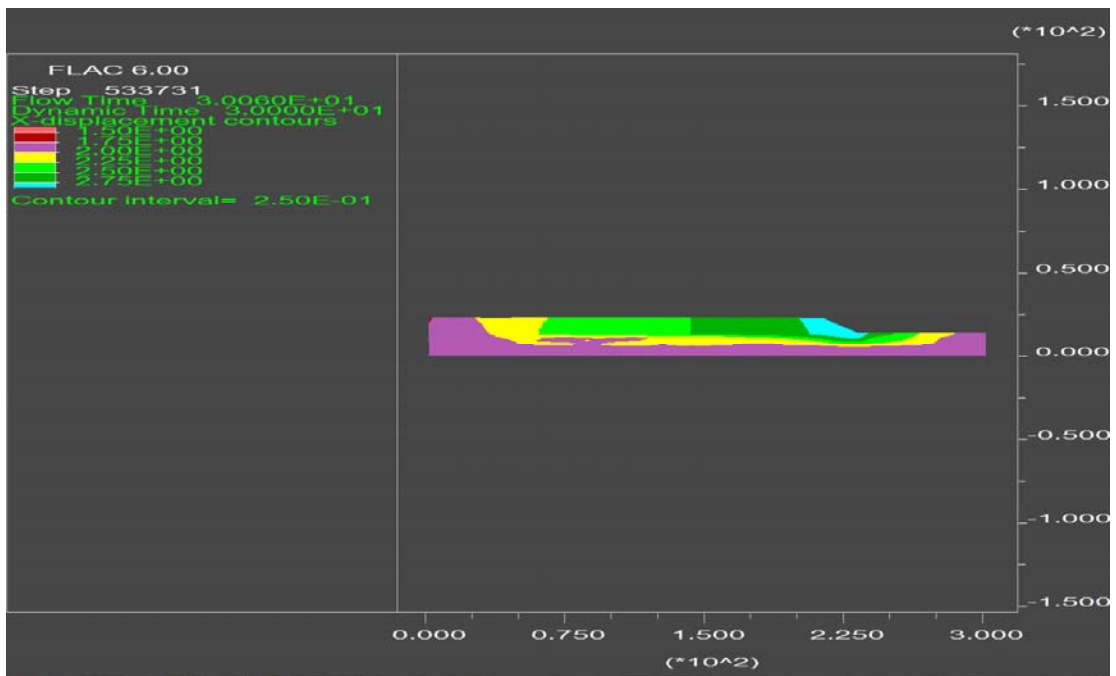
Figure 6B-13. Contours of calculated lateral displacement (9 m embankment height, 8 meter liquefiable sand layer, corrected  $(N_1)_{60}$  blowcount of 8, ground motion = 92 Landers Lucerne 260)

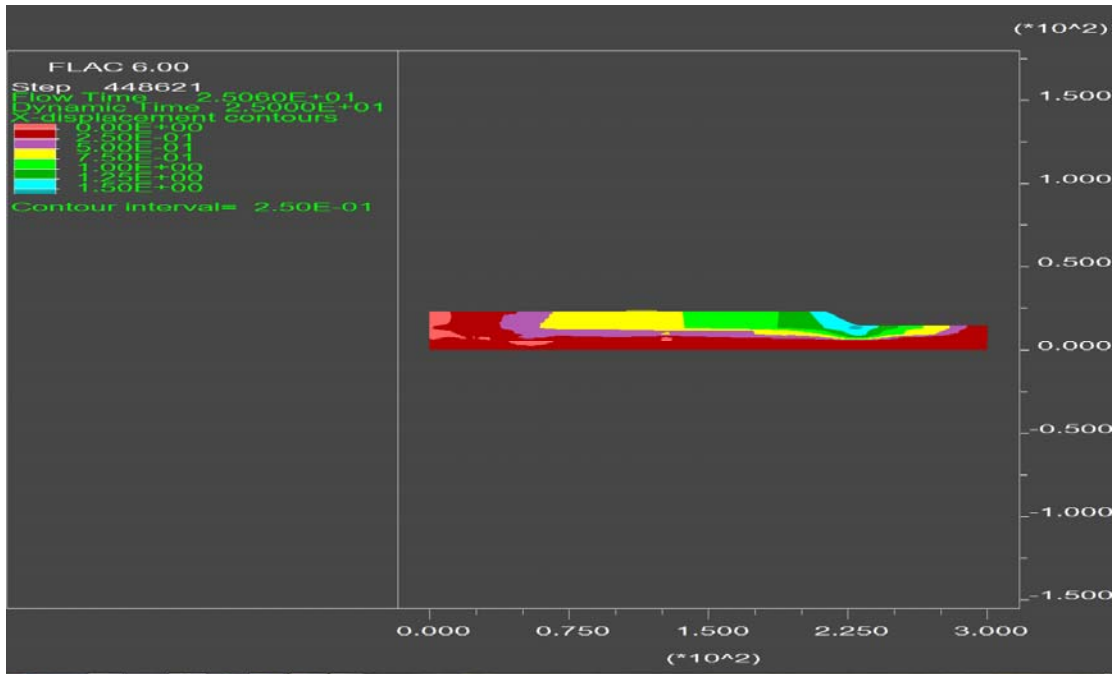
Figure 6B-14. Contours of calculated lateral displacement (9 m embankment height, 8 meter liquefiable sand layer, corrected  $(N_1)_{60}$  blowcount of 8, ground motion = 89 Loma Prieta LGPC 090)

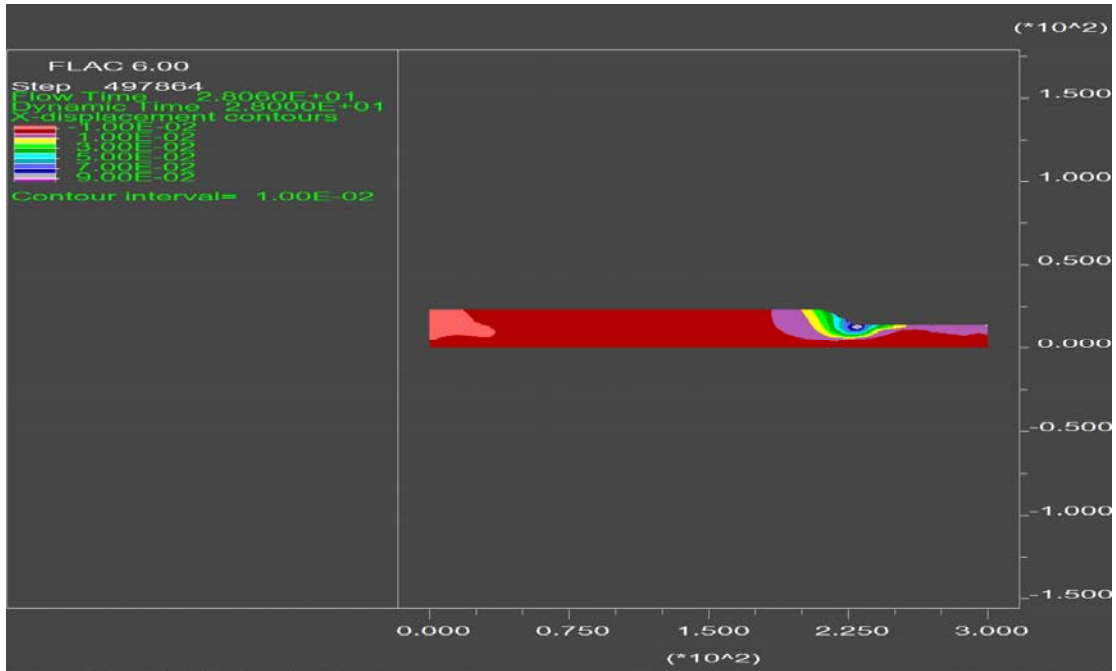
Figure 6B-15. Contours of calculated lateral displacement (9 m embankment height, 8 meter liquefiable sand layer, corrected  $(N_1)_{60}$  blowcount of 8, ground motion = 71 San Fernando LA Hollywood Stor Lot 180)

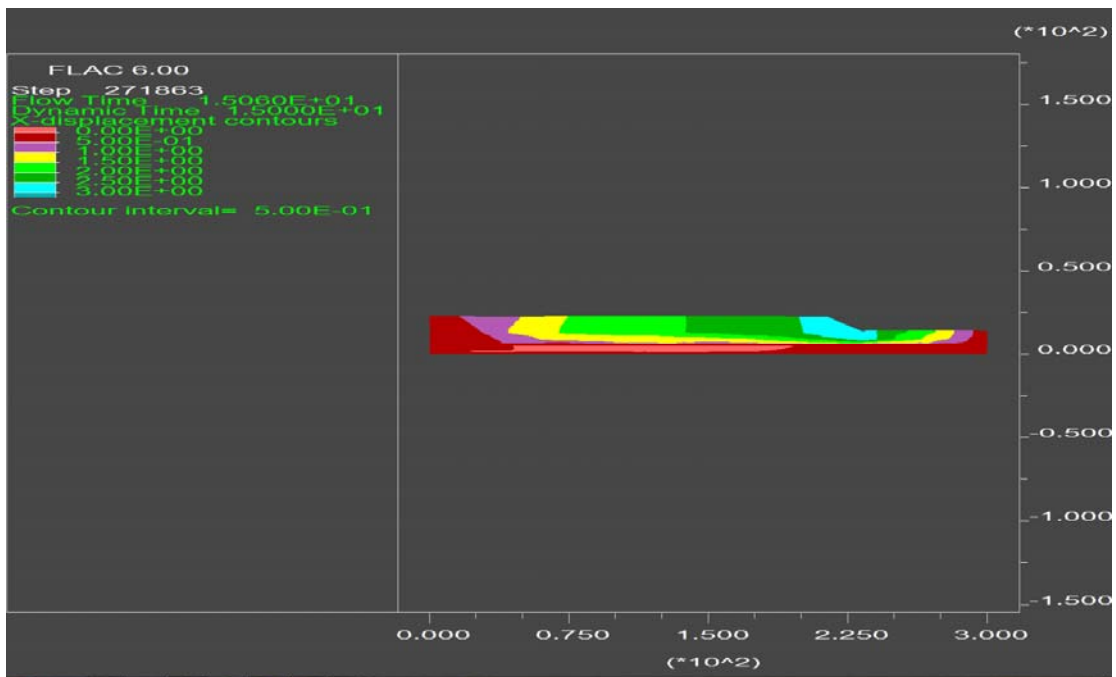
Figure 6B-16. Contours of calculated lateral displacement (9 m embankment height, 8 meter liquefiable sand layer, corrected  $(N_1)_{60}$  blowcount of 8, ground motion = 87 Superstition Hills Parachute T S 315 )

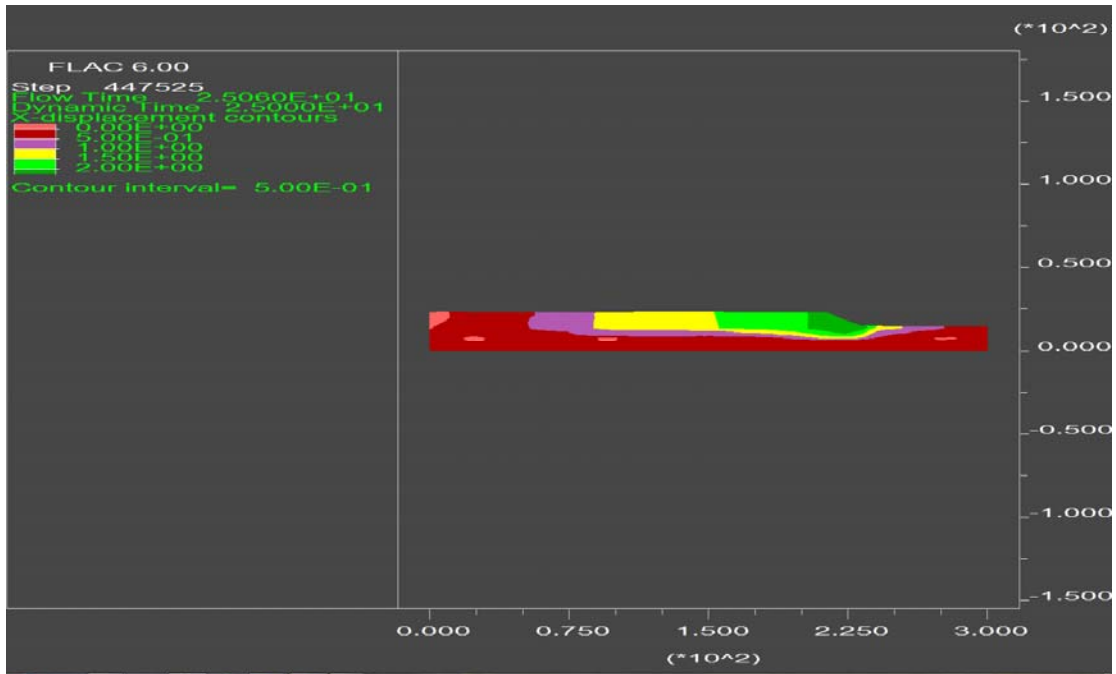
Figure 6B-17. Contours of calculated lateral displacement (9 m embankment height, 8 meter liquefiable sand layer, corrected  $(N_1)_{60}$  blowcount of 8, ground motion = 94 Northridge Rinaldi R Sta 228)

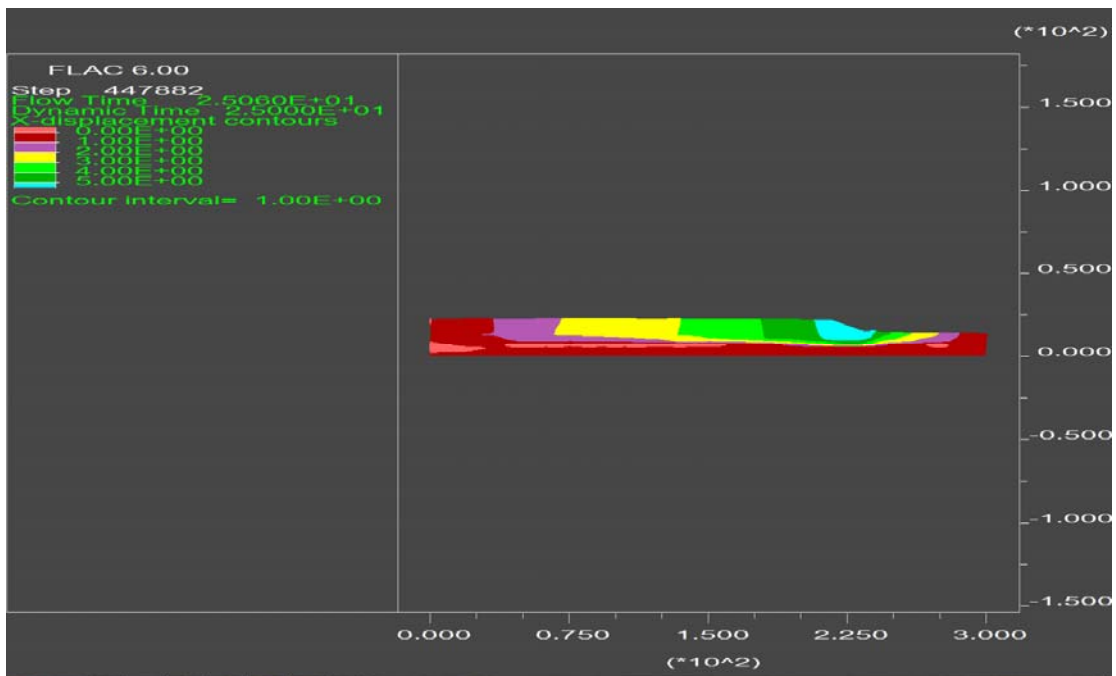
Figure 6B-18. Contours of calculated lateral displacement (9 m embankment height, 8 meter liquefiable sand layer, corrected  $(N_1)_{60}$  blowcount of 8, ground motion = 94 Northridge Sylmar - Conv Sta 052 Scale 0.5x)

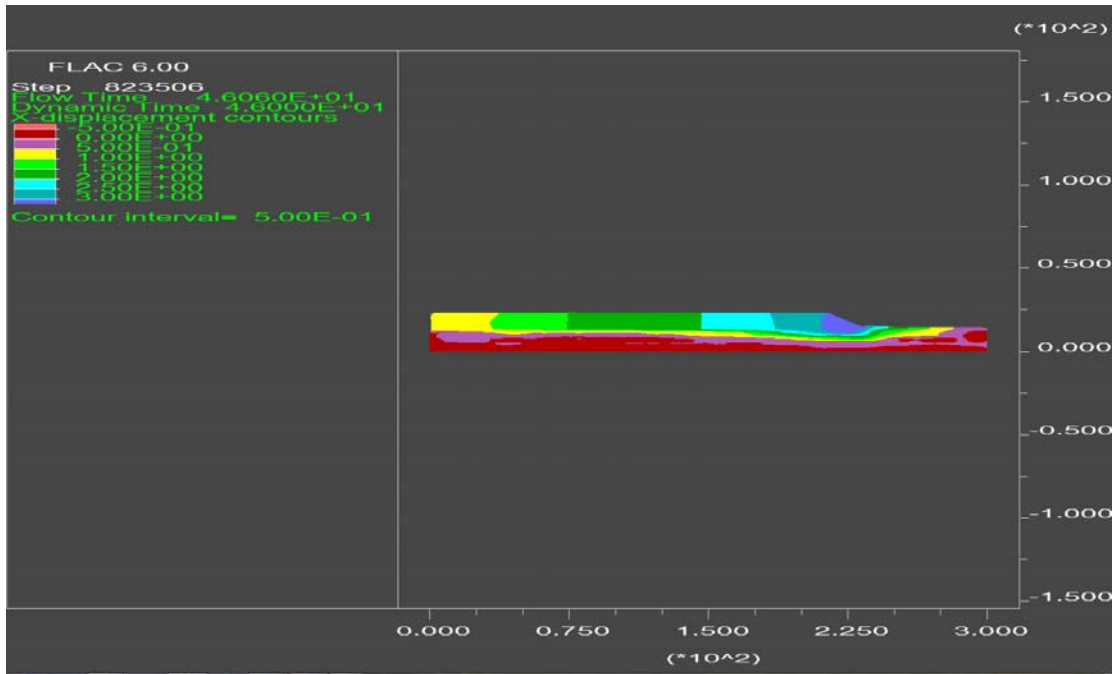
Figure 6B-19. Contours of calculated lateral displacement (9 m embankment height, 8 meter liquefiable sand layer, corrected  $(N_1)_{60}$  blowcount of 8, ground motion = 94 Northridge Sylmar - Conv Sta 052 Scale 1.25x)

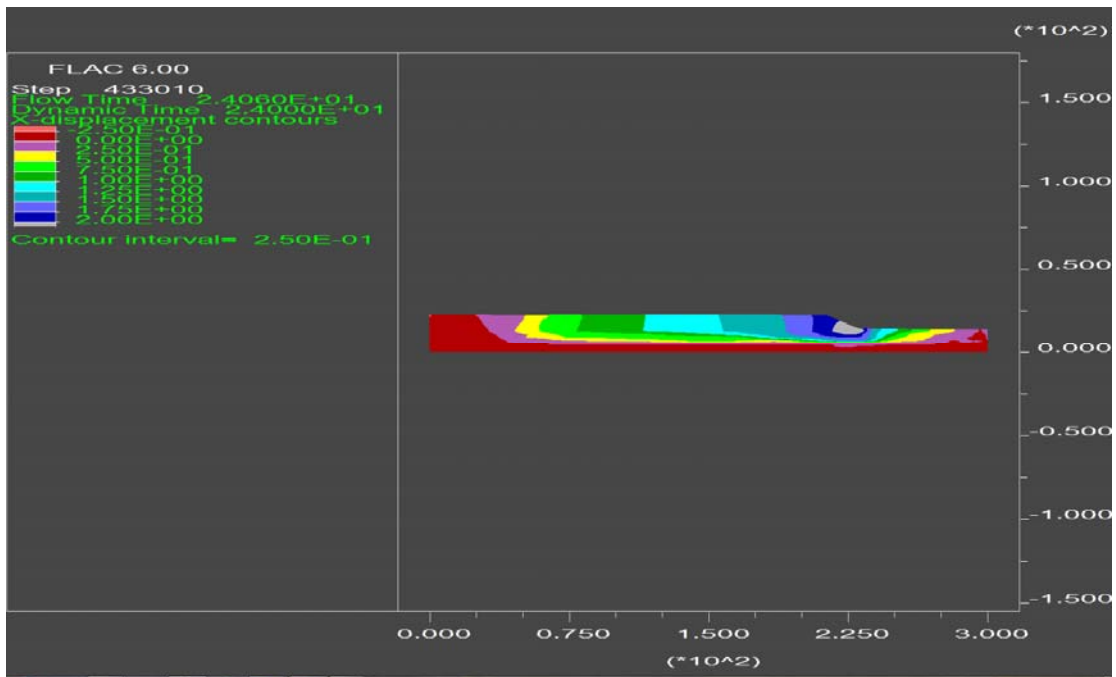
Figure 6B-20. Contours of calculated lateral displacement (9 m embankment height, 8 meter liquefiable sand layer, corrected  $(N_1)_{60}$  blowcount of 8, ground motion = 99 Chi Chi TCU078 270 (E))

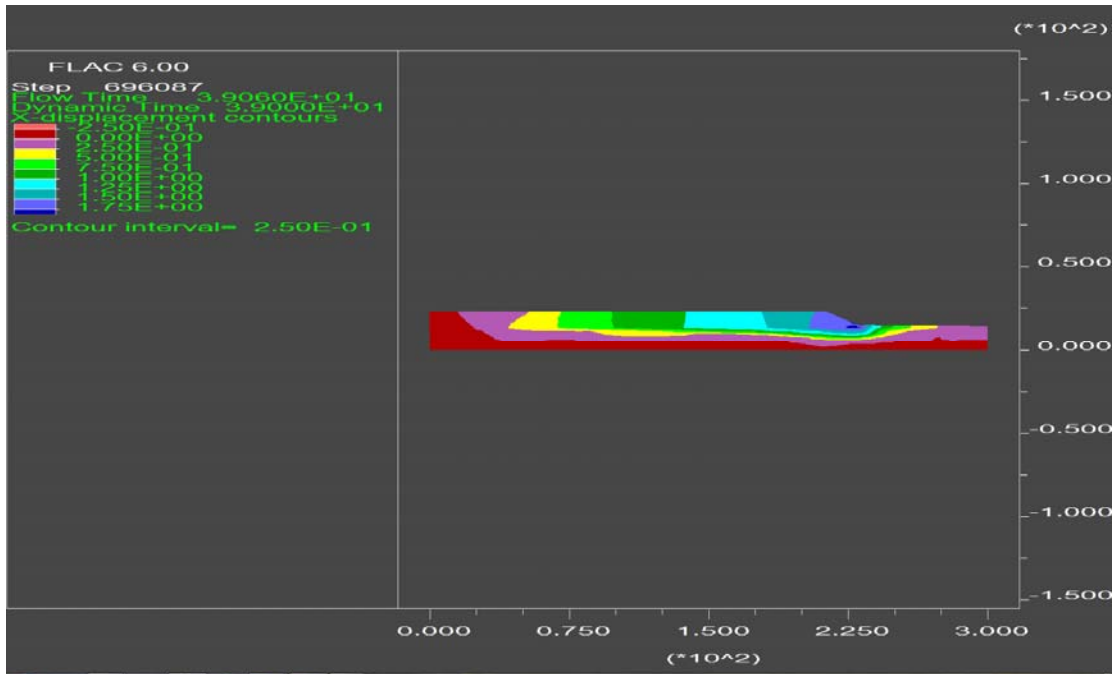
Figure 6B-21. Contours of calculated lateral displacement (9 m embankment height, 8 meter liquefiable sand layer, corrected  $(N_1)_{60}$  blowcount of 8, ground motion = 94 Northridge Newhall - W Pico Cany 046)

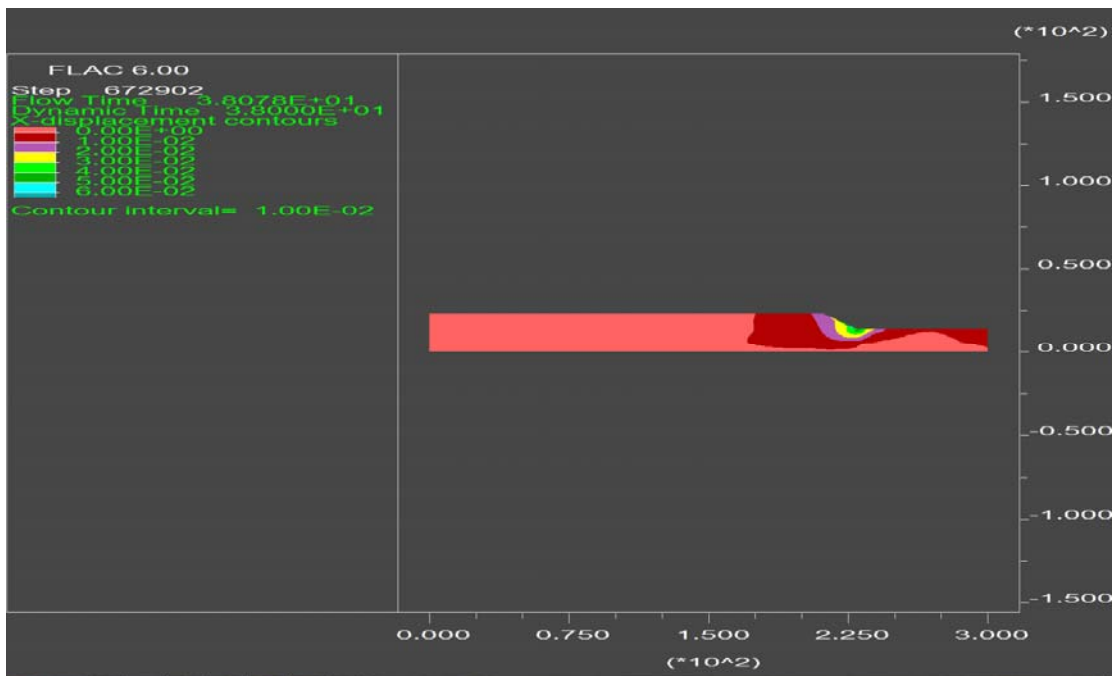
Figure 6B-22. Contours of calculated lateral displacement (9 m embankment height, 8 meter liquefiable sand layer, corrected  $(N_1)_{60}$  blowcount of 8, ground motion = 89 Loma Prieta Saratoga WV Coll 270)

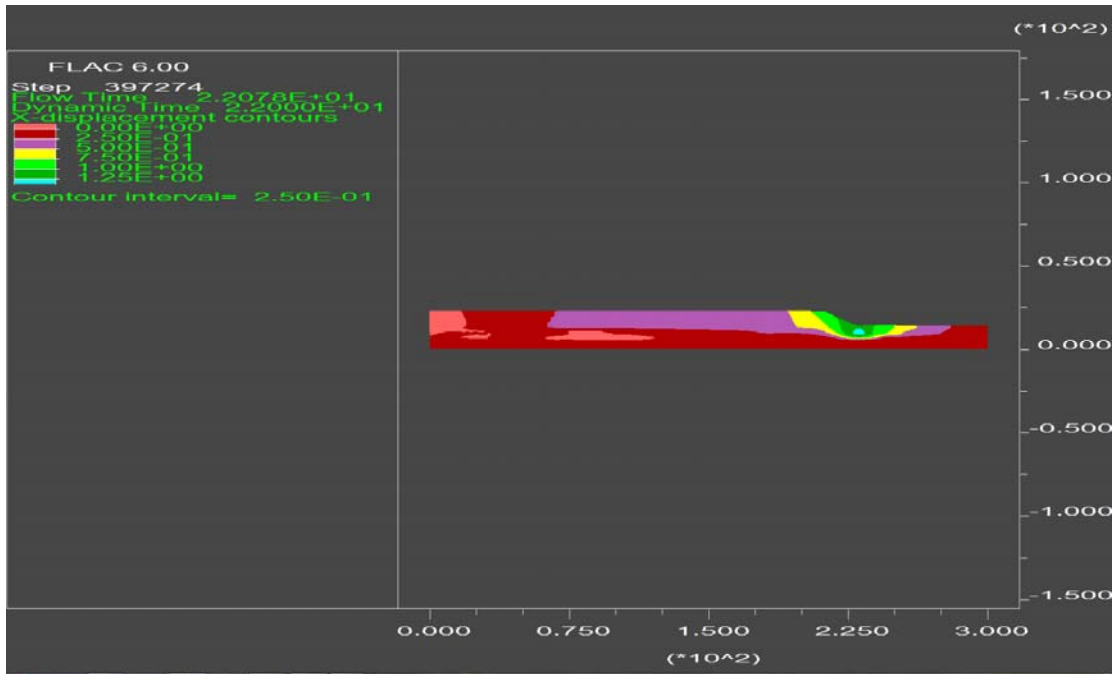
Figure 6B-23. Contours of calculated lateral displacement (9 m embankment height, 8 meter liquefiable sand layer, corrected  $(N_1)_{60}$  blowcount of 15, ground motion = 79 Imperial Valley Brawley Airport)

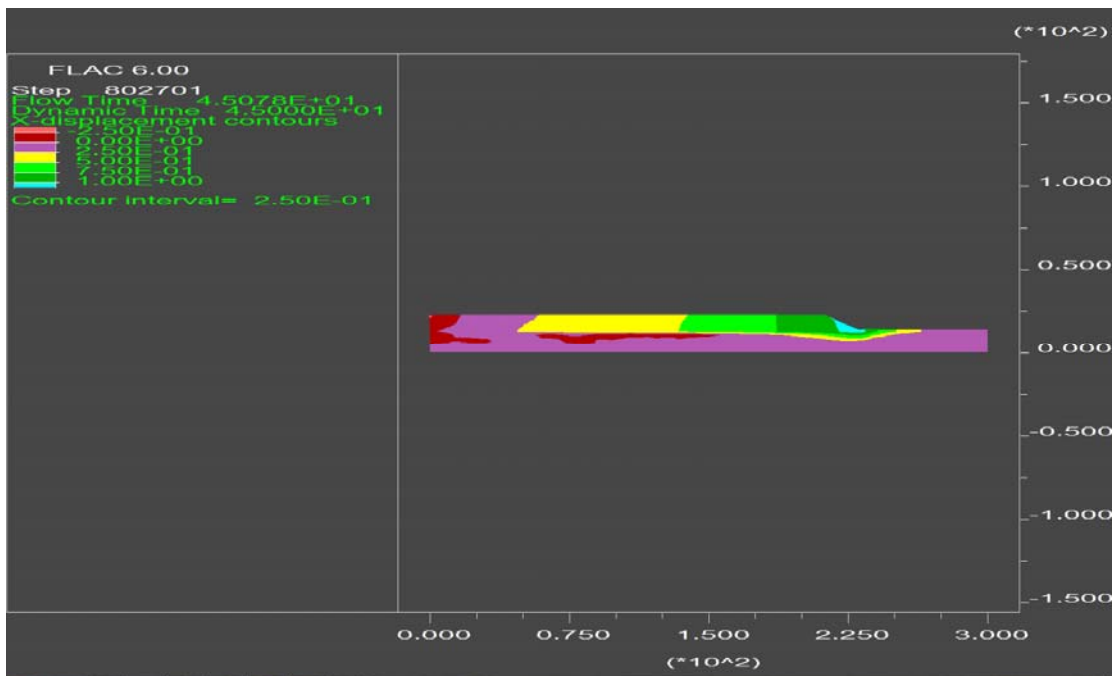
Figure 6B-24. Contours of calculated lateral displacement (9 m embankment height, 8 meter liquefiable sand layer, corrected  $(N_1)_{60}$  blowcount of 15, ground motion = 87 Superstition Hills Superstition Mtn Cam 045)

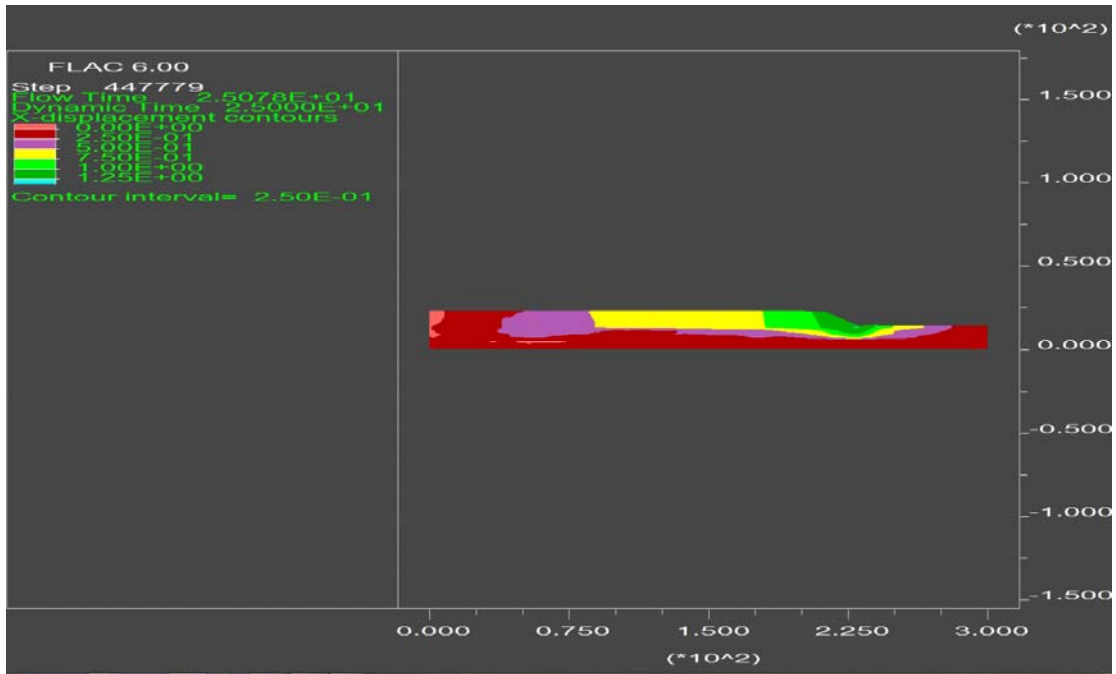
Figure 6B-25. Contours of calculated lateral displacement (9 m embankment height, 8 meter liquefiable sand layer, corrected  $(N_1)_{60}$  blowcount of 15, ground motion = 92 Landers Joshua Tree 090 Scale 0.75x).

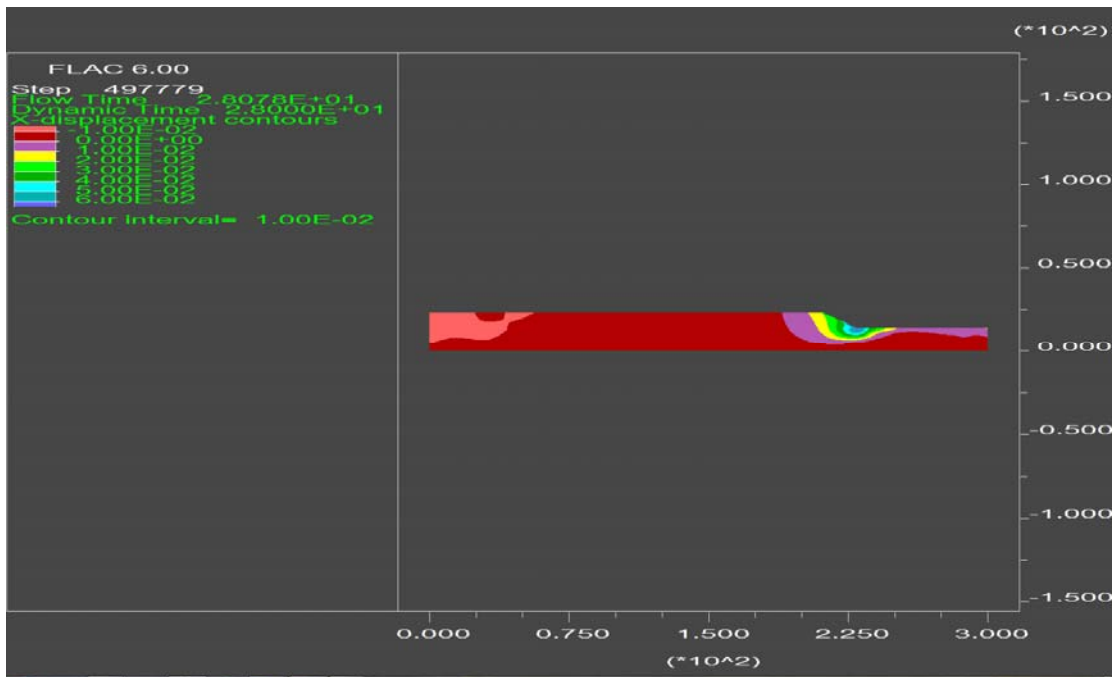
Figure 6B-28. Contours of calculated lateral displacement (9 m embankment height, 8 meter liquefiable sand layer, corrected  $(N_1)_{60}$  blowcount of 15, ground motion = 89 Loma Prieta LGPC 090)

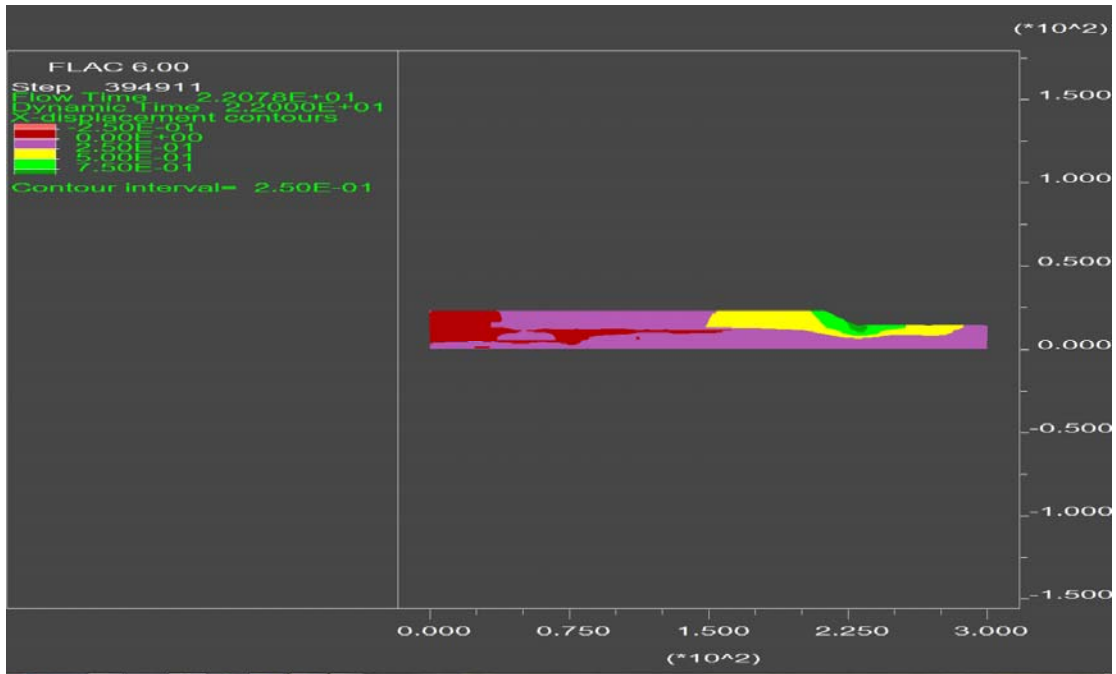
Figure 6B-29. Contours of calculated lateral displacement (9 m embankment height, 8 meter liquefiable sand layer, corrected  $(N_1)_{60}$  blowcount of 15, ground motion = 71 San Fernando LA Hollywood Stor Lot 180)

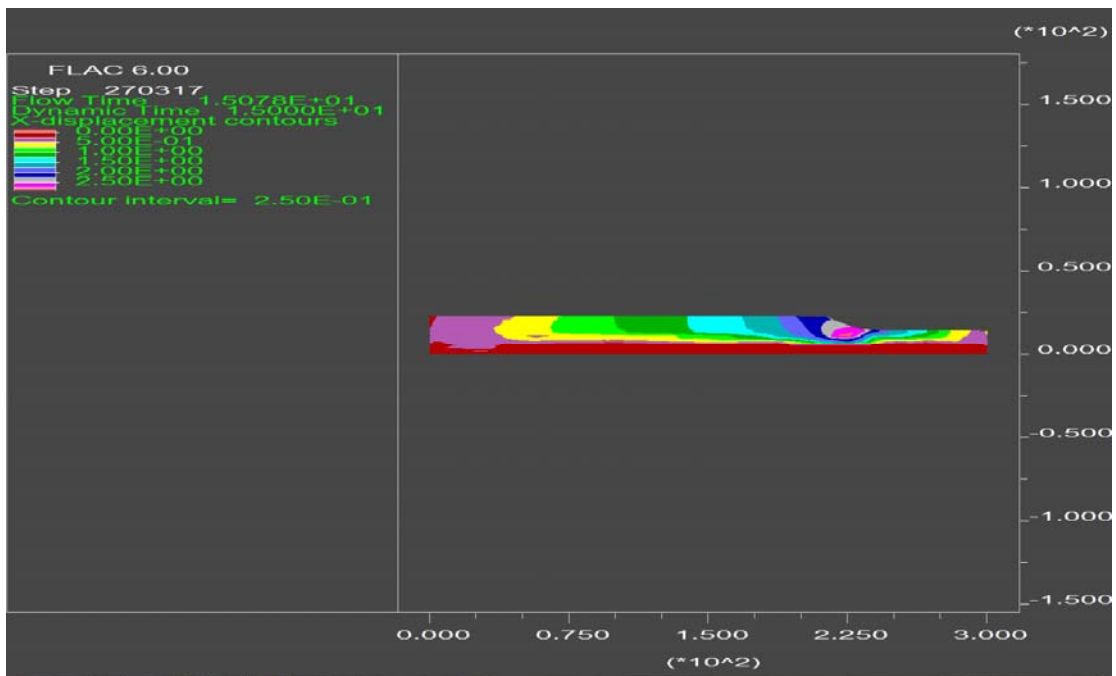
Figure 6B-30. Contours of calculated lateral displacement (9 m embankment height, 8 meter liquefiable sand layer, corrected  $(N_1)_{60}$  blowcount of 15, ground motion = 87 Superstition Hills Parachute T S 315)

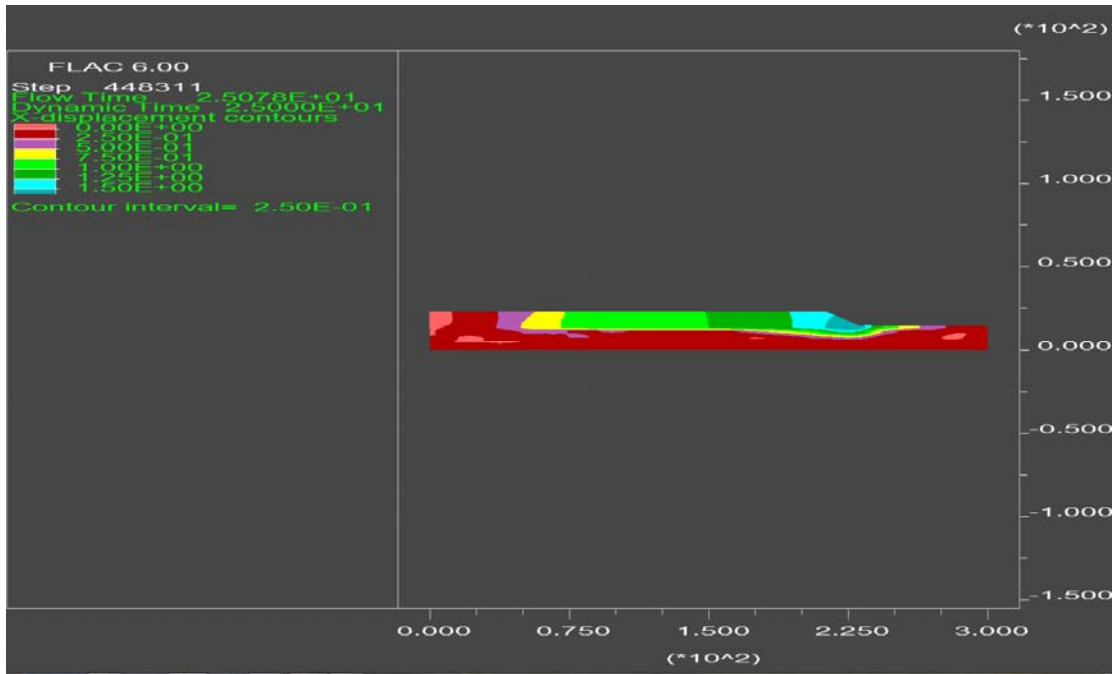
Figure 6B-31. Contours of calculated lateral displacement (9 m embankment height, 8 meter liquefiable sand layer, corrected  $(N_1)_{60}$  blowcount of 15, ground motion = 94 Northridge Rinaldi R Sta 228)

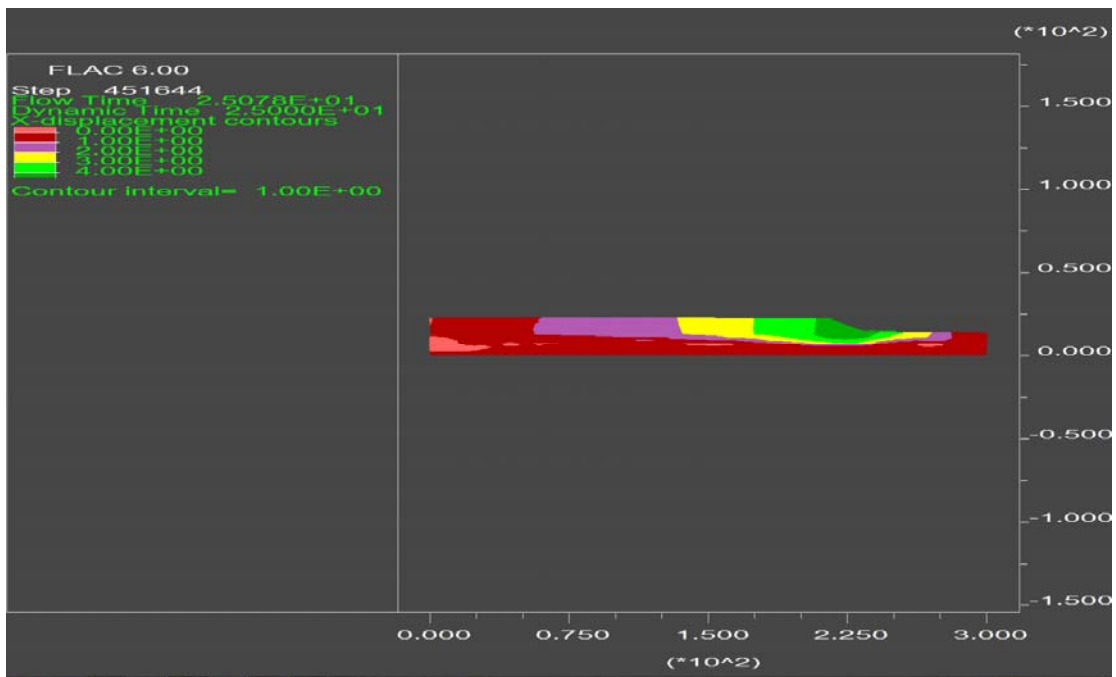
Figure 6B-32. Contours of calculated lateral displacement (9 m embankment height, 8 meter liquefiable sand layer, corrected  $(N_1)_{60}$  blowcount of 15, ground motion = 94 Northridge Sylmar - Conv Sta 052 Scale 0.5x)

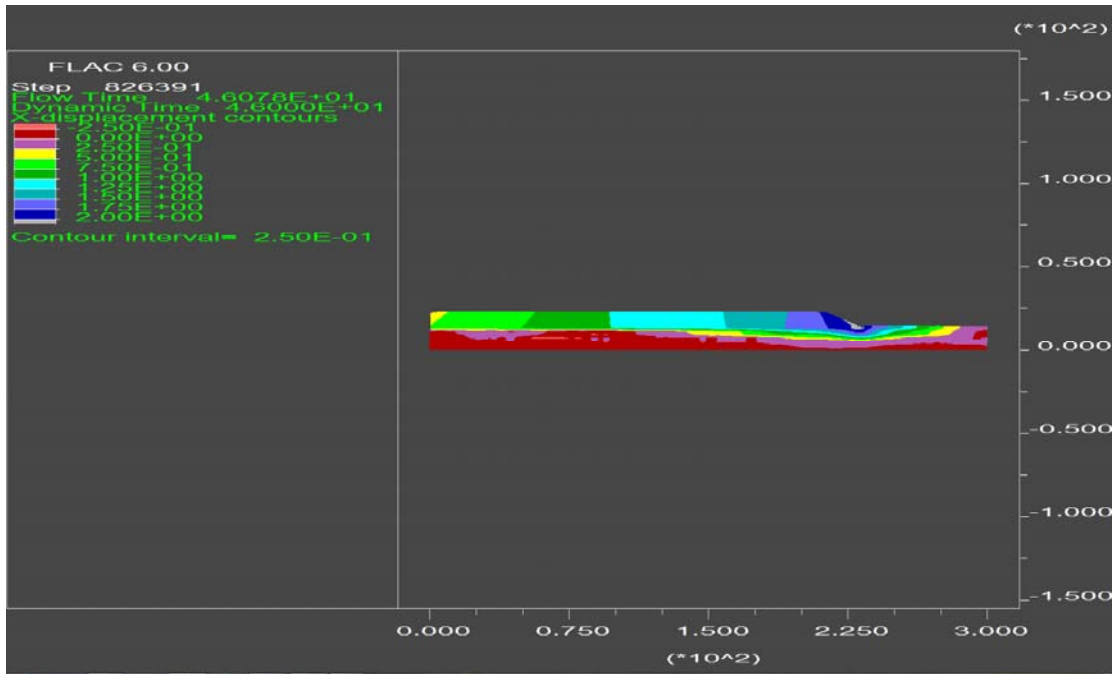
Figure 6B-33. Contours of calculated lateral displacement (9 m embankment height, 8 meter liquefiable sand layer, corrected  $(N_1)_{60}$  blowcount of 15, ground motion = 94 Northridge Sylmar - Conv Sta 052 Scale 1.25x)

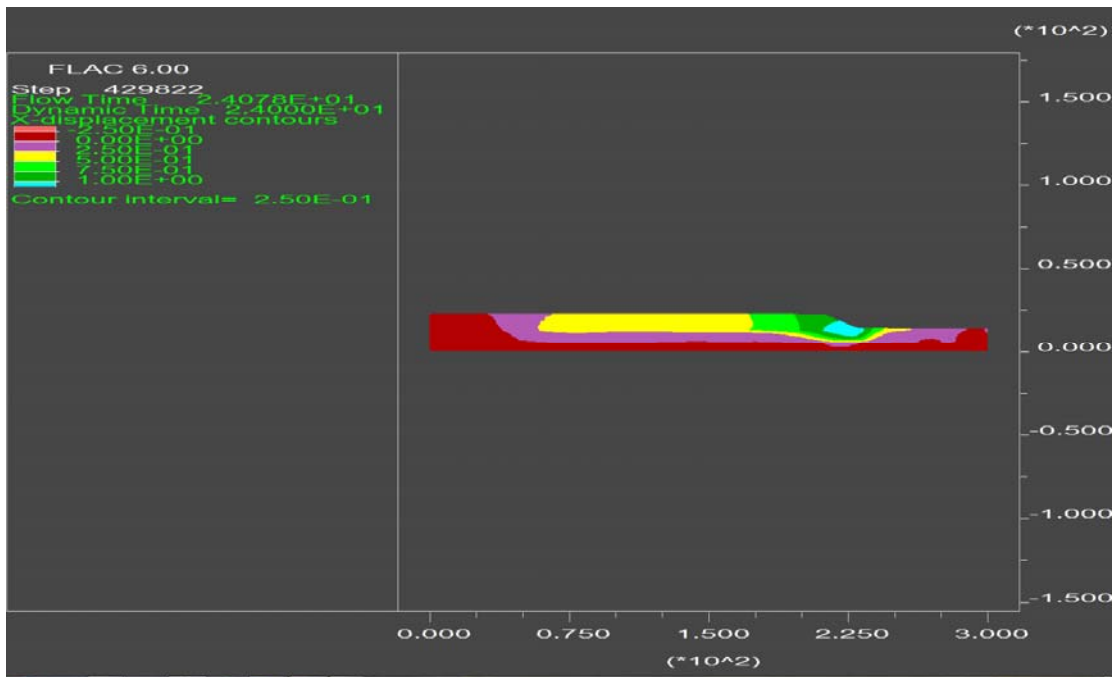
Figure 6B-34. Contours of calculated lateral displacement (9 m embankment height, 8 meter liquefiable sand layer, corrected  $(N_1)_{60}$  blowcount of 15, ground motion = 99 Chi Chi TCU078 270 (E))

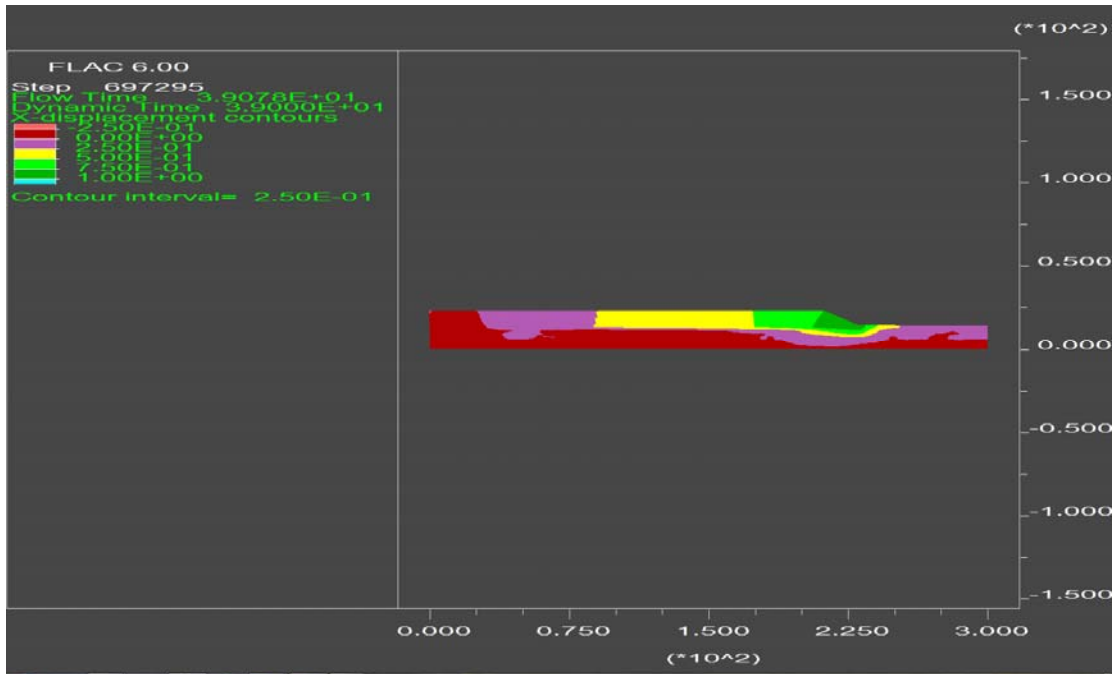
Figure 6B-35. Contours of calculated lateral displacement (9 m embankment height, 8 meter liquefiable sand layer, corrected  $(N_1)_{60}$  blowcount of 15, ground motion = 94 Northridge Newhall - W Pico Cany 046)

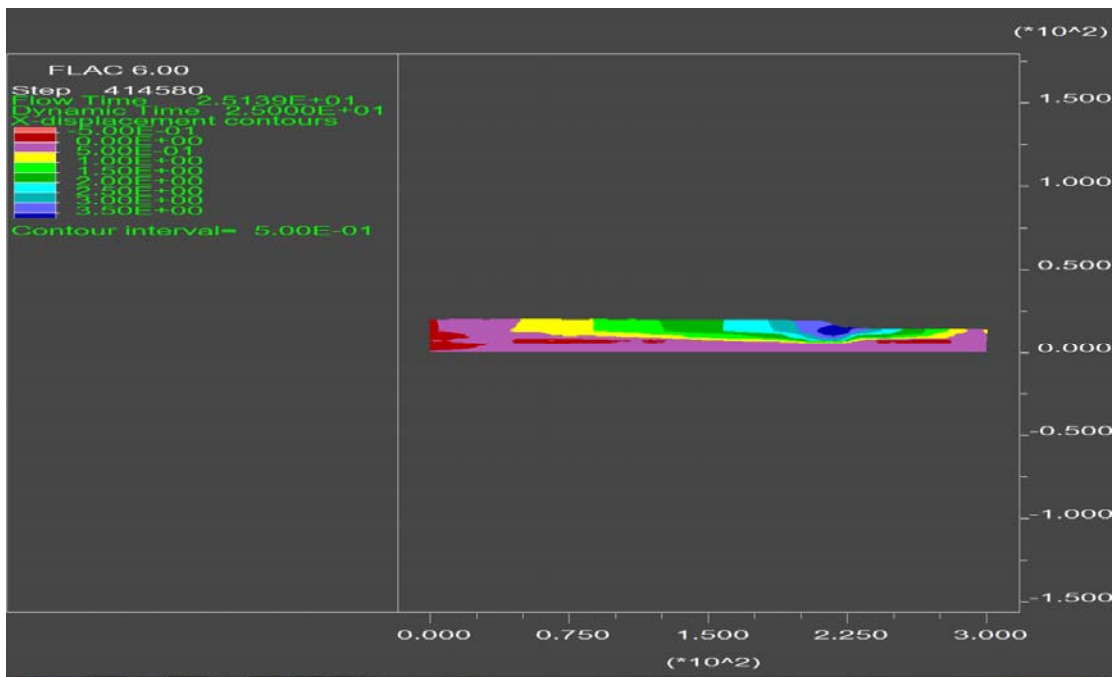
Figure 6B-36. Contours of calculated lateral displacement (9 m embankment height, 8 meter liquefiable sand layer, corrected  $(N_1)_{60}$  blowcount of 15, ground motion = 89 Loma Prieta Saratoga WV Coll 270)

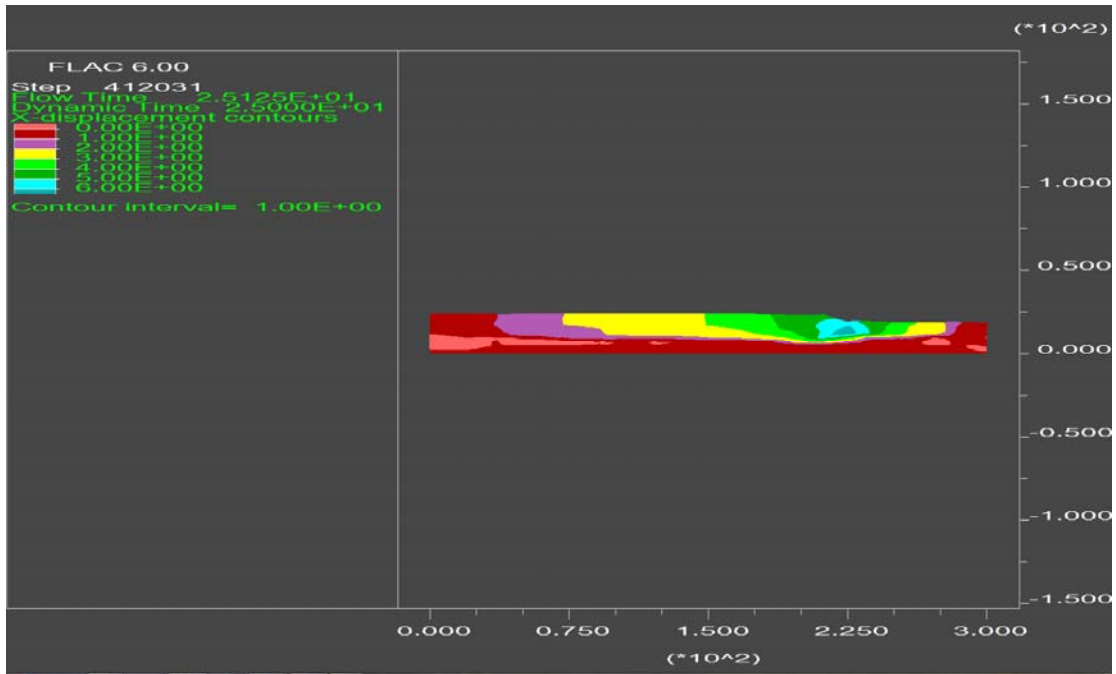
Figure 6B-37. Contours of calculated lateral displacement (6 m embankment height, 8 meter liquefiable sand layer, corrected  $(N_1)_{60}$  blowcount of 8, ground motion = 94 Northridge Sylmar - Conv Sta 052 Scale 1.0x).

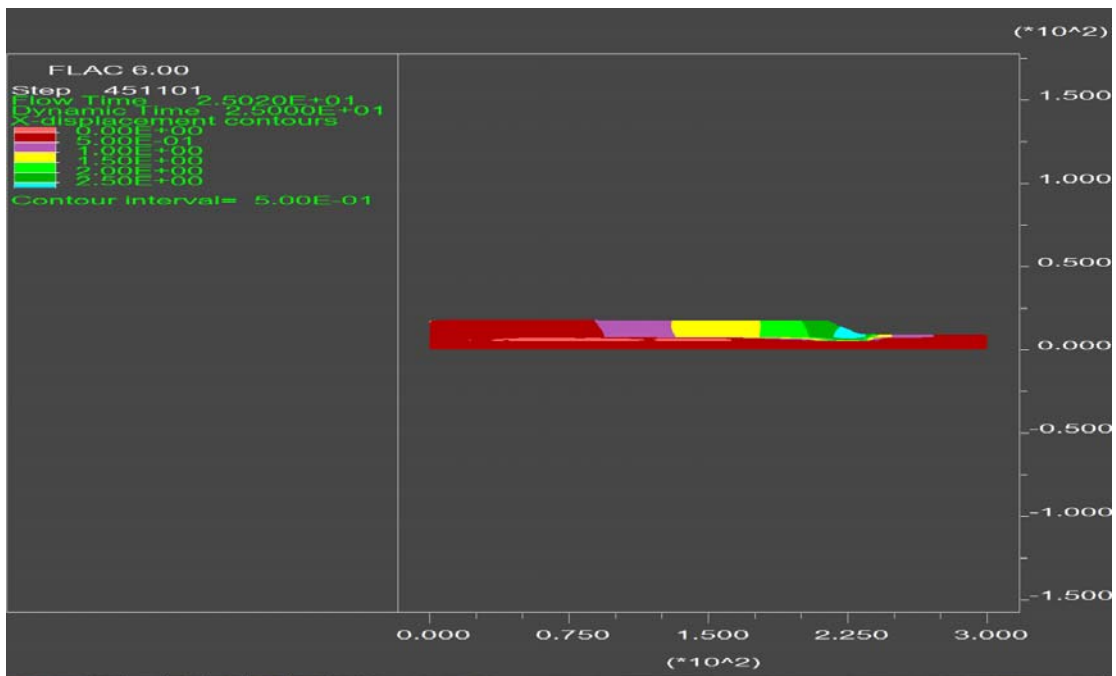
Figure 6B-38. Contours of calculated lateral displacement (6 m embankment height, 12 meter liquefiable sand layer, corrected  $(N_1)_{60}$  blowcount of 8, ground motion = 94 Northridge Sylmar - Conv Sta 052 Scale 1.0x).
