Static and Seismic Performance of California Levees

Michelle Jennifer Shriro

Doctor of Philosophy

Engineering - Civil and Environmental Engineering

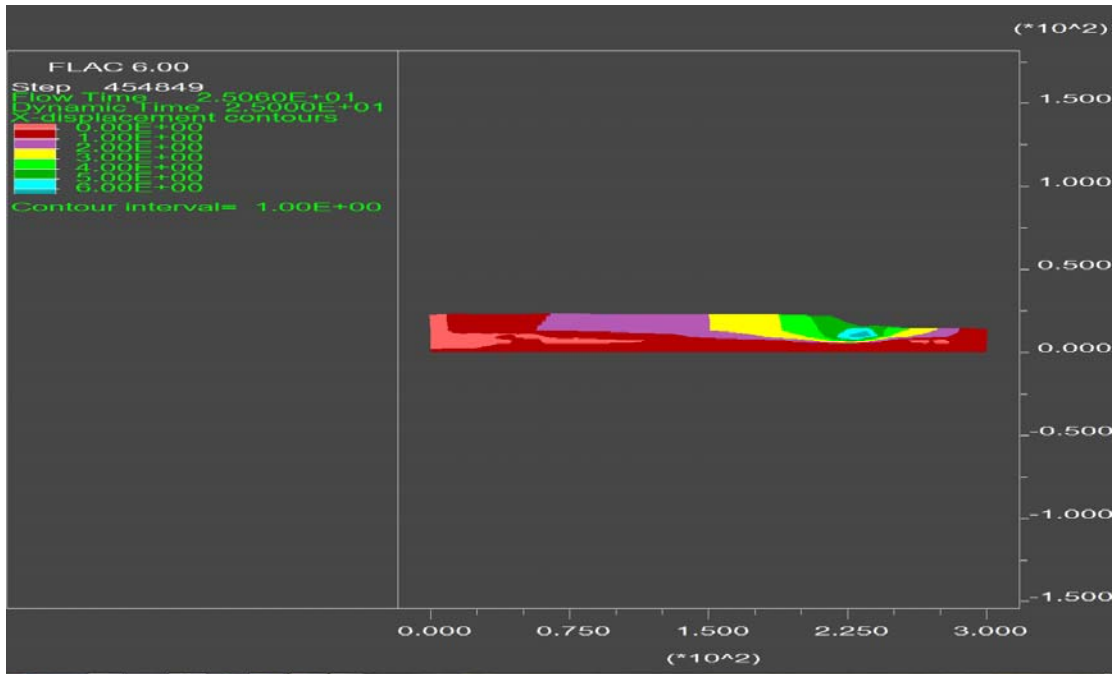
Figure 6B-39. Contours of calculated lateral displacement (9 m embankment height, 3 meter liquefiable sand layer, corrected  $(N_1)_{60}$  blowcount of 8, ground motion = 94 Northridge Sylmar - Conv Sta 052 Scale 1.0x).

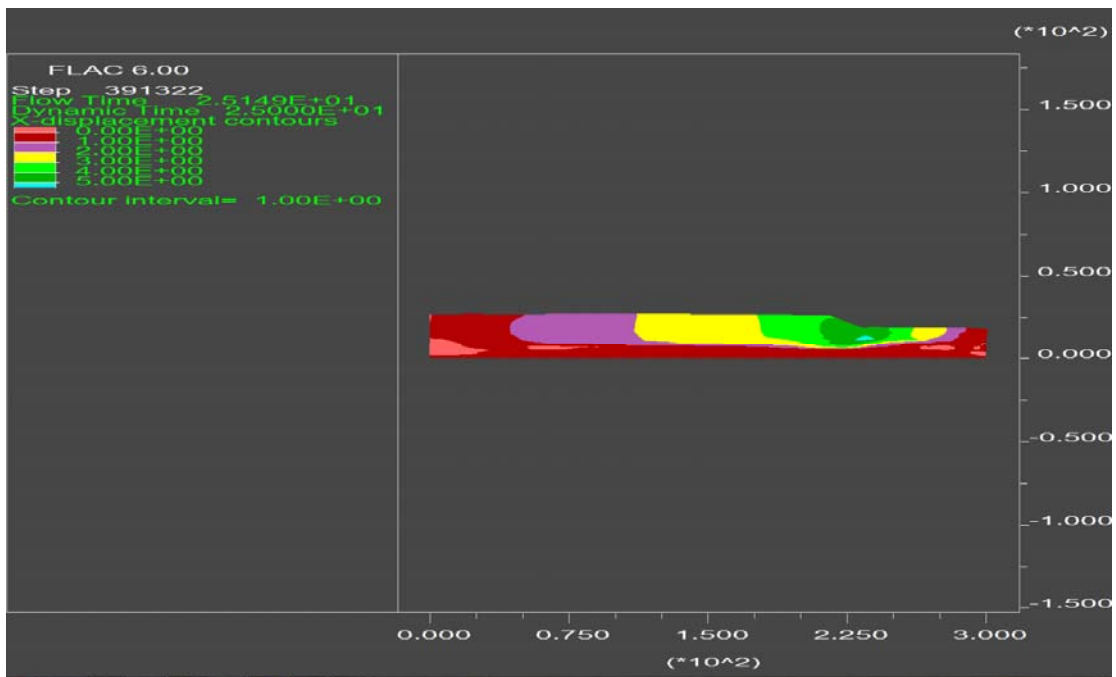
Figure 6B-40. Contours of calculated lateral displacement (9 m embankment height, 8 meter liquefiable sand layer, corrected  $(N_1)_{60}$  blowcount of 8, ground motion = 94 Northridge Sylmar - Conv Sta 052 Scale 1.0x).

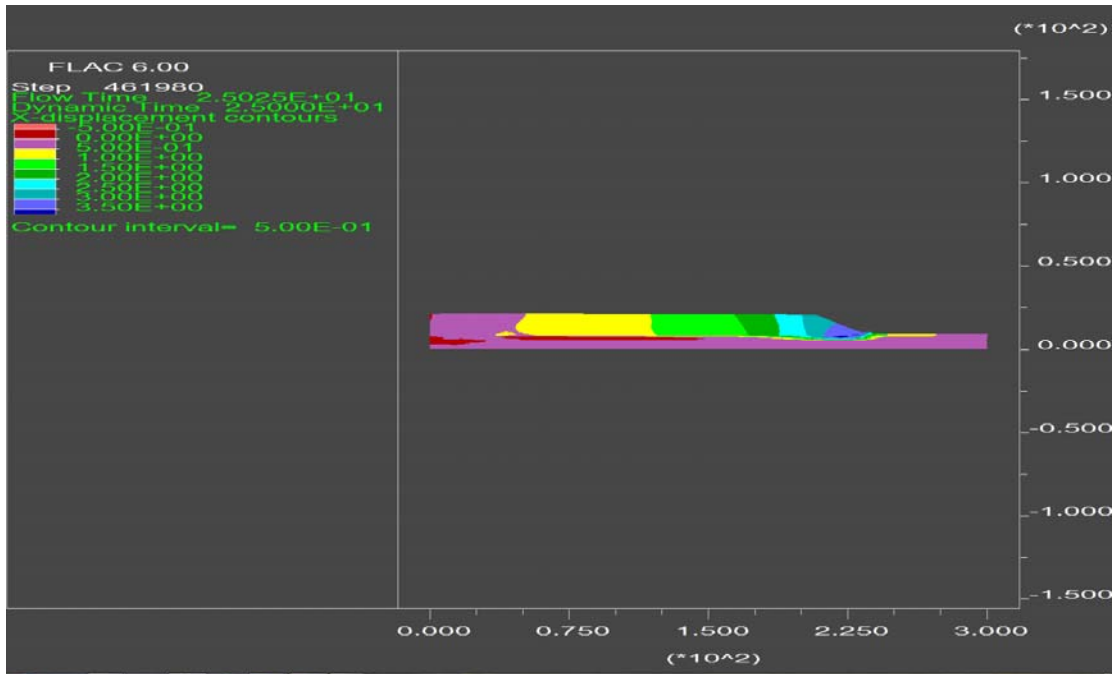
Figure 6B-41. Contours of calculated lateral displacement (9 m embankment height, 12 meter liquefiable sand layer, corrected  $(N_1)_{60}$  blowcount of 8, ground motion = 94 Northridge Sylmar - Conv Sta 052 Scale 1.0x).

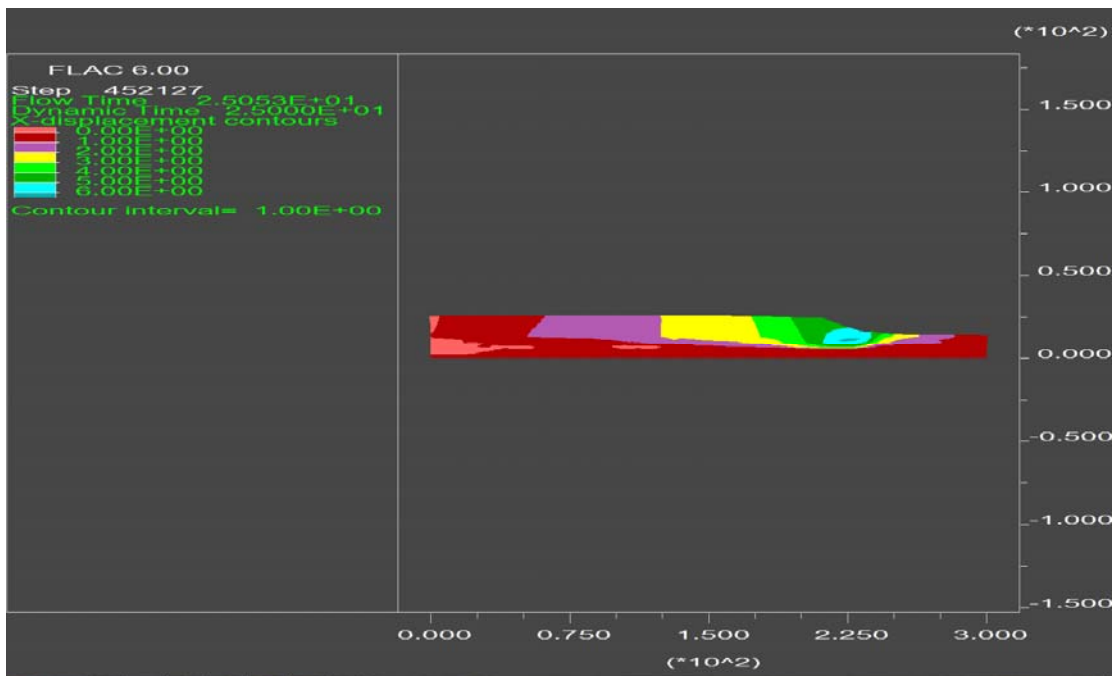
Figure 6B-42. Contours of calculated lateral displacement (12 m embankment height, 3 meter liquefiable sand layer, corrected  $(N_1)_{60}$  blowcount of 8, ground motion = 94 Northridge Sylmar - Conv Sta 052 Scale 1.0x).

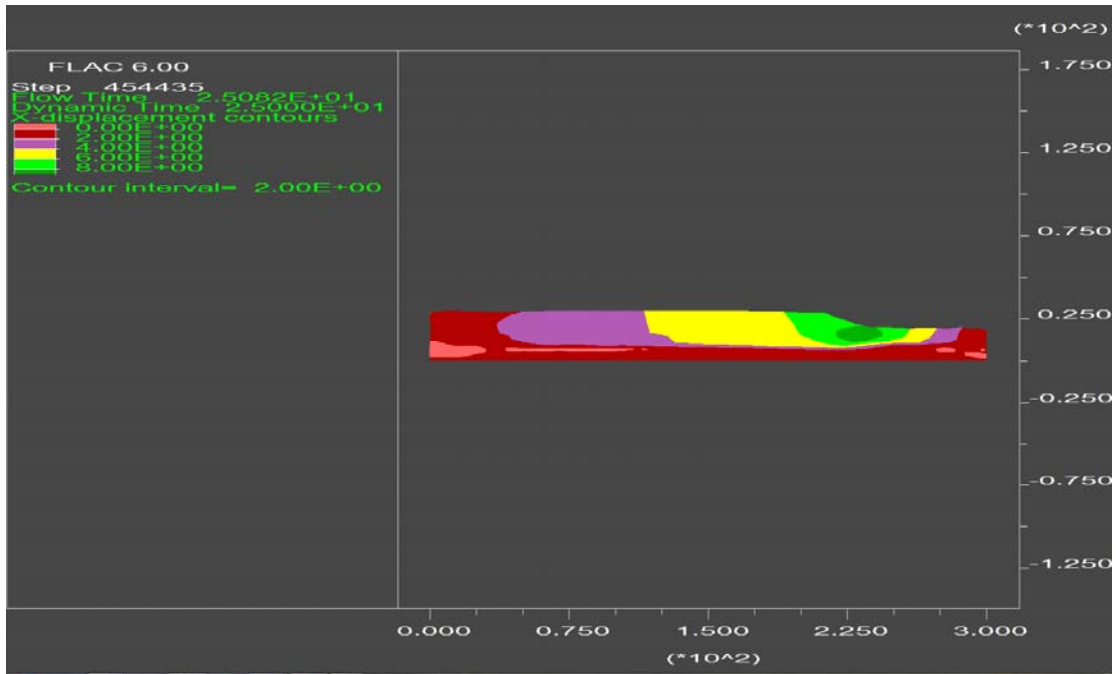
Figure 6B-43. Contours of calculated lateral displacement (12 m embankment height, 8 meter liquefiable sand layer, corrected  $(N_1)_{60}$  blowcount of 8, ground motion = 94 Northridge Sylmar - Conv Sta 052 Scale 1.0x).

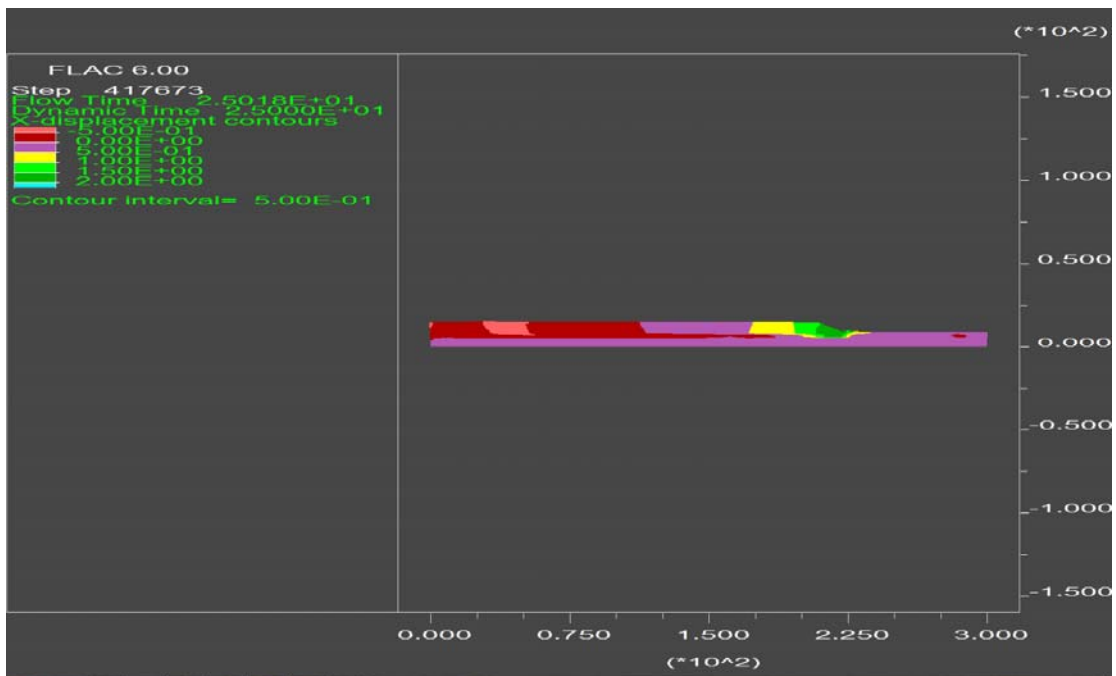
Figure 6B-44. Contours of calculated lateral displacement (12 m embankment height, 12 meter liquefiable sand layer, corrected  $(N_1)_{60}$  blowcount of 8, ground motion = 94 Northridge Sylmar - Conv Sta 052 Scale 1.0x).

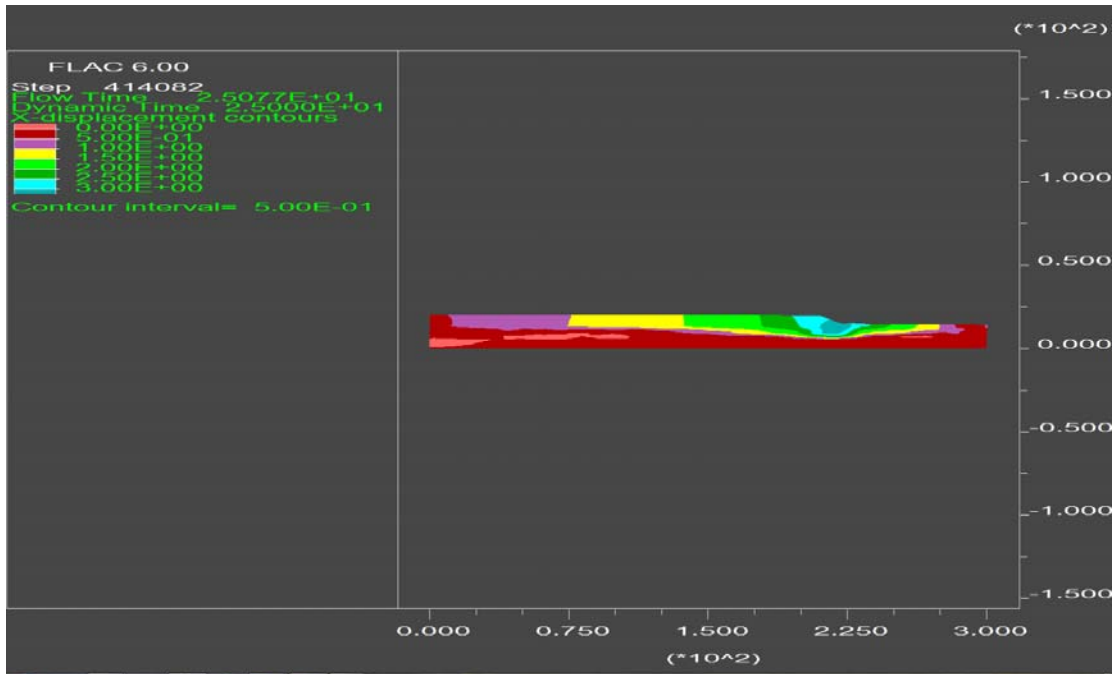
Figure 6B-45. Contours of calculated lateral displacement (6 m embankment height, 3 meter liquefiable sand layer, corrected  $(N_1)_{60}$  blowcount of 15, ground motion = 94 Northridge Sylmar - Conv Sta 052 Scale 1.0x).

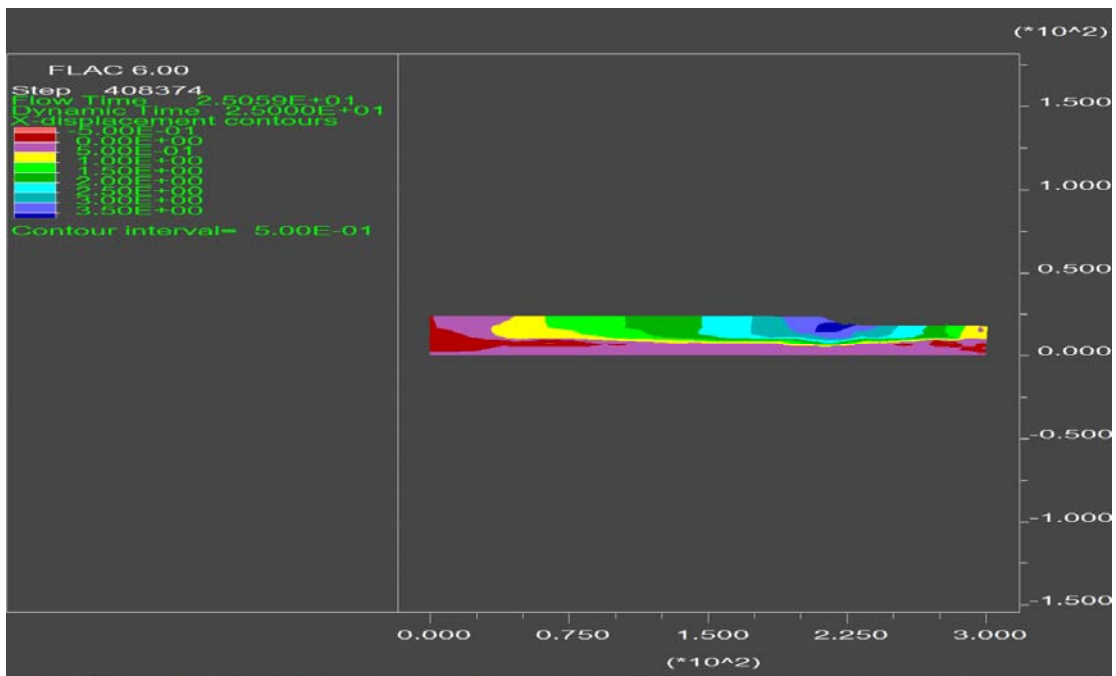
Figure 6B-46. Contours of calculated lateral displacement (6 m embankment height, 8 meter liquefiable sand layer, corrected  $(N_1)_{60}$  blowcount of 15, ground motion = 94 Northridge Sylmar - Conv Sta 052 Scale 1.0x).

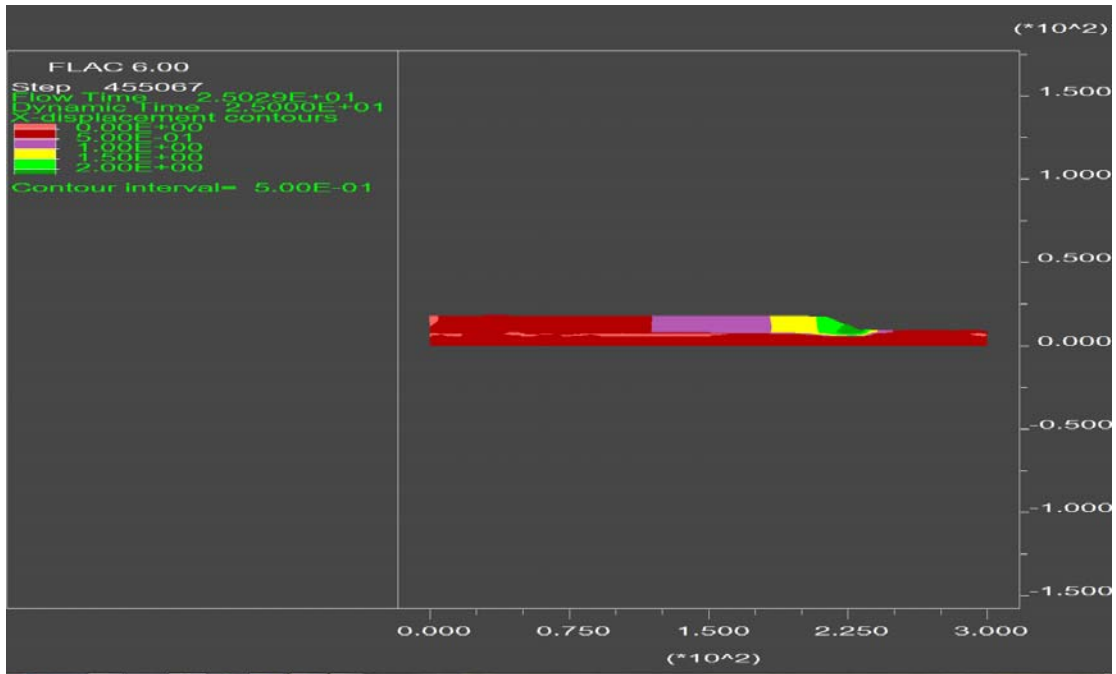
Figure 6B-47. Contours of calculated lateral displacement (6 m embankment height, 12 meter liquefiable sand layer, corrected  $(N_1)_{60}$  blowcount of 15, ground motion = 94 Northridge Sylmar - Conv Sta 052 Scale 1.0x).

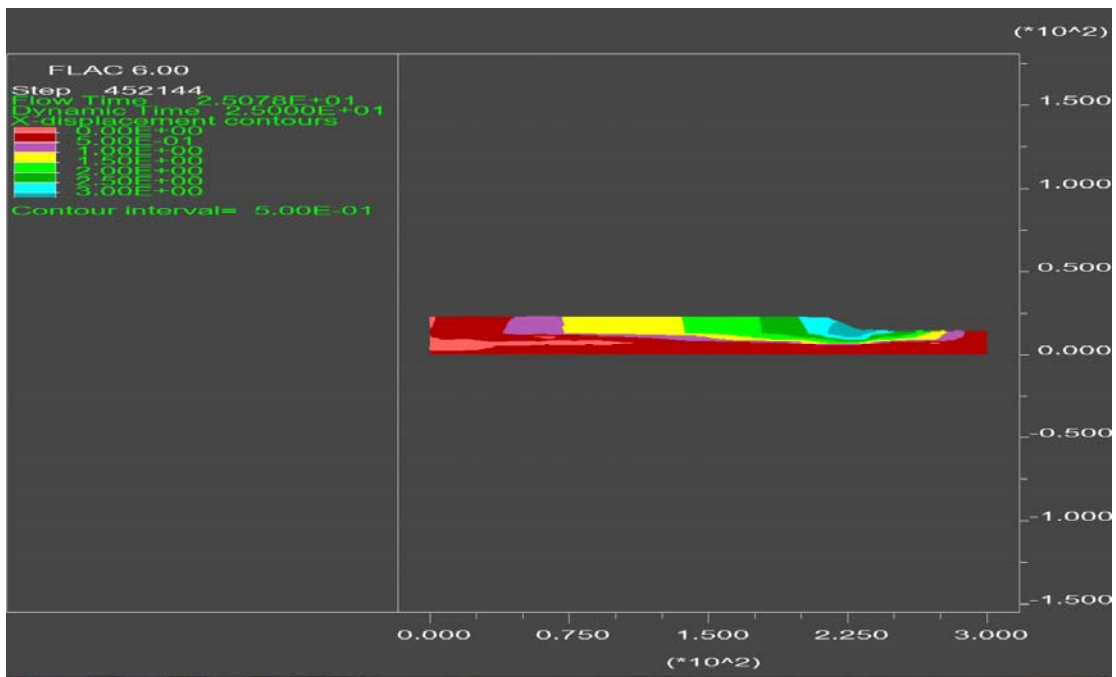
Figure 6B-48. Contours of calculated lateral displacement (9 m embankment height, 3 meter liquefiable sand layer, corrected  $(N_1)_{60}$  blowcount of 15, ground motion = 94 Northridge Sylmar - Conv Sta 052 Scale 1.0x).

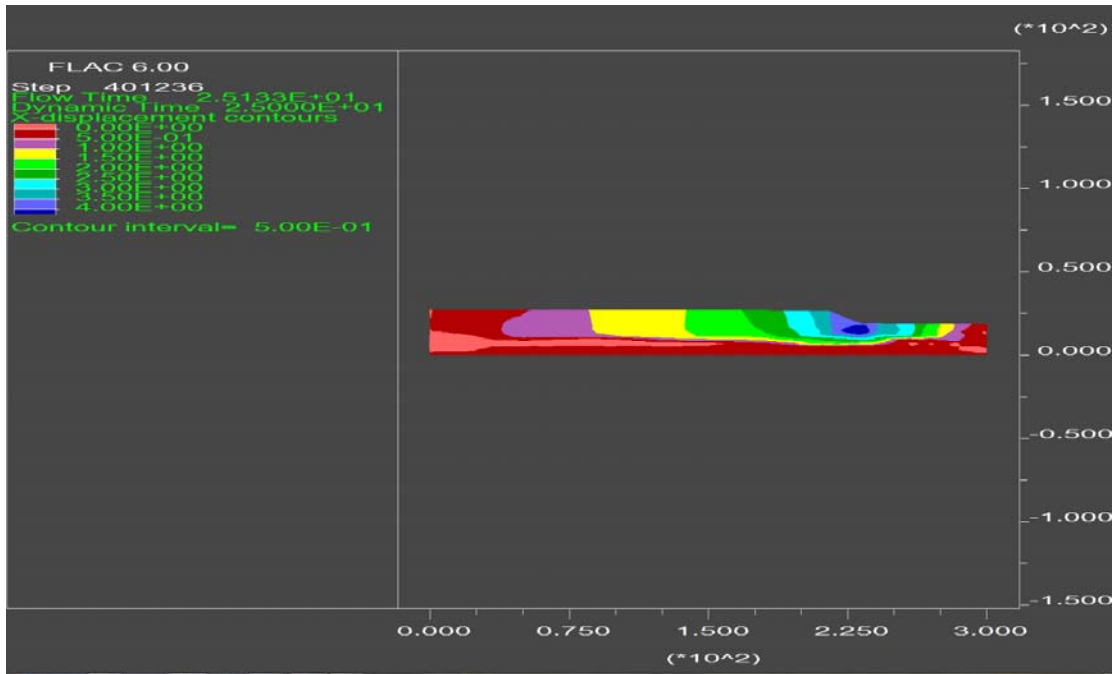
Figure 6B-49. Contours of calculated lateral displacement (9 m embankment height, 8 meter liquefiable sand layer, corrected  $(N_1)_{60}$  blowcount of 15, ground motion = 94 Northridge Sylmar - Conv Sta 052 Scale 1.0x).

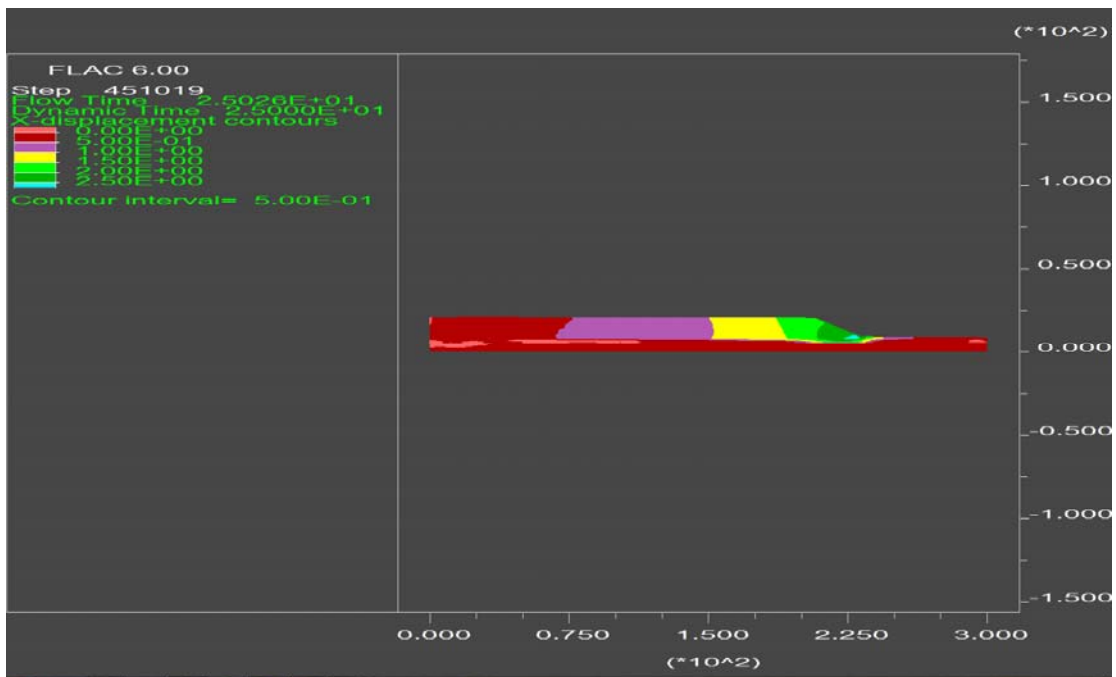
Figure 6B-50. Contours of calculated lateral displacement (9 m embankment height, 12 meter liquefiable sand layer, corrected  $(N_1)_{60}$  blowcount of 15, ground motion = 94 Northridge Sylmar - Conv Sta 052 Scale 1.0x).

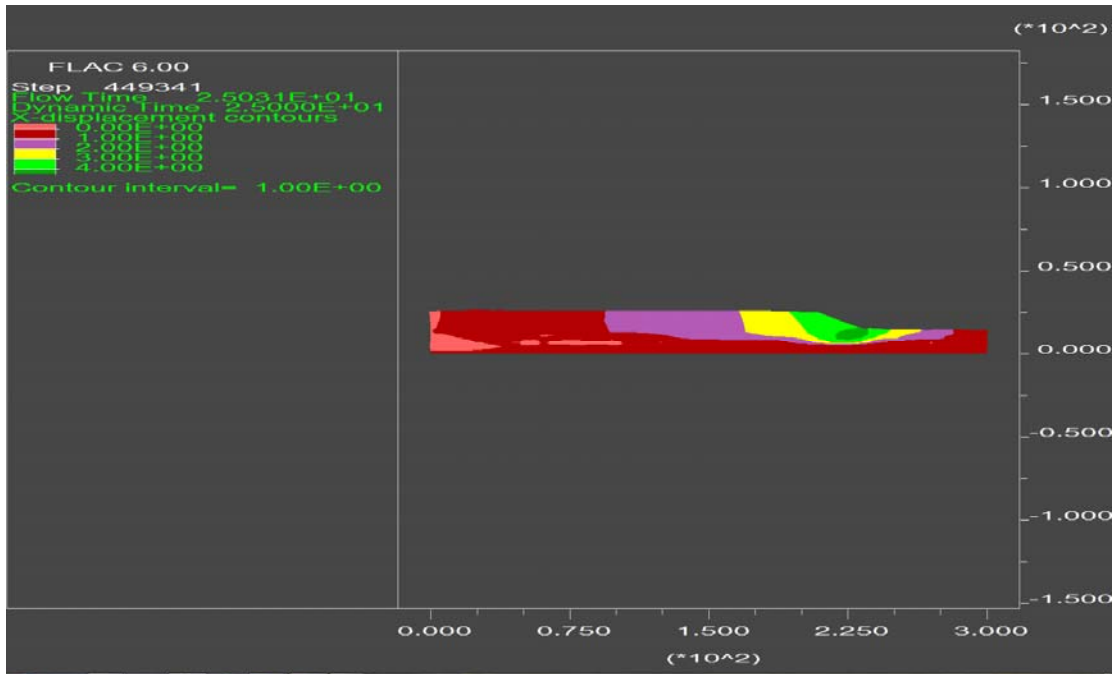
Figure 6B-51. Contours of calculated lateral displacement (12 m embankment height, 3 meter liquefiable sand layer, corrected  $(N_1)_{60}$  blowcount of 15, ground motion = 94 Northridge Sylmar - Conv Sta 052 Scale 1.0x).

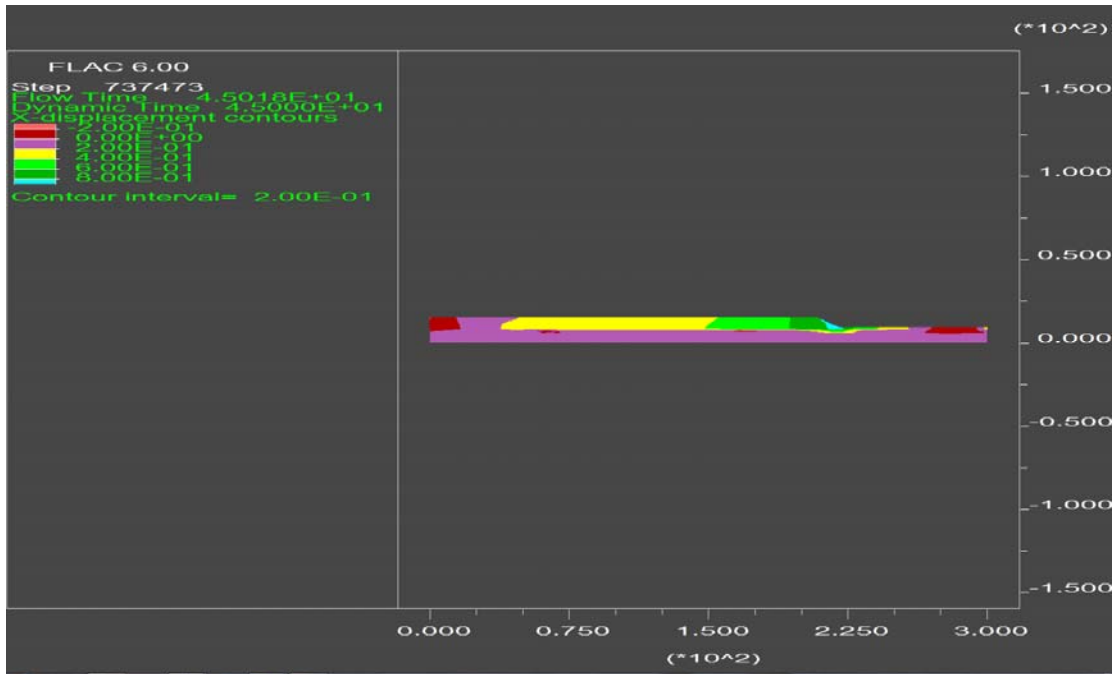
Figure 6B-52. Contours of calculated lateral displacement (12 m embankment height, 8 meter liquefiable sand layer, corrected  $(N_1)_{60}$  blowcount of 15, ground motion = 94 Northridge Sylmar - Conv Sta 052 Scale 1.0x).

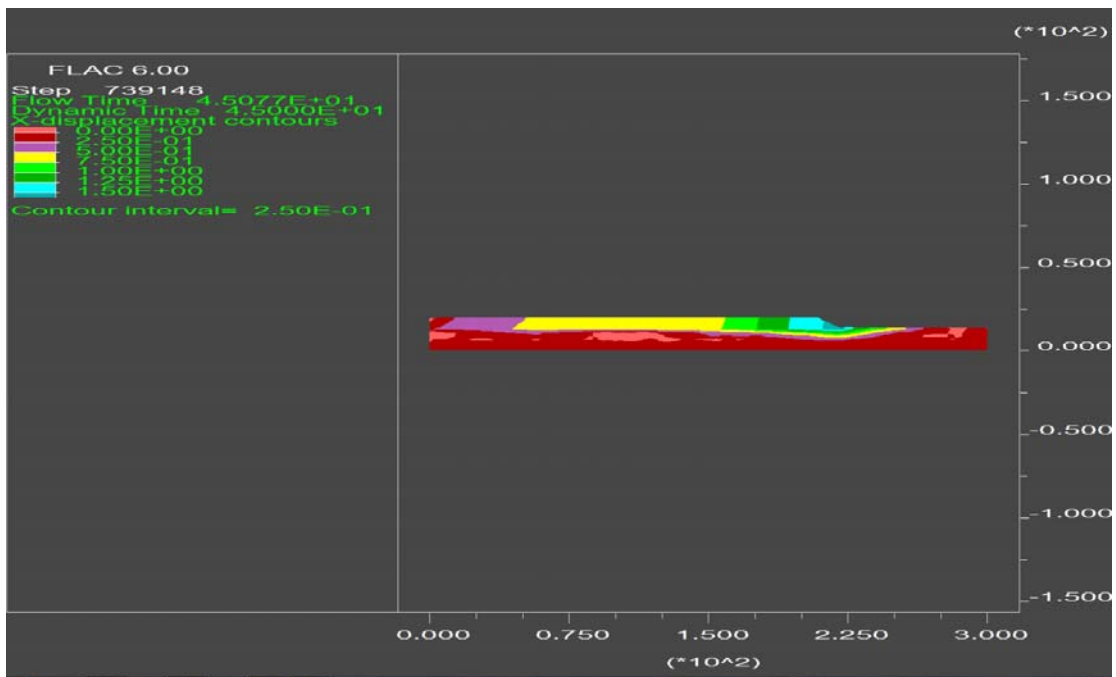
Figure 6B-53. Contours of calculated lateral displacement (6 m embankment height, 3 meter liquefiable sand layer, corrected  $(N_1)_{60}$  blowcount of 15, ground motion = 92 Landers Joshua Tree 090 Scale 1.0x).

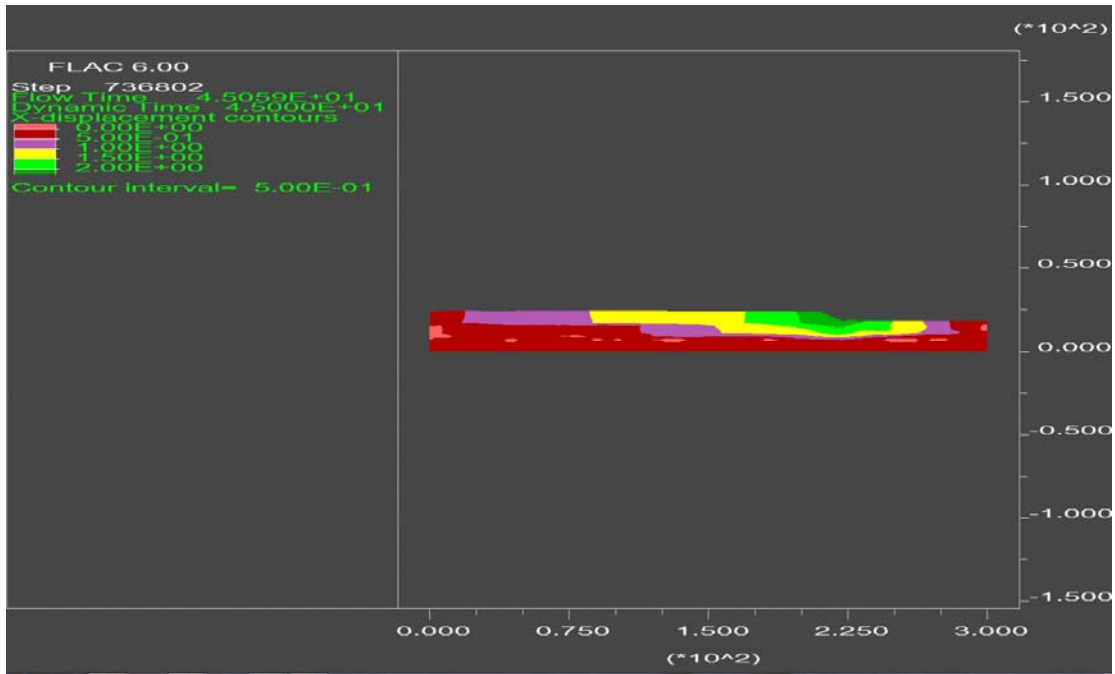
Figure 6B-54. Contours of calculated lateral displacement (6 m embankment height, 8 meter liquefiable sand layer, corrected  $(N_1)_{60}$  blowcount of 15, ground motion = 92 Landers Joshua Tree 090 Scale 1.0x).

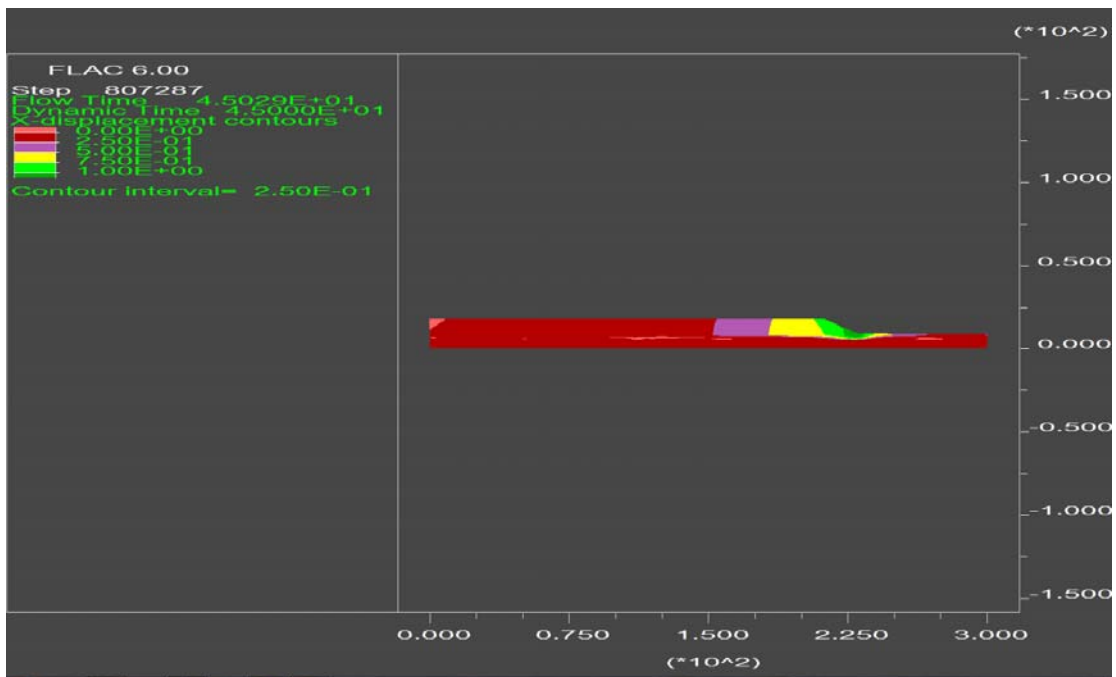
Figure 6B-55. Contours of calculated lateral displacement (6 m embankment height, 12 meter liquefiable sand layer, corrected  $(N_1)_{60}$  blowcount of 15, ground motion = 92 Landers Joshua Tree 090 Scale 1.0x).

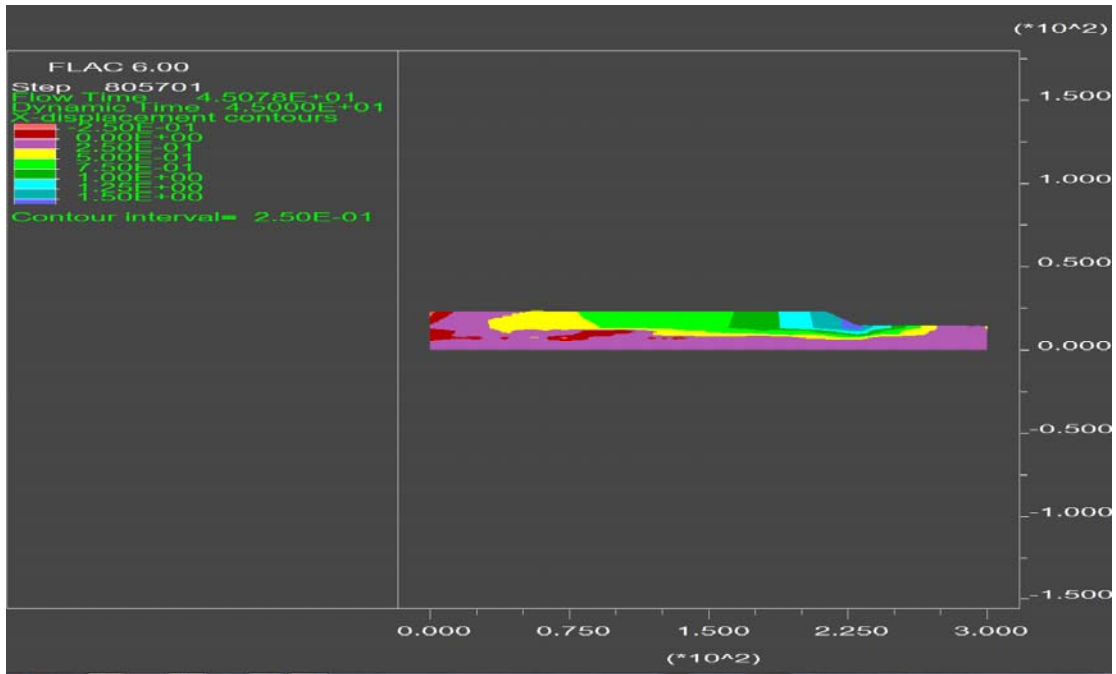
Figure 6B-56. Contours of calculated lateral displacement (9 m embankment height, 3 meter liquefiable sand layer, corrected  $(N_1)_{60}$  blowcount of 15, ground motion = 92 Landers Joshua Tree 090 Scale 1.0x).

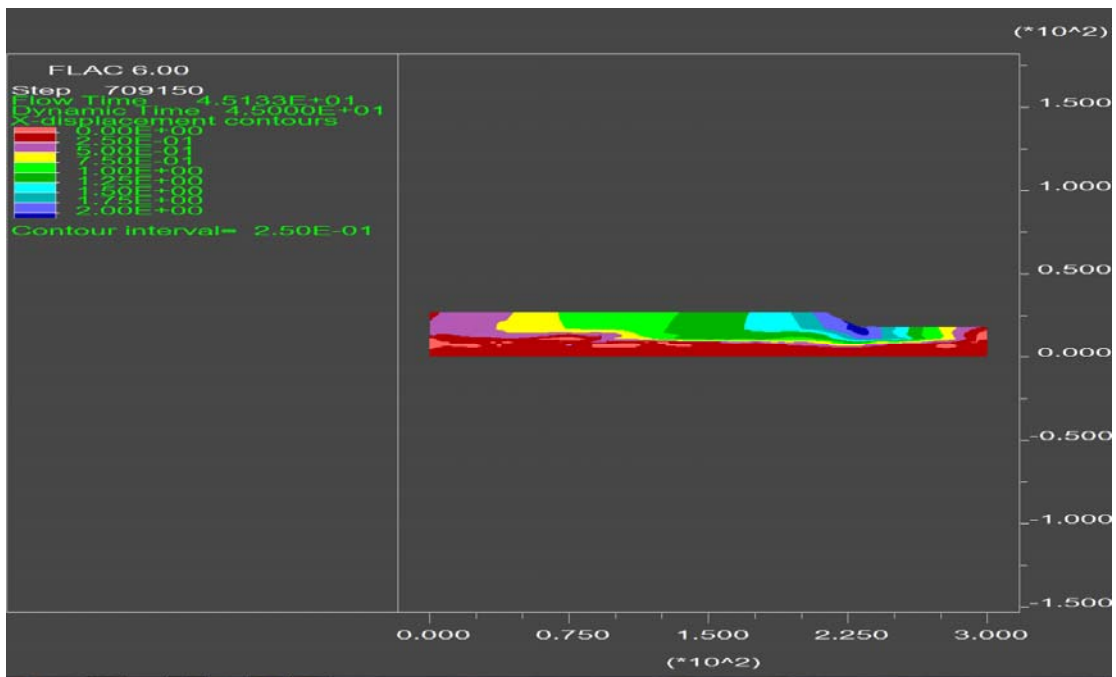
Figure 6B-57. Contours of calculated lateral displacement (9 m embankment height, 8 meter liquefiable sand layer, corrected  $(N_1)_{60}$  blowcount of 15, ground motion = 92 Landers Joshua Tree 090 Scale 1.0x).

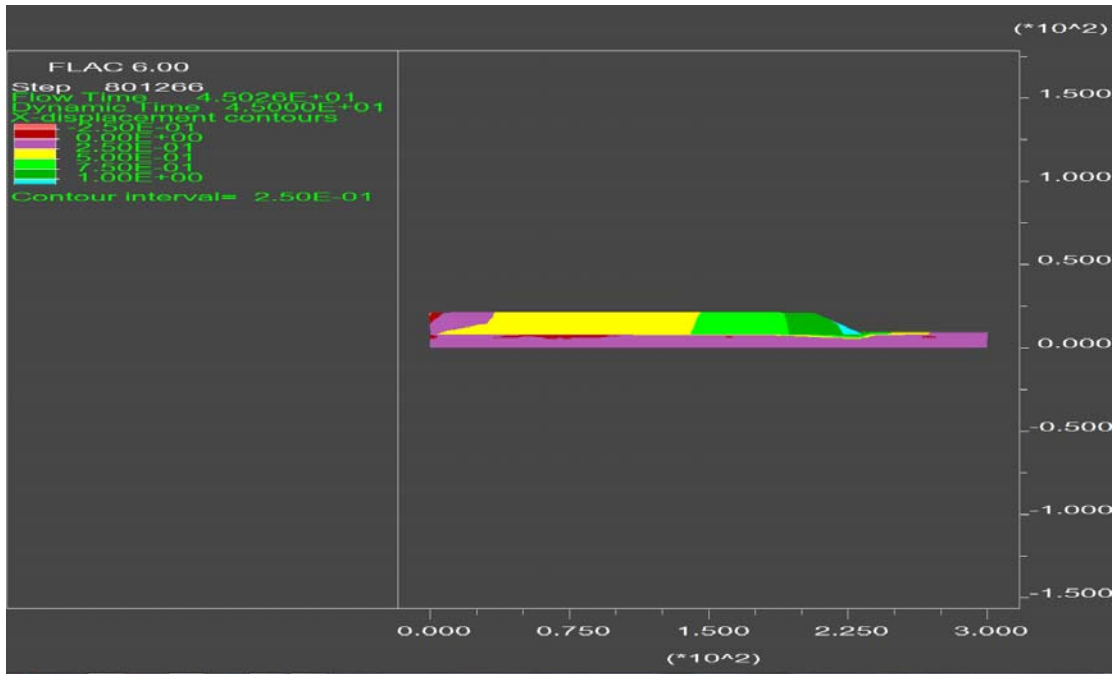
Figure 6B-58. Contours of calculated lateral displacement (9 m embankment height, 12 meter liquefiable sand layer, corrected  $(N_1)_{60}$  blowcount of 15, ground motion = 92 Landers Joshua Tree 090 Scale 1.0x).

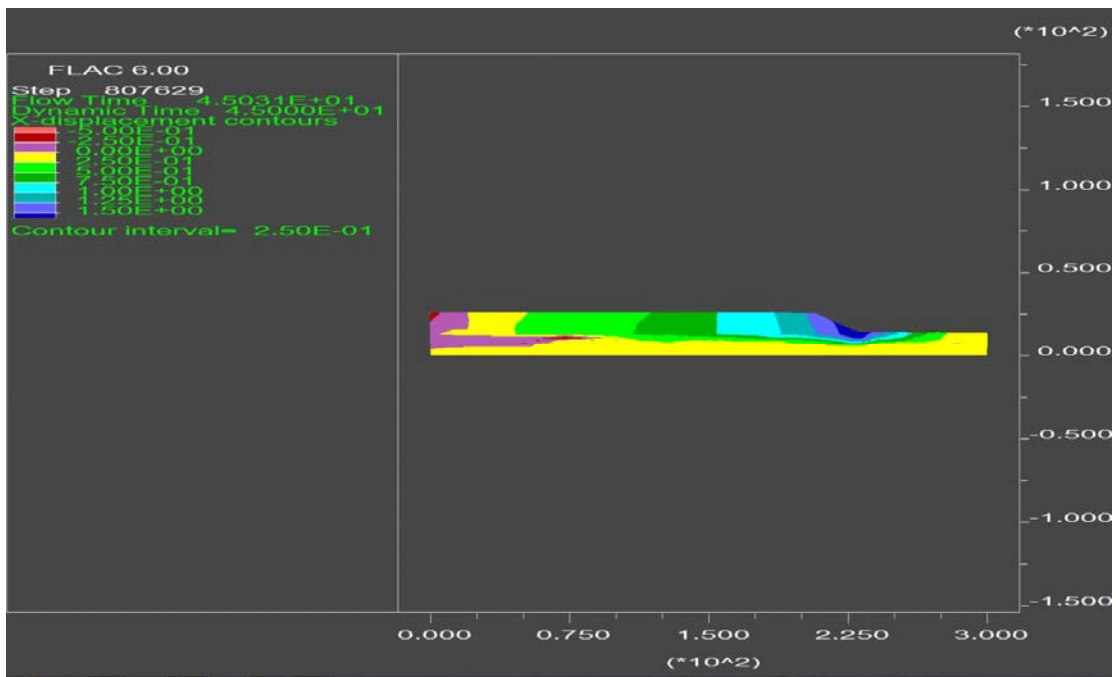
Figure 6B-59. Contours of calculated lateral displacement (12 m embankment height, 3 meter liquefiable sand layer, corrected  $(N_1)_{60}$  blowcount of 15, ground motion = 92 Landers Joshua Tree 090 Scale 1.0x).

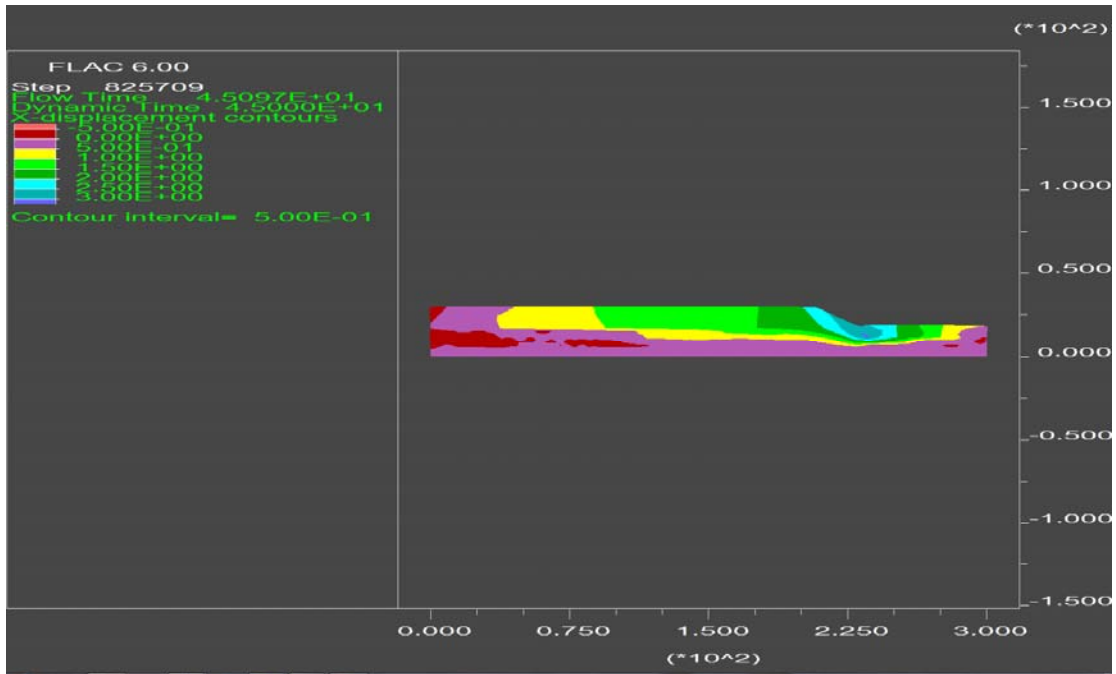
Figure 6B-60. Contours of calculated lateral displacement (12 m embankment height, 8 meter liquefiable sand layer, corrected  $(N_1)_{60}$  blowcount of 15, ground motion = 92 Landers Joshua Tree 090 Scale 1.0x).

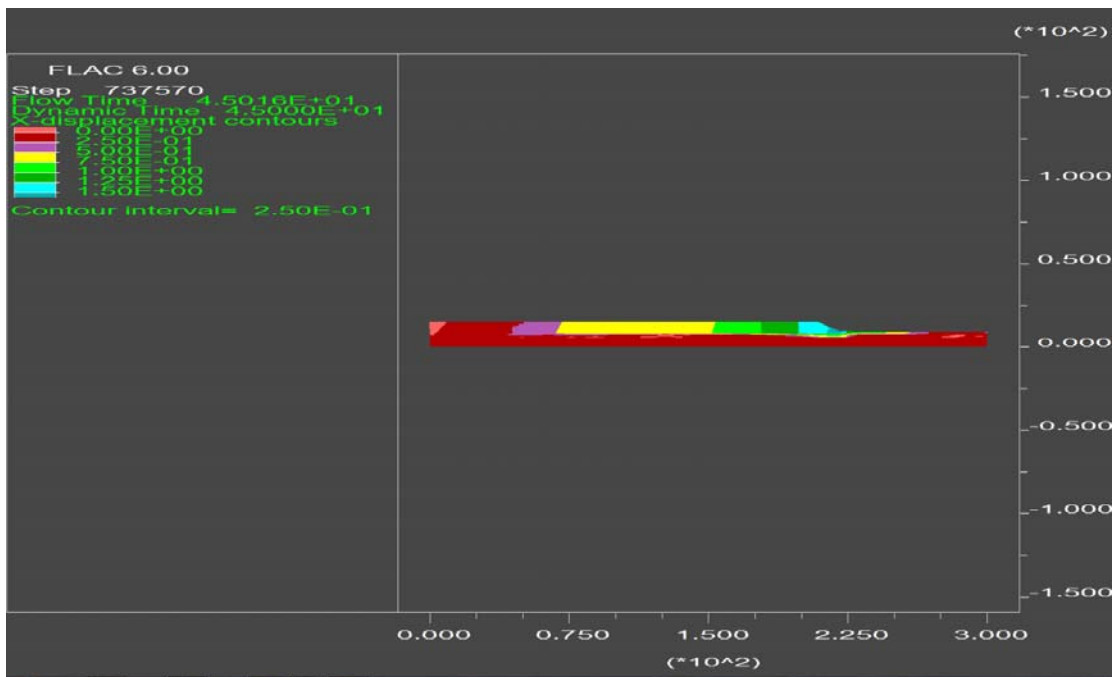
Figure 6B-61. Contours of calculated lateral displacement (12 m embankment height, 12 meter liquefiable sand layer, corrected  $(N_1)_{60}$  blowcount of 15, ground motion = 92 Landers Joshua Tree 090 Scale 1.0x).

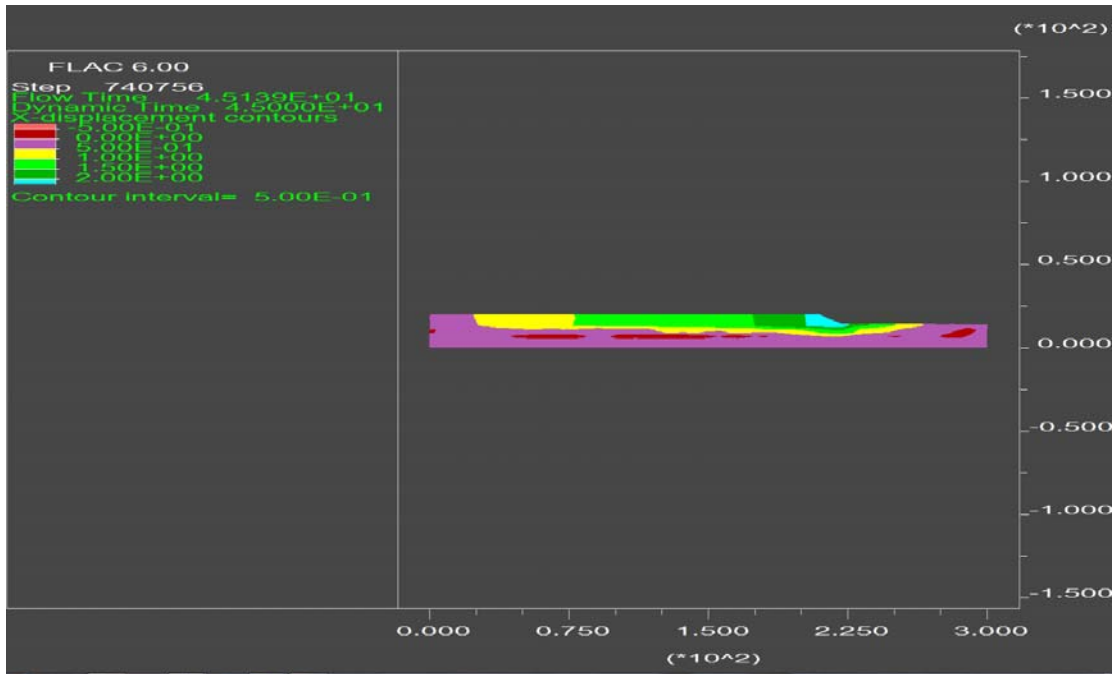
Figure 6B-62. Contours of calculated lateral displacement (6 m embankment height, 3 meter liquefiable sand layer, corrected  $(N_1)_{60}$  blowcount of 8, ground motion = 92 Landers Joshua Tree 090 Scale 1.0x).

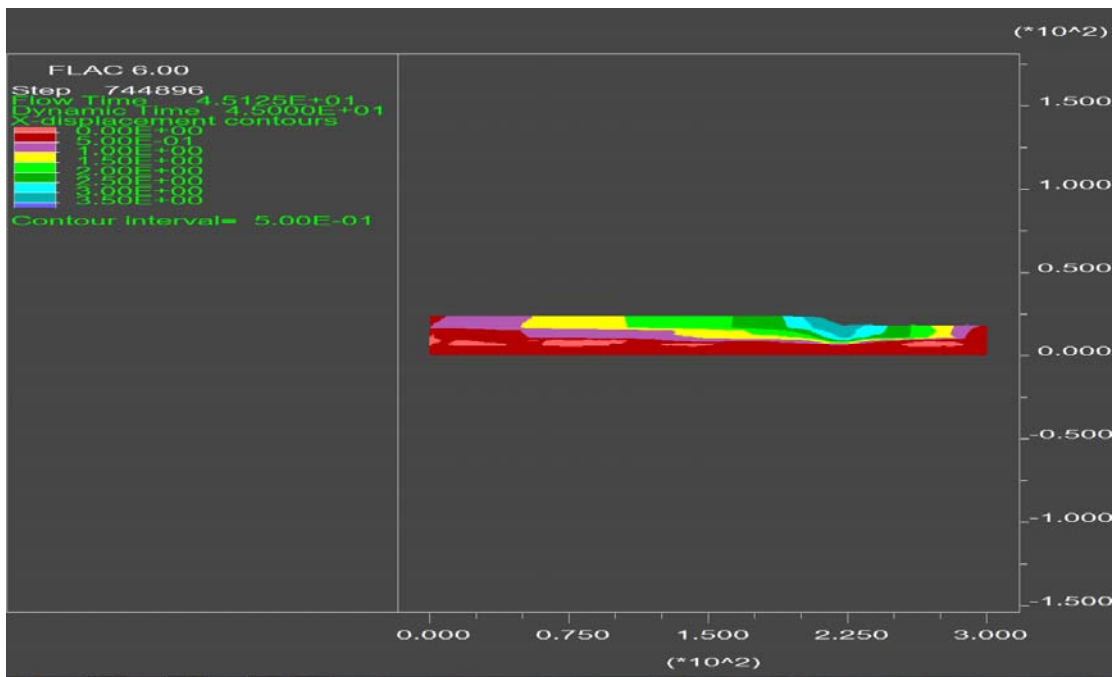
Figure 6B-63. Contours of calculated lateral displacement (6 m embankment height, 8 meter liquefiable sand layer, corrected  $(N_1)_{60}$  blowcount of 8, ground motion = 92 Landers Joshua Tree 090 Scale 1.0x).

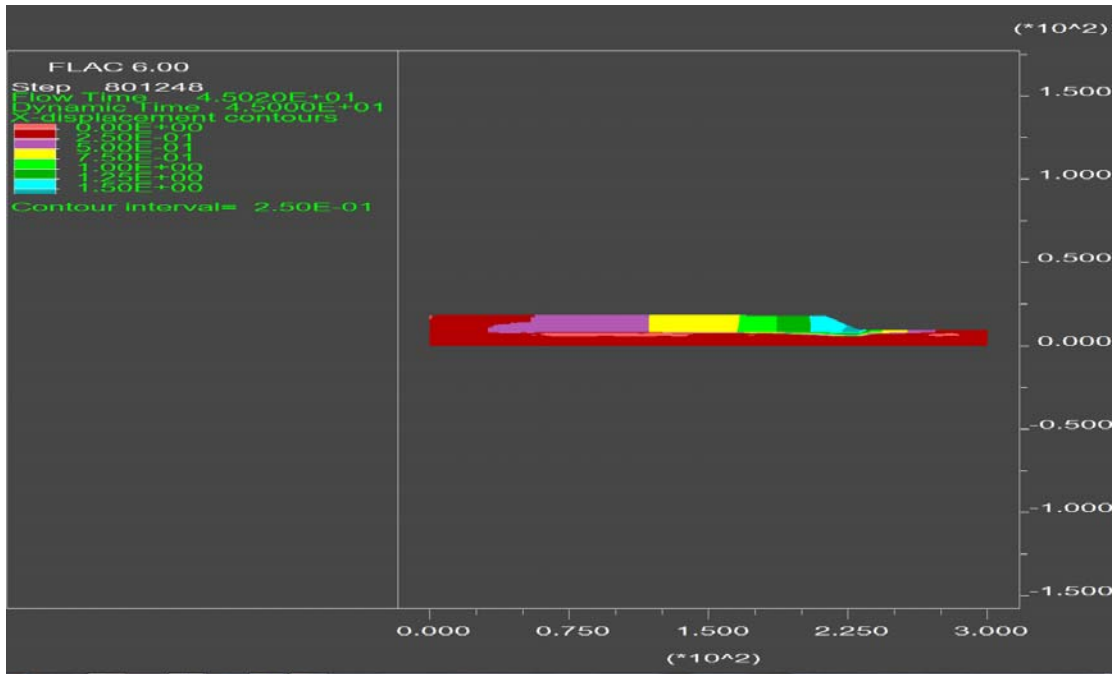
Figure 6B-64. Contours of calculated lateral displacement (6 m embankment height, 12 meter liquefiable sand layer, corrected  $(N_1)_{60}$  blowcount of 8, ground motion = 92 Landers Joshua Tree 090 Scale 1.0x).

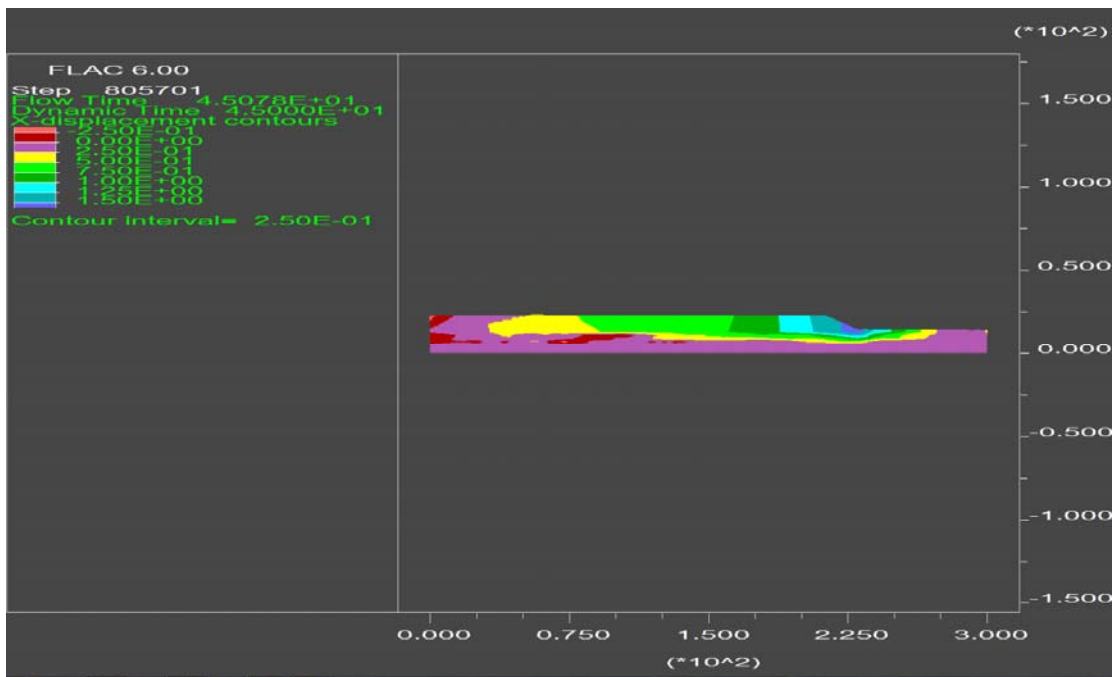
Figure 6B-65. Contours of calculated lateral displacement (9 m embankment height, 3 meter liquefiable sand layer, corrected  $(N_1)_{60}$  blowcount of 8, ground motion = 92 Landers Joshua Tree 090 Scale 1.0x).

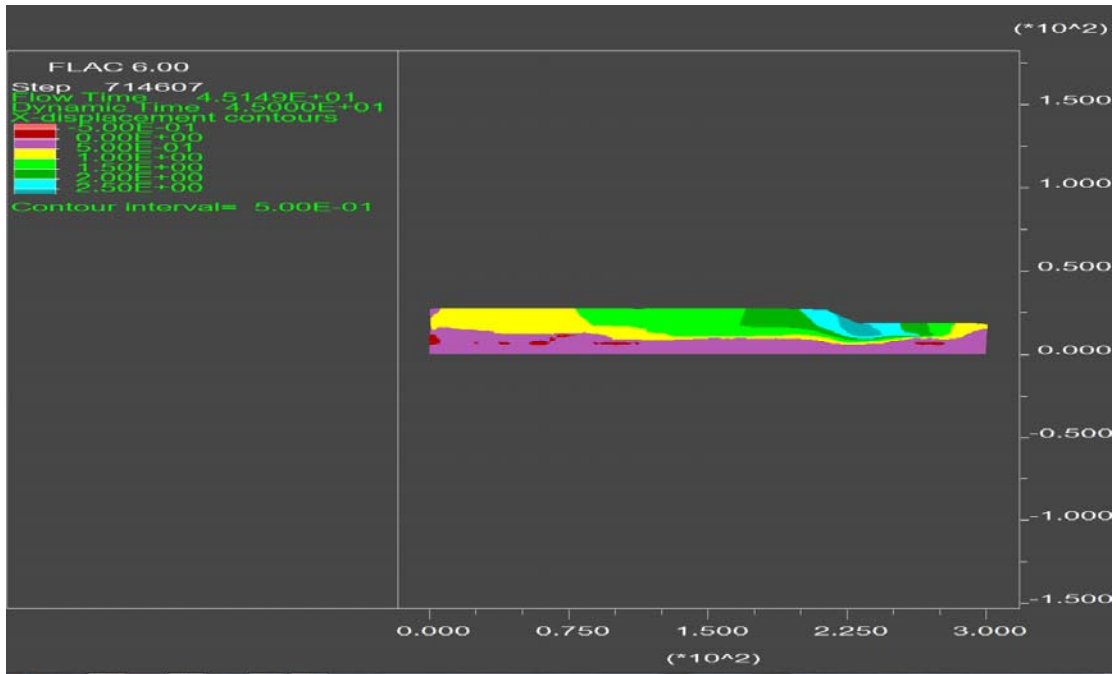
Figure 6B-66. Contours of calculated lateral displacement (9 m embankment height, 8 meter liquefiable sand layer, corrected  $(N_1)_{60}$  blowcount of 8, ground motion = 92 Landers Joshua Tree 090 Scale 1.0x).
