Static and Seismic Performance of California Levees

Michelle Jennifer Shriro

Doctor of Philosophy

Engineering - Civil and Environmental Engineering

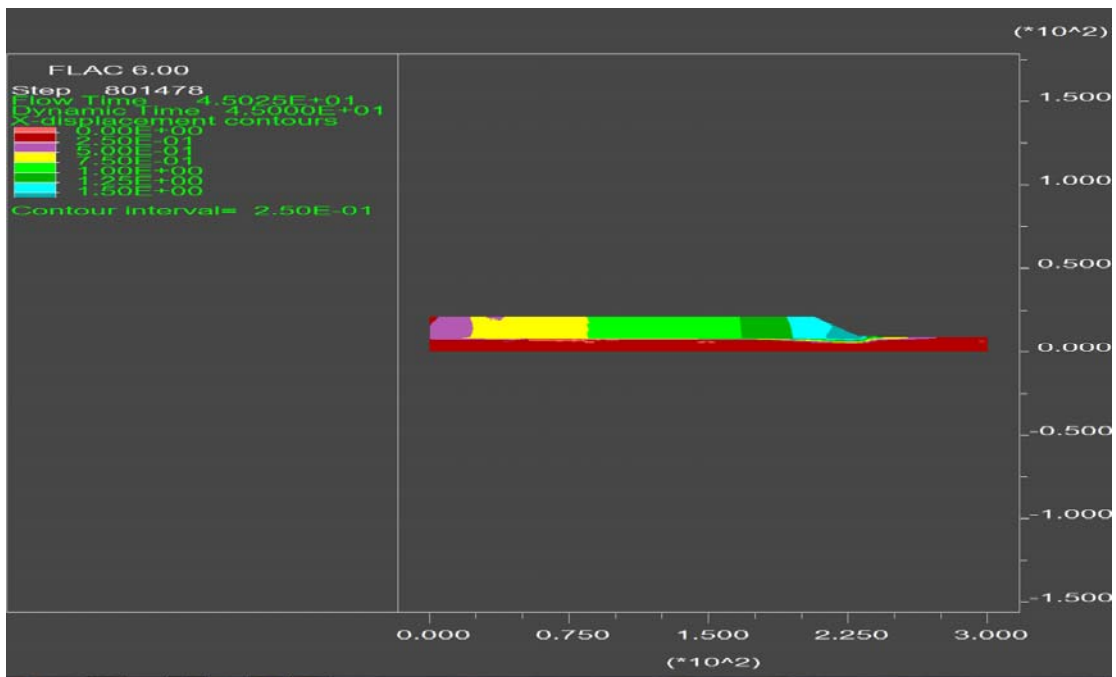
Figure 6B-67. Contours of calculated lateral displacement (9 m embankment height, 12 meter liquefiable sand layer, corrected  $(N_1)_{60}$  blowcount of 8, ground motion = 92 Landers Joshua Tree 090 Scale 1.0x).

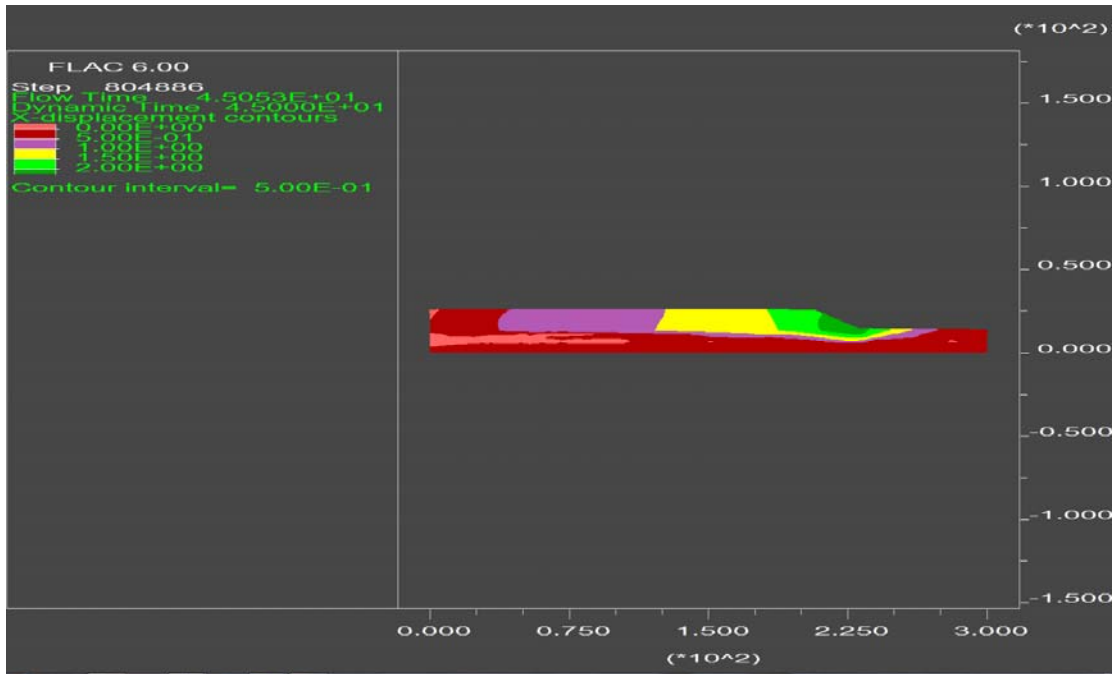
Figure 6B-68. Contours of calculated lateral displacement (12 m embankment height, 3 meter liquefiable sand layer, corrected  $(N_1)_{60}$  blowcount of 8, ground motion = 92 Landers Joshua Tree 090 Scale 1.0x).

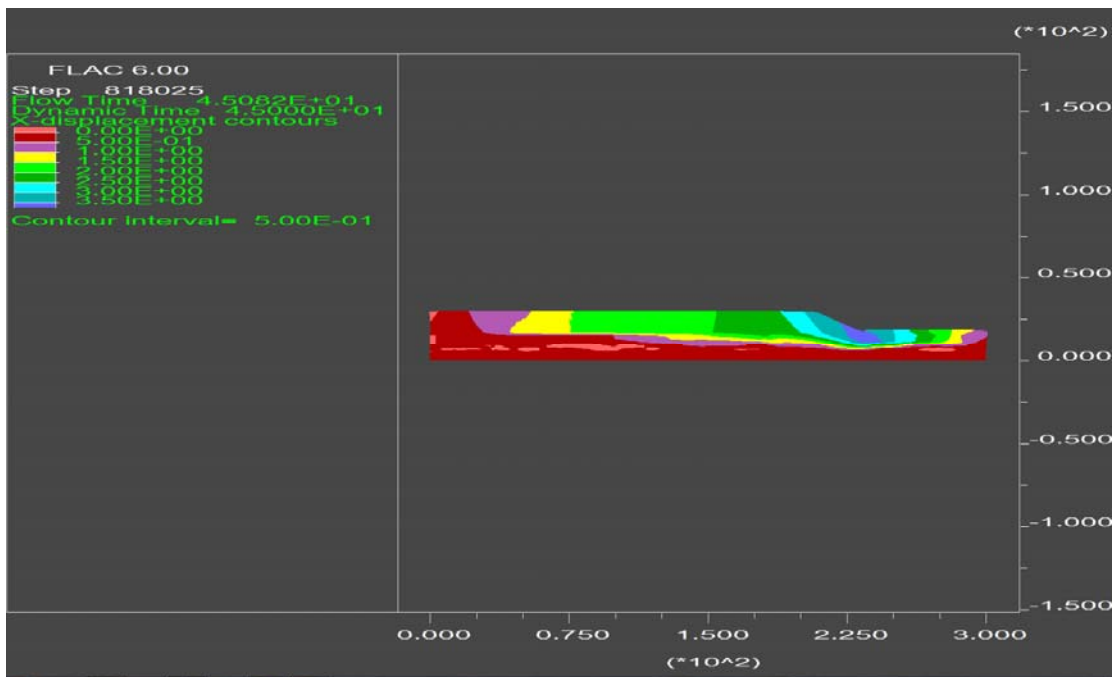
Figure 6B-69. Contours of calculated lateral displacement (12 m embankment height, 8 meter liquefiable sand layer, corrected  $(N_1)_{60}$  blowcount of 8, ground motion = 92 Landers Joshua Tree 090 Scale 1.0x).

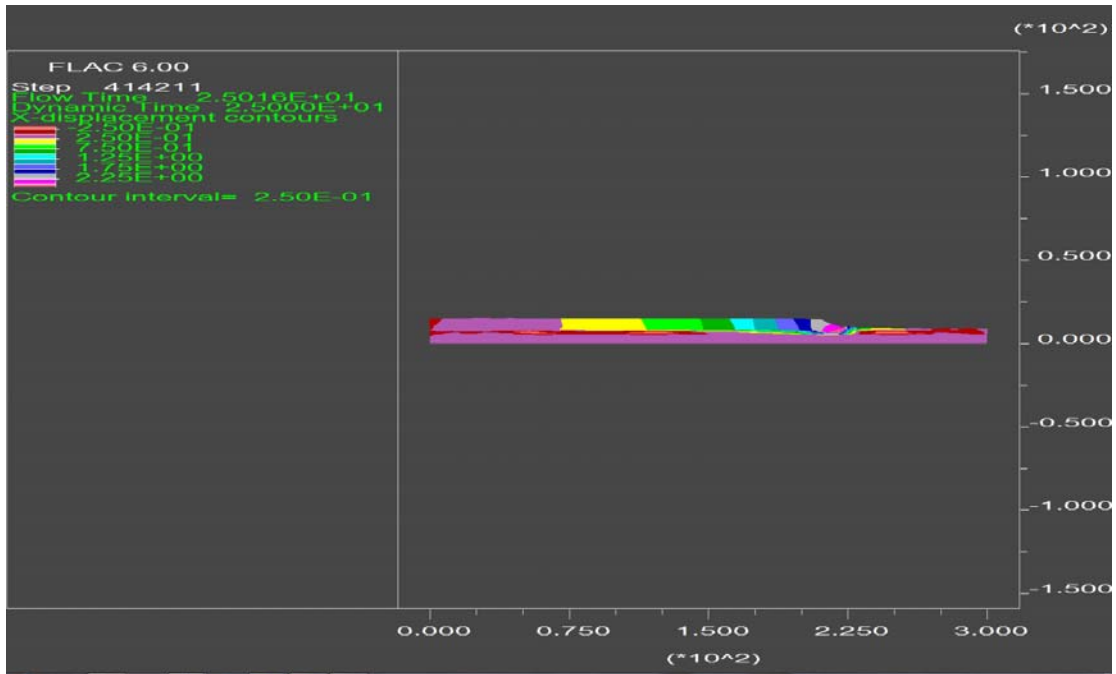
Figure 6B-70. Contours of calculated lateral displacement (12 m embankment height, 12 meter liquefiable sand layer, corrected  $(N_1)_{60}$  blowcount of 8, ground motion = 92 Landers Joshua Tree 090 Scale 1.0x).
