RADON AND REMEDIAL ACTION IN SPOKANE RIVER VALLEY RESIDENCES: AN INTERIM REPORT

To be presented at the 79th Annual Meeting
of the Air Pollution Control Association,
Minneapolis, MN, June 22-27, 1986; and to
be published in the Proceedings

B.H. Turk, R.J. Prill, W.J. Fisk, D.T. Grimsrud,
B.A. Moed, and R.G. Sextro

March 1986

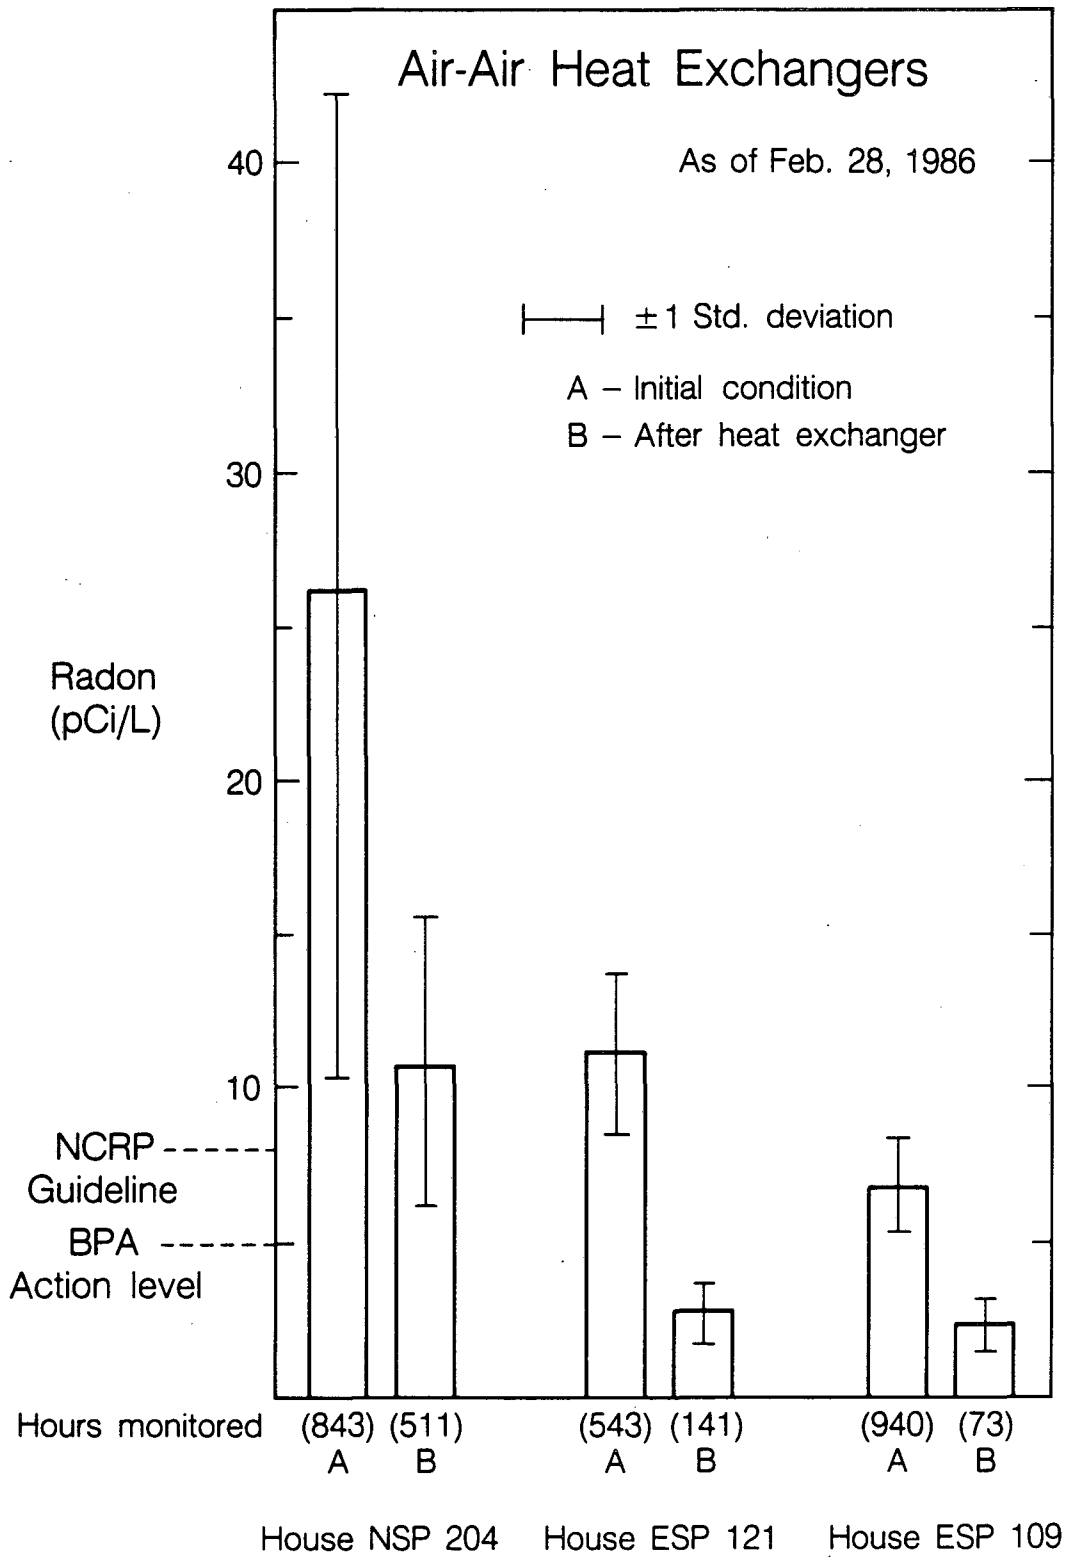
Figure 2.

The use of air-to-air heat exchangers in three homes has shown that the technique is suitable in lowering indoor levels (Figure 2.). In two of the homes (ESP121, ESP109), the new, ducted, central ventilation/heat exchange systems were sized to add approximately 1.0 ach of ventilation. Since the radon obviously enters the house via the basement, both systems were installed to supply air to and return air from two basement locations. At this point, the data represent a variety of supply and return flow rates. Reductions of almost 75%, from 11.2 pCi/l to 2.9 pCi/l, have been achieved in ESP121, and a reduction from 6.9 pCi/l to 2.3 pCi/l in ESP109. At these levels, we consider the technique to be successful.

House NSP204 is a new (1984) energy-efficient home built according to BPA's model conservation standards (MCS) that require the installation of an air-to-air heat exchanger in these low air leakage homes. In its original condition, the AAHX, located in the crawlspace, returned air from the upstairs, but only supplied air to the crawlspace and separate atrium. A more efficient circulation system was installed. Supply air has been delivered to the basement and atrium. Return air comes from only the atrium, upstairs bathroom and heated crawlspace. Levels were observed to fall from 26.3 pCi/l to 10.8 pCi/l. Additional work is planned for other ducting and delivery modifications.

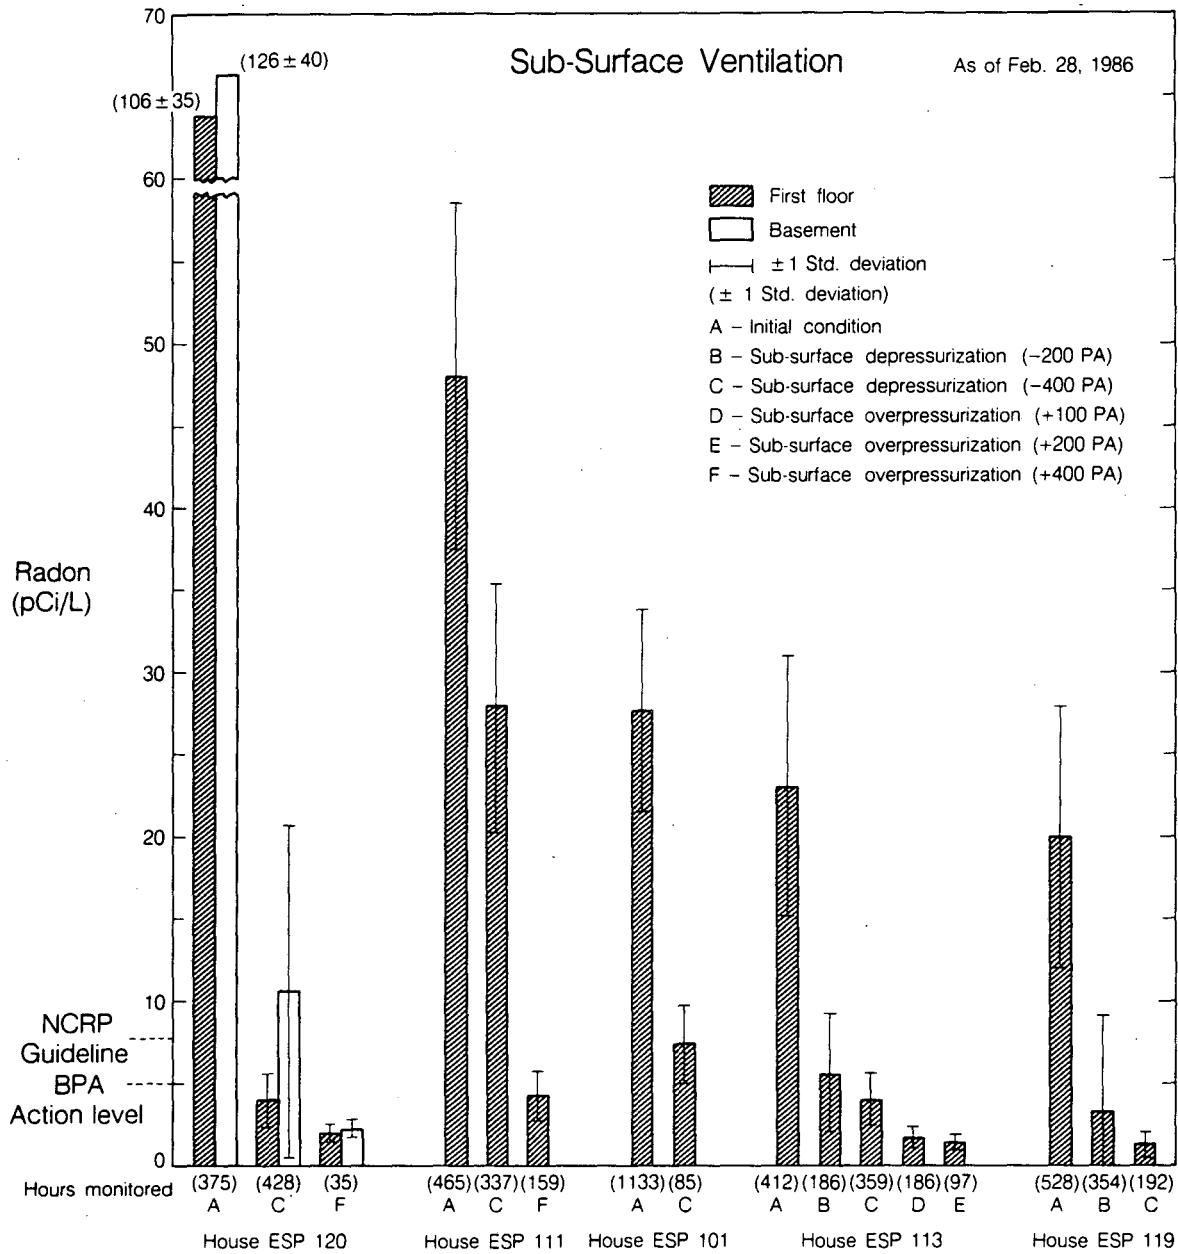
Figure 3.

As seen in Figure 3., the effect of sub-surface ventilation (SSV) is dramatic. In no case has a SSV system, or modification of a SSV system failed to lower concentrations below the target of 5 pCi/l. The surprising discovery is that sub-surface overpressurization has been more effective than subsurface depressurization in the three homes where it has been attempted (ESP111, ESP113, ESP120).

House ESP101 also had significant reductions from 27.6 pCi/l to 7.4 pCi/l upstairs after four SSV pipes were installed and depressurized. One pipe has since been disconnected with no change in radon concentrations. The system has been switched to overpressurization, but results are not yet available.

The largest improvement from switching to overpressurization occurred in house ESP111 where SSV depressurization in two pipes dropped upstairs levels from 47.9 pCi/l to 27.8 pCi/l and overpressurization further reduced levels to 4.2 pCi/l. Additional pipes have been installed to assure still lower concentrations.
