Screw dislocations in GaN

## **Screw Dislocations in GaN**

Z. Liliental-Weber, J. Jasinski, J. Washburn and M.A. O'Keefe

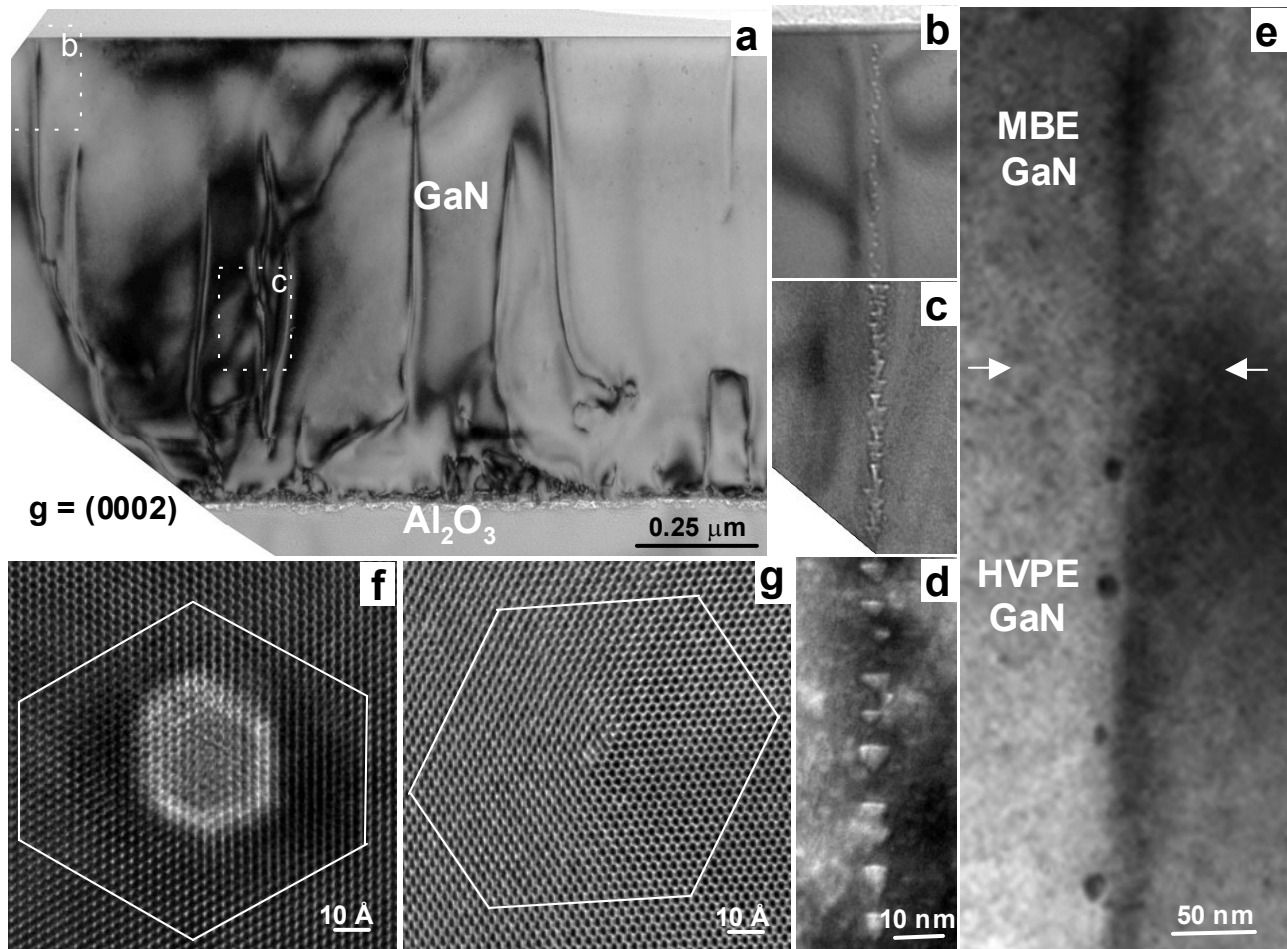
Figure 1. TEM images of screw dislocations in GaN grown on Al<sub>2</sub>O<sub>3</sub>. (a) Cross-section view of HVPE GaN with screw dislocations visible for  $g = (0002)$ . (b,c) Higher magnification images of screw dislocations out of contrast,  $g = (11\bar{2}0)$ , from areas marked on (a) – note voids along dislocation lines. (d) Voids are stacked along the Ga to N bond length parallel to the c-axis – note the separation between adjacent voids. (e) Screw dislocation propagates from HVPE GaN (lower) to MBE GaN (upper) through interface (arrowed), but voids formed in HVPE are not present in the MBE material. High-resolution plan views of screw dislocations show that pits form around screws in HVPE GaN (f) but not in MBE GaN (g) – white lines describe Burgers circuits around the screw dislocations .

Transmission Electron Microscopy (TEM) has been applied to study these layers in plan-view and cross-sections on samples prepared by conventional techniques such as mechanical thinning and precision ion milling. The density of dislocations close to the sample surface of a  $1\mu\text{m}$ -thick HVPE sample was in the range of  $3 \times 10^9 \text{cm}^{-2}$ . All three types of dislocations were present in these samples, and almost 50% were screw dislocations (Fig.1a). When the diffraction condition  $\mathbf{g} \cdot \mathbf{b} = 0$  was applied in cross-sectioned samples so that screw dislocations were out of contrast, small features along each screw dislocation line were still observed (Fig.1b-d). A drastic change of thickness, and a change of contrast from black to white on the edges of these features, was observed when conditions were changed from overfocus to underfocus. These changes allowed us to define the features as voids. In the  $[11\bar{2}0]$  projection, these voids had a triangular shape with a base size of about 3 nm and a height of about 4 nm. The voids were arranged on top of each other, with the direction from the tip to the base along the Ga to N bond length parallel to the c-axis (Ga polarity). Small gaps could be observed between these voids (Fig.1b,d). In plan-view configuration the voids have hexagonal shape. Amorphous-looking features, probably due to TEM sample preparation, could be seen inside the voids when focus was set at the top of the void. By changing the defocus, one can reach the tip of the void and observe crystallographic planes around and below the void (Fig.1f).

EDX and EELS mapping studies were performed in order to confirm the presence of oxygen. The results turned out to be negative, probably due to the fact that the concentration of oxygen is low and beyond the detectability limit of our instrument. We strongly believe that some light element contamination must lead to the formation of such voids, since heavier elements (which would be easier to detect) were not found. We observe screw dislocations in the MBE layers, (a much cleaner growth method compared to the HVPE), grown on the top of HVPE layers. These observations confirm our assumption, and show that no more voids are formed in the MBE material even though they were formed in the HVPE layer (Fig.1e). Plan-view images of screw dislocations in MBE layers do not show any voids (Fig.1g). These studies might suggest that the core structure of screw
