Physical Damage-Measured Response Correlation for Nonstructural Components Tested under Multi-Hazard (Earthquake and Fire) Demands in the CFS10 Building

## Physical Damage-Measured Response Correlation for Nonstructural Components Tested under Multi-hazard (Earthquake and Fire) Demands in the CFS10 Building

This paper is the second of a set presented within the session: *Findings from the CFS10 Multi-Hazard Test Program*. The emphasis within this article is to highlight correlations between physical damage to nonstructural components and systems with measured response during a suite

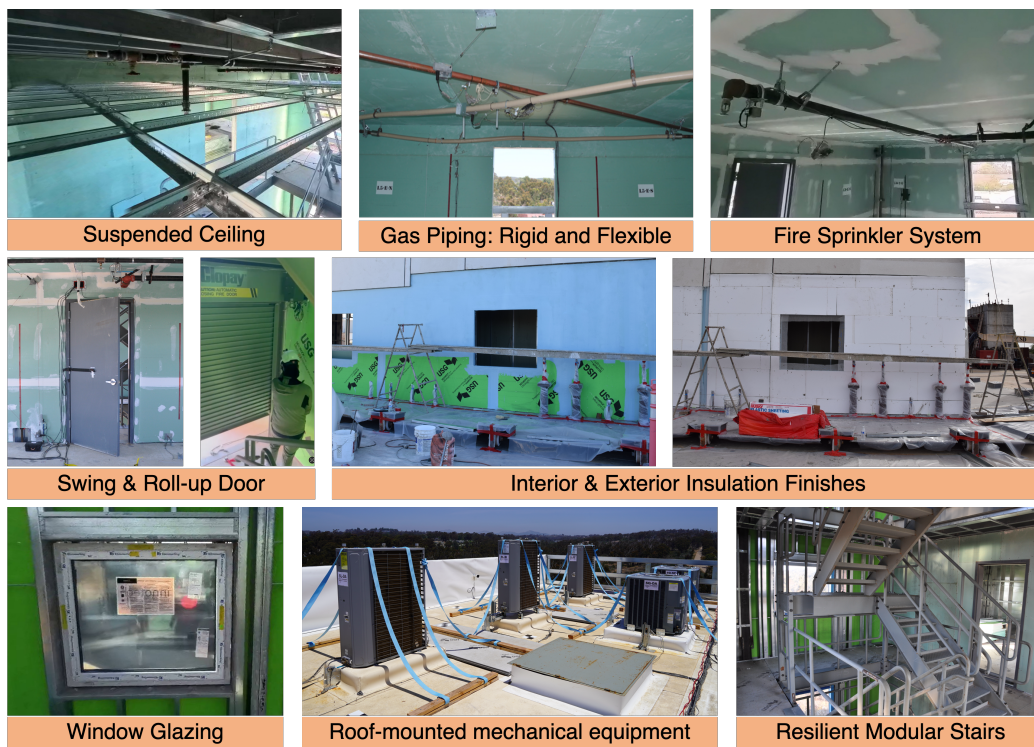
**Figure 2. Nonstructural components and systems installed in the CFS10 building.**

The CFS10 test building was outfitted with a wide range of NCSs including fire sprinkler and gas piping systems, suspended ceilings (Singh et al., 2026), a resilient stair system (Sorosh et al., 2025), windows, swing and roll-up doors, roof-mounted mechanical equipment (Zhang et al., 2026a, 2026b), architectural wall and ceiling finishes, and firestop and protection materials. These systems, shown in Figure 2, were distributed across the different levels of the building. The NCSs as presented in this paper are organized following Sections 13.5 and 13.6 of ASCE 7-22 (2022) in Tables 1 and 2 providing a detailed description of the various components. Recent publications emerging from the project have discussed the seismic response of select NCSs. This paper provides physical test observations correlated with measured engineering demand parameters (EDP) such as floor acceleration, building inter-story drift or peak local temperature responses for NCSs.
