ICEM2010-40121

DEVELOPMENT OF CHARACTERIZATION TECHNOLOGY FOR FAULT ZONE HYDROLOGY

ABSTRACT

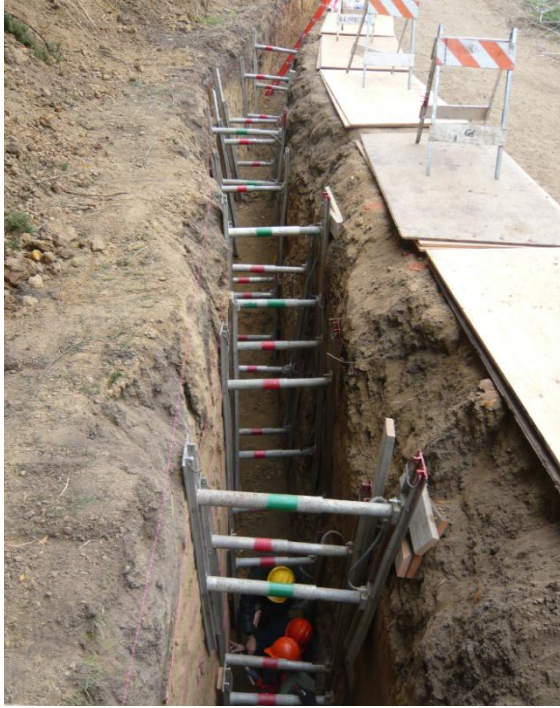
Figure 4 Geologists mapping the wall of the TR-4 trench on the Ridge Road south of LBNL excavated as deep as 4.5m and 60m long.

A total of five trenches have been excavated, crosscutting the fault, to investigate the deformation structure of the fault in the bedrock (Figure 3). The locations were chosen based on the literature and evidence from road/building construction, as well as newly conducted geological surveys. The TR-4 trench was 60 m long, dug as deep as 4.5 m, with a width of 1 m (Figure 4). At least one to (as many as) several faults were observed in all five trenches, although it is yet to be determined whether any of the trenches have intersected the “main” fault. Trench studies are effective when the location of a fault is known and the thickness of the alluvium above the bedrock is not very thick; however, because the observation is near-surface, the properties of the fault may be affected by stress release and

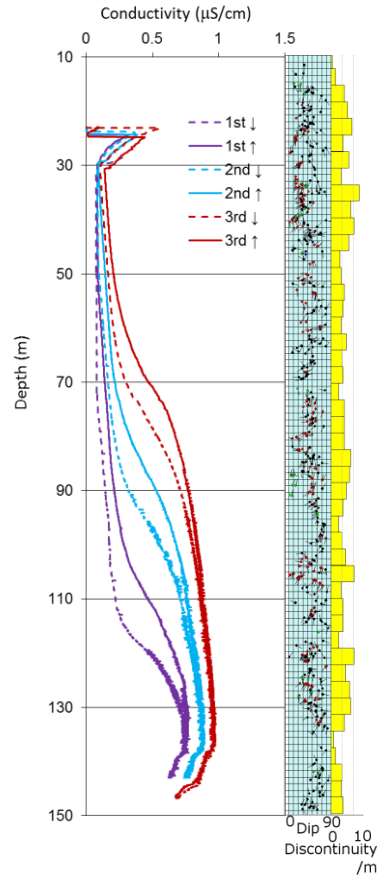
Figure 7 FFEC log results plotted against the tadpole plot of discontinuity and discontinuity counts based on televiewer analysis in WF-2.

Borehole geophysical logs were conducted in all three boreholes including caliper, gamma, resistivity, acoustic televiewer, and sonic log. In addition, flowing fluid conductivity logs (FFEC) were conducted in each hole. FFEC logs can pinpoint inflow zones caused by the electric conductivity contrast artificially created between the formation fluid and that of the borehole under a pumping condition [7]. Figure 6 shows the FFEC results from WF-2 plotted against the tadpole and frequency plot of discontinuities, which include fractures and beddings. As can be seen from the figure, only one inflow point at 136 m was detected by the FFEC log, whereas 309 fractures and 152 beddings were counted by the televiewer log. This result shows that the fracture density is not a good indicator for flow. In fact, the inflow point is at a depth where fracture density is at its lowest. Similar results were obtained in the other two boreholes.
