Features and Dimensions of the Hayward fault zone in the Strawberry and Blackberry Creek Area Berkeley, California

### Features and Dimensions of the Hayward Fault Zone in the Strawberry and Blackberry Creek Area, Berkeley, California

P.L. Williams

March 1995

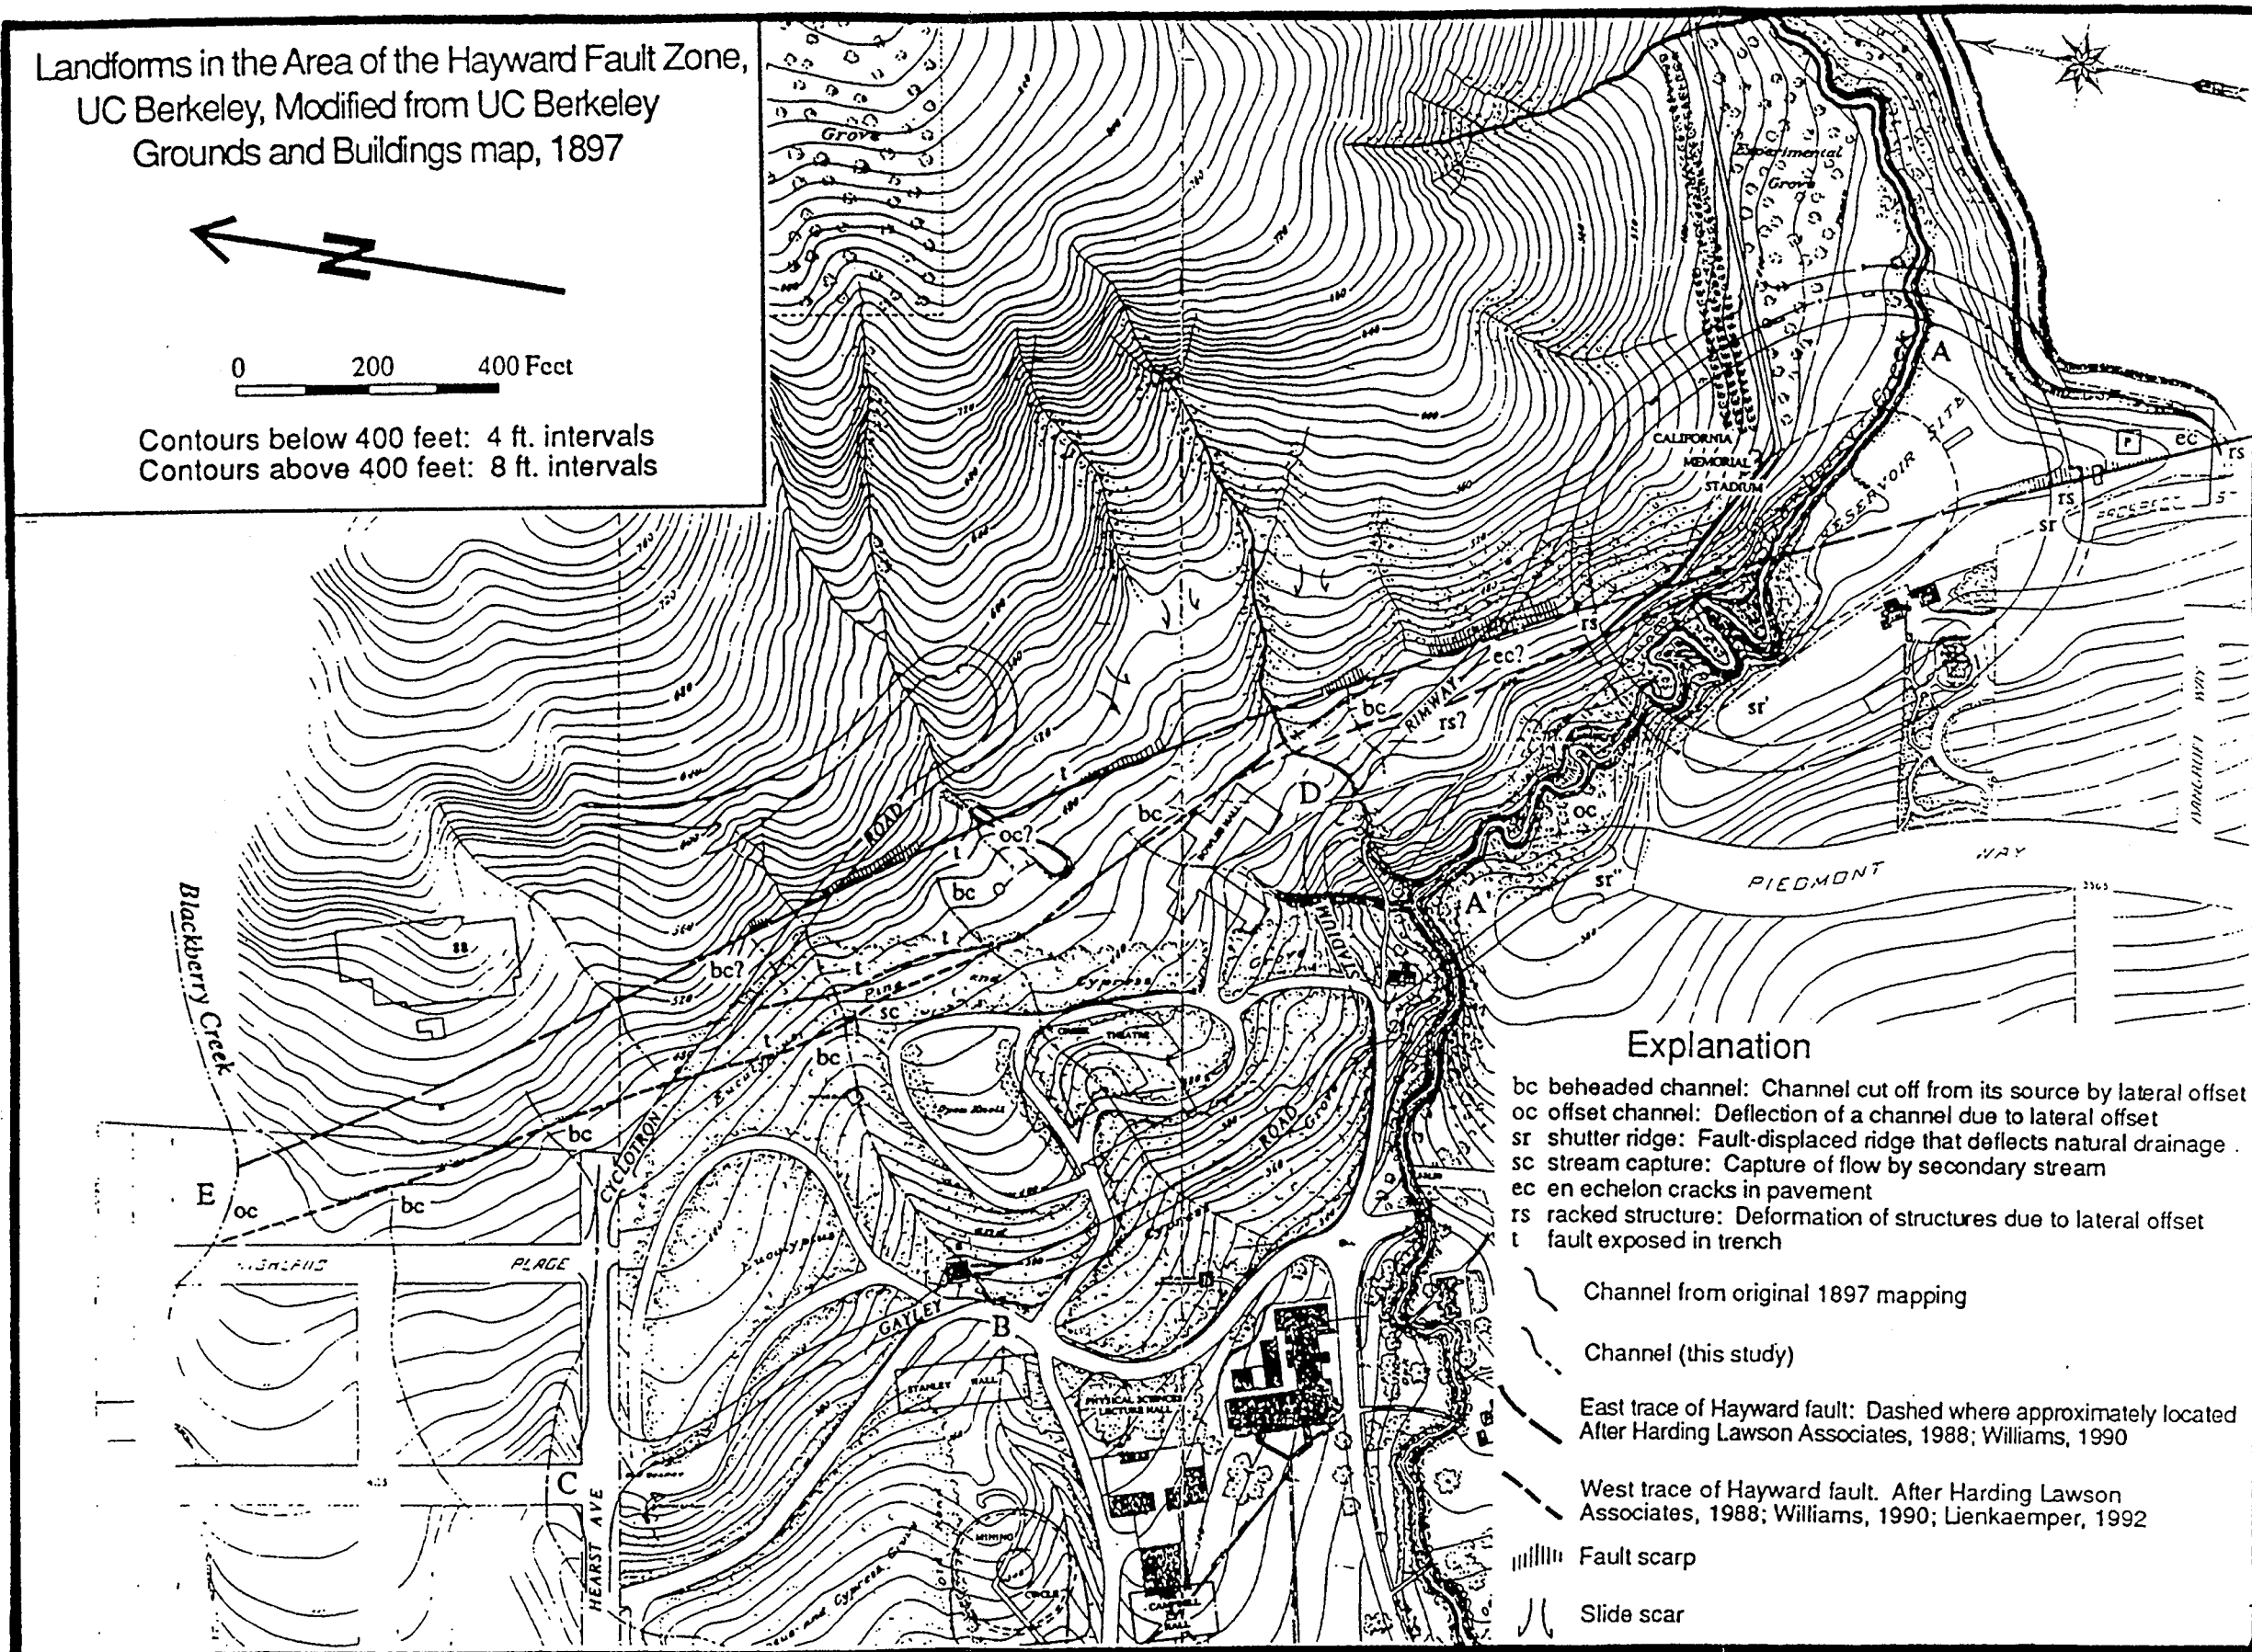
0 200 400 Feet

Contours below 400 feet: 4 ft. intervals  
Contours above 400 feet: 8 ft. intervals

*Offset and beheaded streams.* One of the most direct means of mapping strike-slip (lateral slip) faults is by the identification and alignment of deflected drainages along faultlines. Many drainages are offset by the Hayward fault, and these provide primary evidence of the fault's location. Before construction of the California Memorial Stadium in 1923, the largest intact channel offset along the fault's length was that of Strawberry Creek (Figure 1, location A-A'). This large, competent stream is offset 1100 feet by right-lateral motion. The channel of Blackberry Creek is offset 190 feet by faulting. These two channel offsets are the most prominent evidence of the fault's location adjacent to Lawrence Berkeley Lab. A number of more subtle stream offsets and deflections have been interpreted from the 1897 UC Berkeley Building and Grounds basemap upon which more recent cultural features and the Hayward fault have been superimposed (Figure 1.).

Two former channels of Strawberry Creek cross the Berkeley Campus. These offset channels are termed "beheaded" or "abandoned", since they have been cut off from the Strawberry Creek watershed. The beheaded channels (locations B, C; Figure 1) were described by Buwalda (1929). One is located along a line between the east entrance to UC Berkeley and the Mining Circle. This "Mining Circle Channel" is offset 1900 feet from Strawberry Canyon (Location B, Figure 1). A second (and older) beheaded channel of Strawberry Creek is located beneath Hearst Avenue (Figure 1, location C). The "Hearst

Several additional abandoned and offset stream channels are interpreted on Figure 1. The confidence of these interpretations varies, but where the offsetting fault is also located by additional evidence, the abandoned and offset streams increase confidence in the analysis.

*Shutter ridge.* Buwalda (1929) noted that the course of Strawberry Creek is deflected by a fault-bordering ridge of slope-base deposits, a *shutter ridge* (Located at *sr'-sr''*, Figure 1). The 1000-foot-long shutter ridge ranged in height from 16 to 28 feet. Buwalda documented both the fault's location and lithology of the shutter ridge during construction of the California Memorial Stadium. He found that the ridge contained serpentine fragments. No source of serpentine exists in the Strawberry Creek drainage, but serpentine is present in Hamilton Gulch, 1400 feet southeast. This required that "at a date so recent that the topography of the region was essentially that of today" the ridge deposits had moved at least 1,400 feet from the gulch.

*Fault scarps.* Fault scarps near the foot of the Berkeley Hills appear as abrupt increases in slope angle as shown by tight contour spacing (Figure 1). The crisp definition of several of these scarps indicates the recency of fault movement. The linear trend of these scarps also aids in locating the fault trace. Particularly clear is the east-facing scarp (at *sr*, Figure 1) on the uphill side of the Strawberry Creek shutter ridge

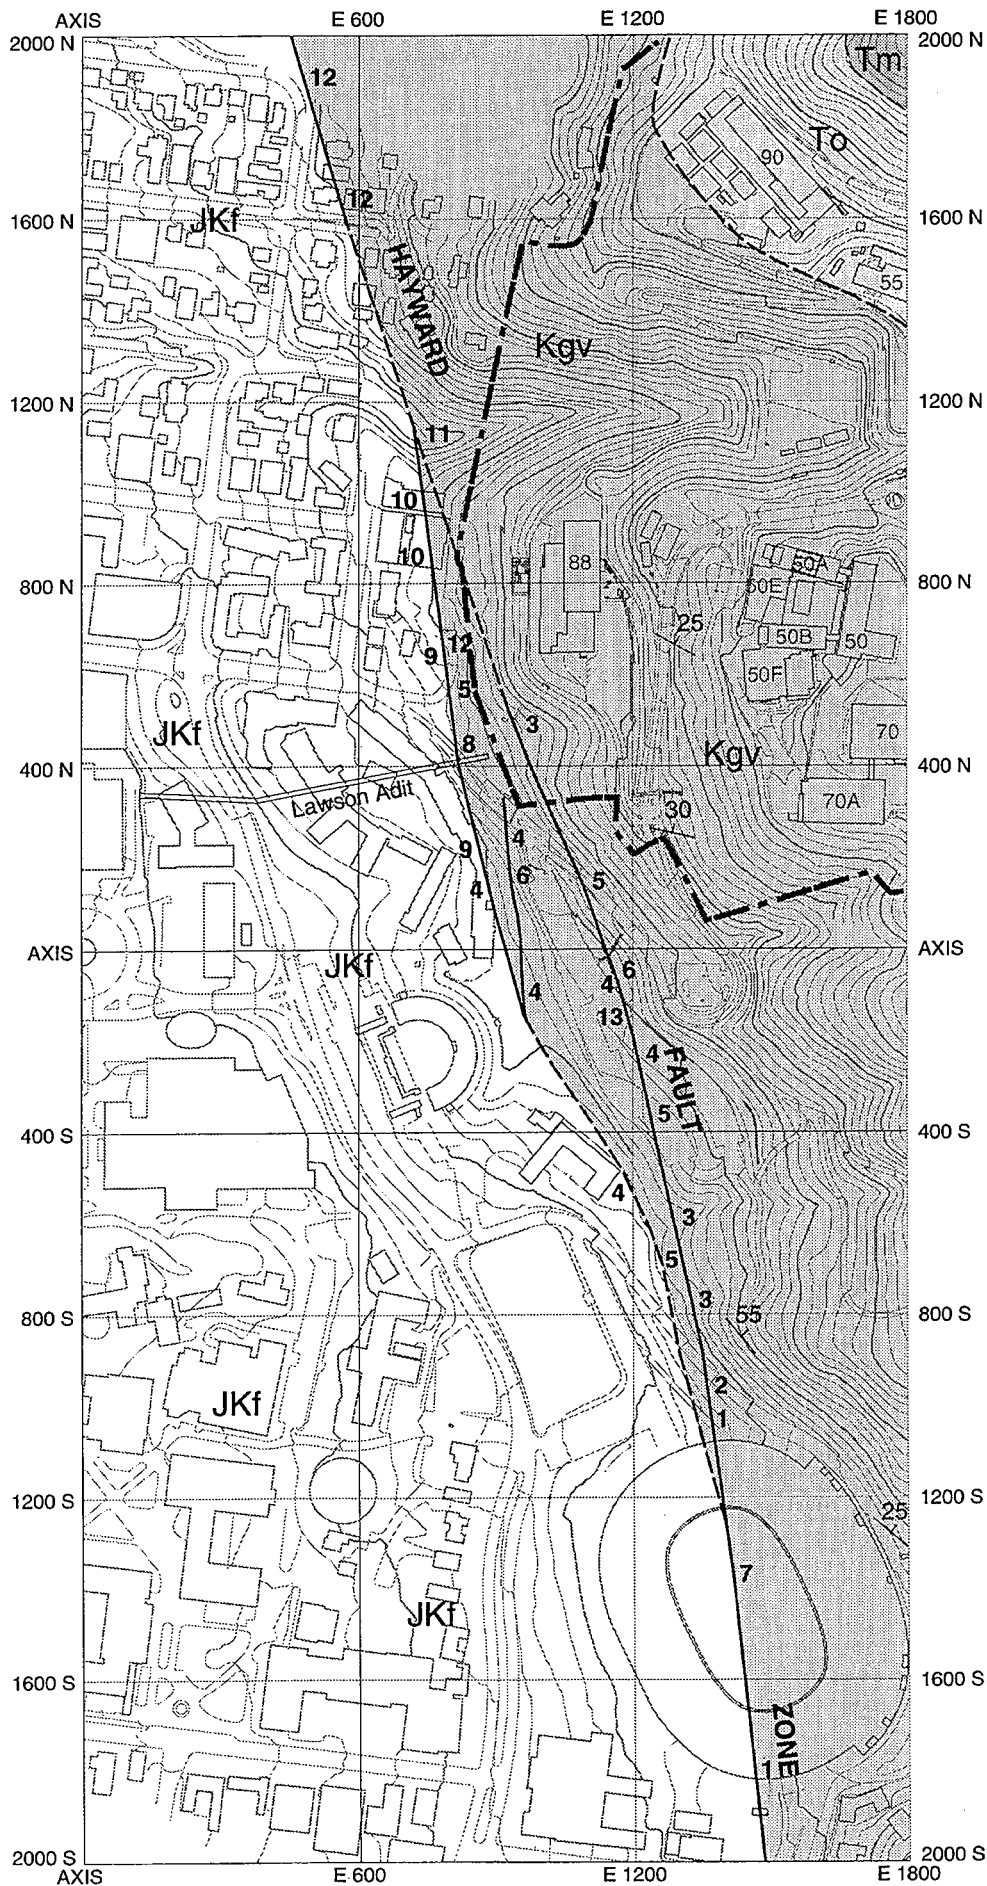
- Tm Moraga Formation
- To Orinda Formation
- Kgv Great Valley Group
- JKf Franciscan Complex

.....  
 Contact, showing dip  
 Long-dashed where approxi-  
 mately located; short-dashed  
 where gradational or inferred.

Near the northwestern corner of the Lawrence Berkeley Laboratory site, the Highlander Apartment complex is offset by fault motion. The Highlander offset, in conjunction with the discovery of offset sidewalks, streets and foundations north of Blackberry Creek, and landform data, provide a high confidence fault location to the north and west of Lawrence Berkeley Laboratory (Figure 2).
