Quiet Pavement Research: Bridge Deck Tire Noise Report

**Authors:**  
E. Kohler  
Dynatest Consulting, Inc.

Work Conducted as Part of Partnered Pavement Research Center Strategic Plan Element No. 4.22:  
Quiet Concrete Pavement Research

**DOCUMENT RETRIEVAL PAGE****UCPRC Report Number:UCPRC-RR-2010-04****Title:** Quiet Pavement Research: Bridge Deck Tire Noise Report**Author:** E. Kohler**Prepared for:** Caltrans**FHWA No.:** CA121200B**Date Work Submitted:** July 22, 2010**Date:** June 2011**Strategic Plan No:** 4.22**Status:** Stage 6, final version**Version No.:** 1

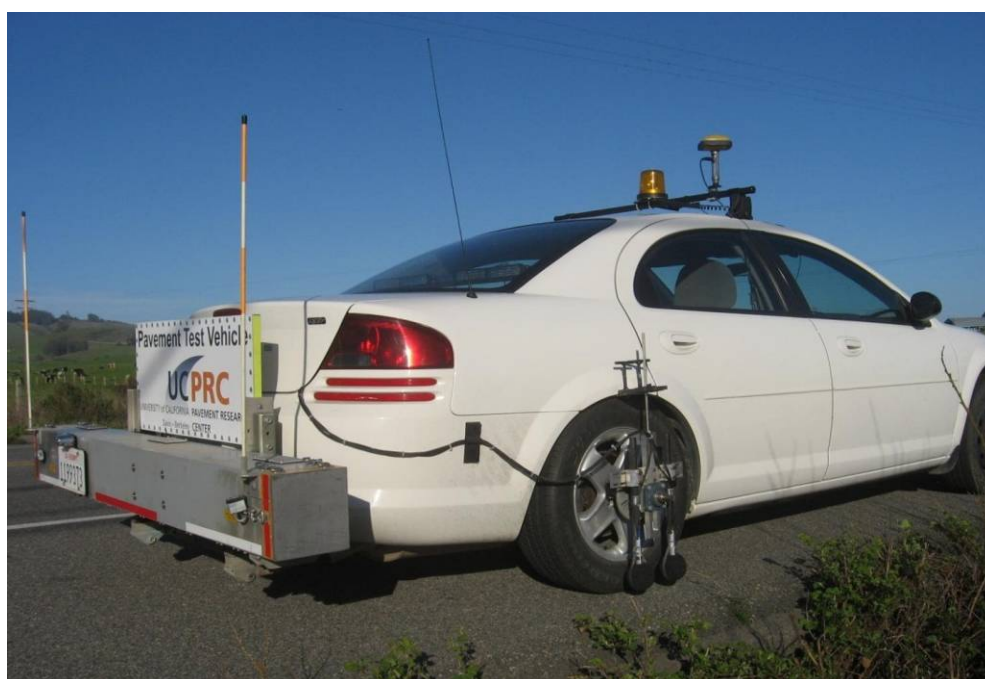
**Figure 2.1: Instrumented vehicle with one set of sound intensity microphones on each side of the tire and an inertial profilometer with spot lasers, including a high-speed spot laser in the right wheelpath.**

Visual observation was necessary for determining the bridge deck surface type. In some cases, bridges were part of heavily trafficked highways which made it impossible to stop and closely examine the bridge surface. In these cases, observations were only made from the moving test vehicle, which is shown in Figure 2.1.

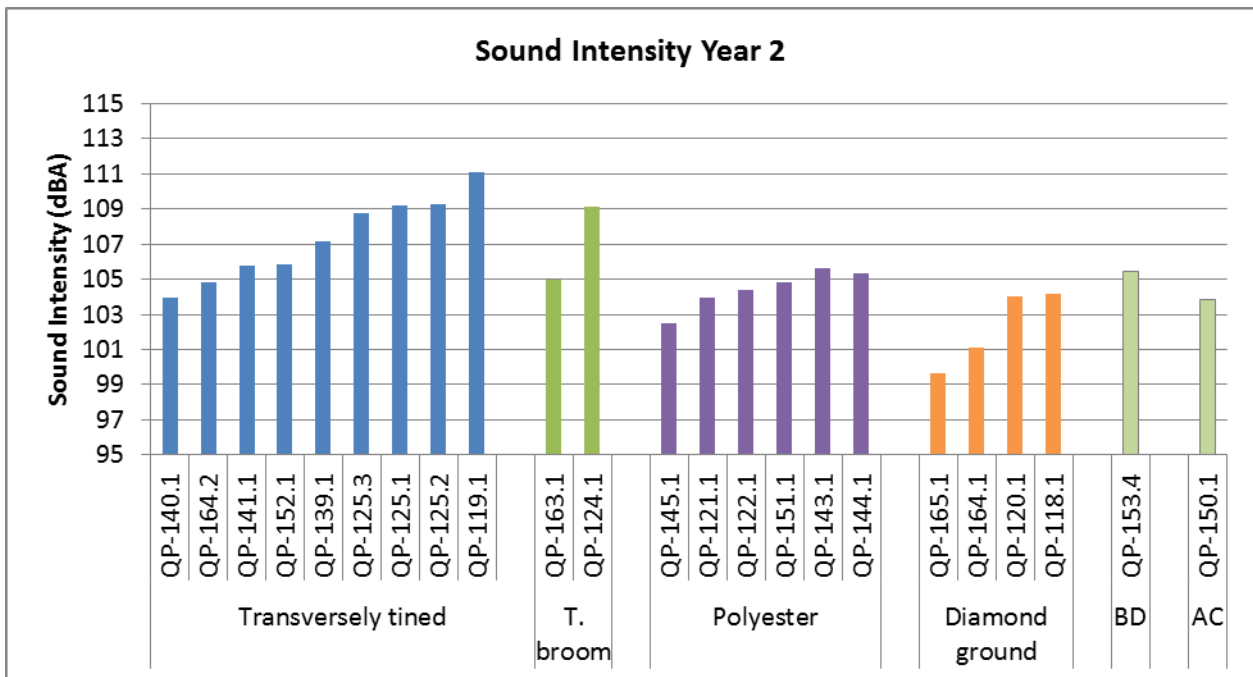
Figure 3.2: OBSI results for each section by surface type, Year 2.

The results by section are presented graphically in Figure 3.1 and Figure 3.2 for Years 1 and 2, respectively. Note that Section QP-149.1 with a polyester overlay surface is shown in Year 1 with a different color than the other polyester overlay sections, but it was not considered in the analysis of aggregated data.

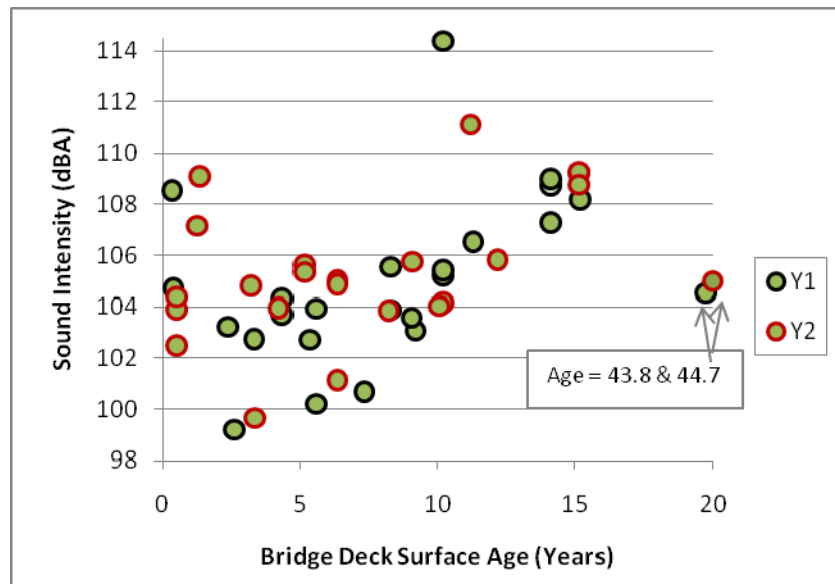
**Figure 3.17: Plot of OBSI versus surface age, all surface types combined.**

Figure 3.17 shows the OBSI level results versus age for all sections, regardless of surface type.

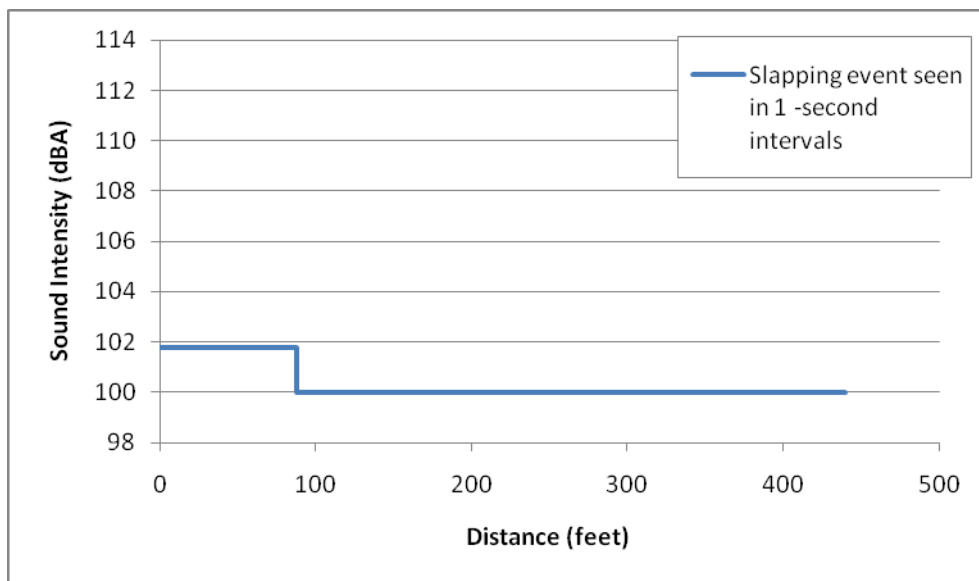
**Figure 3.20: Effect of a single 112 dB(A) slap event expressed in a 1-sec interval.**

However, the effect of slap noise events, such as the vehicle’s passage over a joint, is controlled by both the duration of the event and its magnitude. The OBSI of the slap noise when measured at intervals shorter than the duration of the effect created (in this case 0.034 seconds) would be 112 dB(A) (see Figure 3.19); however when included in a one-second interval (see Figure 3.20), its OBSI is only measured as 101.8 dB(A) because the 100.0 dB(A) surface largely controls the overall noise level if any of it is included in the time interval. For the five-second average normally used for OBSI measurement, the slap noise would cause an increase from 100.0 to 100.4 dB(A). This means that a 112 dB(A) slap noise would have a 0.4 dB(A) effect on the overall noise of a 440-ft section. (The averages here are taken as energy averages, as explained in Section 2.2.)

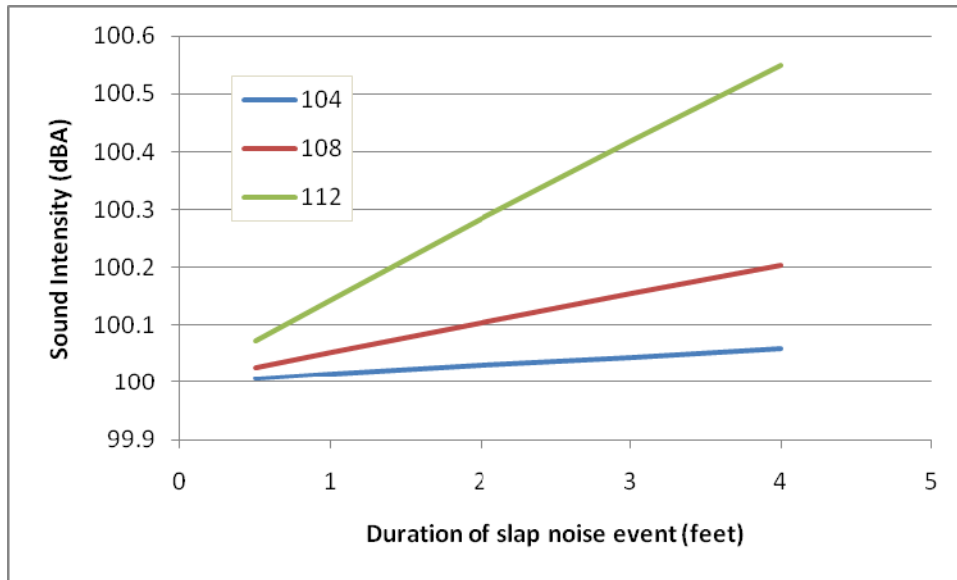
**Figure 3.21: Effect of a single slap event of 104, 108, or 112 dB(A) on a 440-ft long surface with an OBSI level of 100 dB(A).**

The effect of joint slap noise events, such as occurs when a tire rolls over a joint, is controlled by the duration of the event and its magnitude. The above example used a 112 dB(A) event that lasted for an assumed 3 feet. Figure 3.21 shows the effect of events of 104, 108, and 112 dB(A), lasting between 0.5 and 4 feet (0.15 and 1.2 m). Based on the results from this study, the bridge joints seem to fall within this range of possible effects.

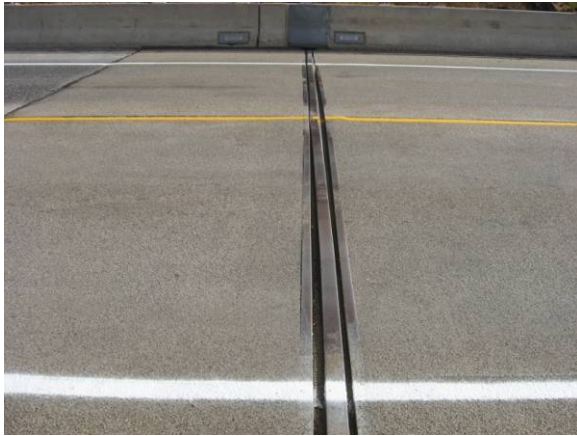
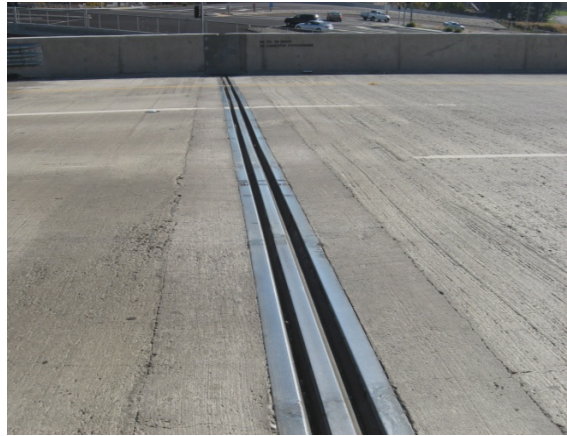
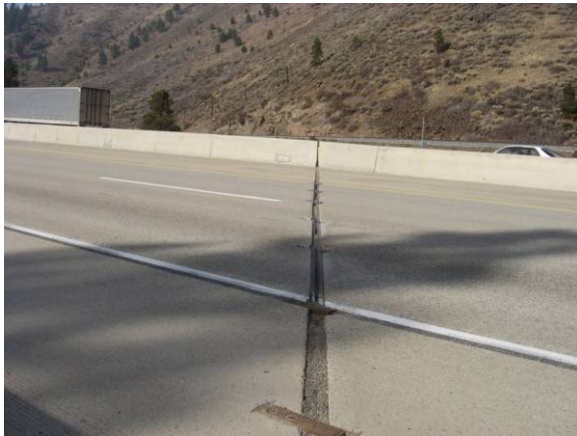
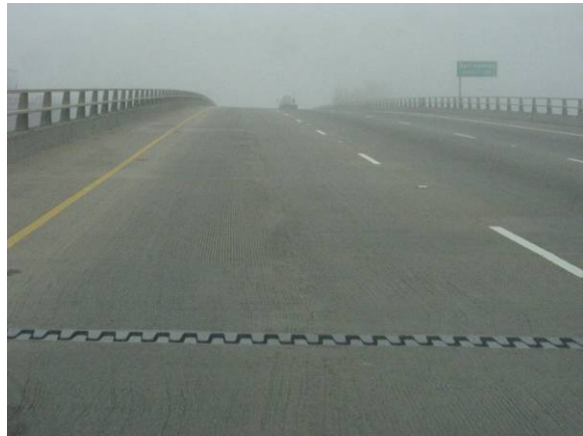
**Figure 3.24: Examples of bridge joints included in this study.**

Figure 3.24 shows example pictures of the bridge joints measured as part of this study.

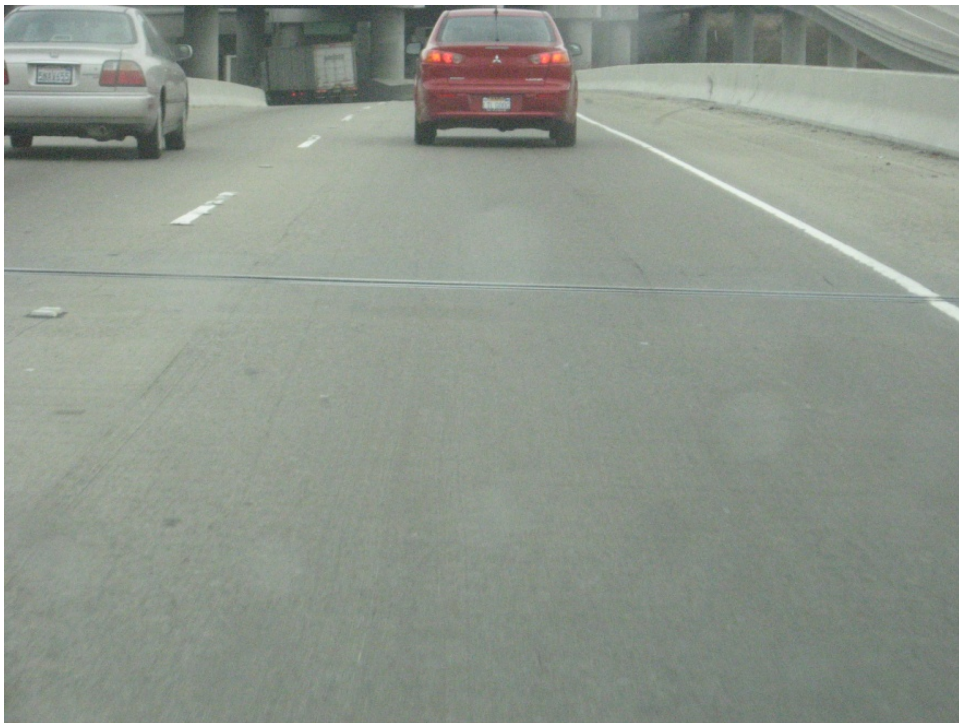
**Figure 4.2: Surface and joint on Section QP-118.1.**

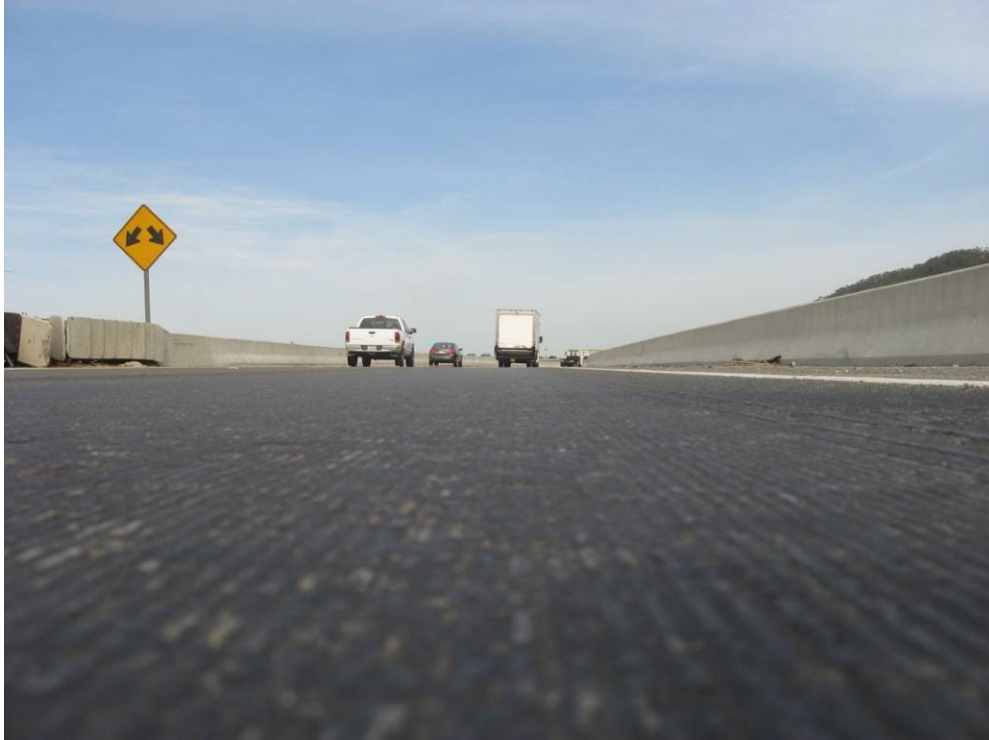
**Figure 4.3: Detailed surface texture on Section QP-118.1.**

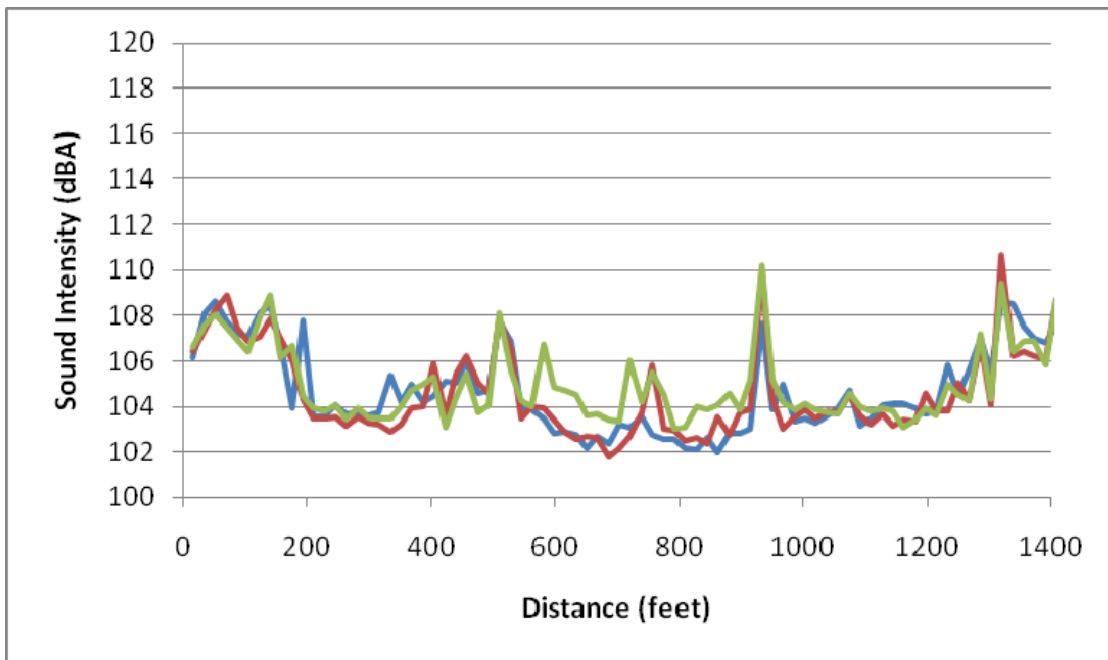
Figure 4.6: OBSI level in 0.2-sec intervals of Section QP-118.1, Year 2, three passes.

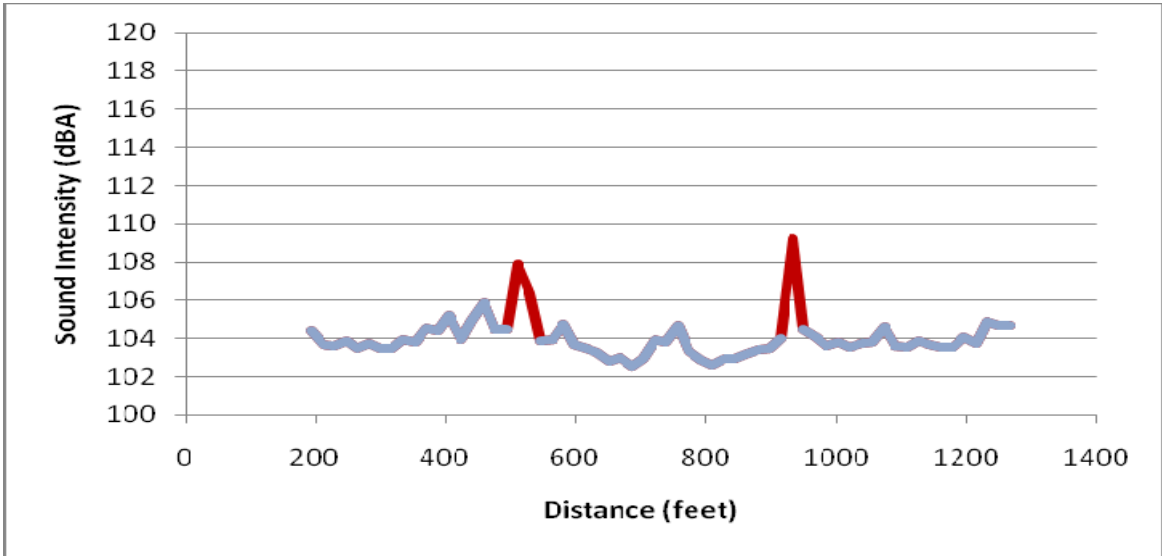
Figure 4.7: OBSI level in 0.2-sec intervals of Section QP-118.1, the bridge only, Year 2, average of three passes, highlighted joints.

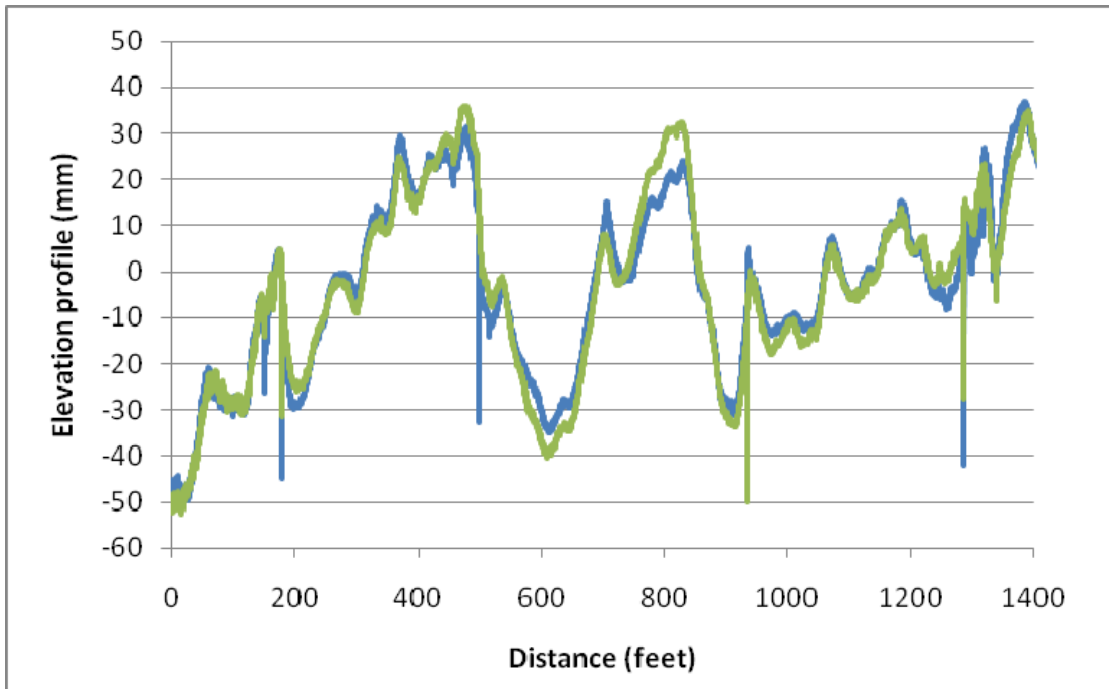
Figure 4.8: Elevation profile of Section QP-118.1.

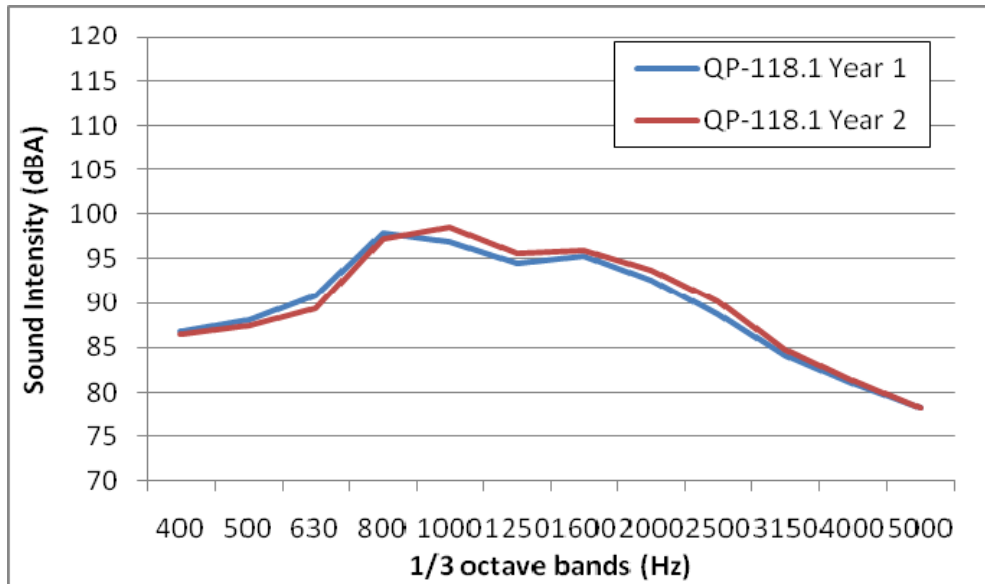
Figure 4.9: OBSI spectra of Section QP-118, Year 1 and Year 2.

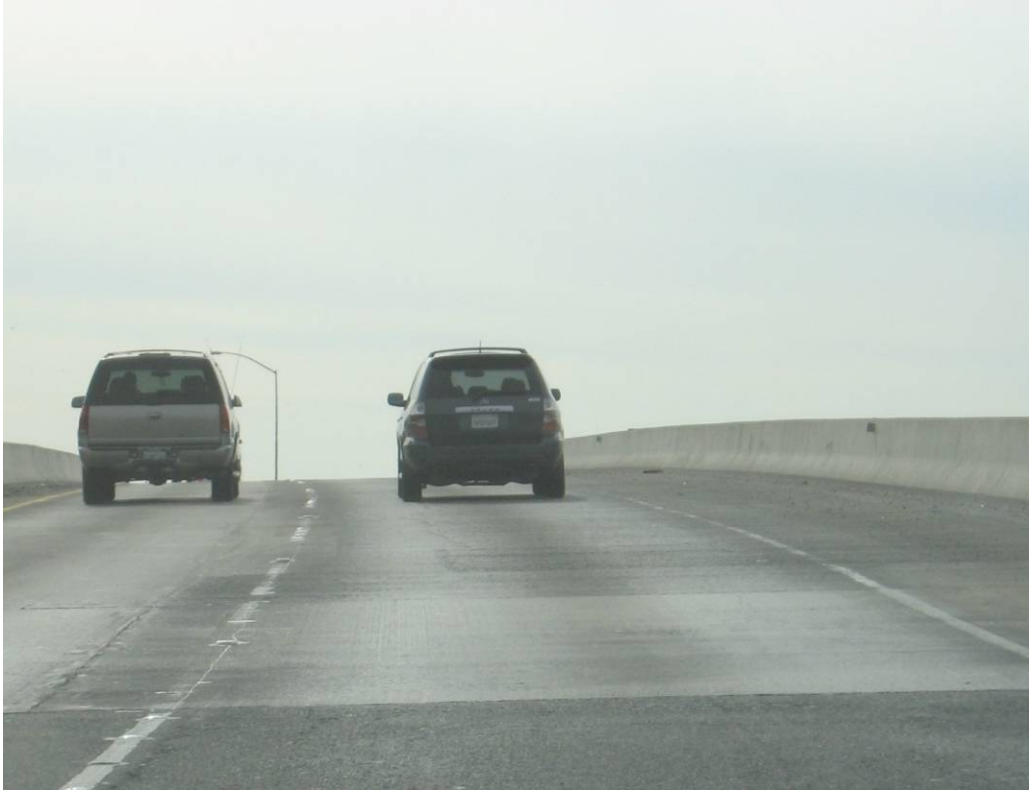
**Figure 4.10: Beginning of Section QP-119.1.**

Section QP-119.1 is on Bridge Number 33 0051L which transitions eastbound I-580 to westbound I-80 in Albany in Alameda County. This heavily textured transversely tined surface (see Figure 4.10 through Figure 4.12) is very loud and in fact had the highest OBSI of the study. It can be seen in Figure 4.12 that along with its heavy transversely tined texture, the bridge deck is also poorly finished and the poor finish likely contributes further to the noise.

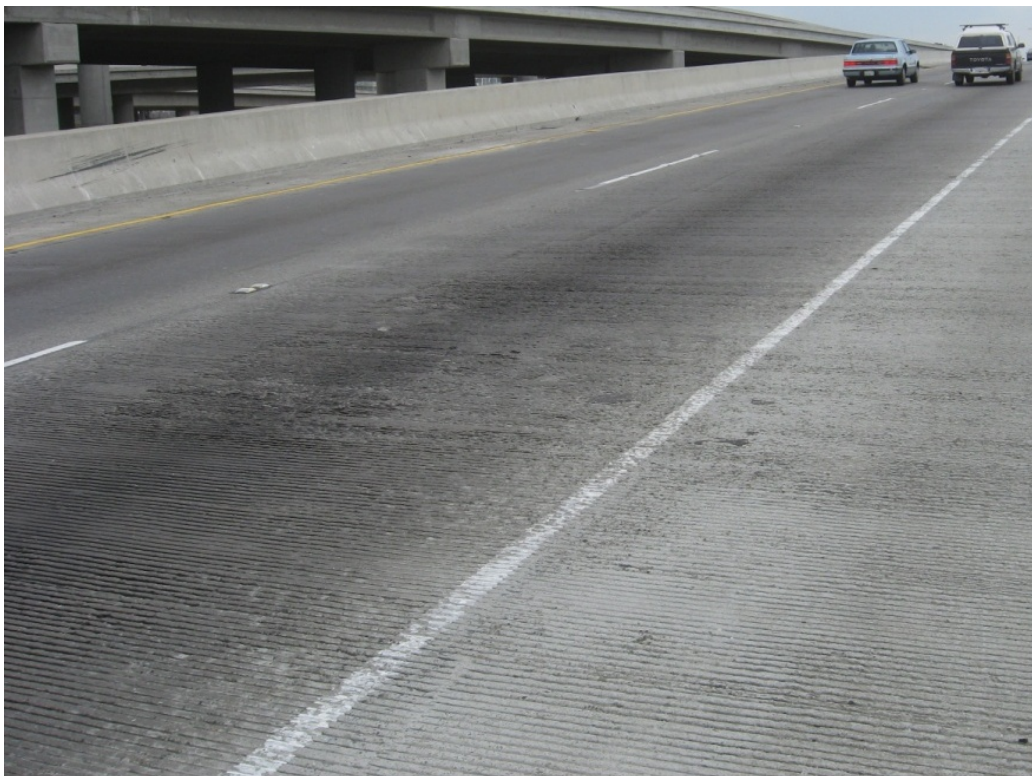
**Figure 4.11: Surface on Section QP-119.1.**

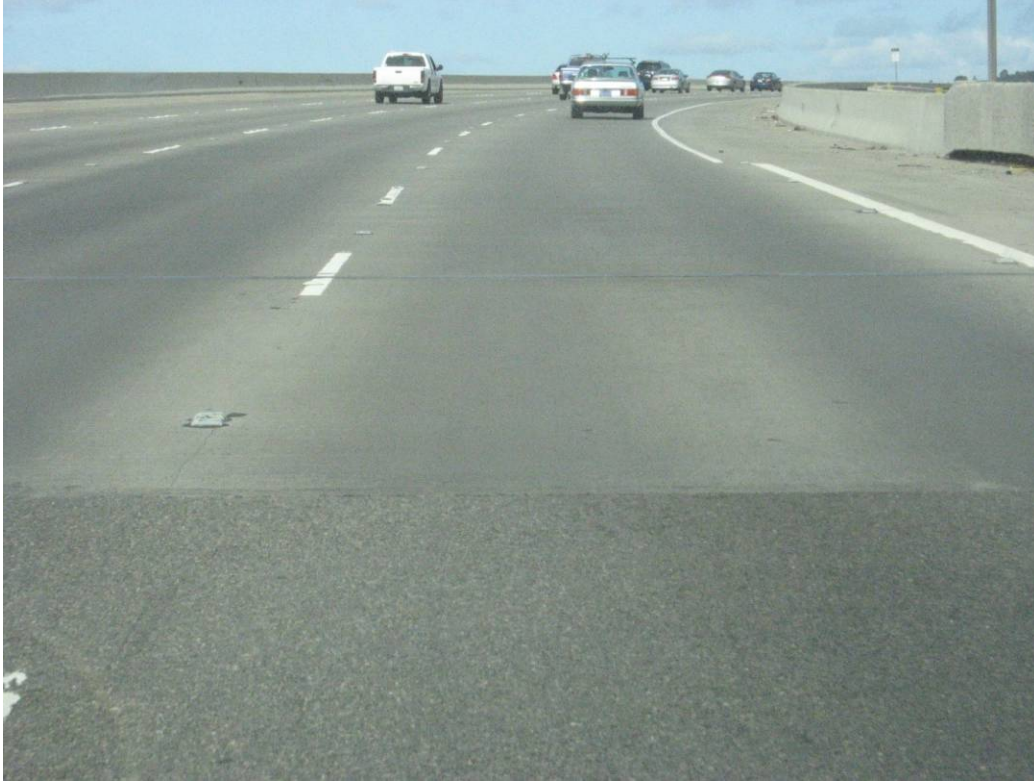
**Figure 4.19: Beginning of Section QP-120.1.**

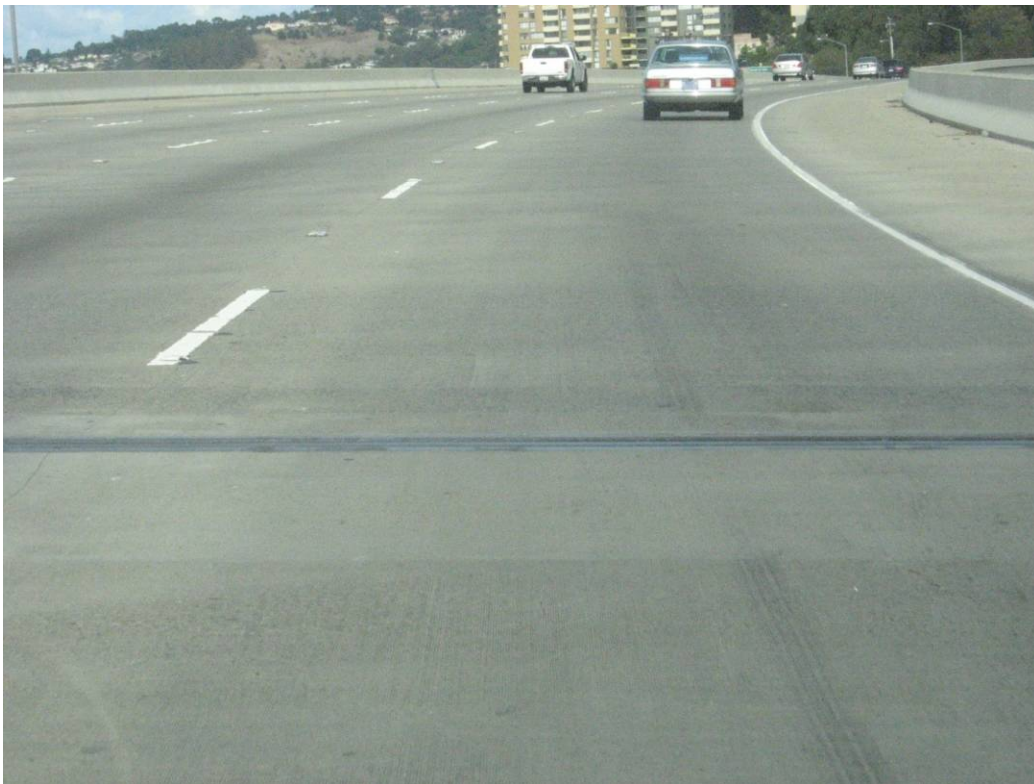
**Figure 4.20: Surface and joint on Section QP-120.1.**

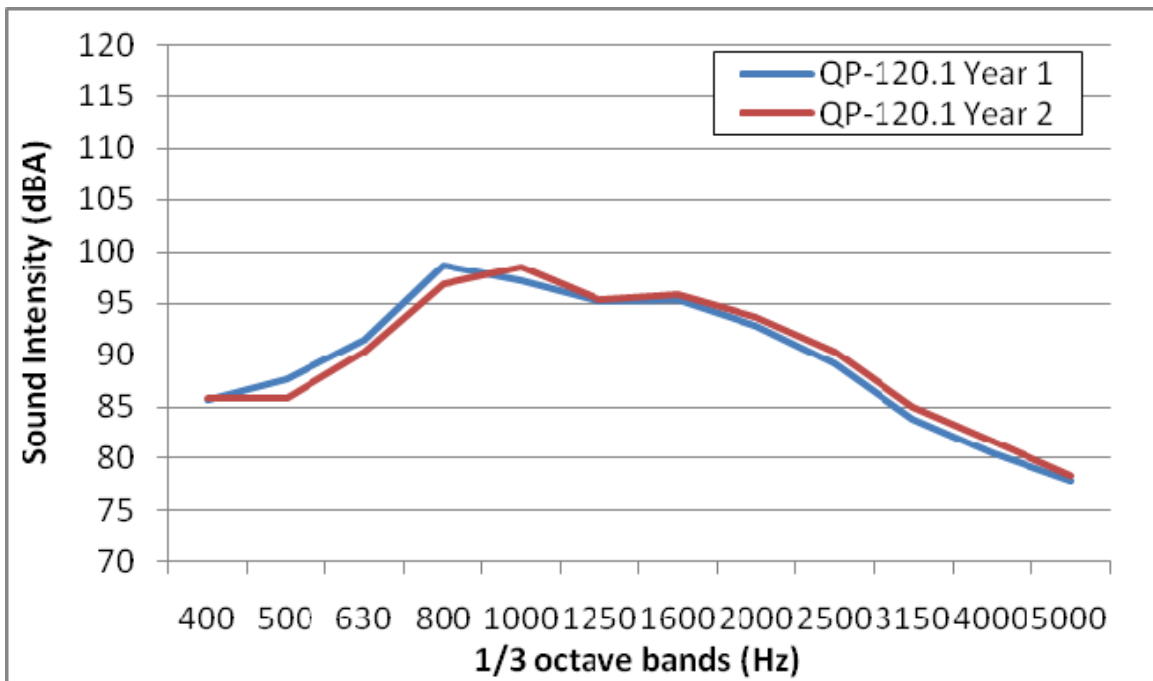
Figure 4.26: OBSI spectra of Section QP-120.1, Year 1 and Year 2.

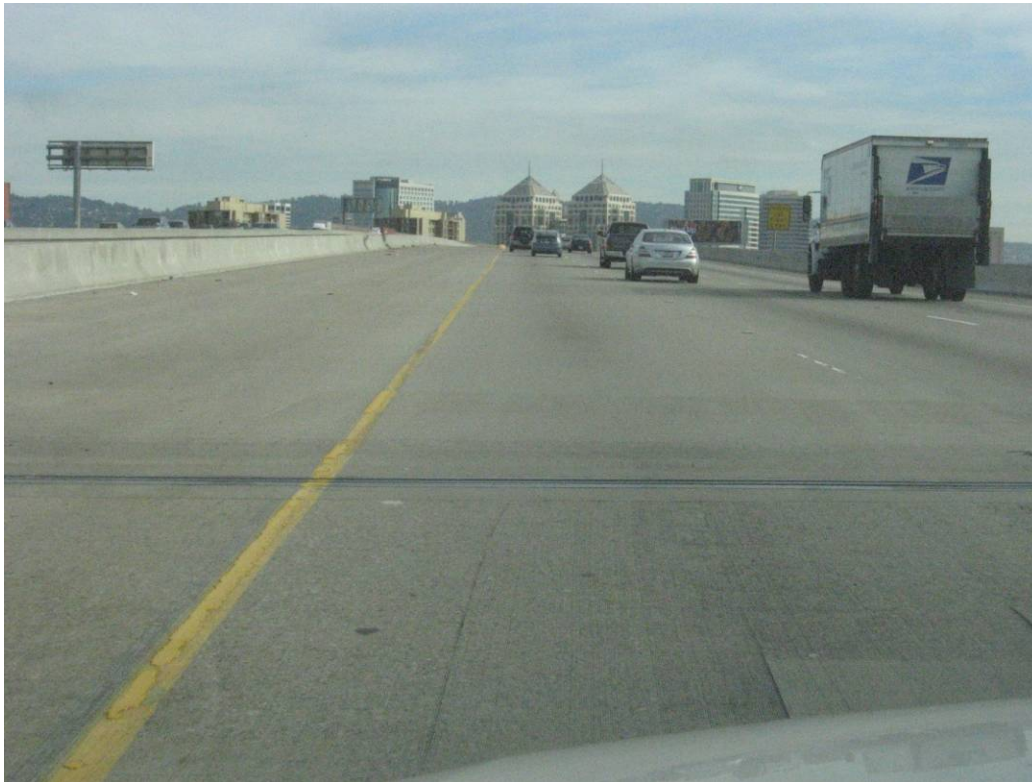
**Figure 4.27: Surface and first measured joint on Section QP-121.1.**

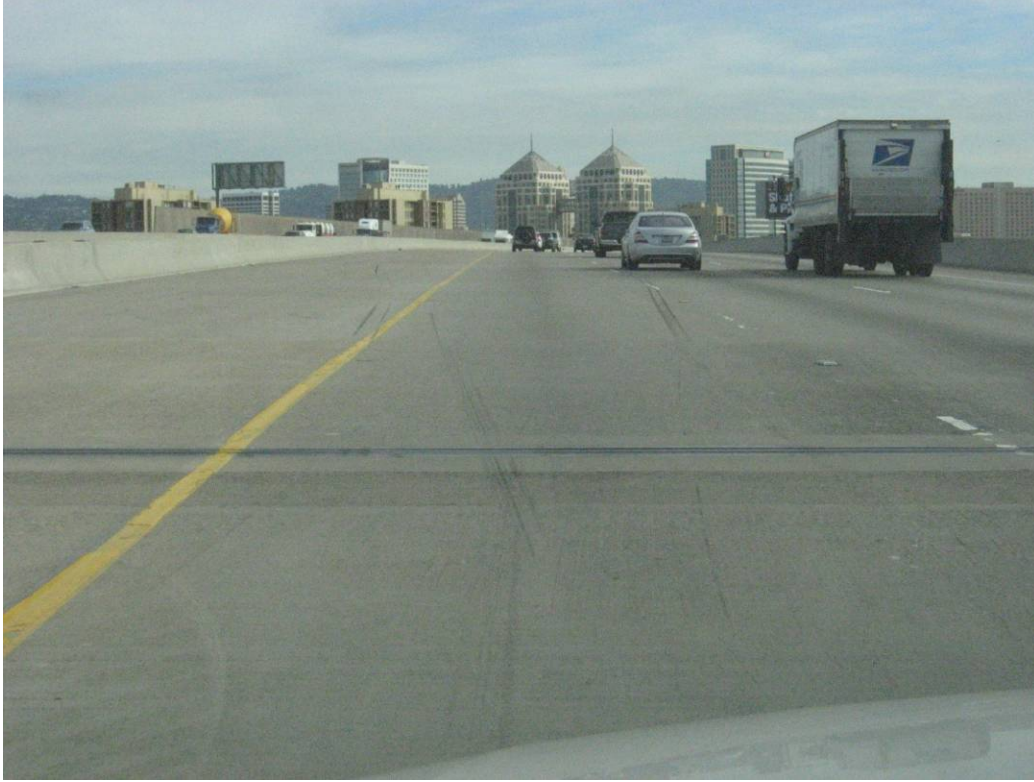
**Figure 4.28: Surface and second measured joint of Section QP-121.1.**

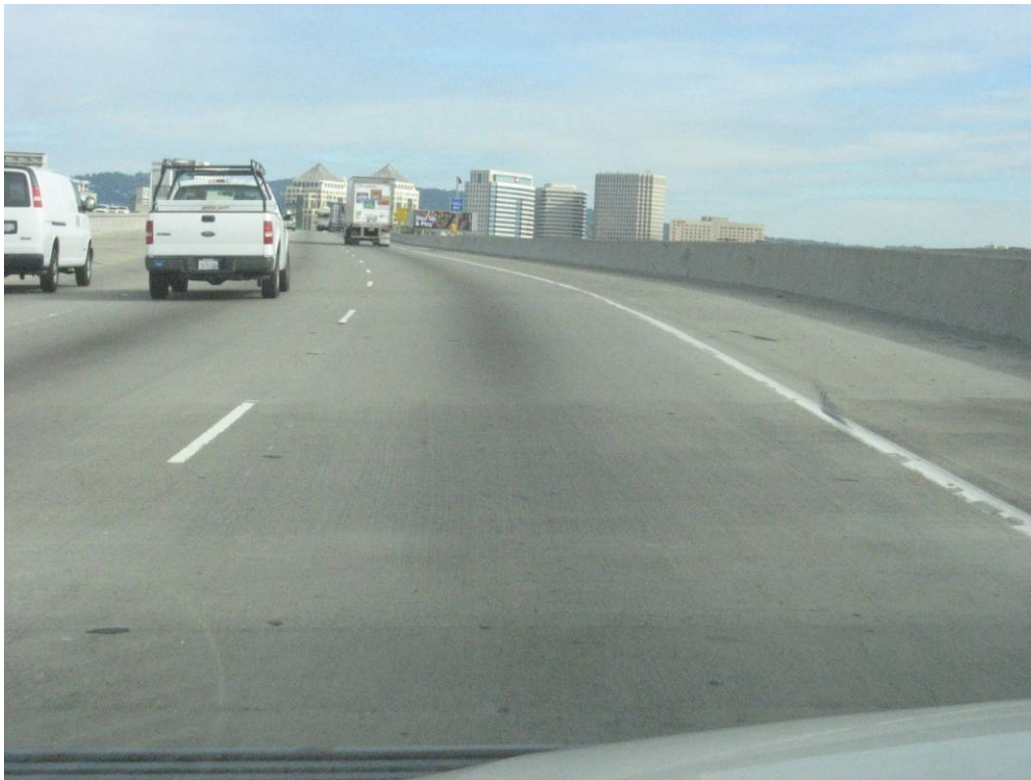
**Figure 4.34: Beginning of Section QP-122.1.**

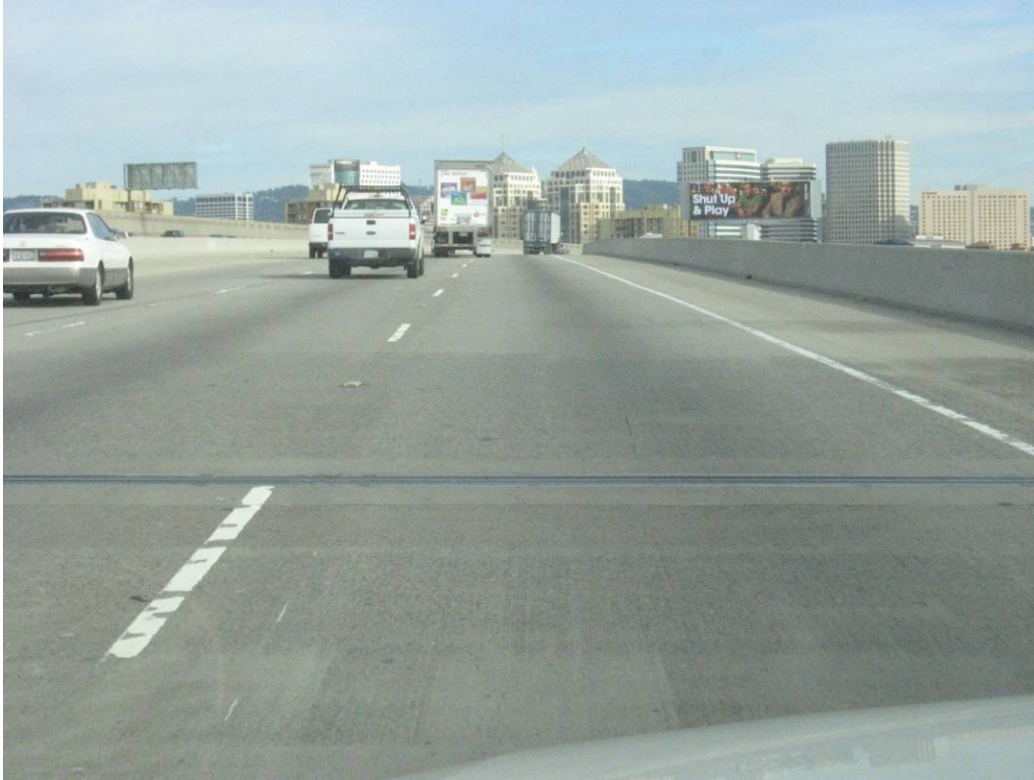
**Figure 4.35: Surface and joint on Section QP-122.1.**

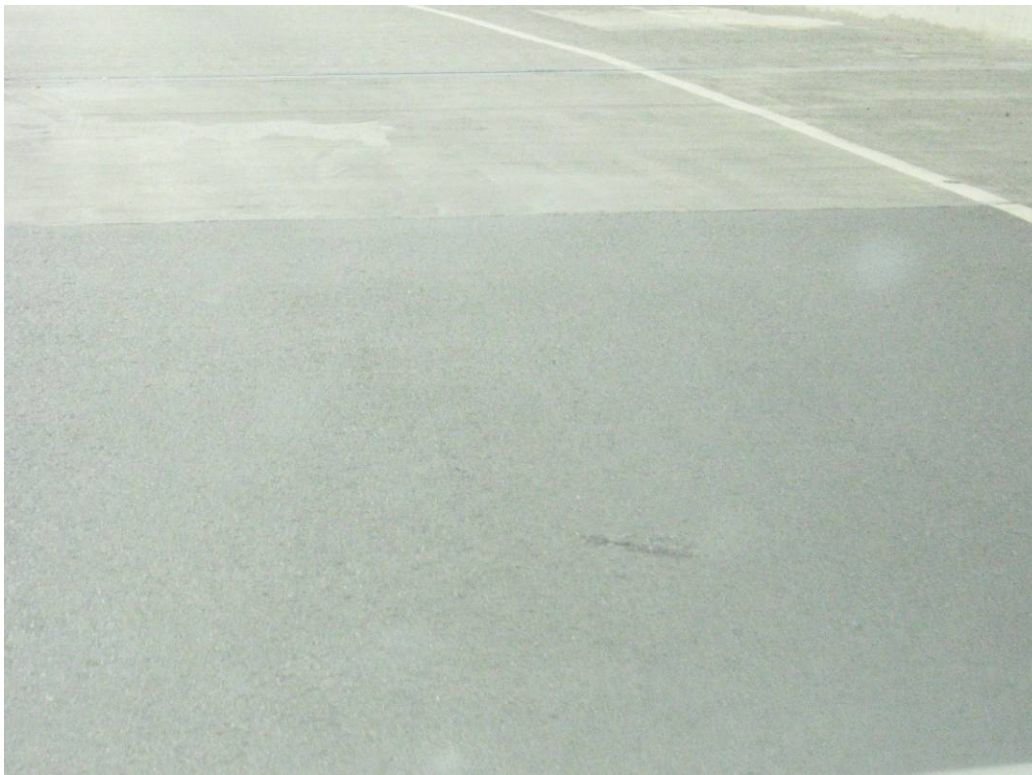
**Figure 4.41: Beginning of Section QP-124.1.**

Section QP-124.1 is located on Bridge Number 37 0244L, which connects I-680 to I-880 between Fremont and Milpitas. The measured section transitions from asphalt concrete pavement to a transversely broomed deck. It can be seen in Figure 4.43 that the transversely broomed texture is aggressive and has a relatively poor finish, although not as poor a finish as Section 119.1 (Figure 4.12). No joint slap noise was identified, but the diamond-ground segments at the joints are visible in the 0.2-sec OBSI plots. Despite the drop in overall noise level from Year 1 to Year 2, the spectra are very similar. It is worth noting that this section is in a curve.

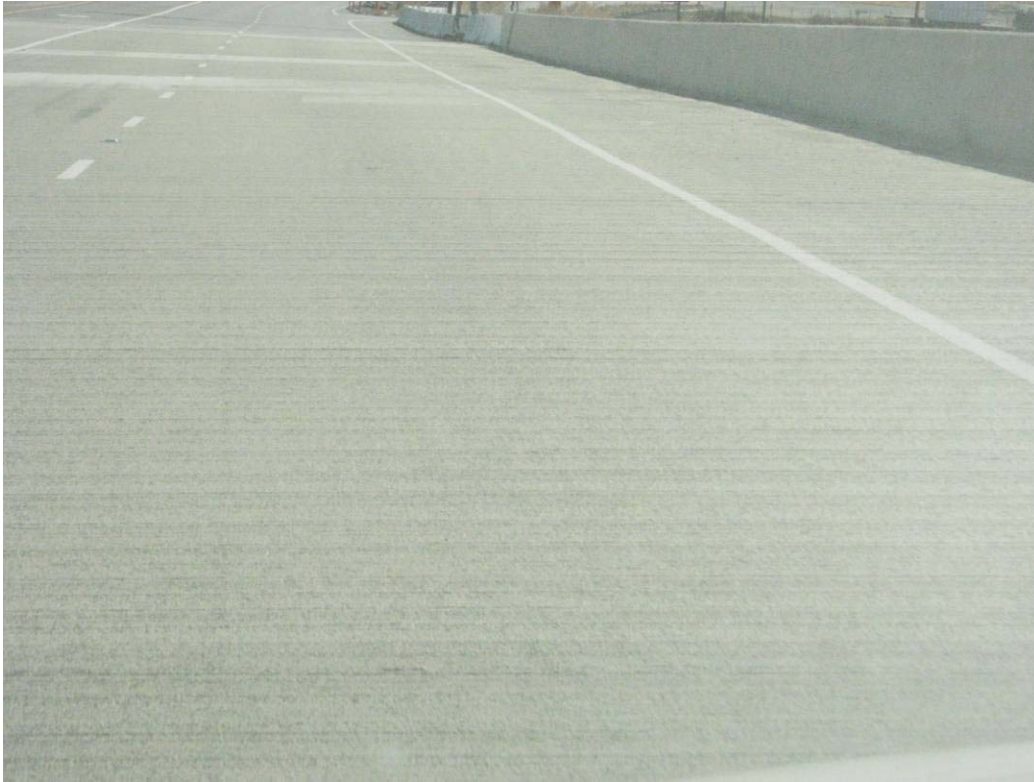
**Figure 4.42: OBSI Surface and diamond-ground segments near joints on Section QP-124.1.**

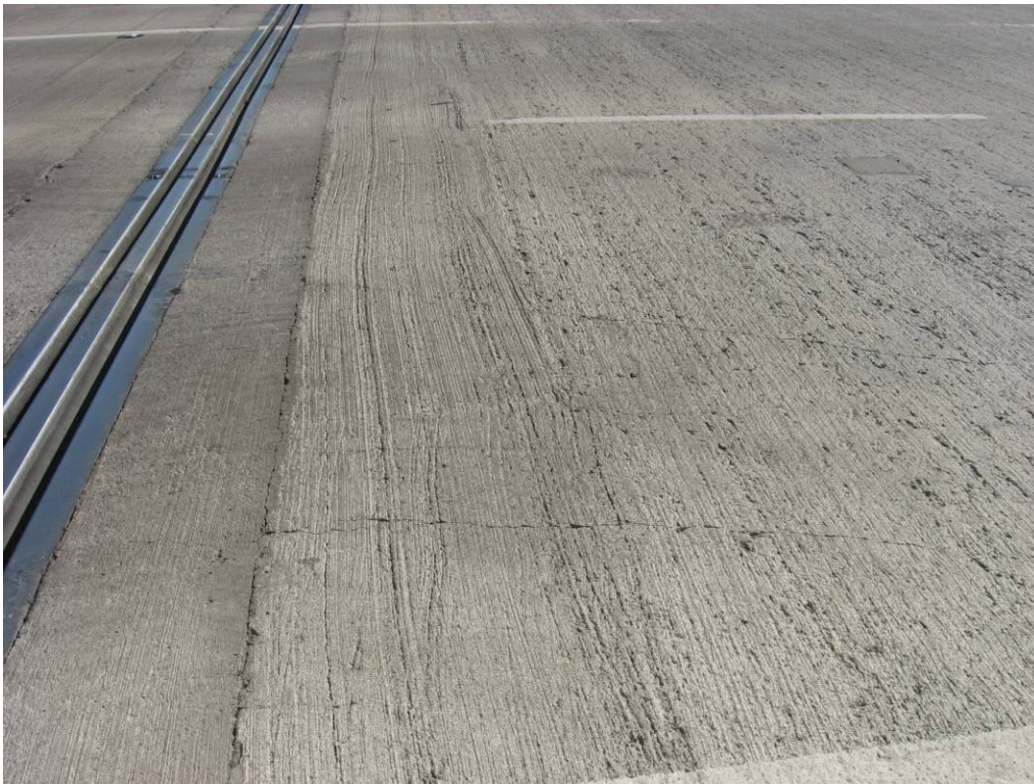
**Figure 4.43: Detail of surface and joint on Section QP-124.1.**

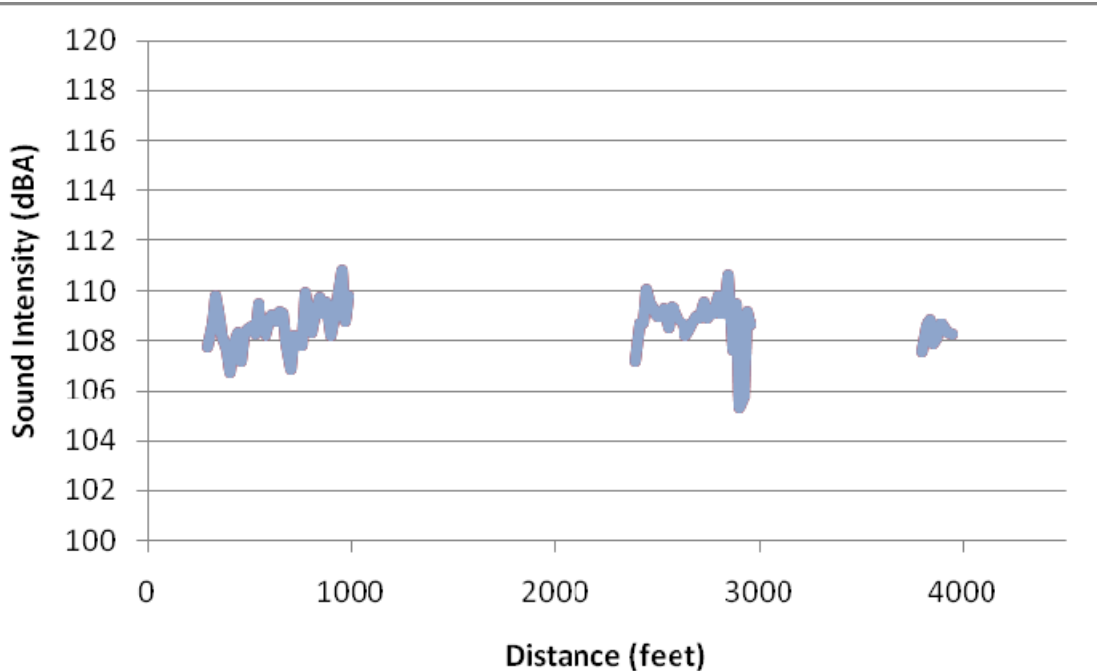
Figure 4.55: OBSI level in 0.2-sec intervals of Sections QP-125, the bridges only, Year 2, average of three passes, no joints to highlight.

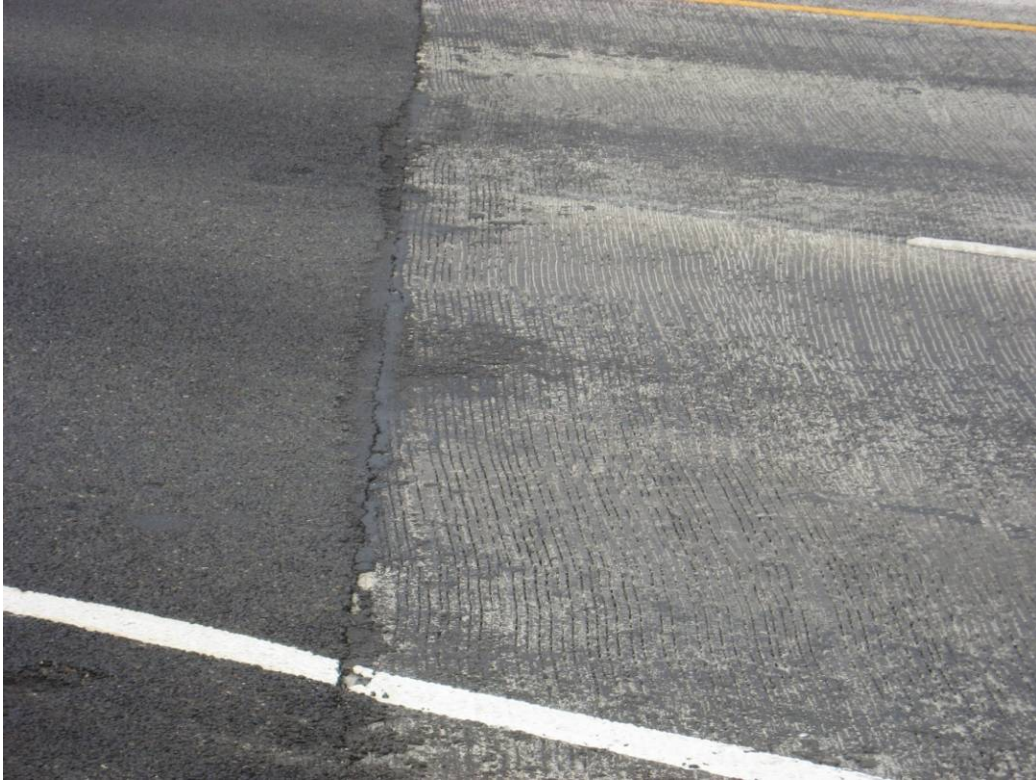
**Figure 4.60: Transition pavement, Section QP-139.1.**

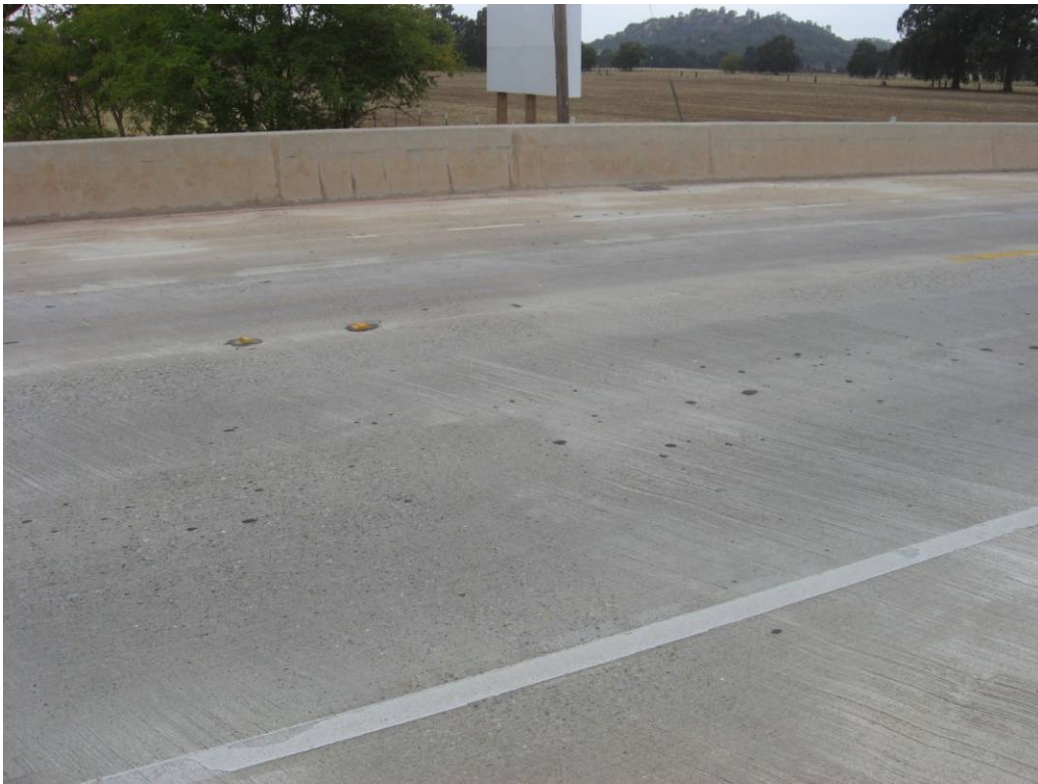
**Figure 4.68: Surface and joint on Section QP-140.1.**

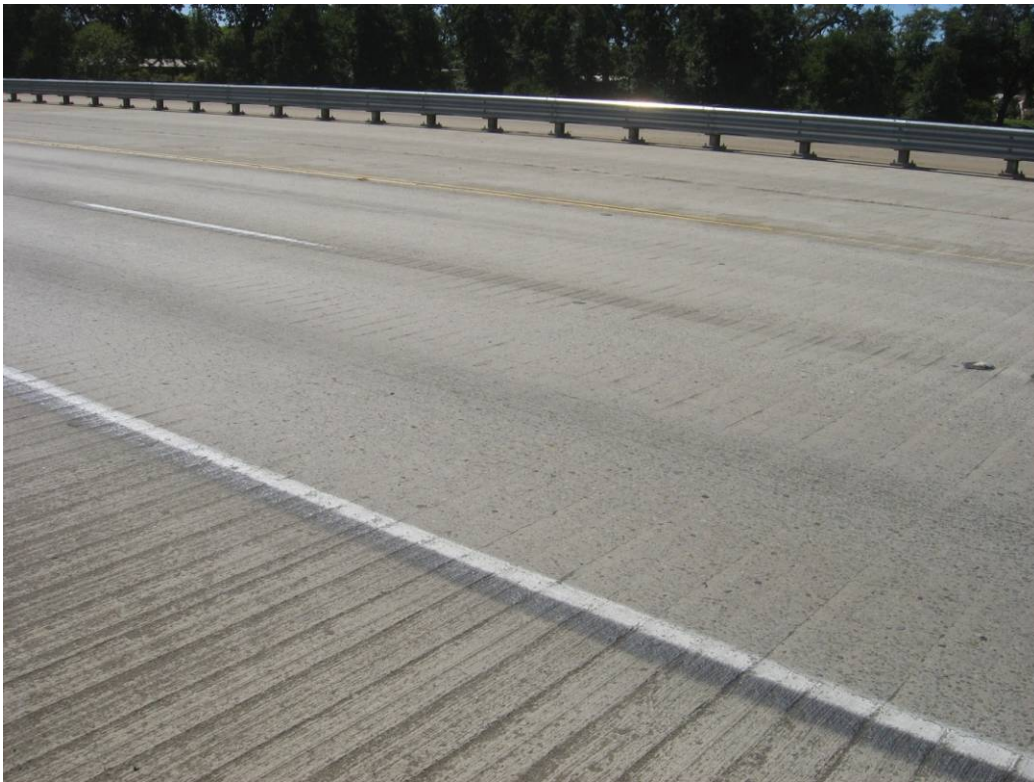
**Figure 4.75: Texture difference in the wheelpath and the rest of bridge deck on Section QP-141.1.**

Section QP-141.1, which is on Bridge Number 06 0128, is located on I-5 eight miles south of Redding, and has a particular transverse-tining texture pattern that is clearly visible on the shoulder. However, the pattern has worn out in the wheelpaths on the bridge deck. Changes in the test car’s lateral position relative to the wheelpaths from one pass to another caused variability in the noise results. This can be seen in Figure 4.78, where the vehicle position for the first pass was different from that of the second and third passes, resulting in different tire/pavement noise. There was no effect from joints.
