Quiet Pavement Research: Bridge Deck Tire Noise Report

**Authors:**  
E. Kohler  
Dynatest Consulting, Inc.

Work Conducted as Part of Partnered Pavement Research Center Strategic Plan Element No. 4.22:  
Quiet Concrete Pavement Research

**DOCUMENT RETRIEVAL PAGE****UCPRC Report Number:UCPRC-RR-2010-04****Title:** Quiet Pavement Research: Bridge Deck Tire Noise Report**Author:** E. Kohler**Prepared for:** Caltrans**FHWA No.:** CA121200B**Date Work Submitted:** July 22, 2010**Date:** June 2011**Strategic Plan No:** 4.22**Status:** Stage 6, final version**Version No.:** 1

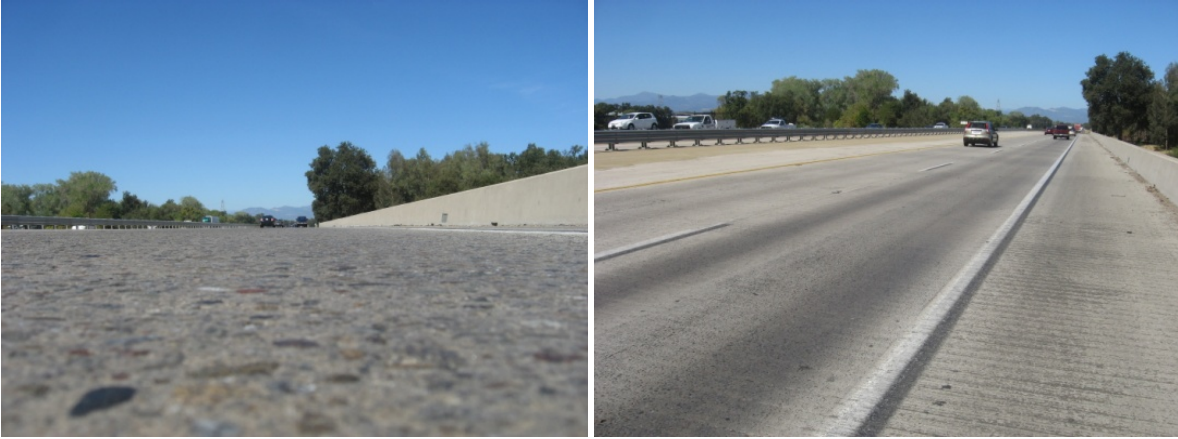
**Figure 4.76: Close up view of wheelpath texture in the wheelpaths and overall view of Section QP-141.1.**

Section QP-141.1, which is on Bridge Number 06 0128, is located on I-5 eight miles south of Redding, and has a particular transverse-tining texture pattern that is clearly visible on the shoulder. However, the pattern has worn out in the wheelpaths on the bridge deck. Changes in the test car’s lateral position relative to the wheelpaths from one pass to another caused variability in the noise results. This can be seen in Figure 4.78, where the vehicle position for the first pass was different from that of the second and third passes, resulting in different tire/pavement noise. There was no effect from joints.

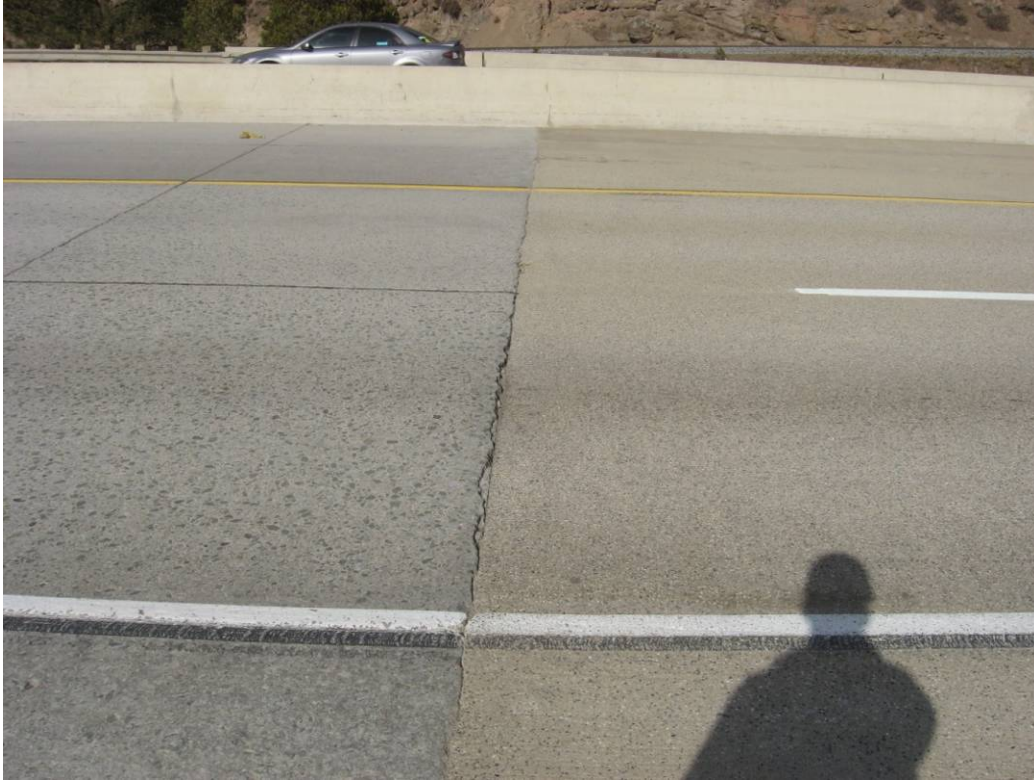
**Figure 4.83: Beginning of Section QP-143.1 (right side of photo).**

Section QP-143.1, on Bridge Number 17 0013, is located on I-80 east of Truckee. The freeway transitions from concrete pavement to a polyester-overlaid bridge deck. There was no effect from joints. The bridge deck is about 1.7 dB(A) quieter than the surrounding pavement (1.9 and 1.5 dB[A] in Years 1 and 2 respectively). This bridge is in an area that receives snow and is therefore subject to winter maintenance which may accelerate damage to the deck.

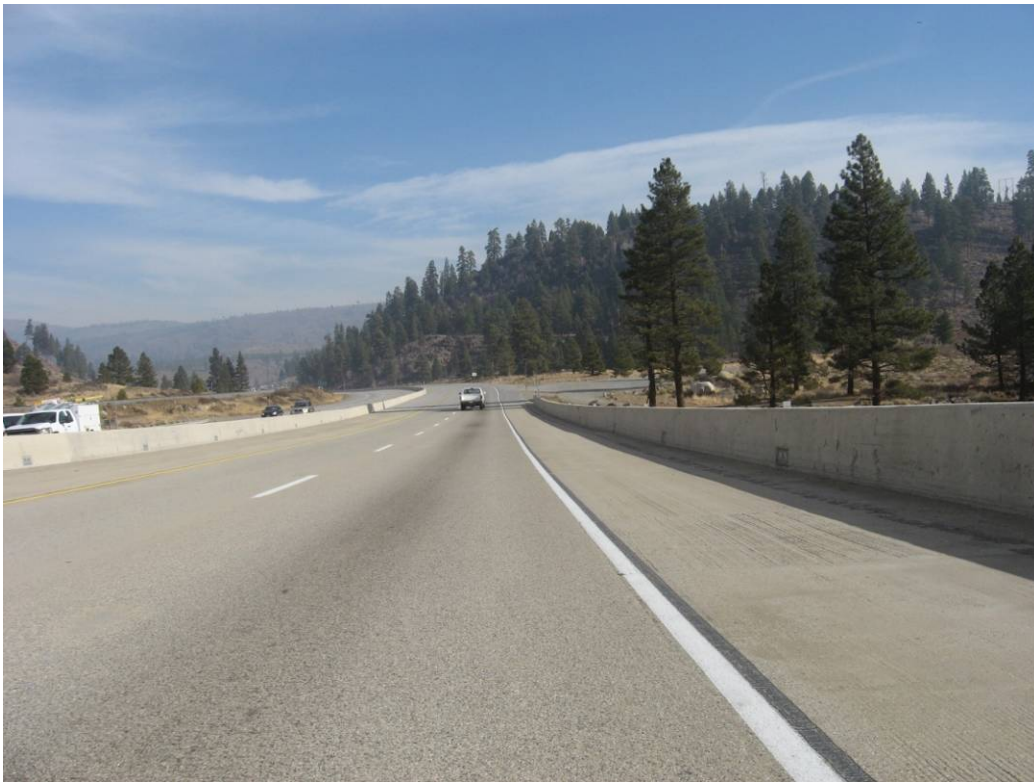
**Figure 4.84: Surface of Section QP-143.1.**

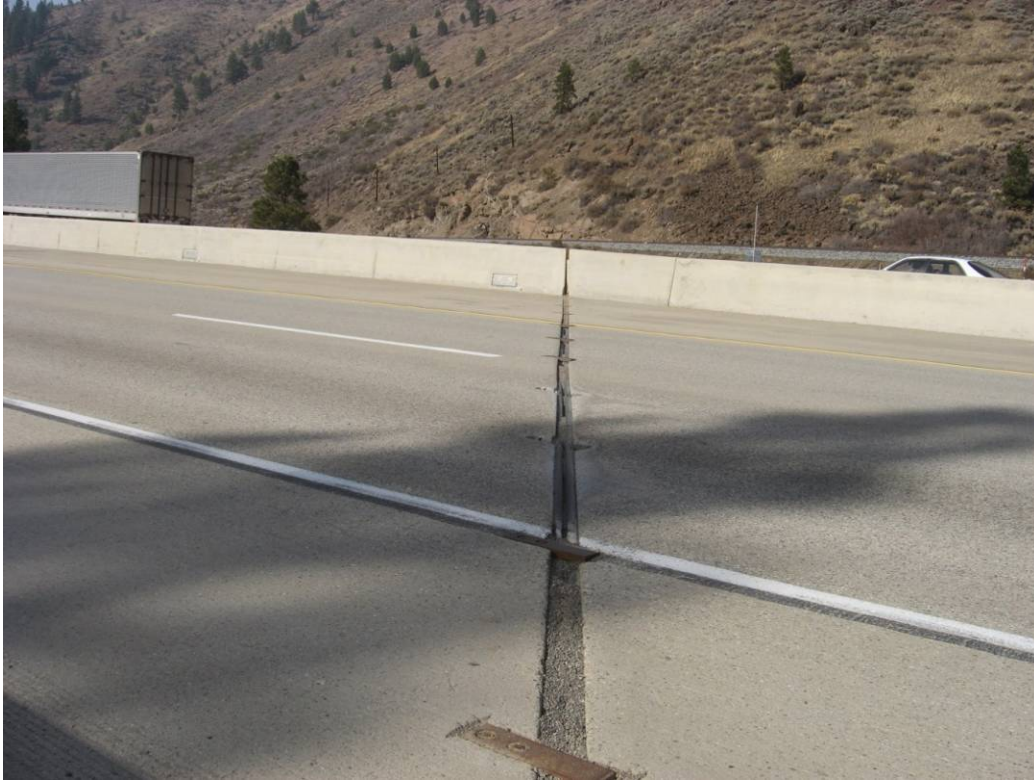
Figure 4.85: Joint on Section QP-143.1.

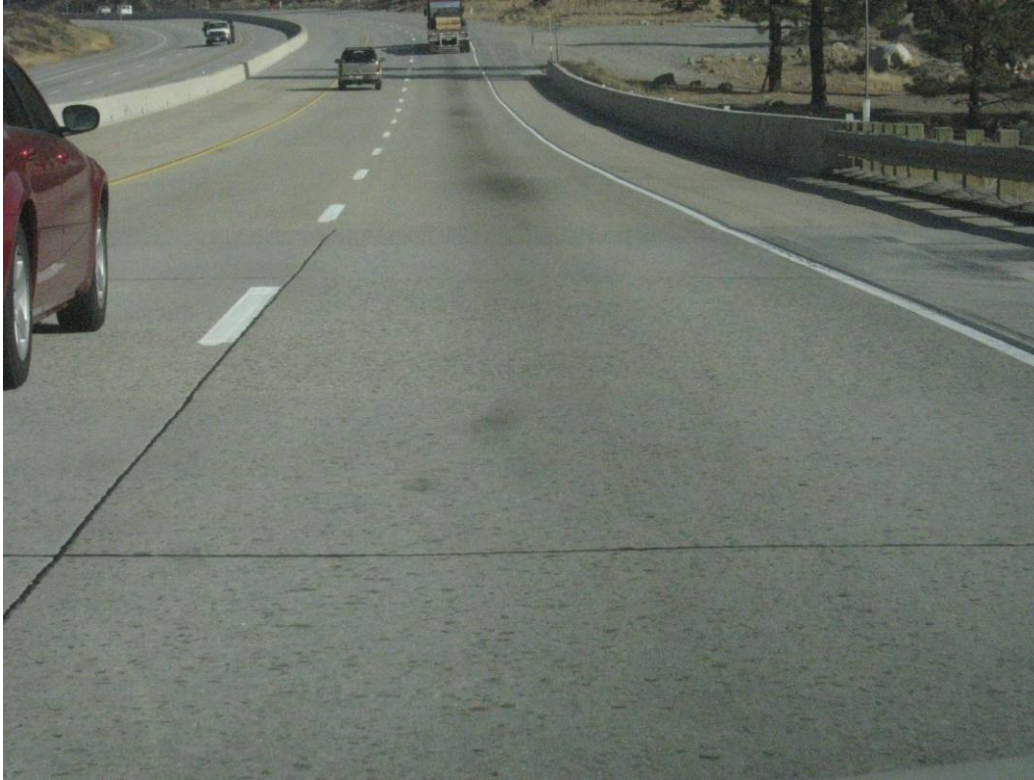
**Figure 4.90: Beginning of Section QP-144.1.**

Section QP-144.1 is on Bridge Number 17 0012, which is on I-80 near Truckee and transitions from concrete pavement to a deck with a polyester overlay that has a longitudinally tined finish. It is located a quarter mile east of Section QP-143.1. The effect of joints was not were excluded from the overall OBSI calculations because they had no effect on it. This bridge also has concrete pavement before and after it that is noisier than the bridge deck. This bridge is in an area that receives snow and is therefore subject to winter maintenance which may accelerate damage to the deck.

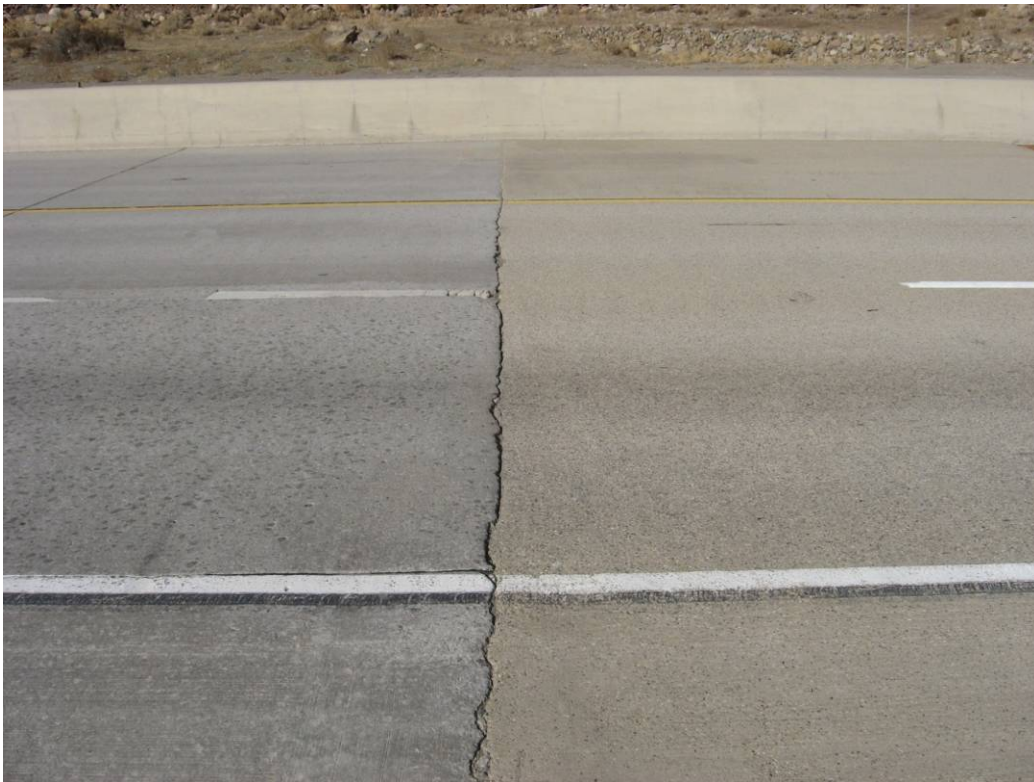
**Figure 4.91: Pavement-bridge transition on Section QP-144.1 (right side of photo).**

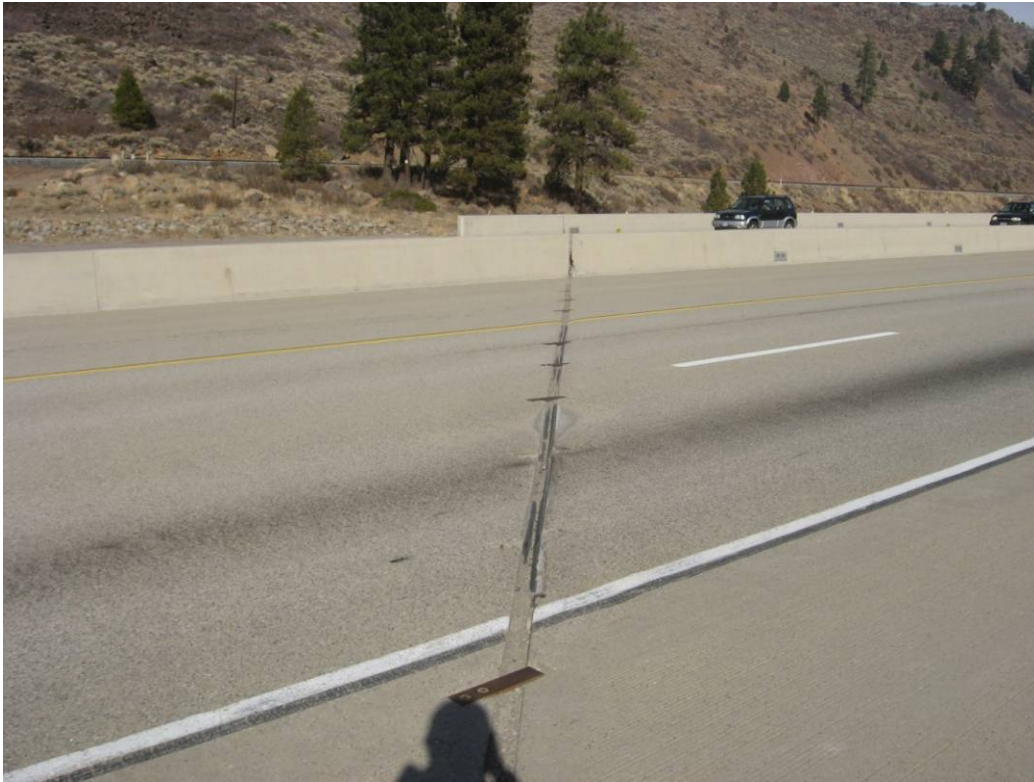
**Figure 4.92: Joint on Section QP-144.1.**

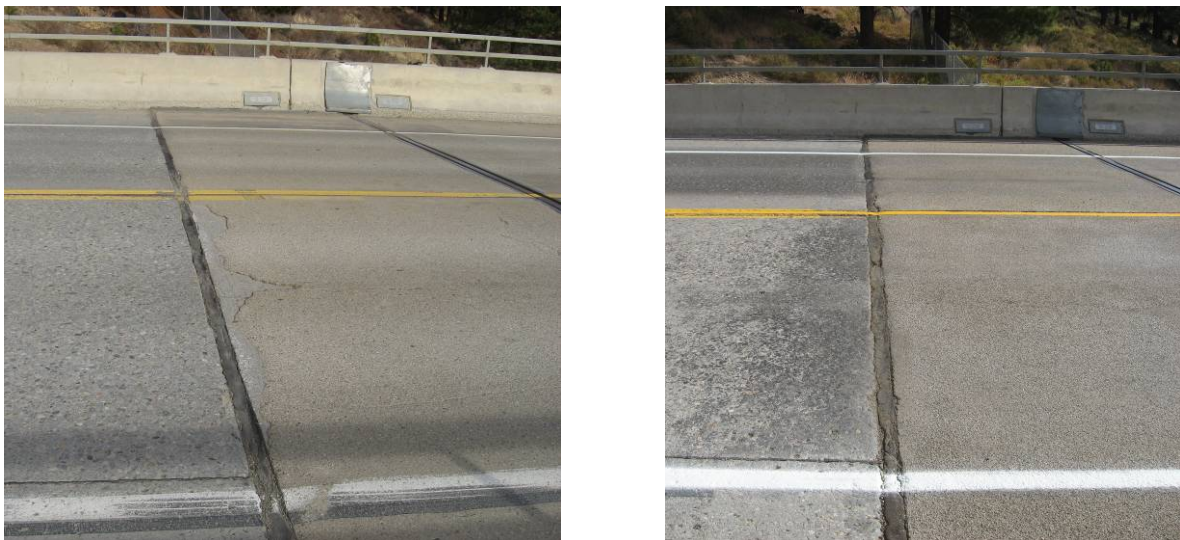
**Figure 4.98: Beginning of Section QP-145.1 (right side of photos), Year 1 (left) and Year 2 (right).**

Section QP-145.1 on Bridge Number 17 0098 is located on I-80 near Truckee. It is a polyester-overlaid deck that was overlaid in 2003 and again in 2009. The three joints were clearly noted, and the bridge was quieter than the adjacent concrete pavement. Using Year 1 data, the bridge was 3.0 dB(A) quieter than the pavement, and using Year 2 data, it the bridge was 4.5 dB(A) quieter. Even though the end joints and the center joint both generated a clear slap noise that reached about 113 dB(A), their effect on the bridge's overall OBSI level was minor, on the order of 0.3 to 0.5 dB(A). This bridge is in an area that receives snow and is therefore subject to winter maintenance which may accelerate damage to the deck.

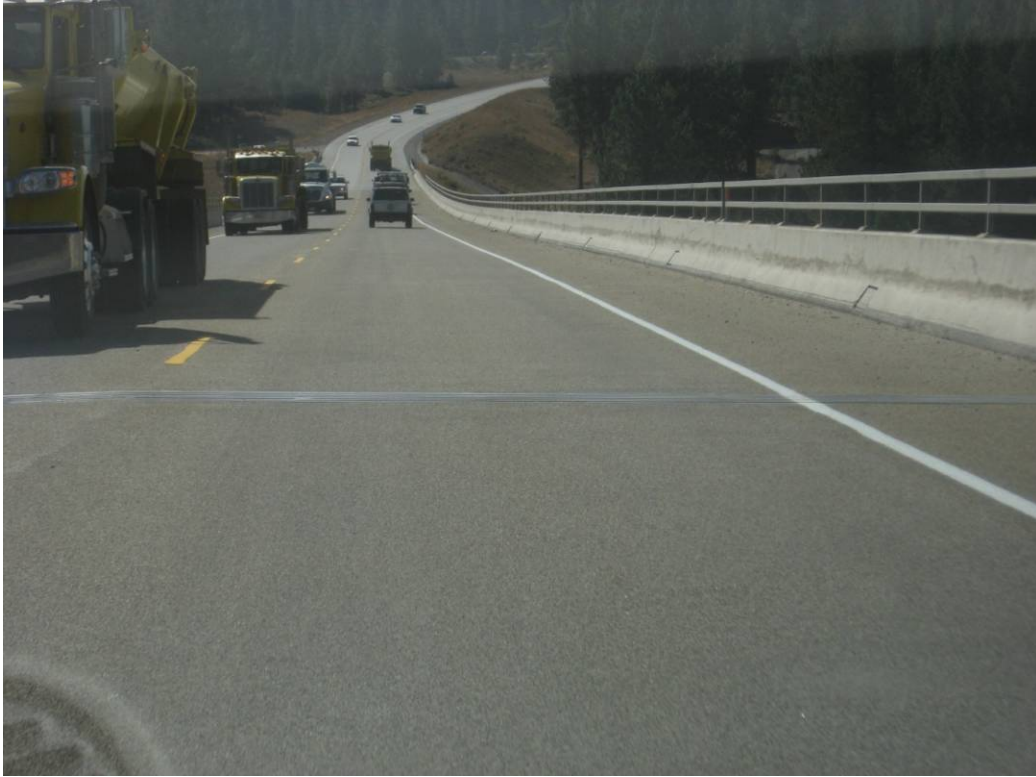
**Figure 4.99: Surface and joint on Section QP-145.1.**

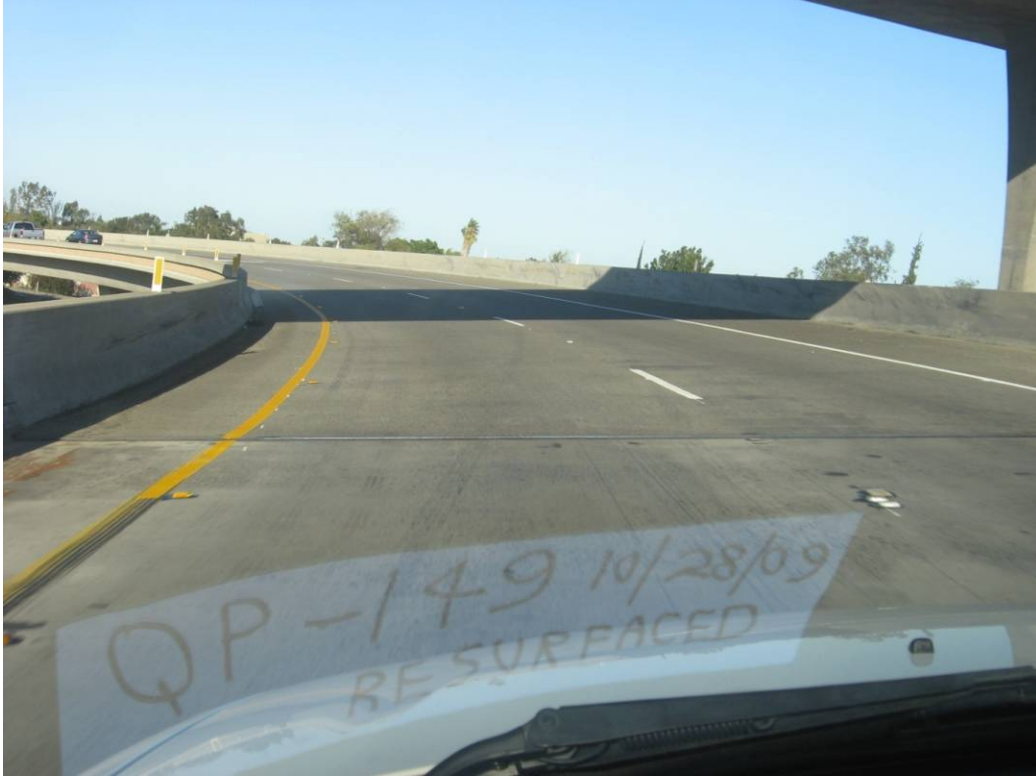
**Figure 4.106: Beginning of Section QP-149.1.**

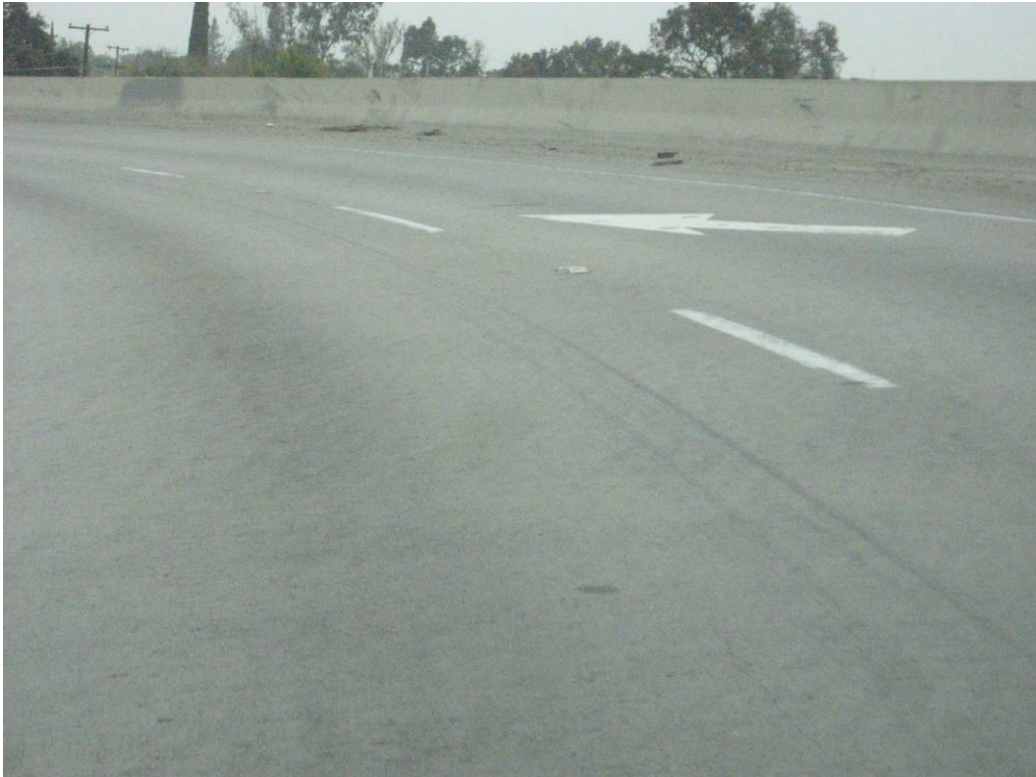
**Figure 4.107: Surface of Section QP-149.1.**

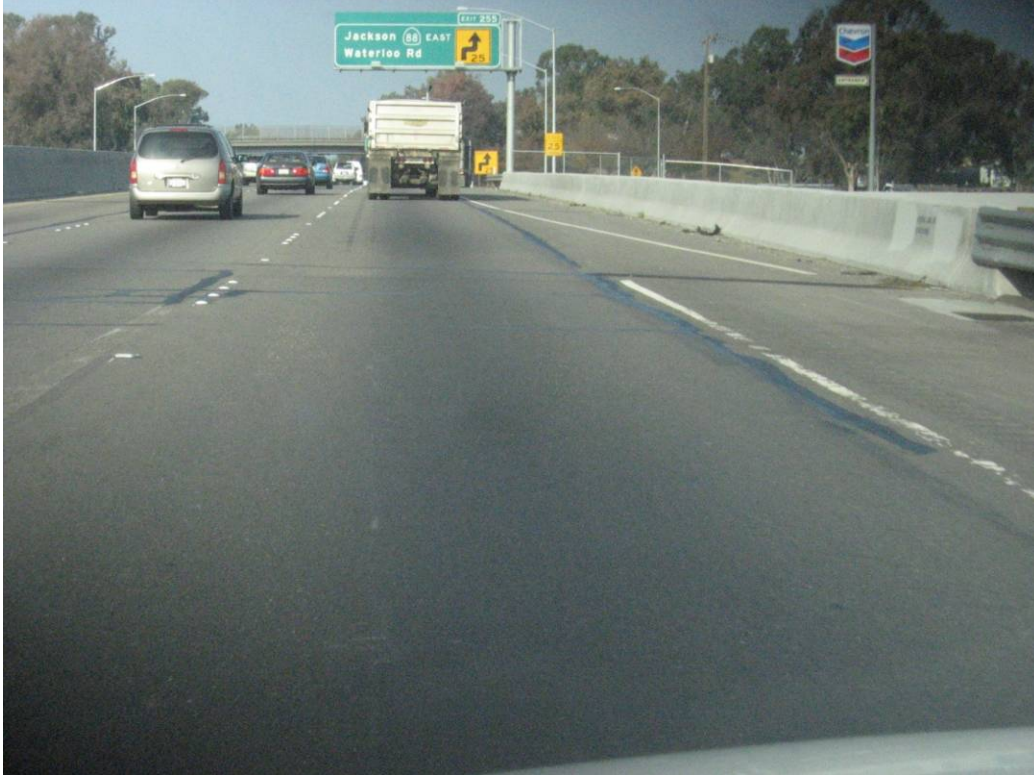
**Figure 4.111: Beginning of Section QP-150.1.**

Section QP-150.1 on Bridge Number 29 0119 is located on State Route 99 south of Stockton. There was no effect from joints, as they had just been filled with crack sealant. The spectra from Year 1 to Year 2, as well as the overall level, show an increase in overall noise level of 3.2 dB(A) from Year 1 to Year 2 that seems to confirm that the deck surface is not a polyester overlay as originally thought. Instead, the surface is thought to be a hot-mix asphalt overlay with a different mix than the asphalt concrete pavement before and after the bridge that has gotten noisier over one year. There is no other apparent explanation for the large changed between the two years.

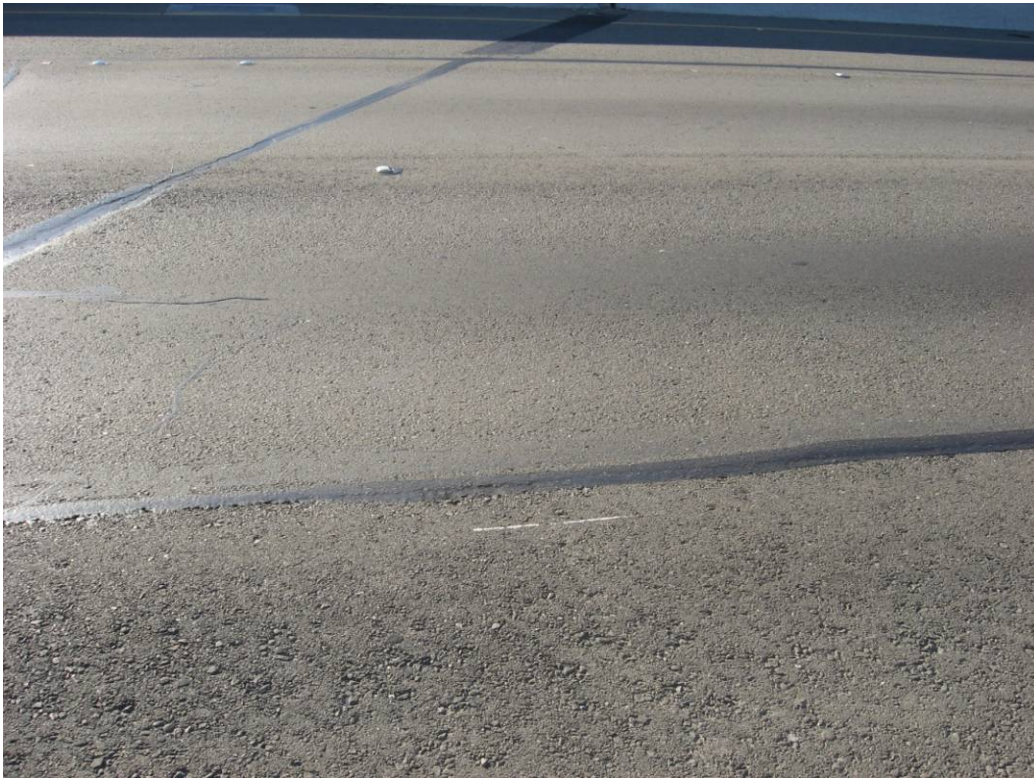
**Figure 4.112: Surface and joint on Section QP-150.1.**

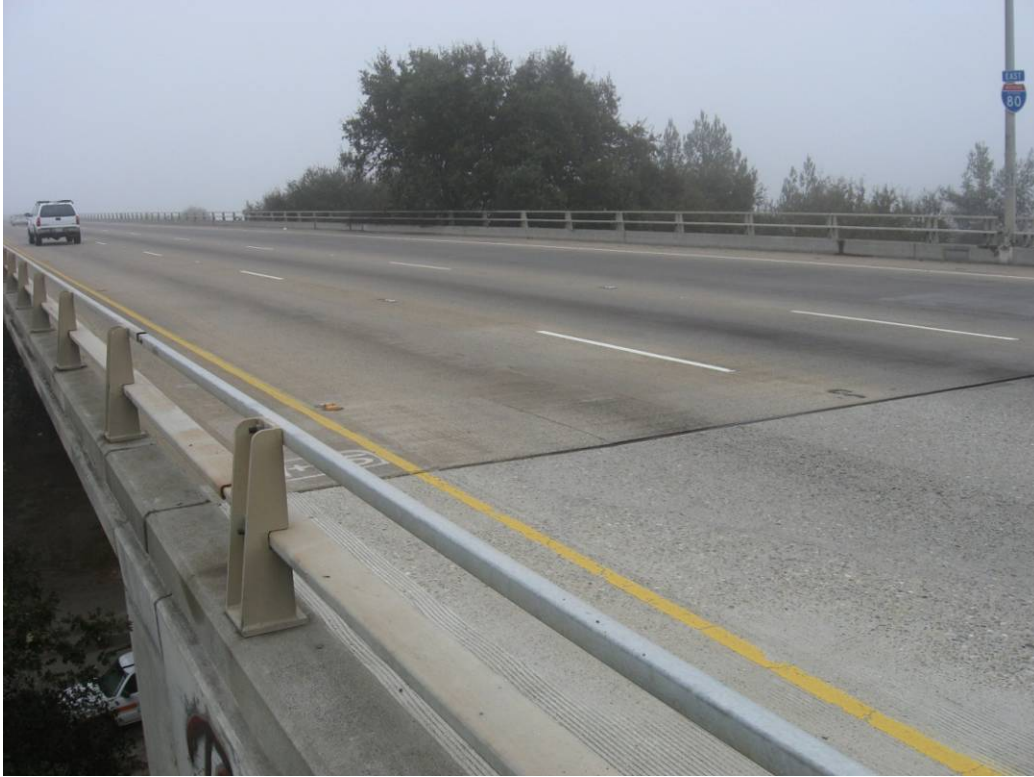
**Figure 4.118: Beginning of Section QP-151.1.**

Section QP-151.1 is on Bridge Number 22 0026R, which is on I-80 where it crosses the Sacramento River north of Sacramento. The bridge is 4,050-ft (1,235-m) long (the longest in this study) and its surface is a longitudinally tined polyester overlay. Noise was measured at the adjacent concrete pavement at the end of the bridge and it was found to be nearly 1.0 dB(A) louder than the bridge itself. Rather than eliminating the clearly identifiable bridge joints from the analysis, the central portion of this long bridge was taken as the “bridge part.” Note that the surface material and texture are the same in areas where there are slap noise-generating joints and in the central area where there are none. There is approximately 1,970 ft (601 m) between the typical joints (see joint in Figure 4.119) at the center of the bridge, and in this region there are four special joints (see Figure 4.120) that are unidentifiable in the noise data and therefore considered as “quiet joints.”

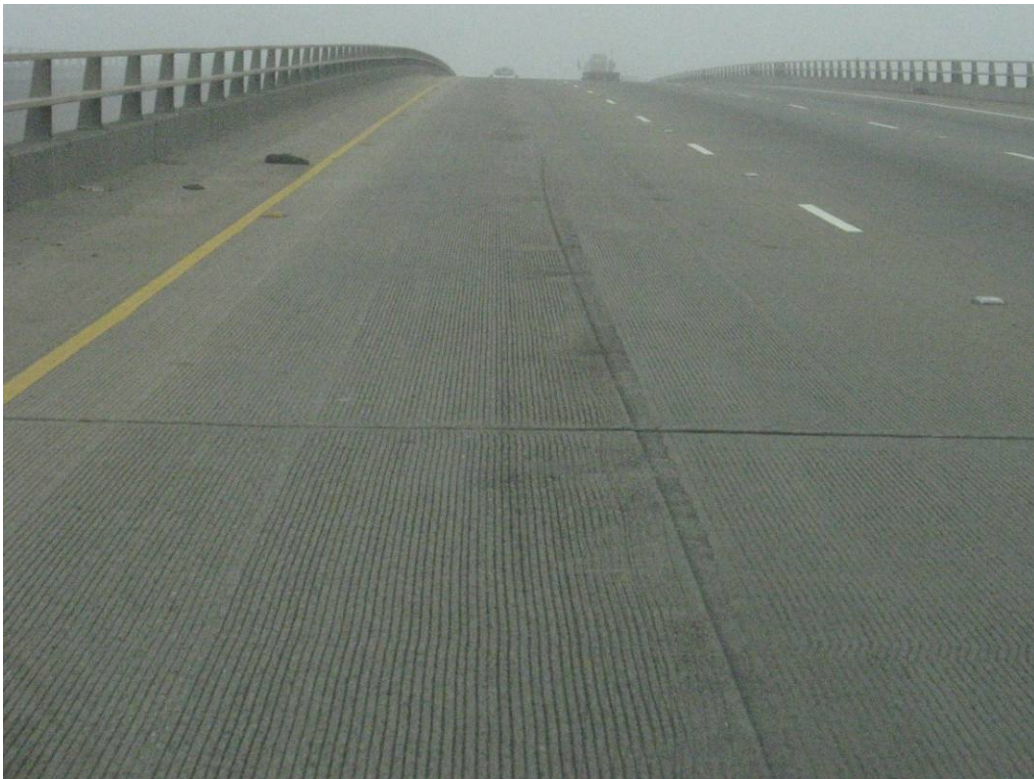
**Figure 4.119: Surface and typical joint on Section QP-151.1.**

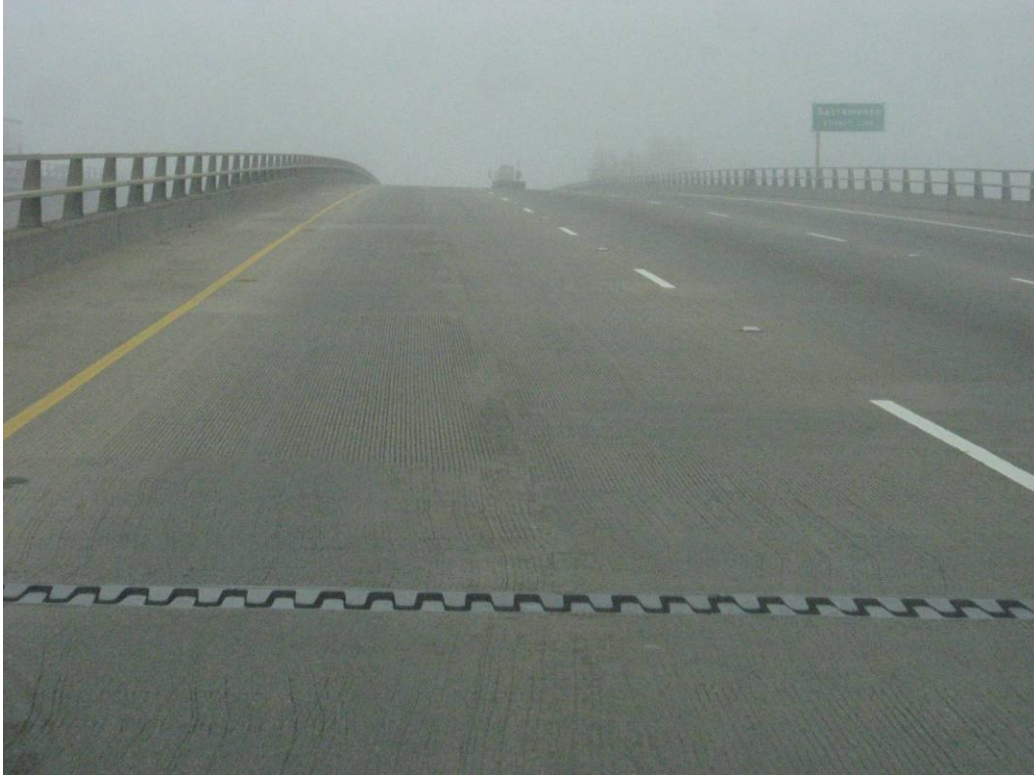
**Figure 4.120: Surface and special longer span joints (one of four) on Section QP-151.1.**

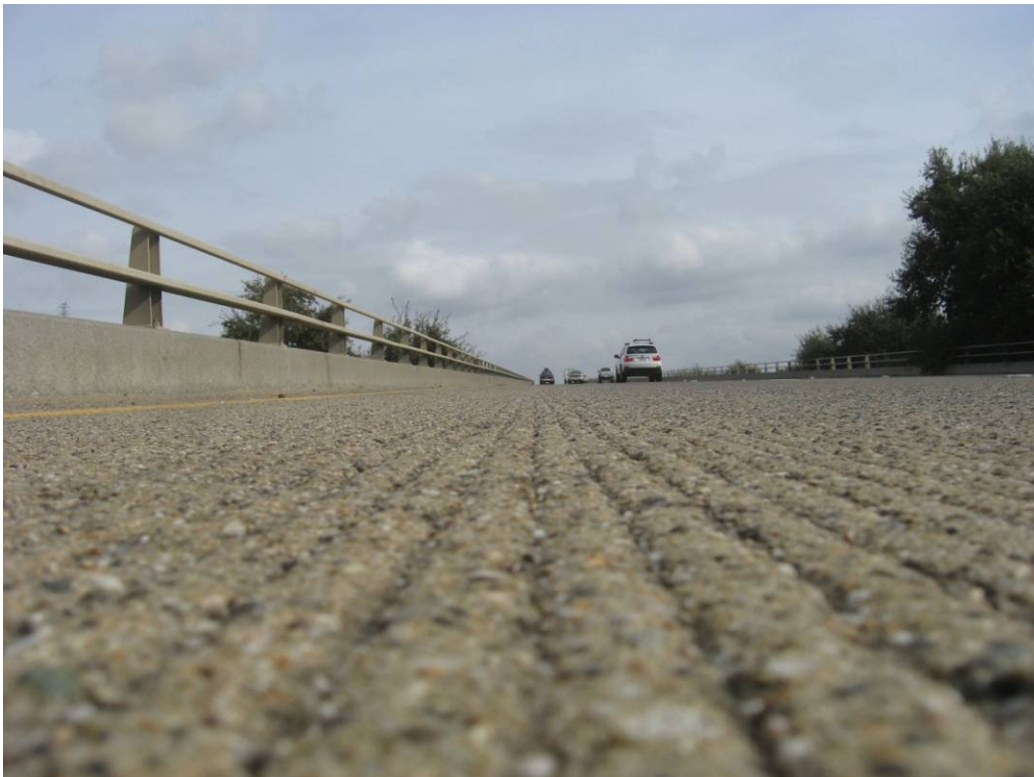
**Figure 4.121: Detail of longitudinal texture on polyester overlay deck on Section QP-151.1.**

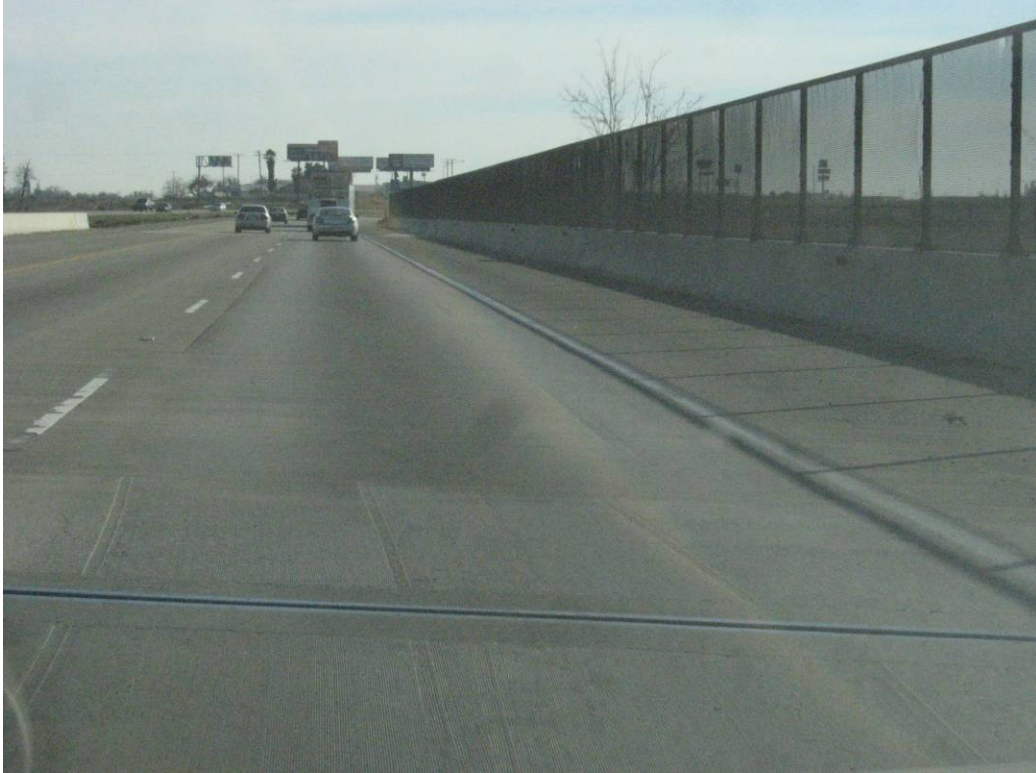
**Figure 4.127: Beginning of Section QP-152.1 with diamond-ground surface near the joint.**

Section QP-152.1 is on Bridge Number 39 0015L, which is on State Route 99 in Merced County and transitions from concrete pavement to a transversely tined deck. It is a single-span bridge and the surface near the joints was diamond ground. There was no effect from joints. The OBSI level in Year 2 decreased by 0.7 dB(A) on the bridge with respect to the Year 1 results, with a similar reduction on the pavement. The surface was the same in both years, as verified pictorially. No explanation was found for this important decrease in OBSI level. The atmospheric conditions were very similar in both years, and the calibration of the microphones did not show any abnormality. It will be important to see OBSI measurements in the following years to help determine whether the repeated measurements are closer to the first year or the second year values.

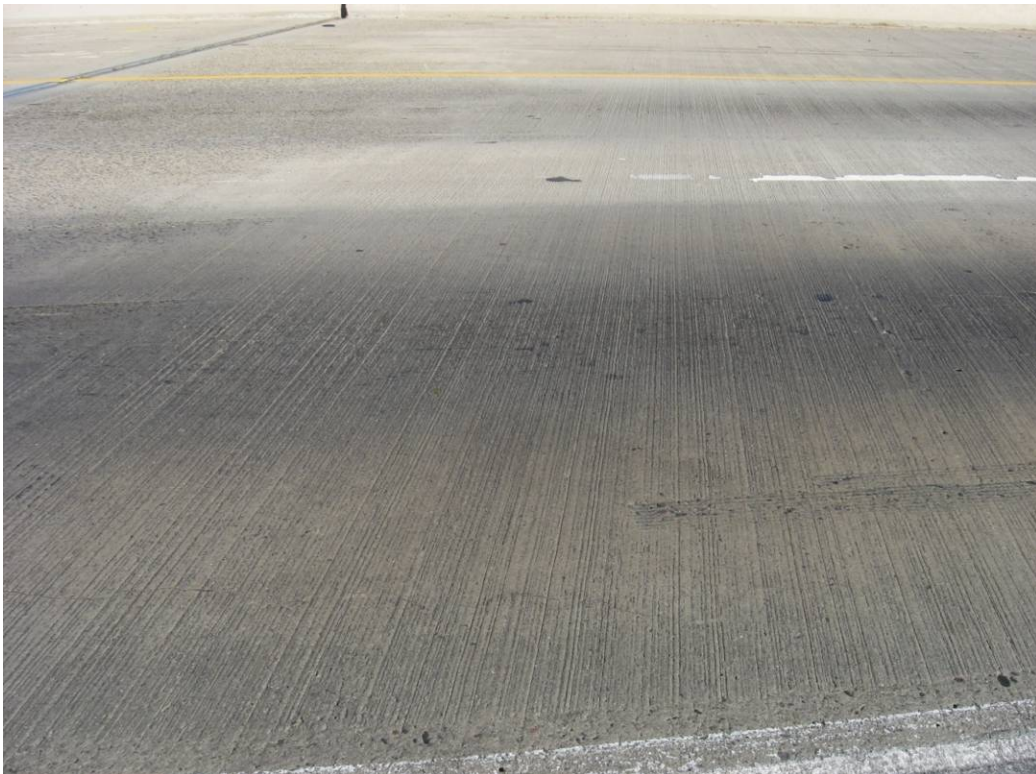
**Figure 4.128: Surface and joint on Section QP-152.1.**

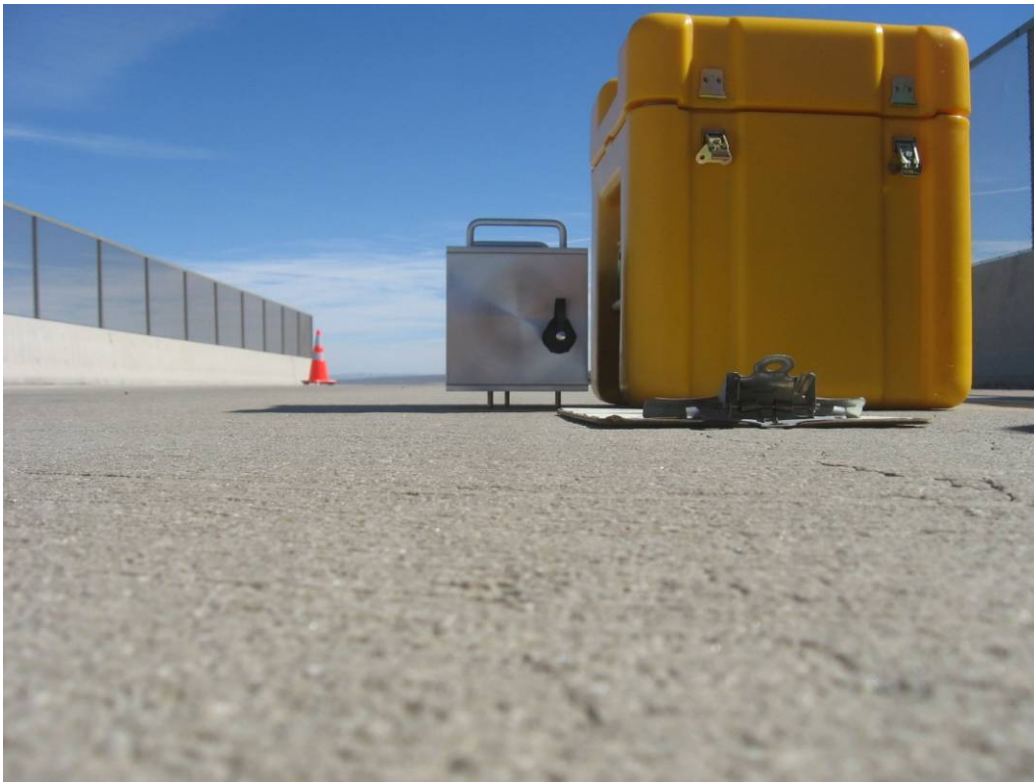
**Figure 4.142: Surface and joint on Section QP-163.1.**

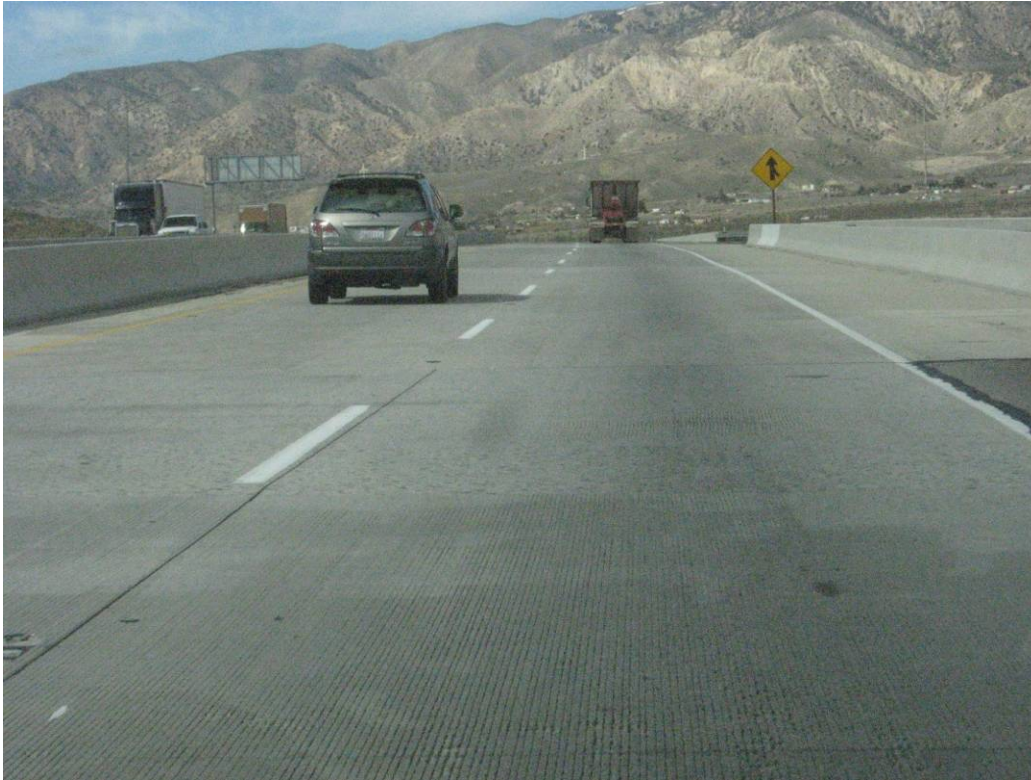
**Figure 4.148: Transition from pavement to Section QP-164.1.**

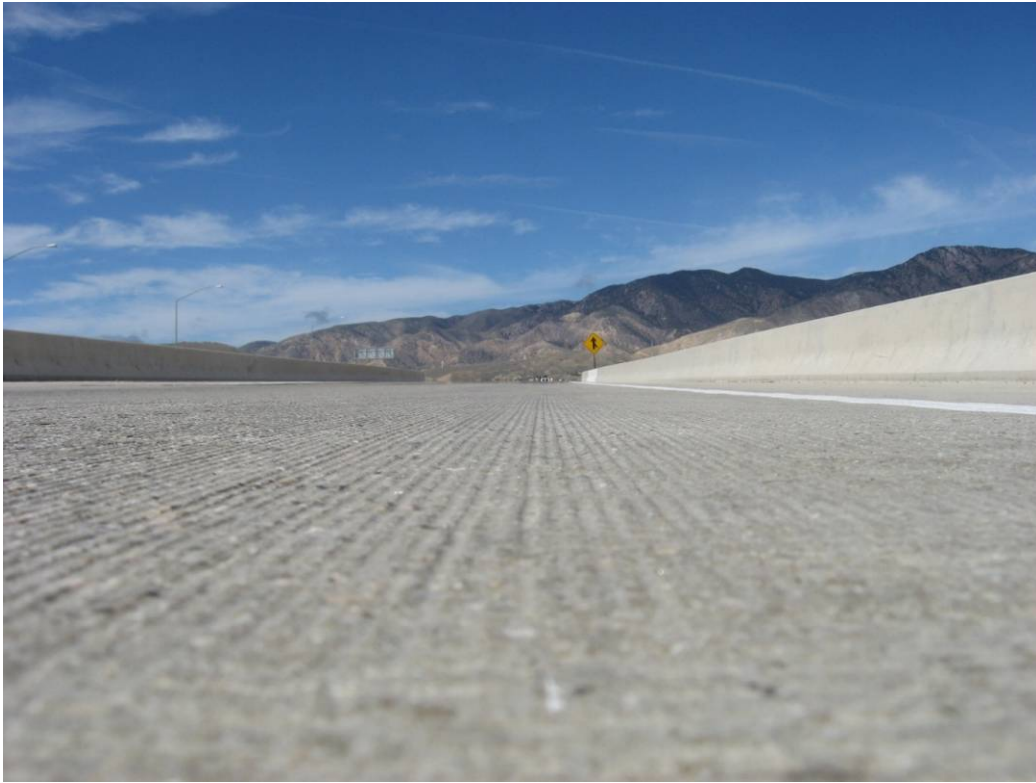
**Figure 4.149: Surface texture on Section QP-164.1.**

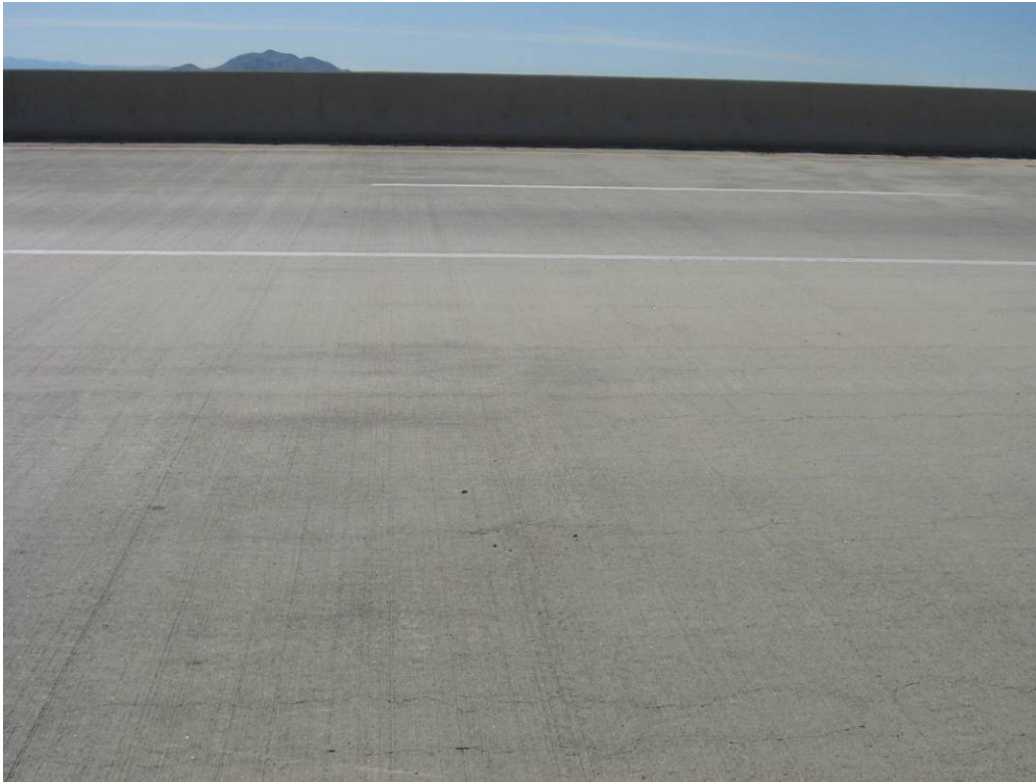
**Figure 4.150: Surface texture on Section QP-164.2.**

The second bridge is the quietest of the transversely tined textures found in this study. Although the photo is not a close-up view, it can be seen in Figure 4.146 that the transversely tined texture is not aggressive and the concrete has a good finish. The finish and noise levels on this bridge can be compared with the poor finish and high noise measurements of Section QP-119.1 shown in Figure 4.12.

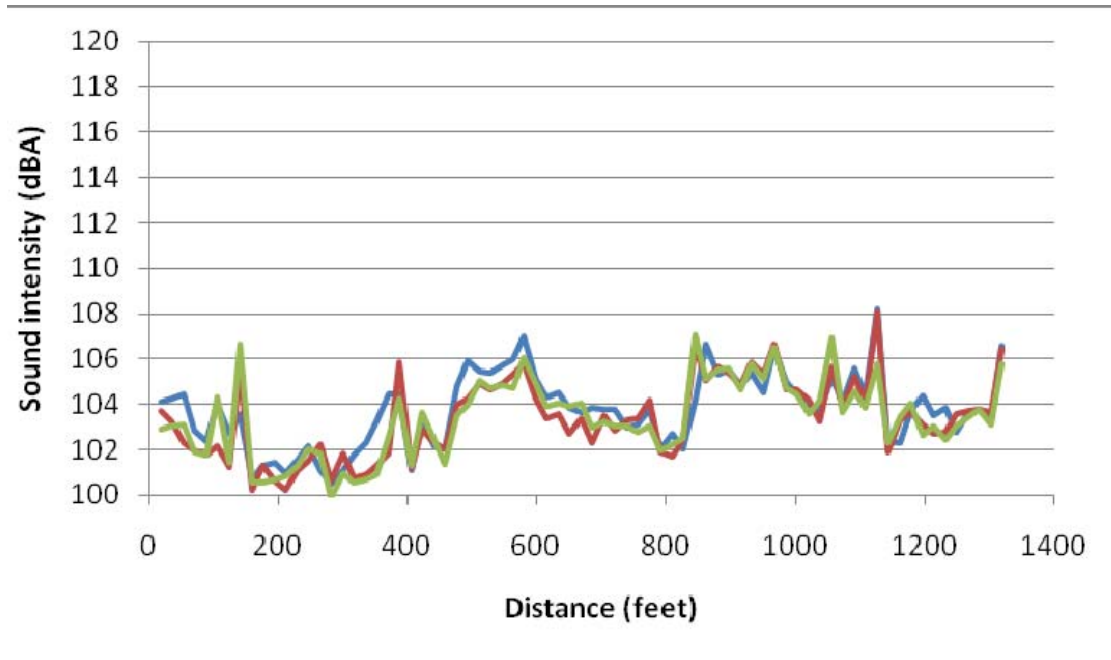
Figure 4.153: OBSI level in 0.2-sec intervals of Sections QP-164.1 and QP-164.2, Year 2, three passes.

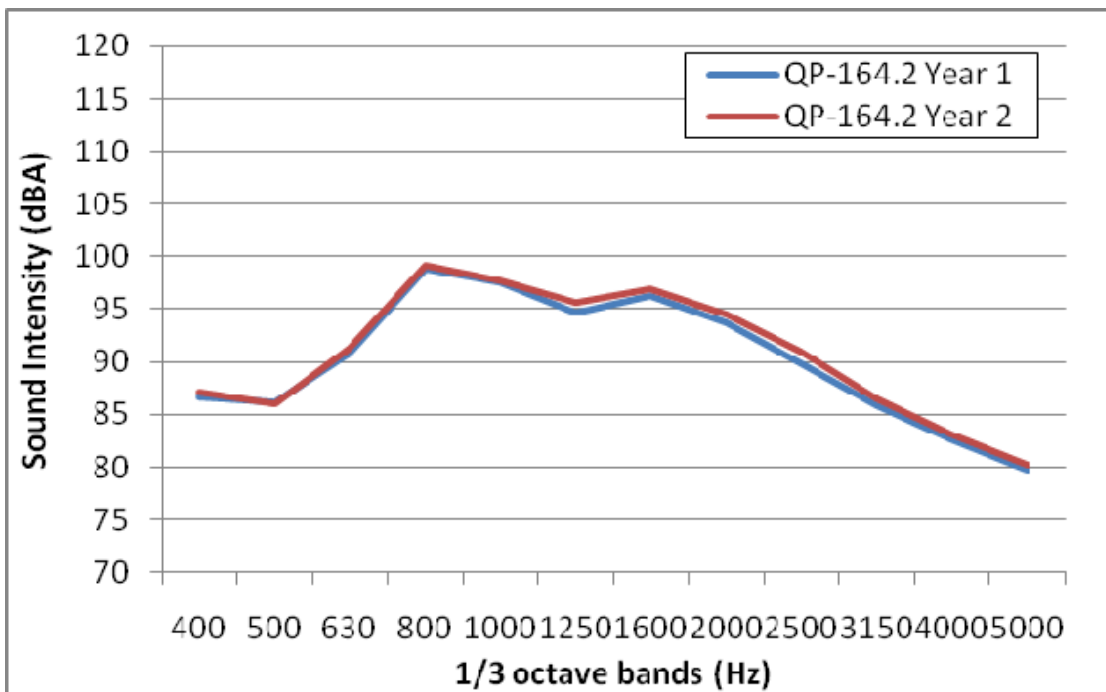
Figure 4.156: OBSI spectra of Sections QP-164.2, Year 1 and Year 2.

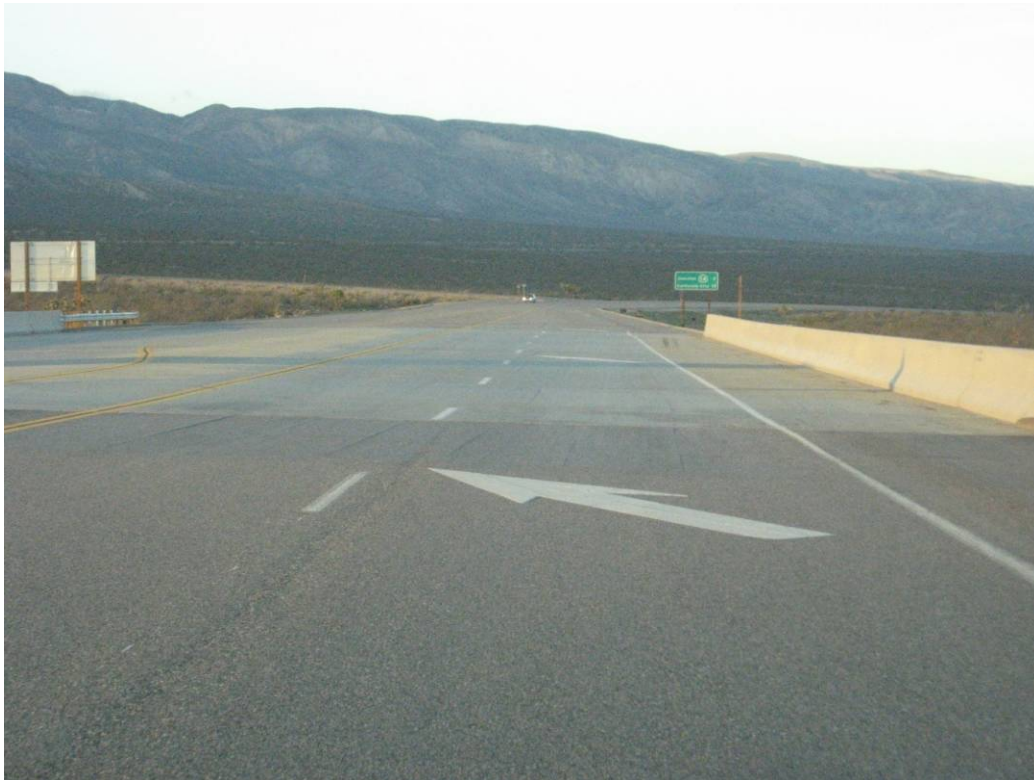
**Figure 4.157: Transition from pavement to Section QP-165.1.**
