Quiet Pavement Research: Bridge Deck Tire Noise Report

**Authors:**  
E. Kohler  
Dynatest Consulting, Inc.

Work Conducted as Part of Partnered Pavement Research Center Strategic Plan Element No. 4.22:  
Quiet Concrete Pavement Research

**DOCUMENT RETRIEVAL PAGE****UCPRC Report Number:UCPRC-RR-2010-04****Title:** Quiet Pavement Research: Bridge Deck Tire Noise Report**Author:** E. Kohler**Prepared for:** Caltrans**FHWA No.:** CA121200B**Date Work Submitted:** July 22, 2010**Date:** June 2011**Strategic Plan No:** 4.22**Status:** Stage 6, final version**Version No.:** 1

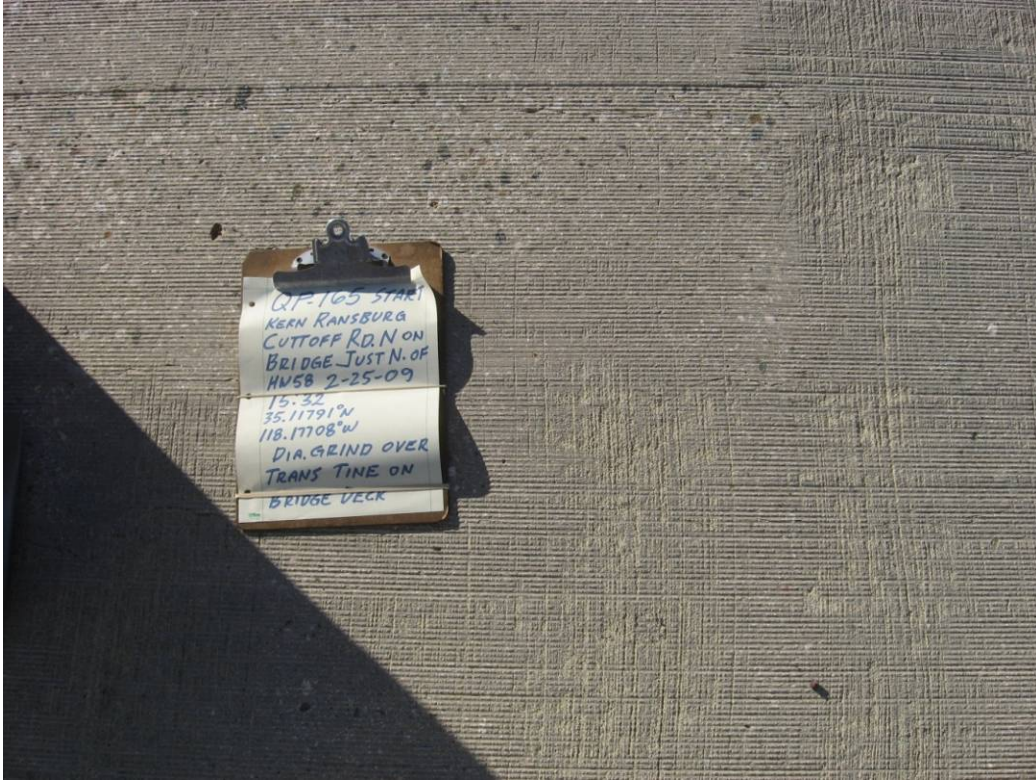
**Figure 4.158: Detailed view of texture on Section QP-165.1.**

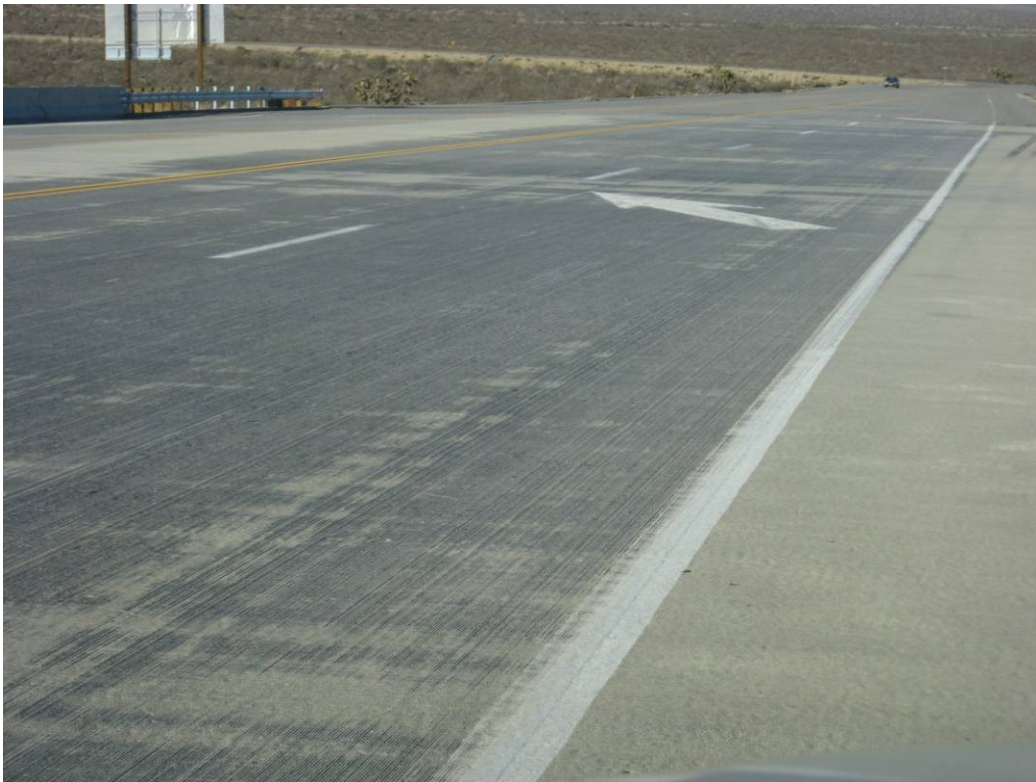
**Figure 4.159: Overall view of texture on Section QP-165.1.**
