Preferential Flow in Fractured Welded Tuffs

Rohit Salve

Earth Sciences Division
Lawrence Berkeley National Laboratory
Berkeley, CA

(Prepared for Water Resources Research)

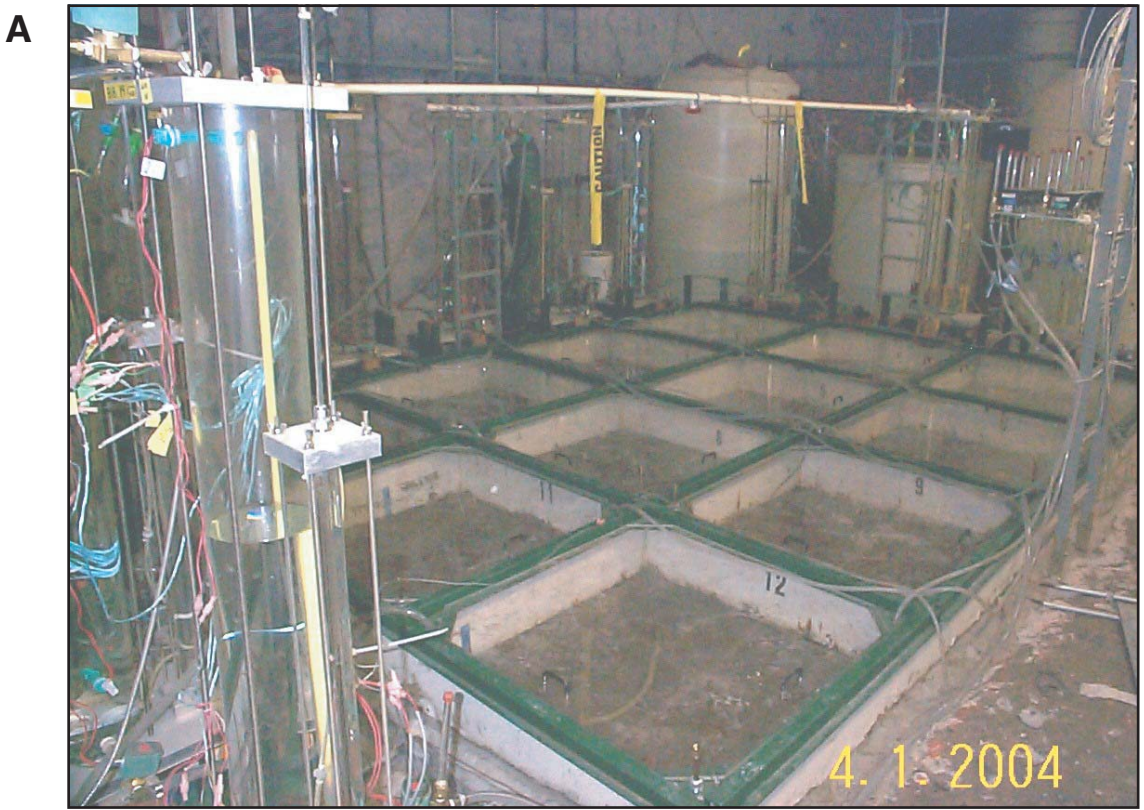
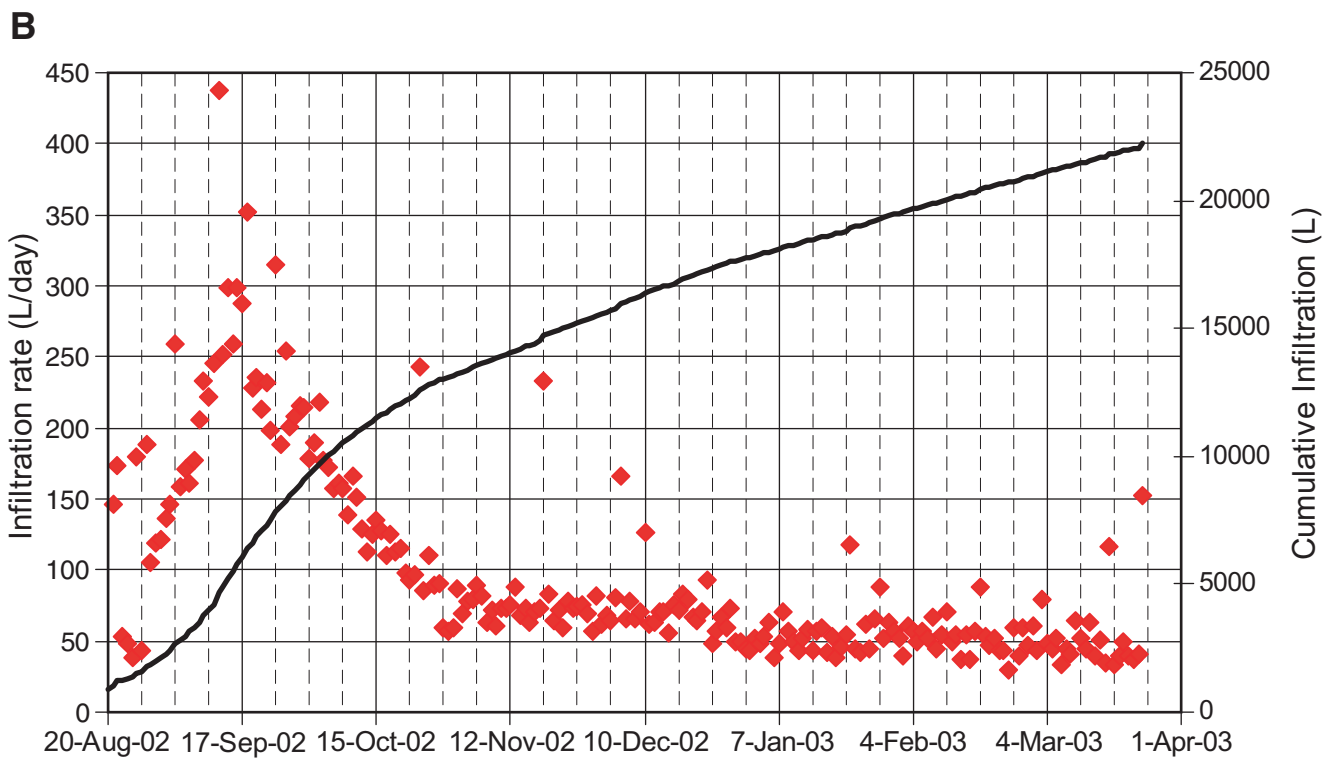
Figure 2. (A) Photograph of infiltration zone in Alcove 8 showing subplots and permeameters that were used to supply water; (B) Cumulative infiltration and daily infiltration rates measured over the entire infiltration plot.

A 3×4 m² infiltration plot was located on the floor of Alcove 8 (Figure 2a). The boundary of the plot was made with steel sheets embedded into the floor. The plot was further divided into 12 square subplots, of similar size (i.e., 1 m²). Each subplot was connected to a permeameter, designed to maintain the desired height of ponded water (i.e., ~0.02 m) while continuously monitoring the rate at which water was released into the infiltration plot. To minimize losses through evaporation, each infiltration subplot was covered with a plastic sheet, and the Alcove 8 cavity was isolated from ventilation effects in the Cross Drift by bulkhead doors.

The ponded infiltration test began on August 20, 2002, and continued until March 24, 2003, during which ~22,000 L of water was released into the test bed (Figure 2b). The daily infiltration rates rapidly increased to ~350 L/day during the first three weeks of ponding. This was followed by a more gradual decrease to ~75 L/day over the next six weeks. From this point onward, during the remaining 3.5 months, the infiltration rate dropped to ~40 L/day.

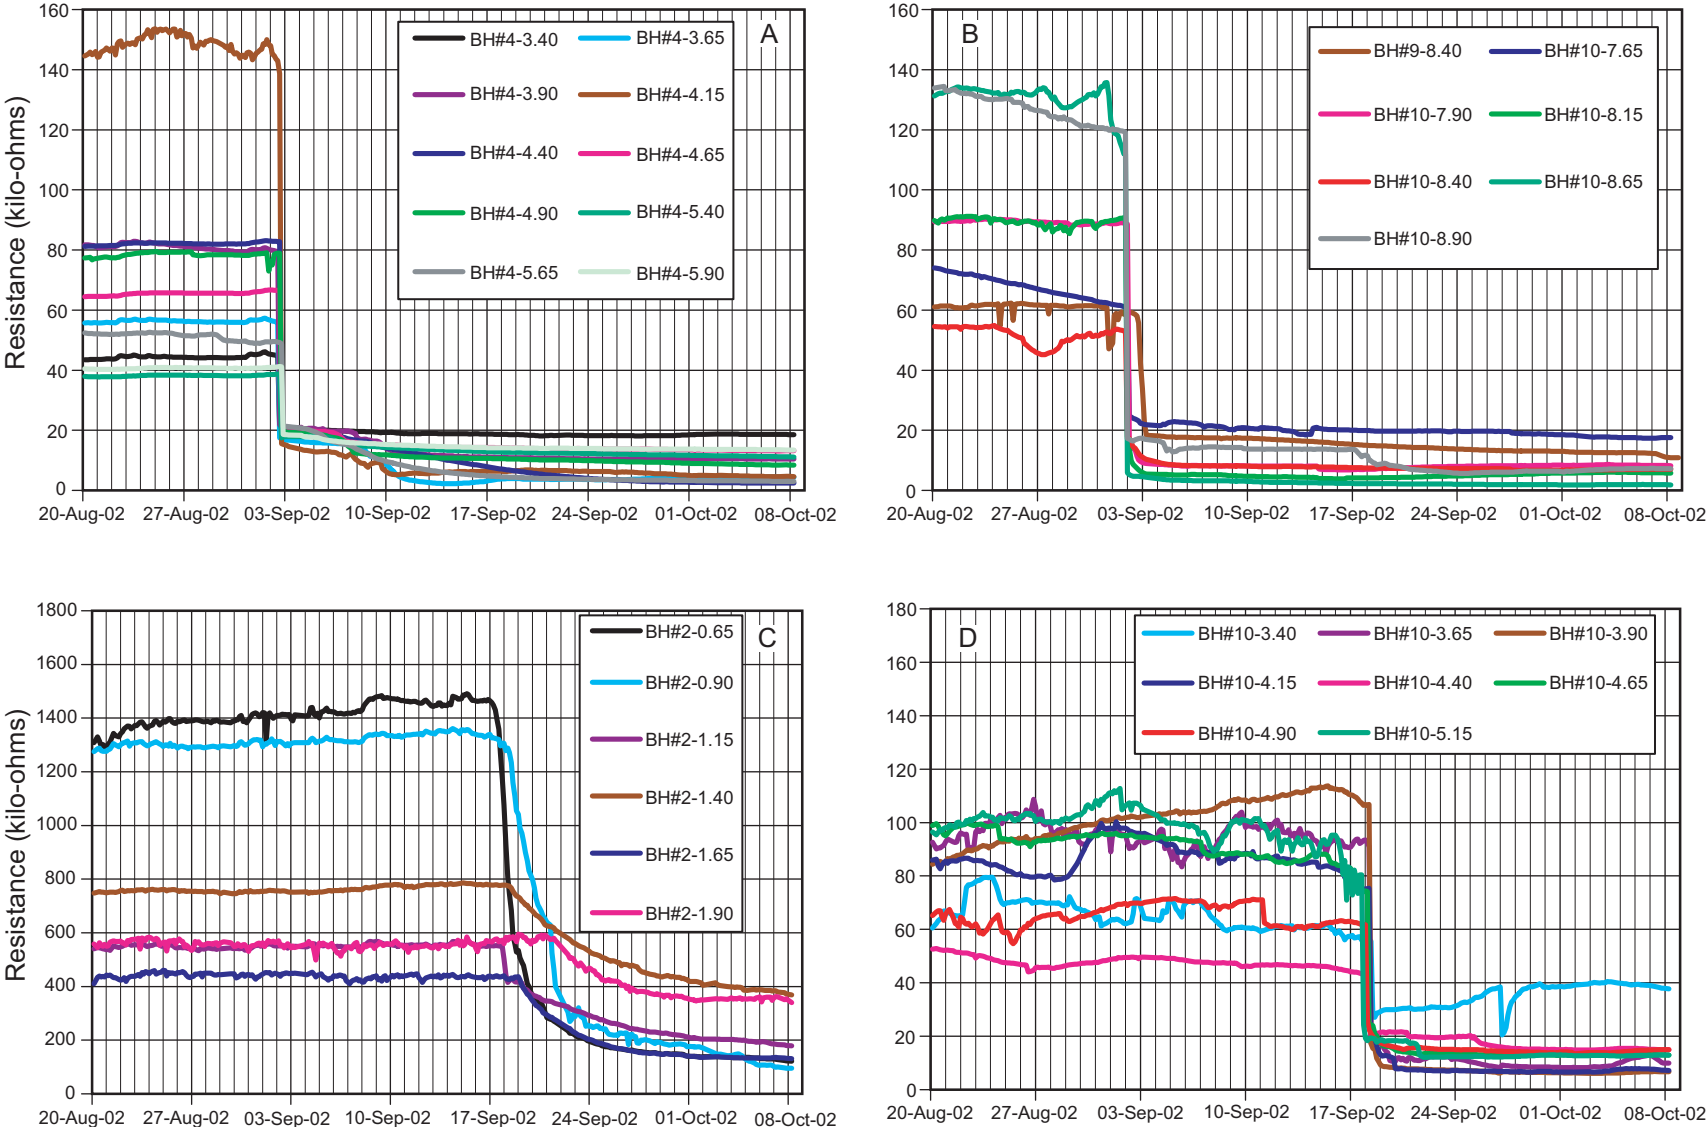
Figure 5. Arrival of wetting fronts in the vicinity of Niche 3 associated with (A) FP-A, (B) FP-B, (C) FP-C, and (D) FP-D. These are four of the six large flow paths (i.e., A-G in Table 1). The 'x' axis starts at the time infiltration began (i.e., on August 20, 2002). The 'Y' axis has the resistance measured at each location along the boreholes. A decreasing resistance indicates wetting.

The fastest observed velocities (i.e., 0.74 m/day) were measured along FP-A, located in the formation behind Niche 3. It included a section of BH4 and two sections along BH7, each ~0.50 wide and separated by a ~1 m wide dry zone that persisted during the entire period that water was released into the infiltration pond (Figure 5a). Along BH4, a ~0.75 m section of the borehole first wetted before the edge of flow spread horizontally over an additional 2.0 m during the next ~6 hours. Complete wetting (as suggested by constant low resistance measurements) occurred at each location as soon as the wetting front arrived. Similar wetting trends were observed along two sections of BH10 that were intercepted by two distinct flows. Since the end of BH 4 is at a horizontal distance of 6.25 m from the nearest edge of the infiltration plot, this flow zone had significant lateral movement as it traversed the ~22 m vertical distance from the infiltration plot to the BH4 and BH7.

FP-B, which was also located immediately behind the end of Niche 3, intercepted BH4, B9, and BH10 (Figure 4a). The ERP response suggests that a ~1.5 m wide flow path intercepted BH10 almost instantly before traveling towards BH4 (Figure 5b). The velocity of the wetting front for this flow ranged between 0.64 and 0.69 m/day as it migrated a distance of ~2.4 -3.8 m from the edge of the infiltration pond.

FP-C was detected along BH2, as a single continuous wet zone 46 days after ponded infiltration began. The pattern of wetting (more diffuse than sharp) along this ~2.5 m section of borehole suggests that the wetting edge moved slower here than in the faster flow paths (e.g. FP-A and FP-B), which were defined by a sharp change in measured resistance (Figure 5c). Here, the wetting began close to the borehole collar before migrating 1.75 m horizontally towards the midsections of the borehole over a period of ~108 hours. Wetting associated with this flow was slow, with saturations gradually increasing over a period of up to 5-10 days.

Flow associated with FP-D was almost as wide at the section of FP-A intercepted by BH4. This flow zone was located vertically below the infiltration pond and extended over a distance of ~2.0 m along BH10 (Figure 5d). However, despite being the flow path closest to the infiltration pond (because of the absence of lateral flow), the flow velocity measured along this zone (i.e., 0.43 m/day) was significantly less than that measured in most other locations.

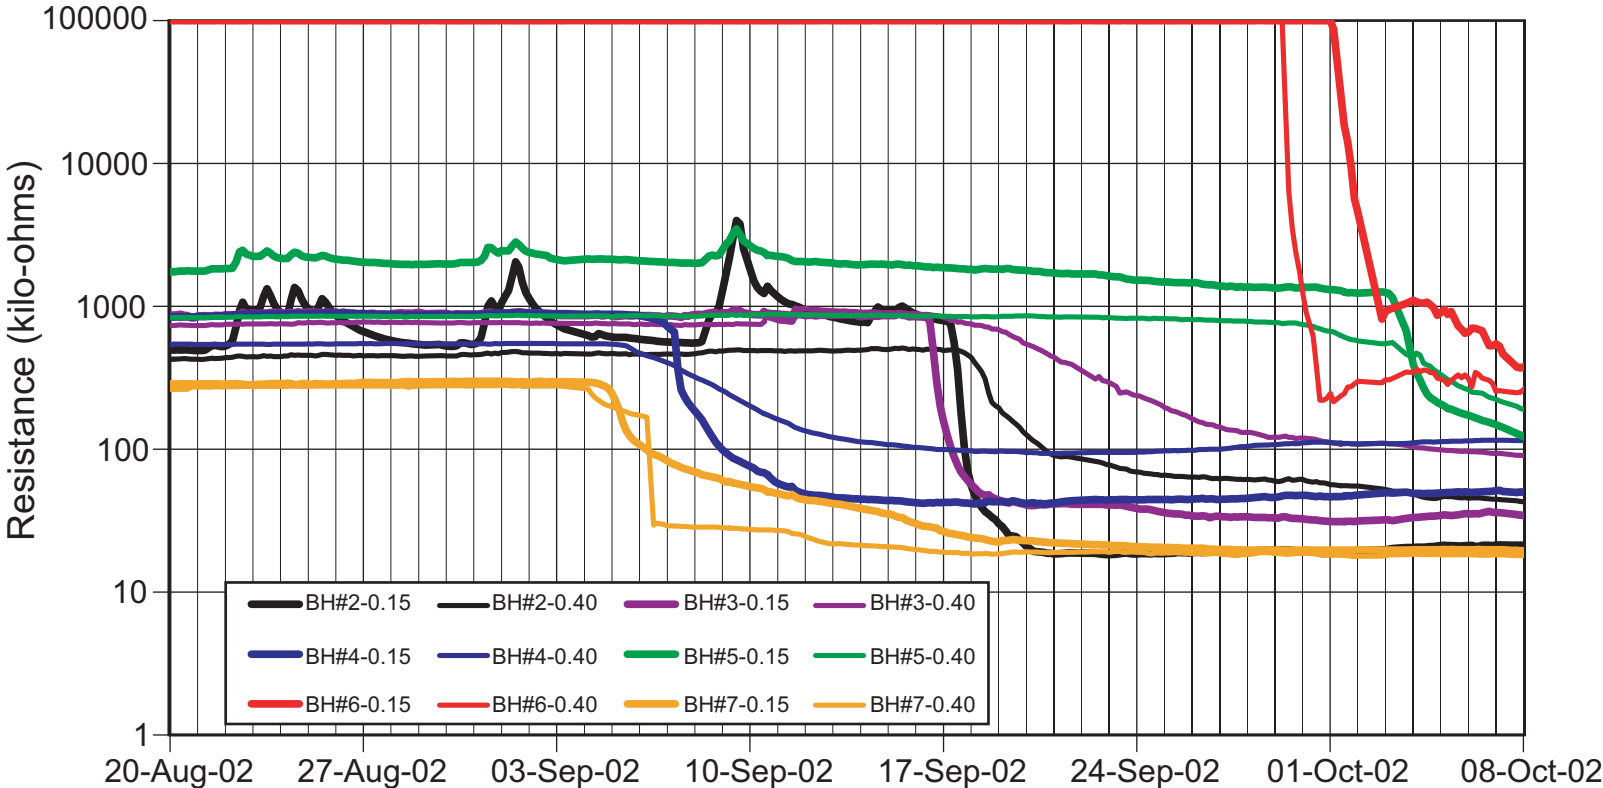
Figure 7. Saturation changes measured close to the walls of Niche 3. Data shown is for the six boreholes with each color representing a separate borehole. Note the legend includes the borehole number and location of sensor along the borehole.

In six of the seven boreholes extending from the walls of Niche 3 (i.e. BH2-BH7), wetting was observed close to the niche walls (Figure 7). In five of these (BH3-BH7), saturations increased to a limited horizontal distance (i.e., 0.50 m), while in the single exception (i.e., BH2), the wetting phase extended ~2.5 m horizontally. Further, periodic observations made along the walls of Niche 3 show the emergence of water through a network of fractures (Figure 8).

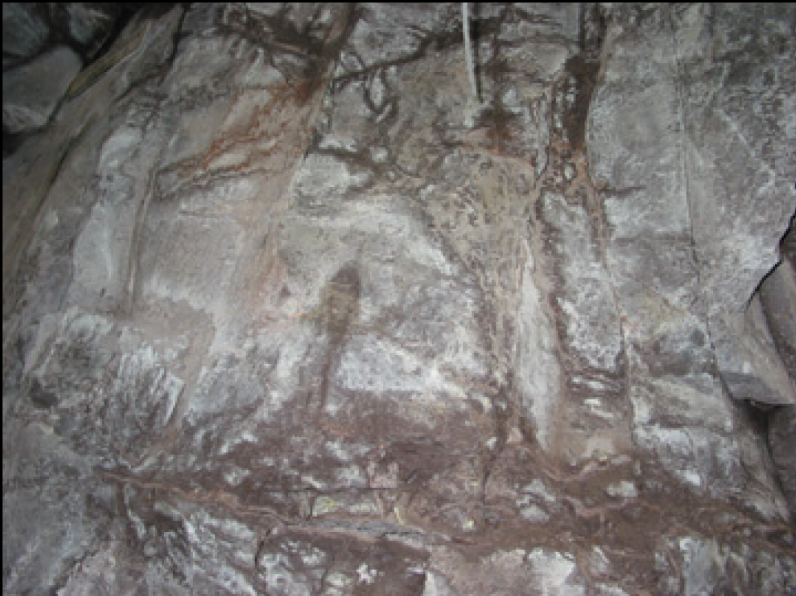
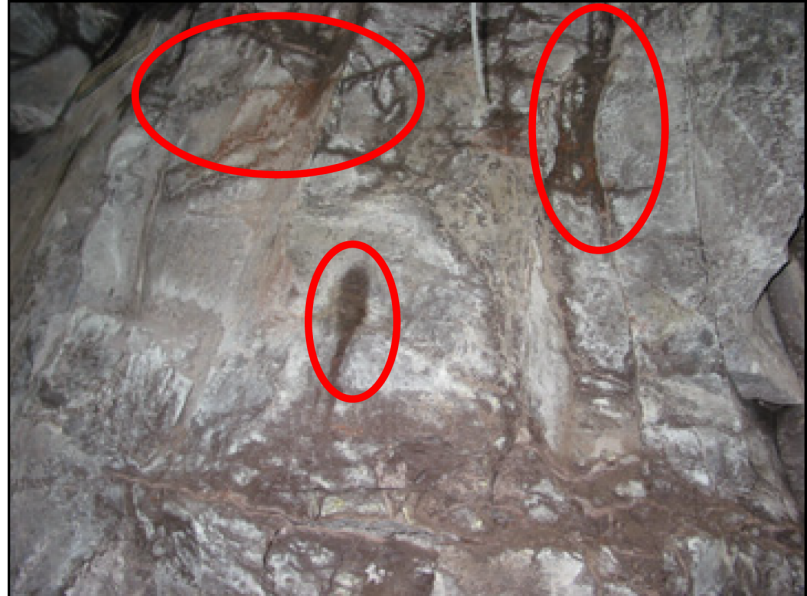
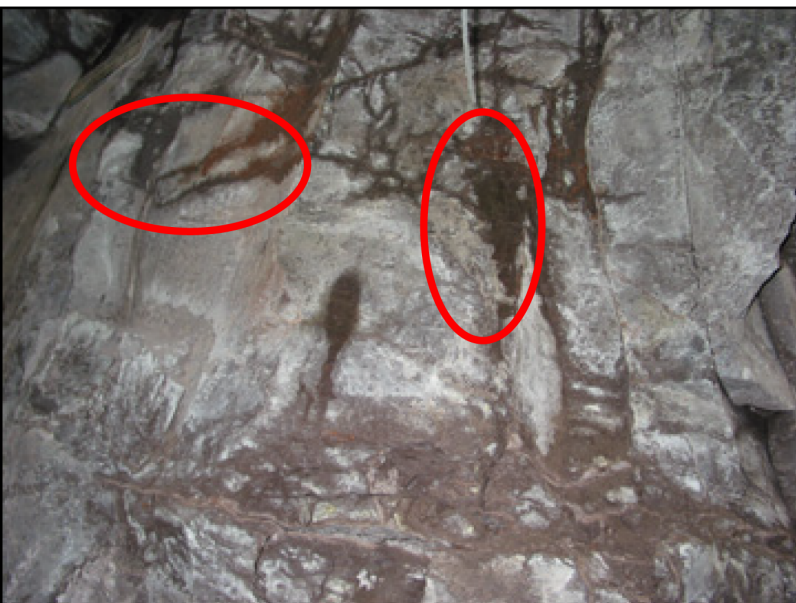
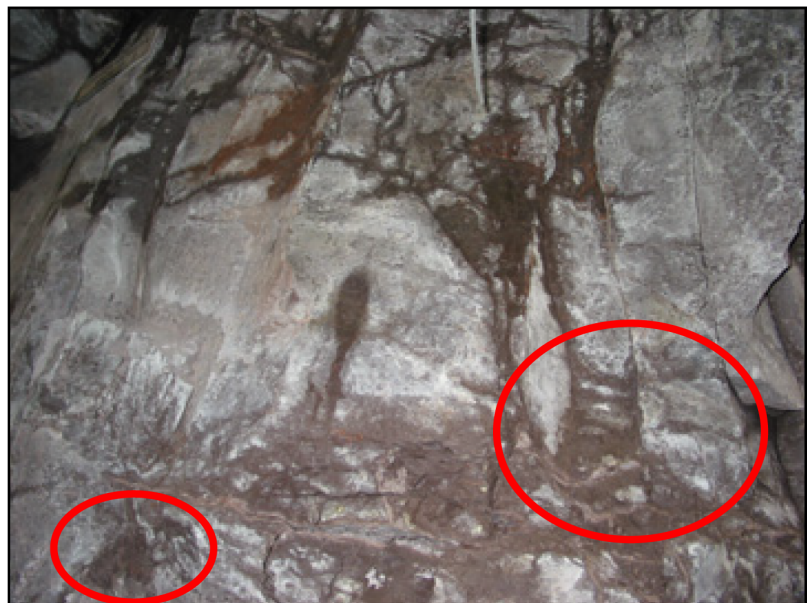
Figure 8. Development of lateral flow along the back wall of Niche 3 over a period of 24 hours. This wetting likely occurred as water was diverted from the ceiling migrated through the formation close to the walls. Circles indicate the location of changes.

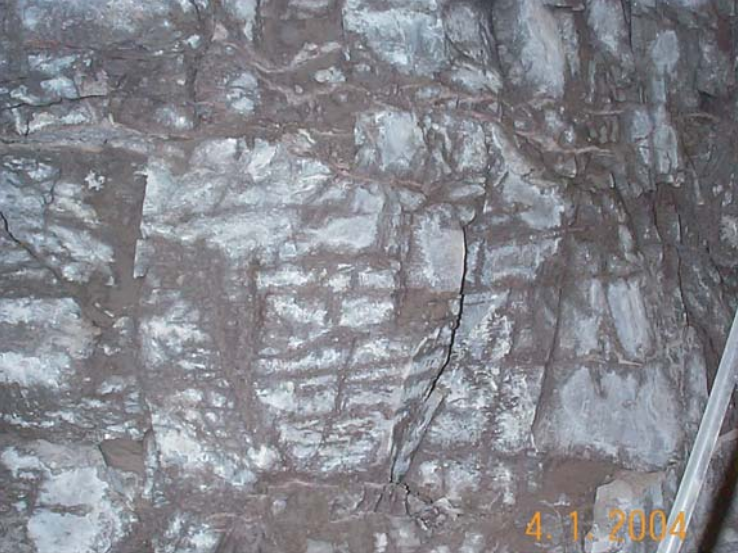
Figure 10. Water emerging along a network of fractures along back wall of Niche 3. The tube in the lower right hand corner had an outer diameter of 1 cm. This photograph shows that flow in this fractured rock is through a network of fractures which is largely made up of fractures which are less than 1m in length.

The nearly instantaneous wetting of individual wet zones of up to 2.75 m (e.g., FP-A) indicates that flows often extended along conduits that varied considerably in size and encompassed a large number of fractures (Figure 10). This observation of flow paths inclusive of many fractures is particularly important because: (1) it suggests that flow in this fractured rock is not restricted to sections of individual fractures, and (2) water flowing along these flow paths is in contact with a large surface area associated with multiple fractures. An accurate assessment of the fracture–matrix interface area (or effective matrix-diffusion coefficient) is required for evaluating the transport of dissolved radionuclides and radioactive colloids in both unsaturated and saturated fractured rock [e.g., Bodvarsson *et al.*, 2001; Neretnieks, 1980, 2002]. If this area is assumed to include only that area wetted by focused flow along fracture surfaces, it is
