Air Corrosivity in U.S. Outdoor-Air-Cooled Data Centers is Similar to That in Conventional Data Centers

**Part of the DOE Roadmap for Compressorless Cooling in Data Centers**

Henry C. Coles, Taewon Han, Phillip N. Price, Ashok J. Gadgil and  
William F. Tschudi

March 2011 Rev.

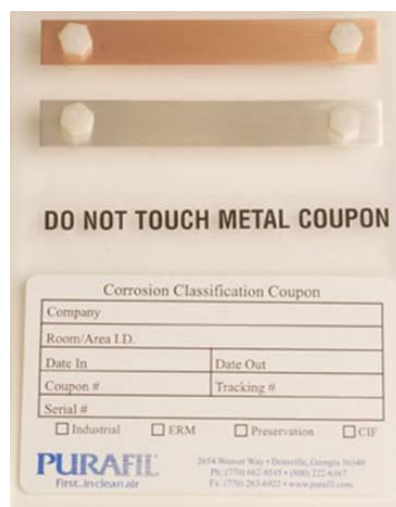
**Figure 1 – Unexposed Corrosion Classification Coupon Containing Copper and Silver Metal Strips**

The use of metal coupons is the best known and simplest of all corrosion monitoring techniques. At least two companies offer coupons and the required analysis; we selected Purafil. The method involves exposing a coupon specimen to the environment for a given duration (e.g. 30 days). Following exposure, the specimens were analyzed. The magnitude of corrosion film, or corrosivity, was quantified by corrosion growth rate as angstroms ( $\text{\AA}$ )/30 days. In addition the analysis can provide some information regarding what type of contaminate was the likely caused of most of the corrosion growth. Under the scope of this project, the research team was not able to analyze this information, but the data is available and this type of analysis is recommended for future studies. Each coupon set (copper and silver) is attached to a Plexiglas support (approximately 4" x 3" x 1/4") and coupon number, date, and location information recorded on the transmittal label (Figure 1). In order to minimize any background corrosion, coupons are provided packed in a zip-lock plastic bag with a Purafil Sachet that acts as a scavenger for any ambient contamination that may have been sealed inside the bag with the coupon. After the exposure period the coupons are repackaged in the original plastic bag with the Sachet and returned for analysis.

The standard method for analyzing corrosion coupon is called cathodic/electrolytic reduction. The thickness of the corrosion film is determined by Purafil's laboratory analysis. The results of the report included a photograph of the returned coupon, ISA Environmental Classification, and film thickness/30 days.

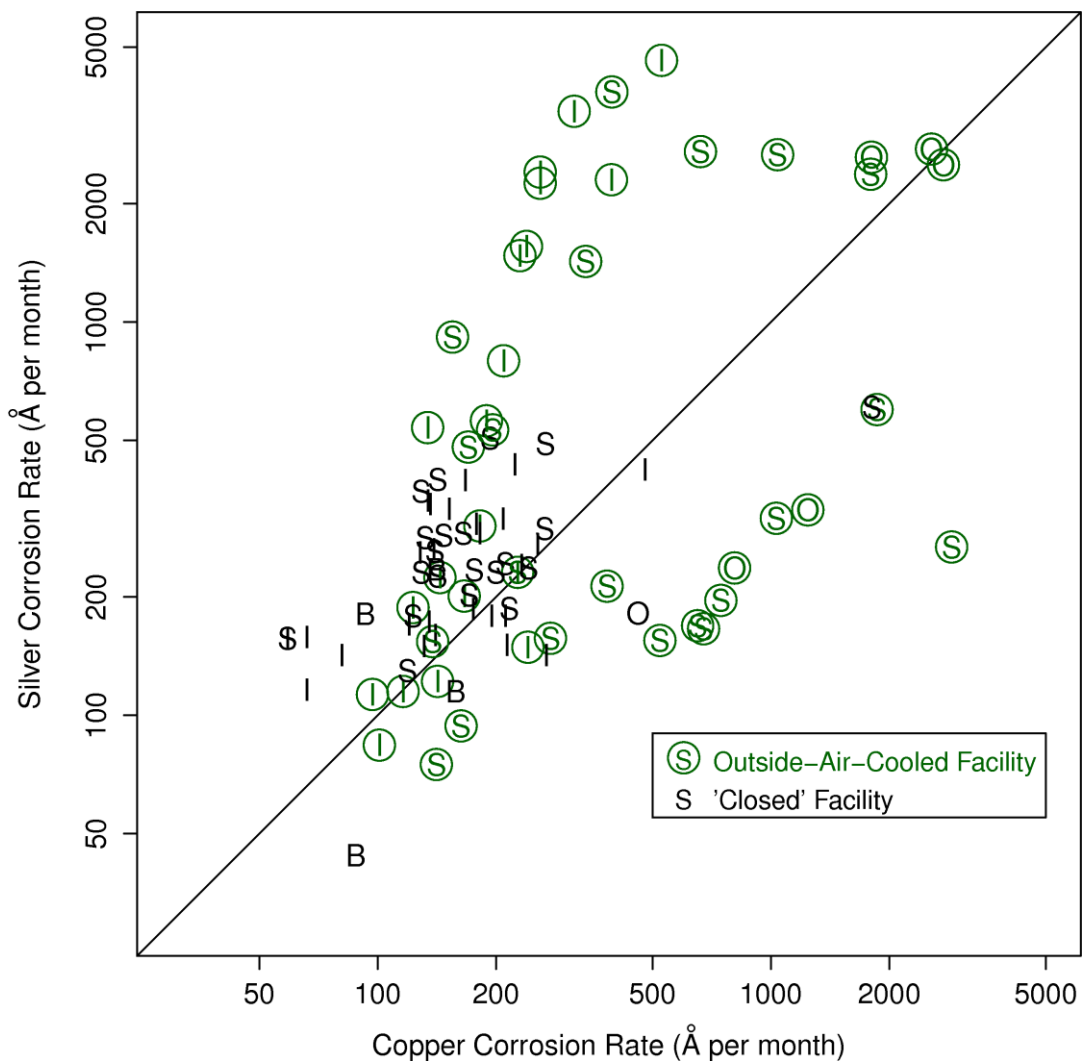
The results of analyzing the reactivity monitoring measurements from 21 data centers follow. Figure 2 shows the copper and silver measurement for all coupons used and recovered. The location type Outside, Supply or Inside is shown by letter O, S or I respectively. The “unexposed” or background measurements are indicated by “B”. The measurements from outside-air cooled data centers have a circle around the location type indicator. Observations are:

- Some measurements from coupons exposed in data centers for 30 days were below the background or unexposed coupon measurements.
- Large silver measurement ranges are associated with small copper measurement ranges.
- Large copper measurement ranges are associated with small silver measurement ranges.

Figure 2 - Measurements From All Data Centers Including All Location Categories, Measurements from Outside-Air Cooled Data Centers are Circled Background or Unexposed Indicated by “B”, Outside Indicated by “O”, Supply indicated by “S”, Inside Indicated by “I”

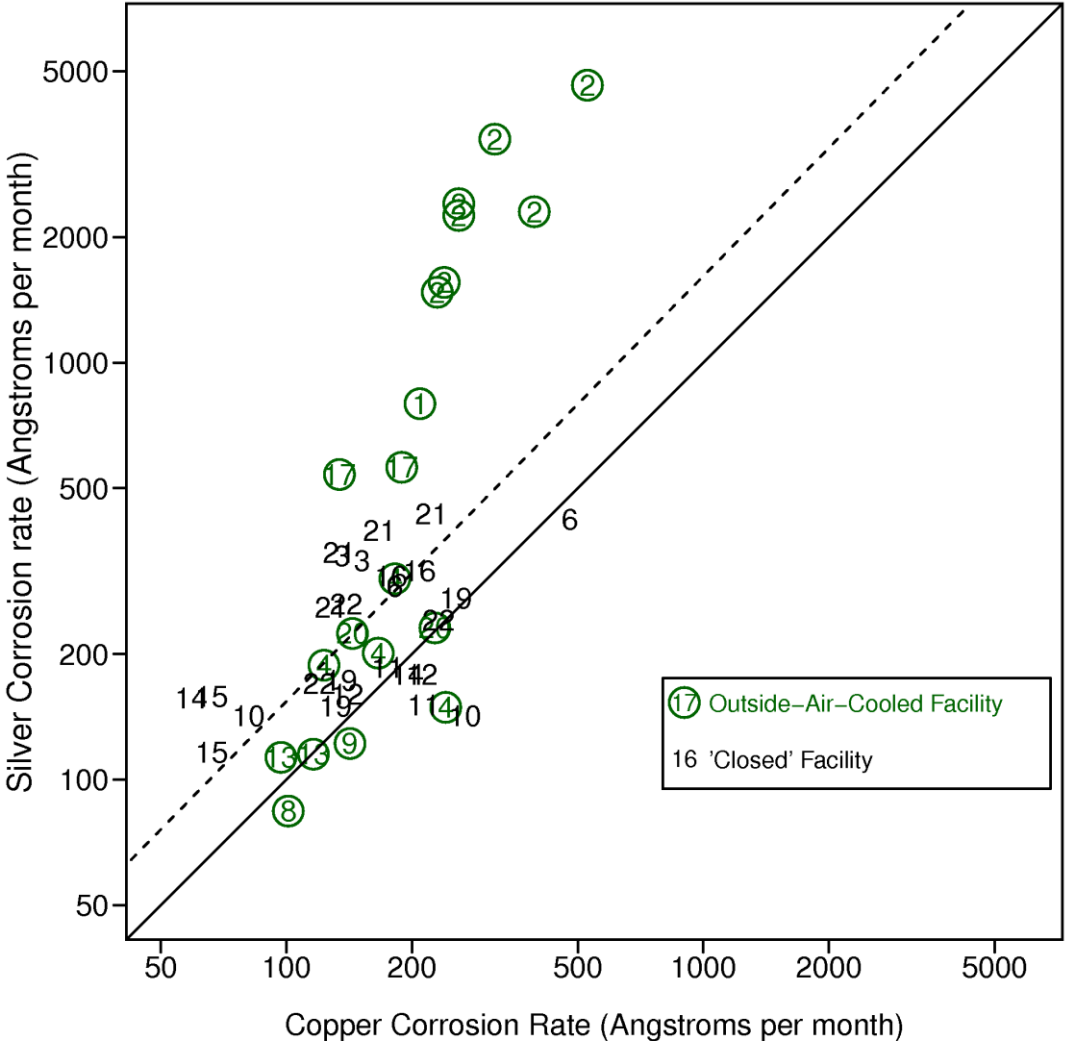
Figure 3 shows the “Inside” only copper and silver measurement for all coupons recovered. The data center identification number is plotted and indicates the measurement value for each coupon. Observations are:

- All copper corrosion rate measurements are below the levels thought to be problematic.
- The correlation between silver and copper corrosion “Inside” rate measurements is poor. The best-fit relationship is shown by the dashed line. Many points fall far off the line, implying that one cannot use a copper corrosion rate measurement to accurately predict the silver corrosion rate measurement in the same facility, or even on the same coupon. (Technical note: the best-fit power-law relationship is linear, and the silver corrosion rate is, on average, 1.4 times the copper corrosion rate. However, the value of  $R^2$  for the fit in log space is only 0.33).
- Note: The highest 7 silver “Inside “measurements came from one (#2) United States data center.

Figure 3 - Measurements From "Inside" Only, Data Center ID Number Located to Indicate Copper and Silver Measurement For Each Coupon, Numbers are Circled for Data Centers Using Outside-Air Cooling, Data Center ID#5 was Not Assigned.

The correlation between silver and copper corrosion rate Inside measurements is poor, as can be seen in Figure 3. The correlation if all measurements location types are considered is much lower. The best-fit relationship for Inside measurements is shown in Figure 3 by the dashed line. Many points fall far off the line, implying that one cannot use a copper corrosion rate measurement to accurately predict the silver corrosion rate measurement in the same facility, or even on the same coupon. (Technical note: the best-fit power-law relationship is linear, and the silver corrosion rate is, on average, 1.4 times the copper

corrosion rate (indicated by the dotted line in Figure 3). However, the value of  $R^2$  for the fit in log space is only 0.33).

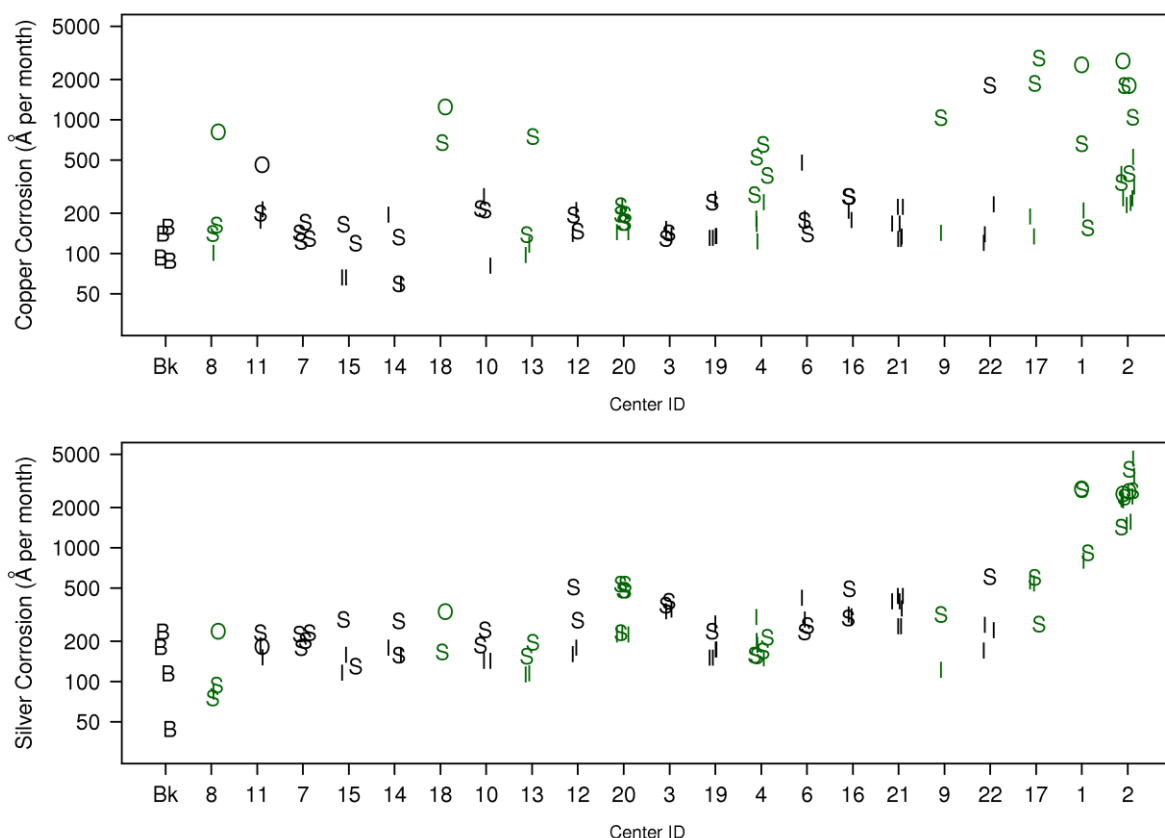
Figure 4 shows the copper and silver measurement for all coupons recovered listed by data center identification. The location type either Outside, Supply or Inside is shown by letter O, S or I. Background measurements are indicated with "B". Observations are:

- Outdoor (Outside) corrosion measurements were made at data centers 1, 2, 8, and 11. In all cases, the copper corrosion rate was much higher Outside than Inside: the ratio of average Outside to average corrosion Inside rate was 12, 7, 8, and 2.4. For silver, the ratio was 3.5, 1.0, 2.8, and 1.1.

- In 75% of data centers, the average copper corrosion rate was higher in the air Supply system than in Inside, and in half of the data centers the ratio of Supply-side to Inside corrosion rate exceeded 1.5; in 25% of centers, the ratio exceeded 2.8. Similarly, in 75% of data centers the average silver corrosion rate was higher in the Supply system than in the Inside, and in half the ratio exceeded 1.3; in 25% of centers, the ratio exceeded 1.8.

- The variation of copper corrosion rates among data centers is lower in the Inside than in the air Supply system: the standard deviation of copper corrosion rate is 63 angstroms/month in the Inside, and 590 angstroms/month in the Supply system. For silver, the standard deviations are 546 angstroms/month for Inside and 602 angstroms/month in the Supply system.

Figure 4 - All Measurements Sorted by Combined Average of Copper and Silver Measurements and Identified by a Data Center ID#, Background or Unexposed Indicated by "B", Outside Indicated by "O", Supply Indicated by "S", Inside Indicated by "I"; ID Number Does Not Correspond to Listing Sequence in Appendix A. Data Center ID#5 was Not Assigned.

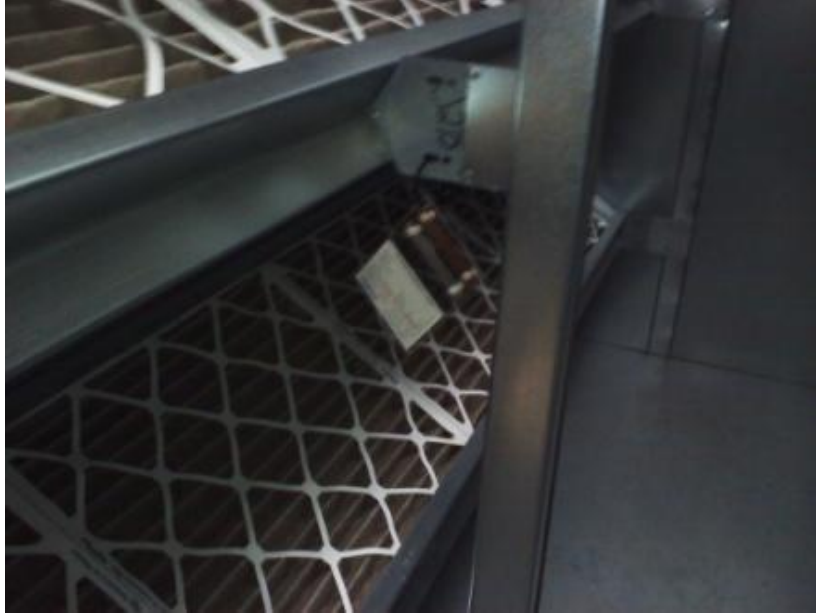
Figure 7 - Typical Coupon Mounting - Example Shown is Immediately Downstream of Supply Air Filters as Found in Large Roof Top Fan Units

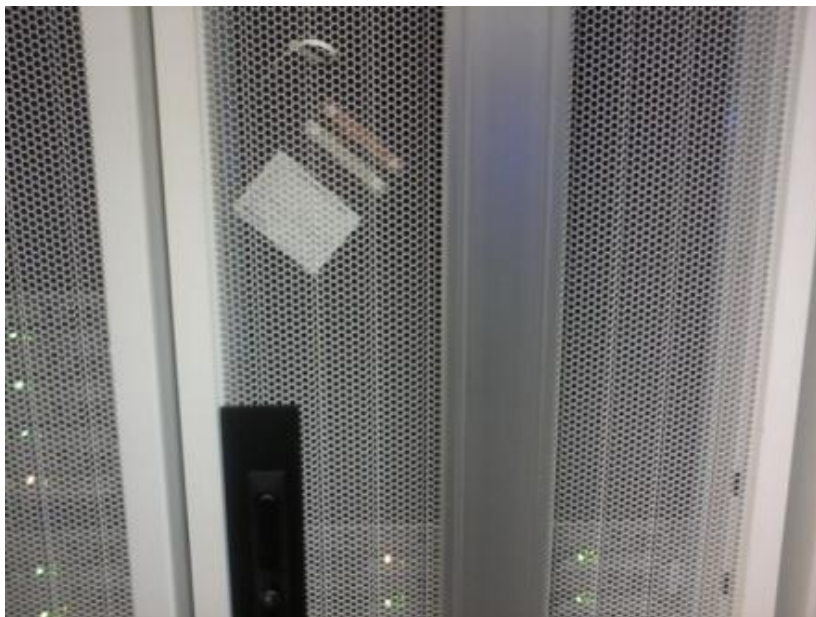
Figure 8 - Typical Coupon Mounting, Example Shown is Just Prior to Cooling Air Entering IT Equipment

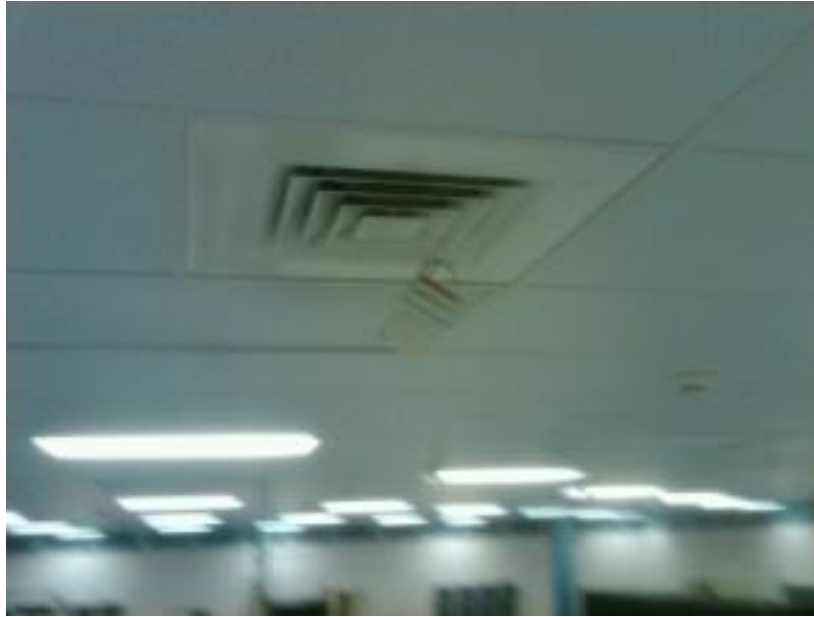
Figure 9 - Typical Coupon Mounting, Example Shown at Data Center Room Supply or Return Grill
