Damage Identification of a Composite Beam Using Finite Element Model Updating

Computer-Aided Civil and Infrastructure Engineering, 23(5)

# **Damage Identification of a Composite Beam Using Finite Element Model Updating**

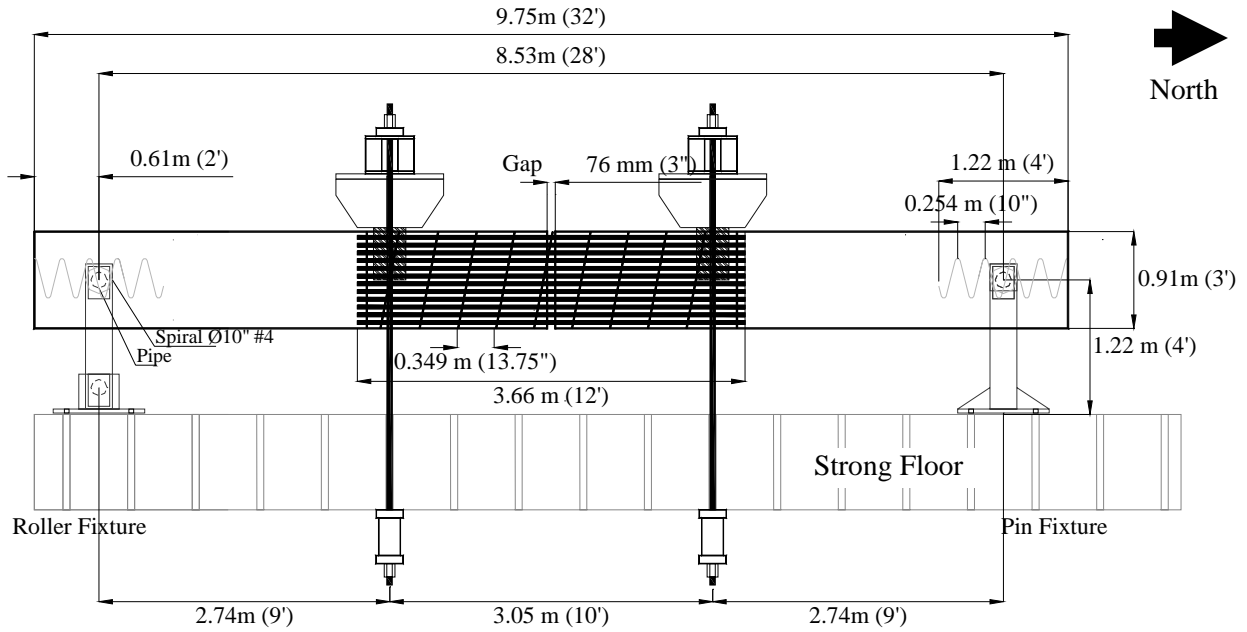
Fig. 3. Schematic test setup: Side elevation (Brestel et al., 2003)

A uni-directional quasi-static cyclic loading was applied to the girder using four 1335kN (300kips) displacement-controlled hydraulic actuators in a four-point bending test (see Figure 3). Initially, the girder was loaded to a total of 1000kN (225kips) to establish a well-lubricated pin connection at the supports of

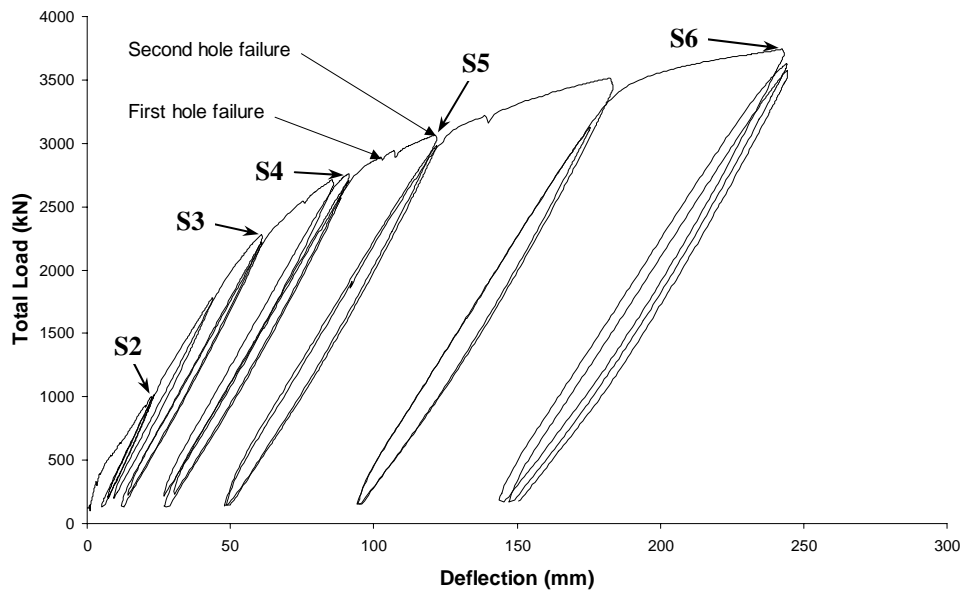
Fig. 4. Total load vs. girder vertical displacement at mid-span

the simply supported girder. The increasing level of the cyclic load progressively introduced damage in the beam through inelastic (irreversible) deformations. The loading history for the test is summarized in Table 1 and the plot of the total load applied versus the girder vertical displacement at mid-span is shown in Figure 4. The load cycle targets for the initial yield ( $F_y'$ ) and the displacement ductility levels ( $\mu_\Delta = 1.0, 1.5, 2.0, 3.0, 4.0$ ) were determined pre-test from moment-curvature analyses. More details of the test setup are provided by Brestel et al. (2003). After load cycles 2, 5, 7, 8, and 12, the loading fixtures were removed to perform a sequence of dynamic tests for system and damage identification studies. This sequence of dynamic tests was performed twice before starting the quasi-static loading cycles and the corresponding undamaged states of the beam are referred to as states S0 and S1. States S2 to S6 refer to the state of the beam after loading cycles 2, 5, 7, 8 and 12, respectively, shown in Figure 4. The repeated sequence of dynamic tests consisted of a set of forced vibration tests using a  $0.22kN$  (50lbs) force electrodynamic shaker followed by a set of impact (free vibration) tests using an impact hammer with integrated load cell recording the applied force. The forced vibration tests performed using the shaker consist of a set of sixteen (Gaussian) white noise excitations followed by three (linear) sine sweeps across the frequency ranges 12-22Hz, 38-48Hz, and 93-103Hz, respectively. These three frequency ranges were selected so as to excite the first three vibration modes of the beam, the frequencies of which were predicted using a finite element model of the beam. The free vibration tests conducted using the impact hammer consisted of three vertical impact tests at each of four locations along the top edge of the girder as shown in Figure 5. Therefore, a total of 12 vertical impact tests were performed on the beam for each of 7 different states (S0 through S6). It was found that the shaker-induced vibration data were of considerably lower amplitude than the impact response data, resulting in a much lower signal-to-noise ratio. Therefore, the modal identification results presented in this paper are based only on the data collected from the vertical impact tests.

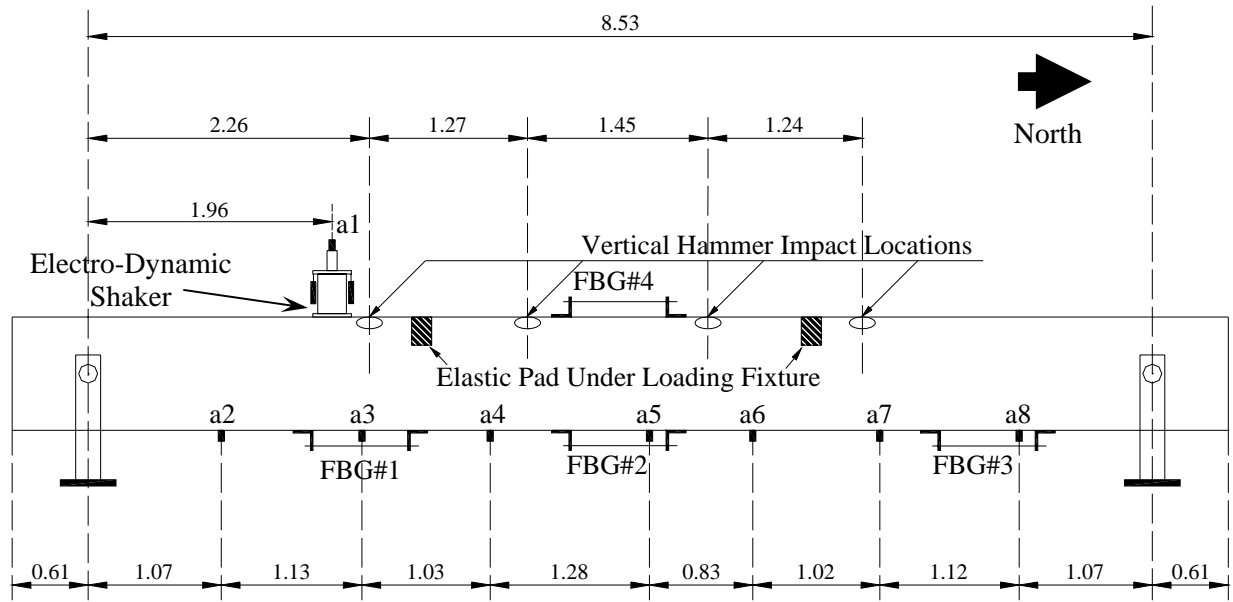
Fig. 5. Locations of accelerometers, FBG sensors, vertical hammer impacts and electro-dynamic shaker

Bragg grating (FBG) strain sensors (1m gage length) and eight accelerometers with the required sensitivity/accuracy for the purpose of the (low-amplitude) payload dynamic tests. The FBG strain sensors were surface mounted using brackets, with a pair of sensors located along the top and bottom of the beam at mid-span, and the remaining two sensors located along the bottom edge of the beam at approximately 1/3 of the beam length on either side of mid-span as shown in Figure 5. The FBG strain sensors were pre-strained in their long-gage packages in order to measure compression as well as tension. In addition to the FBG strain sensors, eight accelerometers were attached to the girder specimen to measure vertical acceleration. Seven of these accelerometers were approximately equally spaced along the bottom edge of the girder and one was mounted on the moving mass of the electro-dynamic shaker to measure the dynamic force applied to the beam (see Figure 5). The technical characteristics of the accelerometers are: PCB model 393A03, amplitude range: 5g pk, frequency range (10%) 0.3-4000Hz, resolution  $5 \times 10^{-6}$  g pk, voltage sensitivity 1000mV/g, excitation voltage 18 to 30VDC. For every dynamic test performed at each of the states S0 through S6, the vibration response of the composite girder was measured by accelerometers a2 through a8, while the four FBG strain sensors measured the vibration response for states S1 through S5 only. Figure 6 illustrates the acceleration (left column) and FBG strain (right column) measurements after an impact applied at location 1 (see Figure 5) at state S1. Figure 7 shows the Fourier Amplitude Spectra (FSA) of two acceleration and two FBG strain measurements for the same impact test.

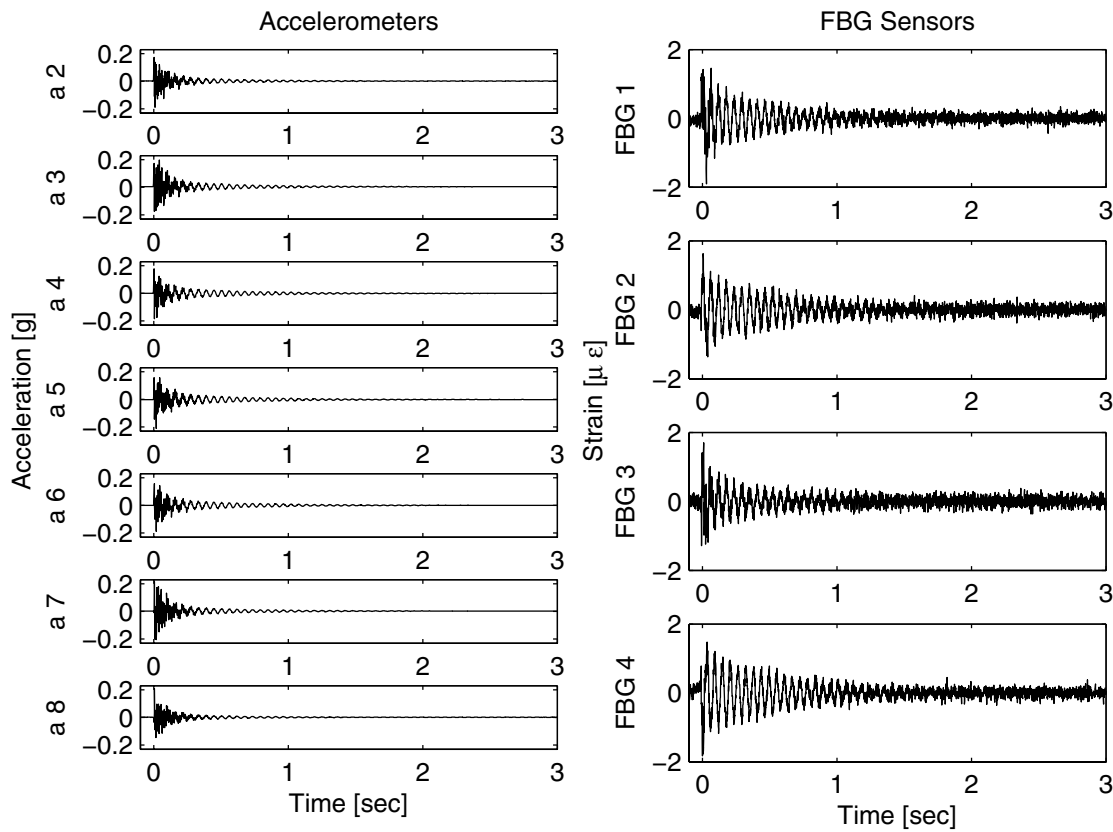
Fig. 6. Acceleration and FBG strain measurements during Test 1 at state S1

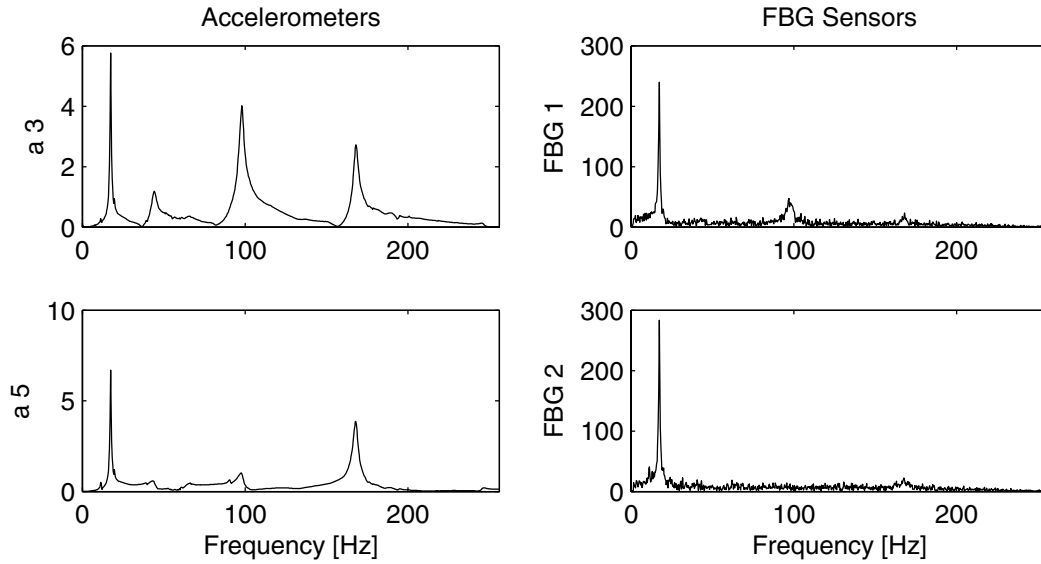
**Fig. 7.** Fourier amplitude spectra of some acceleration and FBG strain measurements during Test 1 at state S1

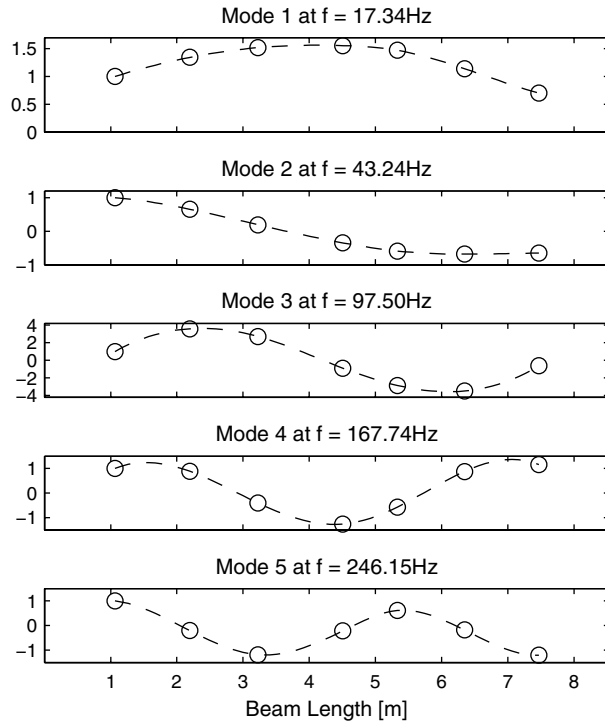
**Fig. 9.** Normalized (real) mode shapes of the composite beam at state S1

In the first case of damage identification, the natural frequencies and displacement mode shapes of the first five modes (see Figure 9) identified from acceleration data are used to form the residual vector which has a total of 35 residual components consisting of 5 eigen-frequency and  $5 \times (7 - 1) = 30$  displacement mode shape residuals. The model parameters (effective moduli of elasticity) of the reference model are updated from state S1 (reference model) through S6. In the second case of damage identification, in addition to the natural frequencies and displacement mode shapes of the first five vibration modes identified based on acceleration data, the macro-strain mode shapes of the first four vibration modes identified based on FBG strain sensor data are considered in the residual vector for a total of 47 residual components consisting of 5 eigen-frequency, 30 displacement mode shape, and  $4 \times (4 - 1) = 12$  macro-strain mode shape residuals. The reference model (which is the same for both damage identification cases) is updated at states S2, S3, and S5. It should be mentioned that the macro-strains obtained from the FBG sensors at state S4 were significantly noisier than at the other states (due to the fact that the FBG sensors were not re-tensioned at this damage state) and therefore the FE model was not updated at this damage state. In the second case of damage identification, the mode shape residual vector consists of two parts: residuals from displacement mode shapes ( $\mathbf{r}_s^{\text{acc}}$ ) and residuals from macro-strain mode shapes ( $\mathbf{r}_s^{\text{ms}}$ ), as  $\mathbf{r}_s = \begin{bmatrix} \mathbf{r}_s^{\text{acc}} \\ \mathbf{r}_s^{\text{ms}} \end{bmatrix}$ , where both parts are defined separately as in the second part of Equation (4). The analytical macro-strain mode shapes are derived from the displacement mode shapes through a transformation matrix  $\mathbf{T}^{\text{ms}}$ . This matrix connects the nodal degrees of freedom (DOFs) of the FE model to the deformation of the FBG sensors based on linear elastic Bernoulli-Euler beam theory with exact displacement interpolation functions (Conte and Liu, 2001).

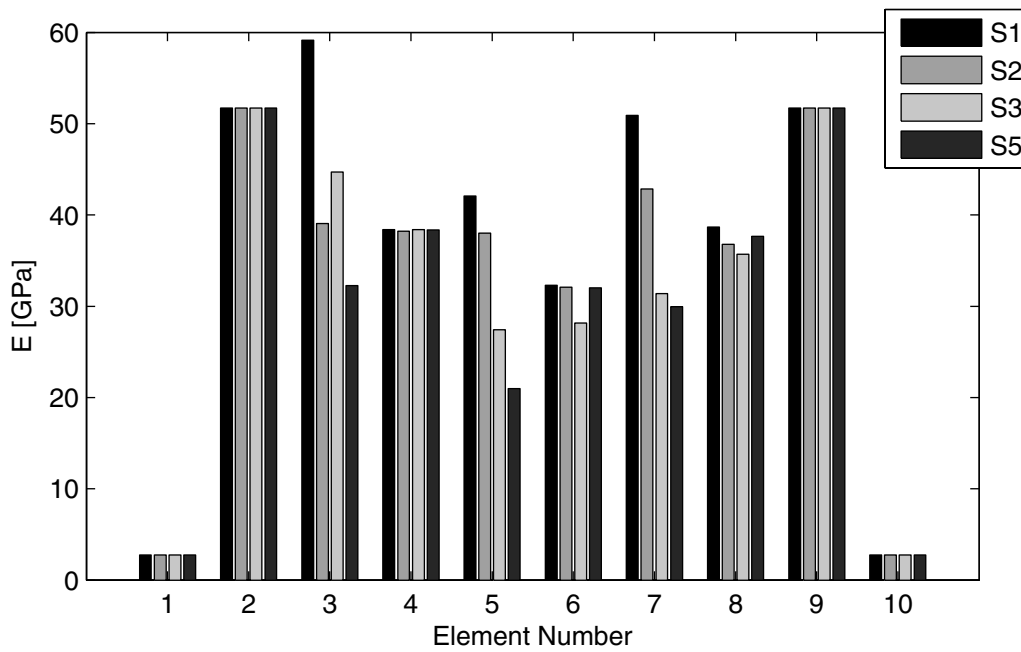
**Fig. 21.** Updated effective moduli of elasticity of 10 beam elements at different damage states (S1, S2, S3 and S5) for second case of damage identification

For the second case of damage identification, Table 10 gives the updated  $E^e$  for the updating elements (# 3-8, 11, 12) and the corresponding damage factors (relative to the reference state S1) at states S2, S3 and S5, while Figure 21 shows in a bar plot the updated  $E^e$  for all beam elements at states S1, S2, S3 and S5. Table 11 presents the experimentally identified modal frequencies together with their analytical counterparts obtained from the updated FE model as well as the MAC values between experimental and analytical mode shapes (for both displacement and macro-strain mode shapes considered separately) at states S2, S3 and S5. Figure 22 compares the damage factors of all updating elements (3-8, 11, 12) obtained from the two considered cases of damage identification at states S2, S3, and S5. From this figure, it is observed that the damage factors computed from these two cases are in relatively good agreement for elements 3, 5, 6, 11 and 12. Damage is identified along element 4 in the first case and not in the second case. Since FBG sensor # 1 is covering part of element 4 (see Figure 5), it is expected that the results from the second case of damage identification for element 4 are more accurate than those from the first case. In the first case, damage is identified along element 8 with almost no damage along element

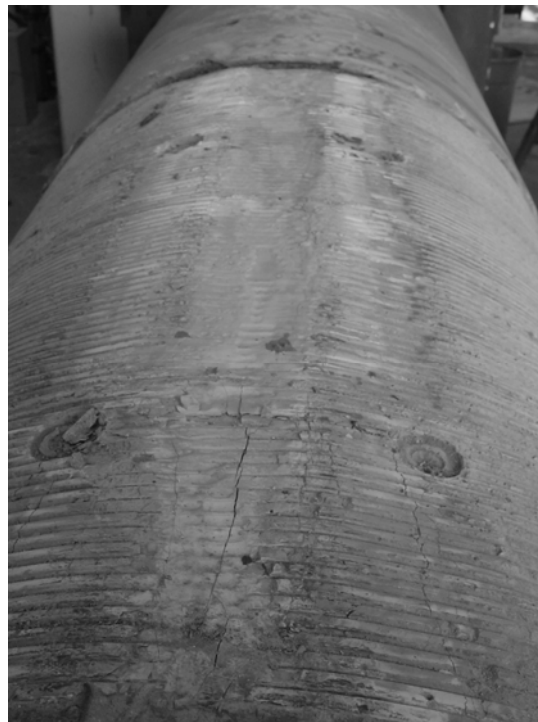
**Fig. 25.** Concrete core at north side of the splice (see Figures 2 and 4)
