Circulation, 83(3)

Intravascular Ultrasound Imaging of Human Coronary Arteries In Vivo

Analysis of Tissue Characterizations With Comparison to In Vitro Histological Specimens

Jonathan M. Tobis, MD, FACC; John Mallery, MD; Don Mahon, MD;
Kenneth Lehmann, MD; Paul Zalesky, PhD; James Griffith, PhD; James Gessert, BS;
Masahito Moriuchi, MD; Michael McRae, MD; Mary-Lynn Dwyer, RN;
Nancy Greep, MD; and Walter L. Henry, MD

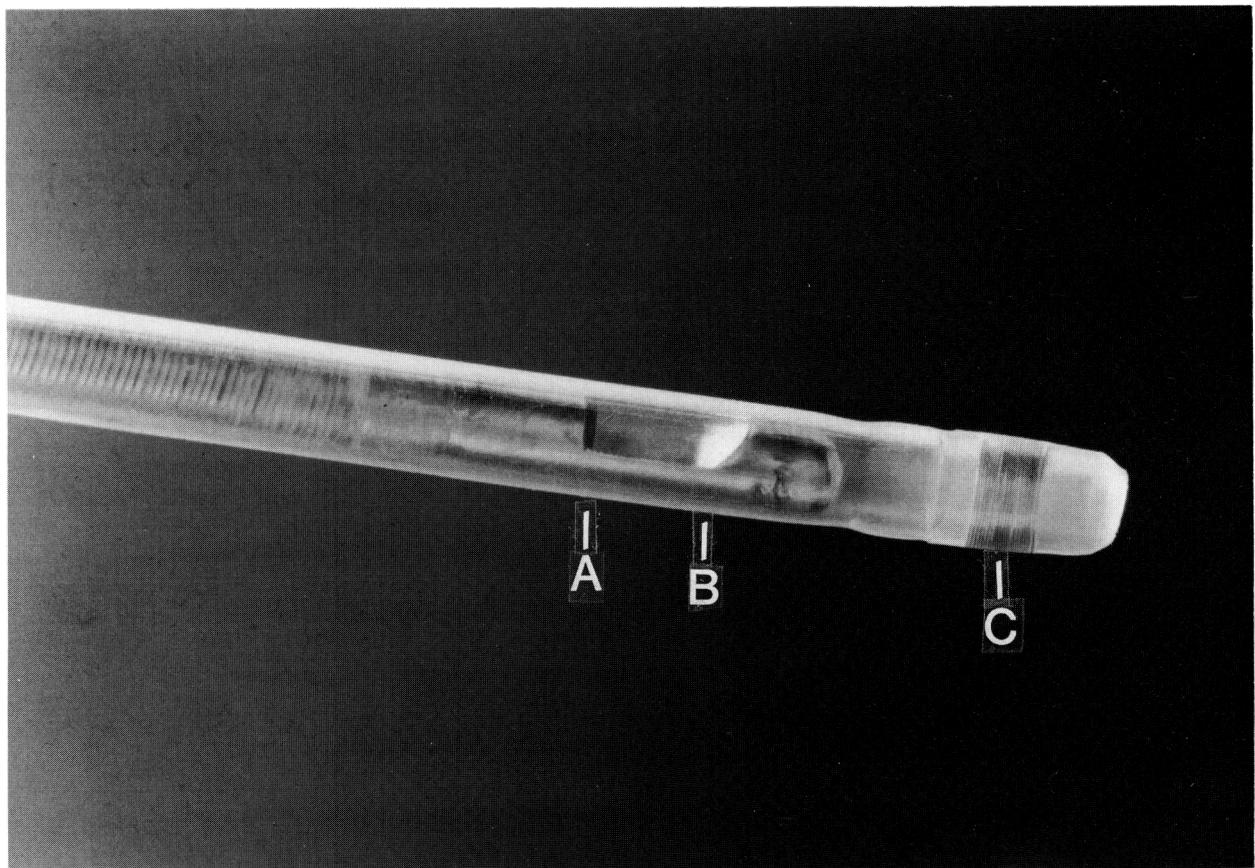
FIGURE 1. Intravascular ultrasound imaging subassembly inserted inside the 1.6-mm diameter plastic sheath. The 7-mm rigid end of the ultrasound subassembly includes the 20-MHz ultrasound transducer (A) and the reflective mirror (B) that deflects the ultrasound beam perpendicular to the long axis of the catheter. Distal end of the plastic sheath has a radiopaque marker (C).

femoral artery approach. The ultrasound device consists of a 1.2-mm diameter cable with a 20-MHz transducer on the distal end with a mirror at 45° that reflects the beam perpendicular to the long axis of the catheter. This design permitted imaging up to the surface of the catheter because the initial transducer oscillations (which produce ring-down artifact with loss of image information) occurred in the space between the transducer and the mirror. The catheter is rotated by a motor at 1,800 rpm to produce real-time cross-sectional images at 30 times/sec. To protect the arterial lumen during the movement of the catheter, the ultrasound subassembly is inserted through a 1.6-mm plastic introducing sheath (Figure 1). After balloon angioplasty, the guiding catheter was replaced with a 9F guiding catheter to accommodate passage of the inflexible, 7-mm long, distal section of the ultrasound device. The previously dilated section of the artery was recrossed with a 0.014-in. guide wire, over which the plastic introducer sheath was positioned distal to the dilated segment. The guide wire was removed, and the ultrasound subassembly cable was inserted under fluoroscopic control to the distal end of the introducing sheath. The motor drive unit was then engaged, and continuous images of the coronary artery were obtained as the ultrasound subassembly was withdrawn through the plastic sheath (which remained stationary in the artery beyond the area of dilatation). Ultrasound images were recorded on super VHS videotape as were fluoroscopic sequences to

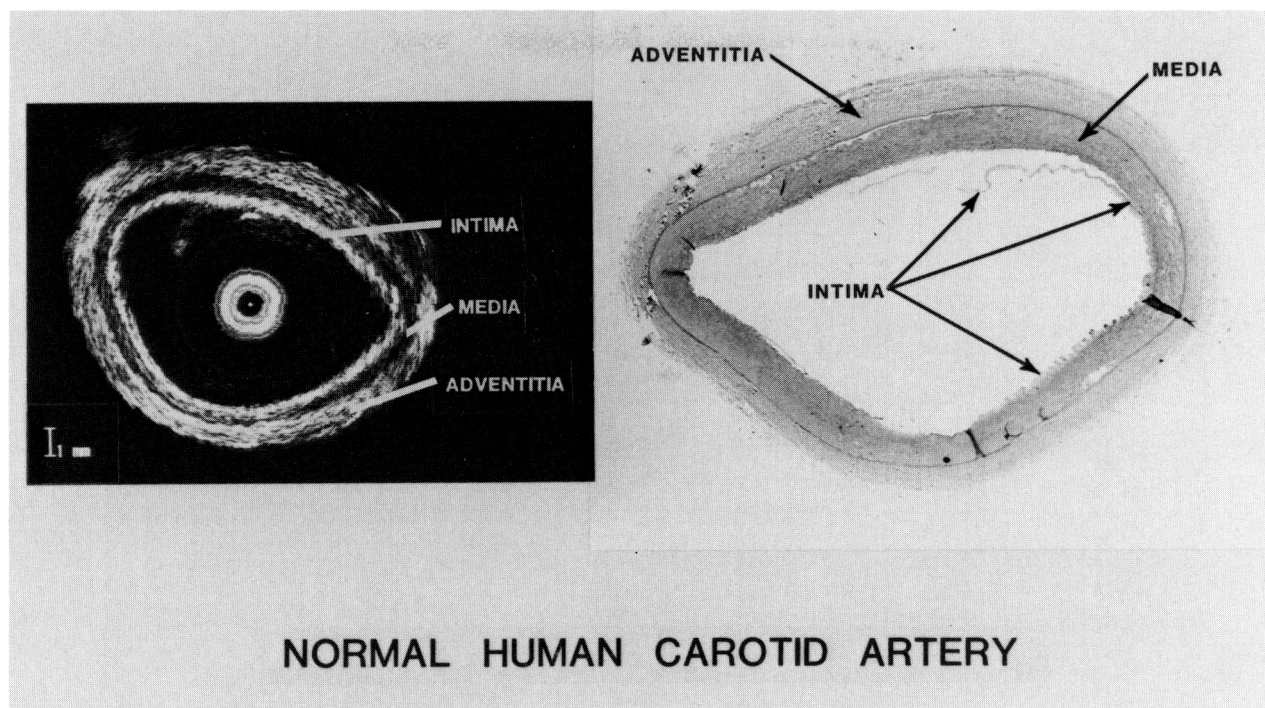
FIGURE 2. Intravascular ultrasound image and histological section of a normal human carotid artery. Characteristic three-layer appearance on the intravascular ultrasound image is seen. Muscular medial layer of the artery was relatively echolucent and provided a reference point in the arterial cross-section separating intima from adventitia. Intima extended from the lumen-tissue interface to the echolucent media. Adventitia consists of all echoes originating peripherally to the media.

Twenty of the 23 arterial images evaluated in this study had intimal thickening according to histological examination; three did not (Figure 2). Eleven (55%) of the artery sections were calcified on the histological sections, and all were correctly categorized by ultrasound (Figure 3). One noncalcified artery was incorrectly categorized because the ultrasound image of a highly fibrotic plaque resembled calcification with shadowing in the ultrasound image. All 20 arteries with atheroma demonstrated some degree of fibrosis on histology that corresponded to moderate echo intense reflections medial to the internal elastic membrane (Figure 4). Three liquid regions (“lakes”) in this series of ultrasound images were correctly identified by all observers, and there were no false-positive images (Figure 5).

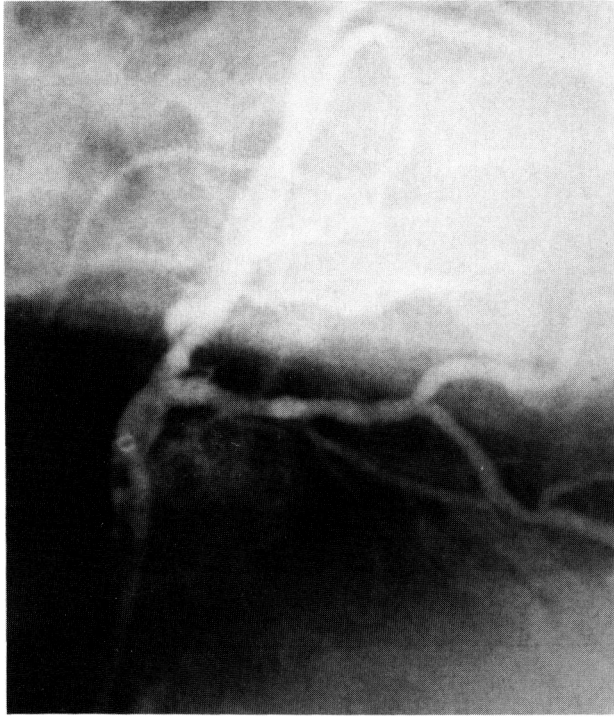
FIGURE 7. Panel A: Angiogram of the left coronary artery in the left anterior oblique projection with cranial angulation demonstrates severe stenosis of the proximal left anterior descending coronary artery. Panel B: Angiogram after balloon dilatation with a 4.0-mm balloon catheter demonstrates an enlarged diameter of the vessel; however, persistent haziness occurs in the contrast media at the level of the previous dilatation. Panel C: Ultrasound imaging subassembly has been inserted into the left anterior descending artery and is at the level of the previous dilatation. Radiopaque marker on the distal tip of the plastic introducing sheath can be observed (arrow).

Figure 7A shows a coronary angiogram in the left anterior oblique projection from a patient with a severe stenosis in the proximal LAD. After balloon dilatation (Figure 7B), there is still a hazy appearance to the segment of the artery that was dilated. The ultrasound imaging device was inserted through a 9F multipurpose guiding catheter, and multiple images were obtained as the ultrasound subassembly was advanced and withdrawn. Figure 7C shows the ultrasound subassembly within the left coronary artery at the level of the previously dilated section of the LAD. The ultrasound images obtained from the various segments of the left main and LAD are shown in Figure 7D. The left main coronary artery lumen was 23.5 mm^2 in cross-section with evidence of minimal atheroma (6.6 mm^2) involving the intimal surface. The atheroma area was 22% of the left main arterial cross-section. Distal to the level of balloon

dilatation, the ultrasound cross-sectional image demonstrated a residual lumen that was 2.3×2.1 mm in diameter or 3.7 mm^2 in cross-sectional area. The external surface of the atheroma is clearly defined circumferentially by the echolucent band that corresponds to the media. In addition, a dense area of calcification is observed that had the characteristic of being highly echo reflective with dropout of ultrasound information distal to the calcium. As the ultrasound subassembly catheter was withdrawn to the level of the previously dilated segment, a loosely speckled echo-reflective structure was noted to take up most of the central-inferior portion of the artery cross-section around the plastic introducer sheath. There was a moderate-sized dissection of the echo-dense atheroma along the line of the media between 3 and 9 o'clock on the ultrasound image. The criterion used to define a dissection on the ultrasound image was a wide echolucency (>0.3 mm) between the atheroma and the media, which was twice as wide as the remaining intact media. The mildly echoreflective density within the central lumen of the artery corresponded to the hazy appearance on angiography, but it is unclear whether this represents thrombus formation or residual atheroma. This central
