Steel Sheet Sheathed Cold-Formed Steel Framed In-line Wall Systems. II: Impact of Nonstructural Detailing

Journal of Structural Engineering, 148(12)

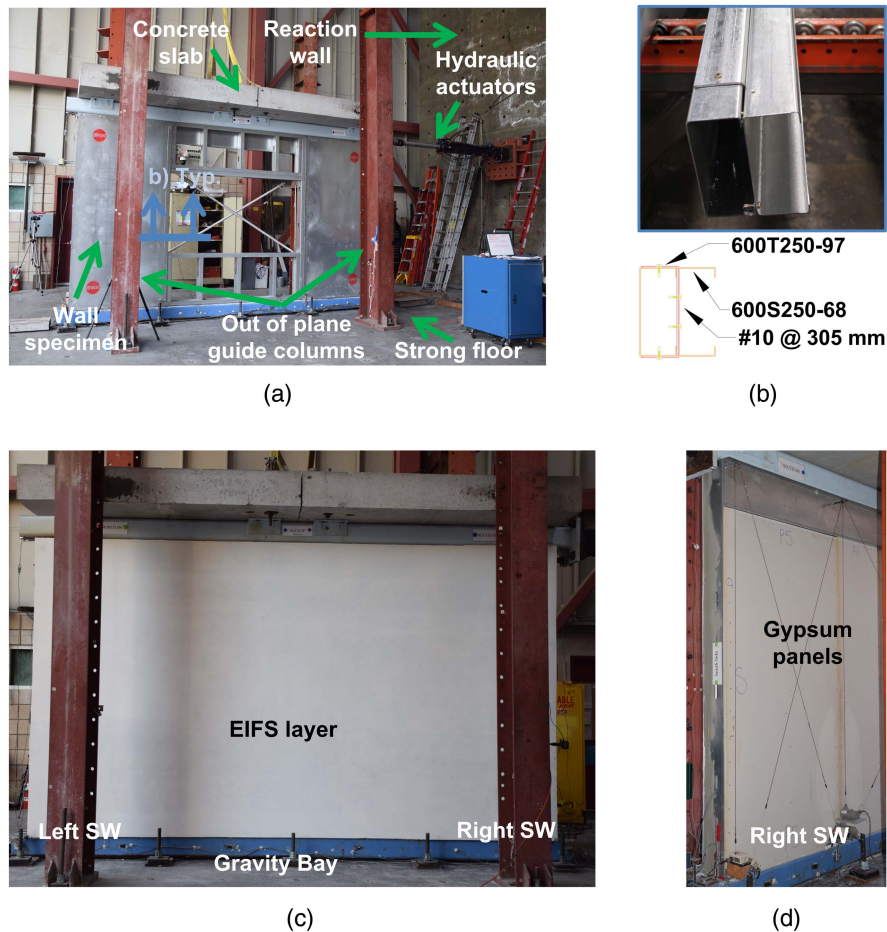
Fig. 1. (a) Specimen SWWS-2 as installed in test setup; (b) jamb stud built-up section used around window opening; (c) front view of exterior face of Specimen SGG-2F; and (d) isometric view of interior face of Specimen SGG-2F.

To support the force transfer around window openings, the jamb studs, sill and header tracks were sized per design codes AISI S240 (AISI 2015a) and AISI S100 (AISI 2016). A window opening

2.18-m (7-ft 2-in.) wide and 1.22-m (4-ft) tall with a sill height 0.76-m (2-ft 6-in.) was installed within the middle 2.44-m (8-ft) bay. This opening would occupy the same space as the gravity bay in the baseline specimen, and hence would similarly have one 1.22-m (4-ft) shear wall segment at each end. Jamb studs were built-up members that utilized 600S250-68 stud and 600T250-97 track members as shown in Figs. 1(a and b). Similarly, the header track was also a built-up member using the same framing members, and the sill track used a single 600T250-97 track member, and the cripple region utilized 600S250-68 studs. Similar components were used for the fabrication of all other wall specimens. Both Type I (SWWS-1) and Type II (SWWS-2) wall-line assemblies with window openings were considered in the test program. One specimen with both a window opening and finish application, SWWS-2F, was also included in the test matrix.

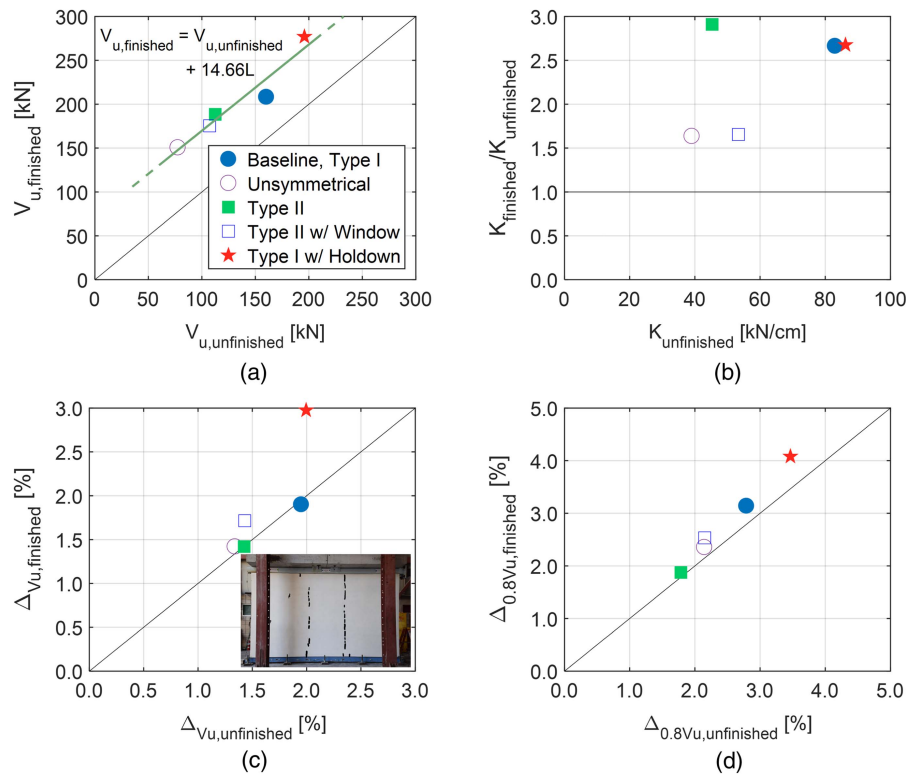
Fig. 4. Effect of finish application on key parameters: (a) lateral strength; (b) elastic stiffness; (c) drift at strength with Specimen SGGS-2F EIFS layer surface damage at strength; and (d) drift at 80% strength postpeak.

the aforementioned conclusions across all considered variables. Finally, a summary of key response measurements is provided in Table 2 with a visualization of these parameters provided in Fig. 4. Using a single additive strength model [Eq. (1)] and linear regression, it was measured that the finish application added 14.66 kN/m (1,005 lb/ft) to wall lateral strength

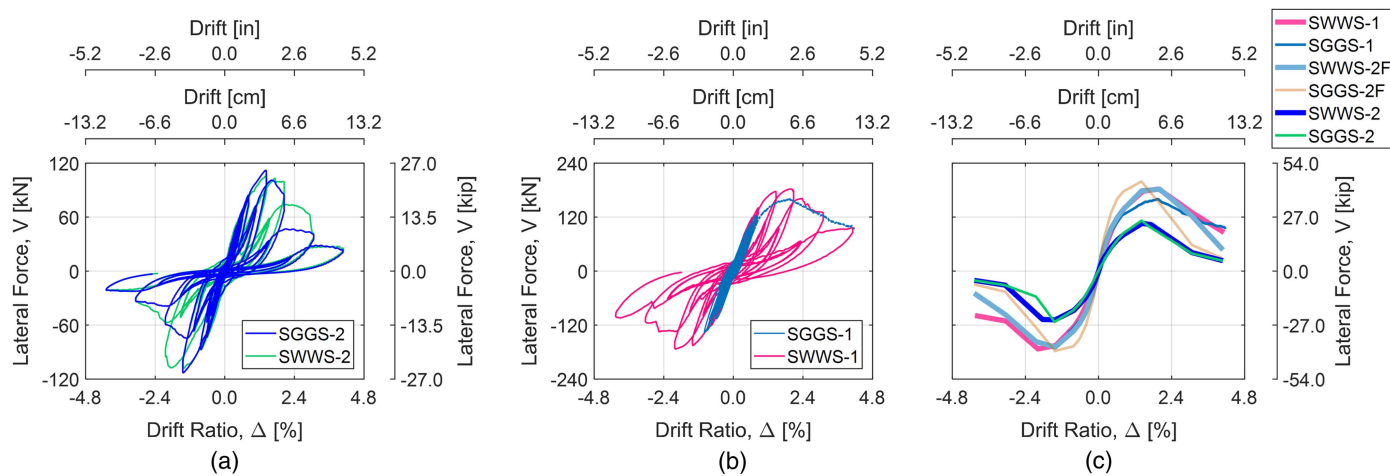
Fig. 9. Effect of window opening: force-displacement response for (a) Type II specimen pair; (b) Type I specimen pair; and (c) backbone curve comparison for Type I and Type II specimens.

referred to as a gravity bay. Fig. 9(a) shows a force-displacement response comparison between wall Specimens SGGS-2 and SWWS-2, and Table 3 summarizes key response measurements of the tested specimen pairs. From the figure, it can be seen that the presence of an opening did not have a significant impact on the global hysteresis response. Moreover, the lateral strengths for the two specimens were within 10% of each other. Additional specimen pairs

shown in Fig. 9(c) comparing the backbones of varying window-no-window wall pairs consistently showed that the lateral strengths are within 10% of each other. In general, there was little to no impact on lateral strength, drift at strength, and elastic stiffness due to the presence of a window opening.

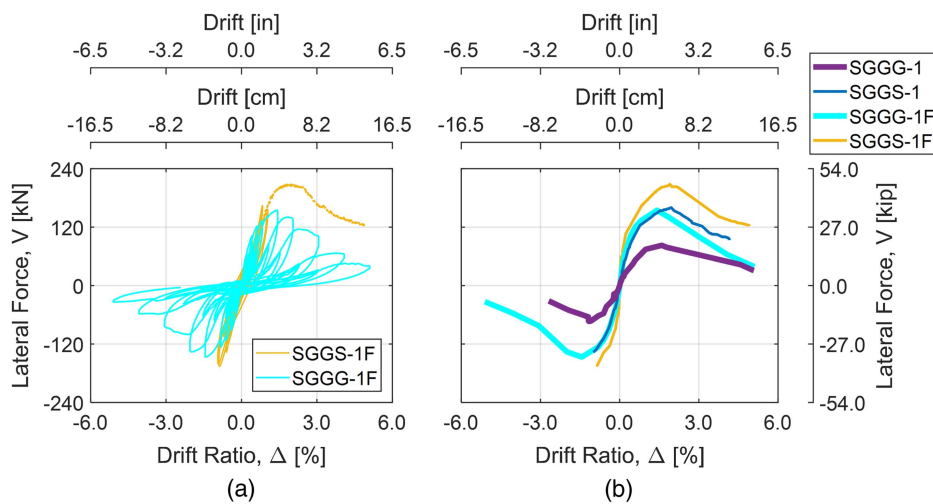
Fig. 12. Effect of asymmetric shear wall location: (a) force-displacement response; and (b) backbone curve comparison.

Two wall configurations included shear wall segments laid out in an asymmetric fashion. These walls had a 1.22-m long shear segment in-line with a 3.66-m long gravity bay. As a result, a direct comparison between walls with asymmetrical or symmetrical shear wall locations was possible. Fig. 12 shows the force-displacement response comparison between wall Specimens SGGS-1F and SGGG-1F, and Table 4 summarizes key response measurements. Results show that the asymmetric specimen reported lower lateral strength compared with the symmetrical specimen. Fig. 12 also shows the backbone comparisons of the two pairs of asymmetrical and symmetrical wall configurations (total of four specimen backbone curves).

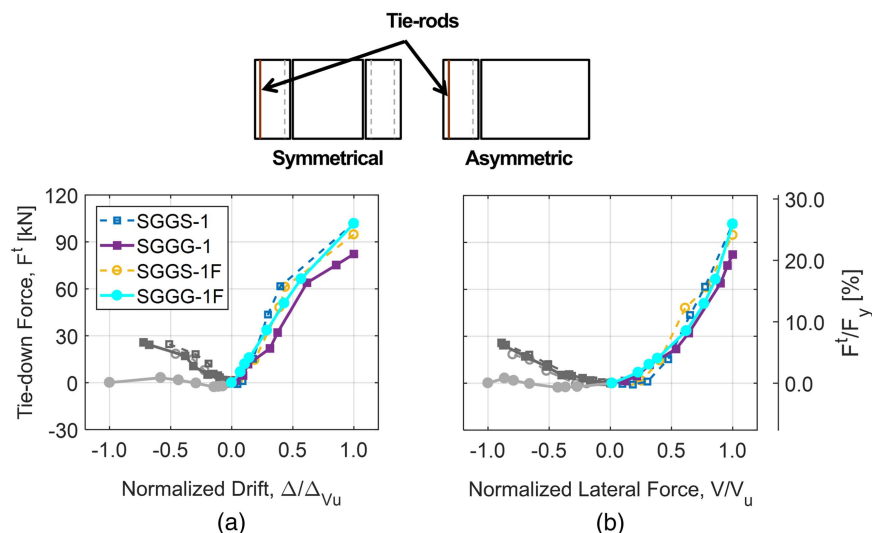
Fig. 14. Effect of asymmetric shear wall location on tension-rod forces with increase in (a) normalized drift; and (b) normalized lateral force.

Fig. 14 shows a comparison of the tension tie-rod force for the two pairs of asymmetrical and symmetrical wall specimens with increasing normalized lateral force and drift. At similar lateral force, the tension rods in the asymmetrical walls were subjected to larger axial forces compared with their symmetrical counterparts. However, when normalized by the individual specimen strengths, the tension rod forces were similar for the two pairs. Tension tie-rod force evolution was also similar for the two pairs when normalized for lateral drift. Due to their increased stiffness, the symmetrical walls experienced larger lateral force compared with the asymmetrical walls at similar lateral drift amplitudes, which resulted in larger axial forces in the tension tie-rods. Consistent with tension tie-rod forces, normalizing for individual specimen strengths or drift at strength, the evolution of wall uplift and panel shear distortion for the two pairs is quite similar. Figures showing the evolution of wall uplift and panel shear distortion with increase in lateral force and drift are not shown here for brevity.

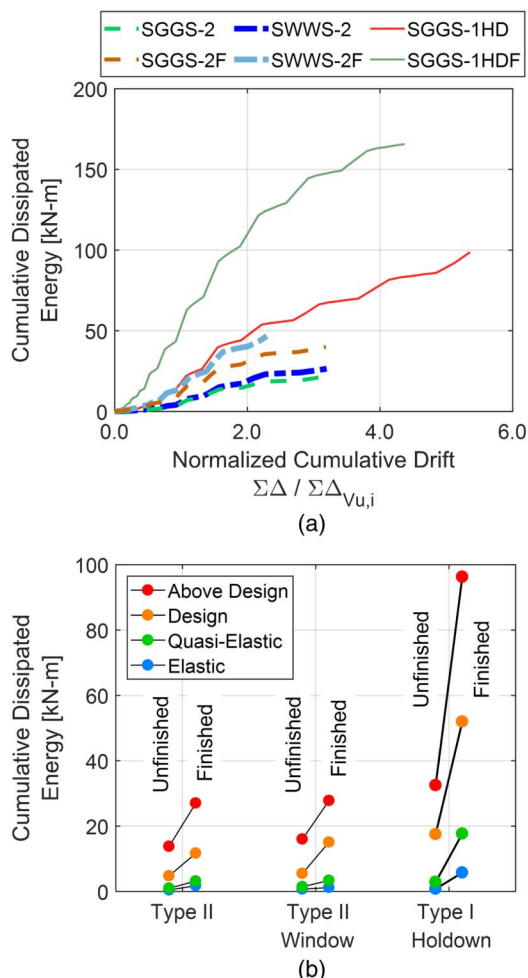
Fig. 15. (a and b) Cumulative dissipated energy comparison for select specimens from quasi-static test phase.

Because the specimens in the quasi-static test phase were subjected to the same loading protocol, the energy dissipation can be readily cross-compared at the different performance levels. Performance levels of interest are those defined for the shake table test phase, namely elastic, quasi-elastic, design, and above-design levels. These performance levels were defined according to the normalized lateral force and drift response of the individual specimens (Singh et al. 2021b). Dissipated energy is calculated as the area enclosed within the hysteresis of the force-displacement response and plotted against the cumulative drift of the specimen (Singh and Hutchinson 2022). Fig. 15(a) shows the comparison of cumulative energy dissipation with respect to cumulative drift ratio, $\Sigma\Delta$, normalized by the average cumulative drift ratio at strength in the two directions, $\Sigma\Delta_{Vu}$, for select specimens from the quasi-static test phase. These results are further synthesized by performance level and aggregated based on their common specimen variable in Fig. 15(b).

These figures show that wall configurations with finish application were consistently capable of dissipating about two to three times more energy compared with their unfinished counterparts. Only at larger drift cycles ($\Delta > 3.2\%$) did the dissipated energy from finished specimens become similar to that of their like unfinished specimens. This is indicated by the traces becoming parallel at larger
