Late-Onset Infection in a Leadless Pacemaker

CASE REPORT: CLINICAL CASE

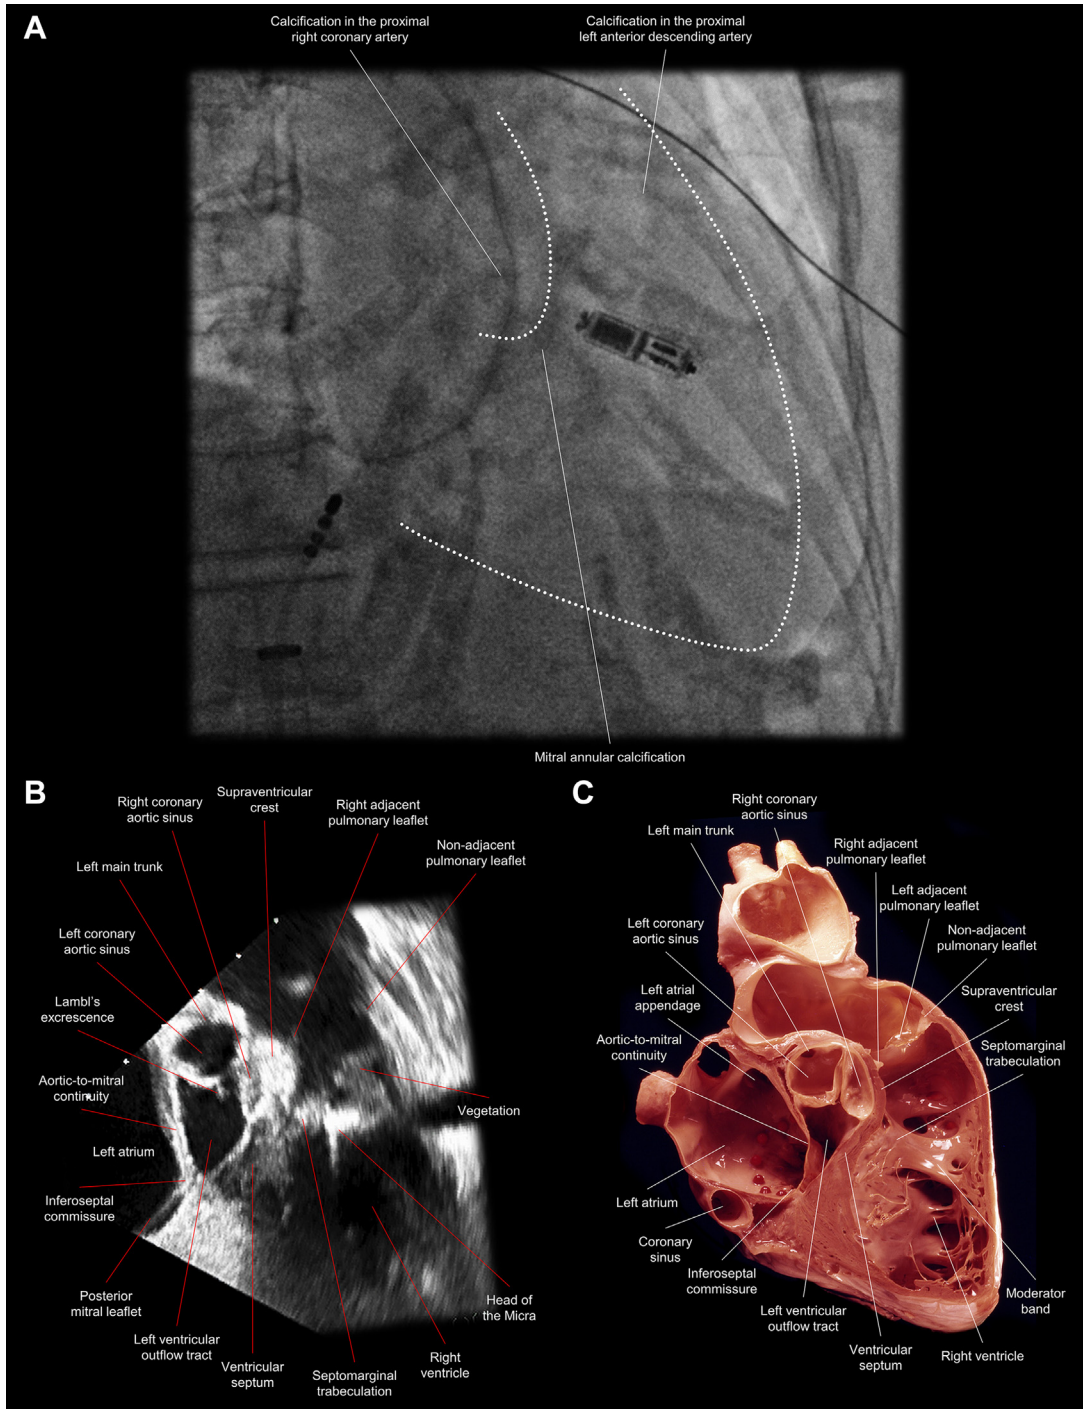
FIGURE 1 Comparative Images Showing the Anatomic Location of the Leadless Pacemaker and a Large Vegetation Attached to It

(A) A right anterior oblique fluoroscopic view shows that the leadless pacemaker was implanted along the septomarginal trabeculation, at the base of the moderator band; white dots delineate the right ventricle and pulmonary root. **(B)** A transesophageal echocardiographic view of the corresponding sectional plane shows a large vegetation (1.4 × 0.8 cm) attached to the mid to distal part of the leadless pacemaker and extending toward the pulmonary valve. **(C)** An anatomic image shows the corresponding sagittal plane of the right ventricular outflow tract. (Illustration courtesy of UCLA Cardiac Arrhythmia Center, Wallace A. McAlpine MD Collection.)

An interesting observation in our case is that, compared with previous ECGs, the patient's ECG following device infection showed possible right bundle branch (RBB) injury (Figure 2). Considering that the LPM had been implanted adjacent to the moderator band (Figure 1, Videos 2 and 3),

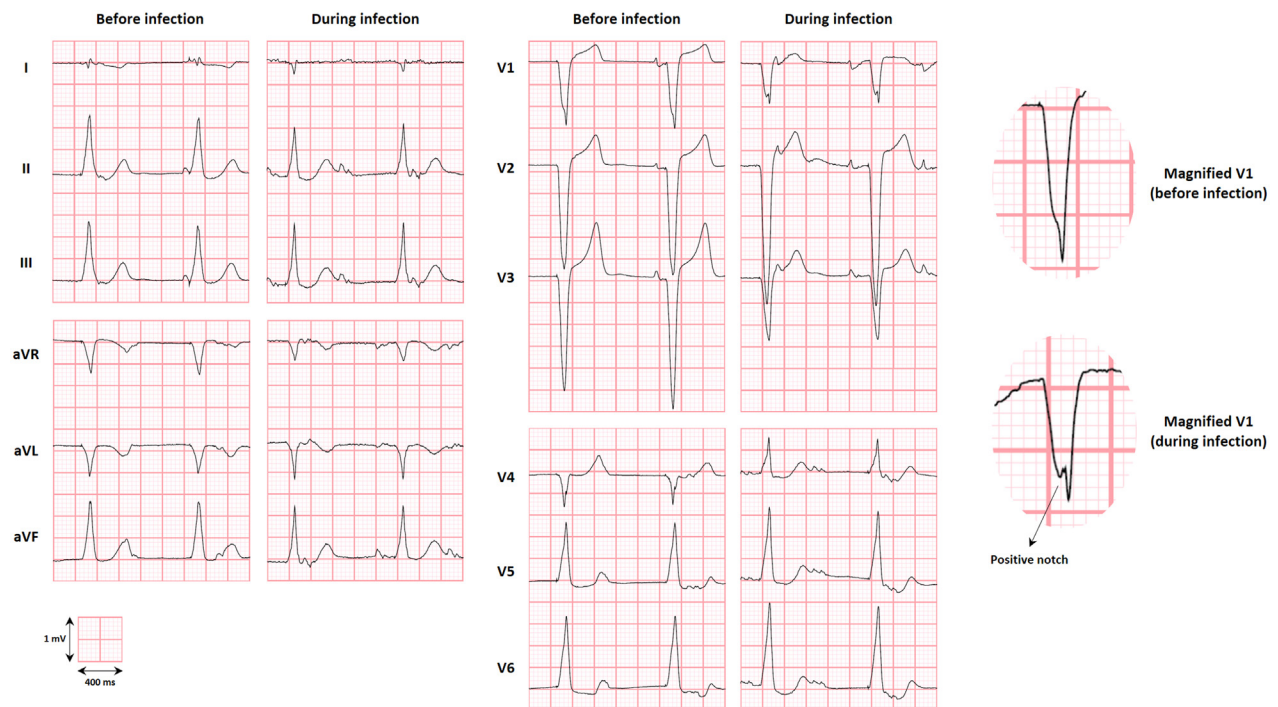
FIGURE 2 The 12-Lead Electrocardiogram Before and After Leadless Pacemaker Infection, Suggesting Right Bundle Branch Injury

Although the change is minor, the appearance of a positive notch within the QRS complex of V₁, indicative of a delay in right ventricular depolarization, may be caused by an infectious involvement of the right bundle branch in the setting of right ventricular septal pacing near the base of the moderator band. An alternative explanation for the notch would be that it represents a myocardial scar or anisotropic conduction in the setting of chronic or acute hemodynamic shifts, given that the V₁ voltage dropped from 14 mV to 10 mV and the P-wave developed a deeper negative deflection suggestive of a P-mitral pattern. The electrocardiograms were recorded 9 months apart and, for the low- and high-pass filters, were set at 150 Hz and 0.05 Hz, respectively. Of note, the shift in precordial transition (V₅ preinfection vs V₄ during infection) seems to reflect only changes in the position of the leads, as this shift was not consistent across serial electrocardiograms.

which contains the RBB, it is possible that the RBB was damaged because of contiguous infection of the ventricular tissue in contact with the device.
