Home Survival in Wildfire-Prone Areas: Building Materials and Design Considerations

**STEPHEN L. QUARLES**, UCCE Natural Resources Advisor, Contra Costa County; **YANA VALACHOVIC**, UCCE Forest Advisor, Humboldt County; **GARY M. NAKAMURA**, UCCE Area Forestry Specialist, Shasta County; **GLENN A. NADER**, UCCE Natural Resources Advisor, Sutter-Yuba Counties; and **MICHAEL J. DE LASAUX**, Natural Resources Advisor, Plumas-Sierra County

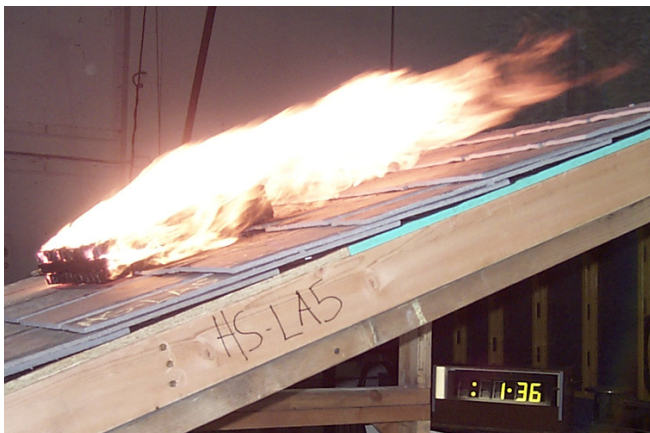
**Figure 2.** A burning *Class A brand* is positioned on a roof covering, constructed according to ASTM E-108. The *Class A brand* is a three-layer sandwich construction assembled using  $\frac{3}{4}$ -inch square sticks, each 12 inches long, made of Douglas fir. The brand is ignited prior to placement on the roof and it is used to produce a standard amount of heat to the roof. Photo: Stephen L. Quarles.

potential of the roof covering. If flame spread is too large, or if fire penetrates through the roof covering and underlying construction materials, the covering cannot be considered Class A. Shown in figures 2, 3, and 4 are a burning *Class A brand*, a *burn through* (i.e., failure), and a gypsum-fiberglass material used in a Class A roof assembly.

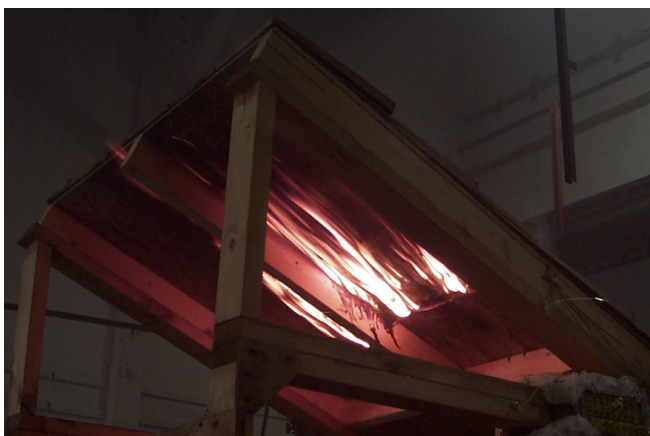
**Figure 3.** Demonstration of a flame-through (burn-through), passing from the roof covering to the underside of the roof deck. As constructed, this is not a Class A roof covering because it allowed flame penetration when subjected to a *Class A* burning brand. Photo: Stephen L. Quarles.

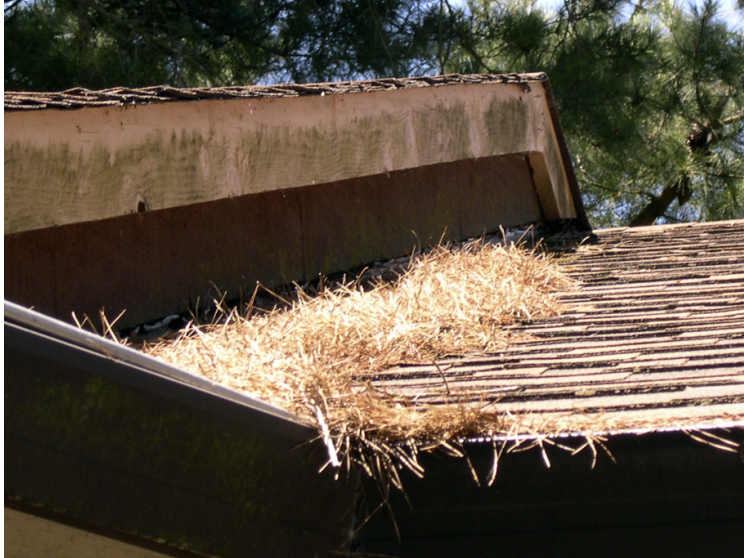
**Figure 5.** Vegetative debris accumulated at this roof-to-wall intersection. Ignition of this debris would expose the adjacent siding to flames, as well as the underlying sheathing above this stand-alone Class A roof covering. Depending on the overall roof design, the Class A roof covering could give the homeowner a false sense of security. *Photo:* Stephen L. Quarles.

A complex roof provides an additional level of vulnerability. The term *complex* indicates that there are a number of horizontal-to-vertical intersections on the roof that could make a Class A roof more vulnerable to wildfire, and in particular to an ember exposure. From a fire performance perspective, these intersections provide collection points for windblown debris (e.g., pine needles and other vegetation), debris from overhanging trees, and—during a wildfire—windblown embers. These locations are also where different construction materials with different fire vulnerabilities will be present on the respective surfaces. If ignited, the flames from the burning vegetative debris would provide a flame contact exposure on the siding material, the roof sheathing or soffit material, or even a window. The vulnerability of these components will depend on material selection and other design considerations. Particularly with a Class A roof, it will be the fire resistance of the siding, sheathing, or window that will determine the vulnerability of the complex roof, not the roof covering itself. Examples of two complex roof features that can increase the vulnerability of a complex roof are given in [figures 5 and 6](#).

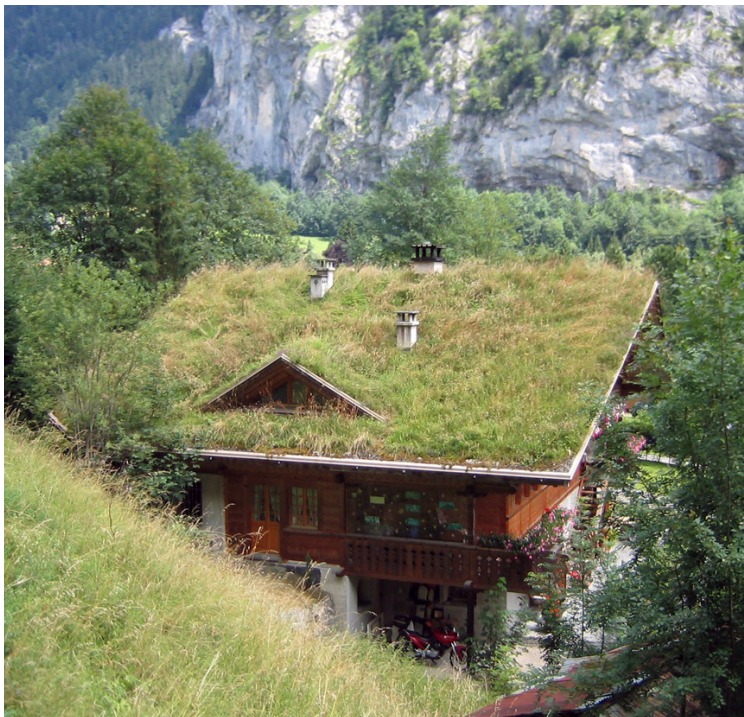
**Figure 6.** This vegetative (green) roof covering provides Class A protection in terms of fire penetration into the attic or living space, but ember ignition and subsequent flame spread and contact with the dormer and window shown in this photograph could result in the glass breaking and fire entering the building. *Photo:* Bernard Harrison.

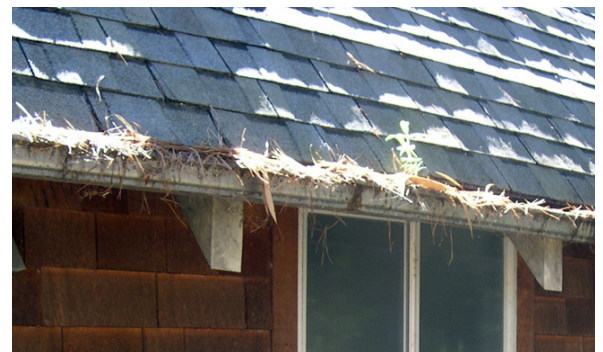
**Figure 7.** Note the heavy needle accumulation in this metal gutter. If ignited by embers, flames would impinge on the roof edge, potentially igniting the roof sheathing. Because of the open eave construction (i.e., exposed rafters), the fire would not immediately enter the attic or cathedral ceiling space. If ignited, the wood shingle siding and plywood skirting also shown in this photograph would threaten the home via a flame contact exposure to the single-pane window and the under-eave area. The ignited shingle siding could also burn into the stud cavity and into the living space of the home. *Photo: Stephen L. Quarles.*

When ignited by embers, the burning debris in the gutter will provide a flame contact exposure to the edge of the roof (fig. 7). The protection provided by the roof edge must be sufficient to resist the entry of flames into the attic space or cathedral ceiling. The roof edge must also protect against the ignition of the exposed roof sheathing or the exposed fascia board. The exposure is more severe if metal angle flashing is not used at the roof edge and if the gutter is hung below the roof edge, leaving the roof sheathing exposed.

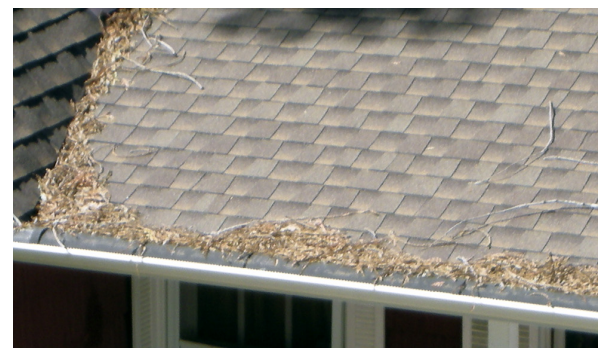
**Figure 8.** Debris accumulation behind a gutter cover device. The gutter is clear of debris, but the roof still should be cleared of debris. Photo: Stephen L. Quarles.

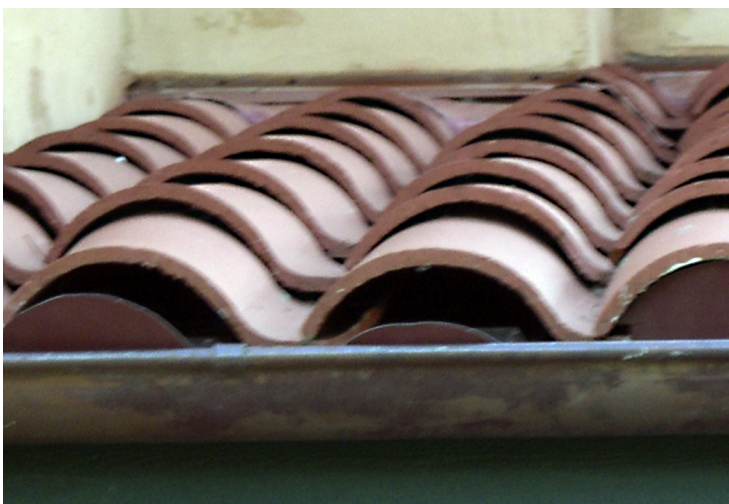
**Figure 9.** Two of the three visible bird stops shown in this clay barrel tile roof covering have been improperly installed or have become detached. Inspection of these should be part of a regular (annual) inspection and repair plan. *Photo:* Stephen L. Quarles.

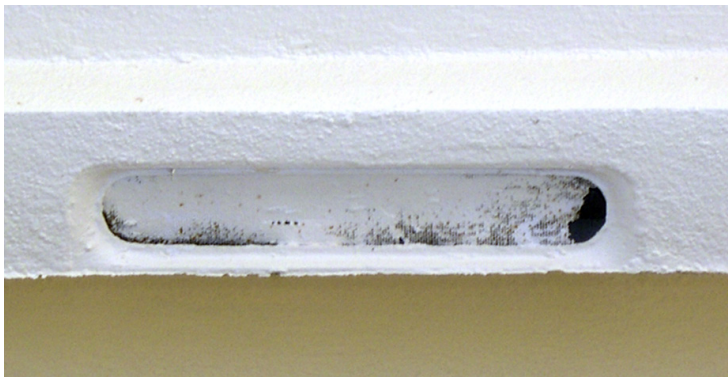
**Figure 10.** Paint easily bridged the gaps in this  $\frac{1}{16}$ -inch mesh screen, reducing the effectiveness of this vent to allow air flow. Note that the screen has become detached from the substrate on the right-hand side. Embers could easily enter through this gap. *Photo:* Stephen L. Quarles.

airborne debris or painted over (fig. 10), thereby compromising the vent's moisture management function; however, somewhat finer mesh screening may eventually be allowed by the building code. Even though finer mesh screening uses wire with a smaller diameter, the total amount of void space (no wire) is reduced when finer mesh screen is used. For example, assume you have a vent opening that is 1 foot on a side (the area would be 1 square foot). Placing  $\frac{1}{4}$ -inch,  $\frac{1}{8}$ -inch, and  $\frac{1}{16}$ -inch mesh over this opening would reduce the void space by 19 percent, 25 percent, and 29 percent, respectively. With finer mesh screening, a building official may require more vents to obtain the required amount of venting. (For equivalents between U.S. and metric systems of measurement, a conversion table is provided at the end of this publication.)

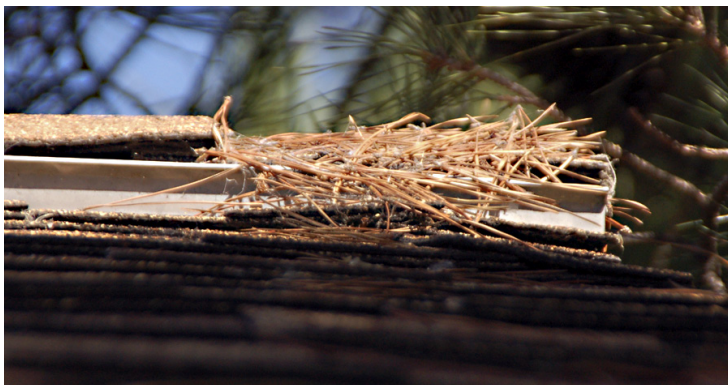
**Figure 11.** Accumulation of pine needles at the entrance to a ridge vent. *Photo:* Stephen L. Quarles.

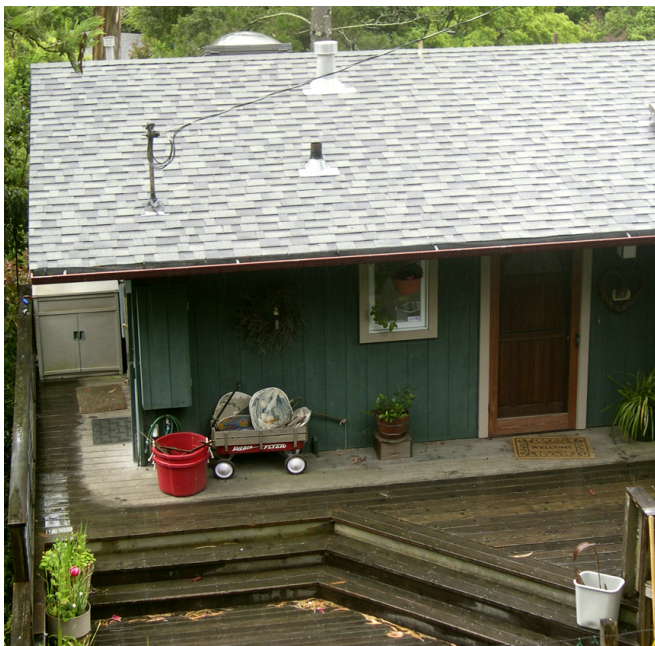
**Figure 12.** The wide overhang on this home protects the exterior wall from rain. Since many water-related problems in buildings can be traced to leaks at penetrations in the exterior wall (e.g., at windows and doors), limiting exposure would reduce the occurrence of water-related problems. Photo: Stephen L. Quarles.

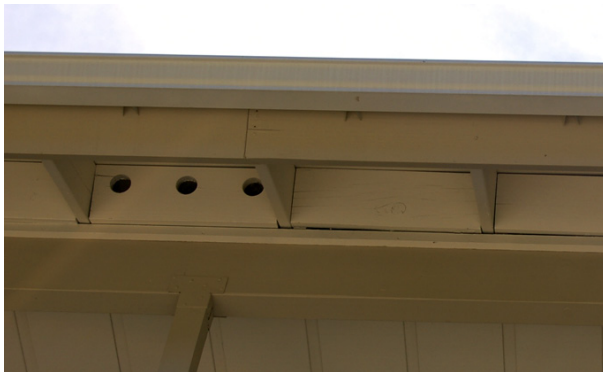
**Figure 13.** An example of open-eave construction. The roof rafter tails are exposed. The circular frieze-block vents shown here are typically located in the blocking. Note the gaps between the blocking and adjacent framing which would allow ember entry. These gaps could be caulked. Backer rod may be needed for wider gaps. The caulked joints should be inspected annually and failed joints repaired. *Photo:* Stephen L. Quarles.

Two basic types of construction exist for the eave. The first is an open eave design where the roof rafters extend beyond the exterior wall and are visible (fig. 13). Blocking is used to fill the space between the top of the exterior wall and the roof sheathing. If present, vent openings would

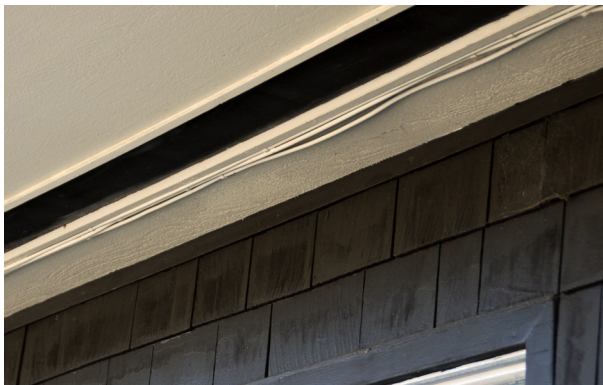
**Figure 14.** An example of a soffited eave, also sometimes called a *boxed-in* eave. Depending on the vulnerability of the vent, embers could enter into the soffit area. Vertical flame spread up the wall would make flame entry through the vent and into the attic more likely. Moving the vent away from the wall (closer to the edge of the roof) would make flame and ember entry less likely. *Photo:* Stephen L. Quarles.

be cut into the blocking. The second is a soffited construction where the eave is enclosed (fig. 14). This type of construction is also called a *boxed-in* eave, although boxed-in is sometimes reserved for situations where an open-eave design is enclosed, following the slope of the exposed rafters. The vulnerability of an unvented open eave or soffited eave construction will depend on the material and joints. Joints that exist between different pieces of building material are particularly vulnerable in combustible soffit material, and they will usually be the location where the fire would enter. For example, the initial failure in a tongue and groove (T&G) soffit material will either be at the T&G joint or at a knot. A knot or internal void in a plywood soffit material would be the likely failure location (Jennings 2000). Joints would also be the most likely failure location in a noncombustible material.

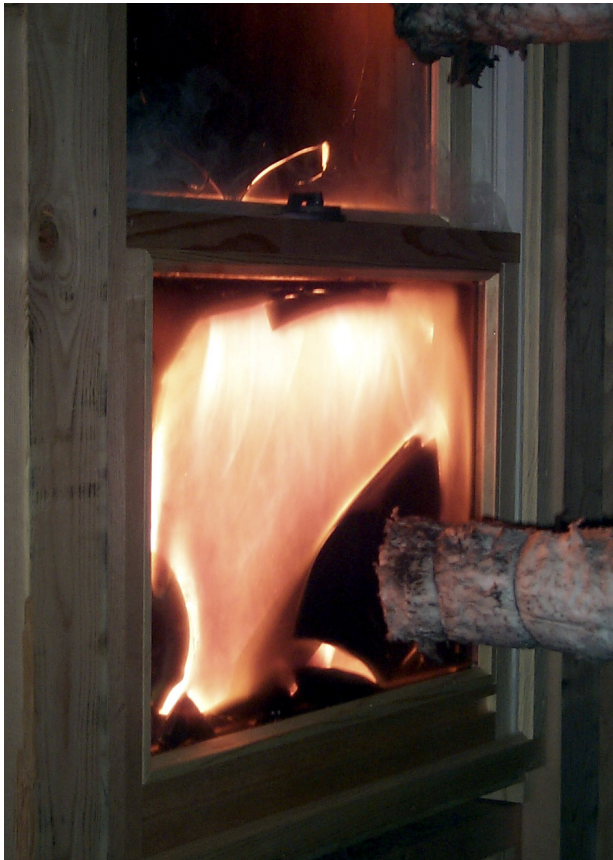
**Figure 16.** The flame contact exposure during laboratory testing of this wood-frame, dual-pane window resulted in glass breakage. The relatively large pieces of glass that remain indicate that annealed glass was used. *Photo: Stephen L. Quarles.*

There has been conflicting information regarding the relative importance of glass versus frame material when windows are subjected to wildfire exposures (fig. 16). For example, some builder's and homeowner's guides (e.g., Slack 2000; FEMA 2008) do not recommend using vinyl- and wood-framed windows. This recommendation, in part, comes from research by Mowrer (1998), where he reported that certain vinyl-framed windows deform under radiant exposures much lower than that required to break the glass. The window fails when the deformed frame allows the glass unit to fall out completely or allows a gap to develop between glass and frame. This problem can occur with windows that have horizontal or vertical separators in the middle of the window (i.e., a single- or double-hung window or a slider window). Research has shown that as long as

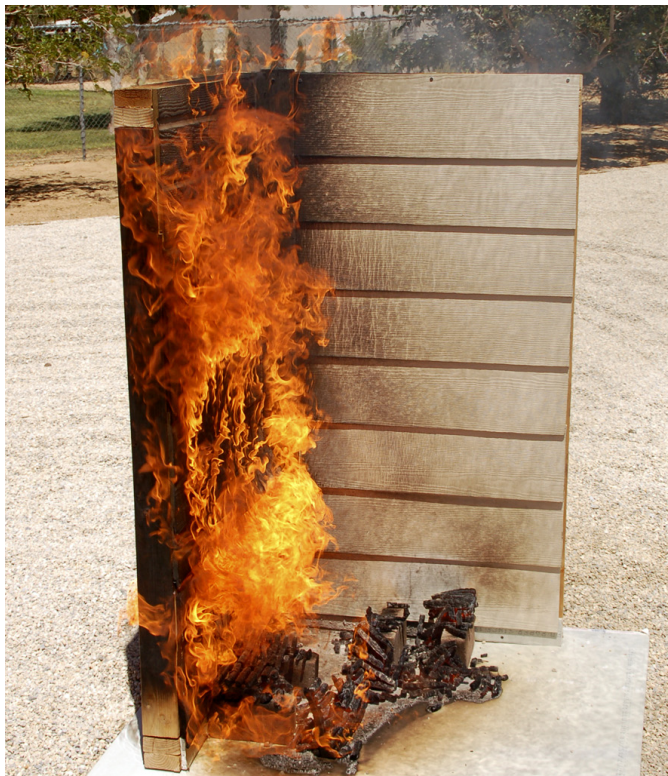
**Figure 17.** This corner section was constructed with a wood-composite siding material (left side) and a noncombustible fiber cement product (right side). The ignition source for both was a burning brand. The wood-composite siding product was ignited by the ignition source, and the fire then spread up the wall. Flames from the fire would have impinged on windows and eave, if they had been present. The wood brand burned out at the base of the fiber cement siding product without causing significant damage. *Photo:* Stephen L. Quarles.

Testing at the University of California Fire Research Laboratory has shown that, when ignited, compressed wood particle or fiber siding products (see fig. 17) and wood shingle siding will result in more rapid vertical flame spread up the wall, and more rapid penetration through the lap joints and into the stud cavity. Similar results have been observed with vinyl siding. In both of these cases, underlying wood or gypsum sheathing would improve the resistance to flame penetration at a lap joint.

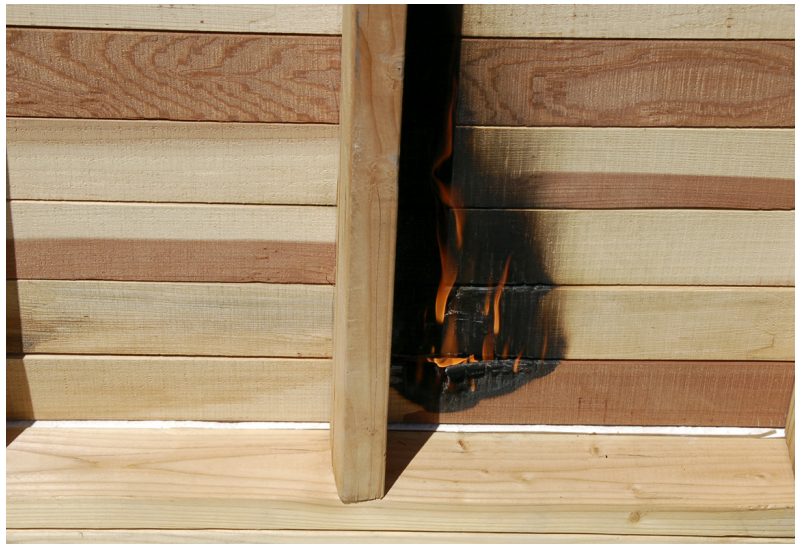
**Figure 18.** Flame penetration (*burn through*) at the rabbeted bevel lap joint in a solid wood siding product, as viewed from the stud cavity side of the wall. This test was conducted at the UC Fire Research Laboratory. Although a panelized sheathing product is commonly used in construction, it was not used in this test in order to allow viewing of the siding performance. Use of sheathing has been shown to increase the time needed for fire to penetrate into the stud cavity, sometimes to the point of excluding entry altogether. *Photo: Stephen L. Quarles.*
