A Comparative Analysis of Pedestrian and Bicyclist Safety Around University Campuses

University of California Transportation Center
UCTC-FR-2014-03

March 2014

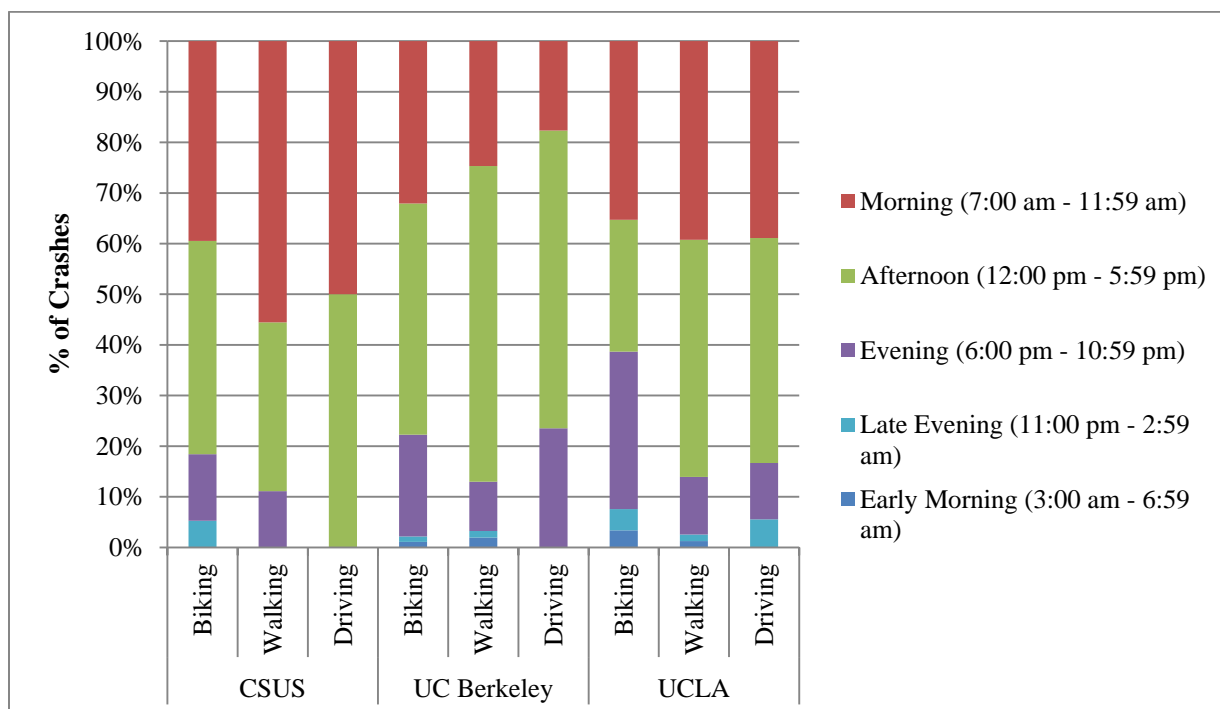
Figure 3.3 Time of Day of Crashes for All Modes and All Three Campuses

Figure 3.3 shows the reported times of day of crashes on the three campuses and by the three modes of travel. Similarly, the majority of crashes occurred in the morning and afternoon. On the CSUS campus, a higher percentage of crashes by the three modes occurred during the morning hours. At UC Berkeley, most crashes occurred in the afternoon. Almost a third (31.1%) of bicycling crashes on the UCLA campus occurred during the evening hours; the highest percentage during this time for any of the modes on the three campuses.

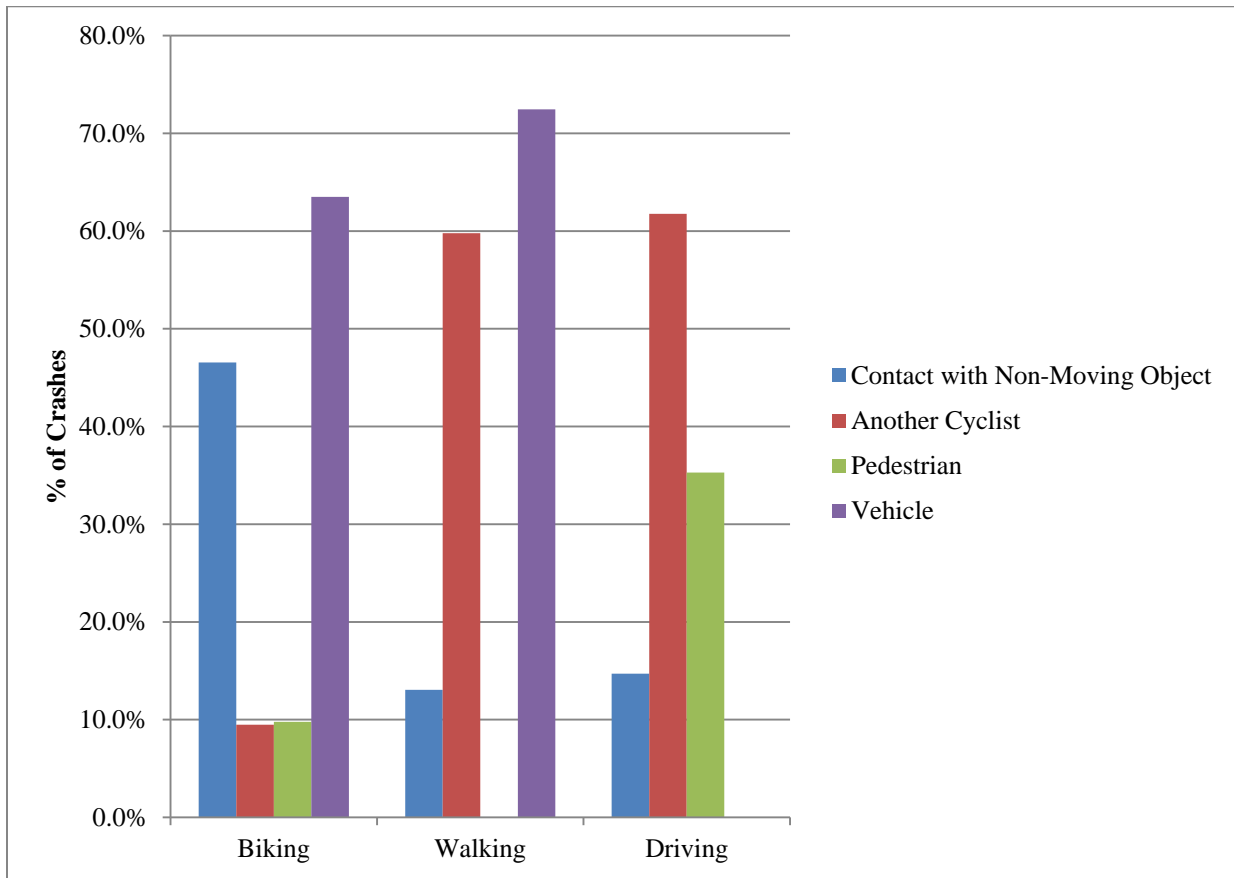
Figure 3.5 Contact Made during Crashes for All Three Modes at All Three Campuses

The sites of most collisions of pedestrians or bicyclists with autos on and around the three campuses were intersections (47.4% for UCLA, 29.4% for UC Berkeley, and the two reported crashes with autos at CSUS). In the case of the two CSUS crashes, both occurred at signalized intersections. This type of site was also the most common for crashes involving pedestrians or bicyclists and autos at UCLA (36.8%) and UC Berkeley (17.6%). Roadways were also common sites for crashes involving vehicles on and around the UC Berkeley (35.3%) and UCLA (31.6%) campuses. (See Figure 3.5.)

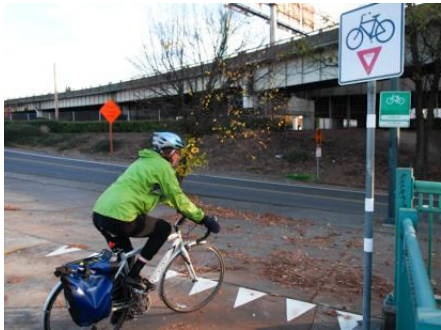
Figure 6.3 Yield Marking and Signage Connecting Two Bicycle Grade-Separated Paths in Portland
(Source: <http://bikeportland.org/2008/11/24/new-markings-meant-to-tame-bike-traffic-11270>)

Oregon. Additionally, pavement markings on the ramp encouraging bicyclists to slow and yield along with bicycle yield signs should be utilized, as shown in Figure 6.3.

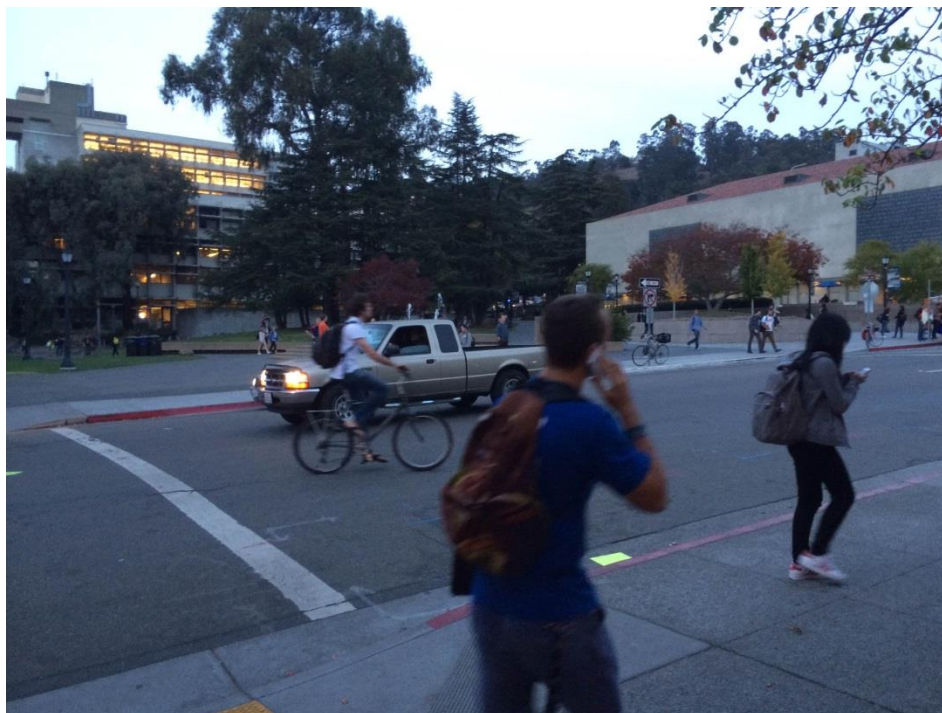
Figure 6.20 Cyclist Traveling Against the Flow of Traffic to Access College Avenue
