EUV mask surface cleaning effects on lithography process performance

Simi A. George<sup>a)</sup>, Lorie Mae Baclea-an and Patrick P. Naulleau

Center for X-ray Optics, Lawrence Berkeley National Laboratory, 1 Cyclotron Road, Berkeley, CA, 94720

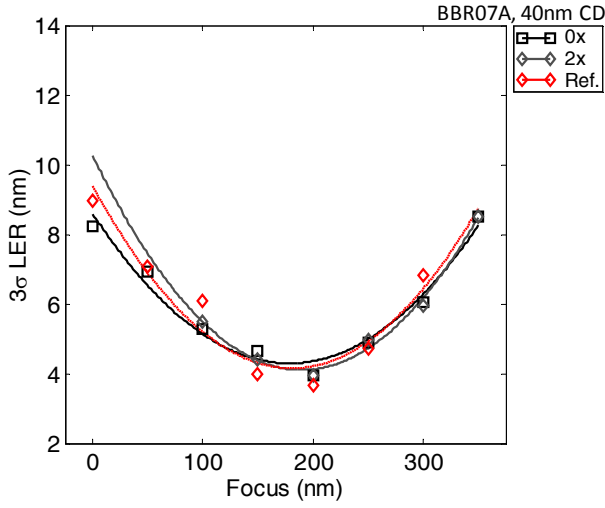
**Figure 2:** Iso-focal CD matched LER curves for all three cases at, A) 40nm and B) 36nm CD. The averaged,  $3\sigma$  LER for all cases is near 4.8nm in the best dose and focus region of the process, with the variations shown to be less than the uncertainty computed to be near  $\pm 0.4$ nm.

The averaged,  $3\sigma$  LER can also be found in table 4, where it is seen that the characterized variations in all cases are well below the measurement and calculation uncertainty of  $\pm 0.40\text{nm}$ . Figure 2 shows the iso-focal CD matched LER curves for all three cases at 40nm and 36nm CD. Not much variation is seen through focus, when comparing the three curves in both plots. In comparing all these metrics, we can safely assume that having gone through two cleans did not impact mask surface or patterns enough to cause process changes.

**Figure 2:** Iso-focal CD matched LER curves for all three cases at, A) 40nm and B) 36nm CD. The averaged,  $3\sigma$  LER for all cases is near 4.8nm in the best dose and focus region of the process, with the variations shown to be less than the uncertainty computed to be near  $\pm 0.4\text{nm}$ .

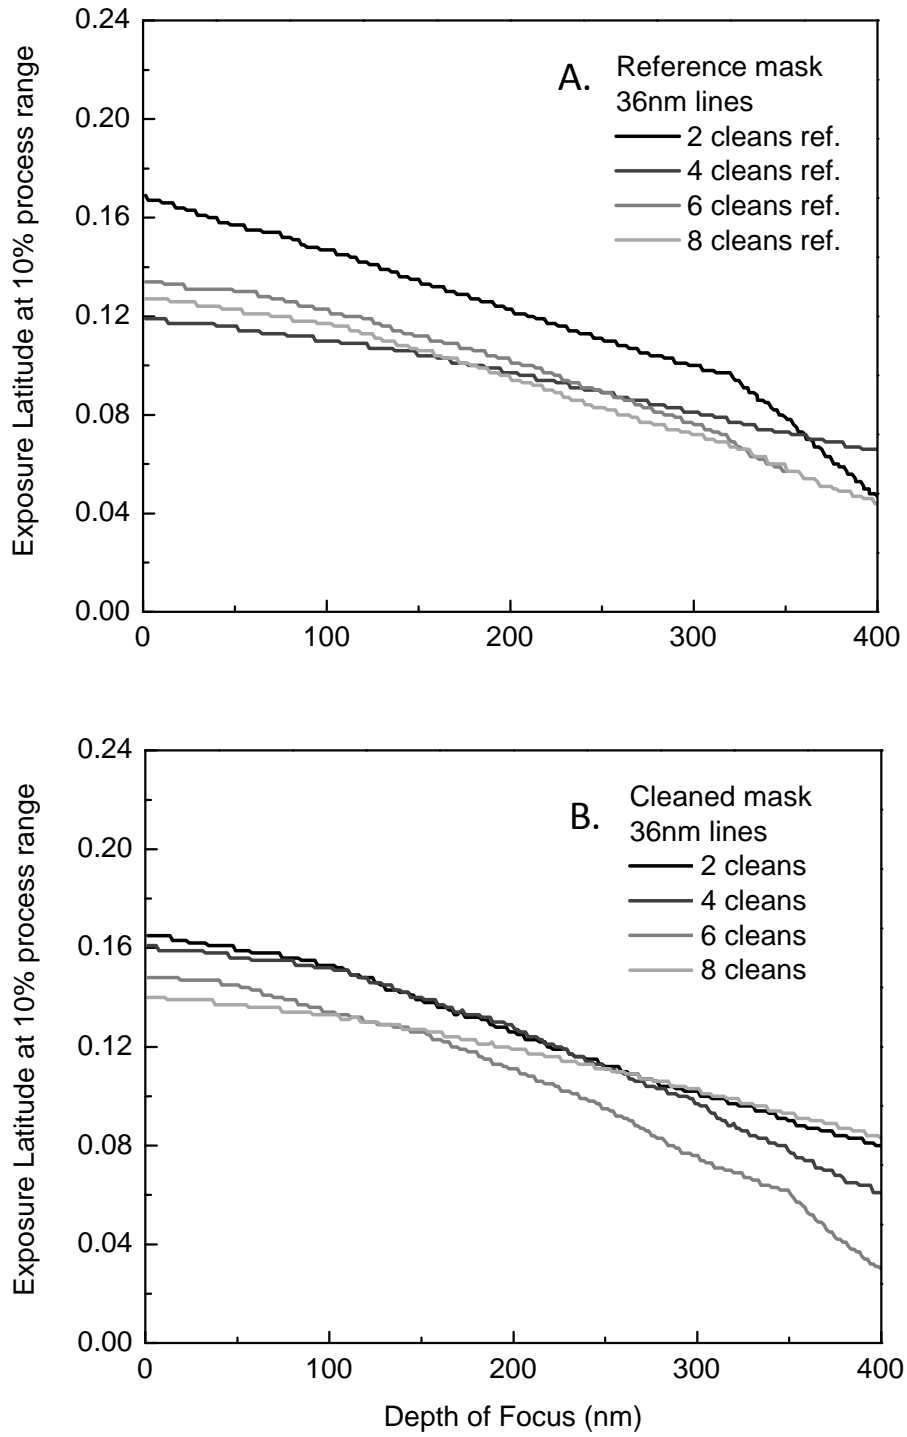
**Figure 4:** Compiled EL vs. DOF at the set cleaning intervals of the (A) test mask and the corresponding (B) reference mask data for the 36nm patterns. All data is similar to the larger pattern widths analyzed.
