A study of defects on EUV mask using blank inspection, patterned mask inspection, and wafer inspection

# A study of defects on EUV masks using blank inspection, patterned mask inspection, and wafer inspection

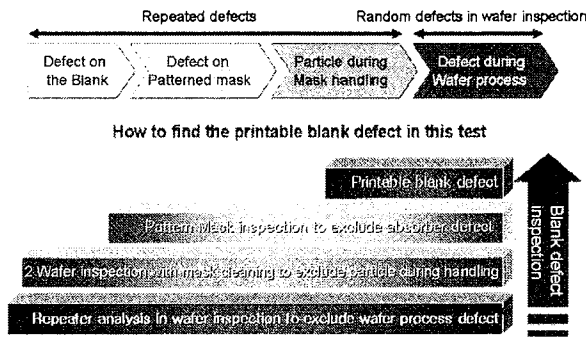
Figure 4. Procedure to identify defects from wafer inspection

- After repeater analysis, any random process defect can be excluded from the results of wafer inspection. Repeated defects include blank defects, pattern defects, and particles.
- Two wafer inspections were conducted. After the first wafer inspection, the mask was shipped back to the mask shop and cleaned to remove the particle from the original site. Overlapping coordinates indicate blank defects and pattern defects. The others are particles added during mask shipping and handling.
- Patterned defects are excluded from the results of the repeater analysis using the information from patterned mask inspection. Finally, a printable blank defect can be obtained without the information from the blank inspection.

inspection. The experimental plan is explained in the Figure 4. After mask fabrication, patterned mask inspection was done to qualify defects on the patterned absorber. After that the mask was shipped from Asia to the USA without using a dual pod. Particles may be added to the mask during mask handling and shipping. These particles cannot be detected by a patterned mask inspection tool. However they will be detected as repeater defects on the wafer inspection tool. At CNSE in Albany, NY, the mask was exposed with the EUV ADT. Then the wafer was inspected with CNSE's KLA 28XX wafer inspection tool to classify printable pattern defects, blank defects, and particles. The mask was then sent back to Asia for cleaning to remove particles from the first ADT exposure. The cleaning removed all the particles, but other particles were added in different locations. One more ADT exposure and wafer inspection was done to exclude the particles on the EUV mask. When the coordinates of the wafer inspection overlap in first and second wafer inspection, they can be considered printable blank or pattern defects. However, when a coordinate does not overlap, it can be classified as a particle, as all particles are removed or added at different locations after mask cleaning. Figure 4 summarizes how to classify defects on the blank and patterned absorber, particles, and process defects. Figure 4 explains the classification procedure, which is outlined in more detail as follows:

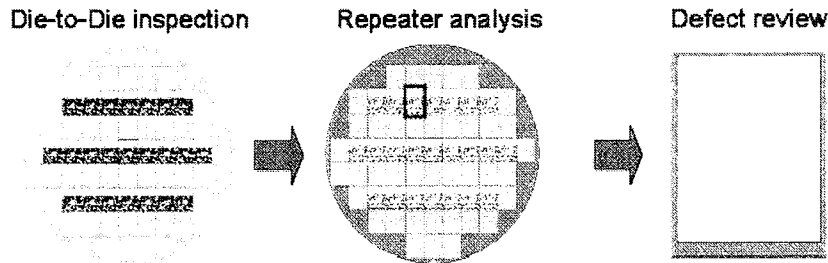
Figure 6. The procedure for wafer inspection and repeater analysis

The wafers were printed using CNSE's EUV ADT with a NA of 0.25 and sigma of 0.5. SERV40, 80nm thick, was used for this test. The 26 die are arranged on the wafer at best dose and focus, which is shown in Figure 6. CNSE's KLA 28XX was used for die-to-die wafer inspection using a developed resist pattern. After repeater analysis, one die was chosen for review to classify the defects.

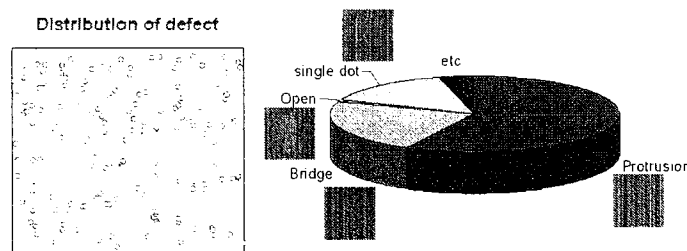
Figure 7. The result of patterned mask inspection

After patterning the absorber, the mask was inspected using a DUV patterned mask inspection tool with a wavelength of 257nm. The tool can inspect part of the inherent blank defects on the substrate and patterned defects generated during patterning of the absorber. Defects were classified as protrusion, bridge, open, single dot, etc. Figure 7 shows the distribution and Pareto chart classifying each defect. Protrusion and bridge types have the highest percentage. The printable/inspectable defects, printable/uninspectable defects, and unprintable defects are classified based on the inspection and defect review.

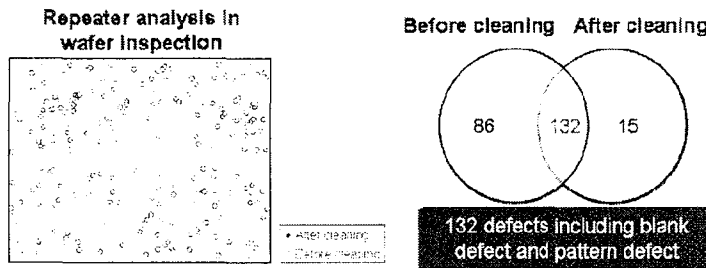
Figure 8. Particles in the repeater analysis to extract defects on the blank and pattern

After repeater analysis, non-repetitive process defects can be excluded from wafer inspection. Two wafer inspections, including mask cleaning, were performed to classify particles added during mask handling and shipping. As a dual pod was not used when the mask was shipped from Asia to the USA, many particles can be added or removed by cleaning. However, when a dual pod is used for this kind of test, fewer particles are added. When the coordinates of the two inspection results are compared, a coordinate that is not overlapped is considered a particle, because all particles can be cleaned or moved to another location. Overlapped coordinates are classified as a printable pattern defect or blank defect. The first and second wafer inspections detected 218 and 147 repeated defects, respectively. Unoverlapped 86 and 15 defects from two repetitive wafer inspections were classified as particles, and 132 defects can be considered blank and patterned defects. This assumption is based on the fact that all particles could be cleaned during mask cleaning. The coordinates of the defects from wafer inspection and patterned mask inspection were compared to determine which patterned defect is detectable by patterned mask inspection. The rest of the defects can be considered printable blank defects, which are detected by wafer inspection tool (see Figure 9). Ninety-five defects were detected by patterned mask inspection, but not by wafer inspection. Fifty-eight defects were detected by both inspection tools. Seventy-four defects were detected by only the wafer inspection tool. Those can be considered printable blank defects. The printable blank defect density was  $0.63 \text{ cm}^{-2}$ .

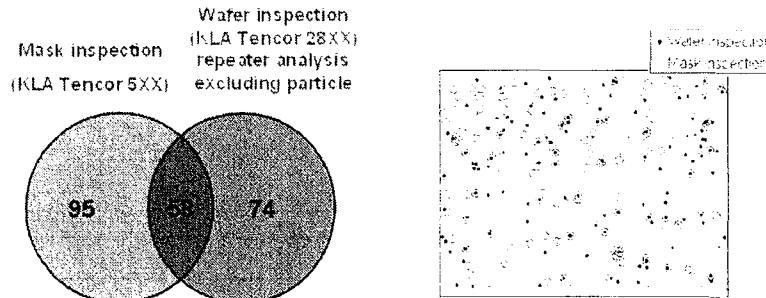
Figure 9. Comparison of patterned mask inspection and wafer inspection

Ninety-five defects, which were detected by only the patterned mask inspection tool, were reviewed by wafer review scanning electron microscopy (SEM) to determine whether they are unprintable on the wafer or undetectable by the wafer inspection tool. Twenty-five defects were printable on the wafer, but not detected by the wafer inspection tool. The other 70 defects were unprintable on the wafer, which is why they could not be detected by the wafer inspection tool. Figure 10 shows the kinds of defects that are more detectable by the wafer inspection tool. Small defects such as protrusions are difficult to detect with the wafer inspection tool, but they can be detected with the patterned mask inspection tool. Large defects or bridge defects are easily detected by both inspection tools. From these results, the patterned mask inspection tool is more sensitive than the wafer inspection tool. We therefore need to find ways to improve the sensitivity of wafer inspection. SEMATECH is focusing on improving sensitivity using the two methods described below. Figure 11 shows some SEM images of the defects from this study.

(a) Comparison of mask inspection and wafer inspection (b) Coordinates of defects

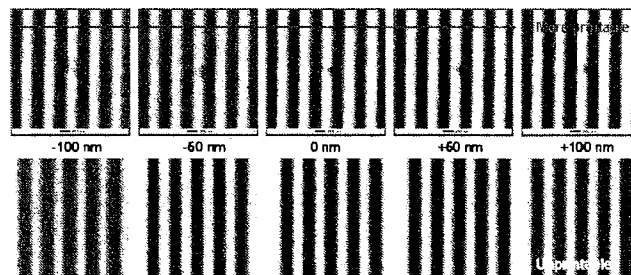
Figure 11. AIT images in through focus @ pixel 4 in M7360

Phase defects on mask blanks have a strong focus-dependent printability on the wafer. The printability of pits and bumps is opposite from through focus. Figure 11 shows some AIT review images of blank defects on the mask [4]. Each defect has a different printability at through focus [5]. This means that through-focus wafer inspection can improve the detectability of the wafer inspection tool. Wafer inspection of the exposed sample from through focus can improve the sensitivity toward blank defects. Defect printability depends on size, profile, and location. Furthermore, different wafer stack will induce different sensitivity. Wafer inspection is less sensitive toward developed resist images than SiN wafer stacks because of the improved contrast in the pattern of the SiN stack on the wafer in the wavelength of the inspection source. An improved wafer inspection sensitivity of about 20% has been demonstrated using an underlayer stack (SiN) rather than developed resist (see Figure 12).
