Neurologic Dysfunction Associated With Mechanically Assisted Crevice Corrosion and Elevated Cobalt Ion Levels After Total Hip Arthroplasty

## Case report

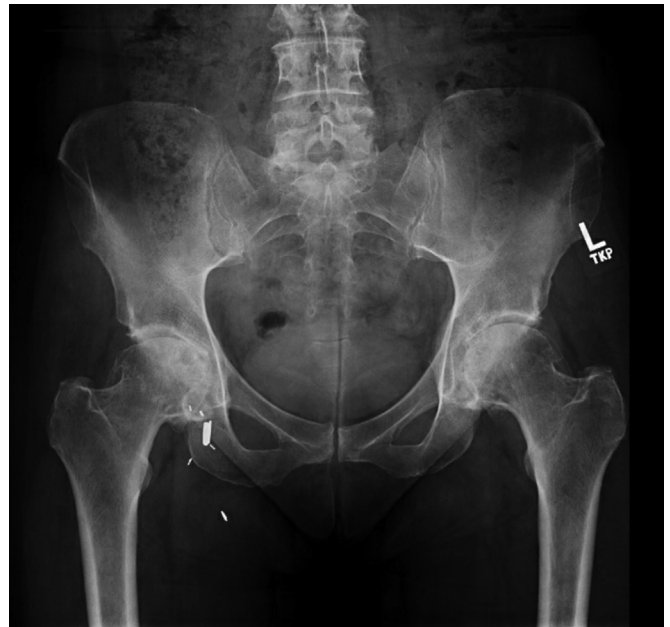
**Figure 1.** Preoperative pelvic radiograph 2 months after first-stage L-THA, February 2010. Note: Metallic objects seen in the right groin are surgical clips from a remote saphenous vein ligation procedure performed in 1988.

A 58-year-old woman who works as a pediatric intensive care unit nurse at a large academic medical center presented in 2009 with bilateral hip pain and pelvic radiographs consistent with advanced degenerative arthritis of both hips. Her past medical history was notable for longstanding hypothyroidism managed with levothyroxine. A corticosteroid injection was given with temporary relief in each hip. One year later, the hip pain worsened and was significantly impacting her quality of life. Pelvic radiographs demonstrated progression of her degenerative arthritis (Fig. 1).

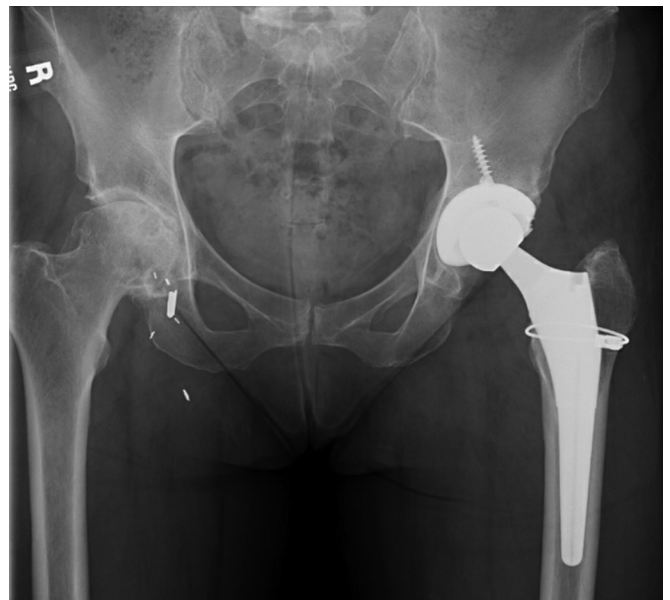
**Figure 2.** Pelvic radiograph 2 years after first-stage L-THA and 7 months before R-THA, October 2012.

The patient was asked to use crutches for weight-bearing for 6 weeks and had an unremarkable postoperative recovery with excellent osseous integration of the stem and no evidence of subsidence. At the 2-year follow-up, she expressed feeling very pleased with the result of her L-THA and had returned to an active lifestyle. While she reported no significant left-sided hip pain, her right hip pain had grown progressively more painful in association with radiographic evidence of osteoarthritis progression (Fig. 2).

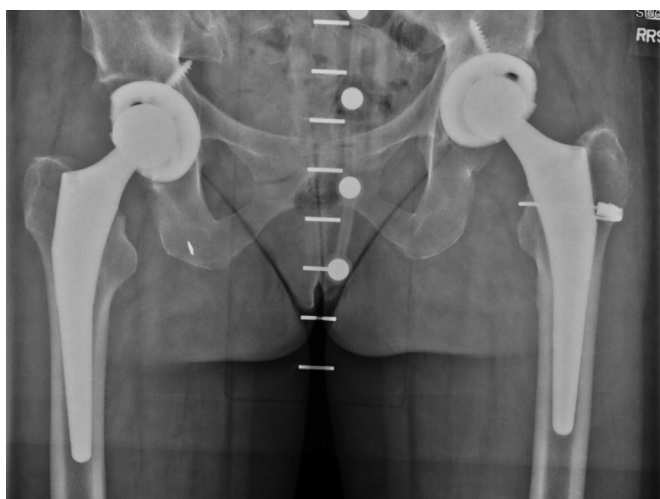
**Figure 3.** Postoperative pelvic radiograph after staged bilateral total hip arthroplasty, July 2013.

Her postoperative course was uncomplicated, and she was able to walk 2 miles and swim daily by 6 weeks after surgery. Pelvic films at follow-up demonstrated well-fixed and well-aligned

cementless bilateral total hip replacements (Fig. 3). She returned to work as a pediatric intensive care unit nurse.

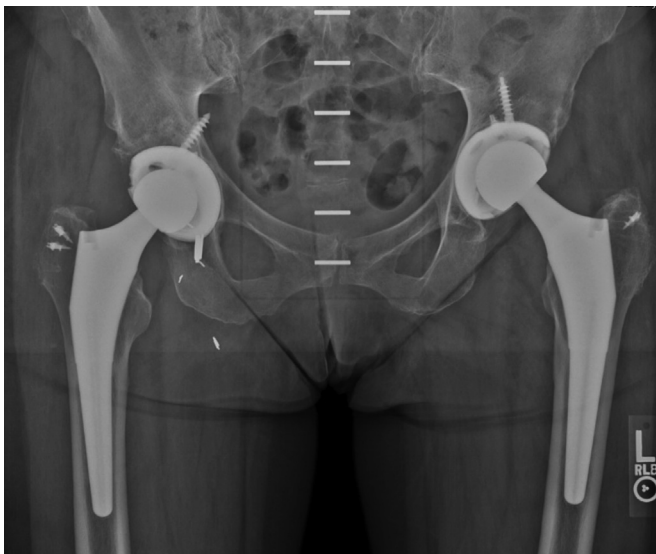
**Figure 5.** Postoperative pelvic radiograph after bilateral revision total hip arthroplasty, March 2021.

As with the left hip, during the revision R-THA surgery to replace the metal head in February 2021, the trunnion was found to be corroded with deposition of black material inside the head and over approximately 50% of the trunnion. The cobalt-chromium head was replaced with a ceramic head with a titanium sleeve. The cup was well fixed, but a 50% detachment of the gluteus medius tendon from the greater trochanter not seen in the preoperative MRI was seen intraoperatively and surgically repaired [23]. The patient had an uncomplicated postoperative course and was sent home with a walker to protect her gluteus medius repair for 8 weeks. She subsequently resumed full weight-bearing and normal activities and reported resolution of her headaches, memory issues, and other neurologic symptoms by 3 months after the revision. Chromium and cobalt levels obtained at that visit, 2.5 mcg/L and 1.8 mcg/L, respectively, returned to normal limits. Pelvic films showed a well-fixed, well-aligned cementless bilateral THA (Fig. 5). She resumed an active, unrestricted lifestyle and clinical nursing.
