Carbon contamination topography analysis of EUV masks

Carbon Contamination Topography Analysis of EUV Masks

Yu-Jen Fan¹, Leonid Yankulin¹, Petros Thomas¹, Chimaobi Mbanaso¹, Alin Antohe¹, Rashi Garg¹, Yunfei Wang¹, Thomas Murray¹, Andrea Wüest², Frank Goodwin², Sungmin Huh², Aaron Cordes², Patrick Naulleau³, Kenneth Goldberg³, Iacopo Mochi³, Eric Gullikson³, Gregory Denbeaux¹

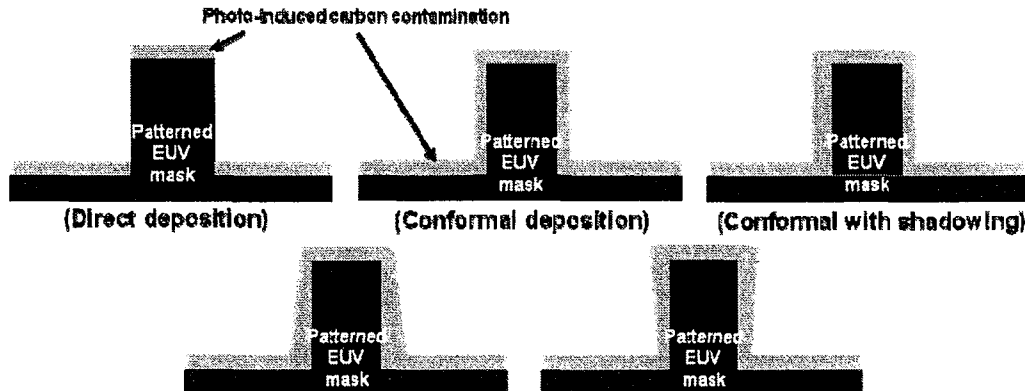
FIG. 1. Different shaped contamination topographies can cause throughput loss, CD change, and dose shift, as well as impacting the efficiency of cleaning process.

Carbon contamination on patterned EUV masks is one issue that still must be resolved before EUV lithography is introduced into high volume manufacturing (HVM). It occurs when mask surfaces are exposed to EUV radiation in the presence of residual hydrocarbons. Current solutions are either to reduce the contamination rate and/or to perform a post-cleaning process on contaminated surfaces. Our previous work showed that the topography of the contaminated features is critical to estimate the effects of carbon contamination. Possible contamination topographies from a patterned mask are shown in Figure 1.⁽¹⁾

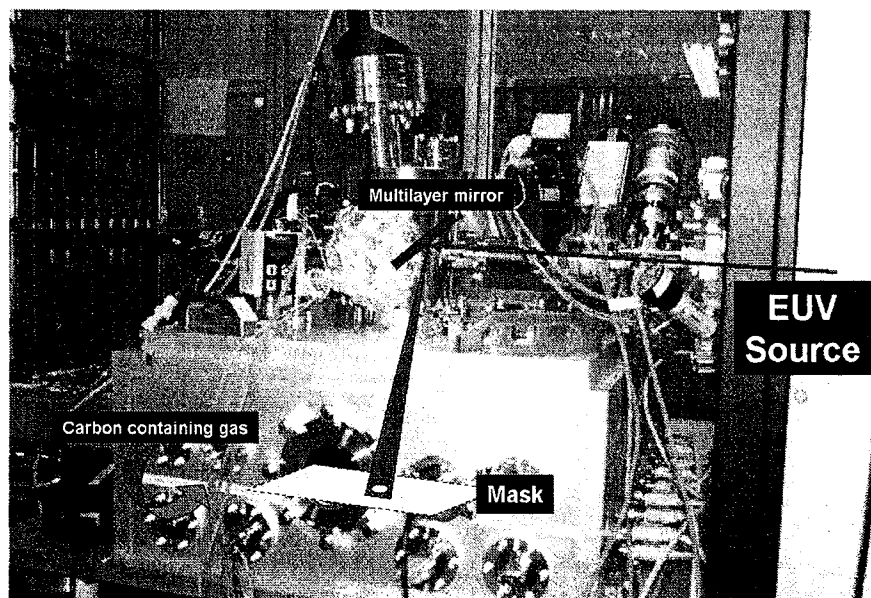
FIG. 2. Layout of the EUV MiMICS at CNSE. Carbon-containing molecules were injected into the vacuum chamber to increase the contamination rate.

A schematic of the EUV MiMICS tool is shown in Figure 2. This tool was designed to study the effects of carbon contamination on the imaging performance of EUV masks. It is equipped with an Energetiq EQ-10M xenon-based discharge-produced plasma EUV source.^[6] The incoming beam reflects off a multilayer mirror at 42° and illuminates the mask at a 6° off-axis angle of incidence. This geometry allows 13.5 nm (92.5 eV) EUV in-band radiation and some longer wavelength up through visible light. Photon energies lower than the bond energies of these carbon-containing molecules are not thought to contribute to the contamination. In order to accelerate carbon deposition rate, local pressure was increased to a level allowing experiments to be performed within a reasonable timeframe. Carbon-containing species were then injected into the vacuum chamber using a needle valve. A 3 × 5 mm oval aperture was used to contaminate only certain features within a selected area.

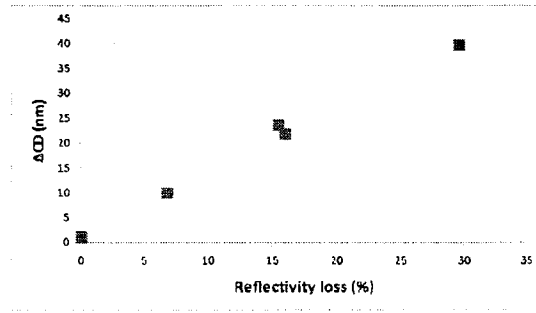
FIG. 3. The CD change was measured as a function of reflectivity loss using a reticle SEM. We observed the ΔCD scales with the reflectivity loss measured from the multilayer surface.

A top-down reticle scanning electron microscope (SEM) and SuMMIT software were used to record and analyze CD changes on the same field before and after contamination to determine the CD variation of the absorbing features.^[9] The CD change (labeled as ΔCD) and the reflectivity loss were measured on the selected fields and recorded in Figure 3. We observed that carbon contamination results in a reflectivity loss and ΔCD , which implies carbon deposition on the sidewalls of the absorbers.

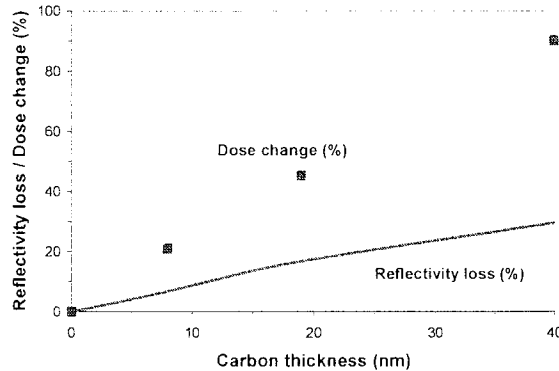
FIG. 4 The required dose change to print dense lines vs. carbon thickness is plotted and compared to the measured reflectivity loss on the selected fields of the mask. Carbon thicknesses were determined by transmission efficiency from the CXRO website.

Images were printed at the SEMATECH Berkeley MET; the exposed wafers were analyzed using a CD-SEM. To investigate the impact of carbon contamination on printing, selected fields on the mask were exposed to EUV radiation with the dose controlled to deposit carbon layers of different thicknesses on each field. Carbon thicknesses were determined to be 8, 19, and 40 nm, respectively, based on the CXRO data and reflectivity measurements before printing.^[10] For a given field on the mask, Figure 4 compares the relative increase in dose to print 40 nm half-pitch dense lines as a function of carbon layer thickness with the relative reflectivity loss for the same carbon thickness. For instance, with 19 nm thick carbon, the dose increased more than 45% while the reflectivity loss was only 16%. This result indicates that the change in dose depends on not only the carbon thickness, and hence reflectivity loss on the mask surface, but also the topography of the contaminated features.

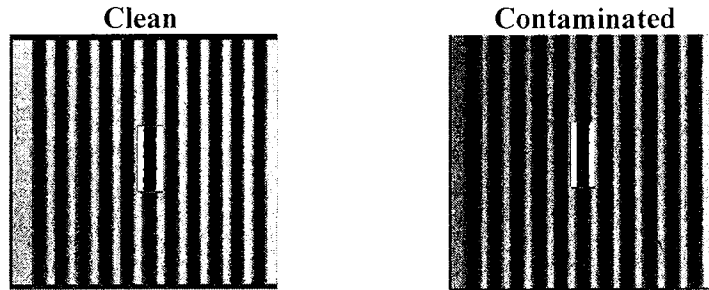
FIG. 5. Aerial images recorded using the SEMATECH Berkeley AIT show 200 nm dense line features on the mask for the clean and contaminated areas. The 0.5 μm x 2 μm boxes shown were selected for data analysis.

The SEMATECH Berkeley AIT was used to inspect the contaminated mask and record aerial images. The images underwent aerial image data analysis of through-focus behavior and processing such as CD measurement, contrast curve, normalized image log slope, line width roughness, and process window using ThroughFocus software.^[11] Figure 5 compares 200 nm dense lines on both clean and contaminated regions of the mask, which are recorded as aerial image profiles in Figure 6. The thickness of the carbon deposited on the contaminated mask was 19 nm after EUV exposure in the MiMICS tool with a 5 J/cm² nominal dose.

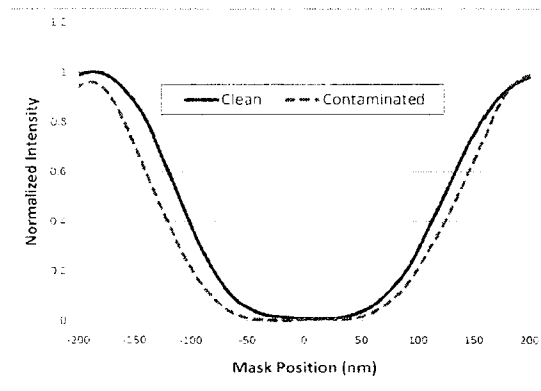
FIG. 6. The intensity profile was recorded based on the location of imaging processing on the mask. Results show an increased CD on a contaminated feature.

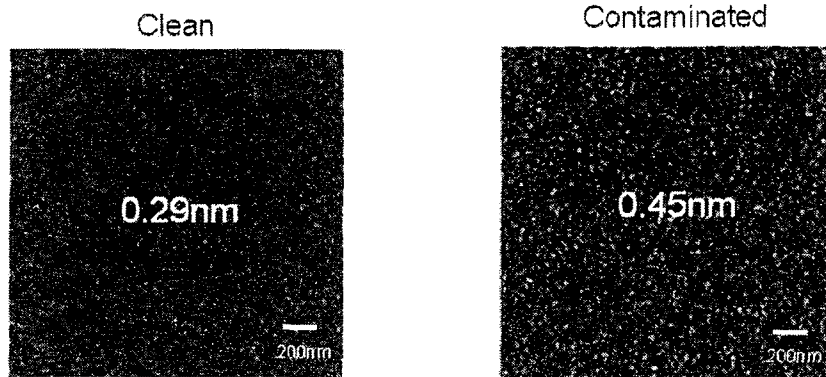
FIG. 7. RMS roughness was increased by approximately 50% on contaminated region with 24 nm of carbon deposited.

A Veeco Dimension 3100 AFM with a high aspect ratio focused ion beam (FIB) tip was used in tapping mode to measure surface topography. The full width at half maximum (FWHM) for the contaminated features increased from 234.8 nm to 275.4 nm, which is a 40.6 nm CD change with 19 nm of carbon deposited on the selected fields of the mask. The root mean square (RMS) roughness of the contaminated region was measured to be 0.45 nm as compared to 0.29 nm in a clean area. The increase of RMS roughness can cause more flare during exposure and could be a potential cause of line edge roughness (LER) on the printed images.^[12-13]

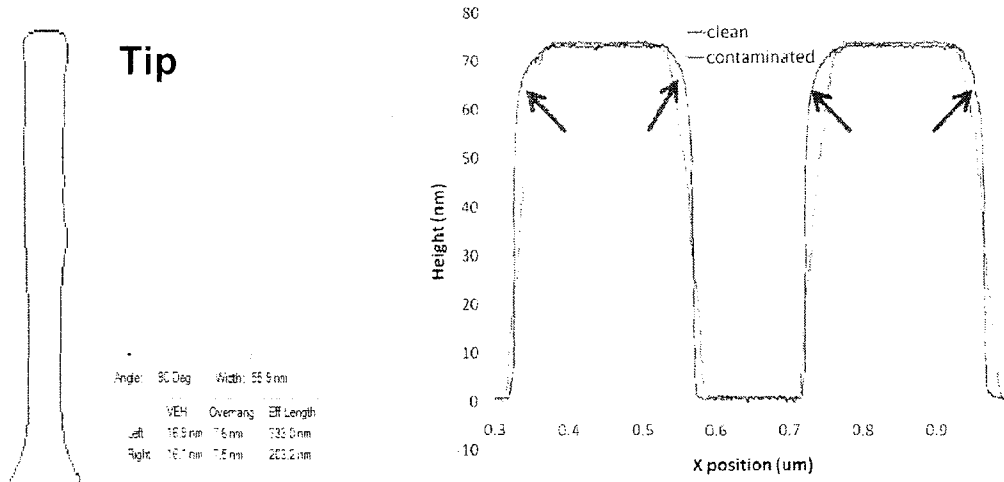
FIG. 8. A tip profile with detailed information indicates the width change before and after the measurement. With capability to monitor tip wear, the cross-sectional profile of contaminated features can be recorded and compared to the clean features on the mask.

A high precision Veeco InSight 3D-AFM was also used to better understand the contamination topography. With the capability of monitoring changes in the tip width, the tip profile can be recorded before and after the measurement, as shown in Figure 8. The cross section profile can then be mapped out and provide an indication of contaminated absorbing features. More carbon was measured near the top corner of the absorbers after contamination. This non-uniform shape could affect the printing performance more than a simple absorption layer model, as well as causing more throughput loss. However, this cannot yet be considered conclusive until the carbon layer can be measured directly.

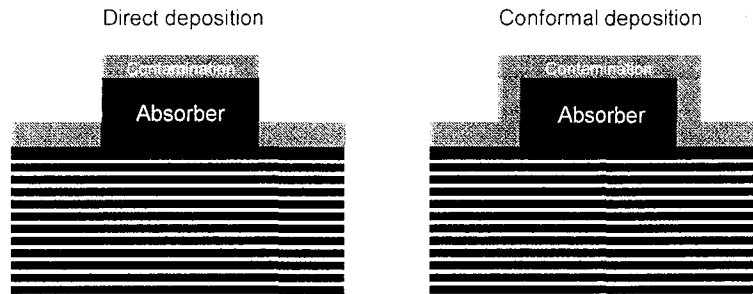
FIG. 9. Two possible topographies: direct and conformal deposition. The film stack used in the simulation consisted of 40 bilayers of Mo/Si, 10 nm of SiO₂ as a buffer layer, and 70 nm of TaN as an absorber layer. The gray layer shown in the schematic view represents the deposited carbon layer.

EM-Suite, lithographic software developed by Panoramic Technology Inc.,^[14-15] was used to investigate the change in the topography of a patterned EUV mask from carbon contamination. It is not yet clear whether the growth rate of the deposited carbon depends on the exposed material such as TaN absorber versus Si or Ru capped multilayers. However, the absorber topography and the illumination angles can still cause different carbon deposition rates between the top surfaces and the sidewalls of the absorbing features. Two extreme cases of possible topography were considered, direct deposition and conformal topography, as shown in Figure 9. Both conformal and direct carbon deposition cause a reflectivity drop due to the absorption of EUV radiation, but the carbon growth on the sidewall in conformal topography increases CD more than direct deposition.

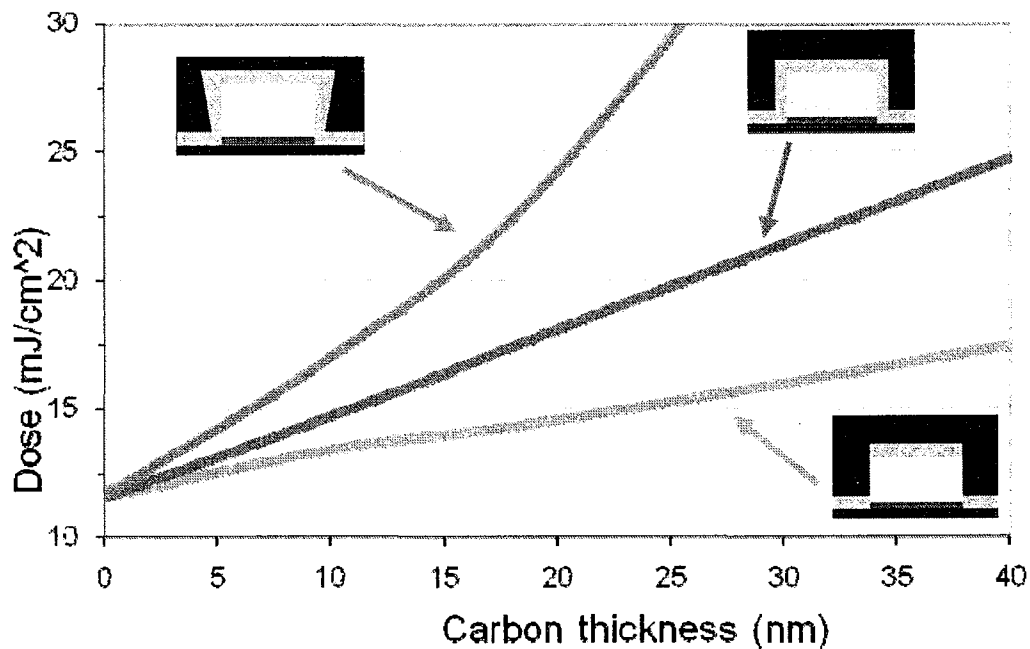
FIG. 10. Simulations were based on our best known topography and compared to direct deposition and conformal deposition.

To understand whether our assumptions matched the experimental data, aerial images and calculated resist parameters were compared to the printed results. As shown in Figure 10, the non-uniform shape was based on our best known topography measured by AFM. Two other possible contamination topography shapes, direct and conformal deposition, were also included. Simulation results show that conformal deposition requires more than 45% more dose to print the target CD compared to a clean area printing and that non-uniform deposition is even worse which means the contamination topography affects the throughput significantly.
