Overview of the Quench Heater Performance for MQXF, the Nb₃Sn Low- β Quadrupole for the High Luminosity LHC

Overview of the Quench Heater Performance for MQXF, the Nb₃Sn low- β Quadrupole for the High Luminosity LHC

Abstract— In the framework of the High-Luminosity upgrade of the Large Hadron Collider, the US LARP collaboration and CERN are jointly developing a 150 mm aperture Nb₃Sn quadrupole for the LHC interaction regions. Due to the large stored energy density and the low copper stabilizer section, the quench protection of these magnets is particularly challenging, relying on a combination of quench heaters attached to the coil surface and CLIQ units electrically connected to the coils. This paper summarizes the performance of the quench heater strips in different configurations relevant to machine operation. The analysis is focused on the inner layer quench heaters, where several heater strips failed during powering tests. Failure modes are discussed in order to address the technology issues and provide guidance for future tests.

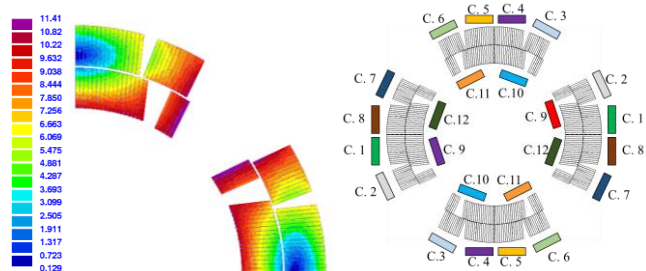
Fig. 1. Cross section of one coil, showing the magnetic field in Tesla at nominal current (16.47 kA) (Left). Schematic of the quench heater circuits per magnet (Right).

The quench protection system of these magnets will include a combination of quench heaters attached to the coil surface and CLIQ units electrically connected to the coils [7]. Every coil is equipped with four outer layer and two inner layer heater strips, connected in series as shown in Fig 1(right), leading to twelve heater circuits per magnet. This paper summarizes the quench protection heaters performance of the tested short model magnets (MQXFS) ([4]-[6]). Scalability of the heater has been demonstrated after measuring similar heater delays in 1.2-m-length and 4-m-length coils tested in mirror configuration [7].

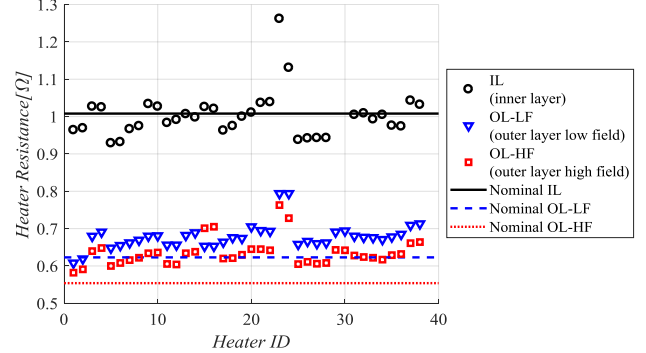
Fig. 4. Measured quench heater resistance at room temperature for the short model coils. IL = Inner layer, OL = Outer layer, HF = High field, LF = Low field

to steel adhesion. The Residual Resistivity Ratio (RRR) of the deposited copper ranges from 25 to 40. Copper, stainless steel and nickel is then removed through chemical etching with the required heater pattern. A second etching of the copper defines the final geometry of the heater stations. The last step is to perforate and polish the trace in order to improve the adhesion during coil impregnation and to improve the cooling during magnet operation. The dielectric strength of the polyimide at the end of the process is verified applying a DC voltage of 3 kV under a local pressure of less than 1 MPa. Fig. 4 summarizes the measured heater resistance in the short model coils and compares it to the nominal resistance.

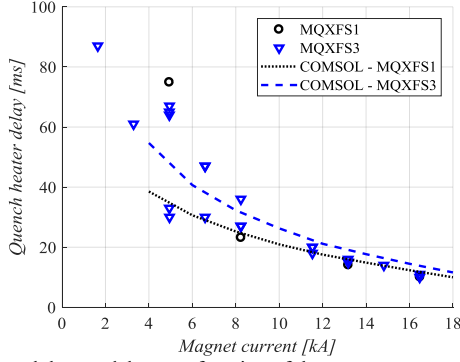
Fig. 5. Quench heater delay as a function of the magnet current for the outer layer high field coil block.

Quench heater delay is defined as the time between the heater powering and the start of a resistive transition in the coil. The measured delays in MQXFS1 and MQXFS3 as a function of the magnet current are plot in Fig. 5, 6 and 7. At nominal operating current, outer layer heater delays are 2 to 5 ms shorter than predicted by the COMSOL model [10] for MQXFS3 and in agreement with expectations in MQXFS1. The heater powering conditions used in the model are summarized in Table III. Larger spread is observed for the inner layer heaters, where measured and modelled delays are within 10 ms at nominal magnet current. At lower current level, the discrepancy between model and measurements increases, in particular for the outer layer low field and inner layer heaters. Due to the larger margin in terms of protection at low current, the longer measured delays in the range of 4 to 8 kA are not considered an issue for the magnet protection. Measurements are consistent in MQXFS1 and MQXFS3 for the outer layer heaters. Inner layer heaters in MQXFS1 were around 10 ms slower than in MQXFS3. According to the model, smaller difference on the inner layer heater delays in between the two magnets is expected.

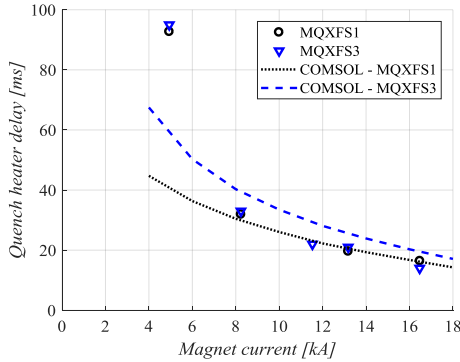
Fig. 6. Quench heater delay as a function of the magnet current for the outer layer low field coil block.

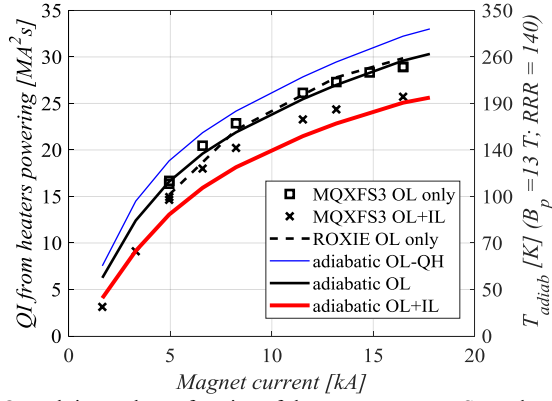
Fig. 9. Quench integral as a function of the magnet current. Secondary y-axis (not in scale) shows the adiabatic hot spot temperature on the conductor assuming a peak field of 13 T and RRR of 140.

A zero-order approximation (0D) of the effectiveness of the heaters can be done by comparing the measured quench load with the expected value assuming that the magnet is fully or partially quenched at the minimum heater delay. Figure 9

shows the expected quench load for the case only the turns in contact with the outer layer heaters are quenched (OL-QH), all the outer layer turns are quenched (OL) and the case the magnet is fully quenched (OL+IL). The simulated QI using ROXIE-2D model [12], which includes the electro-magnetic and thermal transients occurring during the quench, is also plotted. As it can be seen in the graph, in spite of the heater failures (see section IV), inner layer heaters efficiently contribute to a faster discharge of the magnet current, in particular at high magnet current. A reduction of the hot spot temperature of 60-80 K at nominal current is expected thanks to the use of inner layer heaters. Even if the zero-order approximation relies on very crude assumptions, it provides a first good estimation of the quench integral. The measured difference in the quench integral for the OL only and OL+IL case is close to the 0D estimations. ROXIE model is close to the measured values, in particular at high current.

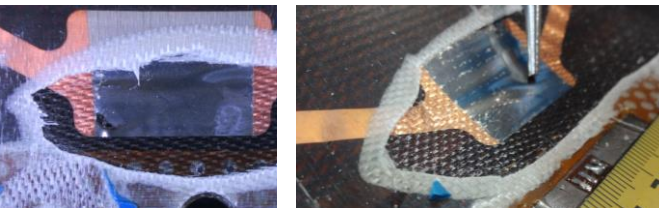
Fig. 13. Example of burned spot on the heater (left). Example of heater to polyimide defect (right).

surface is under production. The post-mortem inspection of coil 7 also showed a burnt spot at the edge of one heater station (see Fig. 13, left) and several locations with a bubble or fold underneath the heater station (see Fig. 13, right). Even if these specific heaters did not fail during cold powering test, long-term reliability is compromised.
