Teledesic broadband center field study

# TELEDESIC BROADBAND CENTER FIELD STUDY

SUMMARY REPORT  
APRIL 2002

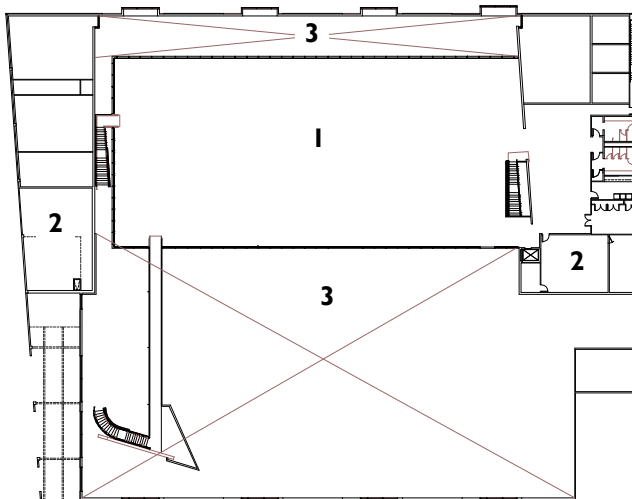
Figure 2.2  
Mezzanine level plan

- 1 Mezzanine open office area
- 2 Mechanical
- 3 Open to below

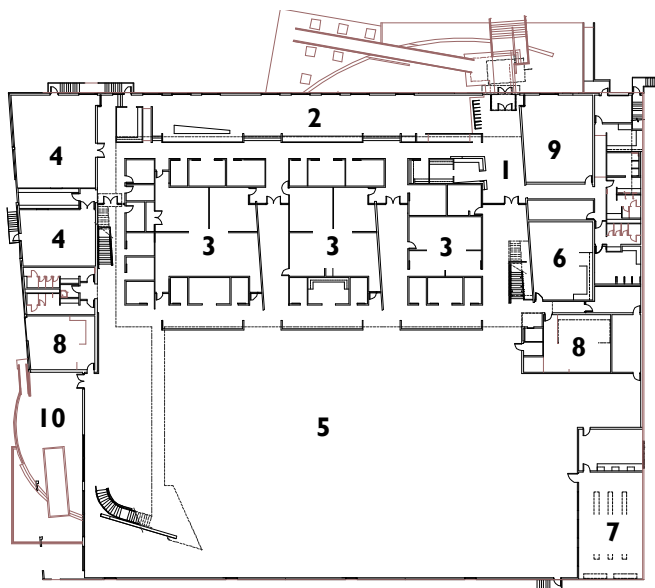
Figure 2.3  
Ground floor plan

- 1 Lobby/reception
- 2 Library/lounge
- 3 Small conf. rooms and work rooms
- 4 Large conf. rooms
- 5 Open office area
- 6 Supply/copy
- 7 Computer room
- 8 Mechanical
- 9 Retail

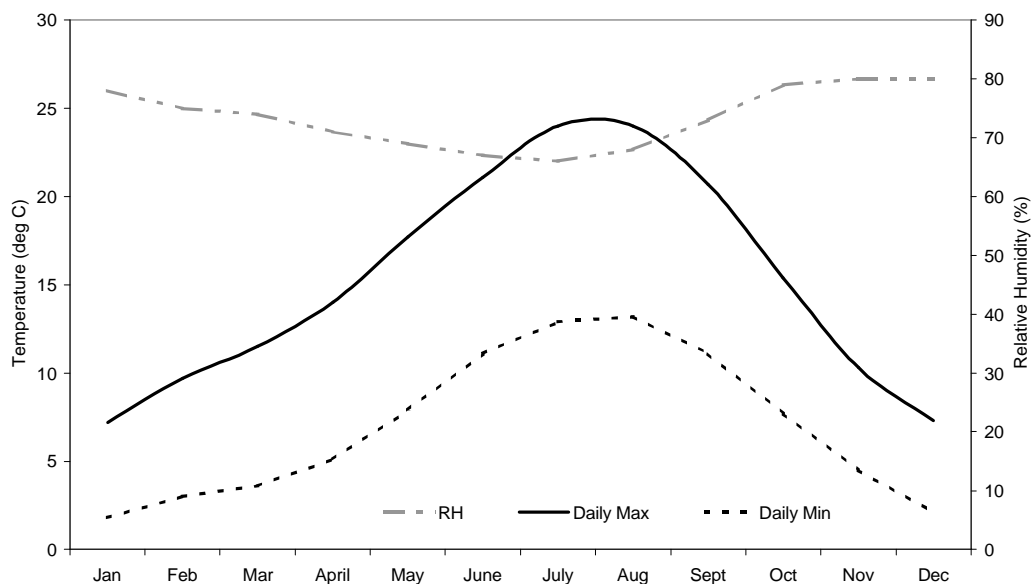
Figure 2.4  
Temperature  
maximums and  
relative humidity for  
Seattle-Tacoma region

Figure 2.4 presents climate data for the Seattle-Tacoma region and indicates the nature of Teledesic's climatic context. An analysis of heating and cooling degree-days reveals that winter conditions clearly predominate for the majority of the year.

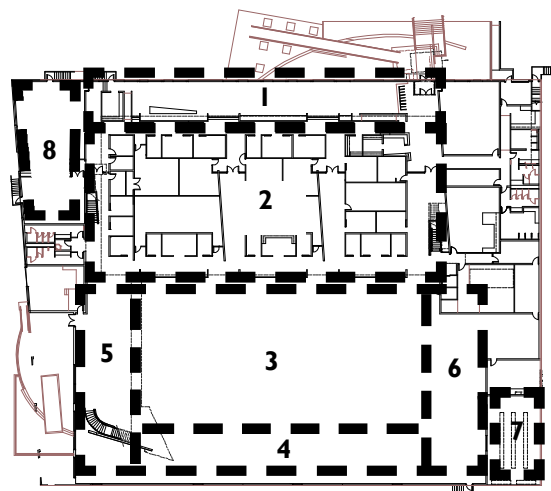
Figure 2.5  
HVAC zones

The space is divided into a number of HVAC zones as shown in Figure 2.5. Plenum partitioning has only been used for the large conference rooms, however ductwork on the main floor and 'air-highways' on the mezzanine level are used to help evenly distribute air through the plenums. The mezzanine has its own air-handling unit, which allows this area to be supplied at a temperature that is independent of the ground floor supply temperature requirements. The mezzanine slab is not insulated from the spaces below; to prevent rising warm air in the ground floor space from transferring heat to the mezzanine plenum above, the mezzanine level air highways are insulated from the floor slab with 1" duct lining.

- 1 North lounge/entry zone
- 2 Small conf. room zone (mezzanine zone above)
- 3 Main workspace zone
- 4 South perimeter zone
- 5 West perimeter zone
- 6 East perimeter zone
- 7 Computer room
- 8 Large conf. room zone

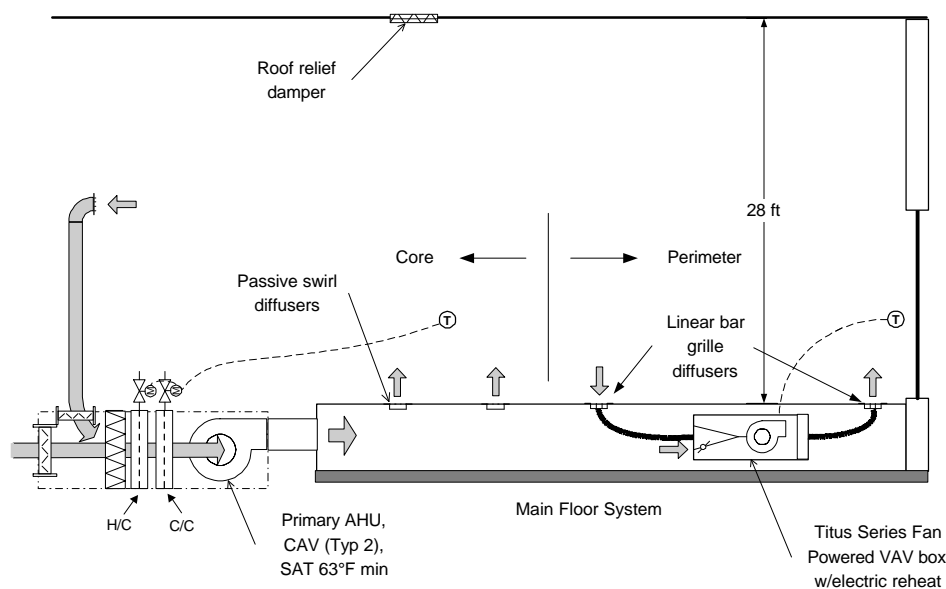
Figure 2.6  
Underfloor system  
schematic, south open  
office area

The main workspace zone is operated as a constant volume, variable temperature (CAV-VT) system with supply air temperature controlled by a number of sensors located in the interior zone and linked to the AHU via an Alerton energy-management system. As the building is essentially single story, significant heat loss through the roof in winter causes a variation in the required supply air temperature between 18°C and 21°C (65-70°F) throughout the year. Under normal operating conditions air is returned to the AHU via return grilles located near the ceiling. Alternatively, when the system is using outside air in an economizer mode, return air is exhausted via a roof relief damper.

In the north perimeter zone, cool plenum air is distributed through linear diffusers located in the kick-plates of the cabinets. These diffusers incorporate a two-position damper that minimizes plenum air delivery during heating. Finned tube convectors located along the exterior wall provide heating for this zone.

Other perimeter zones operate as CAV-VT systems with the use of variable air volume (VAV) fan-powered mixing boxes. During intermediate load conditions, room air is drawn into the plenum through linear diffusers, mixed with fresh plenum supply air and re-emitted through diffusers at the perimeter of the zone that are connected to the mixing box via flexible ducts. Although each zone operates as CAV system, for the system overall the supply air volume varies to some degree as the fan-powered boxes reduce the percentage of plenum air used. In winter, the percentage of plenum air used is the minimum necessary to satisfy fresh air requirements, with re-circulated room air comprising the majority of the volume of supply air.

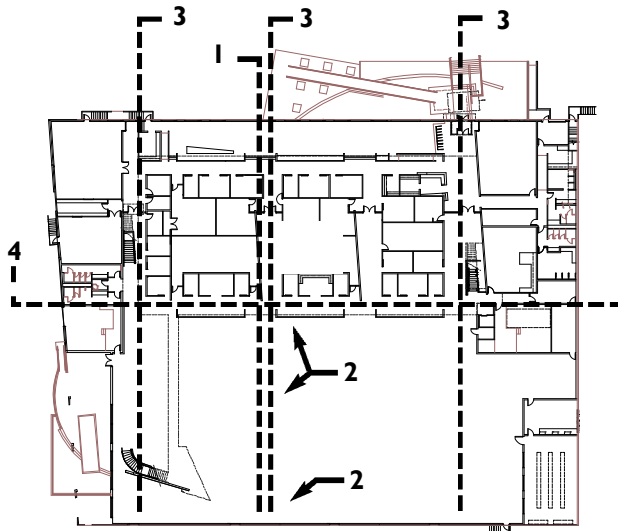
Figure 3.1  
Data collection locations

The investigation team was interested in monitoring supply air temperatures to establish relationships between room air and supply air temperatures in order to study thermal decay. Data loggers were placed in floor diffuser baskets at 20 locations on the ground floor and mezzanine. The locations were chosen to obtain a range of different plenum conditions, such as next to fan terminal units, in the perimeter zones, or in core areas. To compliment this temperature monitoring, spot measurements of the air velocity and sound pressure level were taken, both within and immediately above each floor diffuser containing a data logger. A complete list of field measurements is summarized in Appendix 1. The locations for data collection are shown in Figure 3.1.

- 1 Diffuser temperature data collection line
- 2 Thermal stratification data locations
- 3 Room air temperature data collection lines
- 4 Sound level data collection lines

ducts and through the open plenum. Diffuser temperatures were recorded from the mechanical room northward and southward along line "1" shown on Figure 3.1. Supply air temperatures in both north and south zones are highest approximately 20-30 ft (6-9 m) in from the external wall and lowest in the perimeter areas. The temperature differences are relatively small, all within 2°F (1.1°C) of one another. These variations are relatively small, especially when considering the accuracy of measurements. It is also not clear to what effects air flow patterns (e.g., dead spots) in the plenum might have on diffuser supply air temperatures.

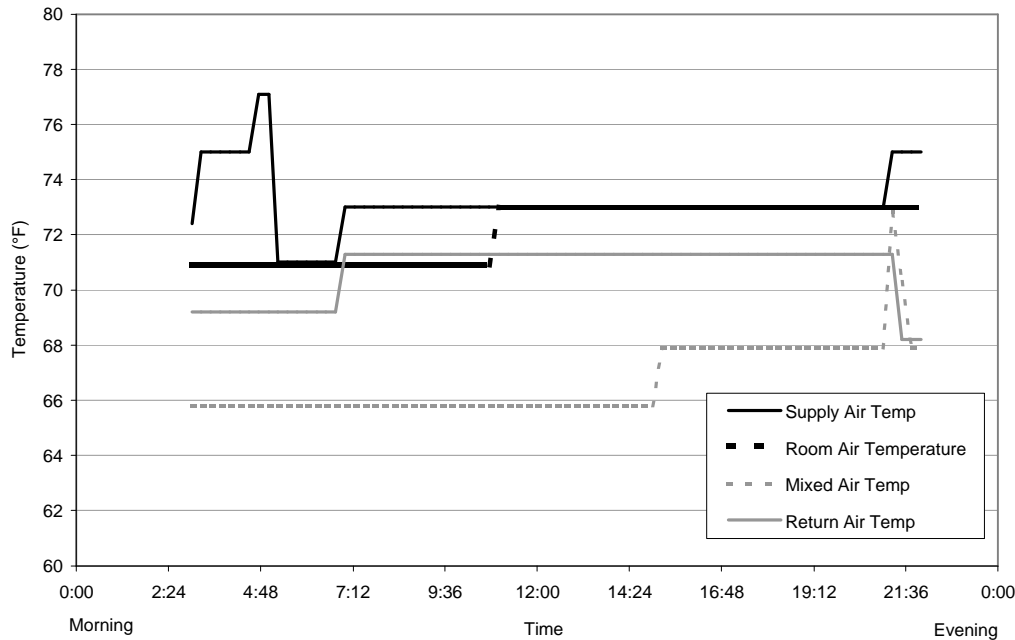
Figure 4.1  
Temperature profiles  
under winter day  
operation

As illustrated in Figure 4.1, heating occurs during winter operation from a mixed air temperature (MAT) of 66-68°F (18.8-20°C) to a 71.5°F (21.9°C) supply air temperature (SAT). The temperature increases to 73°F (22.7°C) in the room followed by a drop to 71.5°F (21.9°C) at the return. The reason the return air temperature is cooler than room air may be due to the cooler supply air temperatures at the mezzanine level, as explained earlier. The outside temperature was in the range of 30-40°F (-1-4°C) during the day represented in this graph.

On a typical winter day additional heating of supply air is not required for the main floor internal zone since a supply air temperature of 71.5°F (21.9°C) is adequate to maintain the zone set-point of 73°F (22.8°C).

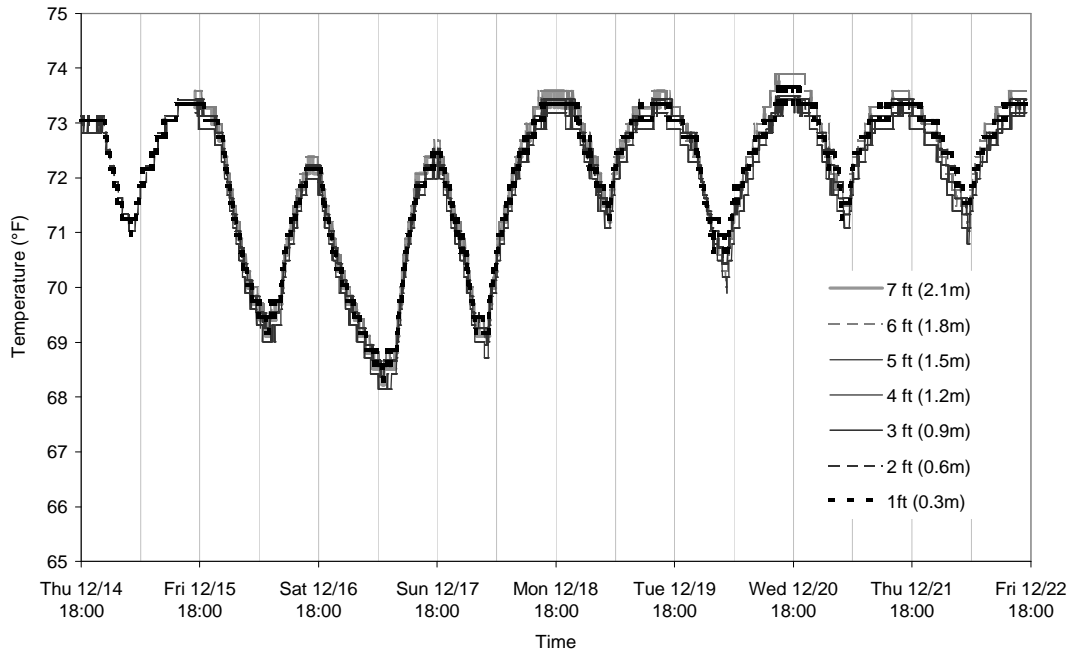
Figure 4.2  
Typical weekly internal zone room air temperatures

Typical patterns of room air temperatures recorded by the stratification measurement data loggers in the interior zone of Teledesic’s workspace over a one week period are shown in Figure 4.2. These temperatures rise steadily from early morning as internal gains accumulate, and decrease in the evening as computers and task lights are turned off, and occupants leave and the UFAD system shuts off. Figure 4.3 illustrates the variations for a single 24-hour period. All temperatures from 1-foot ( 0.3 m) up to a height of 7-feet (2.1 m) follow this regular pattern. The magnitude of these variations is approximately 3.5°F over a 24-hour period.

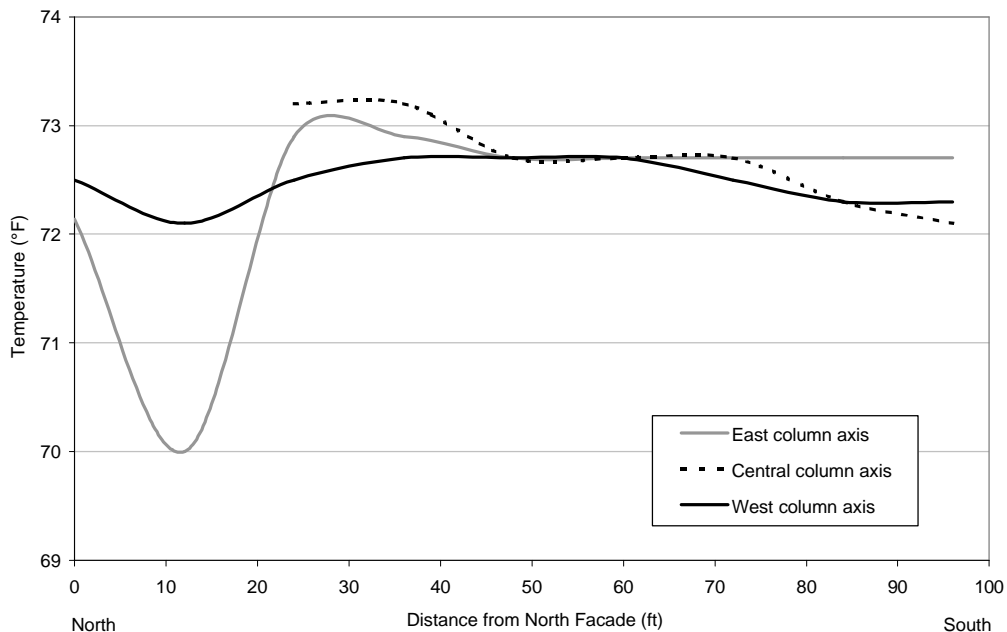
Figure 4.4  
North-south variations in room air temperature

To document room air variation throughout the building, measurements were taken with hand held devices at 4 ft (1.3 m) above the floor level from north to south along three lines within the building, as shown in Figure 3.1. The readings are illustrated in Figure 4.4. The noticeable dip in room air temperatures to the north occurs within the glazed entry area. This temperature drop is due to the combination of northern exposure, fully glazed entrance doors that are frequently opened, and minimal internal gains from intermittent occupancy. (The receptionist seated in this area has installed a large portable electric heater.) Passing through the glazed doors separating the entry

from the main workspace area there is a perceptible temperature difference. However within the main workspace area variations in room air temperatures are within about 0.5°F (0.28°C).

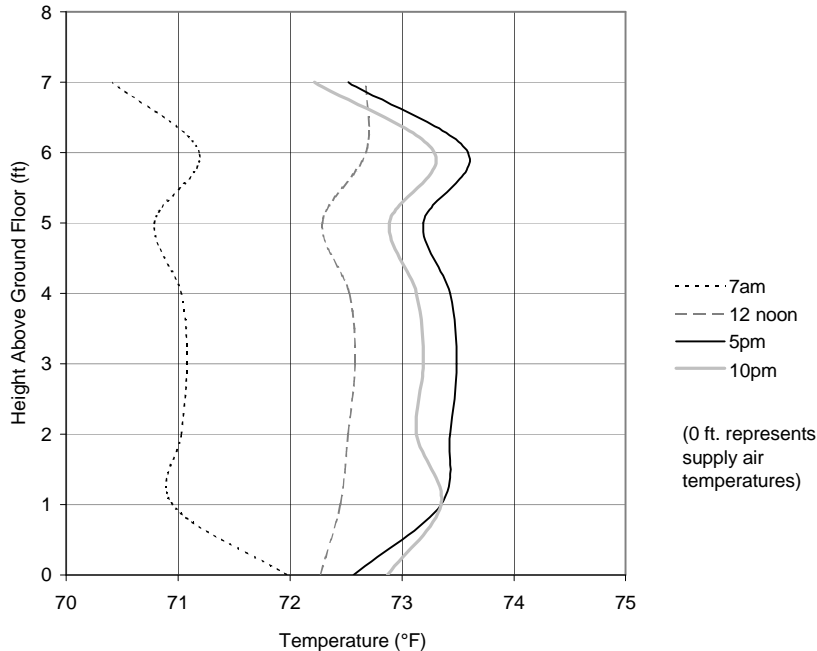
Figure 4.5  
Vertical plane temperature profiles over the working day

Comparison of the data from the two strings of data loggers show that the internal zone was generally 2°F (1.1°C) higher than those recorded in the south perimeter zone. This difference is expected since the perimeter zone is operating at its heating set-point [70°F (21.1°C)] and the internal zone is operating at its cooling set-point (estimated to be 73°F (22.8°C)). Internal gains in the interior and potential fabric heat loss in the perimeter zone cause these temperature differences. The magnitude of this difference is more pronounced as temperatures fall during the evening, and are less during the working day.

Analyzing the entire data set as a whole, Teledesic's internal environment appears to be that of environmental uniformity within and between zones (south, east, west, and mezzanine), except for the north zone where temperatures are somewhat lower due to the proximity of the front door, low internal loads, and significant heat losses.

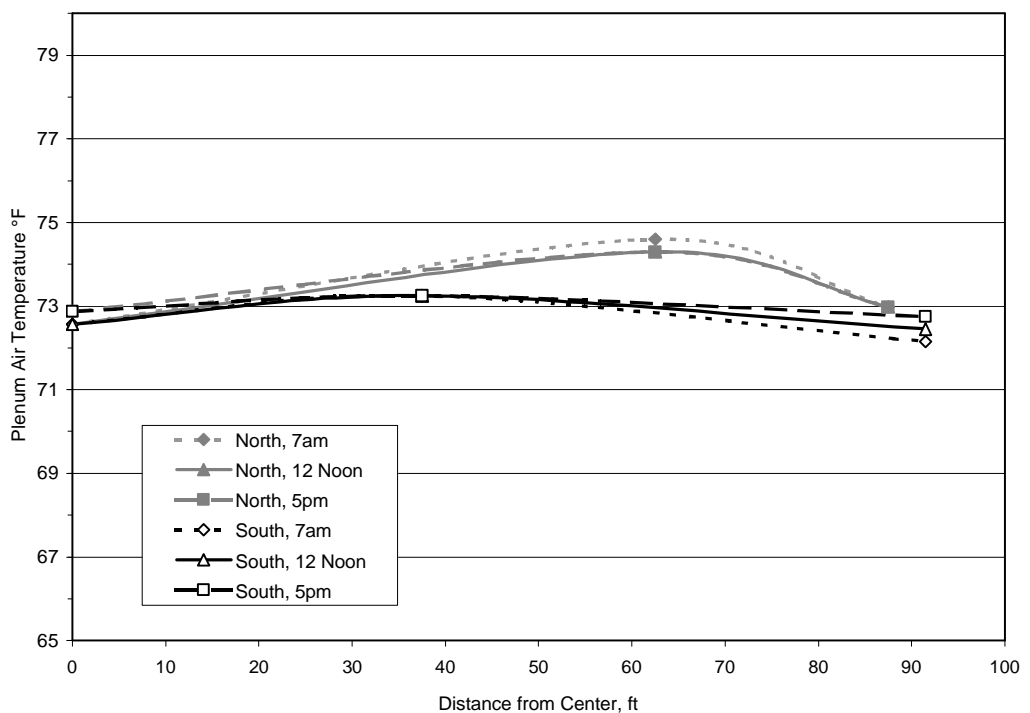
Figure 4.6  
Thermal decay of supply air with distance from the AHU

Figure 4.6 shows the relationship between the supply air travel distance and the temperature recorded at that diffuser. This distance includes the total length through

Thermal transfer between cool supply air and a warmer slab typically leads to an increase in supply air temperature en route from AHUs to diffusers during cooling mode. The fact that the slab temperatures vary little throughout the year and an observed decrease of only 1-2°F occurs during winter suggests that thermal decay will not be significant in the summer cooling season.

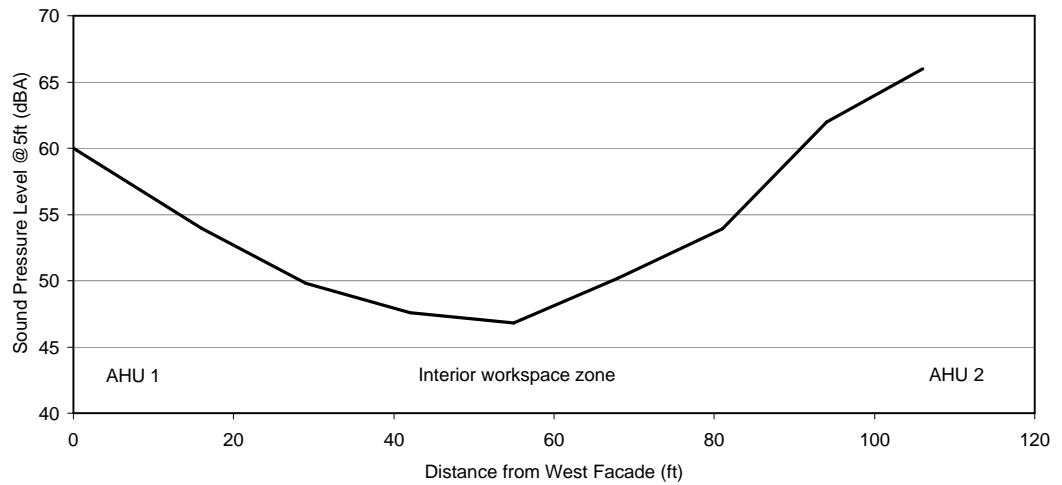
Figure 4.8  
Ambient sound level readings

Figure 4.8 shows sound level profile measured in the ground floor open office area. These readings are considerably higher adjacent to the east and west AHUs. Comparisons with Table 4.3 show that the conditions near the equipment rooms were above the acceptable range of 50-55 dBA for open office environments. In the center of the space levels of 46 dBA were recorded, a level typical of private office environments. While taking measurements in the center of the open office area, researchers noted that the background noise level was so low that if a conversation was started at any location the readings increased considerably. This is consistent with occupant survey results which revealed a great concern that conversations could easily be overheard. This indicates that background noise may be too low in most places (most likely exacerbated by the low number of occupants) so that there is no masking effect to reduce the impact of individual conversations.
