Using dune restoration on an urban beach as a coastal resilience approach

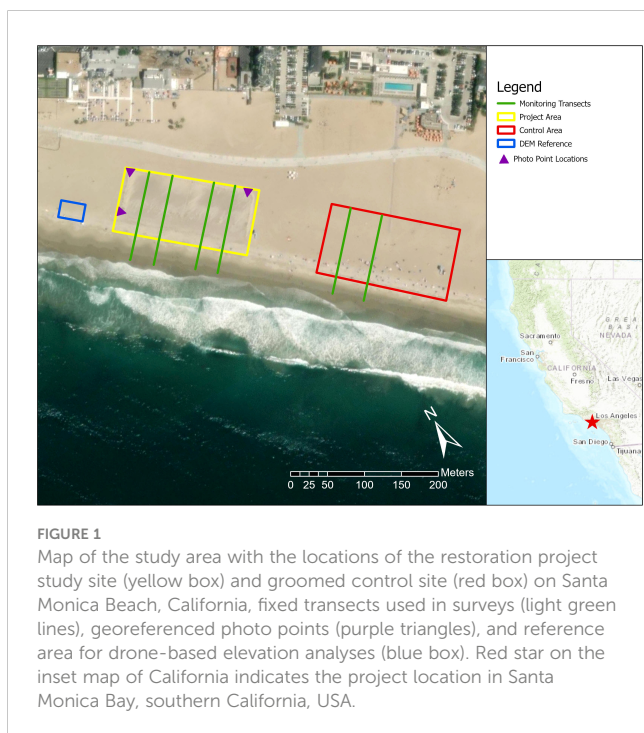
Surveys were conducted to assess sand accretion, geomorphic feature formation, vegetation development, and additional biological indicators over a six-year period. Results of surveys were used to assess changes at the restoration project site including comparisons to pre-project conditions (December 2016) and comparisons to a groomed control site approximately 100 m south of the restoration site (Figure 1).

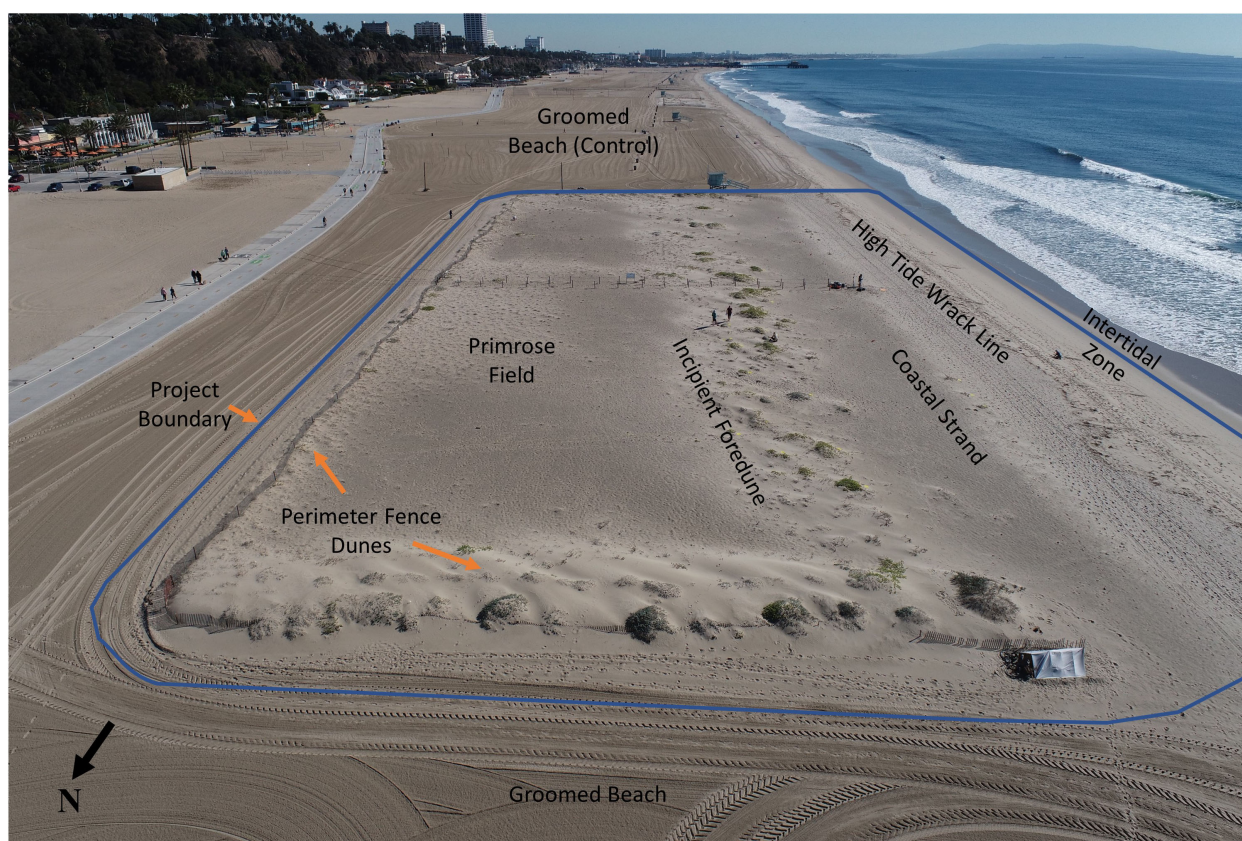
FIGURE 2

Oblique aerial photograph of the restoration project site from the 10 November 2022 UAS flight, with key elements labeled including the project boundary, perimeter fence, various habitat types, adjacent groomed beach (control site), and the incipient foredune ridge. Alongshore distance of the site was ~ 150 m, with a dune cross-shore length of ~ 60 m.

oblique aerial view of the project site taken in November 2022 shows major features including the project boundary, perimeter fence, various habitat types, incipient foredune ridge, and groomed beach (including the control site). Dunes formed along the perimeter sand fence, distinctly visible along the northern fence line. Vegetated plant hummocks and the incipient foredune ridge are visible along the perimeter of the site. The restoration site formed shadow dunes where aeolian transport deposited finer grained sand as a “tail” of some dune features, in areas where wind velocity slowed due to vegetation and reductions in the shear stress, in alignment with the prevailing wind drift vector (Figure 2).

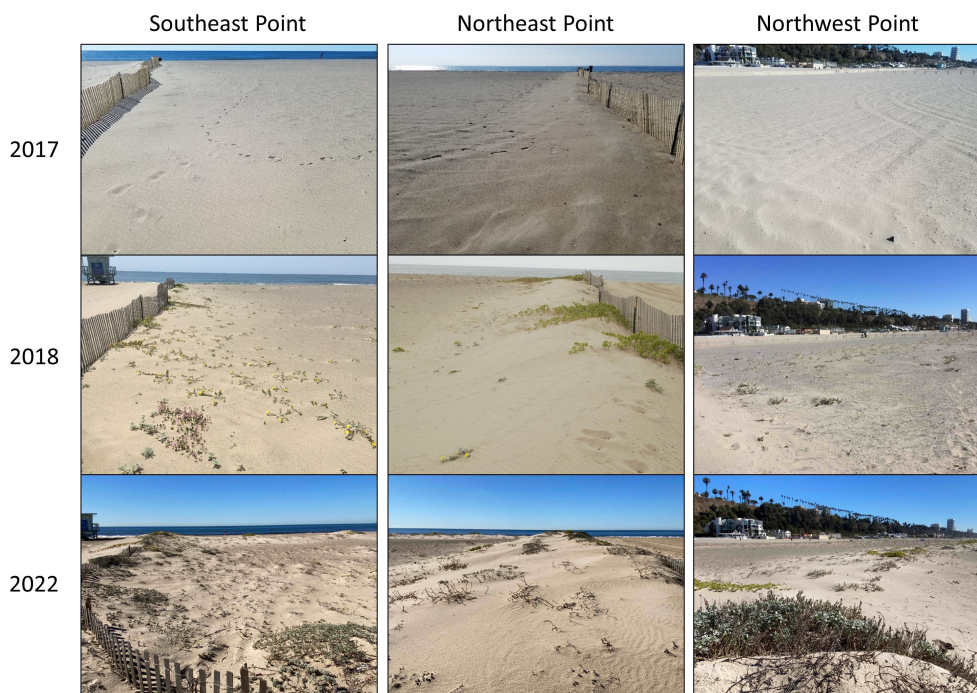
FIGURE 3

Combination panel of georeferenced photographs of the restoration site over time. Top photographs were taken in January 2017, middle in May 2018, and bottom in November 2022. Left series is the southeastern portion of the restoration area and fence line, middle is the northeastern point and fence line, and right is the northwest point facing south across the incipient foredune ridge.

Sand accretion in the restoration site led to dune forms that increased in height and became more complex over time. Changes in vegetation and topography over time are illustrated in the photograph series (Figure 3). The series begins with the first time point (top photos) about a month after the restoration project was installed (January 2017), in May 2018 (middle photos), and ends in November 2022 (bottom photos) (Figure 3, see also Figure 2). The photograph series shows the gradual growth of plants, increases in elevation and changes in topography, including the formation of the incipient foredune ridge (Figure 3, Northwest Point). Plants were repeatedly buried or partially buried by sand, and then continued to grow above the newly deposited sand. The perimeter sand fence was buried over time (e.g., Figure 3, Northeast Point, 2022, and Figure 2).

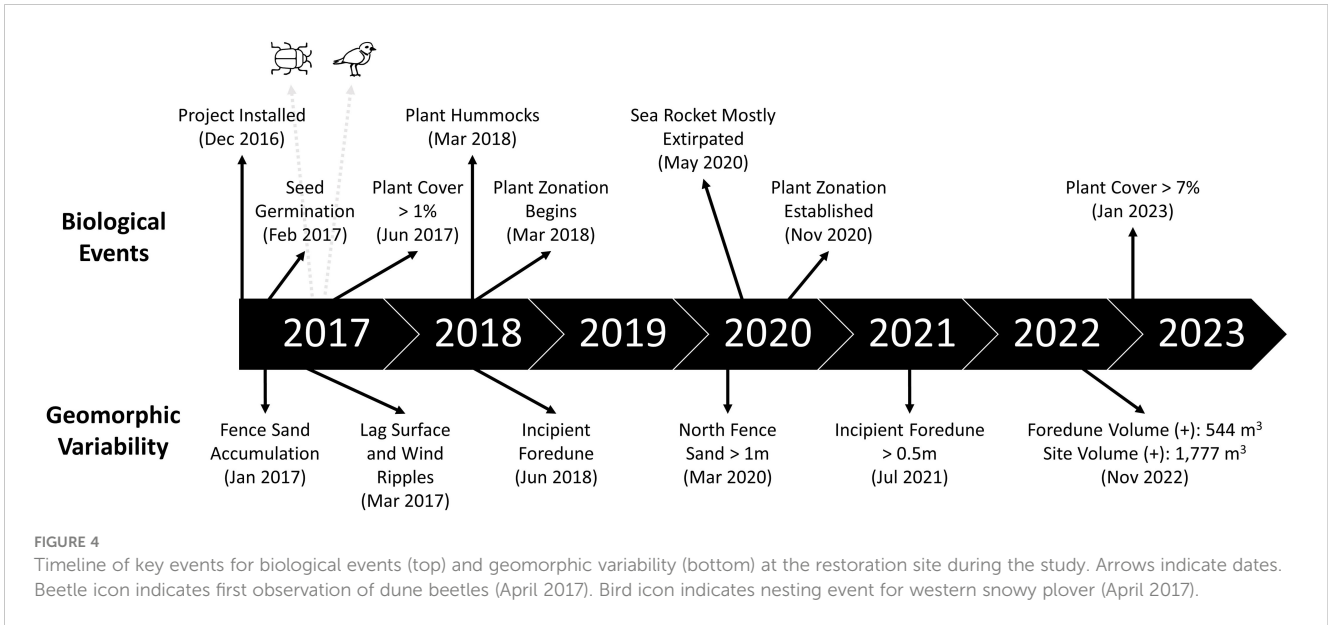
Key vegetation establishment and geomorphic variation events are presented on a restoration timeline in Figure 4, including early sand capture along the fence (within one month of implementation), plant germination (within two months), and the formation of a lag surface

with small pebbles and larger sand grain sizes (within three months). The formation of the incipient foredune ridge was initiated within 18 months of project implementation, beginning with small plants forming hummocks less than 0.5 m in width.

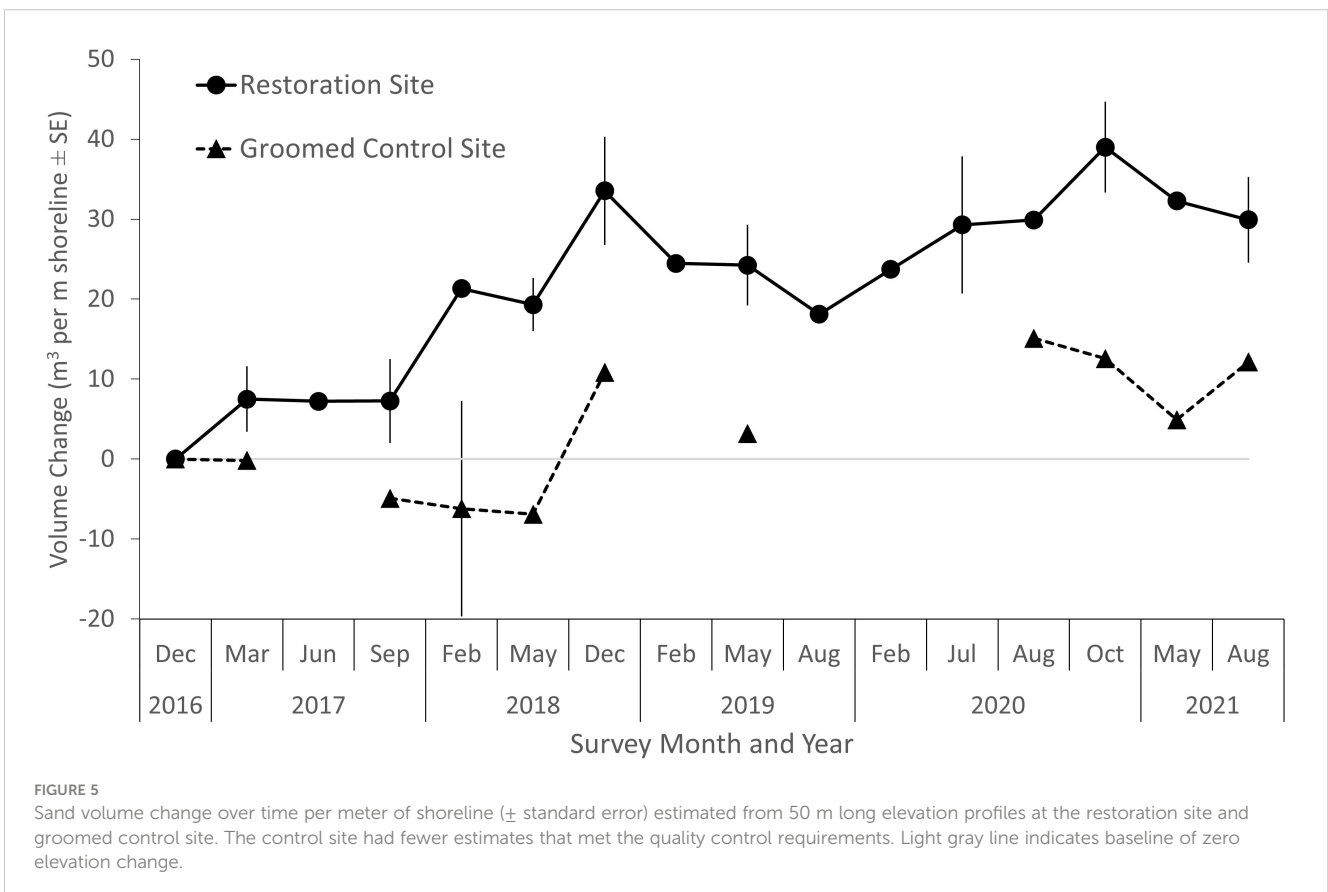
followed an asymptotic curve (Figure 5), with variation in volume change relative to the pre-project conditions. By August 2021, the estimated increase in sand volume was 30 m³ per m of shoreline (Figure 5). At the control site, net sand volume change was lower and varied over time, with erosion in the first two years, and accretion in later years. The dynamics of the variation in the control transects are most likely artifacts of beach grooming

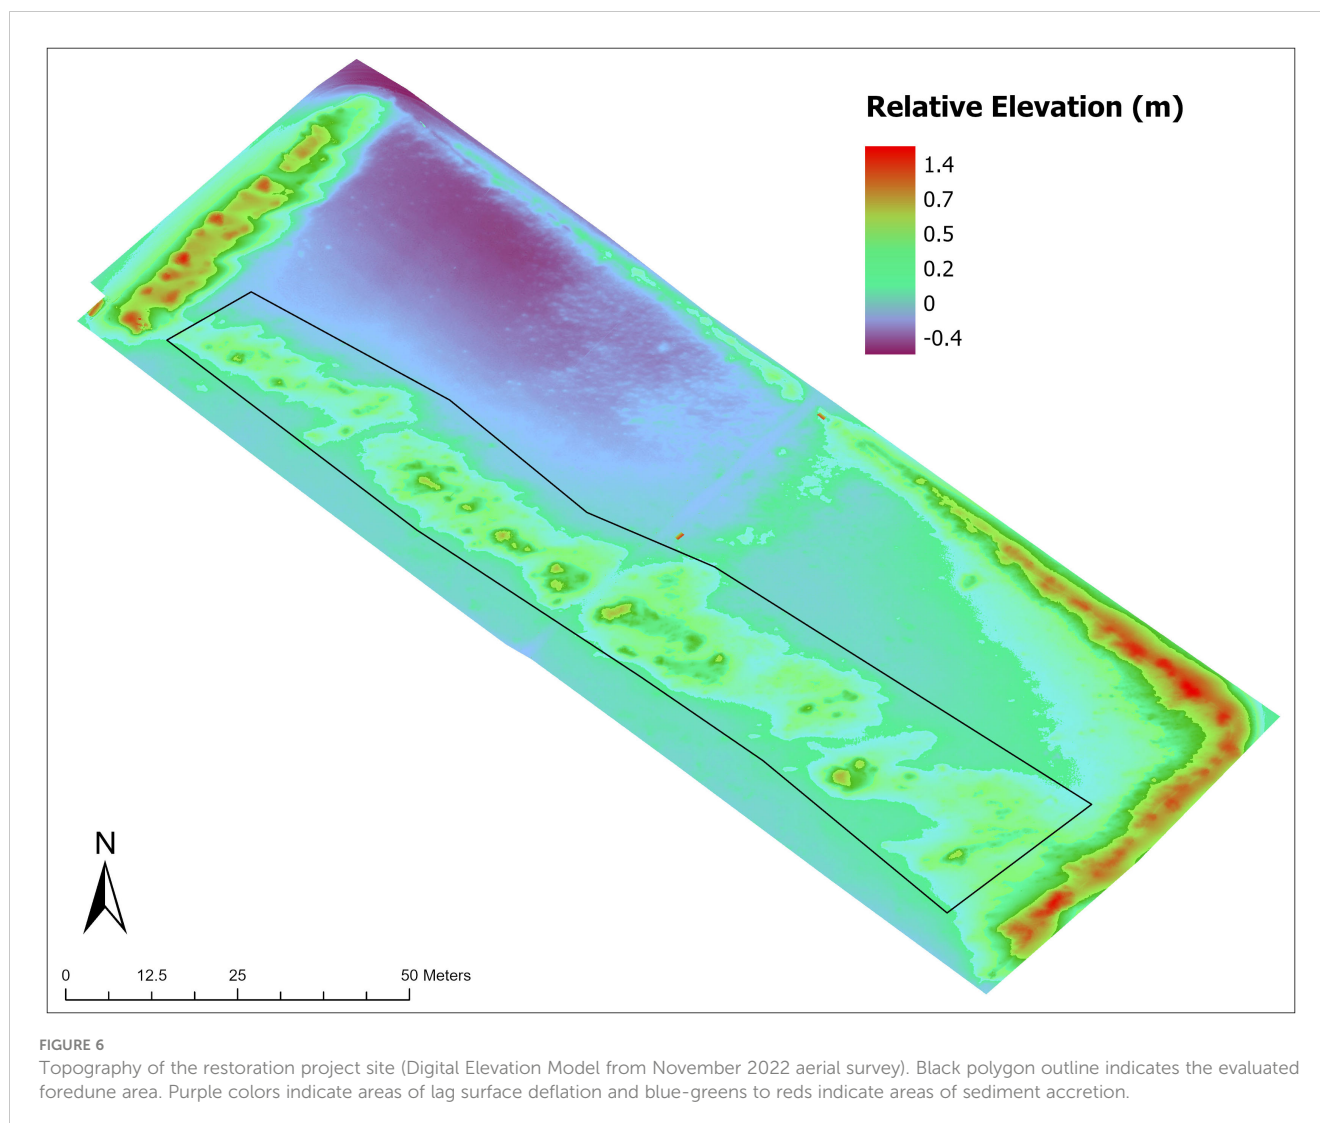
A large amount of sand accumulated along the perimeter fence and the incipient foredune ridge by 2022, along with some erosion in the northern corner of the restoration site (lag surface), and sediment accumulation across the southern half of the site that was similar to the qualitative assessments from the georeferenced

photographs (Figure 6, see also Figure 2). The area of the DEM as defined by the restoration project boundary was 7,777 m². The mean elevation of the restoration site was 0.22 m above the reference control box located outside of the restoration area (Figure 1). The estimated net sand accretion in the restoration site was 1,726 m³. This volume of sand is the equivalent of 2,760 metric tons (using 1,600 kg per m³). The DEM evaluation yielded a volume of approximately 12 m³ of sand per m of shoreline; and an average annual rate of accretion of 2 m³ per meter of shoreline (3 metric tons) per year.

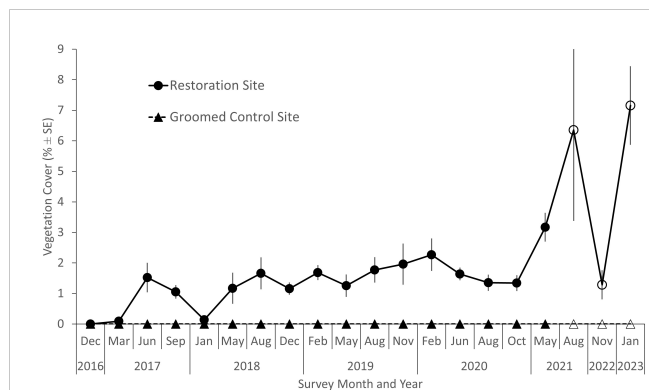
FIGURE 7 Average native vegetation cover over time at the restoration site and groomed control site (\pm standard error). Note: open circles and triangles in August 2021, November 2022, and January 2023 were collected with random transects instead of fixed and the time scale varies.

maximum of approximately 7% native cover by the sixth year (Figure 7, January 2023). Non-native plant cover remained very low across all surveys (\ll 1%). Plant cover varied seasonally due primarily to dormancy of some species, the burial of vegetation by

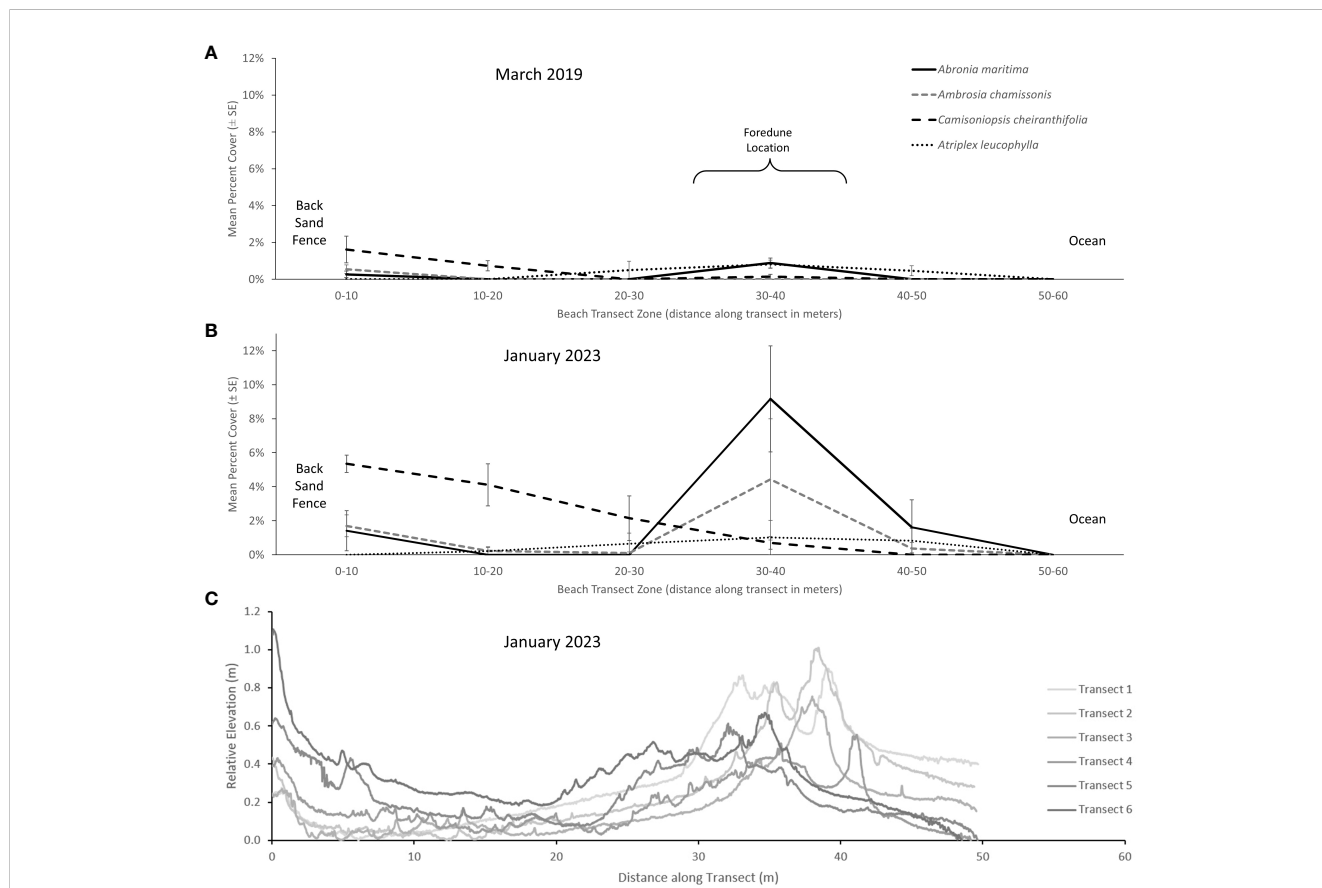
FIGURE 8 The distribution of mean values of cover (\pm standard error) for the three dominant species of native dune plants across 10 m zones extending from the landward (left) to the open ocean perimeters (right) of the restoration site for surveys in (A) March 2019 and (B) January 2023. The incipient foredune ridge occurs largely within the 30-40 m zone. (C) Topography of the restoration site as shown by transects of relative elevation profile extending from the back sand fence to the open ocean perimeter extracted from the January 2023 DEM survey.

Zonation of native plant species developed at the restoration site over time (Figure 8A, B). Although all plant species were seeded evenly across the site, zonation patterns developed rapidly (evident in mid-2018, approximately 18 months after project

Plant zonation was directly associated with areas of sand accumulation based on elevation profiles from the DEM (Figure 8C); areas with higher plant cover also had the highest relative elevation of sand (e.g., sand fencing and foredune areas, Figure 8B). Even with a low cover of dune-forming vegetation $< 2\%$ in the foredune (e.g., Figure 8A, March 2019), the foredune had already accumulated up to 30 cm of sand associated with individual plant hummocks such as *A. maritima* and *A. chamissonis* (see also Figure 4, Supplemental Data A). Accelerated sand accumulation was associated with the foredune plants; by May 2019, an incipient foredune could be identified in the elevation profiles (Supplemental Data A). As the vegetation established and the cover of key dune forming species increased, the resulting relative elevation of the foredune and sand fence showed the continued accretion of sand (Figure 8B, C). By January 2023, the foredune contained the highest plant cover observed and reached a relative maximum elevation of > 0.8 m in several places.

Elevations varied considerably across the restoration site in the recent surveys (Figure 8C). The DEM elevation profiles in the northern portion of the restoration site (e.g., Transects 1 and 2, Figure 8C) display the lower elevation lag surface areas (left-hand side of the graph). In contrast, the elevation profiles in the southern portion of the restoration site (e.g., Transects 5 and 6) display the

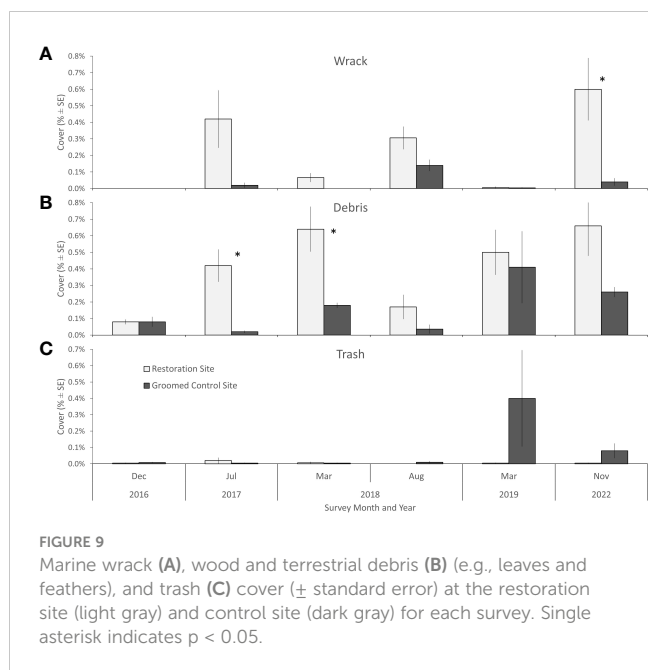
Overall, the cover of marine wrack was very low ($< 1\%$ cover, range 0.0-0.6%) across all surveys at both the restoration and control sites (Figure 9A). The cover of marine wrack was slightly higher in the restoration site compared to the control site for four of the five surveys, with higher cover (> 15 times the control cover) recorded for only one survey (November 2022) (Figure 9A, Kruskal-Wallis (KW) test, $H(5) = 2.76$, $p < 0.05$). Marine wrack was dominated by *Macrocystis pyrifera* (giant kelp), *Phyllospadix torreyi* (surfgrass), and other species common to the study region. The cover of terrestrial debris was also low, averaging $< 1\%$ cover (range 0.0-0.7%) across all surveys (Figure 9B). This material was dominated by small bits of wood, leaves, feathers, and other biological debris washed ashore by waves. The cover of terrestrial debris was slightly higher in the restoration site compared to the control site in four surveys, with substantially higher cover recorded (3 and 30 times higher than control site) for two surveys: July 2017 (KW test, $H(5) = 3.93$, $p < 0.05$; Figure 9B) and March 2018 (KW test, $H(5) = 3.16$, $p < 0.05$). The mean cover of trash was low overall ($< 0.1\%$ cover, range 0.0 to 0.4%) but slightly higher in the control site than the restoration site; trash did not differ between the two sites in any of the surveys (Figure 9C). With the exception of the March 2019 survey of the control site (cover = $0.4 \pm 0.3\%$), the rest of the surveys found $< 0.1\%$ cover of trash.
