Preliminary Evaluation of Proposed LLPRS Rigid Pavement Structures and Design Inputs

CALIFORNIA DEPARTMENT OF TRANSPORTATION

J. Harvey, J. Roesler, J. Farver, and L. Liang

May 2000

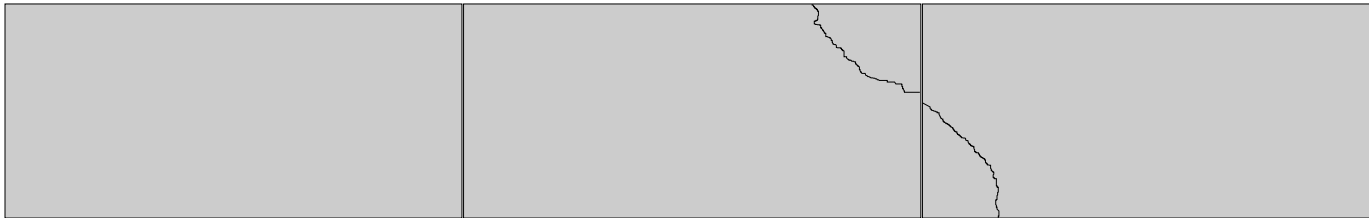
Figure 3. Typical corner cracks in rigid pavements.

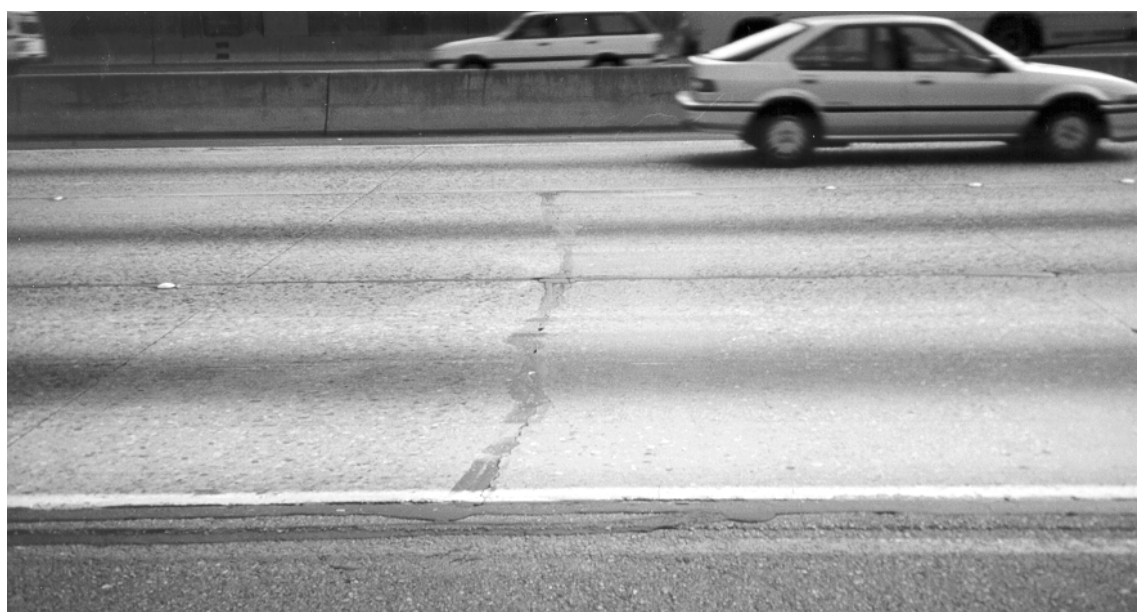
Figure 24. Pavement distresses at postmile 23.7 southbound, Interstate 5, Los Angeles County: transverse fatigue cracking and perpendicular joints.

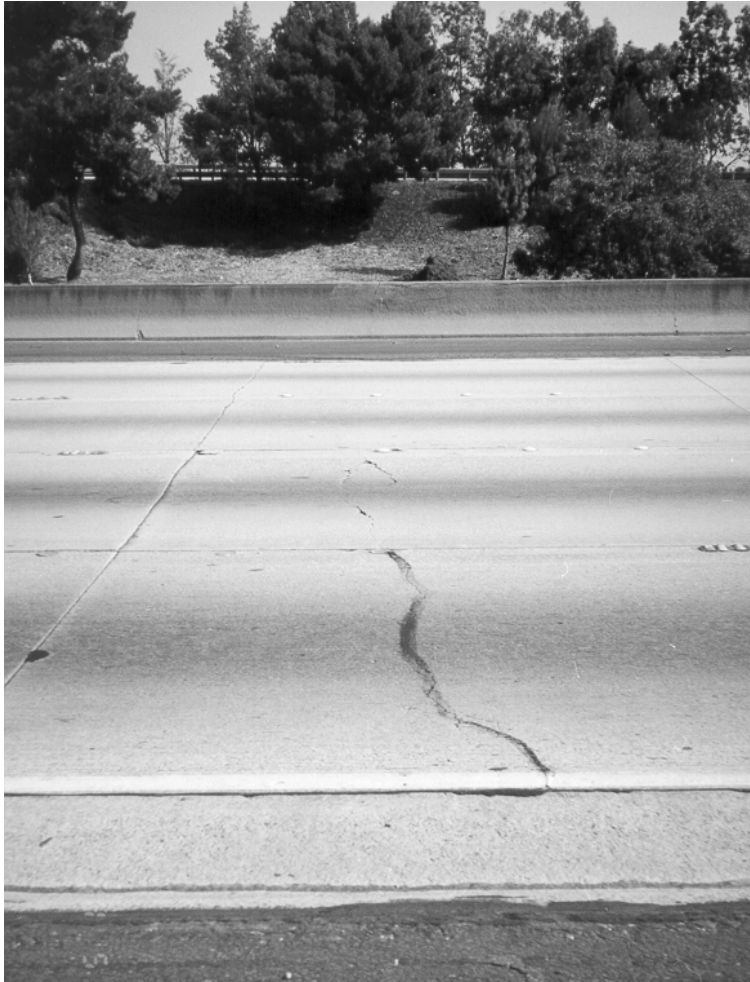
Figure 25. Pavement distresses at postmile 34.9 southbound, Interstate 5, Los Angeles County: transverse fatigue cracking and perpendicular joints.

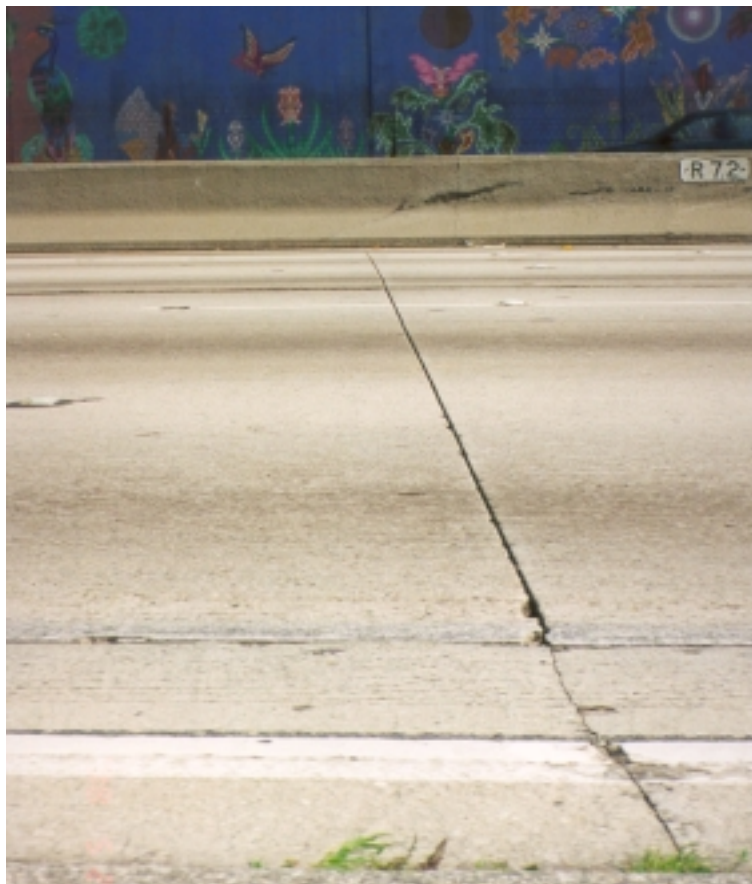
Figure 26. Pavement distress at postmile 12.9 westbound, Interstate 10, between Los Angeles and District 7/District 8 boundary: large joint openings, faulting, no cracking.

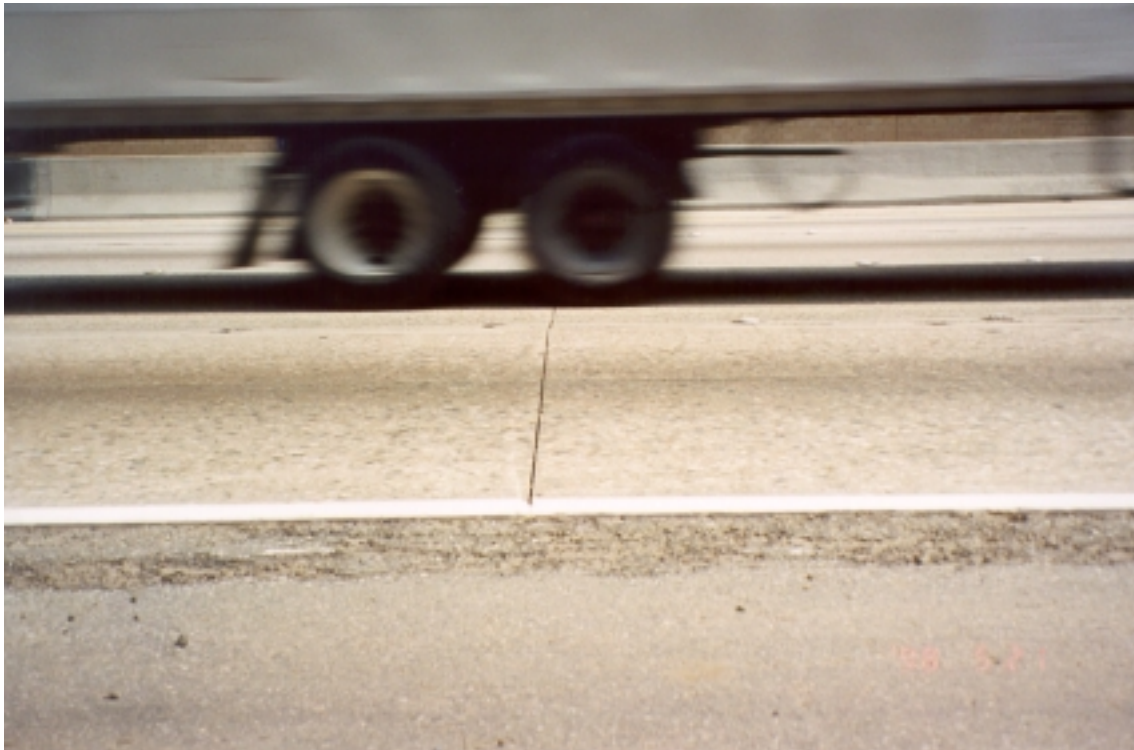
Figure 27. Pavement distress at postmile 30.0 eastbound, Interstate 10, between Los Angeles and District 7/District 8 boundary: large joint openings, no cracking.

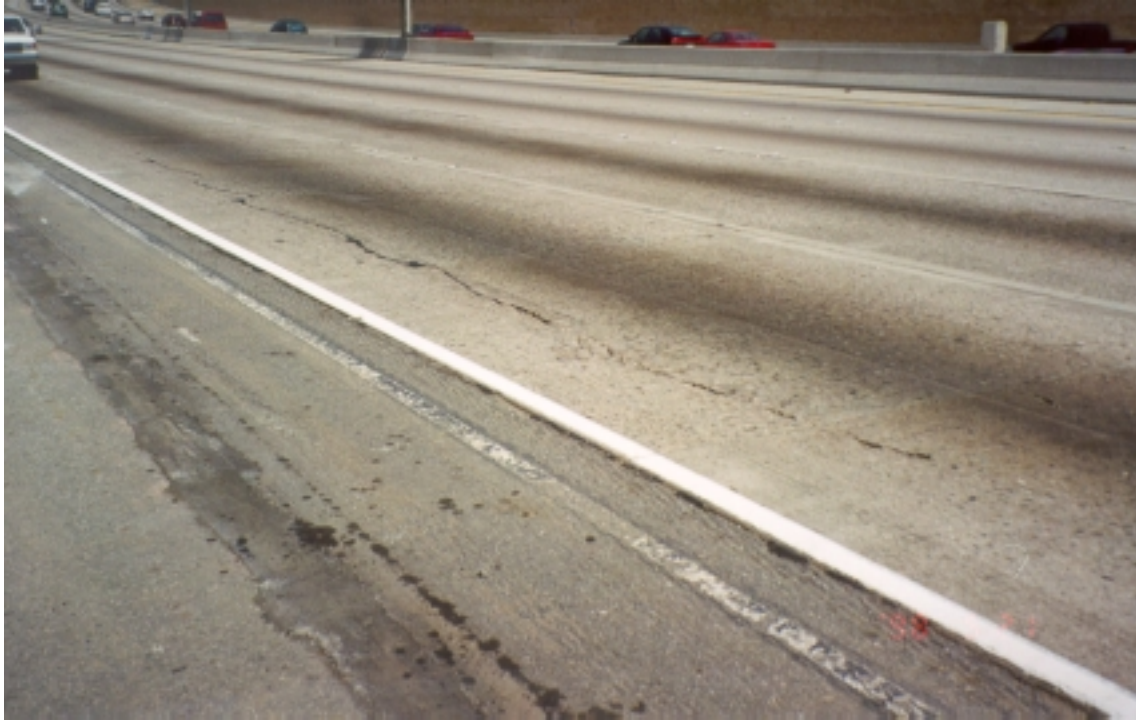
Figure 28. Pavement distresses at postmile 30.0 eastbound, Interstate 10, between Los Angeles and District 7/District 8 boundary: longitudinal cracking.

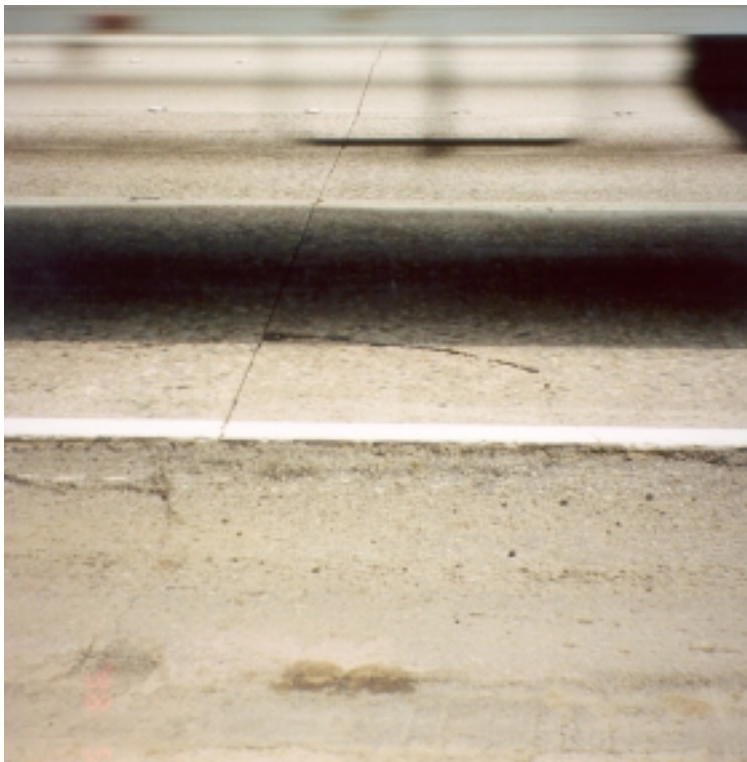
Figure 29. Pavement distresses at postmile 30.0 eastbound, Interstate 10, between Los Angeles and District 7/District 8 boundary: corner cracking.

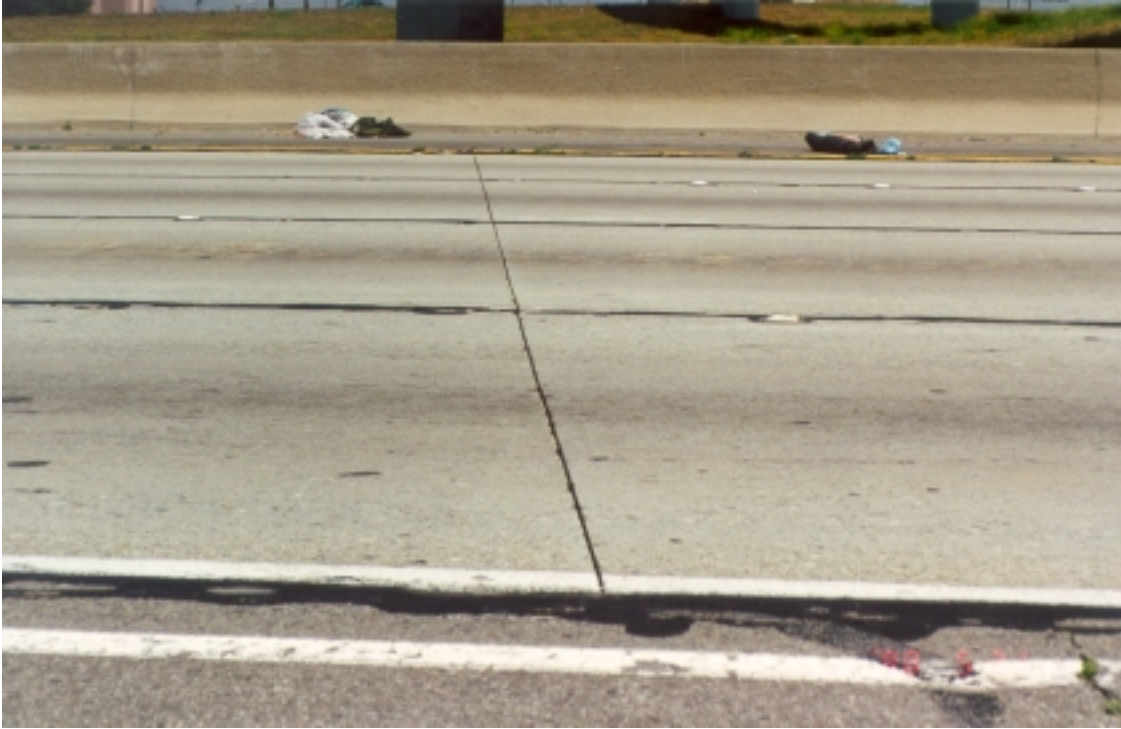
Figure 31. Pavement distress at postmile 9.6 eastbound, Interstate 10, San Bernardino county: large joint opening.

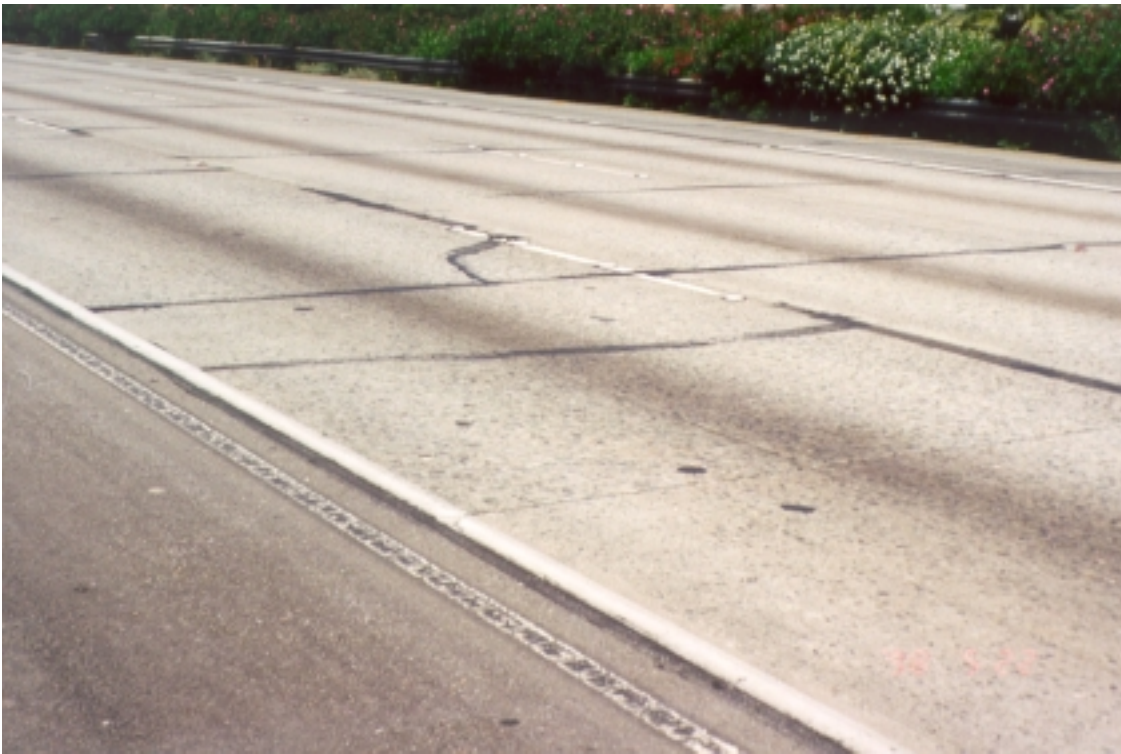
Figure 32. Pavement distress at postmile 7.7 southbound, Interstate 215, District 8: sealed corner and transverse fatigue cracking.

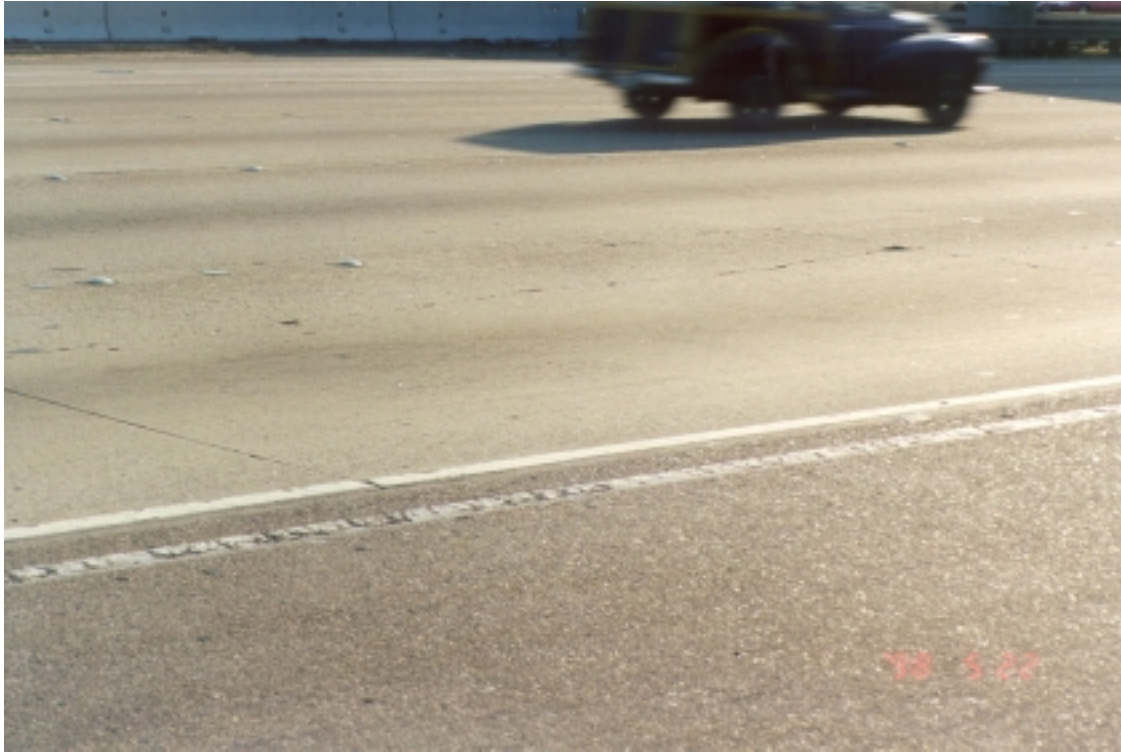
Figure 33. Pavement distress at postmile 2.7 northbound, Interstate 405, District 12: longitudinal cracking.

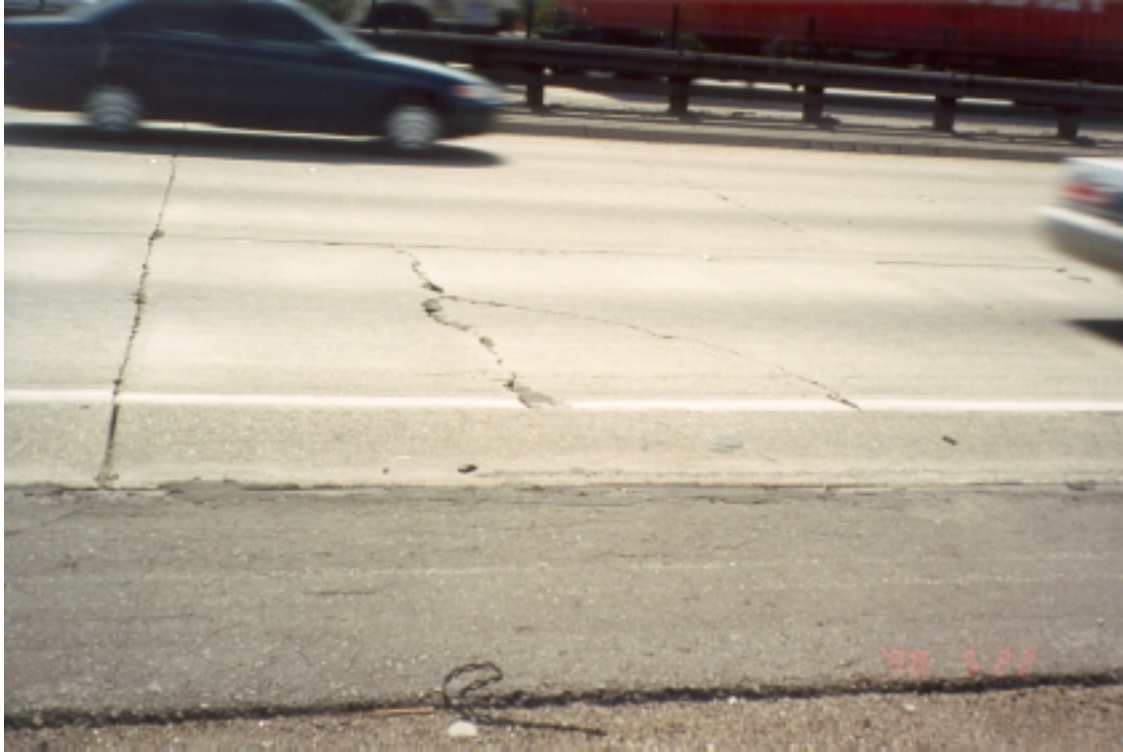
Figure 34. Pavement distress at postmile 8.3 southbound, Interstate 710: transverse fatigue cracking and badly spalled, badly faulted joint.

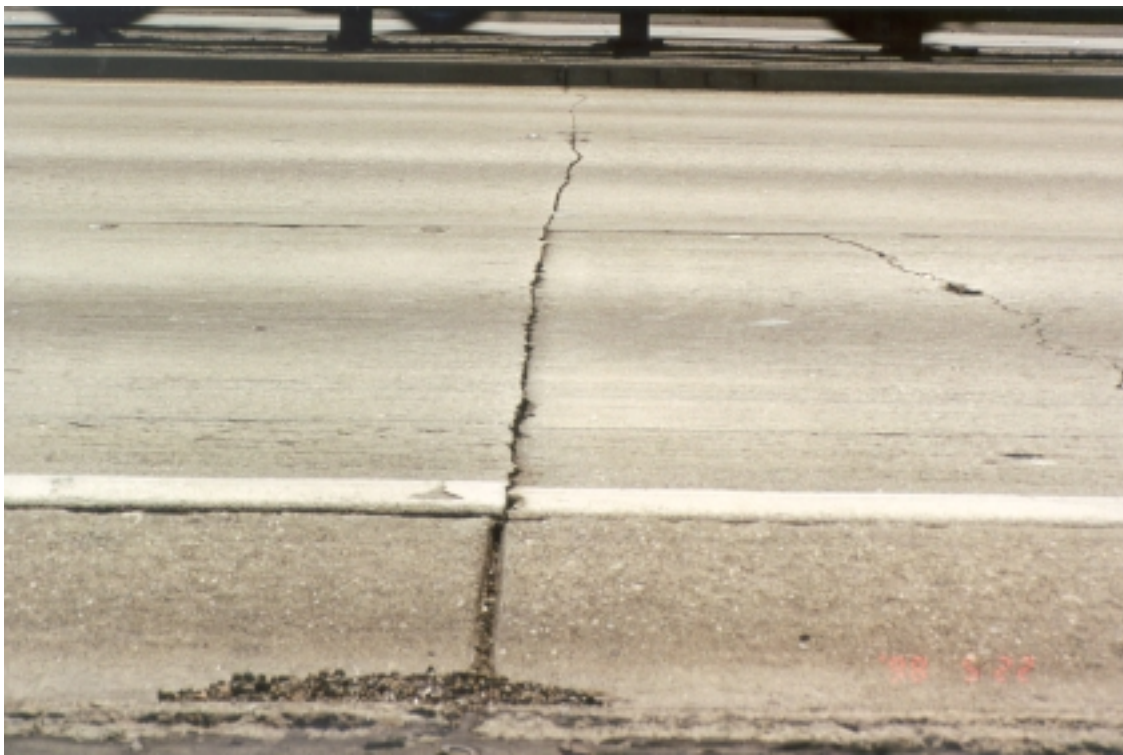
Figure 35. Pavement distress at postmile 8.3 southbound, Interstate 710: spalled joint, transverse fatigue cracking.

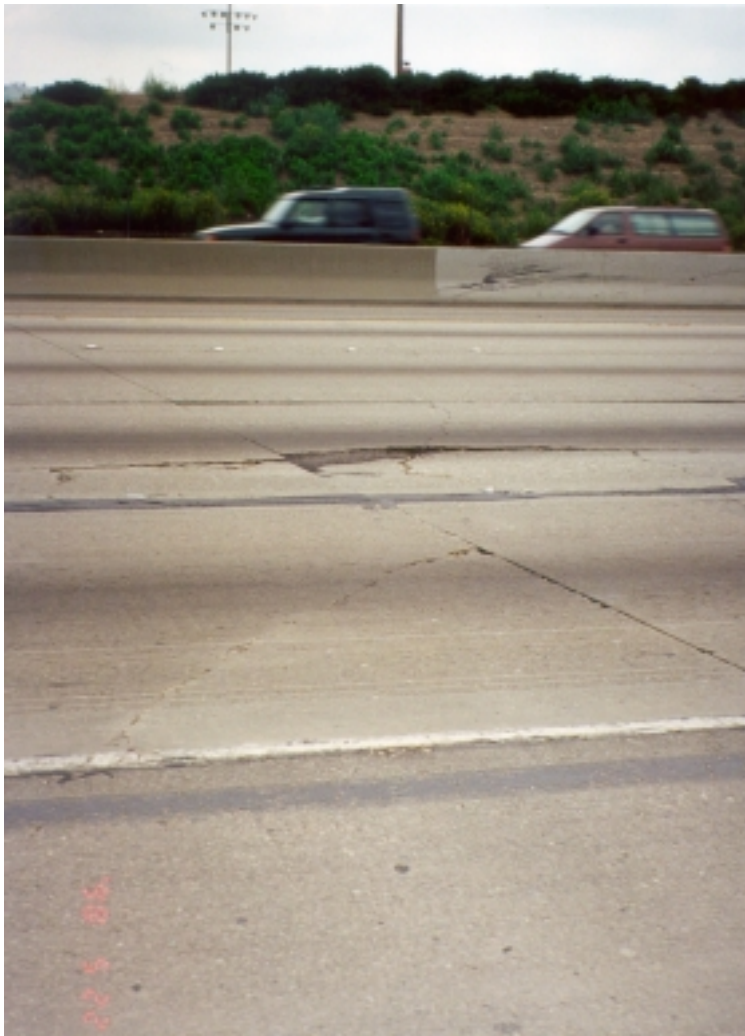
**Figure 36. Pavement distress condition at postmile 17.3 westbound Interstate 60, District 7: corner cracking, transverse cracking, moderate faulting.**

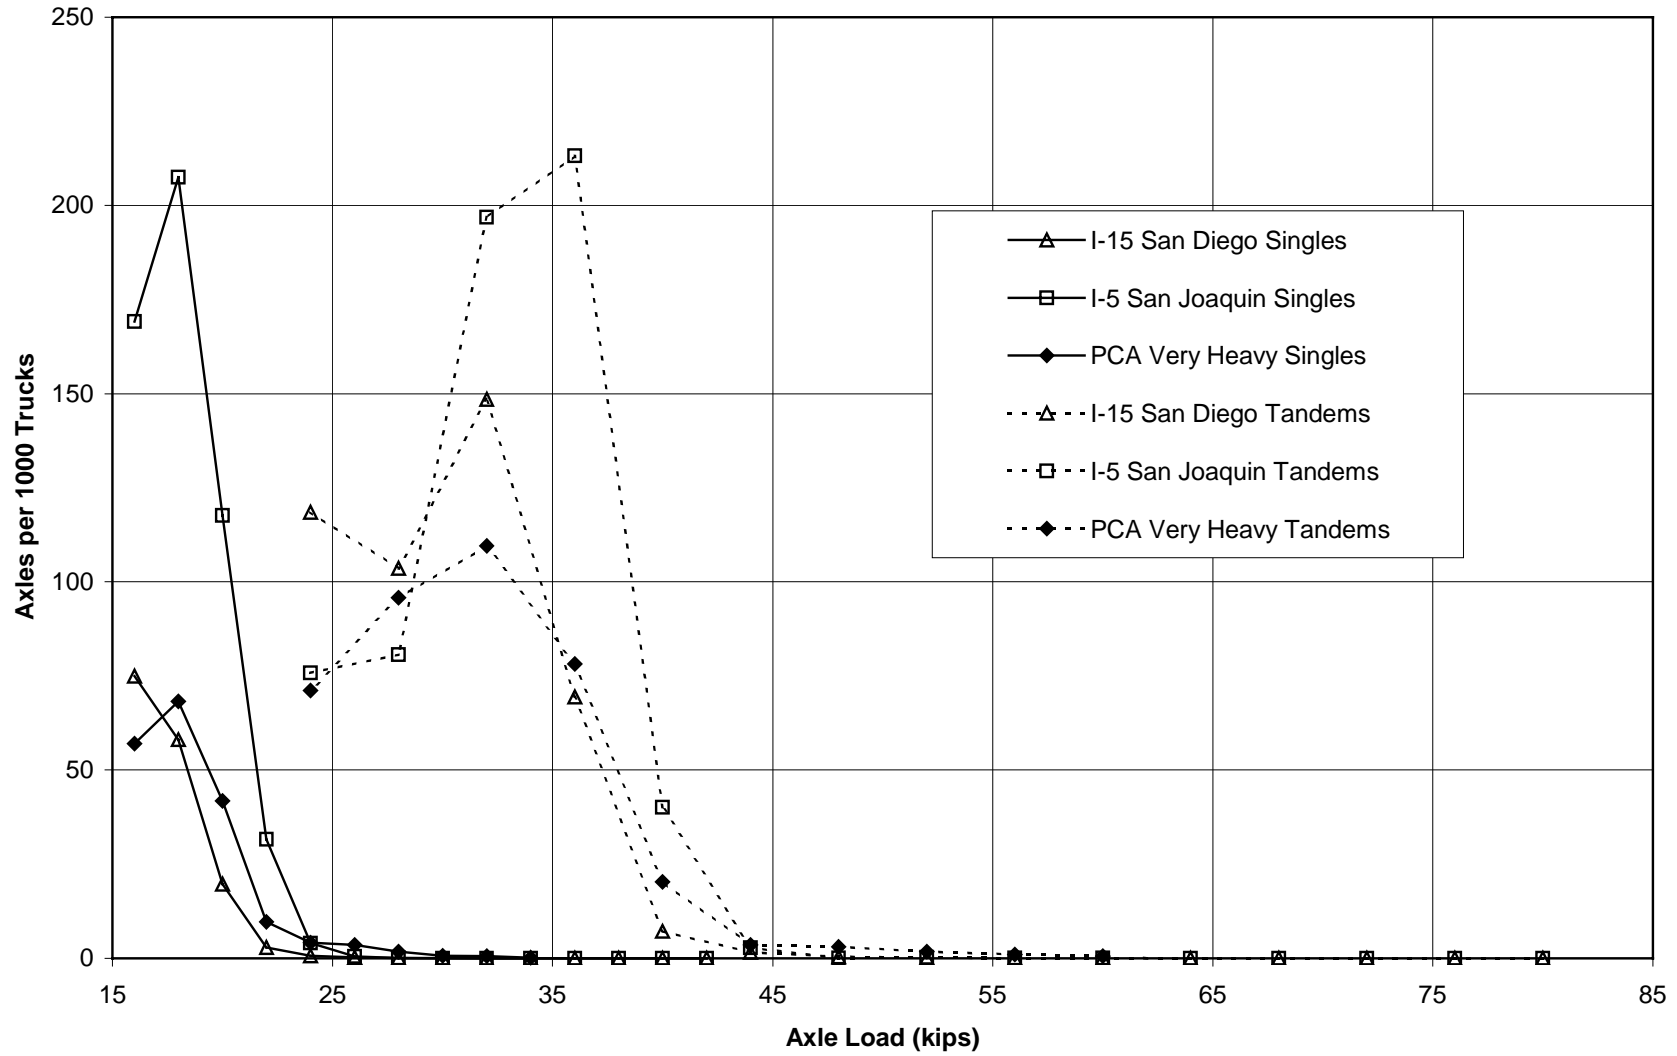
Figure 37. Comparison of PCA “very heavy,” I-5 San Joaquin County, and I-215 San Diego County axle load spectra.

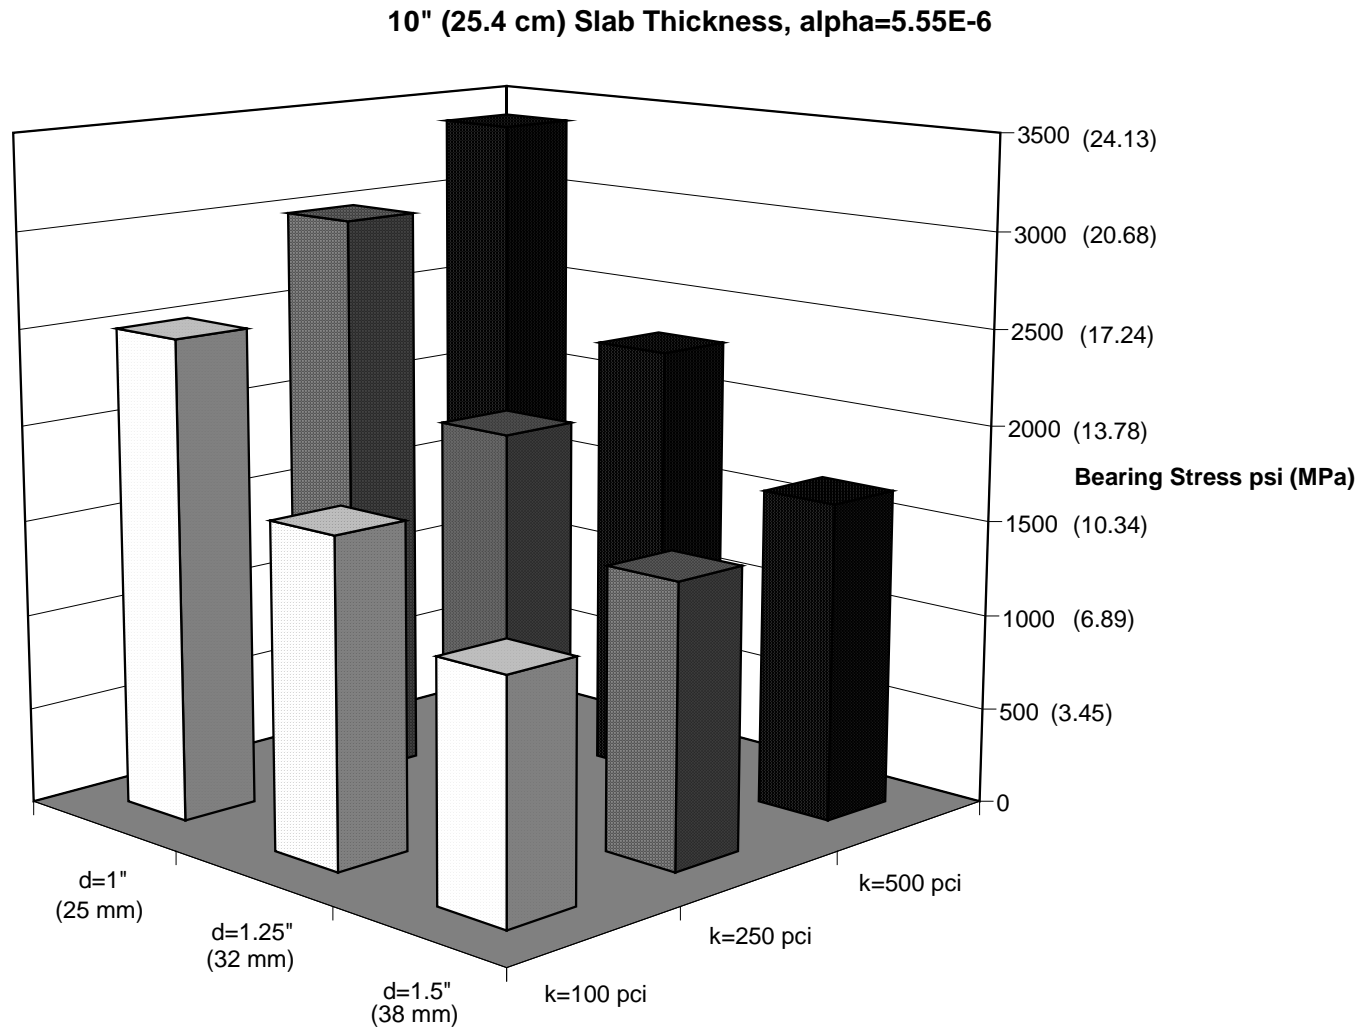
Figure 40. Dowel/Concrete Bearing Stress Versus Dowel Size and Subgrade Stiffness.

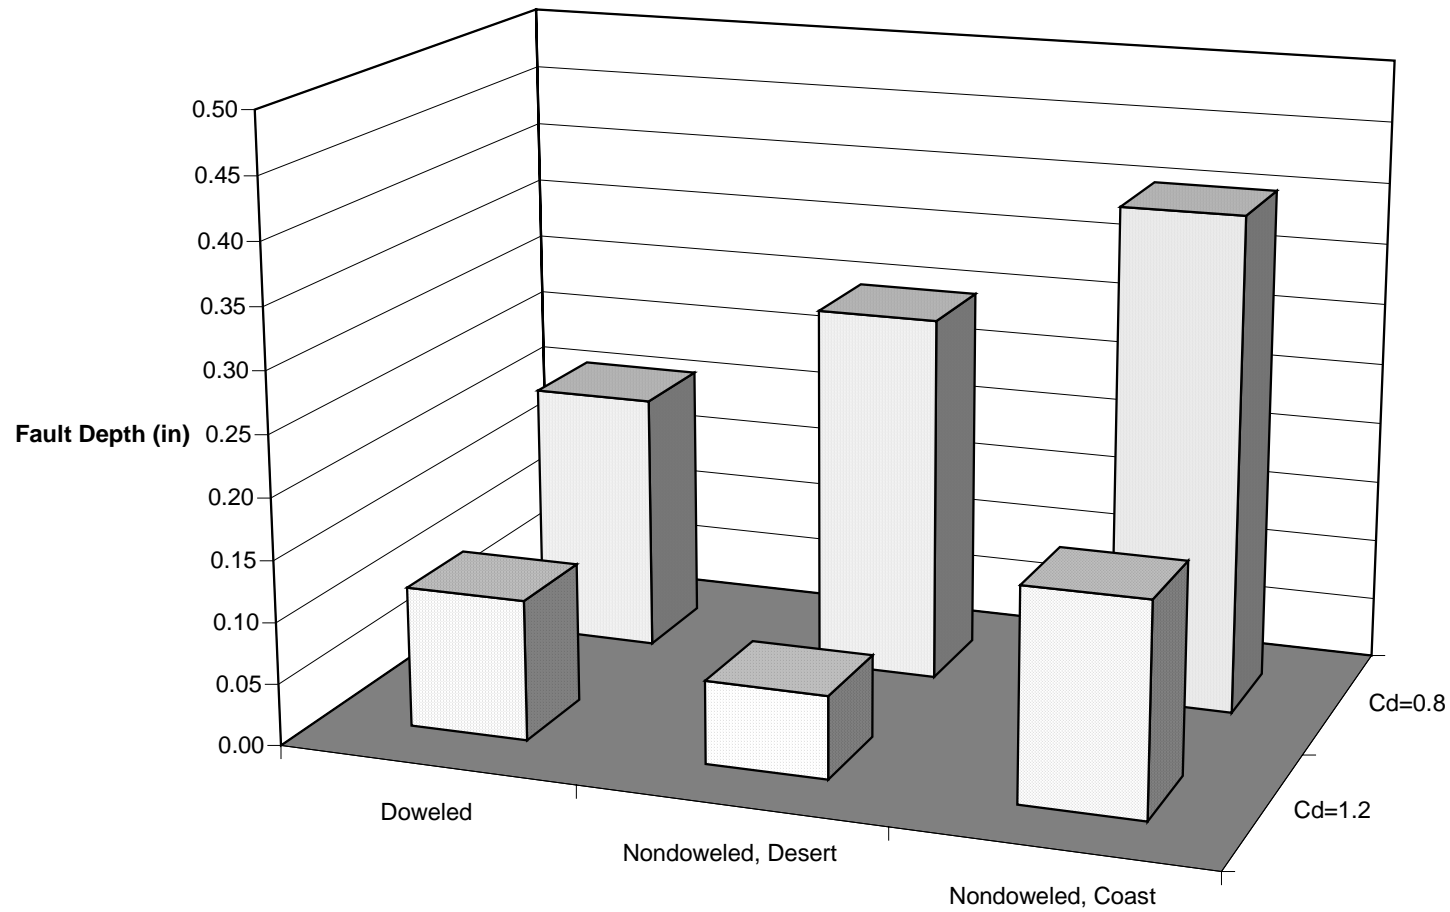
2500 psi (17.24 MPa) Bearing Stress, 15' (4.57 m) Joint Spacing, 8" (20.3 cm) Slab, San Joaquin Traffic, Granular Base, No Widened Lanes, at 20 years

Figure 43. Effects of drainage, dowels, and environment on faulting.
