Comparative OBSI Testing in Northern California: The Davis Rodeo

Part of Partnered Pavement Research Program (PPRC) Strategic Plan Element 4.39:
Continued Monitoring of Selected Quieter Pavement Test Sections

DOCUMENT RETRIEVAL PAGE		UCPRC Reprint Report No.: UCPRC-RP-2014-01		
Title: Comparative OBSI Testing in Northern California: The Davis Rodeo				
Author: Paul R. Donovan				
Caltrans Technical Leads and Reviewers: Bruce Rymer, Linus Motumah, Rupinder Dosanjh				
Prepared for: California Department of Transportation, Division of Research, Innovation, and System Information		FHWA No.: CA152380A	Date Work Submitted: January 2013	Date: January 2013
Strategic Plan Element No.: 4.39	Status: Stage 6, final version		Version No.: 1	
Abstract: This is a reprint of a report written for Caltrans and the University of California Pavement Research Center as part of Partnered Pavement Research Program Strategic Plan Number 4.39, the continued monitoring of selected quieter pavement test sections. The goal of this program is to identify quieter, smoother, safer, and more durable pavement surfaces. The report describes a series of comparative OBSI tests in a so-called "rodeo" performed on 19

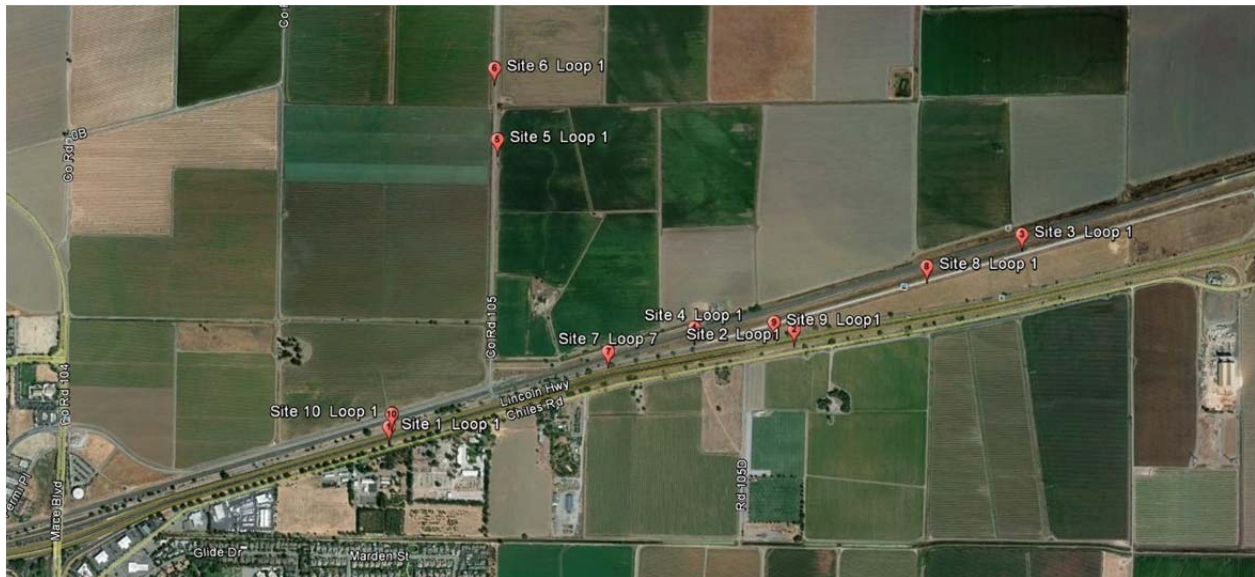
Figure 1: Location of test sites on Rodeo Loop 1

The sites were grouped into two loops with the intent that the testing at each loop would be completed simultaneously by all three teams before moving to the next loop. The locations of the sites in Loop 1 are shown in Figure 1. Several of these sites have been used in previous comparative testing including 2, 3, 5, 6, 8, and 9. In addition, sites 3, 5, 6, and 8 have been routinely used by PRC for on-going calibration. Specific information on each site in Loop 1 is

provided in Table 1. The length of Loop 1 was 12.9 miles resulting in an approximate test time of 15 minutes per circuit given stops and turnarounds. The loop began at the Mace Road

entrance onto I-80, followed I-80 eastbound to the Chiles Road exit which loops around to westbound County Road (Co) 32, proceeds northbound on Co 105 past Site 5. After a turnaround farther up Co Rd 105, the loop proceeds southbound to Co Rd 32 eastbound and back on to westbound I-80 to the Mace Road exit.

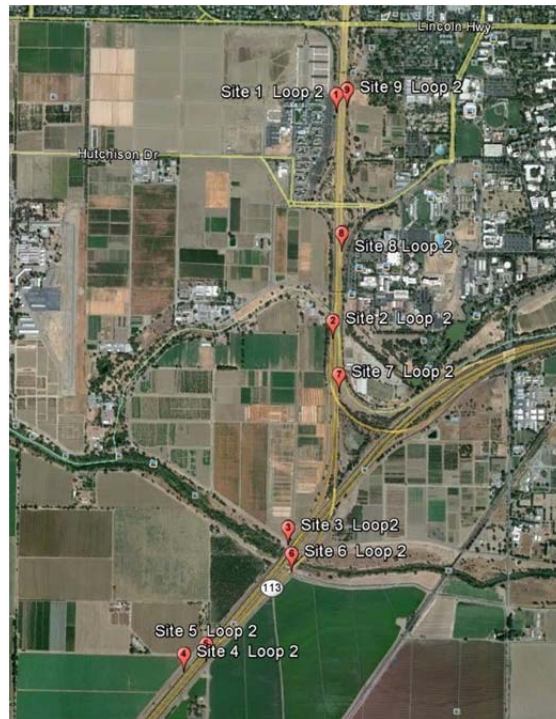
Figure 2: Location of test sites on Rodeo Loop 2

The nine test sites on Loop 2 are shown in Figure 2. This loop is approximately 6.8 miles in

length and can be traversed in about 9 minutes with turnarounds. Information on these sites is provided in Table 2. This loop begins southbound on State Route (SR) 113 from the Lincoln

Highway ramp, proceeds southbound exiting on to westbound I-80, proceeds on I-80 to the Kidwell Road exit used as a turnaround to eastbound I-80. After two sites on eastbound I-80, the loop follows northbound SR 113 back to the Lincoln Highway exit for a turnaround back onto the loop.

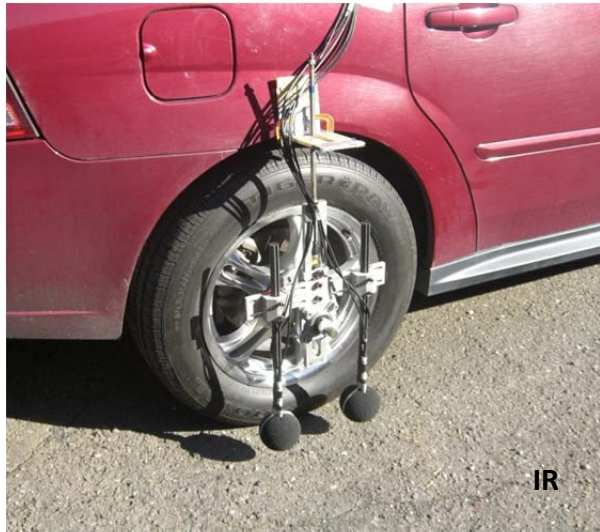
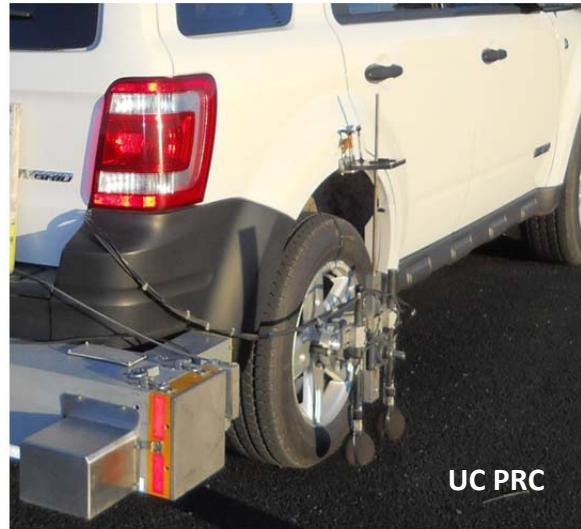
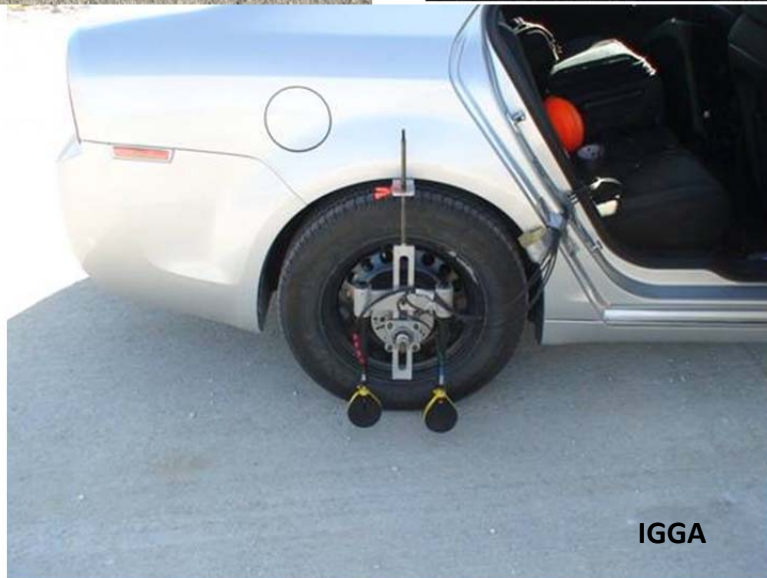
Figure 3: OBSI fixtures on IR, UC PRC, and IGGA test vehicle

All three teams used similar OBSI fixtures, microphones, and preamplifiers to acquire the sound pressure signals needed to measure sound intensity. These are shown mounted on test vehicles for each team in Figure 3. Each team did use different analyzers to process the signals into sound intensity levels. IGGA uses a five-channel Brüel & Kjaer PULSE system to produce the leading and trailing edge probe signals into sound intensity levels. PRC uses a four-channel Harmonie box built into a Soundbook computer as produced by Sinus Messtechnik GmbH. IR uses a National Instruments (NI) analogue to digital converter to acquire four signals and processes these in a laptop computer using LabView software to obtain the sound intensity levels. This NI system also uses an external four-channel G.R.A.S. microphone power supply that in turn feeds into the computer. Prior to the on-road measurements, a bench-top comparison of the data acquisition/processing systems was completed using a G.R.A.S. Type 51AB Intensity Calibrator and the differences between systems was found to be negligible.

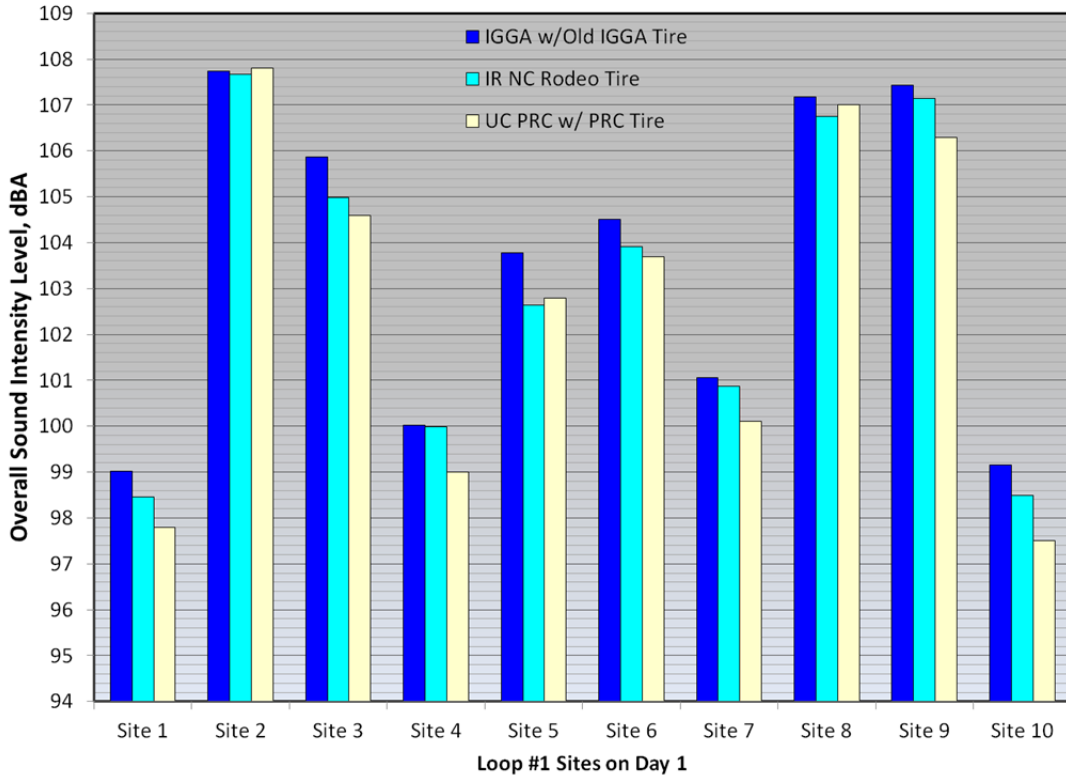
Figure 4: Overall OBSI levels for all teams on Loop 1 measured October 10th

The overall OBSI levels measured on October 10th for Loop 1 are shown in Figure 4. For these sites, the UC PRC results are typically lower than the other teams with the average difference being 0.4 dB lower than IR and 0.9 dB lower than IGGA. The range in OBSI levels between the teams was calculated on each site. The maximum range was found to be 1.7 dB and average range for all sites was 1.0 dB with a standard deviation of 0.5 dB. For the Loop 2 results in Figure 5, the levels for the UC PRC tend to be slightly higher than the other two although there is some variation in the rank ordering of the teams between the different pavements. For Loop 2, the UC PRC levels average 0.4 dB higher than IGGA and 0.8 dB higher than IR. For these data, the maximum range was 1.7 dB while the average range was 1.1 dB with a standard deviation of 0.5 dB. Since the two loops were measured at almost the same air temperature, they can be

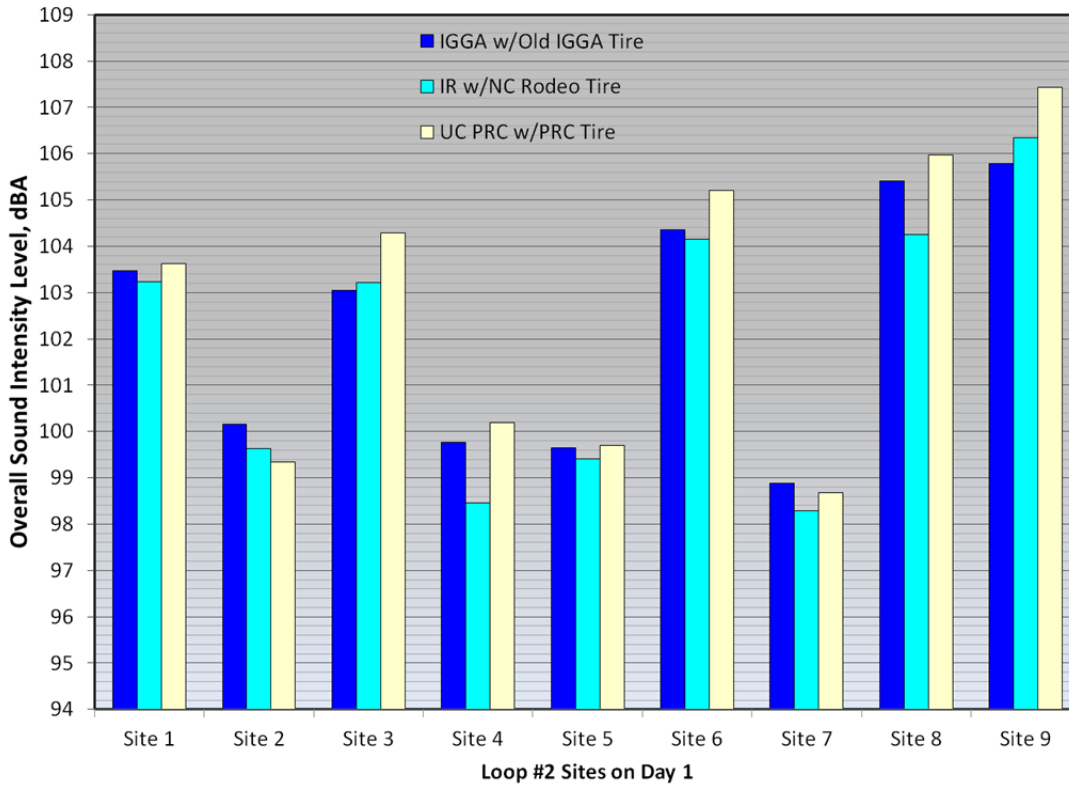
Figure 5: Overall OBSI levels for all teams on Loop 2 measured October 10th

combined to consider directly the statistics of both data sets. The results from the two loops are plotted in Figure 6 in which the individual data points are plotted against the average of the three teams for each measurement site. Compared to the average of all teams, the average for the UC

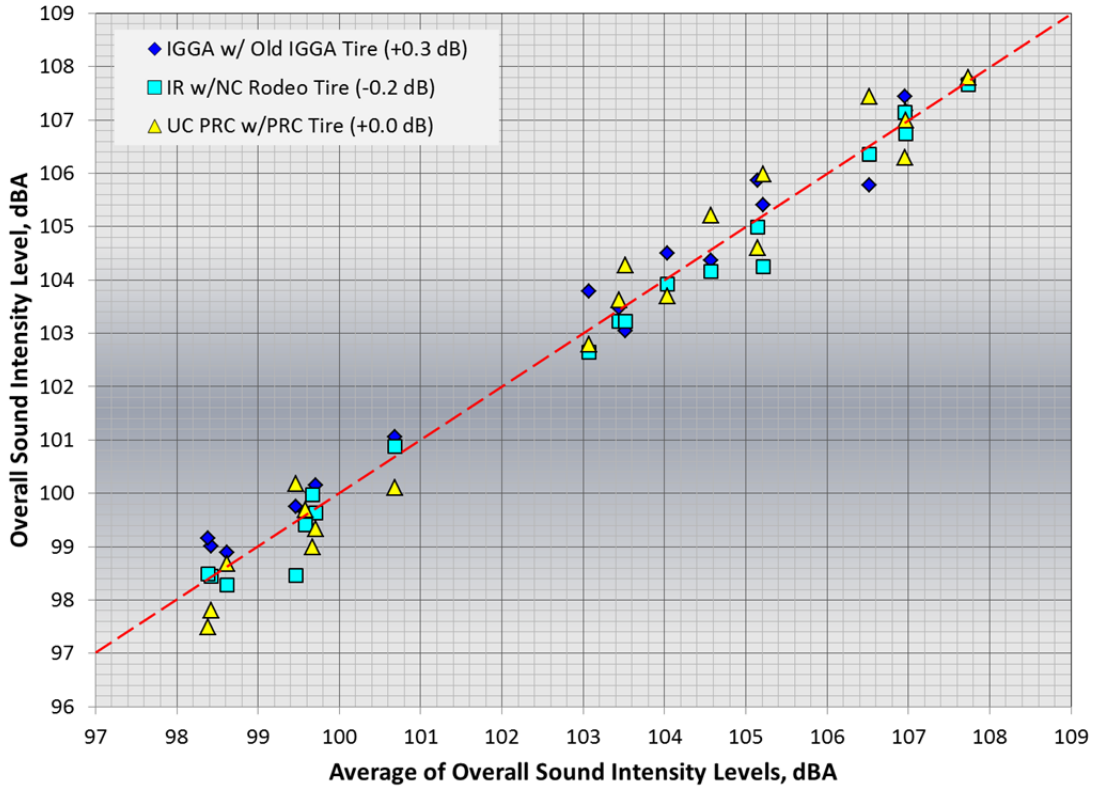
Figure 6: Plot of overall OBSI levels for each team vs. the average of teams at each test site

PRC levels is equal to the average of all teams while the IR average is 0.2 dB less and the IGGA average is 0.3 dB greater for a total range of 0.5 dB. The statistics for combined loops of this Davis Rodeo are compared to previous rodeos [3] in Table 5. The average difference or average range for the Davis Rodeo was lower than the previous rodeos by 0.2 dB to 0.5 dB. The standard deviation is similar to the others and maximum range is lower by 0.3 to 1.2 dB. The statistics are also well within the range of precision and bias statements of the TP 76 procedure.

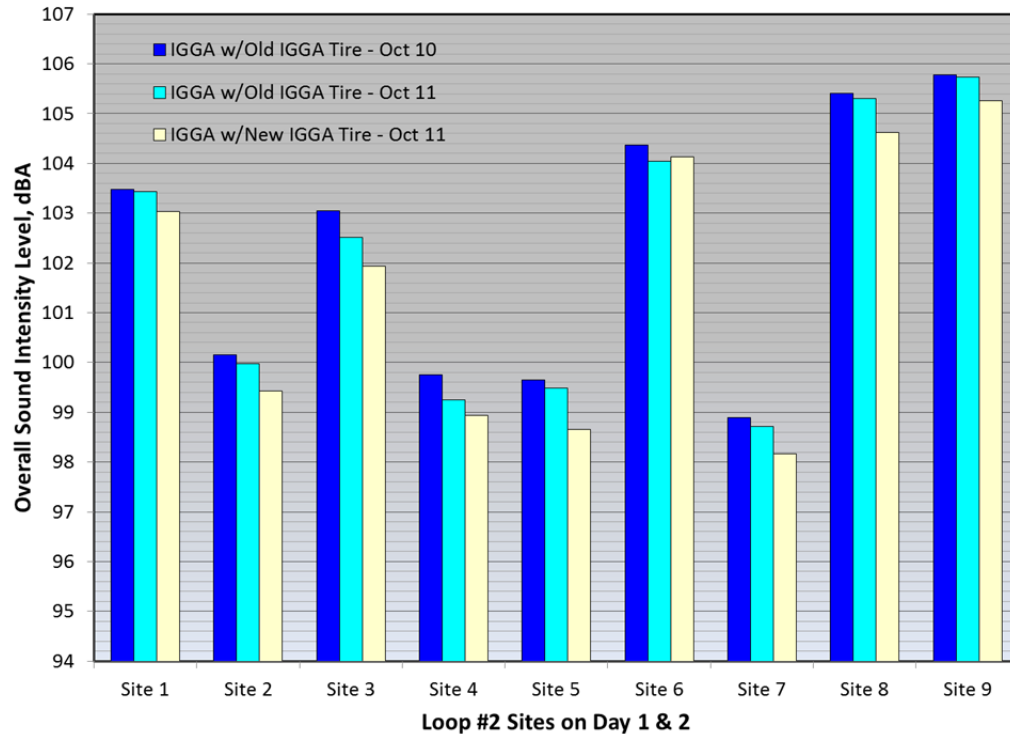
Figure 7: Overall OBSI levels for new and old IGGA tires tested on the IGGA vehicle

From Table 4, the temperatures on October 11th were about 10 to 18°F cooler than the day before. From the temperature gradient of -0.04 dB/°F, the measured levels for the same tire would be about 0.4 to 0.7 dB higher on October 11th. From the results shown in Figure 7 for the IGGA testing on both days, the levels on the warmer day are actually slightly higher averaging about 0.2 dB higher. Data for the two-day comparison were not normalized for temperature for two reasons: normalizing the temperatures for these pavements did not improve the results, and the change in temperature was relatively small. Figure 7 also provides a comparison of the old IGGA tire and new(er) IGGA tire on October 11th with a temperature difference of only 7° F. As would be expected from the data of Table 3, the levels for the newer tire were slightly lower

(0.5 dB) than the older tire. This is consistent with the finding from the NCHRP Project 1-44-1 in which older tires as a group were found to average 0.4 dB higher in level than the average of a group of new tires. In the NCHRP study, it was also determined that OBSI level increases at rate of 0.055dB/hardness number. With the hardness number difference of 8 for the old and new IGGA tires, the expected increase would be 0.4 dB which compares well to the measured increase from this rodeo. The decreased tread depth of the Old IGGA tire could also contribute slightly (less than 0.1 dB) to the higher noise levels as decreasing tread depth is expected to increase overall level by 0.106 dB/mm [2]. This same tire comparison was made on the IR vehicle on October 11th producing a somewhat different result. Without taking temperature into account, the newer tire was measured to be 0.1 dB higher than the older tire. When temperature was taken into account, this trend was reversed with the older tire being 0.2 dB higher in level. Accounting for temperature, this trend is reversed with the older tire being 0.2 dB higher in level. The levels measured with the IR test vehicle were also higher than those measured on the IGGA vehicle for the respective tests measured on October 11th with an average difference for the old tire of 0.5 dB and 1.1 dB for the newer tire.

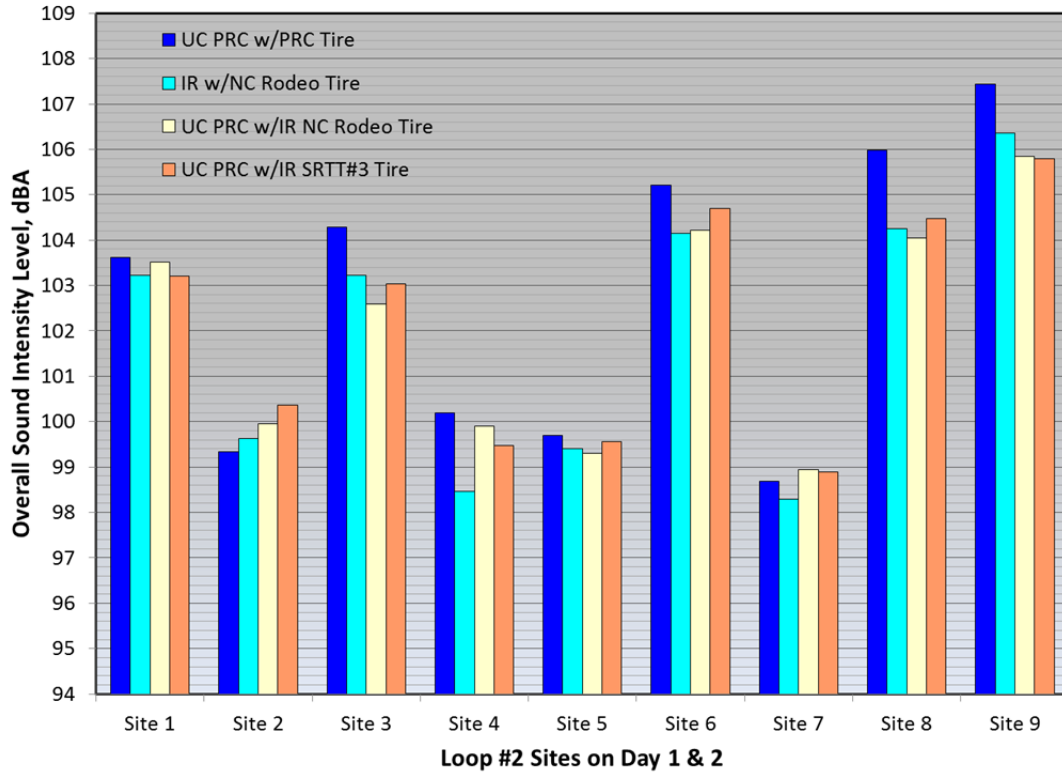
Figure 8: Overall OBSI levels measured on UC PRC & IR test vehicles

Several more comparisons are shown in Figure 8 which includes all of the data from for UC PRC vehicle and results for the NC Rodeo tire tested on both the IR and UC PRC vehicles. As with

the results in general, these data vary in rank ordering with pavement, for example, Site 2 shows the opposite rank order of the tires/vehicles on Site 9. In general, the UC PRC tire on the UC PRC vehicle tends to produce higher levels than the other cases. Considering the UC PRC vehicle only, the UC PRC tire is 0.7 dB and 0.5 dB higher than the NC Rodeo tire and SRTT #3 respectively. From Table 3, this is not unexpected as the NC tire and SRTT #3 have lower hardness numbers than the UC PRC tire and more tread depth. Even though the PRC tire is newer, its accumulated mileage is greater than the other tires. In comparing the NC Rodeo tire measured on the IR and UC PRC vehicles, the levels are very similar with an average difference of only 0.1 dB. This further supports a conclusion that differences seen between the PRC tire and the other cases is due primarily to the tire itself rather than any vehicle or test team biases.

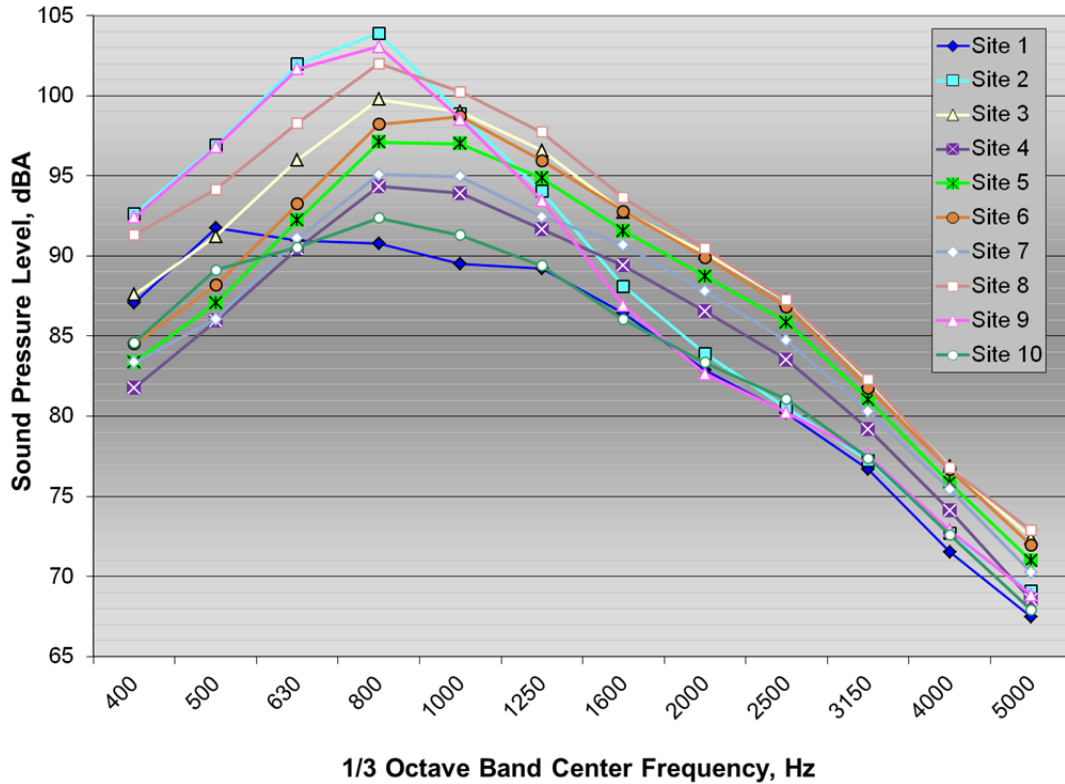
Figure 9: 1/3 octave band levels for Loop 1 measured by IR test car with the NC Rodeo tire

The one-third octave band spectra for all ten measurement sites in Loop 1 are shown in Figure 9 as measured by IR with the NC Rodeo tire. As suggested by the range of the overall OBSI

levels, there is also a considerable range in level between the sites on a one-third octave band basis. Below 1250 Hz, the differences range from about 10 dB to 13 dB. In the higher frequencies, the differences are smaller, but still range between 5 dB and 8 dB. For Loop 2, the differences are slightly smaller with the range below 2500 Hz being about 8 dB while the higher frequency range is about the same as the Loop 1 sites. For the Loop 2 pavements in shown in Figure 10, there is a definite grouping of the newer AC sites (2, 4, 5, and 7) with the range for these pavements being about 2 dB or less. These pavements are also lower in level by about 5 to 8 dB for bands above 800 Hz.

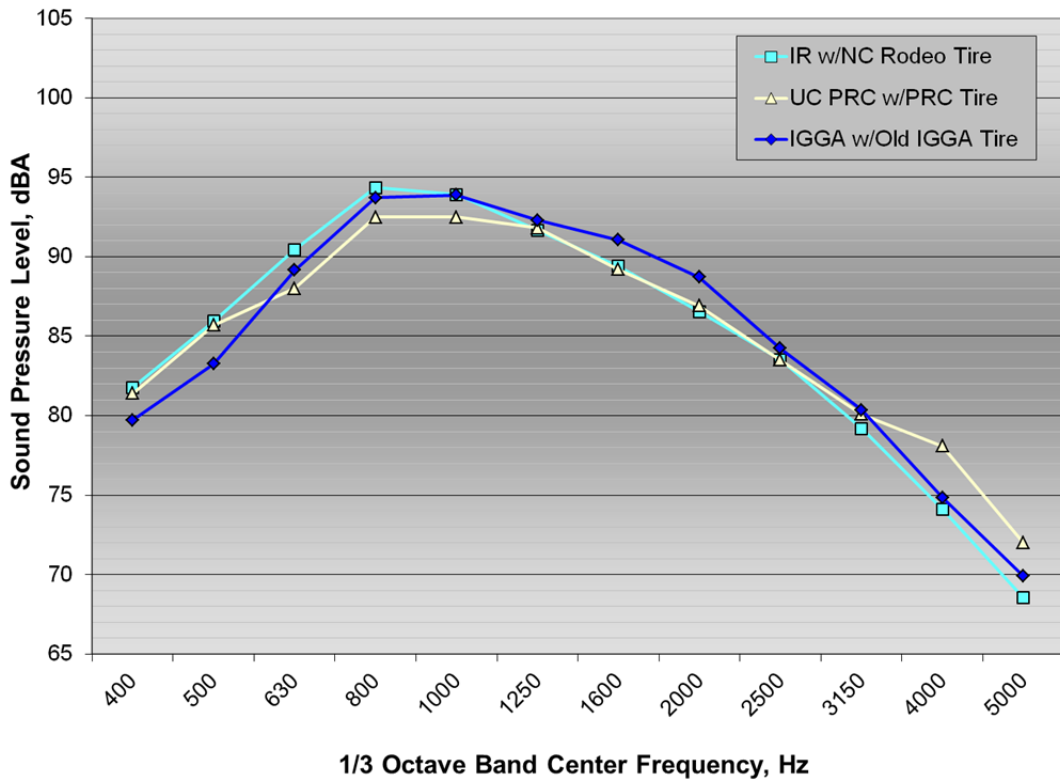
Figure 11: 1/3 octave band levels for all three teams on Site 4 of Loop 1

Comparing the spectra for each team on each pavement indicated that the results are fairly consistent as typified by the results shown in Figure 11. For Loop 1, the average range in one-third octave level is 1.6 dB with a standard deviation of 0.7 dB. For Loop 2, the average range was somewhat larger at 2.0 dB with a standard deviation of 0.9 dB. As general trend, the levels for IGGA data with the Old IGGA tire were higher than the IR and UC PRC results at 800 Hz and above as shown in Figure 12. This same trend is consistently apparent in comparing the spectra for the new and old IGGA tires as exemplified in Figure 13. This is thought to be due to

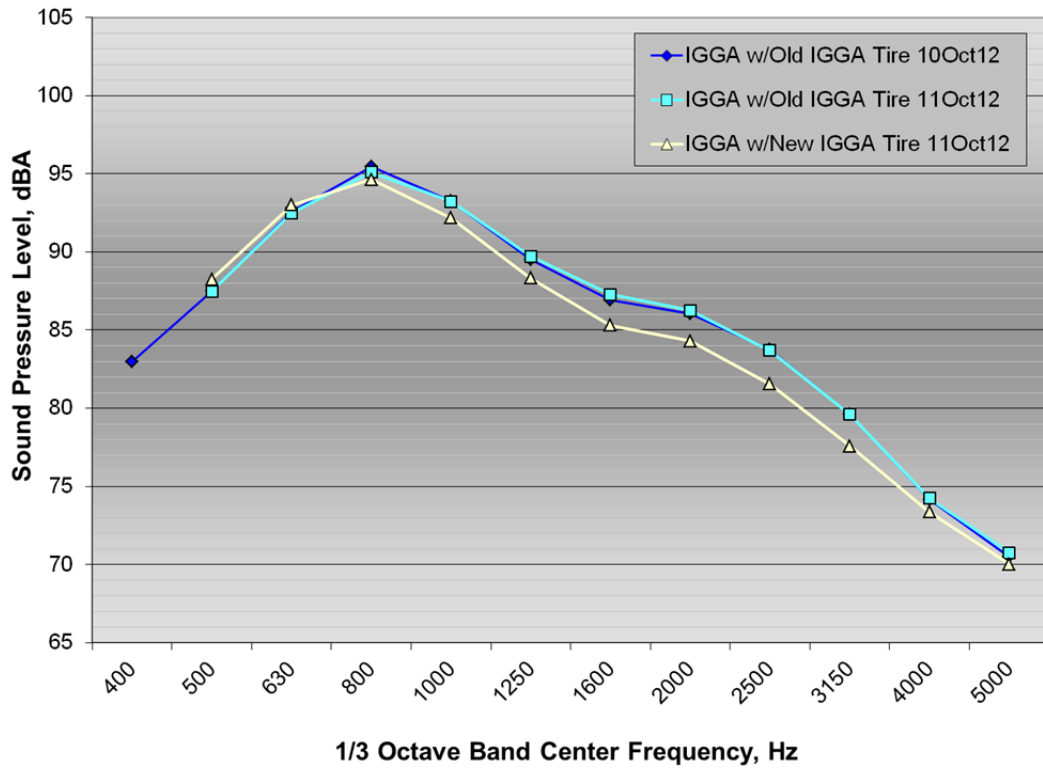
Figure 13: 1/3 octave band levels for old & new IGGA tires on Site 2 of Loop 2

the greater hardness of the older IGGA tire and its effect on the scrubbing mechanism [4,5]. The UC PRC tire also produced one-third octave band levels in the higher frequency bands that fell in between the Old IGGA tire and the NC Rodeo tire (see Figure 12) consistent with its hardness number being in between these other two tires. Figure 13 also provides an indication of test repeatability as the Old IGGA tire was tested on October 10th and 11th producing virtually identical results.
