Develop Methods to Reduce or Prevent Backing Crashes

**California PATH Research Report
UCB-ITS-PRR-2010-30**

Final Report for Task Order 6206

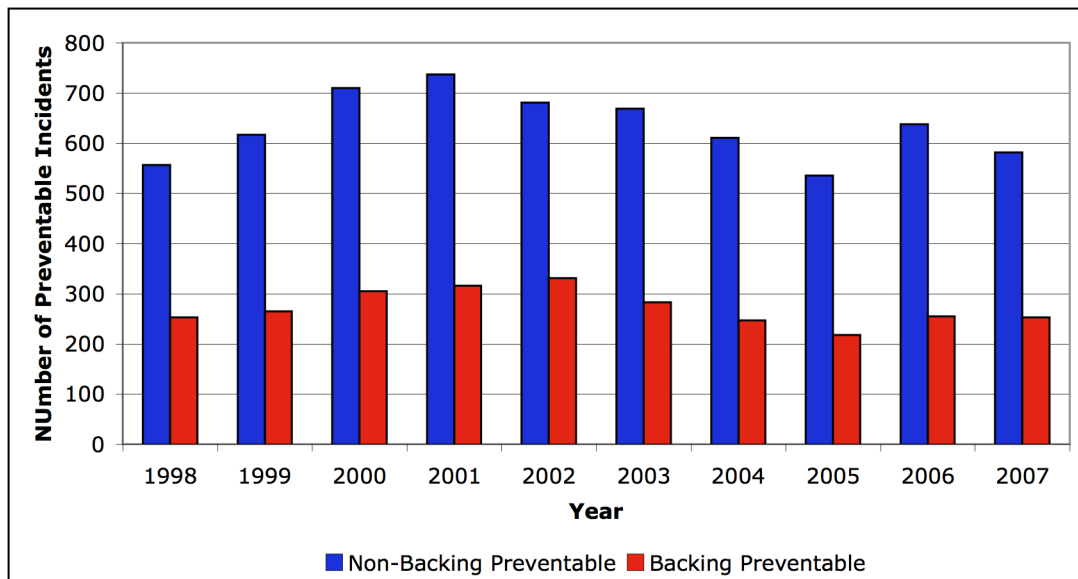
Figure 1 shows the ten-year trends for preventable backing and non-backing crashes. In 2006, both categories of crashes began a reversal of a multi-year downtrend. When examining the vehicle’s action just prior to the crash (“Movement Preceding Collision”), of the 18 possible choices on the data input accident form, “backing” was found to be the single most common, accounting for approximately 30% of total preventable crashes. This was followed by “Driving Straight Ahead” (25.4%) and “Stopped” (10.5%).

Figure 1: Backing Crashes as a Share of All Preventable Crashes 1998-2007

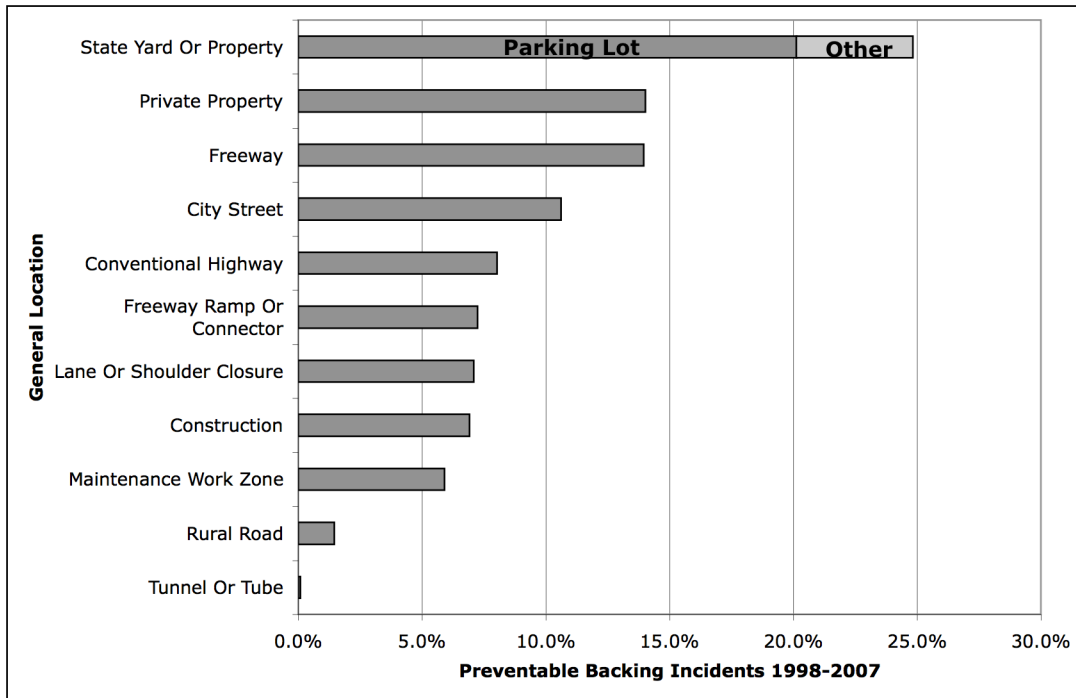
In addition to the 11 general location categories listed in Table 1, Form PM-S-0270 offers eight specific location designations, including “Parking Lot.” To obtain a clearer understanding of those backing incidents that occur in the general location “State Yard or Property,” Figure 2 breaks the category down into two subcategories: “Parking Lot” and “Other.” The assumption here is that “Parking Lot” refers to Caltrans yards. Subdivided in this way, it can be determined that Caltrans yards account for the largest location category (20%) of backing incidents.

Figure 2: Preventable Backing Collisions by Location 1998-2007

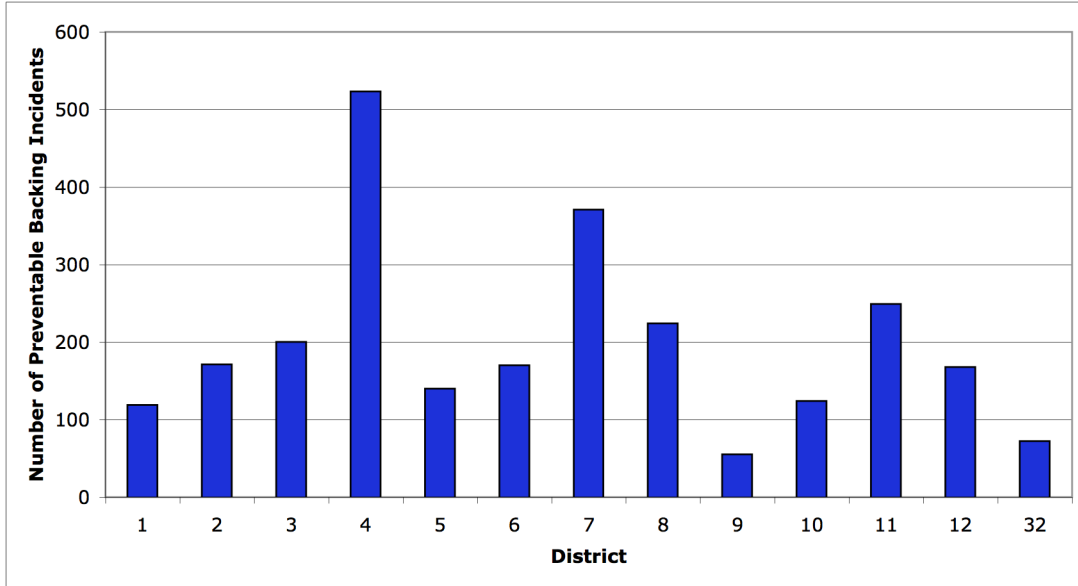
The total number of preventable backing crashes that occurred between 1998 and 2007 varies dramatically by district (Figure 3), with the highest number in Districts 4 (Bay Area) and 7 (Los Angeles) and the lowest numbers in District 32 (Headquarters) and 9 (Inyo County). Given the differences in district size and number of vehicles in use in each district, this variation is understandable. Information on employee populations, job assignments, and distribution among the districts is needed to gain a clearer picture of the factors that contribute to the variations. The requirement for additional data is discussed further in Section 3.2.2: Additional Data Needs.

Figure 3: Total Number Preventable Backing Crashes by District 1998-2007

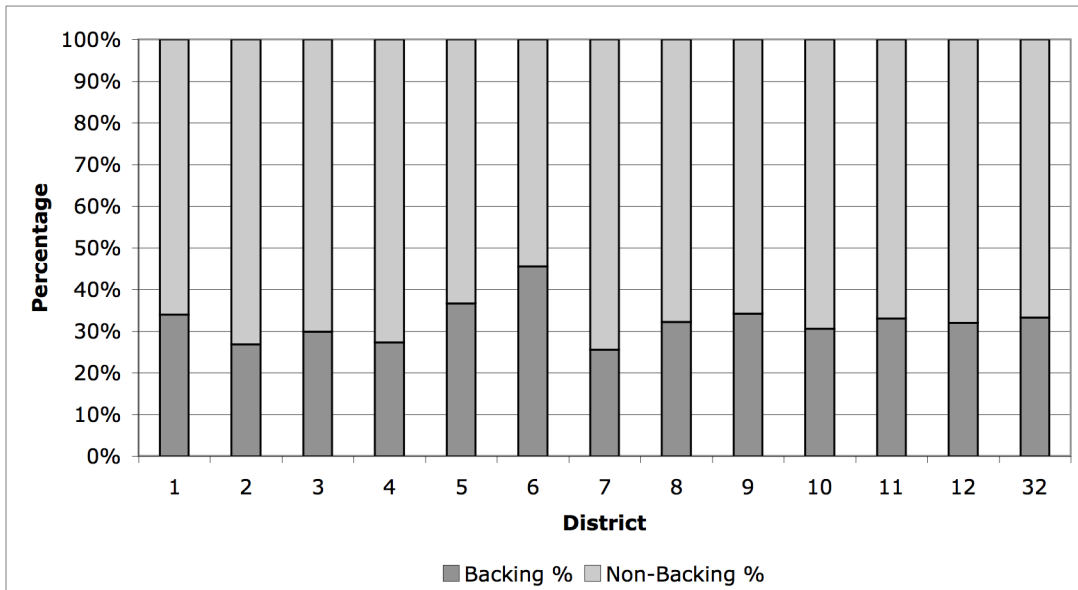
The proportion of preventable backing crashes versus preventable non-backing crashes also varies among districts (Figure 4), with the highest proportion of backing crashes in District 6 (Fresno), with 44%. In the majority of districts, on average, 35% of preventable crashes involved backing.

Figure 4: Percentage of Preventable Backing and Preventable Non-Backing Crashes by District 1998-2007

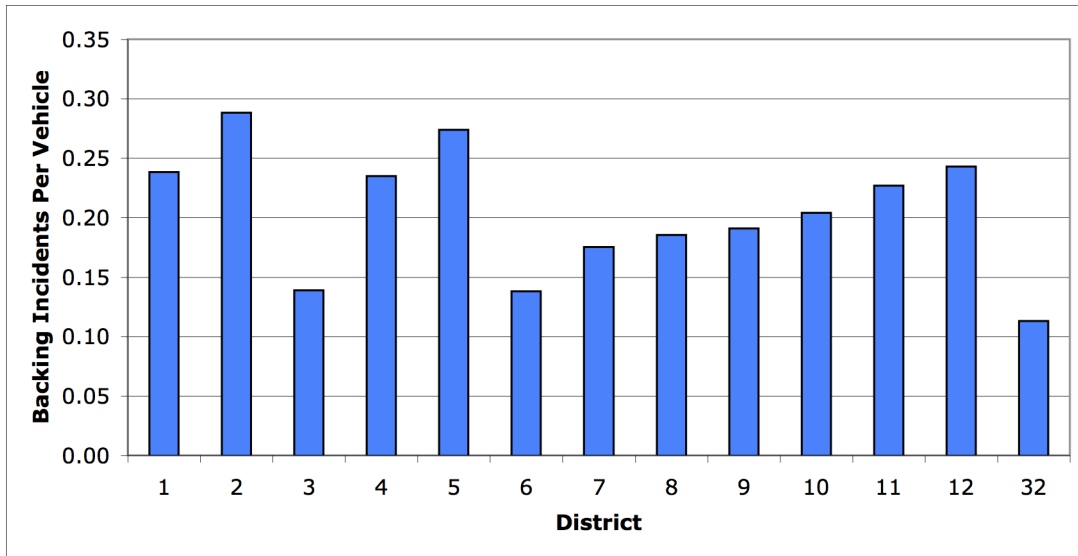
Figure 5 shows the number of preventable backing crashes normalized by the number of vehicles in each district. While displaying less variability than the non-normalized numbers, these figures reveal large variations among Caltrans districts. Further research regarding specific vehicle types and usage (e.g., mileage, road, and weather conditions) in the different districts would help clarify the causes of variation among the districts.

Figure 5: Preventable Backing Crashes by District Normalized for Number of Vehicles 1998-2007

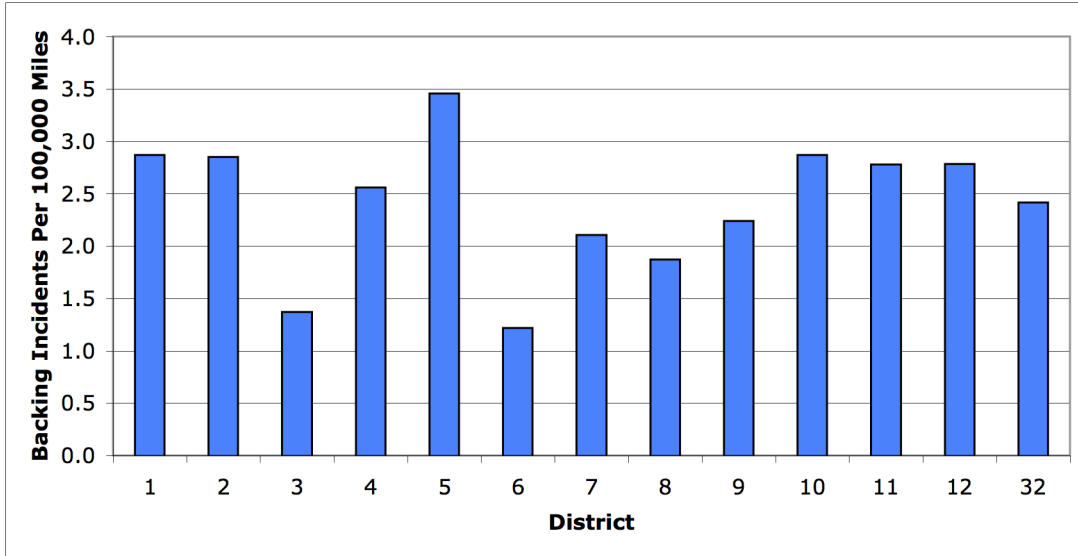
Because this variability between districts could be attributable, at least in part, to the differences in miles the vehicles are driven, we calculated the number of incidents per 100,000 miles driven. Mileage information is a rough estimate derived from data collected on an ad hoc basis from the Division of Equipment's vehicle repair records. The analysis results are shown in Figure 6. Again, the numbers vary considerably among districts. From 1998 to 2007, the highest number of preventable backing collisions per 100,000 miles driven occurred in District 5 (Monterey), District 1 (Eureka), District 2 (Redding), District 10 (Stockton), District 11 (San Diego), and District 12 (Irvine). The lowest number occurred in District 6 (Fresno).

Figure 6: Preventable Backing Crashes Per 100,000 Miles by District 1998-2007

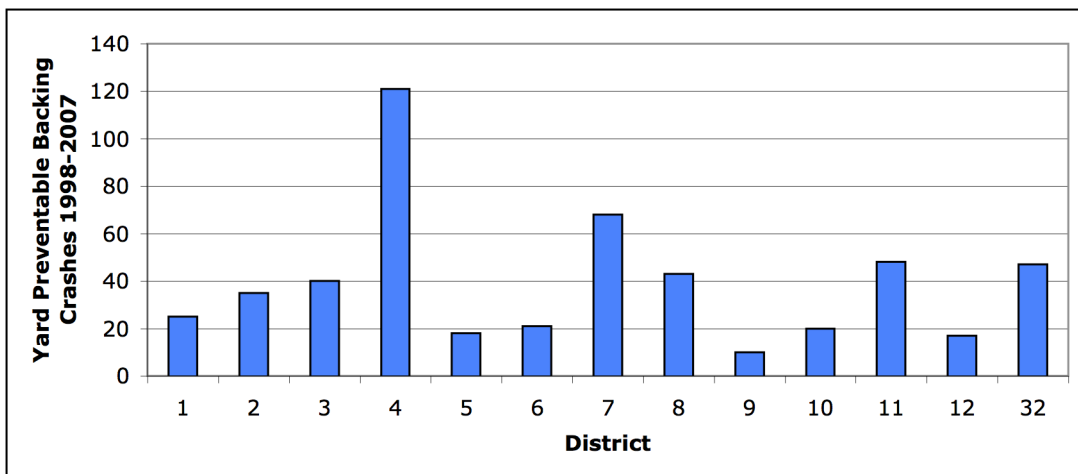
The total number of preventable backing crashes that occurred in Caltrans yards also differs significantly by district, as shown in Figure 7. Between 1998 and 2007, 121 preventable backing incidents occurred in District 4 (Bay Area) compared with 68 in District 7 (Los Angeles). District 4 recorded a greater number of drivers and vehicles than District 7 and may also have more pickup trucks or wreckers. More research will be necessary to understand what might be responsible for increased rates of backing collisions in the Bay Area.

Figure 7: Preventable Backing Crashes in Caltrans Yards by District 1998-2007

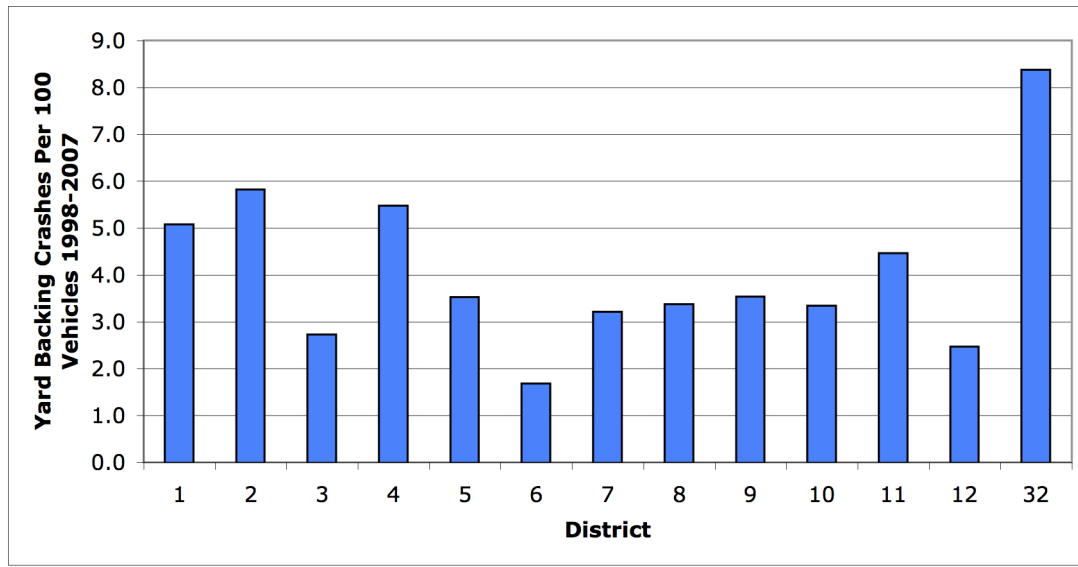
Figure 8 illustrates the rates of yard crashes per 100 vehicles, which also vary across districts, from a low of 1.7 in District 6 (Fresno) to a high of 8.4 in District 32 (Headquarters). On average, there were 3.7 preventable yard backing incidents per 100 vehicles per year per district. The outsized number of yard crashes in District 32 (Headquarters), over two times the average, is a cause for concern. Further research is needed to identify the reasons for this high crash rate.

Figure 8: Preventable Backing Crashes 1998-2007 per 100 Vehicles in Caltrans Yards by District

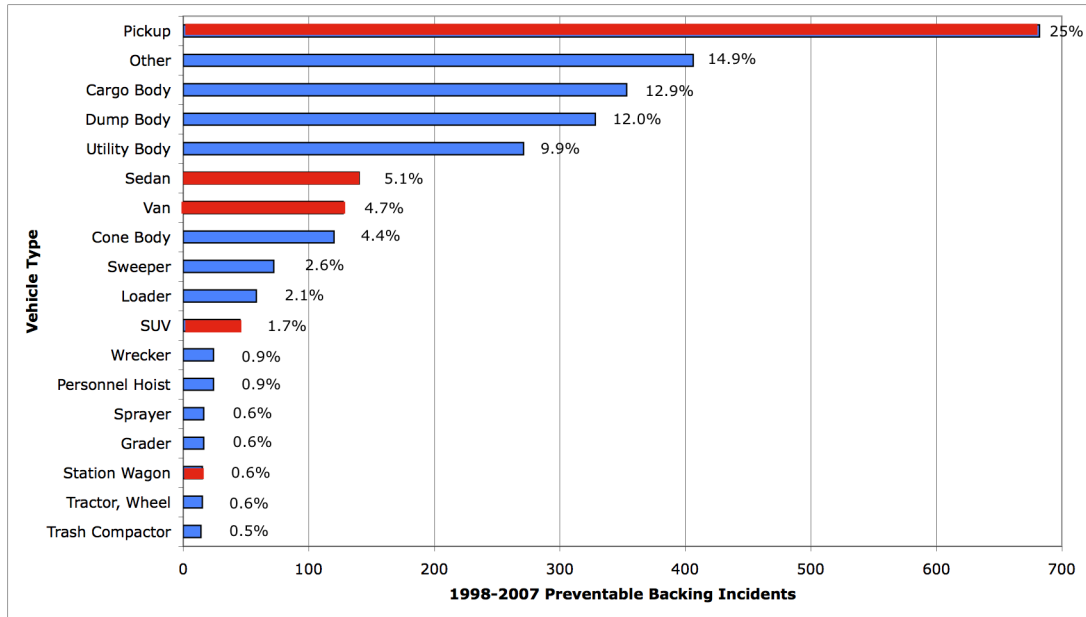
Between 1998 and 2007, pickup trucks were involved in more preventable backing crashes (682) than any other vehicle category, comprising 25% of all preventable backing crashes (Figure 9). Although this data is not normalized (there are more pickup trucks than other types of vehicles in the Caltrans fleet), it provides a focus for potential remedial actions. By addressing backing problems in pickups, sedans, vans, SUVs, and station wagons (vehicles whose size and rear visibility are not likely to be contributing crash factors), 37% of backing crashes could be eliminated. This could be achieved through changes to policies and procedures and would need not involve new equipment.

Figure 9: Number of Preventable Backing Crashes by Vehicle Type 1998-2007

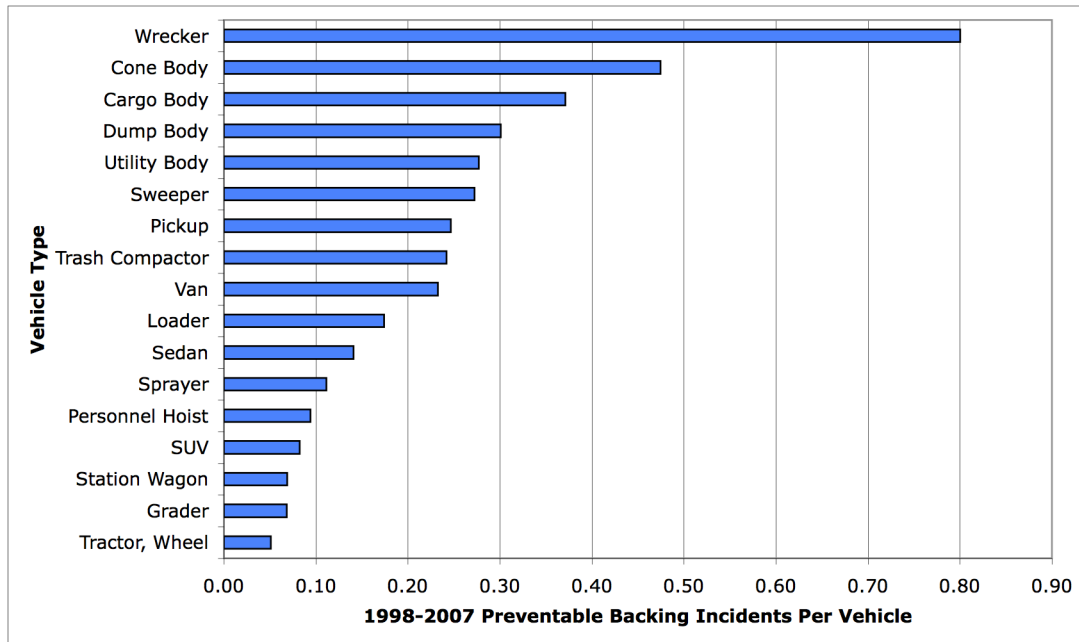
When the incident data by vehicle type are normalized—that is, when the number of each type of vehicle is taken into consideration—a different picture emerges (Figure 10). In this analysis the larger vehicles, many with limited visibility to the rear, have the highest preventable backing crash rates. Wreckers have the most incidents, which could be due in part to the backing-intensive nature of the work they perform. However, because of their small numbers, wreckers’ high incident rates account for less than 1% of all backing incidents, or roughly three crashes per year. Still, wrecker operations may be a productive focus for remedial programs.

Figure 10: Preventable Backing Crashes by Vehicle Type Normalized for Number of Vehicles 1998-2007

As Figure 10 shows, overall crash rates for different types of vehicles vary substantially. Crash rates by vehicle type also vary among Caltrans districts. As shown in Figure 11, for example, the average annual crash rate for cargo-body vehicles in District 12 is three times that of District 6. It may be that usage for these vehicles (by miles or hours, neither of which is currently available in the SIMS database) may be substantially higher in District 6. Alternatively, operating methods, procedures, or factors in the working environment may play a role. Further investigation is needed to understand factors that impact different rates.

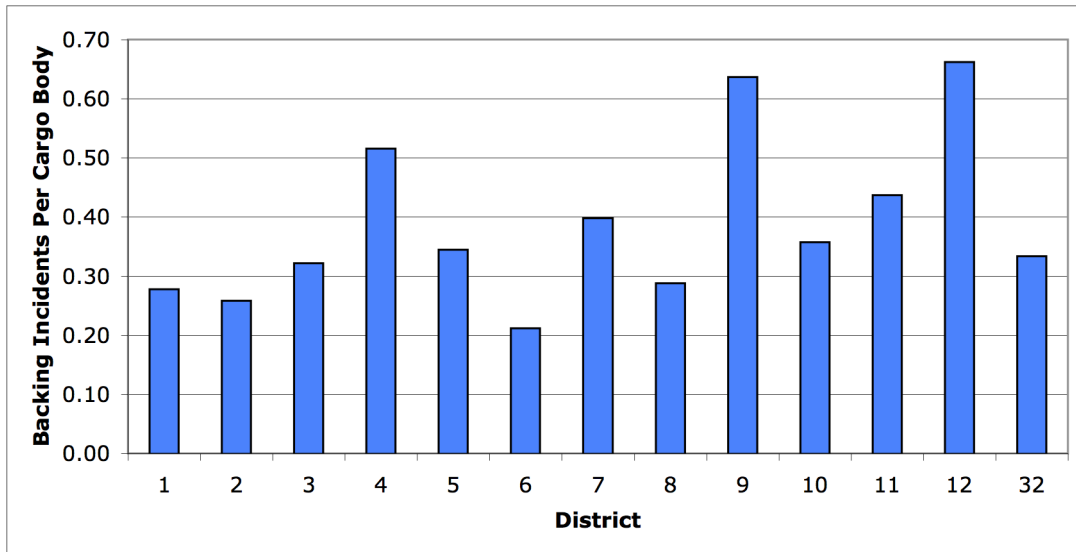
Figure 11: Average Annual Number of Cargo-Body Vehicle Preventable Backing Crashes by District 1998-2007

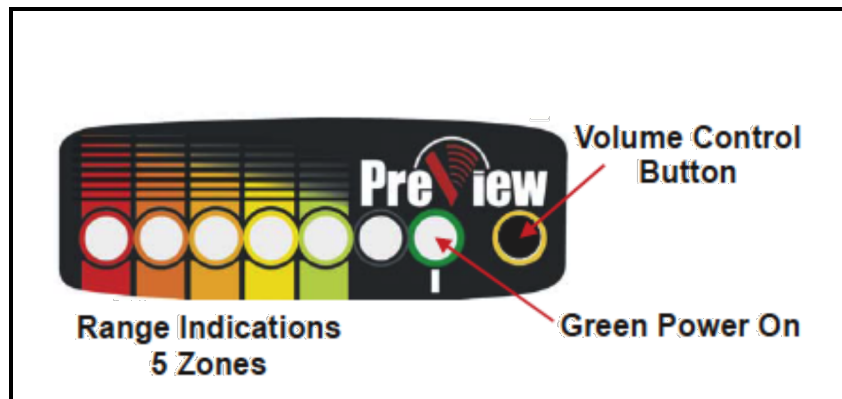
The systems operate in a pre-defined coverage area and report the distance of the closest object via visual range indicators and an audible signal to a vehicle operator. The in-cab display is shown in Figure 12.

Figure 12: The Preco PreView™ Display
