Rehabilitation Design for 02-PLU-36, PM 6.3/13.9 Using Caltrans ME Design Tools: Findings and Recommendations

Partnered Pavement Research Program (PPRC) Contract Strategic Plan Element 3.4: Development of Improved Rehabilitation Designs for Reflective Cracking

Technical Memorandum: UCPRC-TM-2008-01

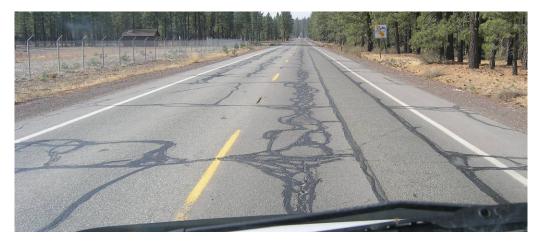
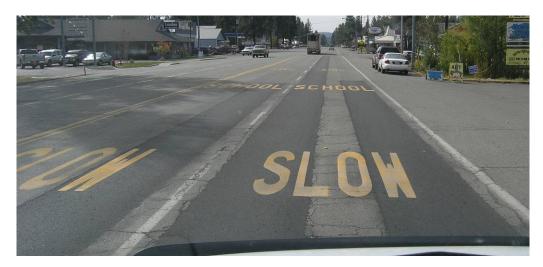
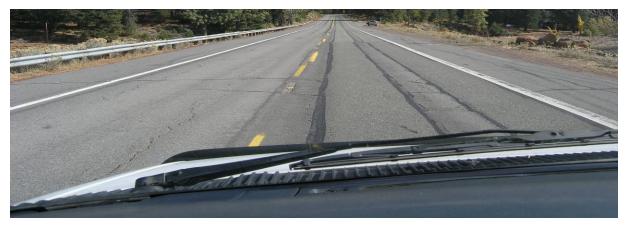
The pavement surface had extensive fatigue-type cracking in the wheelpaths and extensive transverse cracking across the roadway throughout the project length. The transverse cracking was likely thermal cracking, given the area's climate conditions (High Mountain climate region). At numerous locations, transverse cracks progressed to a small area of fatigue-type cracking in the wheelpaths, and then changed to continuous wheelpath cracking. There were also extensive areas where one or both wheelpaths had been dug out and inlaid with new HMA material. The extracted cores showed that the cracking was either mostly surface-initiated or the result of debonding between the upper HMA layers. Representative photographs of the pavement are shown in Figure 3, Figure 4, and Figure 5.

Figure 3: Two-lane section west of Chester adjacent to western part of Chester airport, approx. PM 6.9, WB.

Figure 4: Four-lane section in Chester, approx PM 8.4 (near Riverwood), EB.

Figure 5: Two-lane section over causeway, approx. PM 10.4, EB.

It was concluded that thermal cracking was the predominant distress mechanism at work, as this process allows ingress of water which then softens the layers below the HMA layer and results in fatigue cracking of the HMA layer. The application of thin overlays does little to prevent reflective cracking due to cracks in the existing structure.

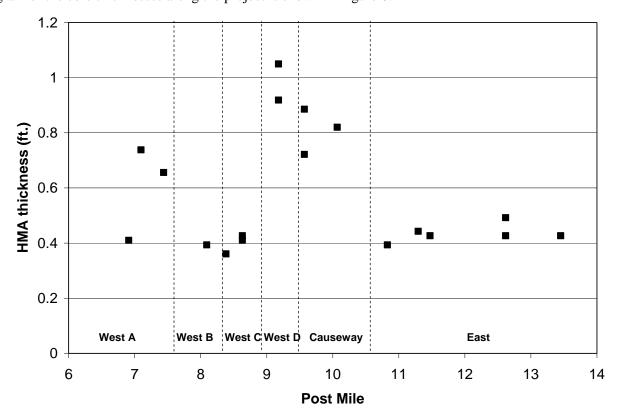
Results from the coring operations showed a consistent HMA layer with a thickness of 0.37 ft (115 mm) in sections West B, West C, and West D. Section West A had a thickness of 0.41 ft (125 mm) at STA 32+83 (1,000 m) and an average thickness of 0.69 ft (212 mm) at STA 42+68 ft (1,300 m) and 60+74 ft (1,850 m). The extent of the thicker section of HMA material in Section West A was unknown. (Note: A ground penetrating radar investigation would be able to show the extent of the thicker section of HMA and also the variability in the thickness of the HMA layer.) The thickness of the HMA layer on the Causeway section varied from 0.80 ft to 0.98 ft (245 mm to 300 mm), with an average thickness of 0.87 ft (265 mm) based on three cores. It was determined from five cores that the East section had an average thickness of 0.43 ft (130 mm) in the HMA layer and that this layer showed low variability. All of the cores from the East section showed a consistent pattern: an initial HMA layer (about 0.23 ft [70 mm]) and then a series of overlays approximately 0.08 ft (25 mm) thick. A diagram of the core thicknesses along the project is shown in Figure 6.

Figure 6: HMA core thicknesses by section and post mile (see Figure 2).

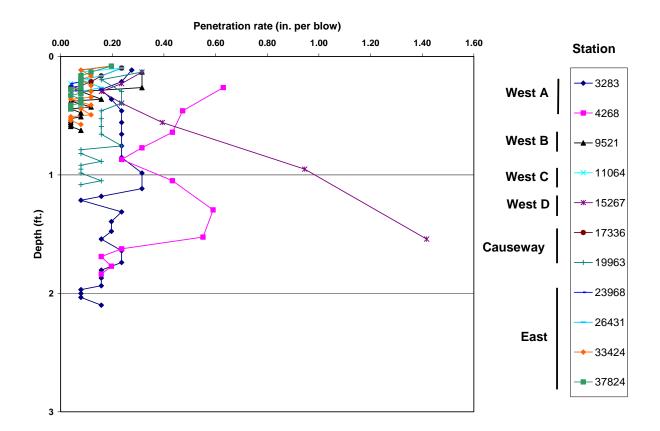
Figure 7: DCP locations and results.

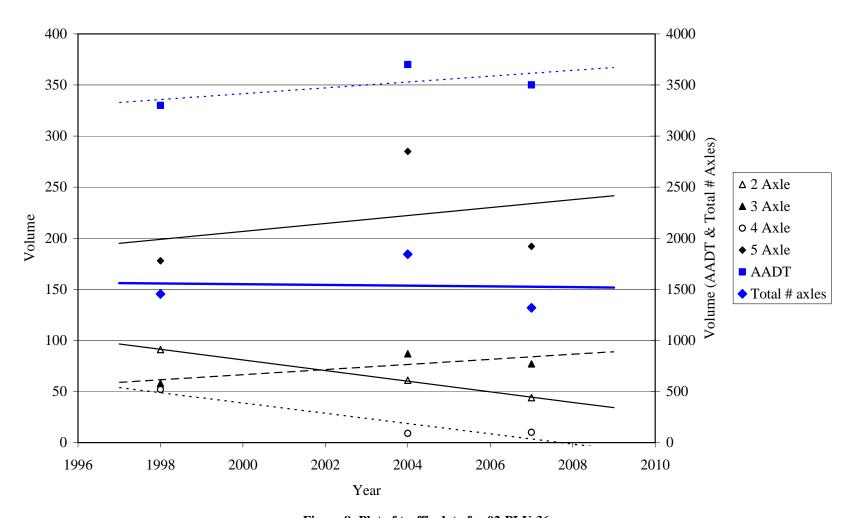
PLU36 PM 6.283 (36 & 89 Junction) Verified Daily Traffic Counts

Figure 8: Plot of traffic data for 02-PLU-36.

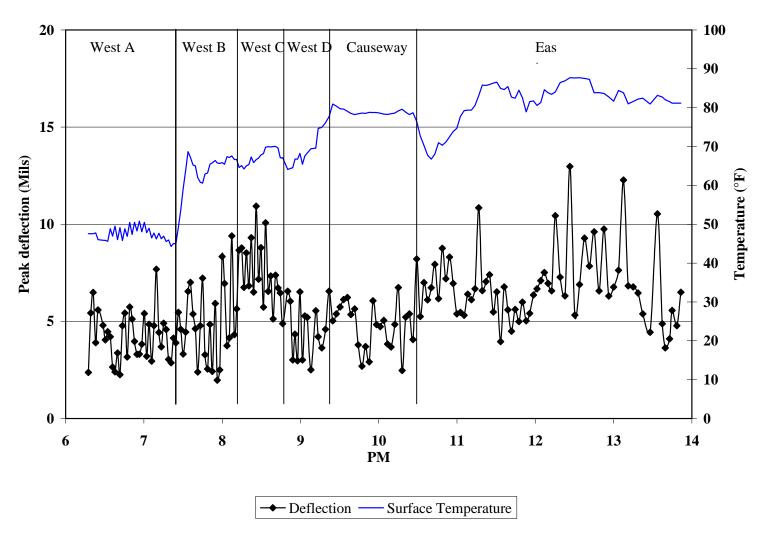
Inner Sensor (D1) Deflection and Surface Temperature versus PM

Figure 10 shows the Falling Weight Deflectometer deflection data for inner sensor (D1) and HMA surface temperature versus post mile. Figure 11 shows the Falling Weight Deflectometer deflection data for the outer sensor (D8) and HMA surface temperature versus post mile. Deflection testing started in the morning at Section West A, and proceeded generally eastbound as indicated by increasing surface temperatures with post mile. Figure 12 shows the temperature-adjusted layer moduli from *CalBack* for the entire project. Reference stiffnesses for SC, SM, and Clay were comparable in this project since *CalME* did not contain sufficient calibrated soil materials at the time of analysis. Table 7 through Table 10 present the raw westbound and eastbound FWD data. Figure 13 shows the deflection bowl from Station 1850.

Figure 10: FWD inner sensor (D1) peak deflection and surface temperature versus post mile.

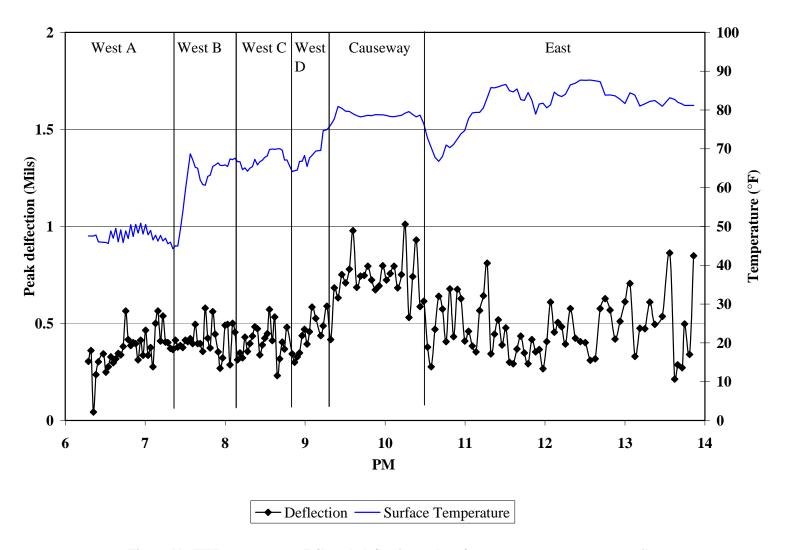
Outer Sensor (D8) Deflection and Surface Temperature versus PM

Figure 11: FWD outer sensor (D8) peak deflection and surface temperature versus post mile.

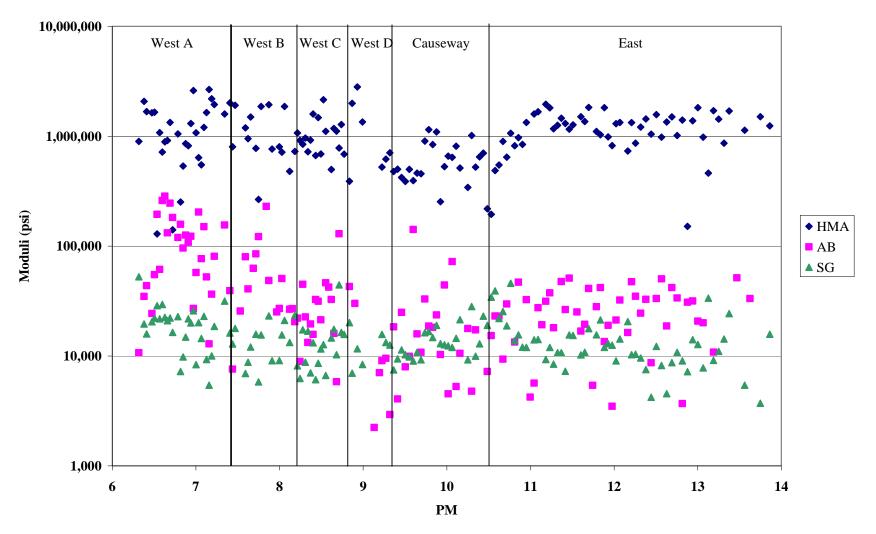
Backcalculated Layer Stiffness (psi) versus PM

Figure 12: Backcalculated layer stiffness (temperature adjusted) versus post mile.

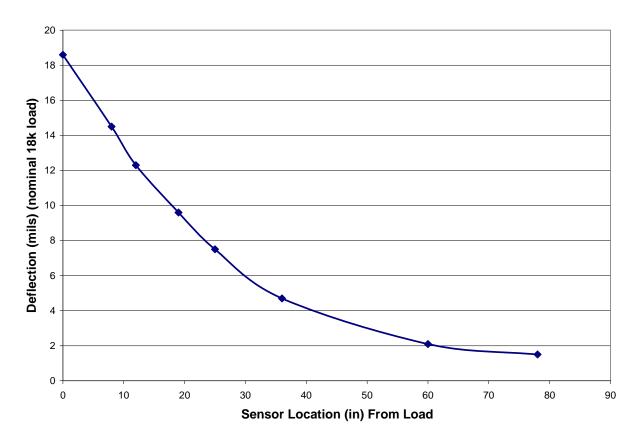
Figure 13: Typical deflection bowl from FWD testing.

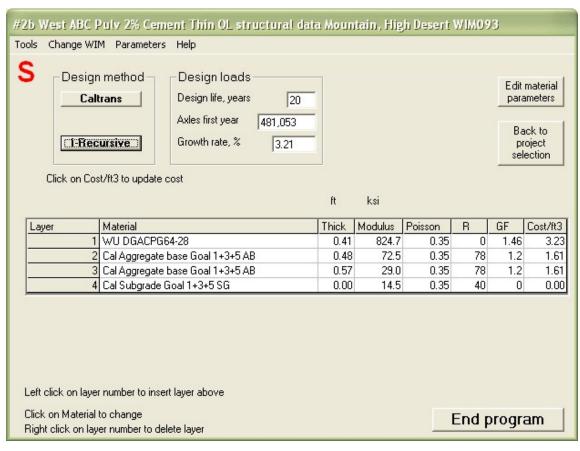
Presented below are input screens for Design Option 2B—2 percent cement, thin overlay. Figure 14 shows the data input screen for *CalME*, with material layers, thicknesses, and stiffnesses. Note the button "Edit Material Parameters," which allows the user to very specifically tailor a given material behavior in *CalME*. Most of these parameters are preset for the user. Figure 15 presents the run options within *CalME* to analyze the pavement design. Figure 16 shows a rutting-versus-time plot for this design option. Note the progression in rut depth (blue/dark line) and the established limiting criteria (pink/light line). The pavement reaches the desired 20-year life. Figure 17 shows cracking-versus-age plot for this design option. Here, the pavement fails in cracking at about 20 years. Figure 18, Figure 19, and Figure 20 present the recursive material parameters for the surfacings used in this project, PG64-28, and existing RHMA-G and DGAC, respectively. These factors were generally left unchanged throughout the analysis procedure. Figure 21 shows the recursive material parameters for the aggregate base. These parameters were left unchanged throughout the analysis.

Figure 14: Structural input screen from CalME for Design 2B.

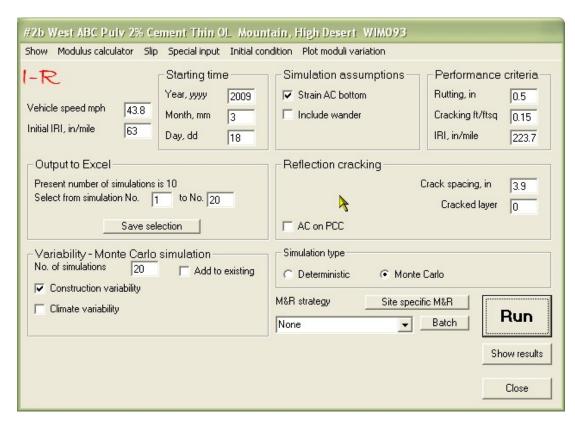
Figure 15: CalME run options screen for Design 2B.

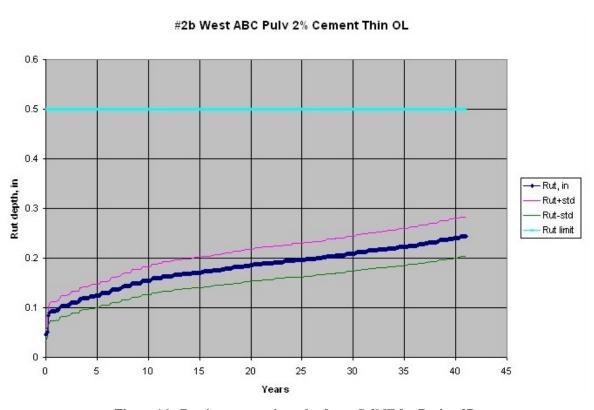
Figure 16: Rutting-versus-time plot from CalME for Design 2B.

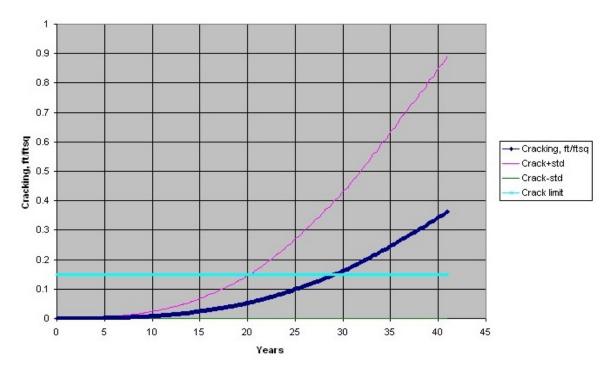
#2b West ABC Pulv 2% Cement Thin OL

Figure 17: Cracking-versus-time plot from CalME for Design 2B.

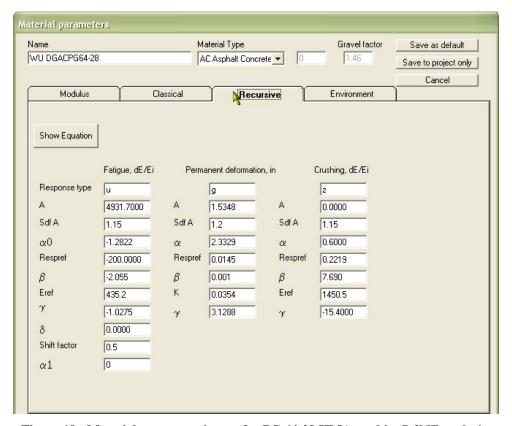
Figure 18: Material parameter inputs for PG 64-28 HMA used in CalME analysis.

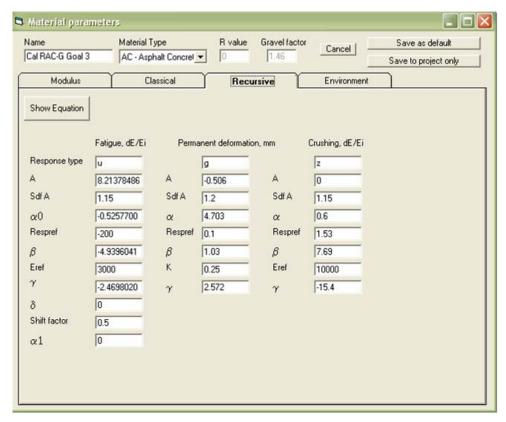
Figure 19: Material parameter inputs for existing RHMA-G used in CalME analysis.

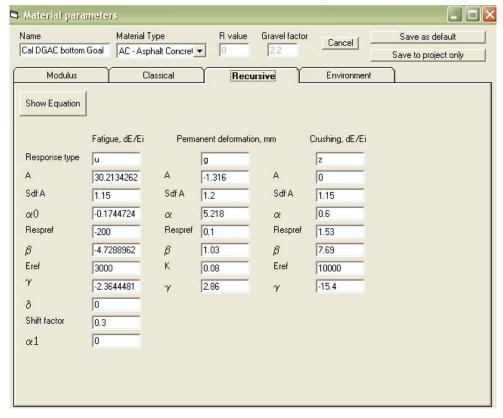
Figure 20: Material parameter inputs for existing DGAC used in *CalME* analysis.

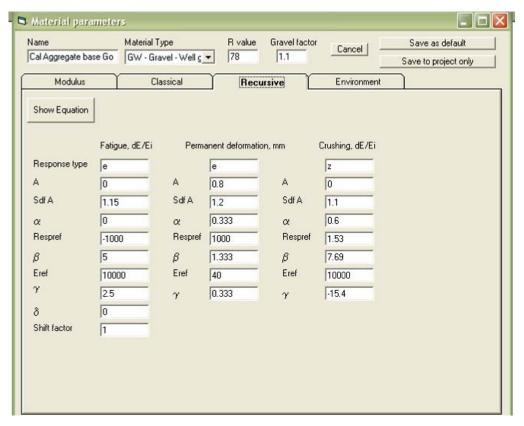
Figure 21: Material parameter inputs for calibrated aggregate base used in CalME analysis.
