Optimizing Rubberized Open-graded Friction Course (RHMA-O) Mix Designs for Water Quality Benefits: Phase I: Literature Review

Partnered Pavement Research Center (PPRC) Strategic Plan Element 2.7 under Caltrans Contract 65A0628

1. REPORT NUMBER UCPRC-RR-2019-03	2. GOVERNMENT ASSOCIATION NUMBER	3. RECIPIENT'S CATALOG NUMBER
4. TITLE AND SUBTITLE  Optimizing Rubberized Open-graded Friction Course (RHMA-O) Mix Designs for Water Quality Benefits: Phase I: Literature Review		5. REPORT PUBLICATION DATE September 2020

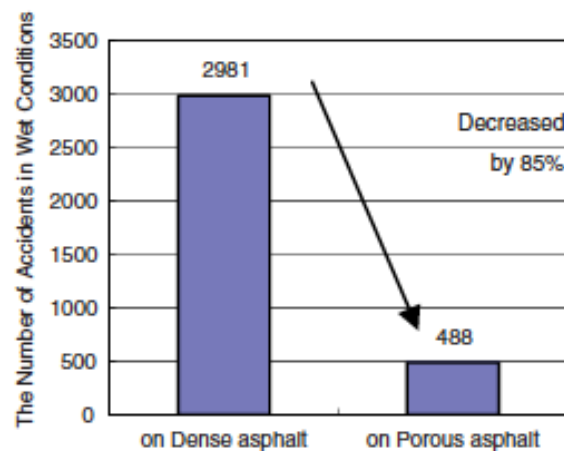
**Figure 2.2: Change in accident number from one year before to one year after OGFC construction compared to dense-graded asphalt pavement.**  
(Source: Shigeki Takahashi [2013], data from 213 rain accident-prone sites nationwide)

The safety-related benefits associated with OGFC pavements were also confirmed by several international studies. For example, a study conducted in Japan by Shimento and Tanaka (2010) showed that the rate of fatalities on OGFC pavements was about 1.9 per 100 million miles traveled whereas the rate of fatalities for dense graded asphalt pavement was 6.2 per 100 million miles traveled. Takahashi (2013) also evaluated the safety aspects of OGFC in Japan nationally. This study's results, shown in Figure 2.2, are based on the change in the number of accidents during the year before OGFC construction and the number during the year after, and it compared those results with accident numbers from the same period on a dense-graded pavement. The result clearly indicates that the OGFC significantly reduced the number of fatalities during rainy weather in Japan when compared with standard dense-graded asphalt pavement.

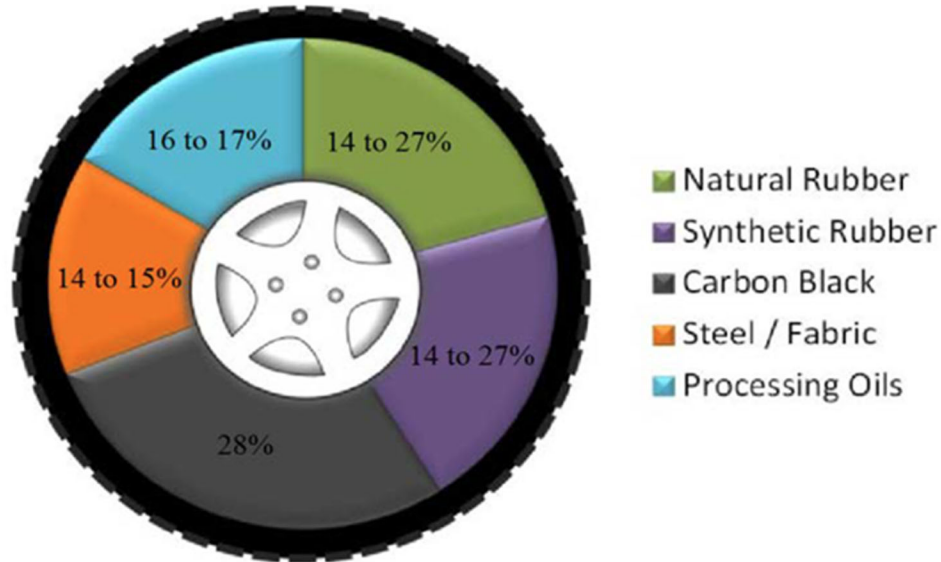
**Figure 2.4: Average components of a typical tire (Adapted from FHWA 2014).**

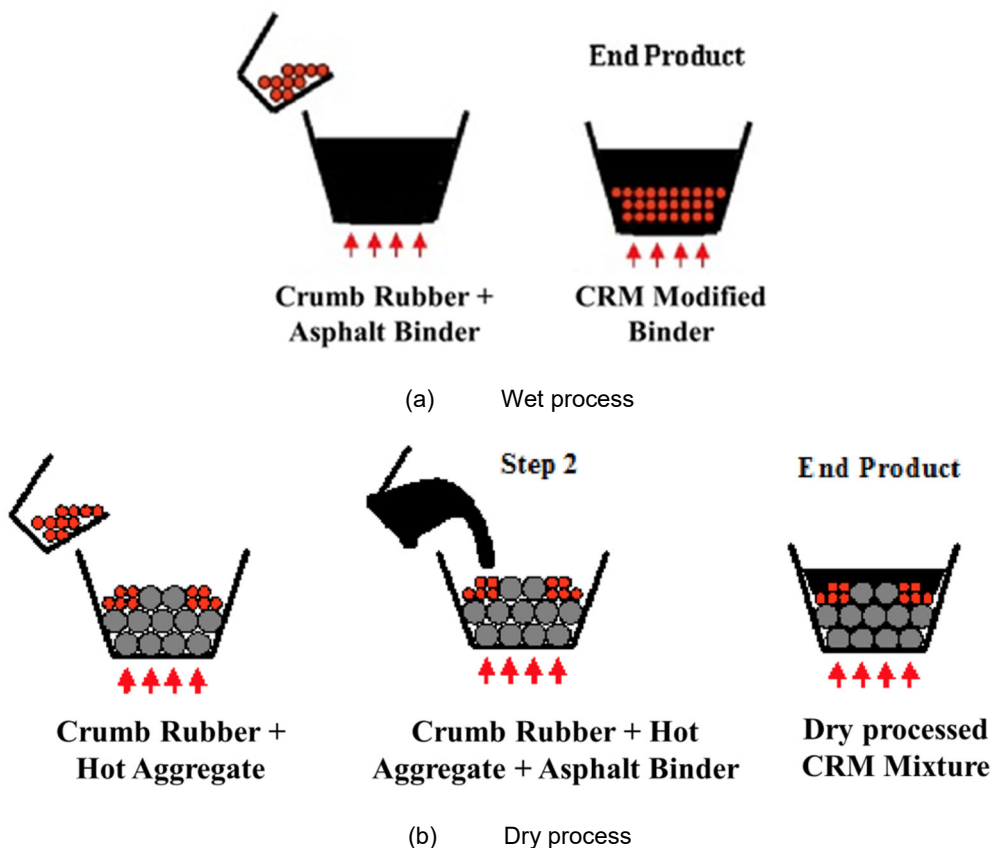
**Figure 2.5: Preparation methods for rubberized asphalt binder: (a) the wet process, and (b) the dry process (Adapted from Hassan et al. 2014).**

At present, two methods are used to blend CRM into asphalt pavement binder: the *wet process* (also referred to as *terminal blending* or *on-site blending*), and the *dry process*. As shown in Figure 2.5(a), in the wet process, finer mesh crumb rubber is introduced into liquid binder (often with other additives), and this is followed by cooking and “digestion” of the rubber into the binder before it is used in asphalt production. In the dry process, shown in Figure 2.5(b), larger crumb rubber particles are introduced onto hot aggregates, and then asphalt binder is added before the mix is used in asphalt pavement production. Descriptions of these processes are summarized in Table 2.5.

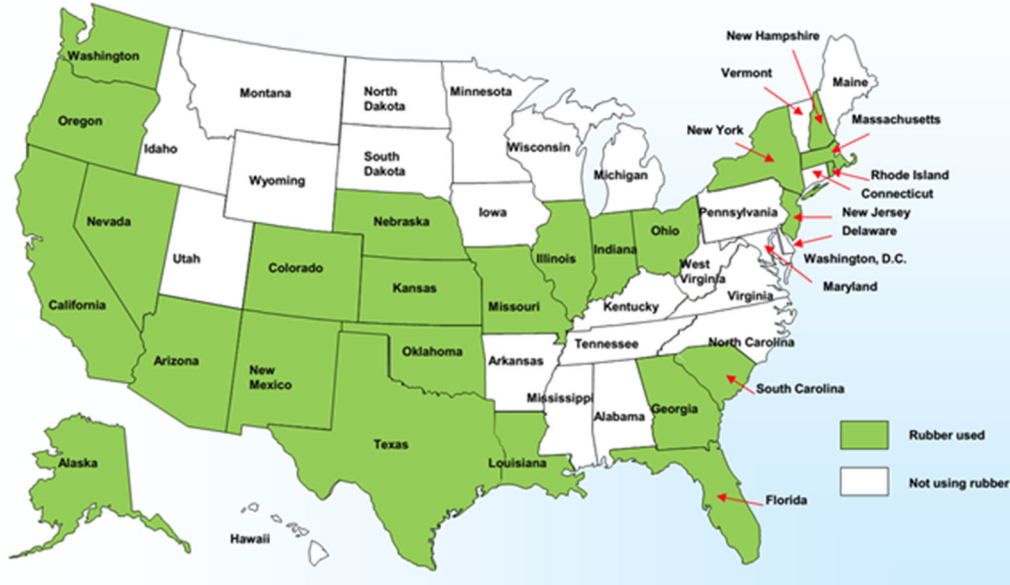
Figure 2.6: States where the DOT uses tire rubber in asphalt pavements (Blumenthal 2013).

A separate survey study performed by Blumenthal et al. (2013) showed that 25 state DOTs were using crumb rubber in asphalt pavements (see Figure 2.6). According to this survey's results, still many states are reluctant to use crumb rubber, mostly because of some unfavorable history and outdated perceptions. In 2016, Ghabchi et al. (2016) surveyed transportation agencies known to be using crumb rubber in pavement construction. The results of this survey (see Figure 2.7) indicated that crumb rubber materials are used in a wide range of applications, such as in chip seals, fog seals, and crack seals in thin overlays; in stress absorbing membranes (SAM) and stress absorbing membrane interlayers (SAMI), in thick overlays, and in rubberized open-graded friction courses (RHMA-O). From Figure 2.7, it is clear that the majority of DOTs use crumb rubber for chip sealing and thin overlay dense-graded pavement applications. The leading four states currently using RHMA-O include Arizona, California, Florida, and Texas (Ghabchi et al. 2016). The current application of RHMA-O by these four DOTs was verified by the author of this literature review through e-mail and phone communications with representatives of each DOT (Moseley 2019; Barborak 2019; Crerand 2019). Together, these four states recycled almost 36 million scrap tires in asphalt pavement applications from 1995 to 2001 (Willis et al. 2012). In a study conducted for Caltrans in 2005, it was reported that the number of scrap tires used per ton of HMA in the states of Arizona, California, Florida, and Texas, were 4.4, 3.3, 1.9, and 4.9, respectively (Ghabchi et al. 2016). Discussion of some state DOT experiences with field applications and experiments using RHMA-O are presented below. Variations in mix designs and other specifications used for RHMA-O pavements by these states are examined in Chapter 3.

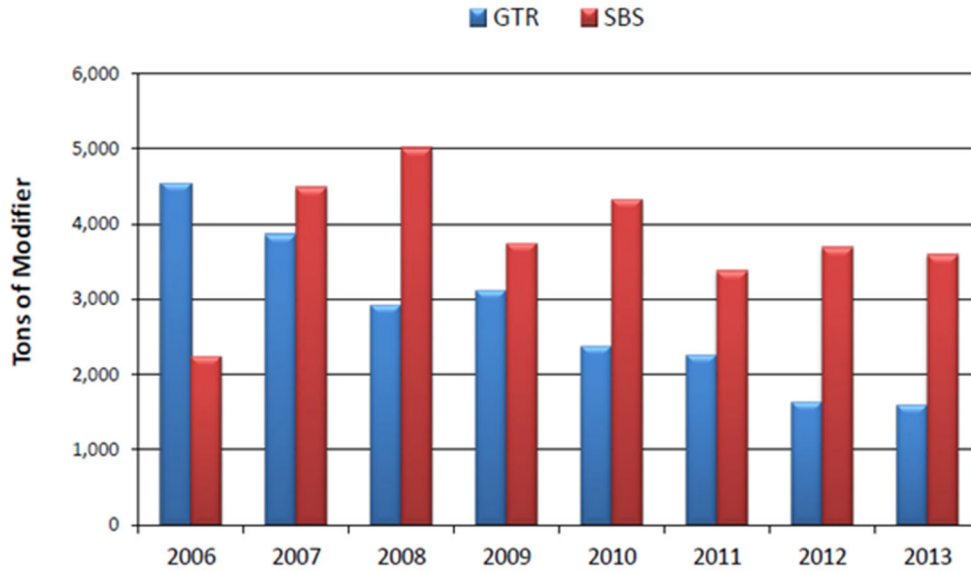
**Figure 2.9: Usage of polymer and rubber-modified binder in Florida.**  
(Source: FDOT)

(Figure 2.9) clearly shows the gradual decrease in rubber-modified binder usage in the state. According to one study (Moseley 2019), the use of rubberized binder during fiscal year 2018 fell to less than 3 percent of the state’s total binder use.

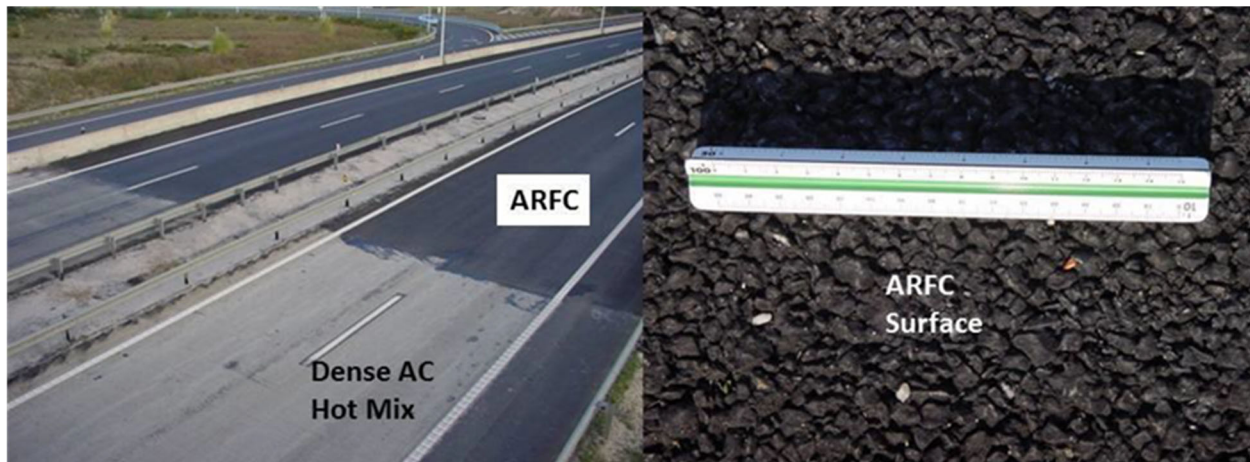
**Figure 2.10: Dense-graded asphalt cement (AC) hot mix and asphalt rubber open-graded friction course (ARFC) surfaces in Portugal.**

Portugal began to use RHMA-O surfaces in 2003 to provide a smooth riding surface, good wet-weather skid resistance, and less tire-pavement noise (see Figure 2.10). The RHMA-O was reported to have a noise level 5 to 6 dBA lower than a typical dense-graded hot mix asphalt and 8 to 10 dBA lower than a typical concrete surface (Way et al. 2012).

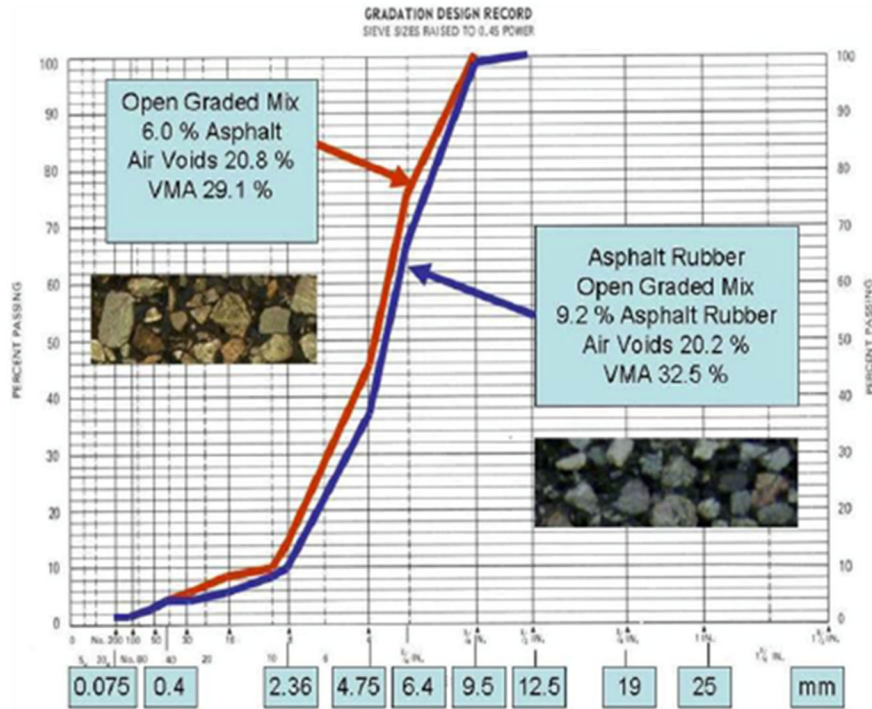
**Figure 2.11: Arizona DOT rubberized and non-rubberized OGFC gradation and binder content.**

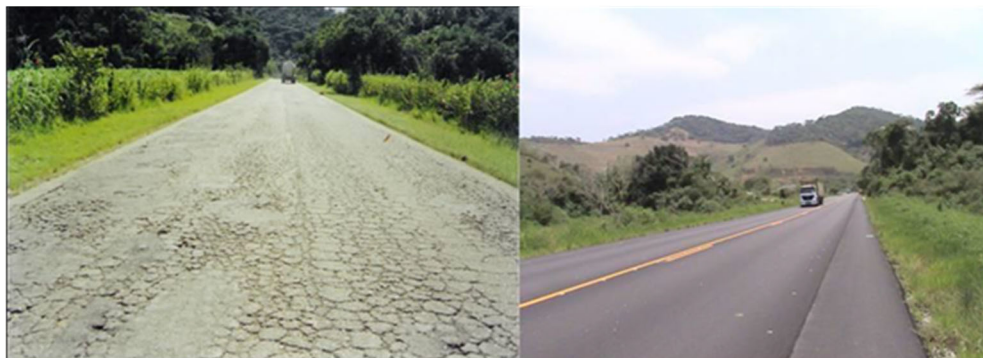
**Figure 2.12: Highway RJ-122 pavement in Brazil before and after overlay placement with an ARFC surface.**

and uncomfortable (see Figure 2.12). This highway’s traffic volume was high and composed mainly of heavy trucks, and therefore the pavement needed to be rehabilitated to handle heavy loads. As a result, a rubberized pavement mix design was selected for the Highway RJ-122 overlay project (Pinto and Sousa 2012).

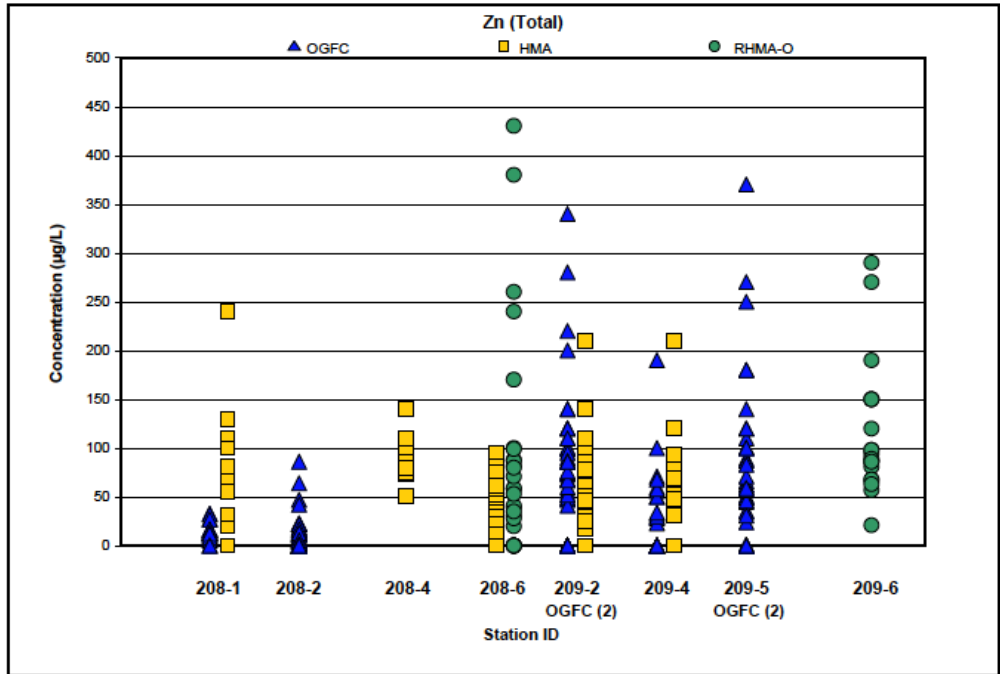
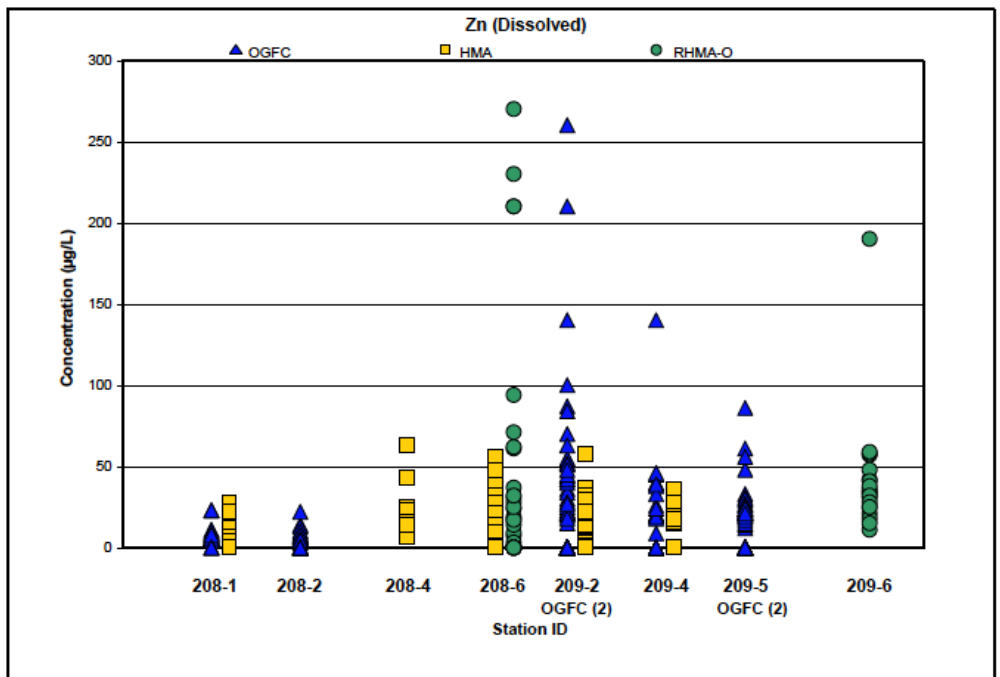
(a) Total Zn

(b) Dissolved Zn

**Figure 4.1: Concentration of total and dissolved Zn from rubberized and non-rubberized OGFC compared with conventional impervious HMA sites monitored during from 2007 to 2011. (Note: the concentration of total and dissolved Zn for runoff generated from conventional HMA impervious surface is generally lower compared OGFC and RHMA-O overlays.)**  
 Source: Caltrans (2012)

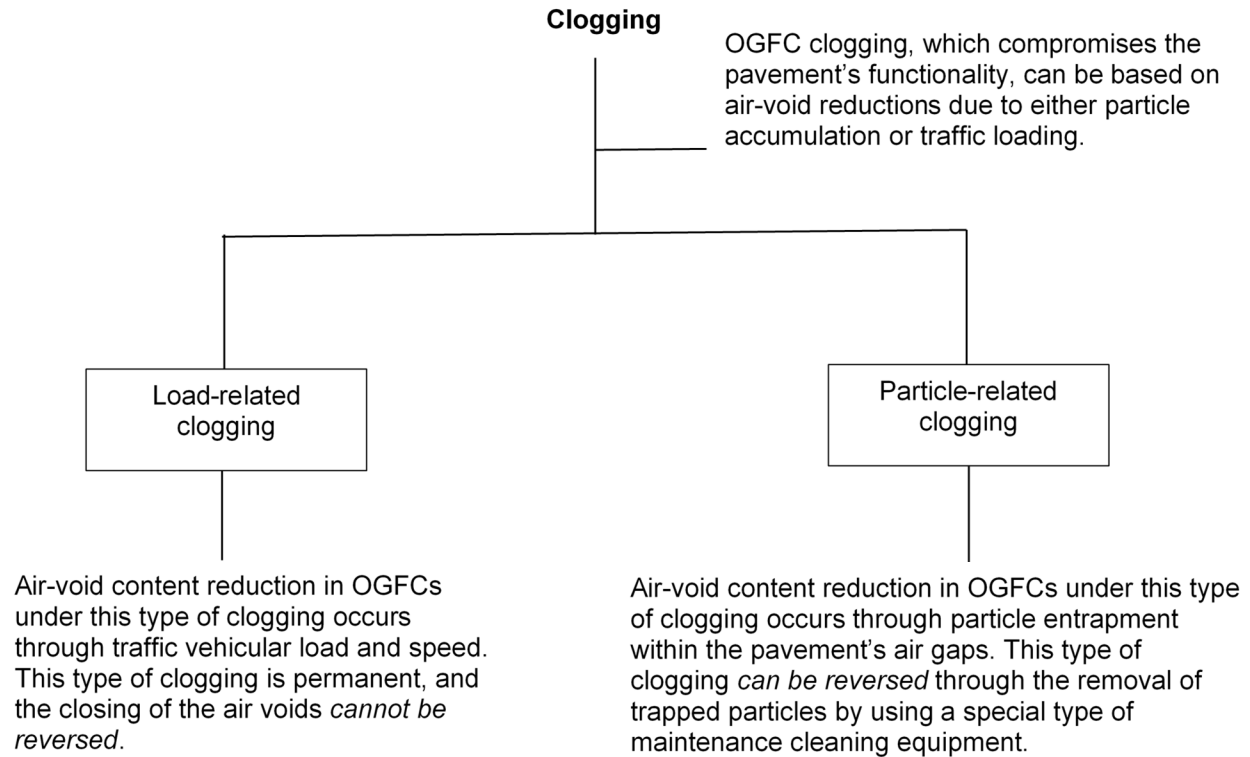
**Figure 5.1: Void reduction of OGFC due to particle-related or load-related clogging.**

Clogging due to particle accumulation within the void spaces of OGFC has been studied by numerous investigators. Some have found that particle clogging usually occurs in the pavement's upper layer (Kayhanian et al. 2012a, Mata and Leming 2012, Yong et al. 2013). Which clogging processes are at work depends on characteristics of the pavement (e.g., void content and pore size) and the solids that reach the pavement. The particles that cause clogging may originate from pavement wear due to tire friction erosion from adjacent areas, vegetation, or the application of sand (if allowed) during winter months (Ferguson 2005). Even without sand application during winter, solid particles will reach the pavement surface via vehicles traveling from other roads that have been sanded (Ferguson 2005). Thus, the permeability of pavements must be maintained to obtain the full benefits of open-graded pavements over the full course of their service life.

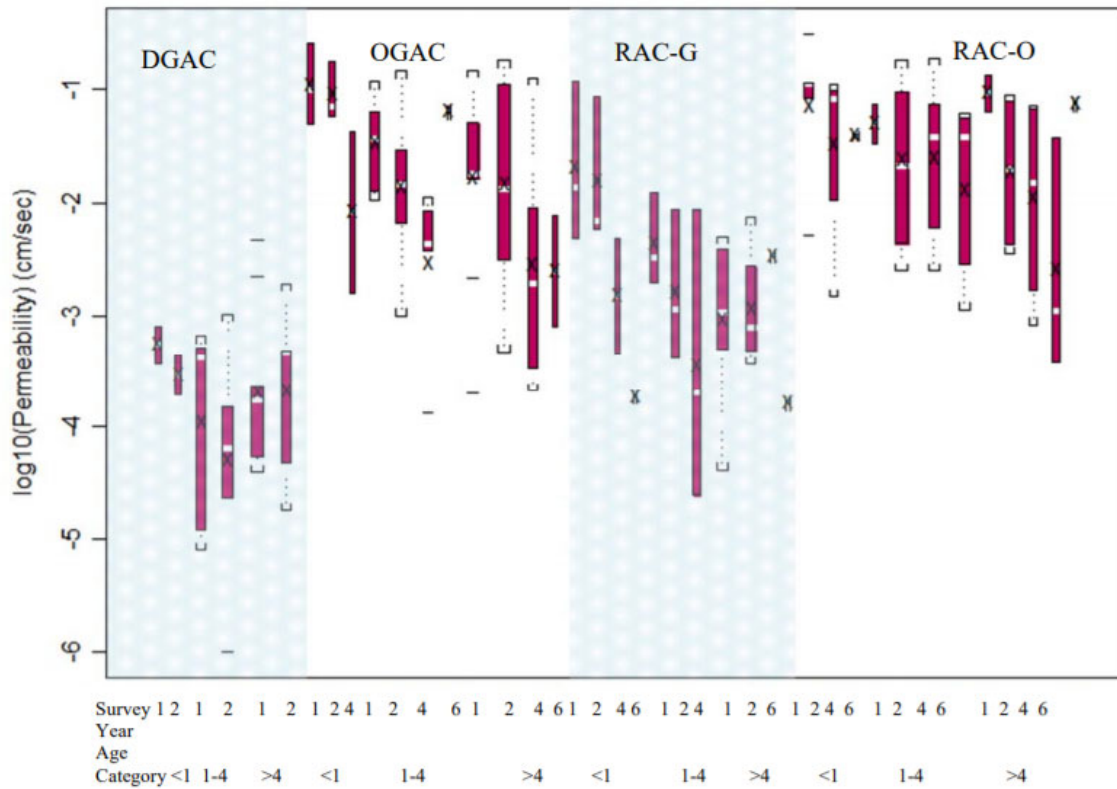
**Figure 5.2: Permeability measurements over six years of multiple California dense-graded, gap-graded, and open-graded (rubberized and non-rubberized) pavements with ages between zero and 16 years.**

throughout the life service of the pavement is more important than the type of device or method used for permeability measurement.

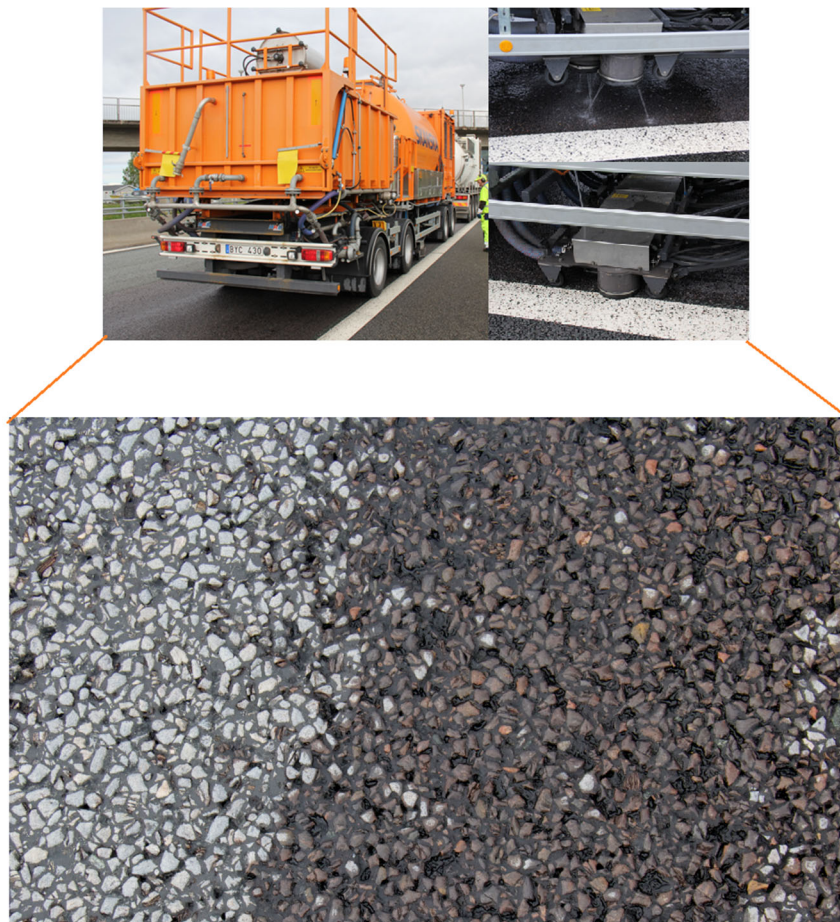
**Figure 5.3: Vägren truck high-pressure cleaning equipment used for OGFC cleaning in Sweden.**  
(Source: Ahmed 2015)

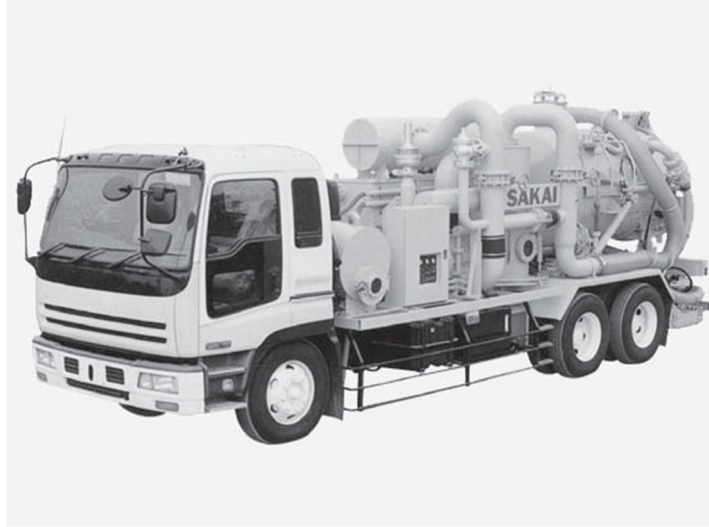
**Figure 5.4: Truck-mounted high-pressure water washing and vacuuming equipment used for OGFC cleaning in Japan.**  
(Source: Nielsen 2005)

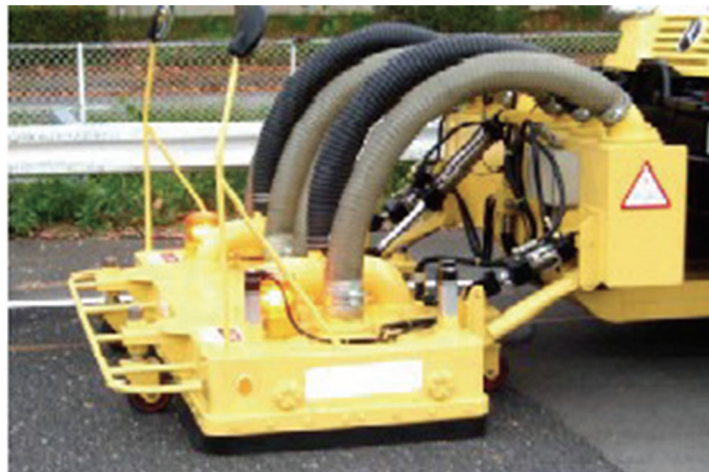
**Figure 5.5: High-pressure air with vacuuming equipment used to remove clogging of OGFC surface pavements in Japan.**  
(Source: Nielsen 2005)

In Japan the high-pressure air-cleaning equipment with vacuuming (see Figure 5.5) has also been used. These machine types are referred to as “function maintenance” machines since their application is intended to maintain the pavement’s noise-reduction function. This high-pressure air cleaning equipment operates between speeds of 10 and 20 km/h. Compared with high-pressure water cleaning equipment, the use of high-pressure air cleaning equipment found to be more cost-effective (Nielsen et al. 2005).

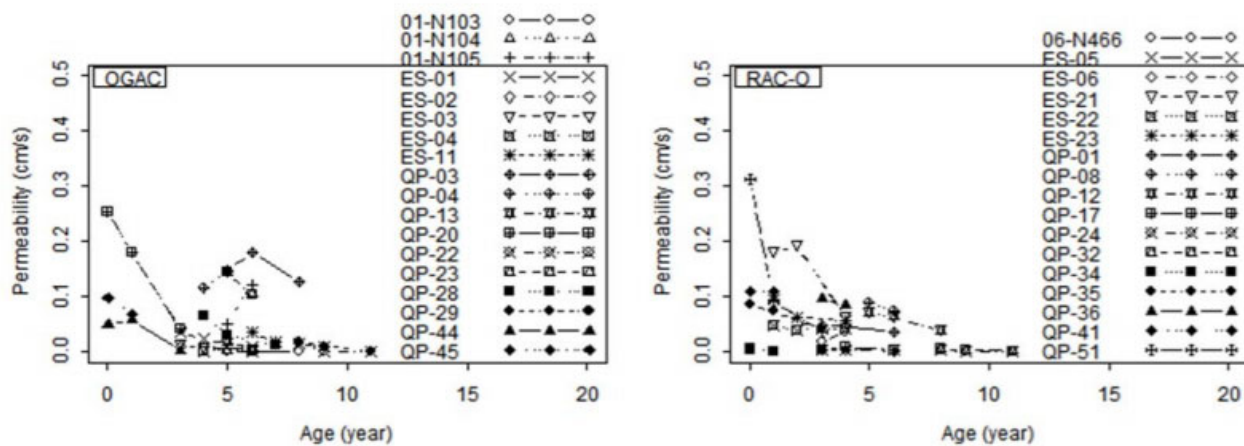
**Figure 6.2: Permeability against pavement age based on different pavement type for multiple sites in California. (Source: Rezaei and Harvey, 2013)**

Retaining RHMA-O and OGFC overlays' filtration capability over their service life depends on keeping the void spaces open for duration of their service. While self-cleaning is desired, depending on a site's characteristics, particles might continuously accumulate within the void spaces of the RHMA-O and OGFC layers. If this occurs it will cause a significant reduction in permeability and consequently diminish their expected water quality and other environmental benefits. As was discussed in Chapter 5, in addition to particle accumulation, over their the years of operation, the void spaces in the wheelpaths of OGFC and RHMA-O overlays may also be reduced by the effects of rutting through loading, and this will also contribute to lower permeability and runoff water treatment effects. This latter problem is heavily dependent on the pavement's mix design and construction. For example, research study performed by UCPRC (Rezaei and Harvey, 2013) showed that the permeability of OGFC and RHMA-O pavements lessened gradually as a function of pavement age (see Figure 6.2). Again, with the limited research results available and without knowing the actual treatment mechanisms at work during rain events, it is difficult to discretely assess the contribution of filtration treatment compared to the overall removal of pollution by non-rubberized and rubberized OGFCs. For example, one important question that needs to be addressed is, how long will the filtration continue before pavement permeability reaches to a threshold level without surface cleaning or replacement?

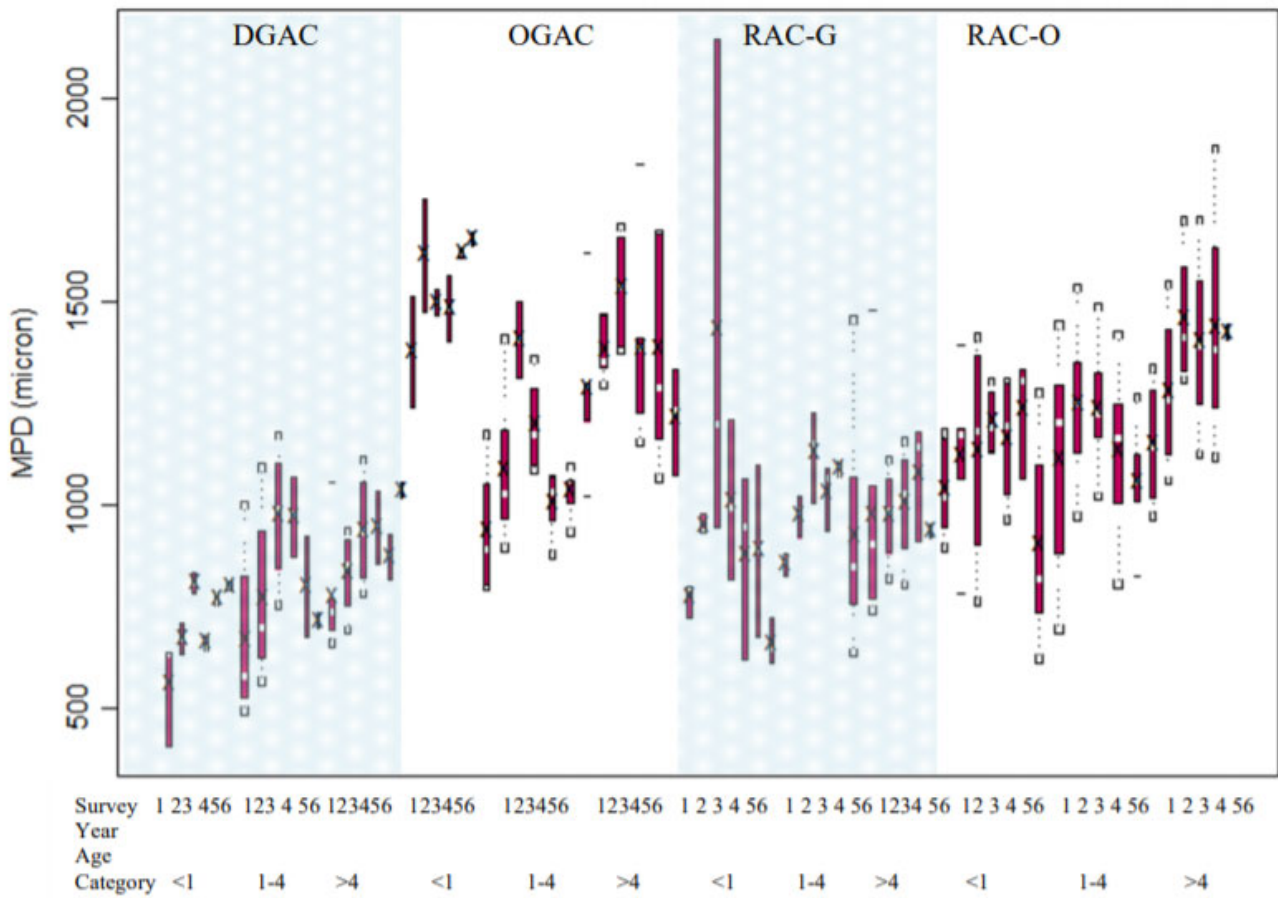
**Figure 6.3: Distribution of MPD values for different mix types and different age categories across the six years of data collection. (Source: Rezaei and Harvey, 2013)**
