After Study for the Richmond-San Rafael Bridge (Phase I)

# After Study for the Richmond-San Rafael Bridge (Phase I)

June 30, 2022

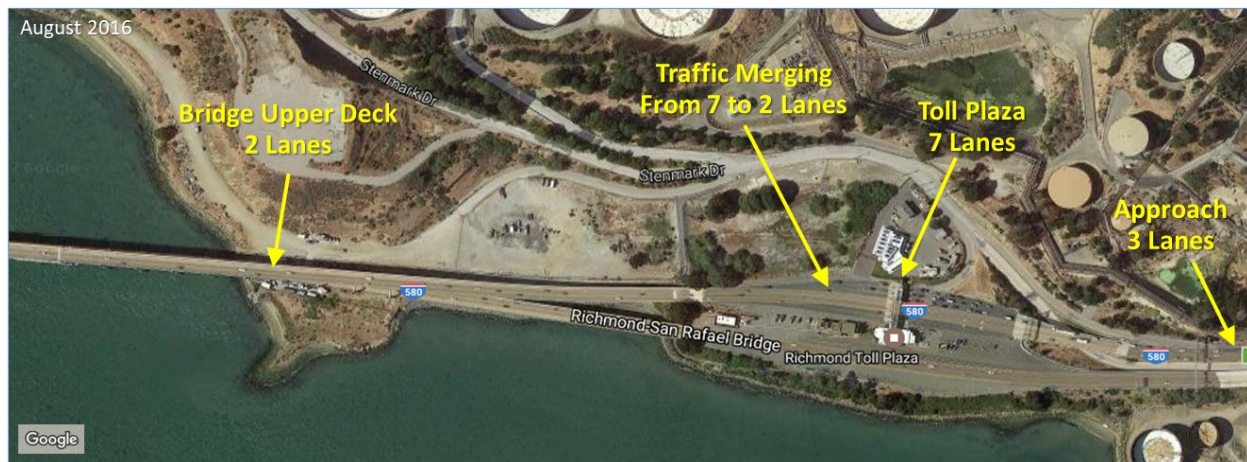
**Figure 2-5: Initial Conditions – Westbound Bridge Approach in Richmond**

Over time, increased volumes have led to increasing congestion on the westbound approach to the bridge. As indicated in Figure 2-5, the two main congestion-contributing factors were the toll collection activities and the fact that the bridge only carried two lanes of traffic while the freeway leading to it had three lanes. While it was often hypothesized that the toll collection activities were the primary cause of congestion, merging activities downstream of the plaza was the real culprit. Following a continuous

reduction in the number of vehicles paying the toll with cash, the expectation was that congestion upstream of the plaza would reduce. This is not what happened. By increasing the rate at which vehicles were able to go through the toll plaza, the adoption of electronically toll transponders by motorists resulted in more vehicles entering the merge area downstream of the plaza. This, in turn, caused increased frictions and slower speeds at the entrance of the bridge that propagated back through the toll booths.

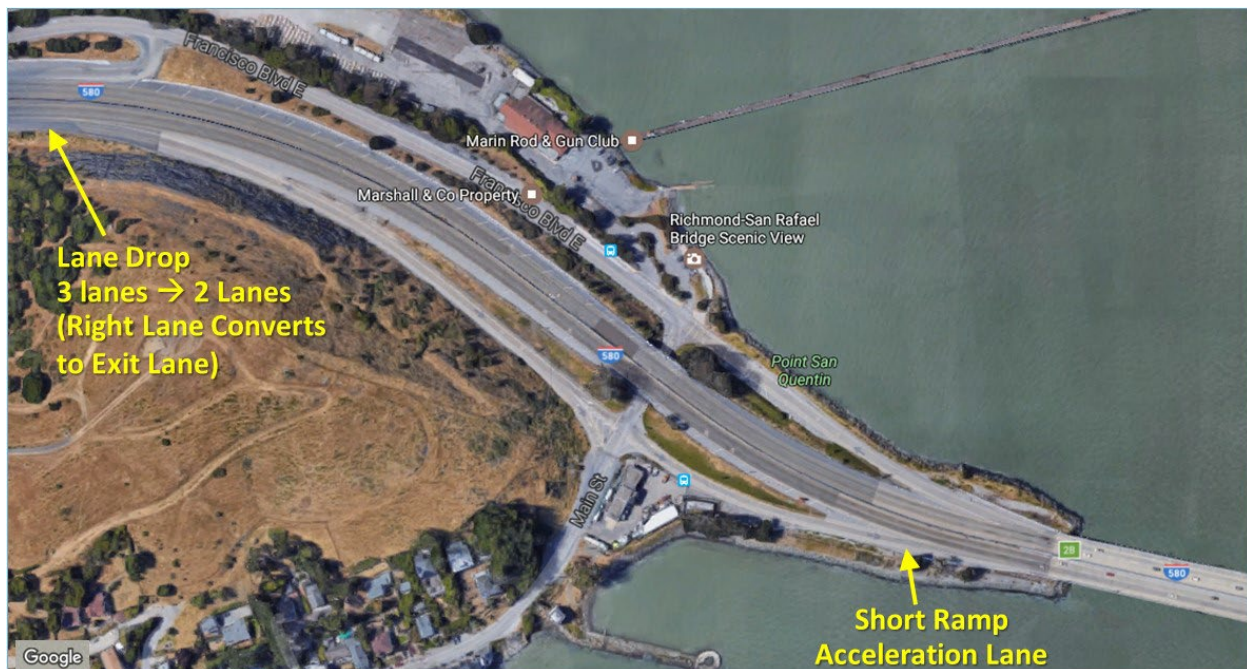
**Figure 2-6: Initial Conditions – Eastbound Bridge Approach in Marin County**

The eastbound approach in Marin County, shown in Figure 2-6, had also experienced a significant increase in congestion during the PM peak period due to increased traffic. In this case, the congestion was primarily caused by a reduction in the number of traffic lanes from three to two as the right-most lane converts to an exit lane approximately 2,000 feet from the foot of the bridge. Traffic merging from Main Street merging onto the freeway through a very short acceleration lane also contributed to the problem.

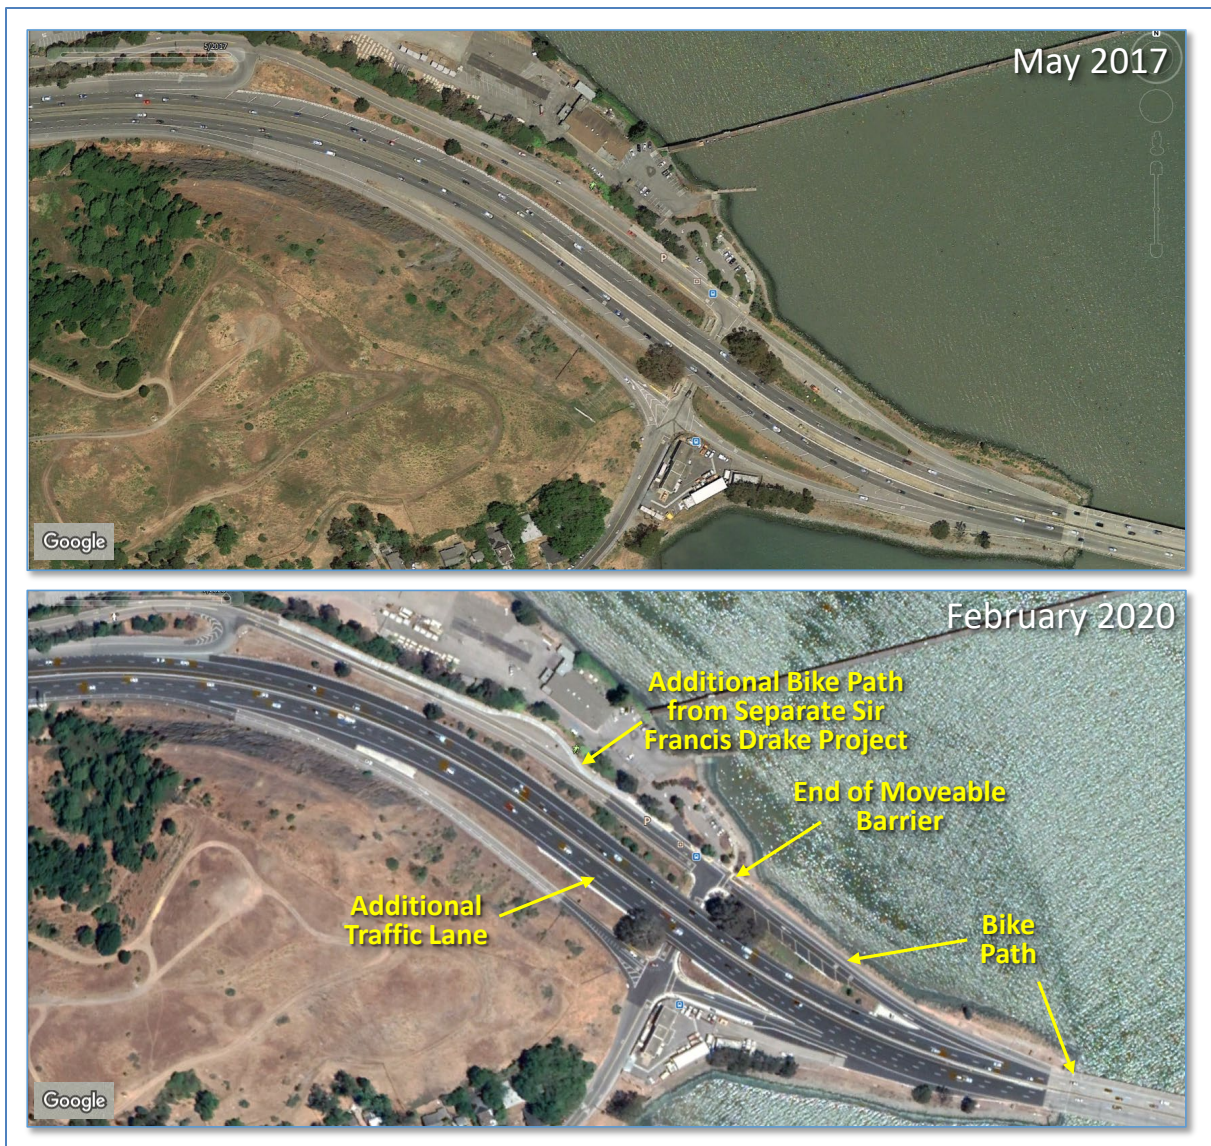
**Figure 2-19: Modifications of Marin County Approach**
