# THE STONES OF TIAHUANACO

A STUDY OF ARCHITECTURE  
AND CONSTRUCTION

JEAN-PIERRE PROTZEN  
AND STELLA NAIR

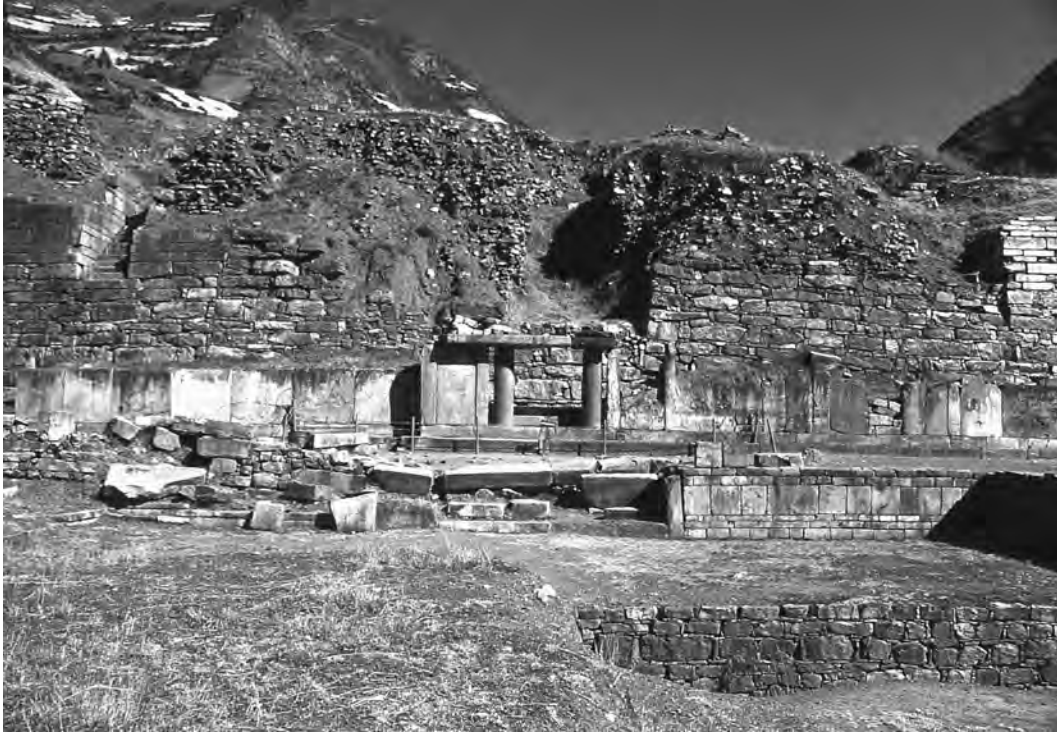
**Figure I.3.** Cut-stone architecture at Chavín de Huántar.

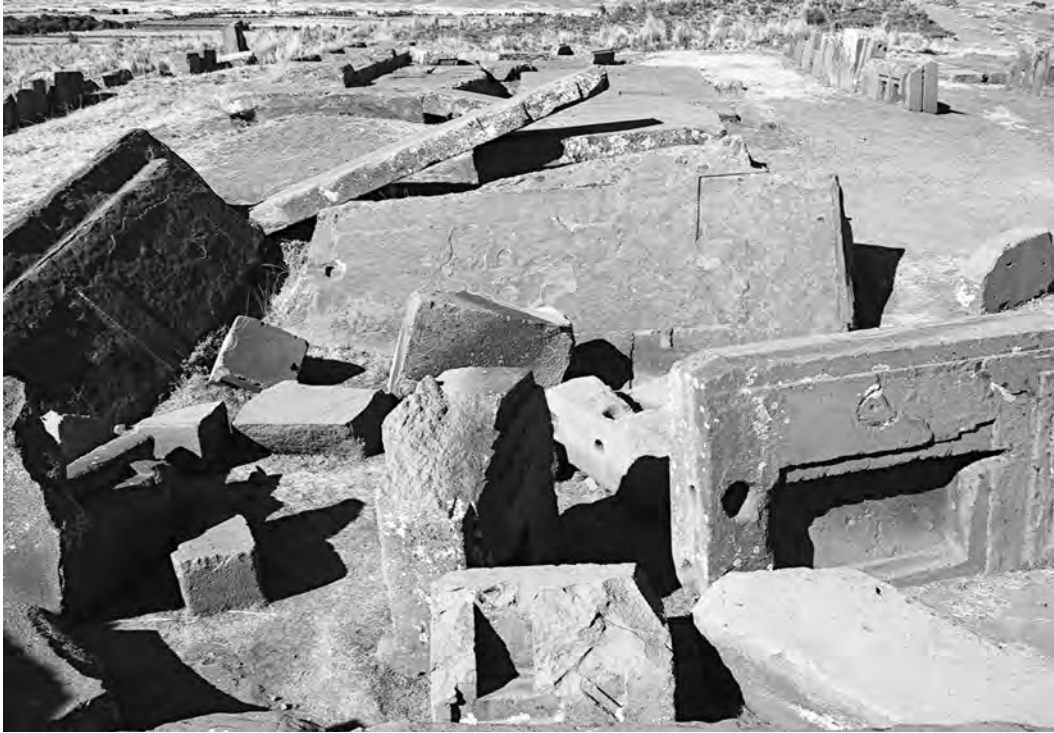
**Figure I.5.** Jumble of building stones at Pumapunku.

The archaeological site has suffered unspeakable damage ever since the arrival of the Spanish (Figure I.5). Not only did they mine the ruins to construct the colonial town and church of Tiahuanaco, but carted away building stones to as far away as La Paz, approximately 70 km from Tiahuanaco (Castro y del Castillo 1906:211).<sup>2</sup> Further havoc was brought about by colonial era treasure hunters who believed that major caches of gold and precious stones were waiting to be carted away. One such treasure hunt left a big and deep gash on Akapana, one of Tiahuanaco’s major platform mounds, destroying whatever architecture crowned the mound. Worse than the Spanish colonialists were the railroad barons of the early 1900s. The railroad line connecting the capital city of La Paz to the port of Guaqui on the shores of Lake Titicaca was run precisely through the archaeological site of Tiahuanaco. In the process uncountable building blocks, statues, and stelae were blown up with dynamite to provide ballast for the tracks (Baptista 1975:41). To add insult to injury, the inhabitants of the modern town of Tiahuanaco dismantled and destroyed nearly everything Georges Courty uncovered within days, even hours, of his excavations in 1903–1904 (Posnansky 1945:Vol. 2, 106). The depredation did not end there, but continued for many years and culminated in the probably well-intentioned, but ill-conceived and uninformed, reconstruction of the Kalasasaya, a large, enclosed platform structure (Figure I.6).

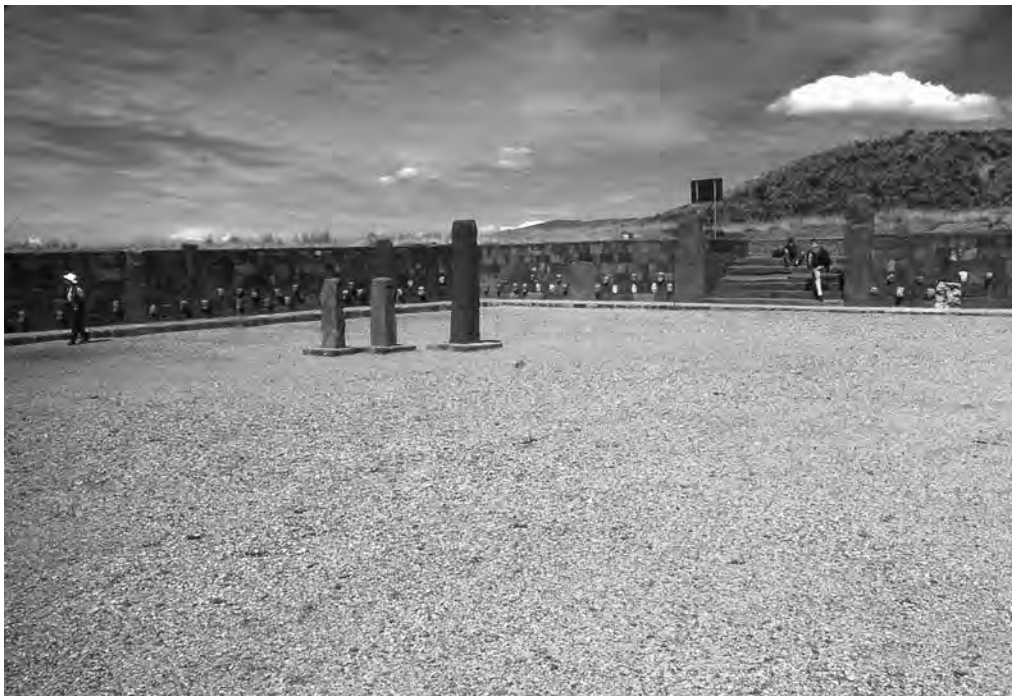
Figure 2.2. Walls of the Semi-Subterranean Temple with uprights and tenon heads.

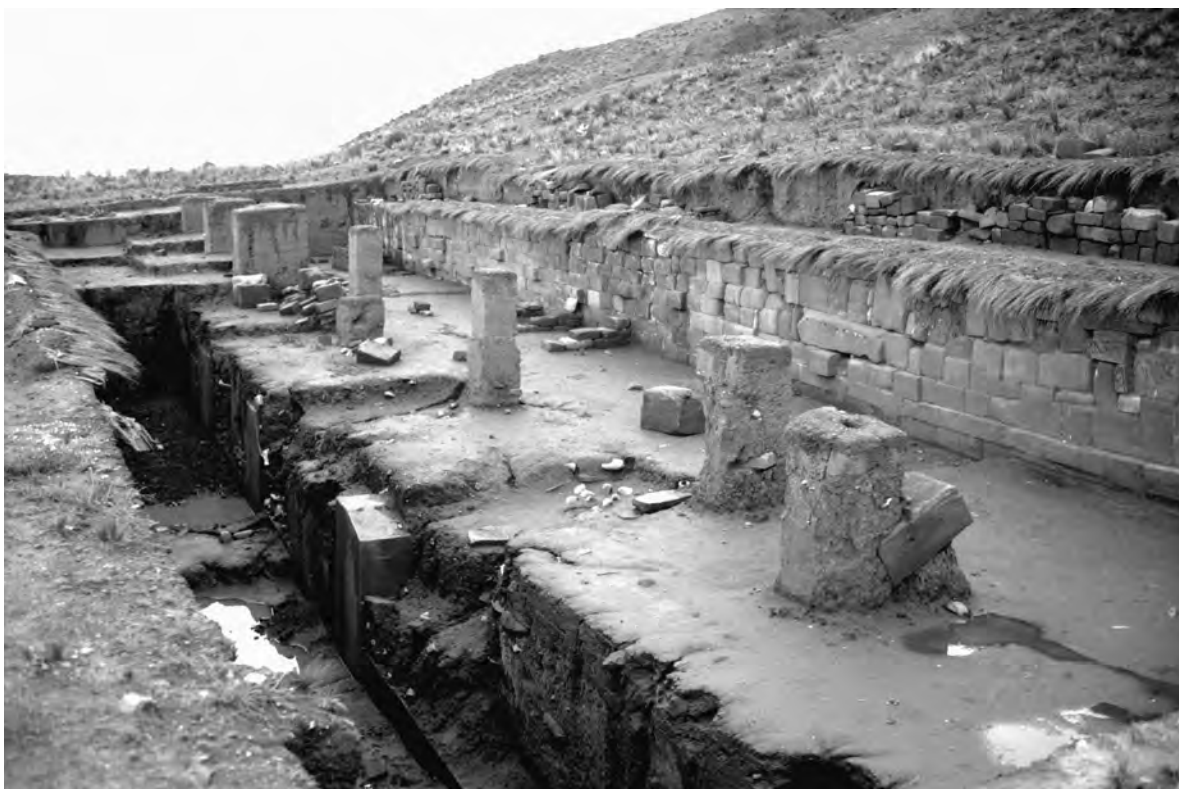
**Figure 2.15.** Basewall and second wall of Akapana's south side.

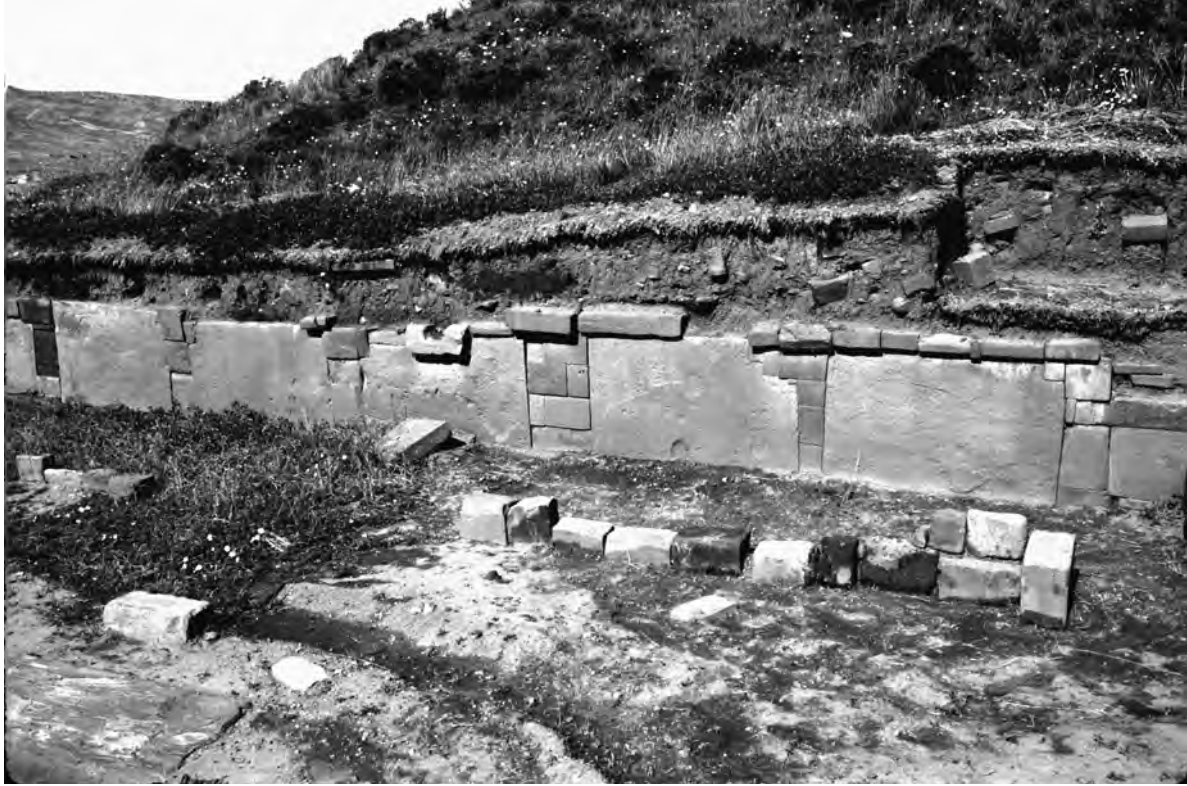
Figure 2.22. Second wall with spout (Type “d”) Akapana’s west side.

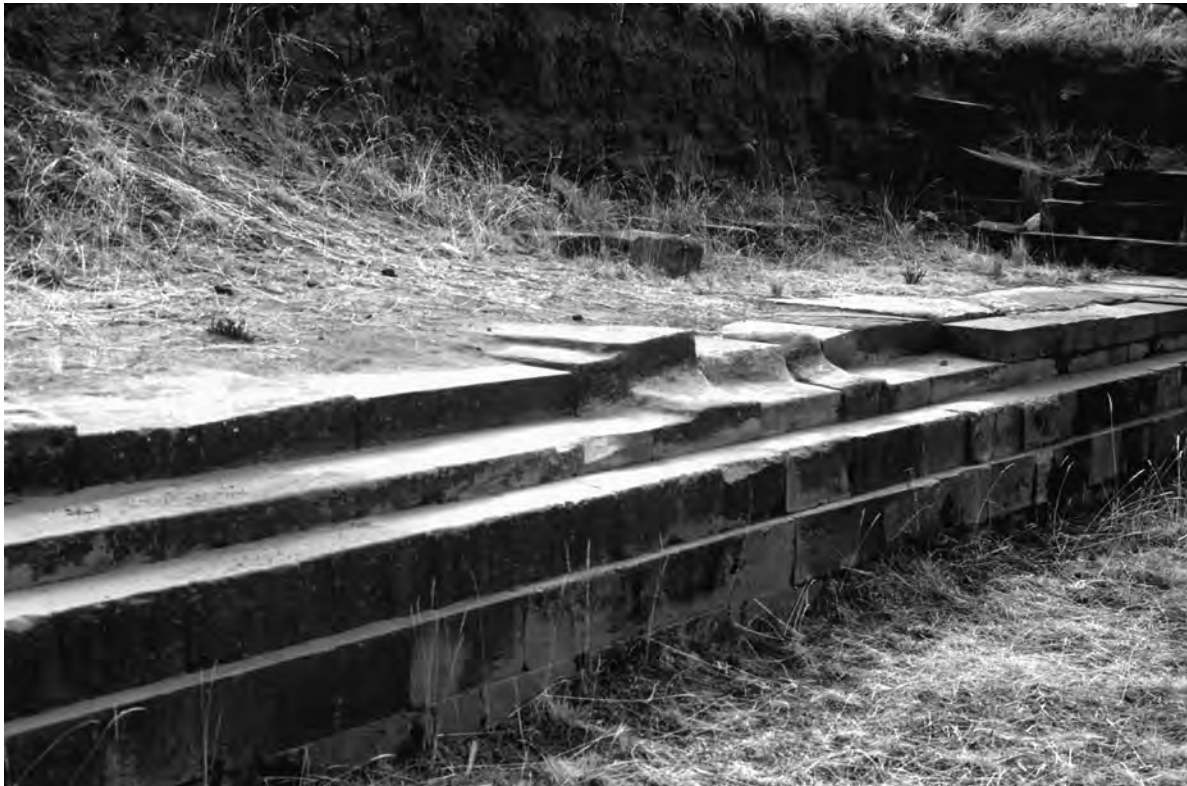
**Figure 2.48.** Stereobate on Pumapunku's south side with not fully carved top step (center) and infill with andesite blocks (right).

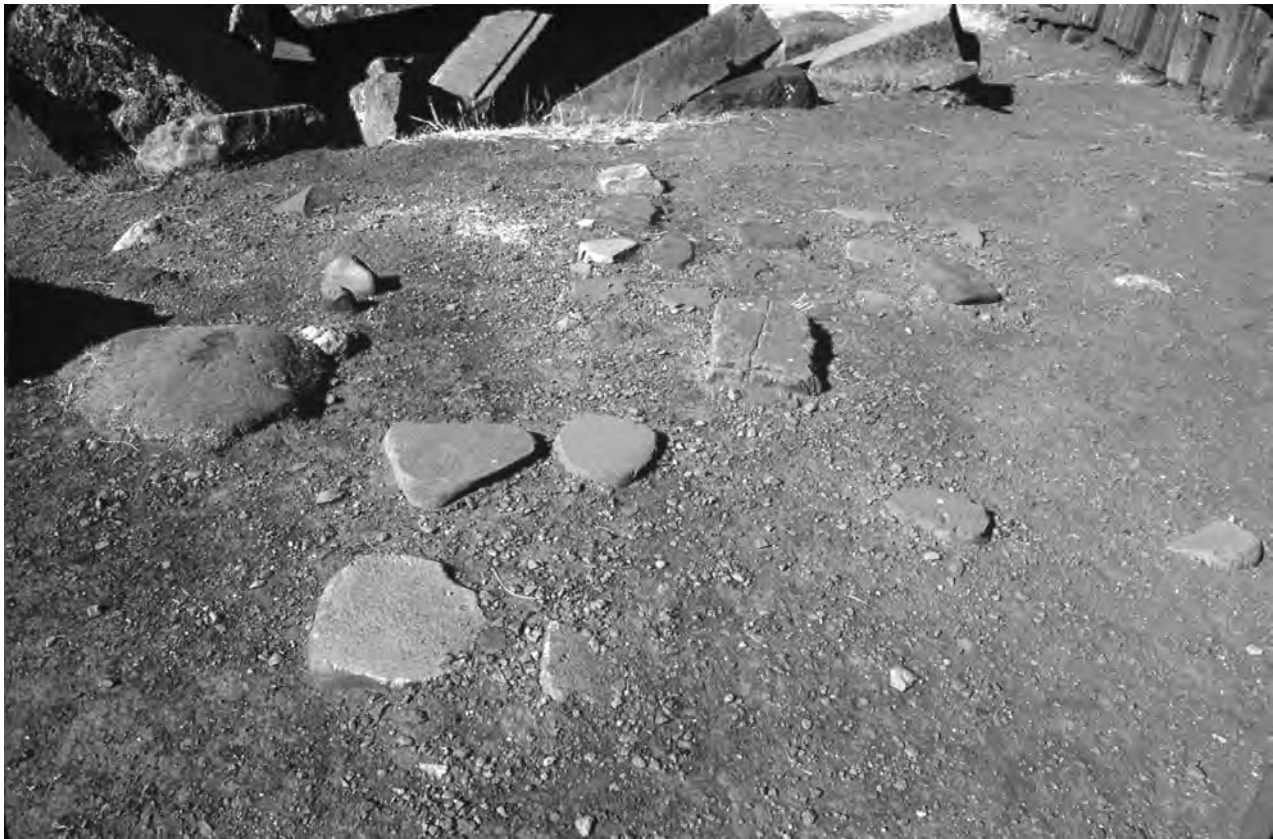
**Figure 2.56.** Foundation stones west of Platform IIa.

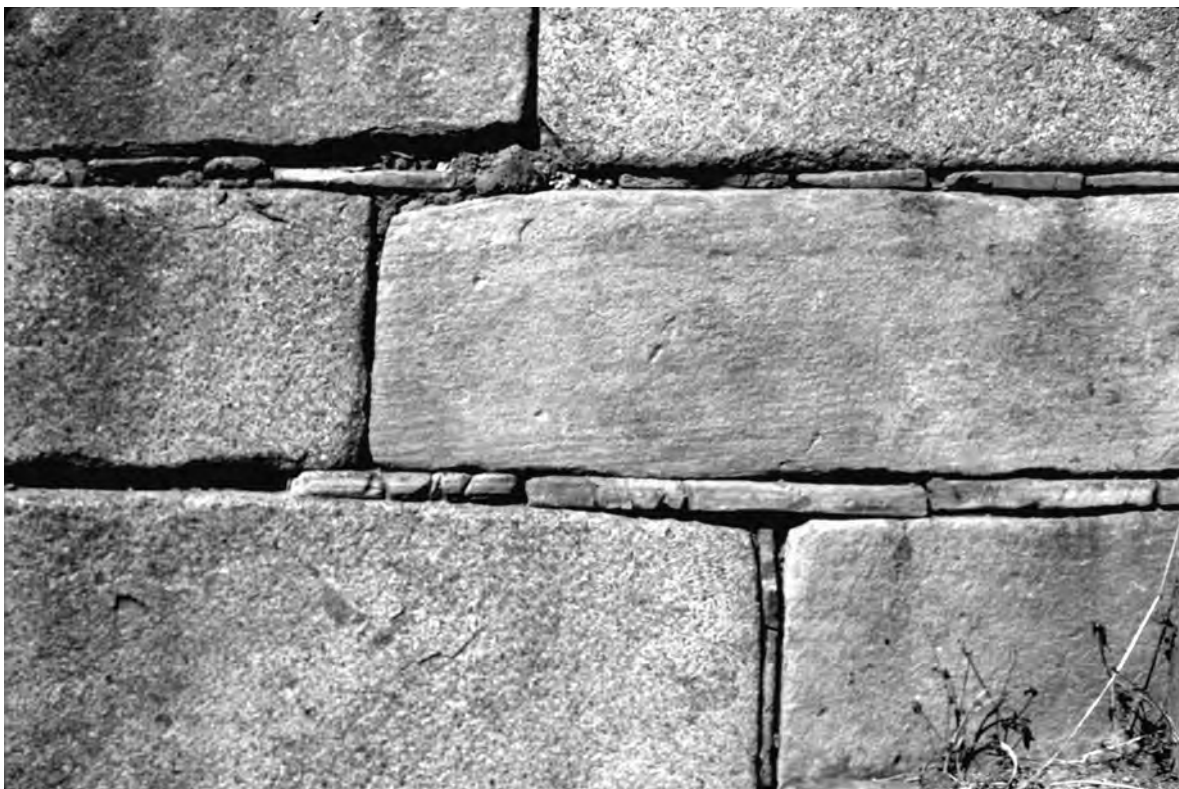
**Figure 2.70.** Chinked cut-stone masonry at Chavín de Huántar.

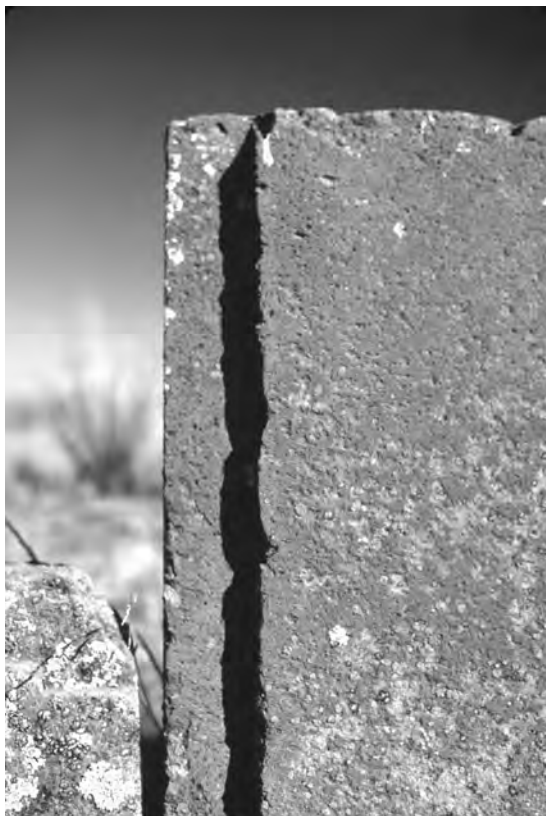
Figure 3.1. Straight rabbet.

Rabbits are longitudinal grooves cut along one or more edges of a stone (Figure 3.1). Some rabbits are straight, others are stepped at one or the other of their ends (Figure 3.2). Step moldings are L-shaped rectilinear moldings adding variety to plain surfaces (Figure 3.3). Dentils are small projecting rectangular blocks<sup>1</sup> (Figure 3.4).

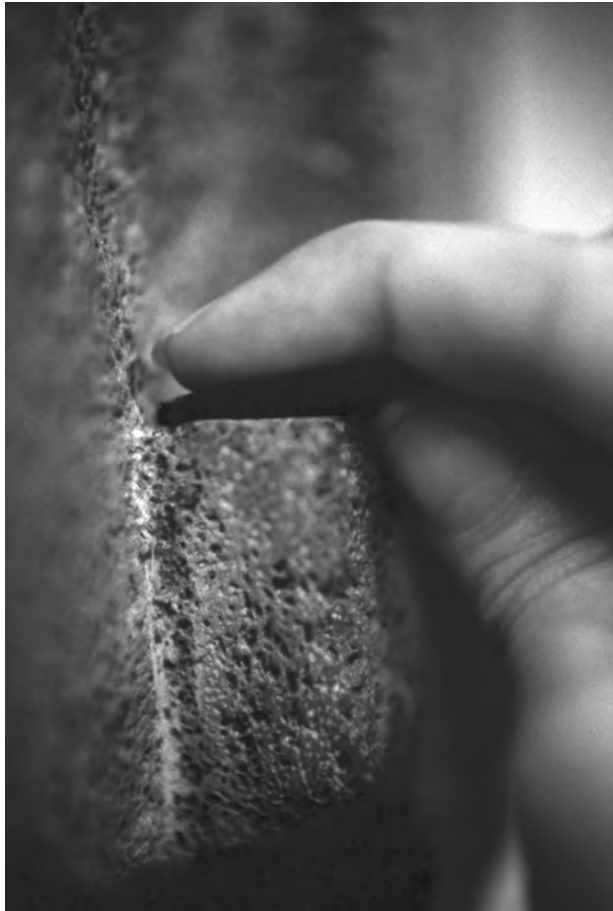
**Figure 5.13.** Obsidian being used as polisher and incisor.

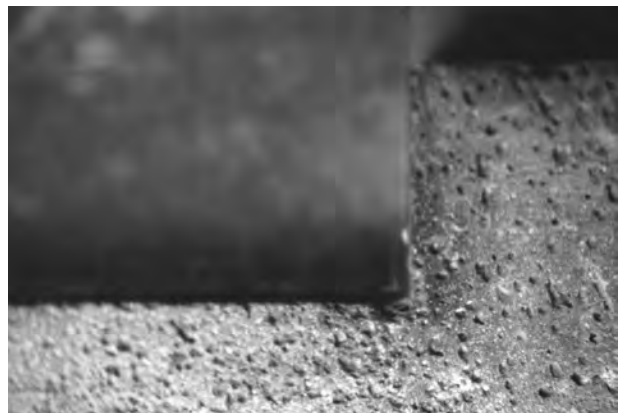
**Figure 5.14.** Close-up of finished corner in the motif, revealing the precision obtained in the form of a perfect right angle. Note also the damaged surface of the interior angle where Nair learned how fragile this area is, and hence, the need to preserve this area until the very final stages in the carving.

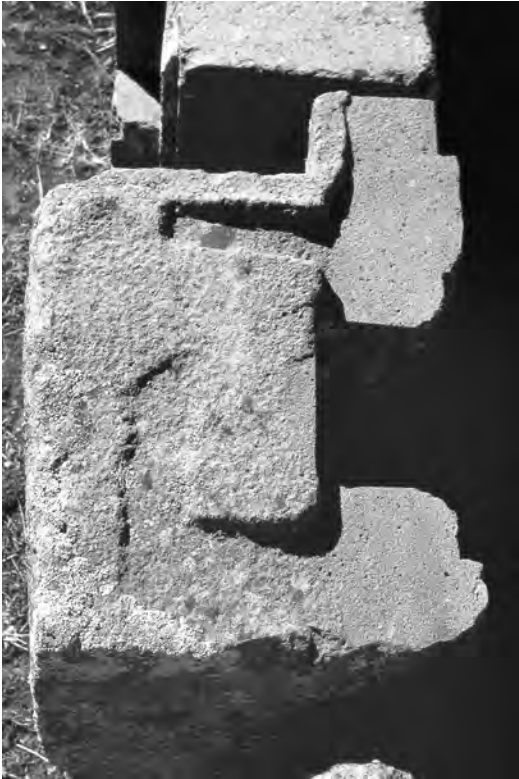
**Figure 5.15.** Note how a flattened, planar surface (one that has been worked with large and then very small hammer tools) is moved along a single plane (where only large hammer tools are being used).

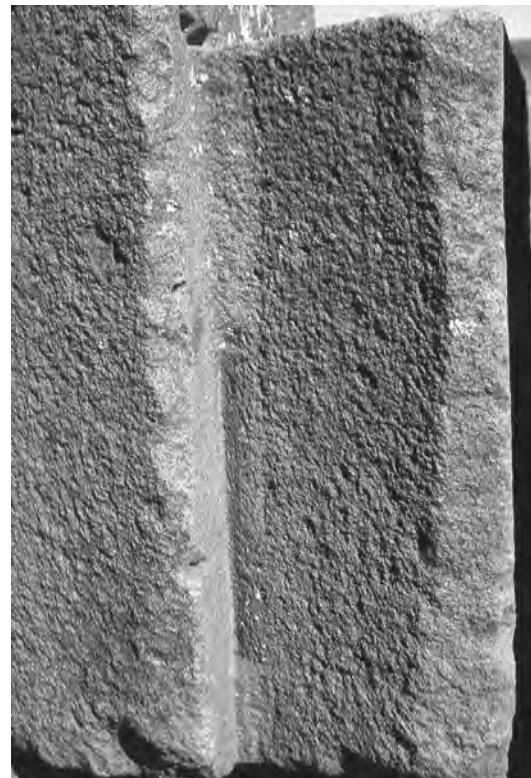
**Figure 5.18.** Close-up of right-hand corner of Sawtooth stone, showing three carving stages in the process of making the interior corner.

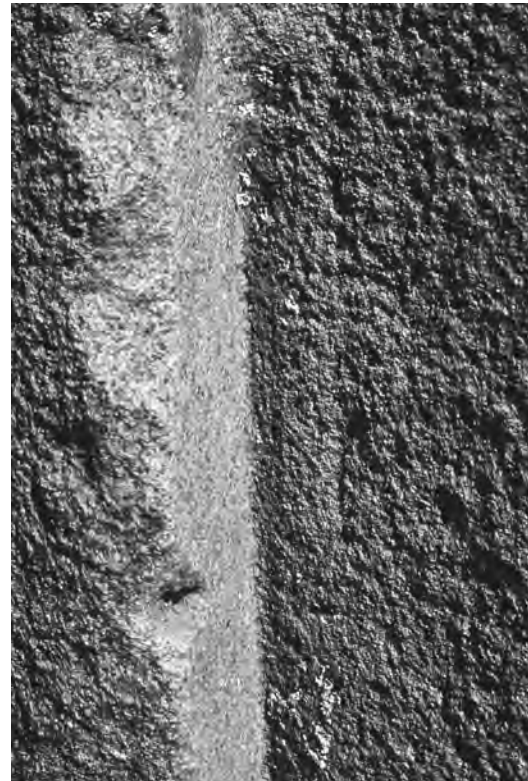
**Figure 5.20.** Note that the corner is made ever tighter toward the bottom. The round tool marks are replaced by sloping lines. These chisel marks show the transition to an ever smaller and more easily controlled tool head. Note also that the plane to the left of the corner is smooth (pock marks of a small hammer tool), while the plane to the right of the corner is rough (pock marks of large- and medium-sized hammer tool).

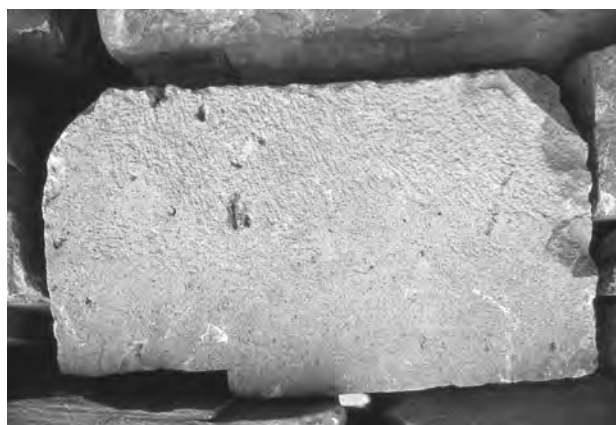
**Figure 5.27.** Stone Type 4.3 in the Akapana, showing chisel marks.

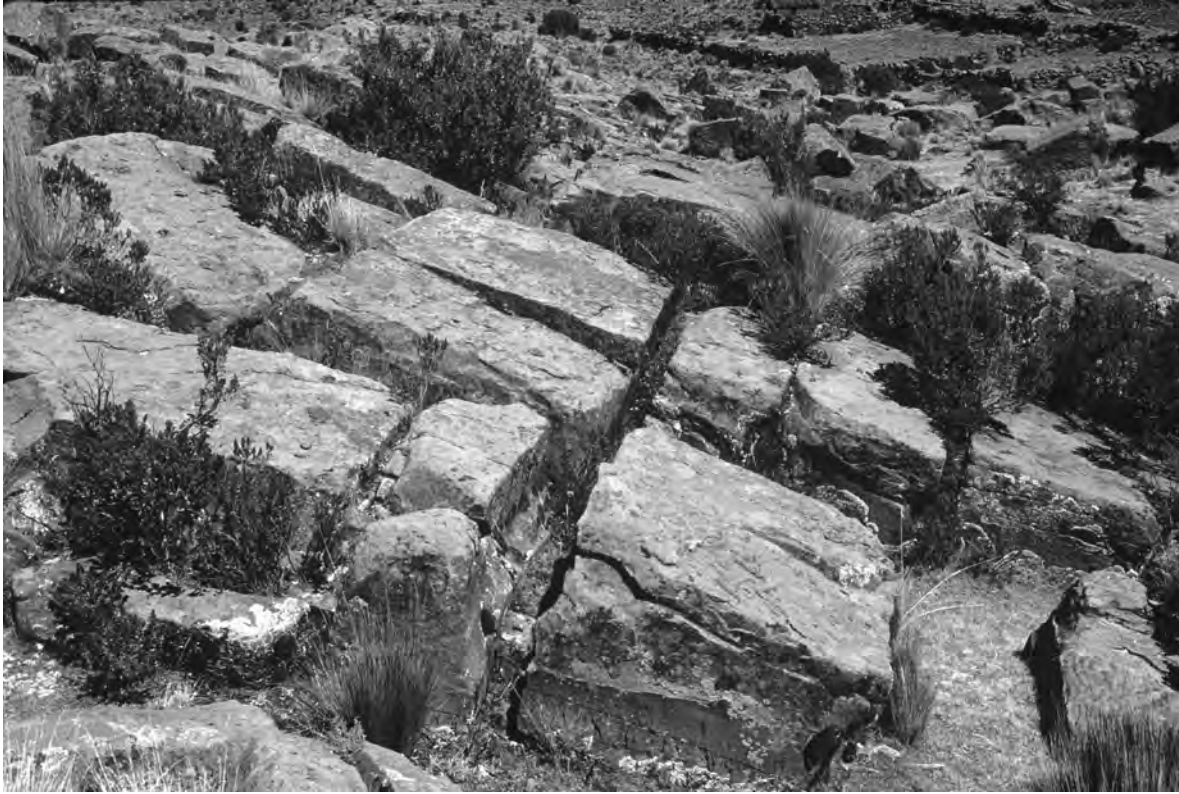
**Figure 6.4.** Natural fracture planes in the sandstone formation at Kaliri.

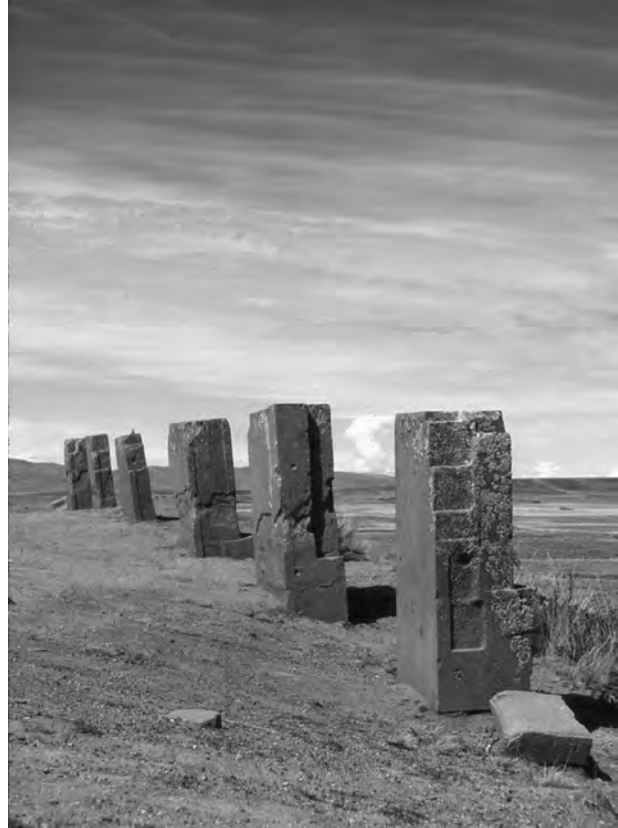
**Figure 6.9.** Imprints on the uprights on top of Akapana give clues to the position and size of the infill masonry.

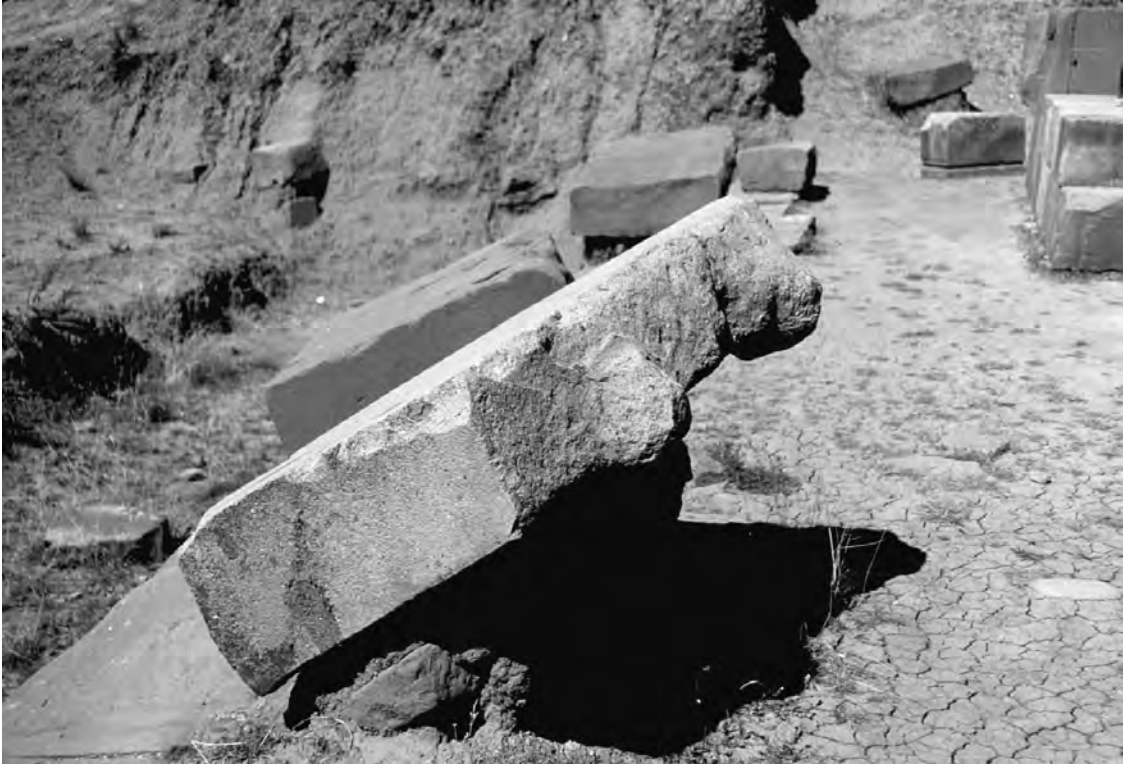
**Figure 6.13.** Protuberances or bosses to handle stones.

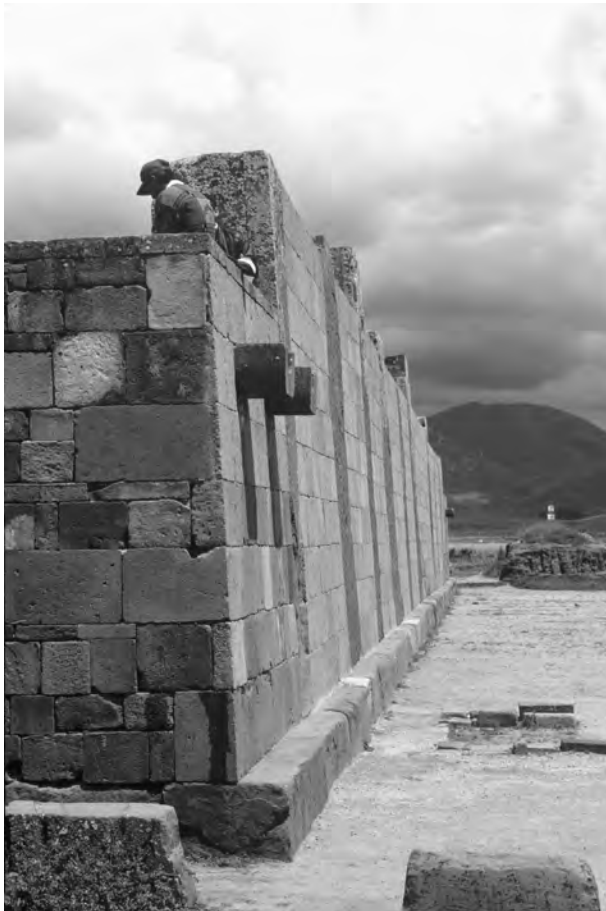
**Figure 6.19.** Sandstone blocks as foundation under the Balcony Wall.

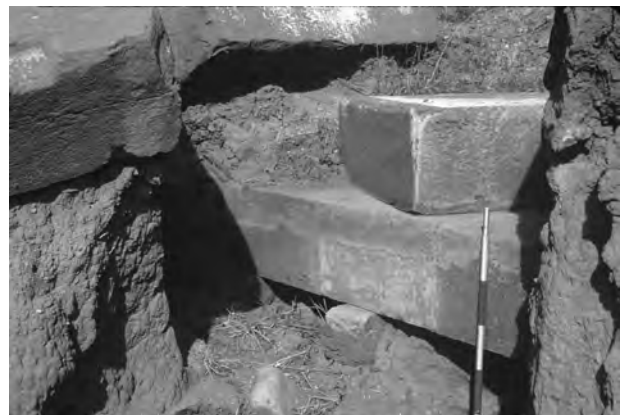
**Figure 6.20.** Bottom of stereobate on Pumapunku's north side resting on cut-off soil nails.

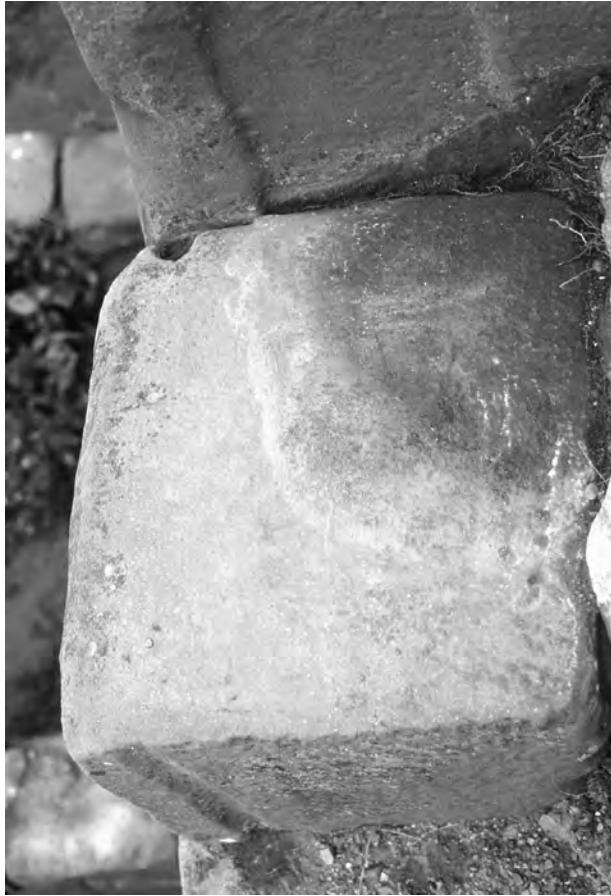
**Figure 6.22.** Rabbet joint on upright. Also note the rope chase on the block fitted to upright.

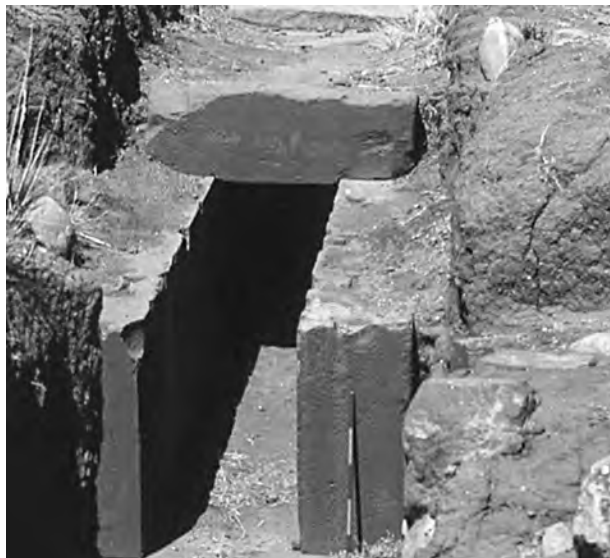
Figure 6.24. Canal with cover on Pumapunku, south side.

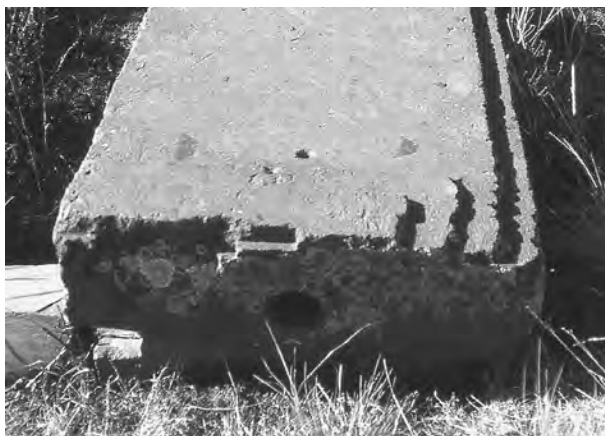
**Figure 6.27.** Recessed cone in jamb of the Akapana Gate.

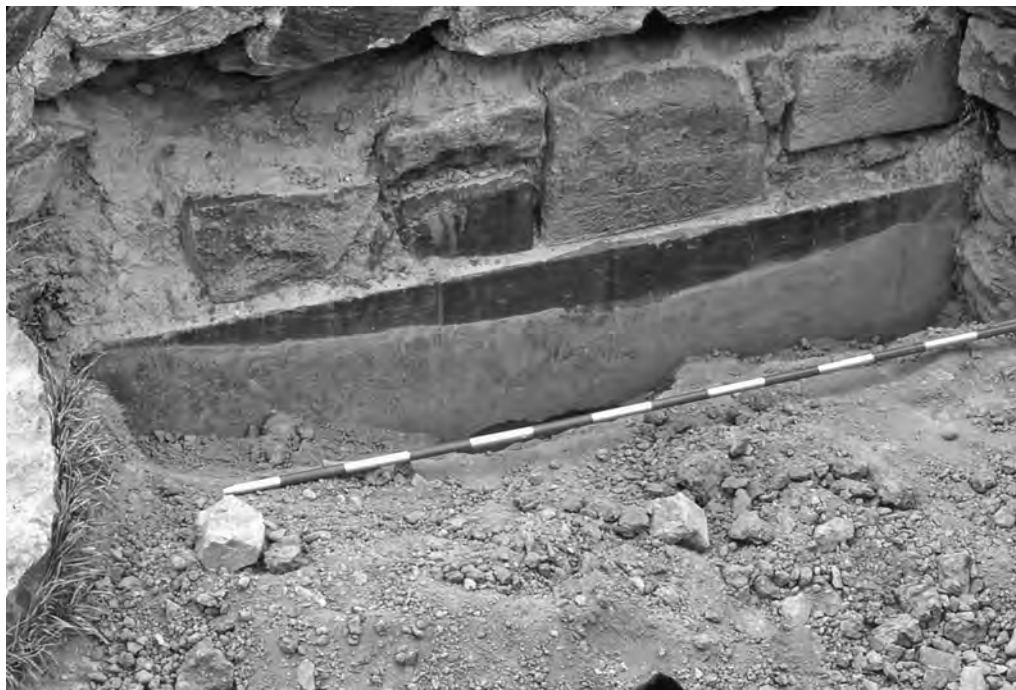
**Figure C.1.** Llanos wall at Ollantaytambo with Tiahuanaco-like masonry.
