Assessing Current Site Conditions and Vulnerabilities to Sea-Level Rise and Saltwater Intrusion: Lower Carneros Creek, Elkhorn Slough

Final Draft

Prepared by Emma Lasky and Olivia Won

University of California, Berkeley

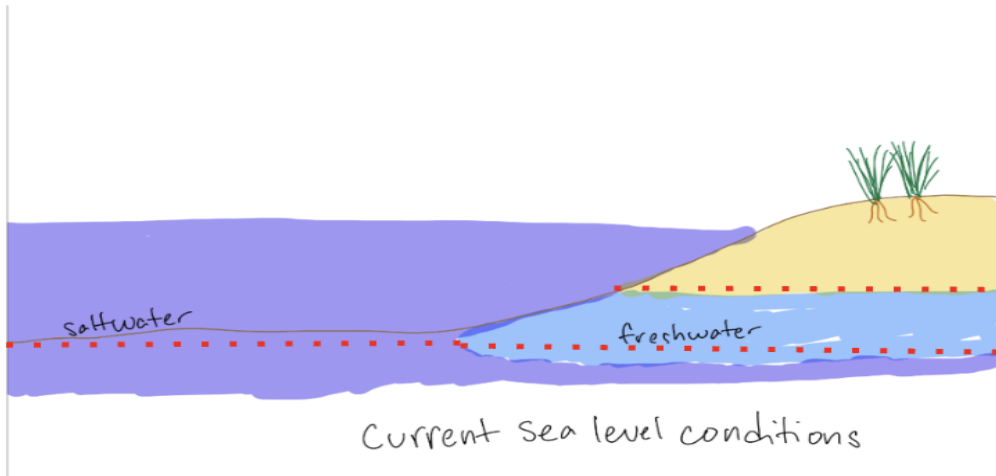
Figure 5. Schematic demonstrating the sea-level rise induced groundwater rise and saltwater intrusion. The red dashed line depicts the fresh and saltwater groundwater boundaries.

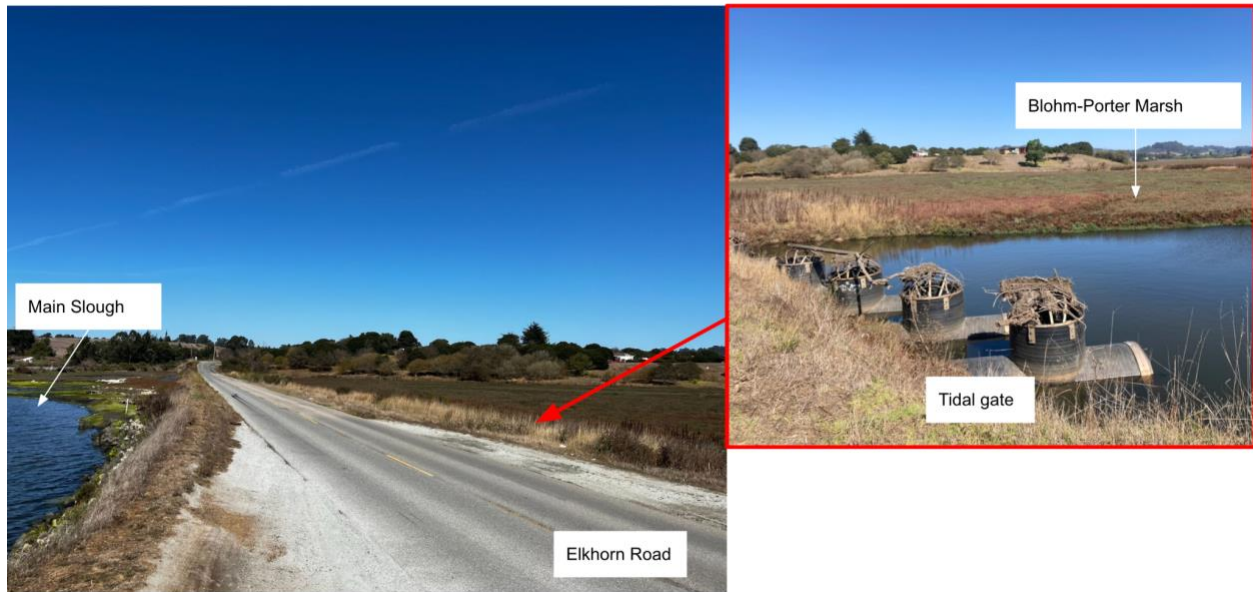
Figure 6. Tidal gate at Elkhorn Road separating the Blohm-Porter Marsh Complex from the main Elkhorn Slough channel. The Blohm-Porter Marsh Complex is at a noticeably lower elevation than the land on the other side of the road by the slough channel.

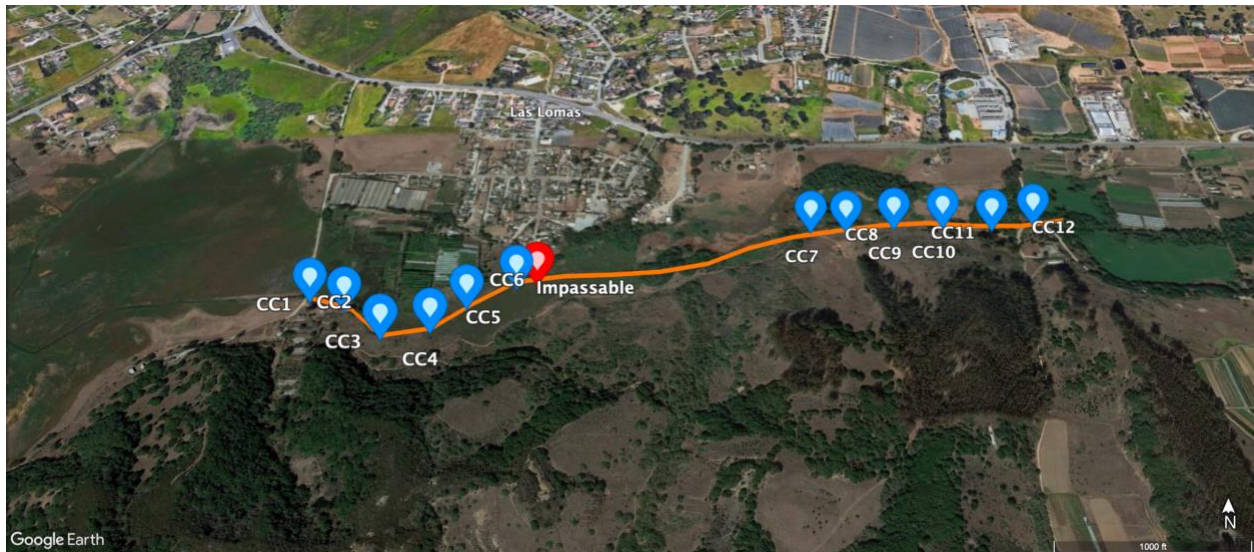
Figure 8. Sampling locations along Lower Carneros Creek. There were 12 sampling sites in total and are marked as “CCX” with “CC” signifying Carneros Creek and “X” signifying the sampling number and these sites are marked in blue. The red mark indicates the beginning of the impassable stretch of the creek; this continued until CC7.

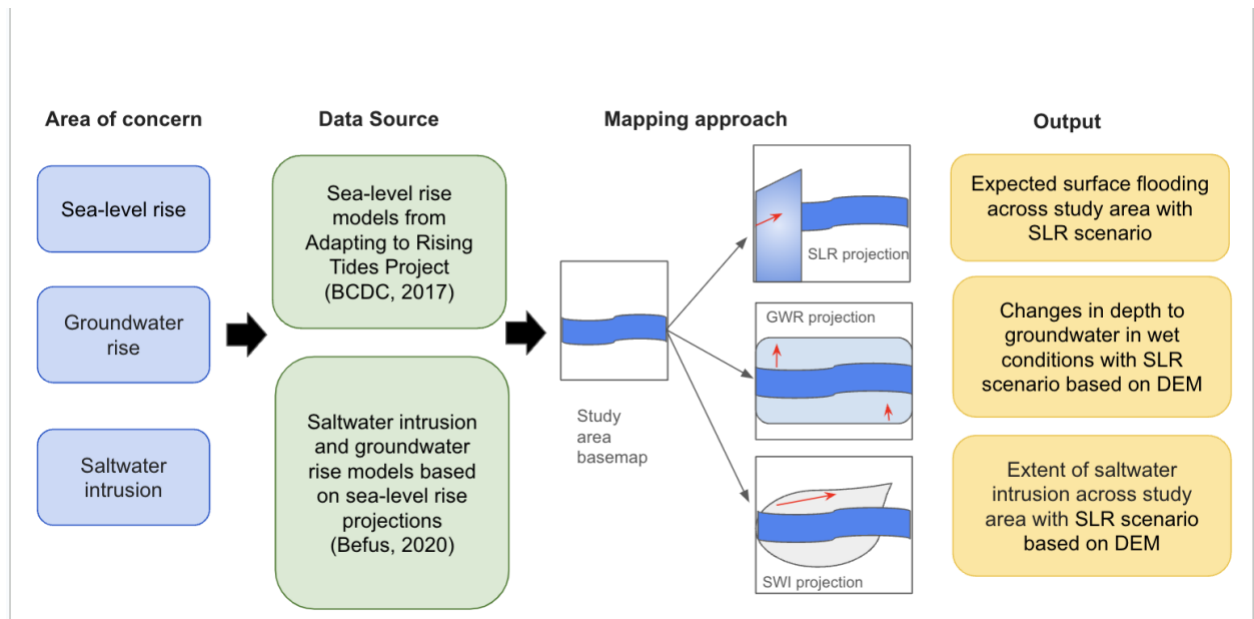
Figure 9. Study approach to evaluate future impacts of sea-level rise, groundwater rise, and saltwater intrusion in Lower Carneros Creek site.

We completed spatial analyses to assess risks related to sea-level rise induced groundwater rise and saltwater intrusion along Lower Carneros Creek using ArcGIS Pro (Figure 9; Esri Inc., 2023). Sea-level rise models were downloaded from Bay Conservation and Development Commission's *Adapting to Rising Tides 2017* (BCDC, 2017).

a 0.25m sea-level rise scenario. Once identified, we visualized the locations of wells and color-coded sites with halophytes present (Figure 9). With the selected wells, we produced a scatterplot in RStudio (version 2021.09.2; RStudio Team) to visualize the quantity of chloride observed in well sampling (Supplemental Figure 1). Chloride is commonly used as a proxy for saltwater and therefore can be used to identify evidence of saltwater intrusion (Dugan et al., 2017).

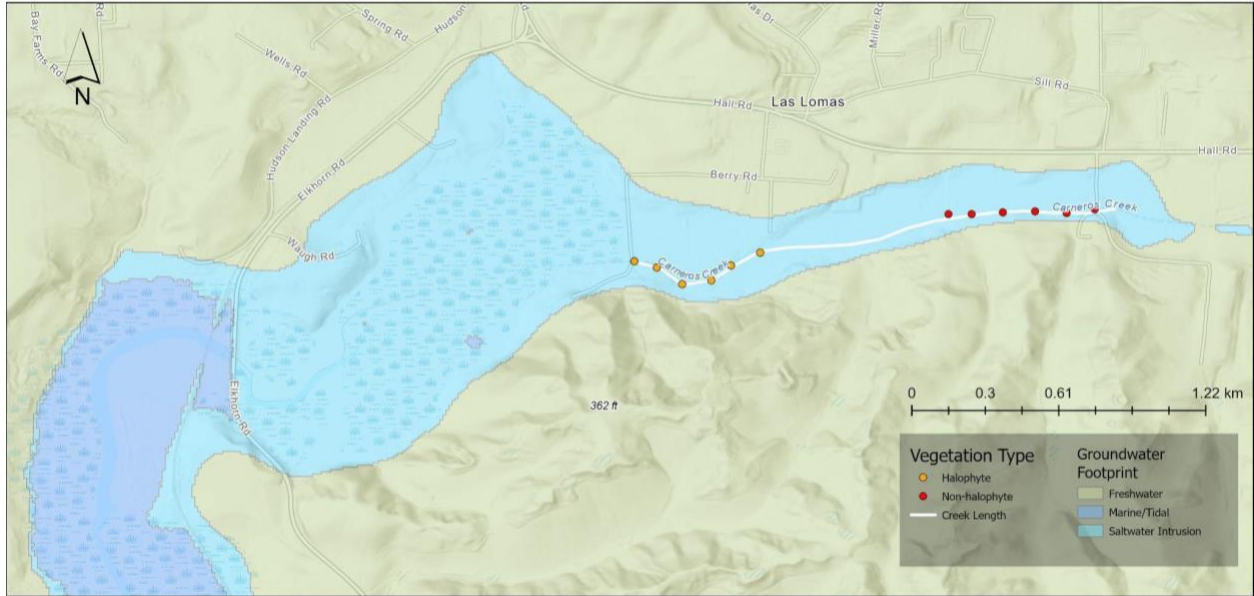
Figure 10. Points of survey sites along Carneros Creek from Blohm Road to the Eastern ranch road with or without halophytic species overlaid onto the groundwater footprint during a .25m sea-level rise scenario with a Kh of 0.1.

Riparian vegetation composition varied across the LCC extent. The downstream sites (1-6) were characterized by the consistent presence of halophytic species, such as *Salicornia pacifica* and *Atriplex prostrata* which are also dominant in adjacent Blohm-Porter Marsh (Figure 2, Figure 6). Site 7 had the vegetative composition that characterizes a freshwater marsh and was dominated by *Schoenoplectus spp.* Upstream sites (8-12) were characterized by freshwater riparian species such *Salix spp.*, *Rubus ursinus*, and *Persicaria sp.* Detailed descriptions of species and percent cover for each site are included in the supplemental material of this report (Appendix: *Sites*). There was no identifiable trend of varying species diversity or native versus non-native species presence along the downstream- upstream gradient for LCC (Table 1; Figure 12). Most notably, halophytic species were present across sites 1-6 (Figure 10; Figure 12).

compositions along LCC show that this system was historically tidally influenced and retains tidal wetland vegetation compositions (Figure 10; Table 1).

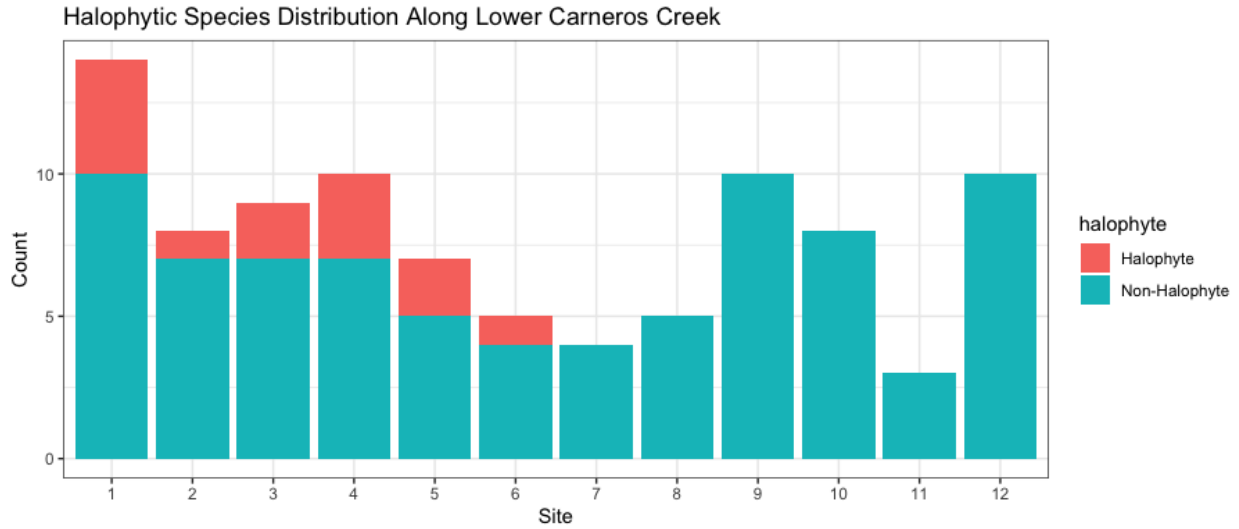
Figure 12. Halophytic Species vs Non-Halophytic Species across LCC sampling sites

These results demonstrate that, even with existing tidal controls, saltwater will intrude underground into the Blohm-Porter Marsh complex and Lower Carneros Creek (Figure 12). These hydrological changes will alter the vegetation composition in the riparian zone, including the extent of our sampling area. As our vegetation data demonstrates, halophytic species are already present in the riparian areas. We can infer that as groundwater rises, the middle and upper segments of Lower Carneros Creek will be inundated for longer portions of the year and potentially exposed to salinized groundwater. These changing physical conditions will likely result in plant composition shifts. Freshwater riparian species like *Salix spp.* have low saltwater tolerances and will likely be imperiled as soil salinity increases. These conditions will support species that can withstand inundation for long periods of time as well as salinized soil conditions (RI Coastal Resources Management Council, 2007).

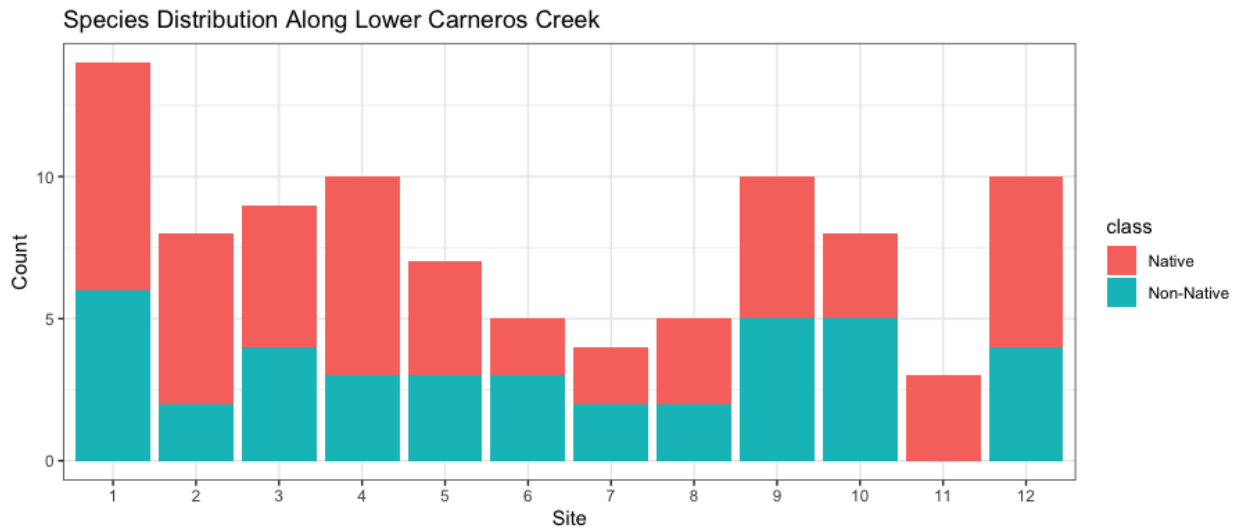
Figure 13. Native Species vs Non-Native Species across LCC sampling sites
