Land Disposal of San Luis Drain Sediments, Panoche Water District, South Dos Palos, California

# Land Disposal of San Luis Drain Sediments, Panoche Water District, South Dos Palos, California

Peter Zawislanski, Sally Benson, Robert TerBerg, and Sharon Borglin **Earth Sciences Division**

July 2002

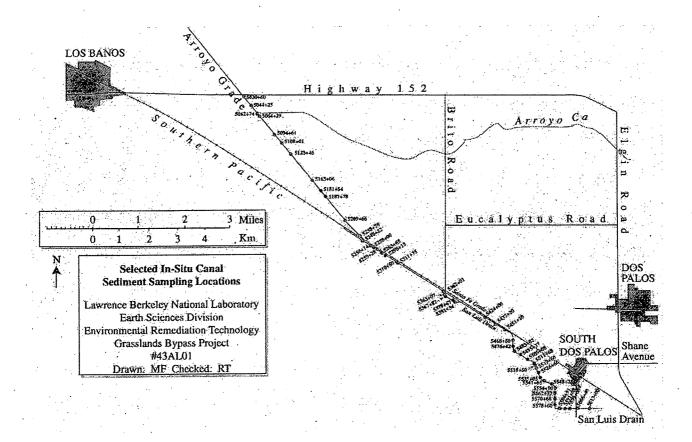
Figure 1: Location of LBNL sediment sampling points along the SLD.

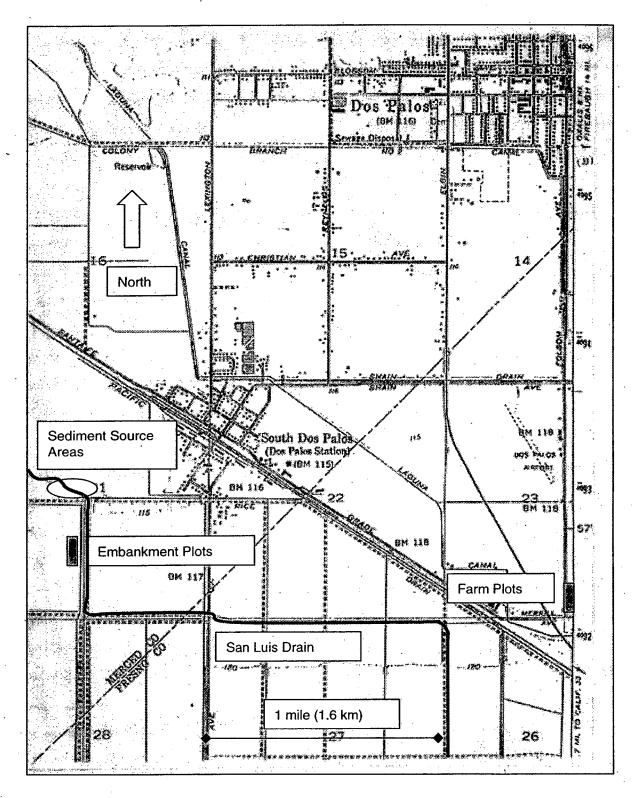
Figure 2: Locations of sediment source areas, embankment plots, and farm plots, relative to the SLD.

Two sites were selected for the pilot-scale application. Both are south of Dos Palos (Figure 2). Sediment from Source Areas 1 through 3 was laid down on the adjacent or nearby embankment, west of the SLD, in embankment plots (EPs) 1, 2, and 3 (EP-1, EP-2, and EP-3), respectively. The embankment was chosen because it is a likely candidate for large-scale sediment disposal, due to its proximity to the source area, easy access, and well-compacted, engineered soils, which limit infiltration. Sediment from Source Areas 4 and 5 was laid down on two farm plots (FPs) within a cultivated field, FP-1 and FP-2. This type of application is another candidate for large-scale disposal. It offers the advantage of a far

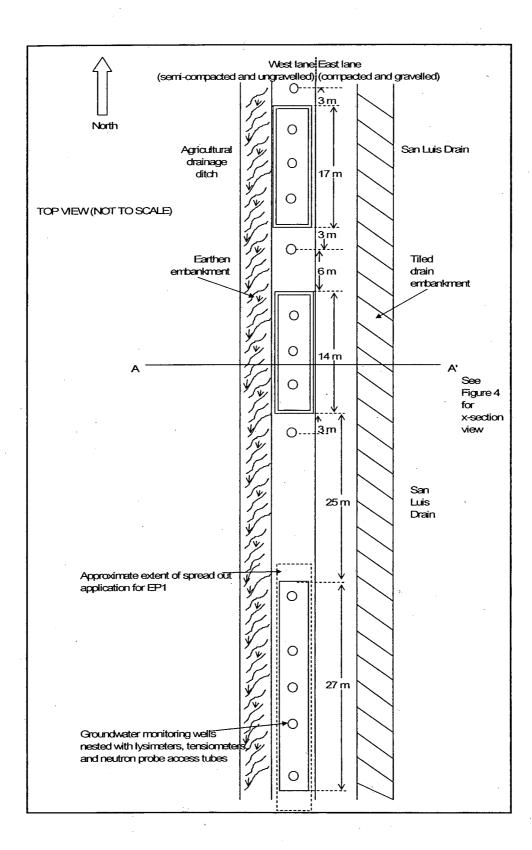
Figure 3: Layout of embankment plots and monitoring equipment.

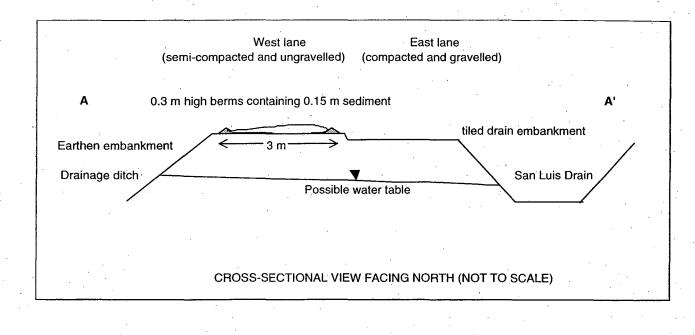
Figure 4: Cross-sectional view of embankment plots along Section A-A'.

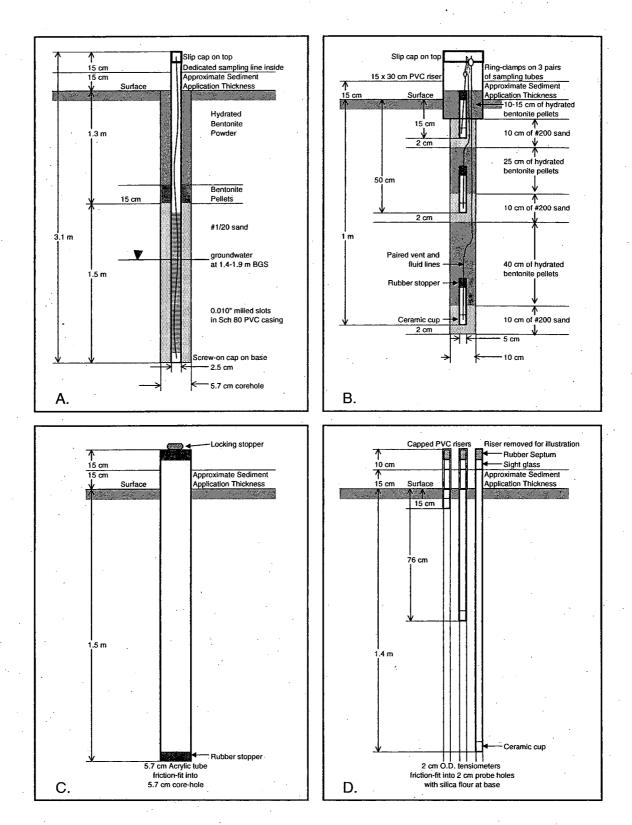
Figure 5: Construction detail of embankment plot instrumentation: a.) groundwater monitoring well; b.) suction lysimeter; c.) neutron probe access hole; and d.) tensiometer cluster.

- Five 5-cm-diameter cores were drilled into each plot.
- For each plot, one core was drilled to 2.4 m in an effort to locate the water table, one core was drilled to 1.5 m (the apparent water table), and three cores were drilled to 1.2 m.
- All cores were retained and sectioned into 15-cm intervals for subsequent processing and analysis.
- Geological conditions were uniform across both plots: dark gray silty clay from 0 to 0.45 m, medium olive brown clay from 0.45 to 1.5 m, and medium brown clay with sand from 1.5 to 2.4 m.
- Temporary lysimeters (4.7-cm diameter) were installed in 2.4-m- and 1.5-m-deep holes, reamed to 6.3 cm. The lysimeters were set with lines for water sampling and air venting to the surface. Silica flour was used to fill the annular space around the ceramic cup and

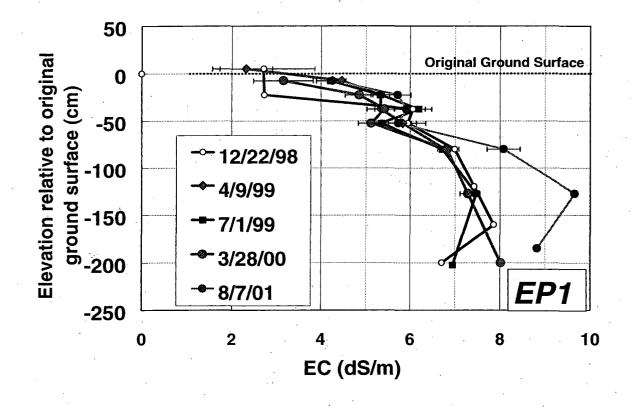
Figure 8: Electrical conductivity in water extracts of soils collected in EP-1. Error bars represent one standard deviation on either side of the mean.

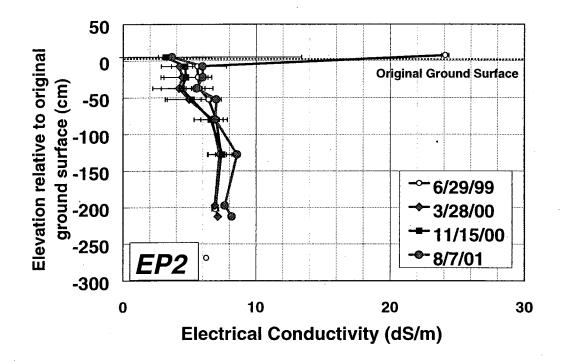
Figure 11: Electrical conductivity in water extracts of soils collected in EP-2. Error bars represent one standard deviation on either side of the mean.

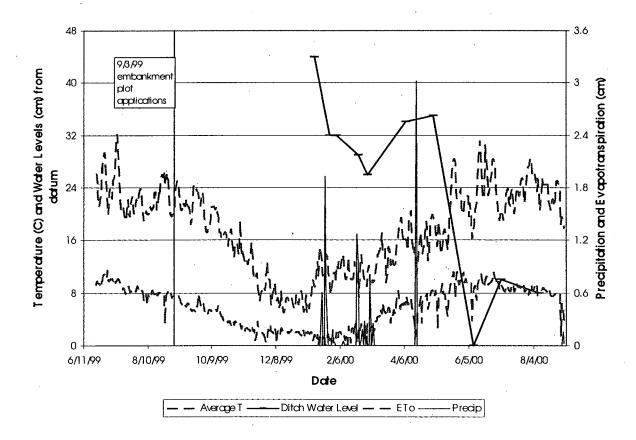
Figure 12: Daily weather records and ditch water levels at the embankment plots.

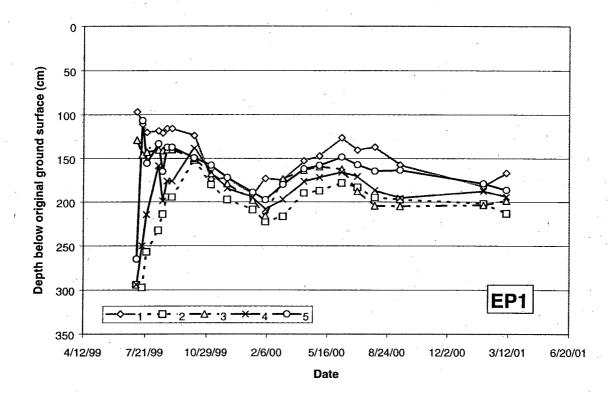
Figure 13: Depth to groundwater at EP-1.

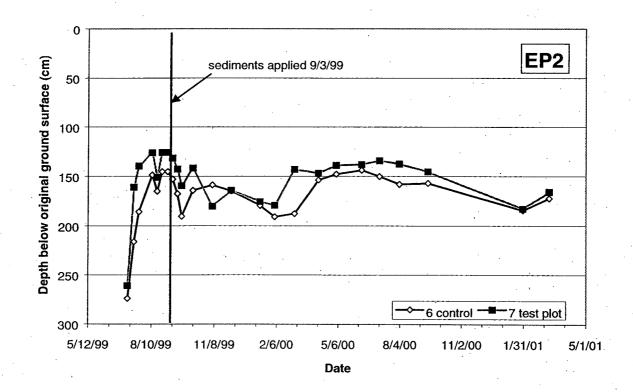
Figure 14: Depth to groundwater at EP-2.

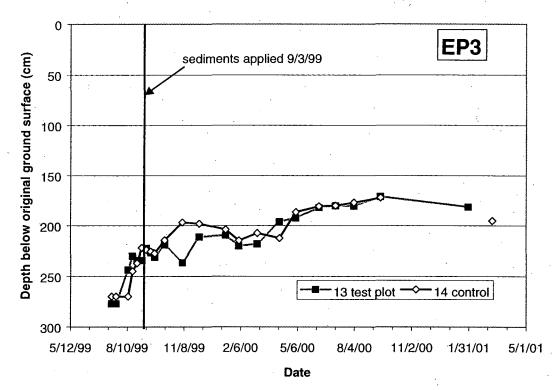
Figure 15: Depth to groundwater at EP-3.

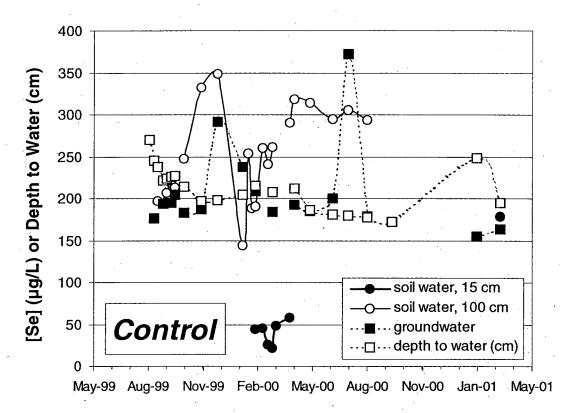
Figure 23: Soil water and groundwater Se and depth to water in the embankment control plot.

Soil water sampling in the embankment plots yielded nearly continuous data from the 100cm-deep samplers, intermittent data from the 15-cm-deep samplers, and very rare data from the intermediate-depth samplers at 50 cm. This is due to limited rainfall infiltration, resulting in a matric potential close to or beyond the effective working range of vacuum lysimeters. The 100-cm samplers were close enough to the water table that they readily yielded samples. The 15-cm lysimeters produced samples following some of the larger rainfall events, specifically in February and March 2000. Samples from the 50-cm lysimeters were available on only a few days and in only 3 out of 14 monitoring clusters. Groundwater was collected regularly and without any difficulty. Selenium data from representative instrument clusters in EP-1, EP-2, and EP-3 are presented in Figures 20 through 22. Also shown is the depth to the water table at each of these locations. Corresponding results from a control site are shown in Figure 23.

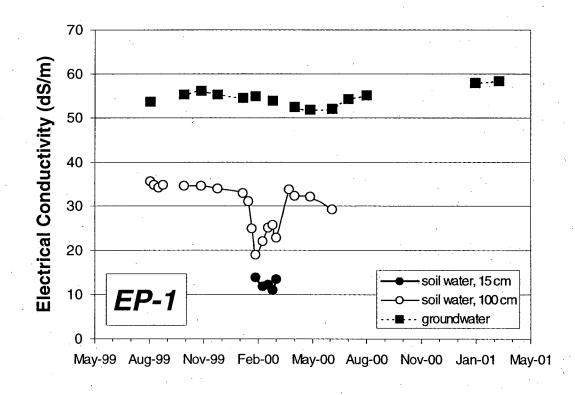
Figure 24: Soil water and groundwater electrical conductivity in EP-1.

Dissolved salts are represented by measurements of EC. Data for EP-1, EP-2, and EP-3 and a control site are shown in Figures 24 through 27, respectively. Unlike Se, EC is consistently and substantially higher in groundwater than in overlying soil water, and ranges from 50 to 55 decisiemens per meter. EC trends in soil water at 100 cm are very similar to Se trends, although observed changes have a smaller amplitude. The initial EC gradient with depth was representative of an unvegetated site. Because the site became vegetated during the spring and summer 2000, a change in the distribution of salts and Se was anticipated, though most of those changes will occur in the top 50 cm of soil, where solute monitoring is impeded by low soil moisture content. Nonetheless, EC measurements in 2001 showed increases in dissolved solids in both groundwater (Figures 24 through 27) and soil water (Figures 26 and 27), including the control plot.

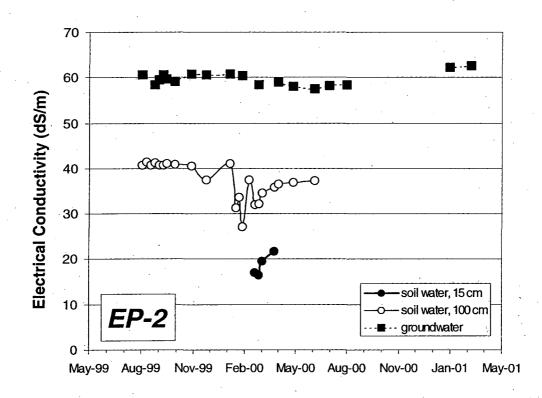
Figure 25: Soil water and groundwater electrical conductivity in EP-2.

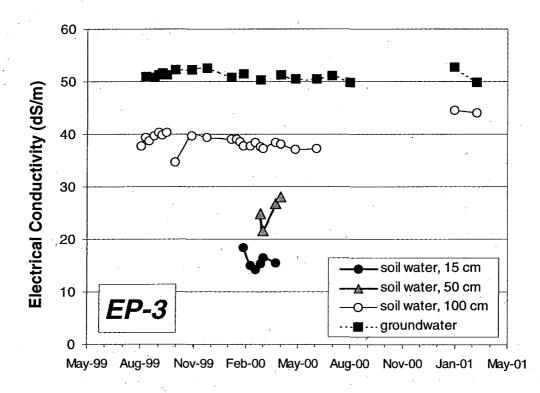
Figure 26: Soil water and groundwater electrical conductivity in EP-3.

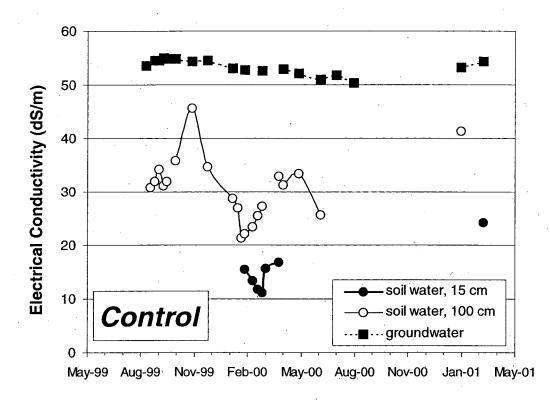
Figure 27: Soil water and groundwater electrical conductivity in the embankment control plot.

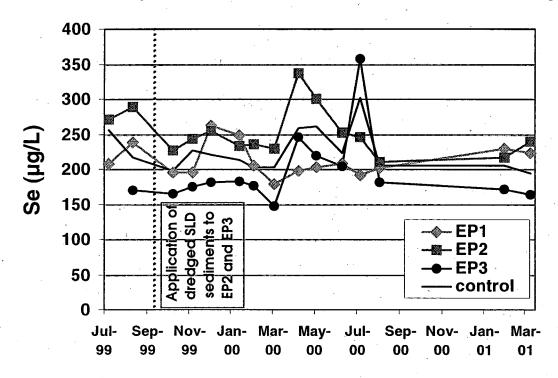
Figure 28: Groundwater Se in embankment test plot wells and in control wells.

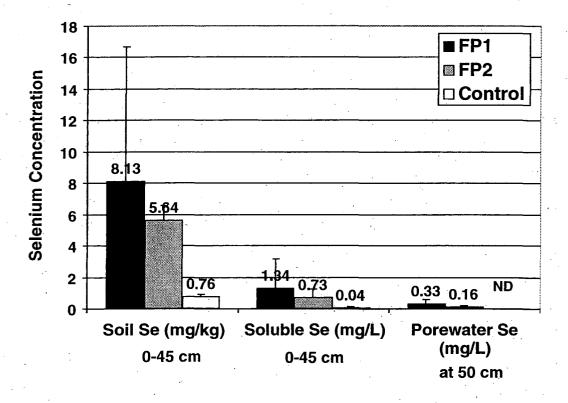
Figure 31: Total, water-soluble, and soil water Se in the Top 45 cm of FP-1, FP-2, and FP-C (control). Error bars represent one standard deviation on either side of the mean.

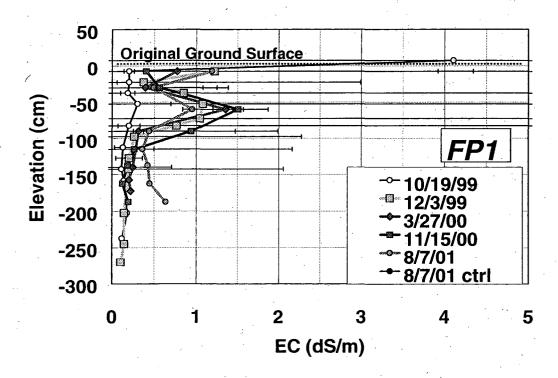
Figure 32: Electrical conductivity in water extracts of soils collected in FP-1. Error bars represent one standard deviation on either side of the mean.

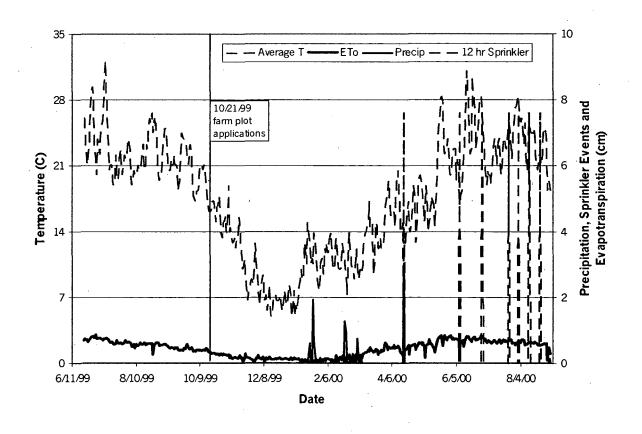
Figure 33: Daily weather records and irrigation events for farm plots.

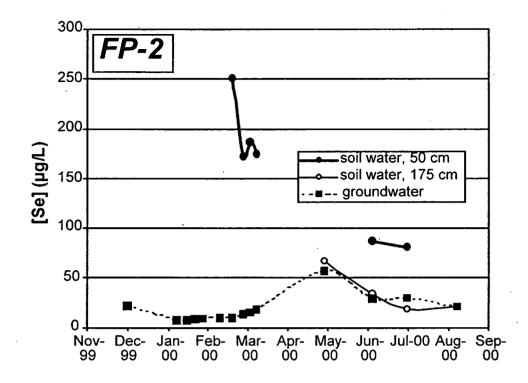
Figure 35: Soil water and groundwater Se in FP-2.

Groundwater Se concentrations in FP-1 and FP-2 remained in the range of 10 to  $100 \mu g/l$ . Although there appears to be an increase in groundwater Se at times corresponding to the heavy rainfall periods in February and March 2000, the absence of groundwater level measurements makes it difficult to establish whether this change is due to Se leaching or simply to differences in soil water Se at different depths in the soil profile. It should be noted that groundwater Se levels prior to any possible leaching of applied sediments were already in the 20 to 50  $\mu$ g/l range. In samples from intermediate lysimeters, Se levels are initially high, especially in FP-1 (Figure 34), but quickly dissipate to less than 100 µg/l and by June 2000 are less than 10  $\mu$ g/l. The initial higher concentrations are perhaps indicative of a high-Se pulse followed by rainfall and irrigation infiltration after the more soluble Se fraction was leached. Shallow FP-1 data is too sparse to confirm this, but soil water at 50 cm in FP-2 shows a similar pattern in soluble Se concentrations. Initial values in February 2000 were around 250  $\mu$ g/l, but dropped by March to 175  $\mu$ g/l and by June to less than 100  $\mu$ g/l. Groundwater Se concentrations are plotted on a time scale along with irrigation and rainfall events in Fig. 36. There is no short-term or long-term correlation between irrigation and rainfall events, and groundwater Se.

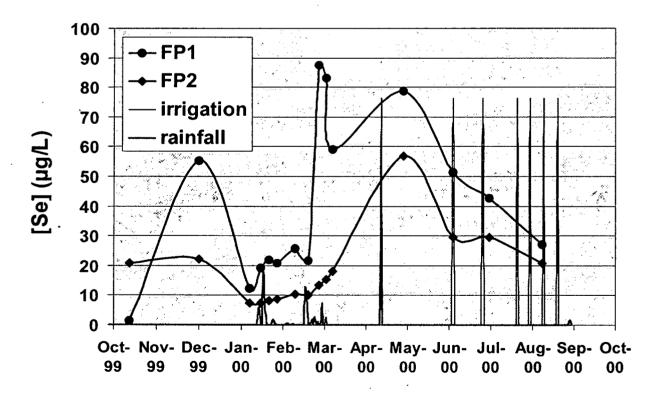
Figure 36: Groundwater Se and irrigation and rainfall events (mm) at farm plot.

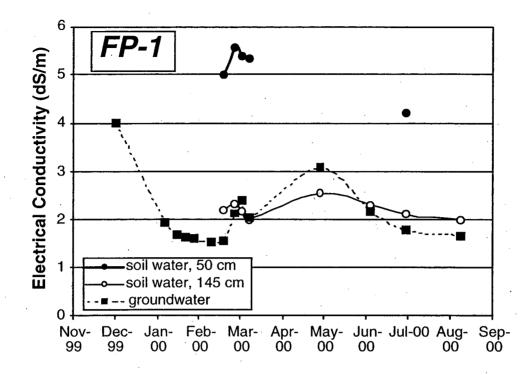
Figure 37: Soil water and groundwater electrical conductivity in FP-1.

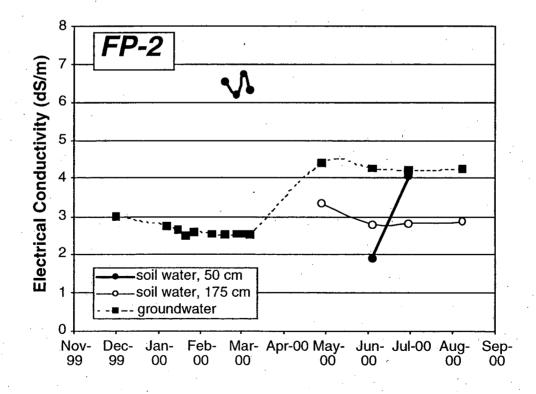
Figure 38: Soil water and groundwater electrical conductivity in FP-2.

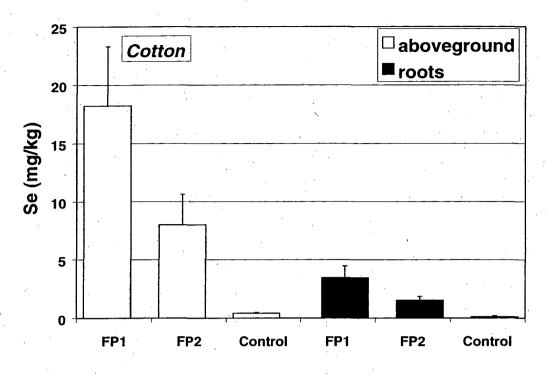
Figure 39: Average Se concentrations ( $\pm 1$ s.d.) in cotton tissue from FP-1, FP-2, and a control area, 7/14/00.

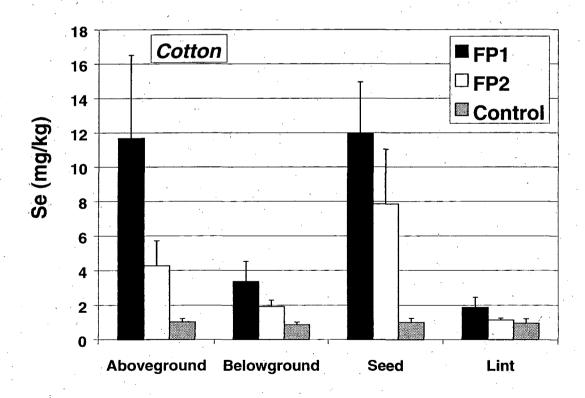
Figure 40: Average Se concentration ( $\pm 1$  s.d.) in above ground parts (stems and leaves), below ground parts (roots), seeds, and lint of cotton plants from FP-1, FP-2, and a control area, 11/4/00.

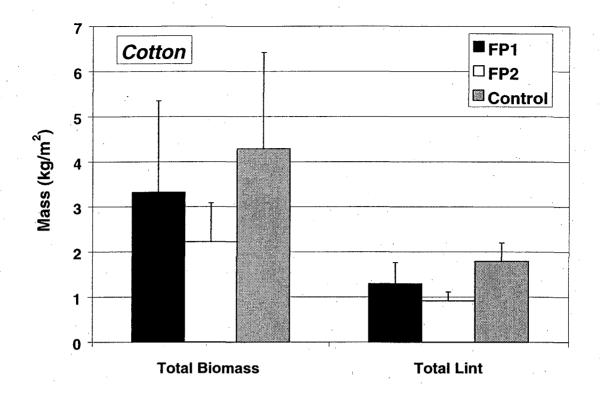
Figure 41: Average cotton biomass and cotton lint yield ( $\pm 1$  s.d.) in FP-1, FP-2, and a control area, 11/4/00.

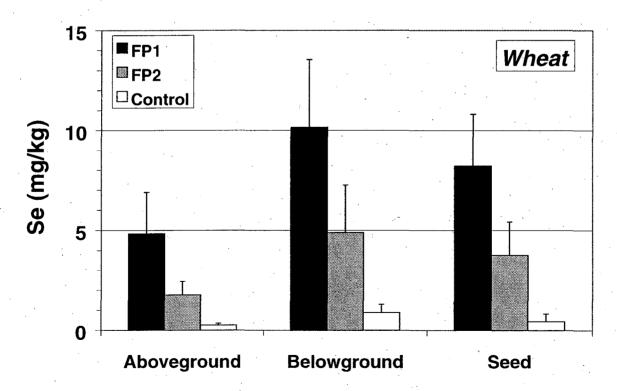
Figure 42: Se concentrations in wheat tissue in FP-1, FP-2, and a control area, 6/7/01.

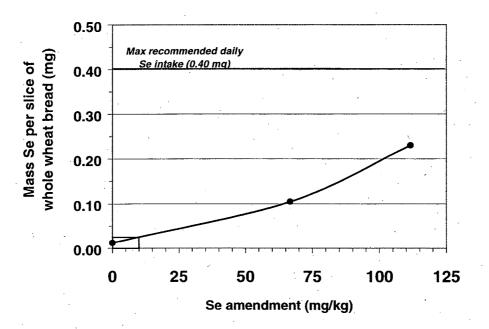
Figure 46: Mass of Se in hypothetical slice of whole wheat bread made from wheat seeds from FP-1, FP-2, and FP-C, compared with the maximum recommended daily Se intake. The box on the lower left indicates the Se concentration range of the majority of SLD sediments.

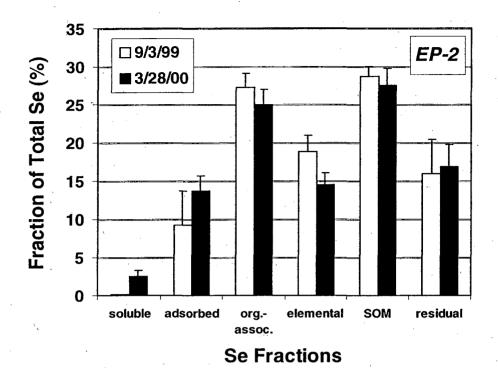
Figure 47: Se fractions in SLD sediment applied to EP-2.

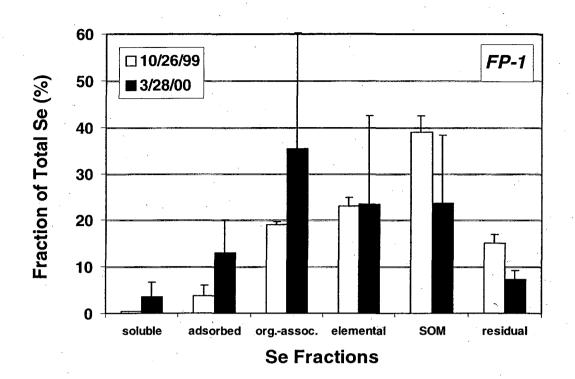
Figure 49: Se fractions in SLD sediment applied to FP-1.

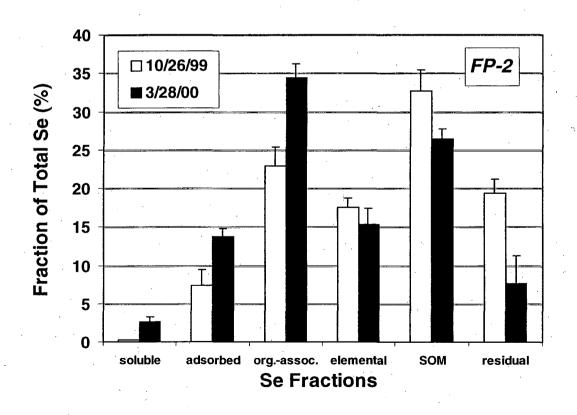
Figure 50: Se fractions in SLD sediment applied to FP-2.

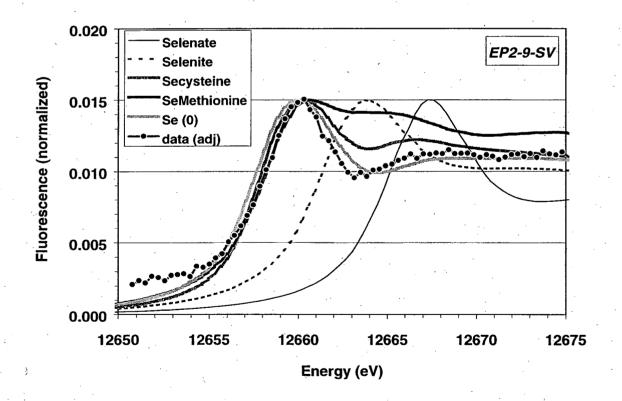
Figure 52: Se K-edge absorption spectra of Se standards and SLD sediment sample EP2-9-SV. Collected on 9/3/99, immediately after application.

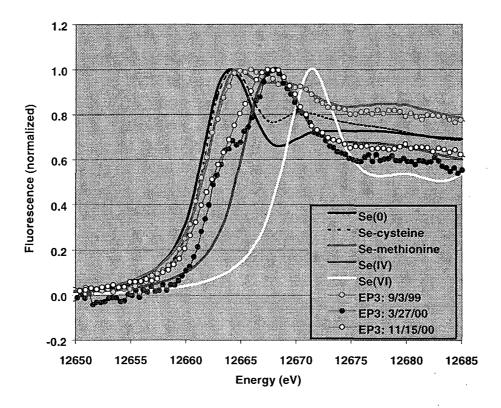
Figure 54: Se K-edge absorption spectra of Se standards and SLD sediment samples. Collected on 9/3/99, 3/27/00, and 11/15/00 from EP-3.

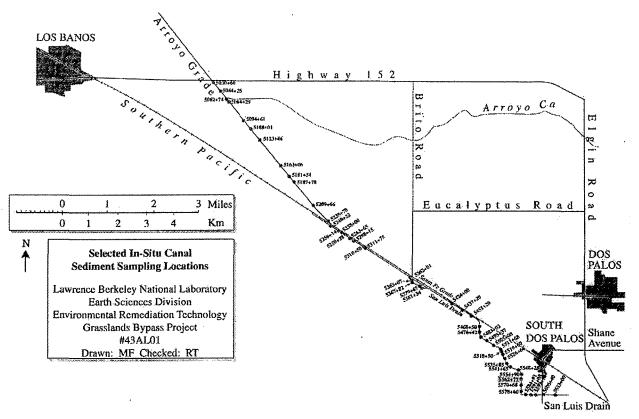
Figure A-1. Location of LBNL sediment sampling points along the San Luis Drain.

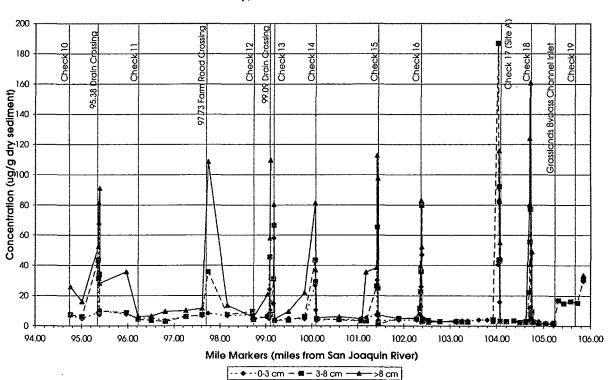
Chart 1: Total Se in San Luis Drain Sediment LBNL Survey, December 1998 - March 1999

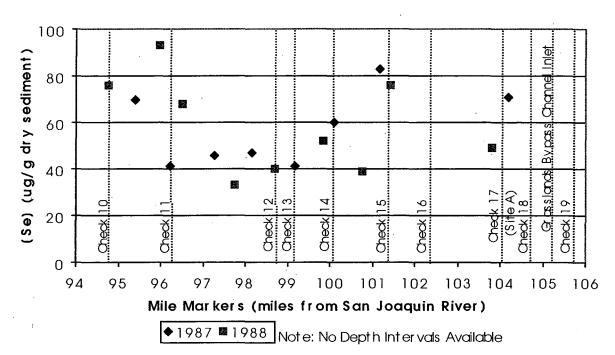
Chart 8a: USBR Surveys, 1987, 1988

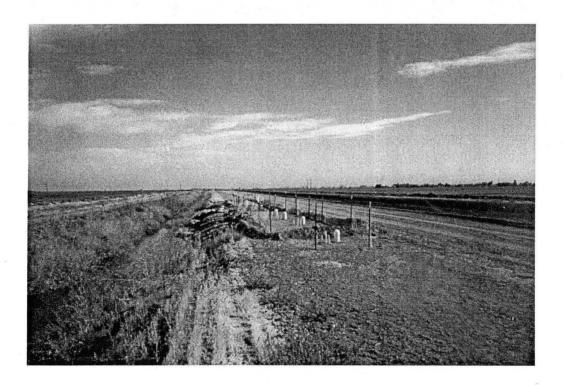
Figure C.2: Sites EP-2 and EP-3, prepared for sediment application (9/3/99). View to the north.

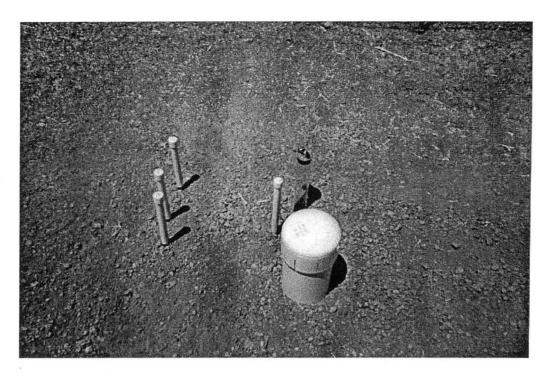
Figure C.3: Instrument cluster 7 in EP-2. From left to right: tensiometers (covered with PVC pipe), neutron probe access pipe (clear acrylic), and soil water suction lysimeters (under large PVC cap).

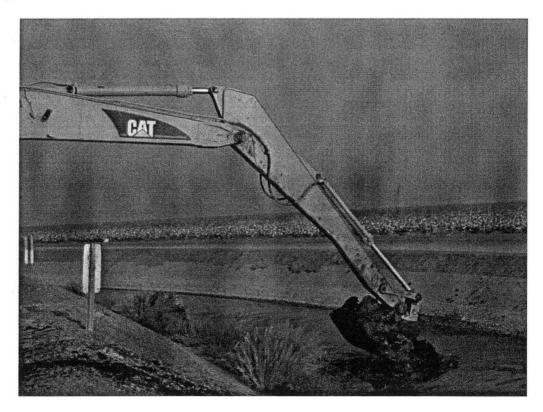
Figure C.4: Dredging of SLD sediment.

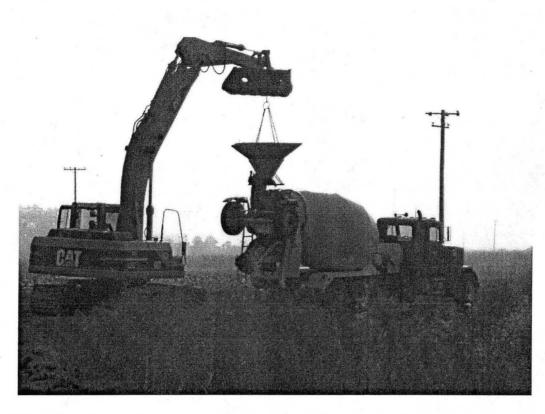
Figure C.5: SLD sediment being placed in cement truck via hopper.

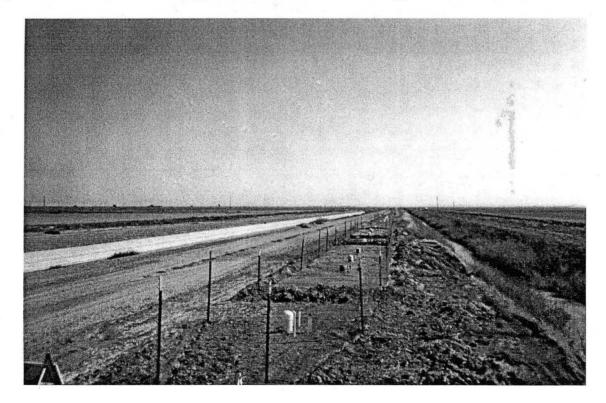
Figure C.6: Sites EP-3 (foreground) and EP-2, immediately after sediment application (9/3/00).

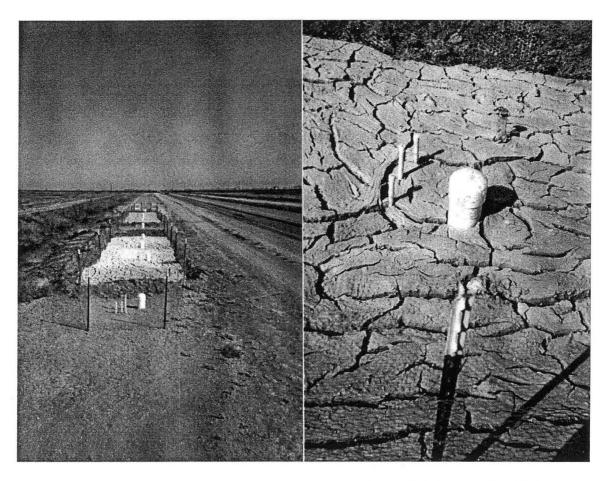
Figure C.7: Left: Sites EP-2 and EP3 after a few days of drying (9/9/99). Right: Close-up view of drying cracks around one of the monitoring cluster.

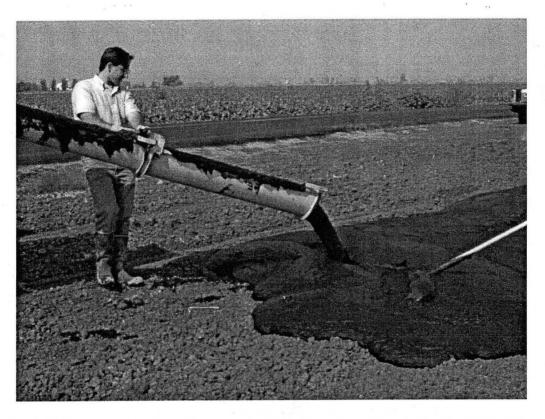
Figure C.8: Application of SLD sediments to FP-1 using cement-truck chute (10/21/99).

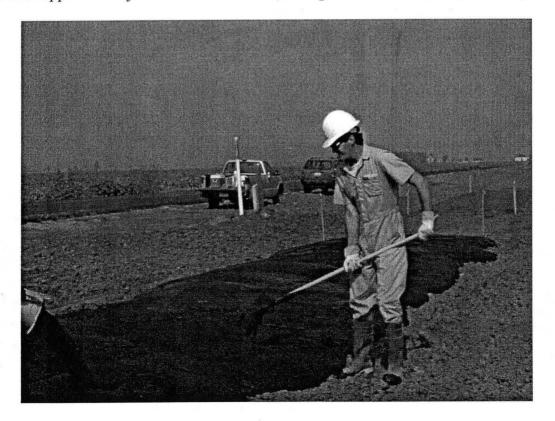
Figure C.9: Spreading of SLD sediments in FP-1 using cement rake (10/21/99).

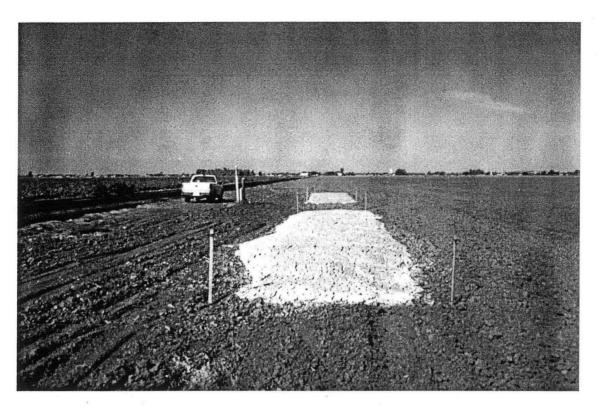
Figure C.10: Sites FP-1 (foreground) and FP-2 after a few days of drying (10/28/99). View to the north.

By October 28, 1999, the farm plot applications had become gray and fissured with drying cracks. There was record of rain at the test site up to November 5, 1999. On November 15, 1999, the farm plots were plowed by shanks that cut to 45 to 50 cm, with 45-cm lateral separation. On November 19, 1999, the plots were disked to 15 to 20 cm. Disks are 15 to 20 cm apart. On November 29, 1999, the plots were plowed by a deep chisel with shanks that cut to 70 to 75 cm, with 45 cm lateral separation. Plowing was performed in north-south furrows, the longer dimension of the field, while disking was performed in east-west traverses. Approximately weekly rainfall events occurred from January 12, 2000 to March 8, 2000. On March 27, 2000, the plots were again plowed by a deep chisel. By April 7, 2000, the field had been disked again twice and set with north-south furrows. On April 16, 2000, sprinkler irrigation was started on a 10-day cycle to continue through the summer. An isolated, 3-cm rainfall event, recorded on April 17, 2000 at Panoche Water District (CIMIS #124) weather station, was the last rainfall event for the 2000 water year.

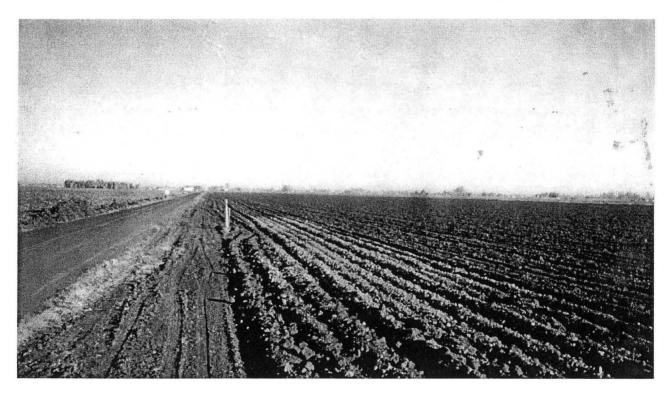
Figure C.11: Sites FP-1 and FP-2 after plowing (11/19/00). View to the north.

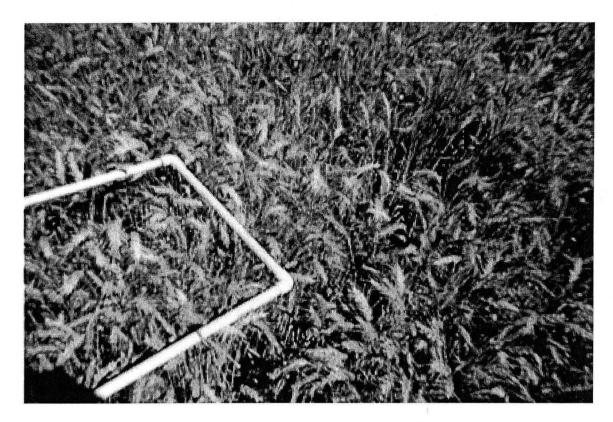
Figure C.18: Sample grid, randomly thrown over winter wheat, 6/7/01.
