Experimental study of the effect of hydrothermal alteration on proppant brittleness

Harrison Lisabeth¹, Jack Norbeck²

Geothermal reservoir stimulation, proppant, corrosion, mechanics, fracturing

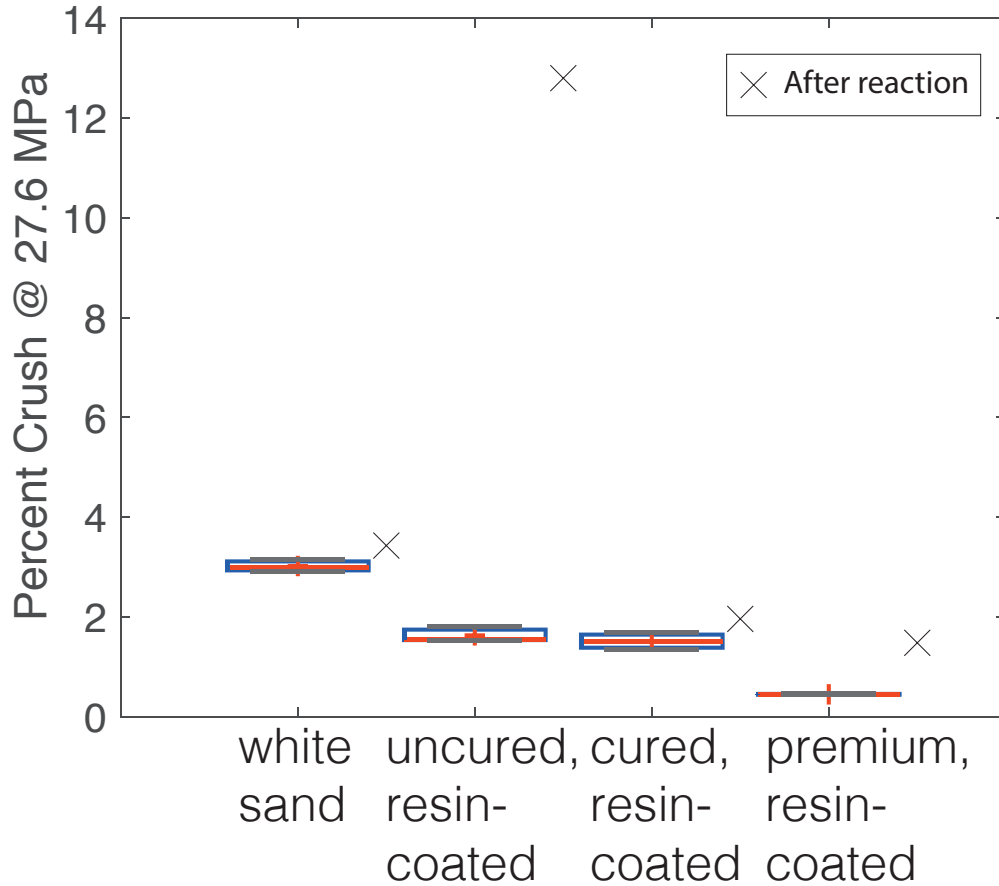
Figure 1: Results from crush tests for 7-day reactions. Red bars indicate mean values from 3 crush tests performed on pre-reaction proppants. Blue boxes represent one standard deviation and black bar represent the full extent of the data. Xs represent post-reaction data.

Pre-reaction white sand had 2.9% average crushed grains, and after this increased only nominally to 3.4%. Pre-reaction uncured, resin-coated proppant had 1.5% crushed grains, increasing substantially to 12.8% after reaction. Pre-reaction cured, resin-coated proppant had 1.5% crushed grains, increasing only nominally to 2% after reaction. Finally, pre-reaction premium, resin-coated had 0.5% average crushed grains, increasing nominally to 1.4% after reaction. Synthetic proppant grains were too small to conduct a meaningful crush test.

Crush tests for the week-long reacted samples show little effect on the brittleness of all proppants, with the exception of the uncured, resin-coated sample. Little, if any reaction was observed in the samples reacted without cuttings, so crush tests were only performed on samples reacted with cuttings.

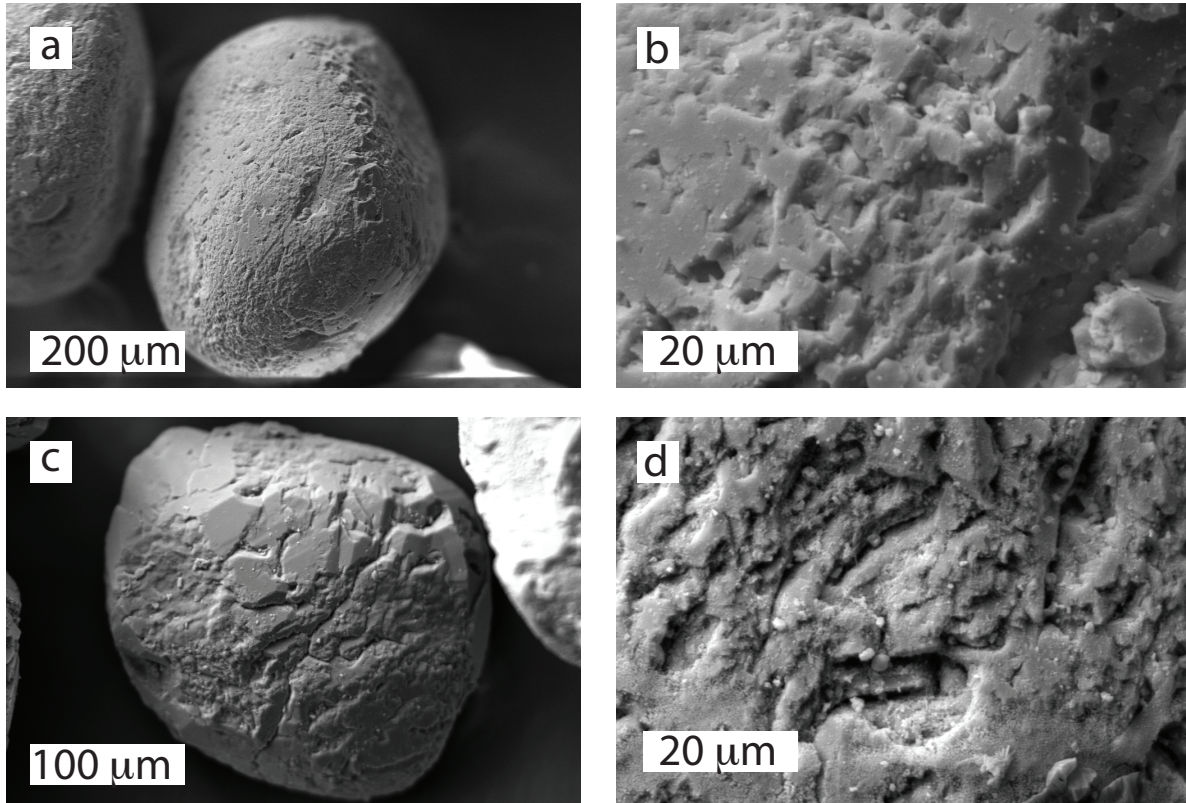
Little textural change on the surface of white sand grains of all size fractions. For simplicity, only 30/50 mesh size fractions are discussed. The main feature that can be seen for white sand is surface etching of the quartz sand. It is apparent that reaction with brine leads to some additional pitting, but changes are not dramatic.

Figure 2: SEM images of white sand. a,b) Prior to reaction. c,d) After reaction.

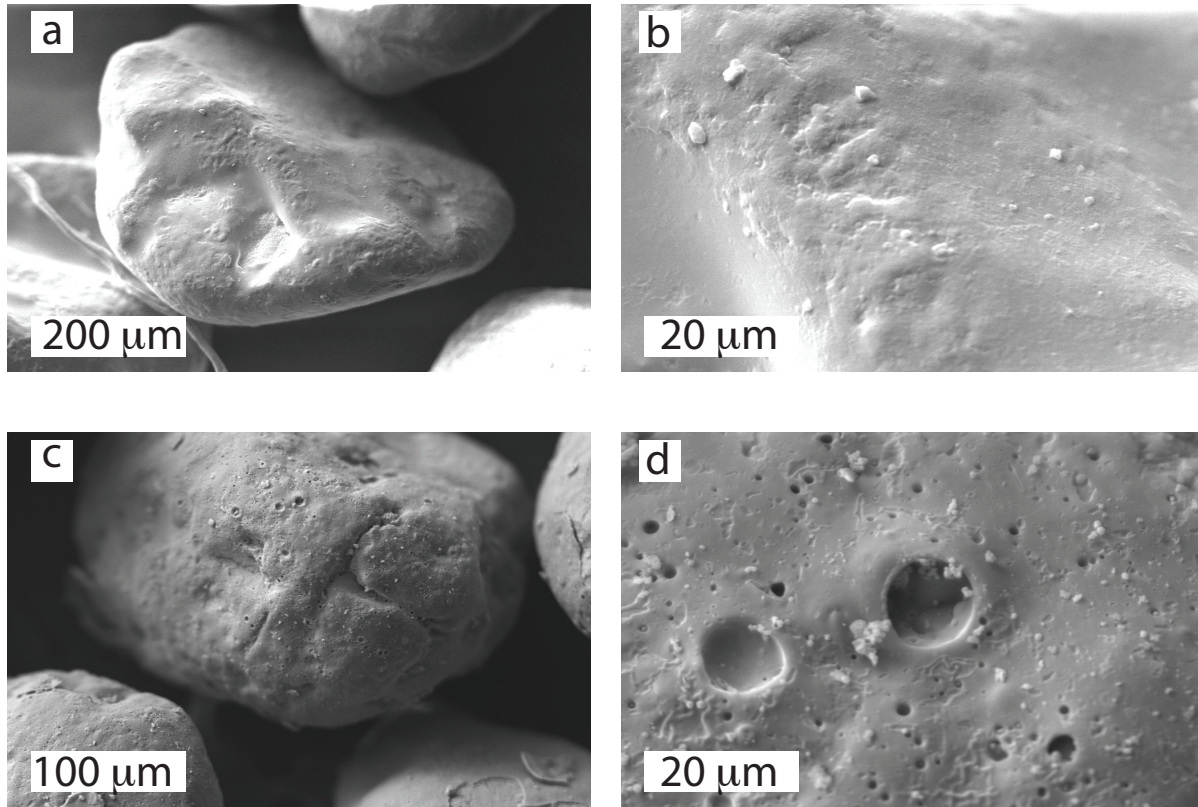
The main change in the surface texture of uncured, resin-coated proppant is due to degassing of solvent from the resin coating. This is an uncured proppant, so significant degassing is apparent. Unreacted proppants have smooth, continuous resin coatings. After reaction, the resin coating shows significant pock marks where solvent has degassed. In some areas, fresh quartz is exposed under resin.

Figure 3: SEM images of uncured, resin-coated proppant. a,b) Prior to reaction. c,d) After reaction.

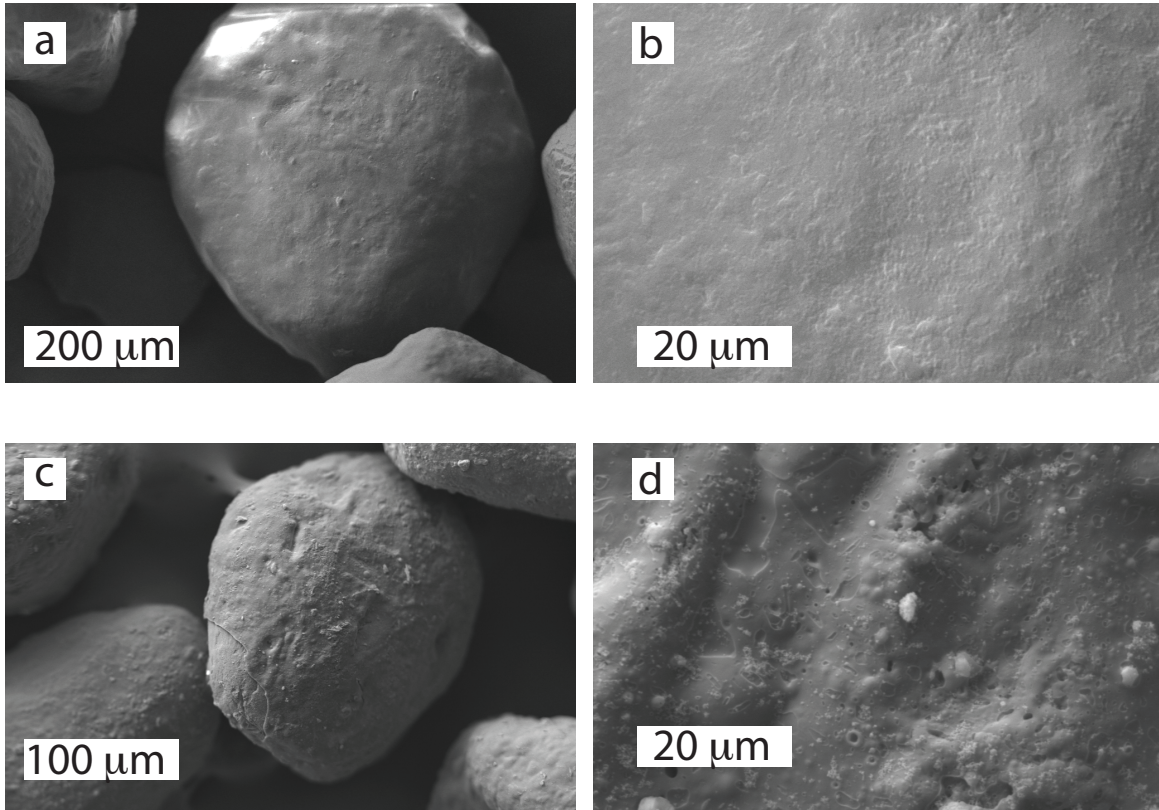
The main change in the surface texture of cured, resin-coated proppant is also due to degassing of solvent from the resin coating. Unreacted proppants have smooth, continuous resin coatings. After reaction, the resin coating shows some pock marks where solvent has degassed, though the alteration was less than observed for uncured, resin-coated proppants. Fresh quartz was not observed to be exposed in this sample.

Figure 4: SEM images of cured, resin-coated proppant. a,b) Prior to reaction. c,d) After reaction.

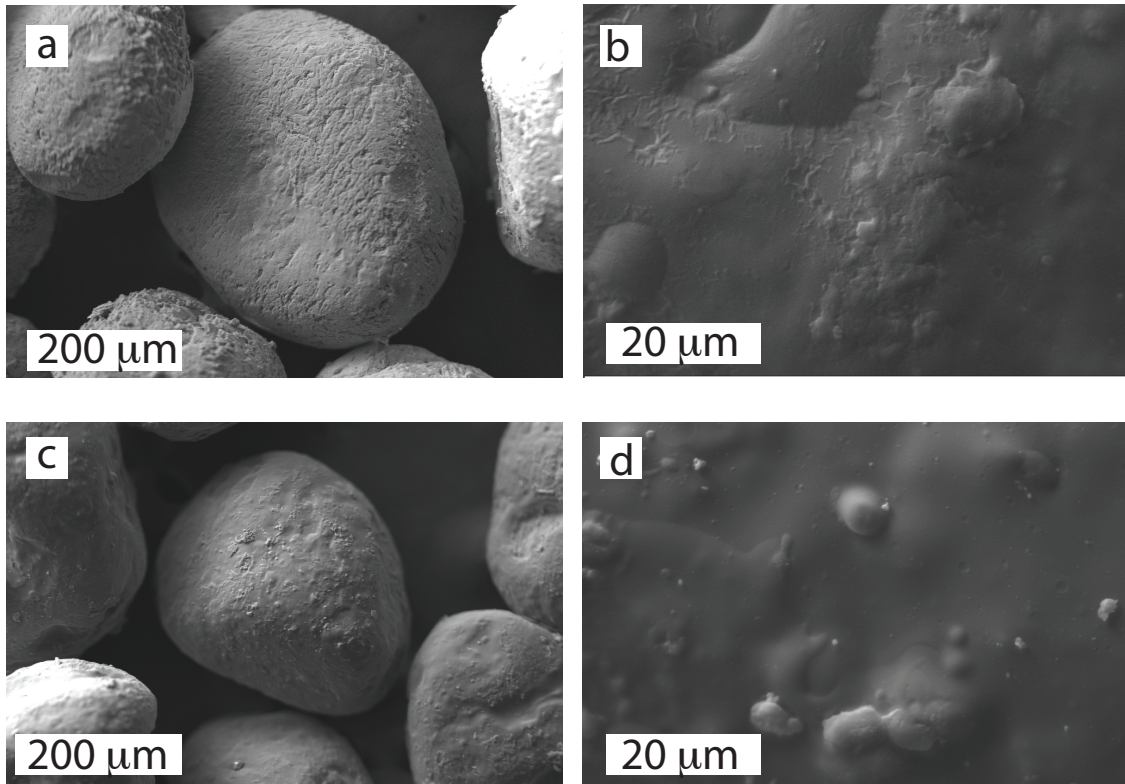
Little change in the surface texture of premium, resin-coated proppant is observed. Unreacted proppants have smooth, continuous resin coatings. After reaction, the resin coating appears largely unaffected. Fresh quartz was not observed to be exposed in this sample.

Figure 5: SEM images of premium, resin-coated proppant. a,b) Prior to reaction. c,d) After reaction.

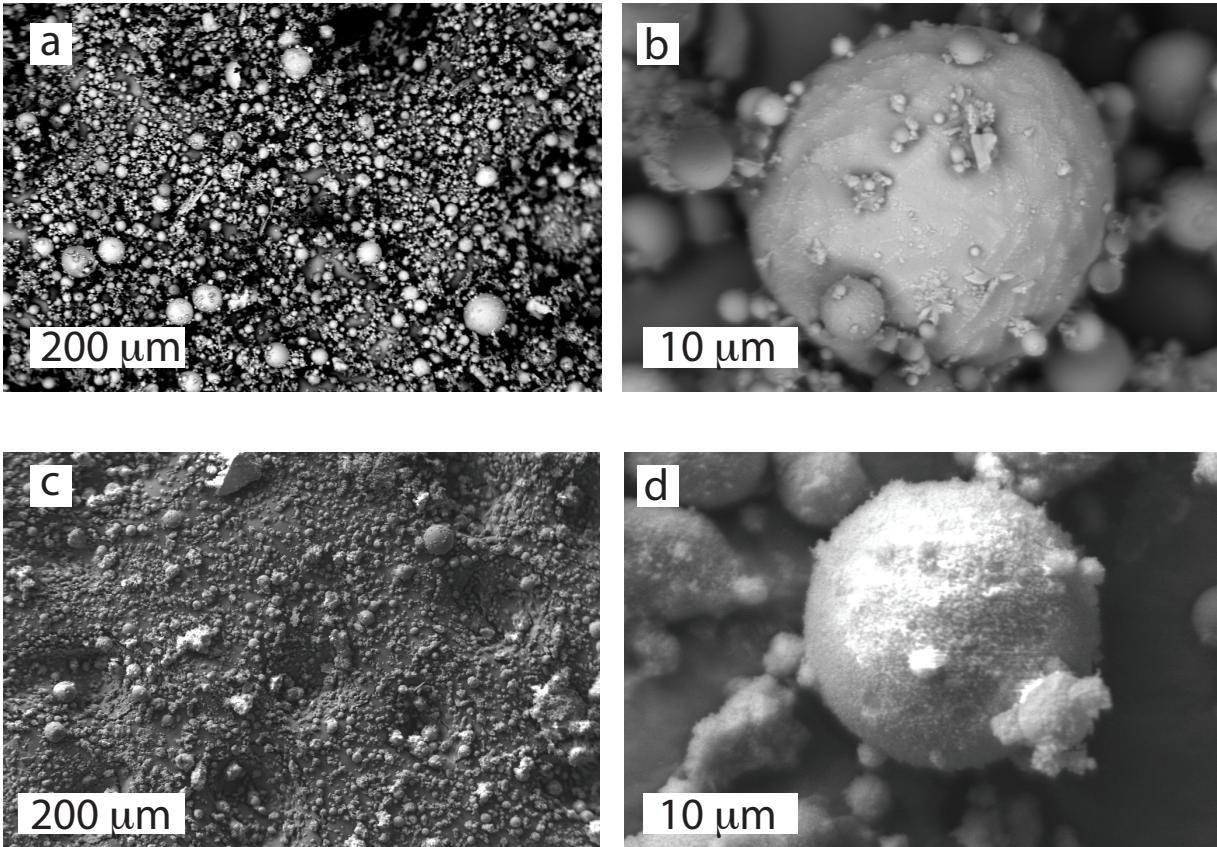
The synthetic proppant grains were much smaller than other proppants, so were more difficult to image in detail. They appear extremely spherical, with grain sizes from 20 to <1 micron. Surfaces appear smooth. No significant change was observed after reaction.

Figure 6: SEM images of synthetic proppant. a,b) Prior to reaction. c,d) After reaction.

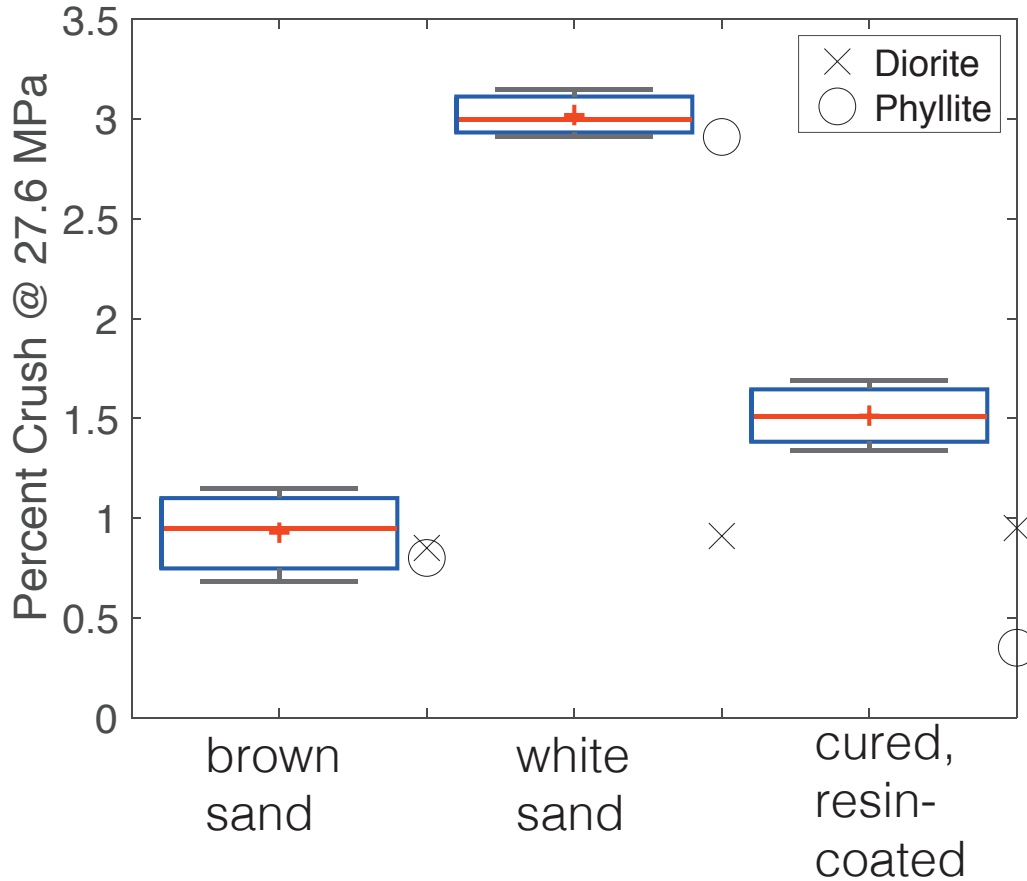
Figure 7: Results from crush tests for 63-day long reactions. Red bars indicate mean values from 3 crush tests performed on pre-reaction proppants. Blue boxes represent one standard deviation and black bar represent the full extent of the data. Xs represent samples reacted with diorite and Os represent samples reacted with phyllite.

Pre-reaction brown sand had 1% average crushed grains, and after this decreased only nominally to 0.9% for diorite and 0.8 for phyllite. Pre-reaction white sand had 2.9% average crushed grains, and after decreased to 0.9% for diorite and 2.8% for phyllite. Pre-reaction cured, resin-coated proppant had an average of 1.5% crushed grains, decreasing to 1% for diorite and 0.4% for phyllite.

Crush tests for the 63-day reacted samples also show little effect on the brittleness of all proppants investigated. Slightly more reaction was observed in samples reacted with diorite.

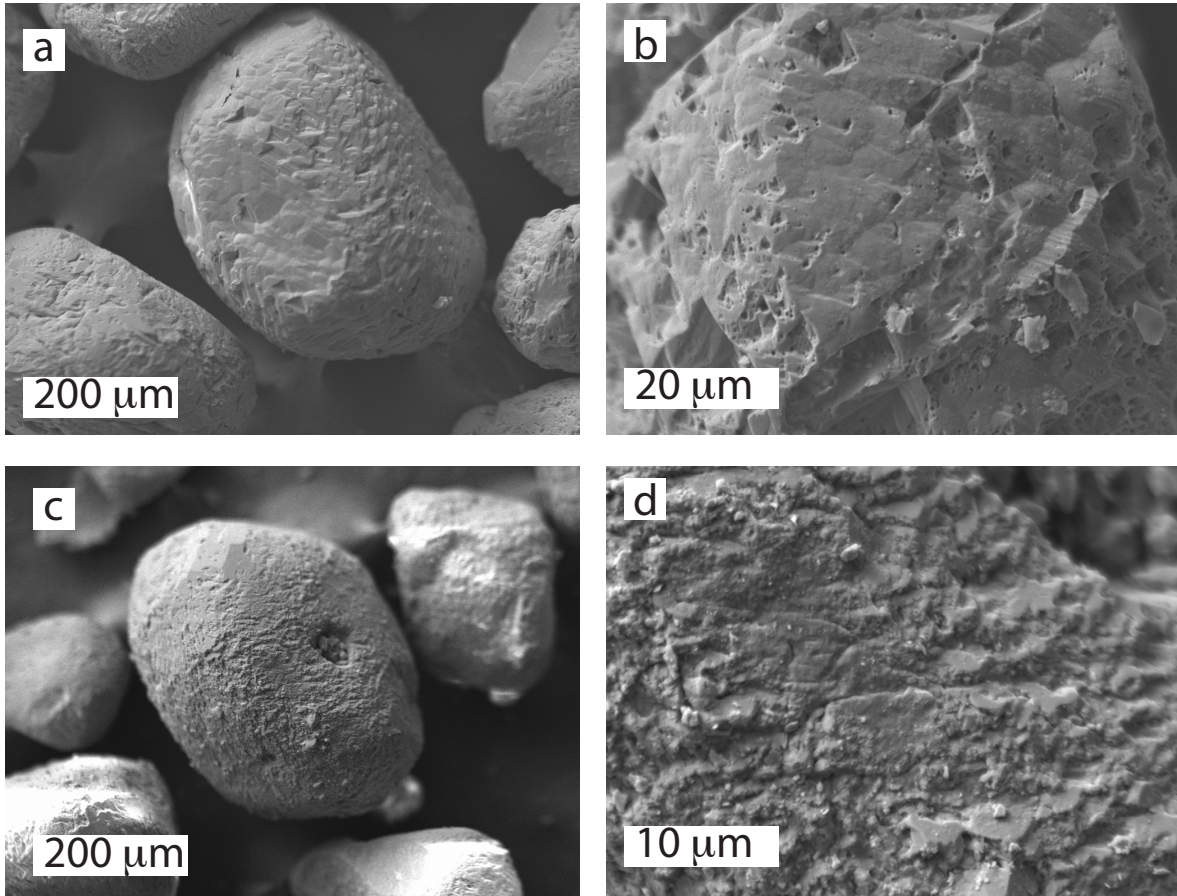
The longer reaction time does not appear to have led to appreciably more pitting of the surface of white sand grains. The sample reacted with phyllite appears very similar to unreacted and 7-day reacted samples. The sample reacted with diorite appears to have similar levels of pitting but also shows limited precipitation of fine-grained, platy minerals on the surface of grains.

Figure 8: SEM images of white sand. a,b) Proppant reacted with phyllite powder. c,d) Proppant reacted with diorite powder.

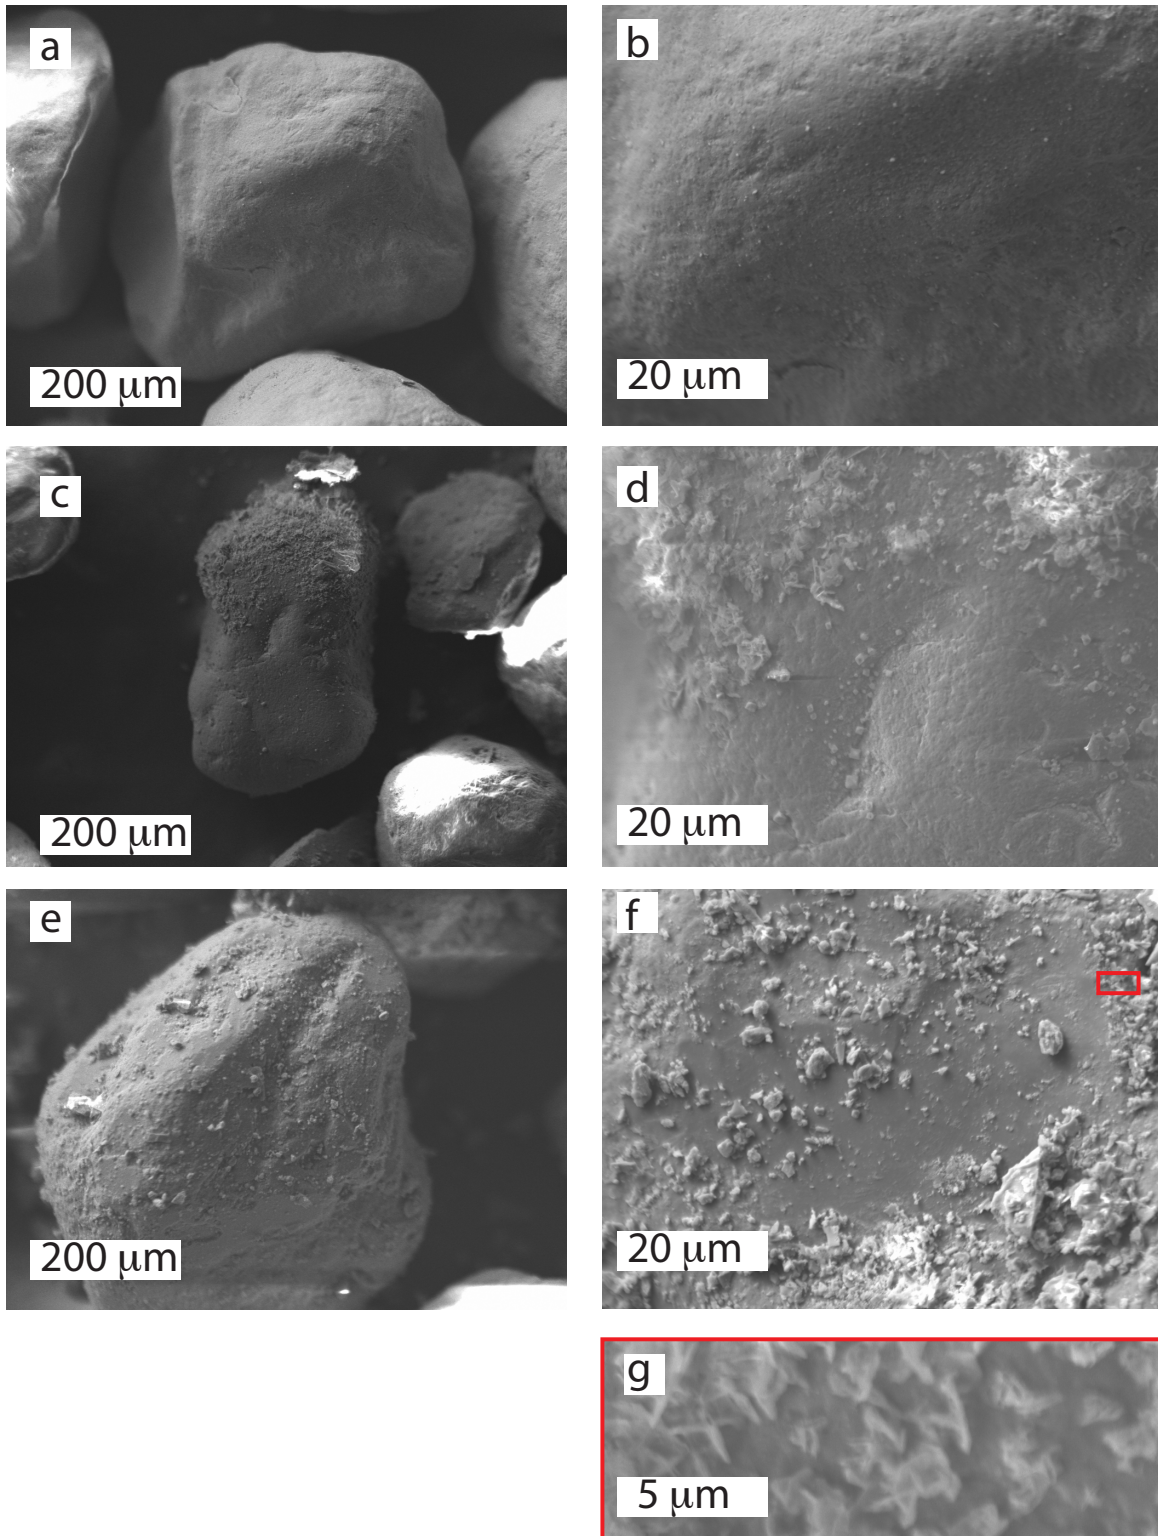
The brown sand samples show the largest degree of alteration of all the samples considered. Unaltered samples have clean, smooth surfaces. Samples reacted with phyllite show little evidence of dissolution, but do have some precipitation of secondary minerals on grain surfaces. Samples reacted with diorite also show little evidence of dissolution, but have significant precipitation of secondary minerals on grain surfaces. Secondary minerals are all fine-grained with platy habits, which we interpret to be clay minerals created by reaction of feldspar minerals with brine.

Figure 9: SEM images of brown sand. a,b) Prior to reaction. c,d) Proppant reacted with phyllite powder. e,f) Proppant reacted with diorite powder. g) Close-up of platy secondary minerals.

One interesting finding of this study is that less well-sorted sands that include higher fractions of feldspar, which tend to be less expensive, produce more secondary mineralization under hydrothermal conditions. This dissolution-precipitation reaction does not appear to cause significant alteration of proppant mechanical characteristics; however, more study of whether the production of fine-grained secondary minerals can cause significant reductions in permeability is warranted.

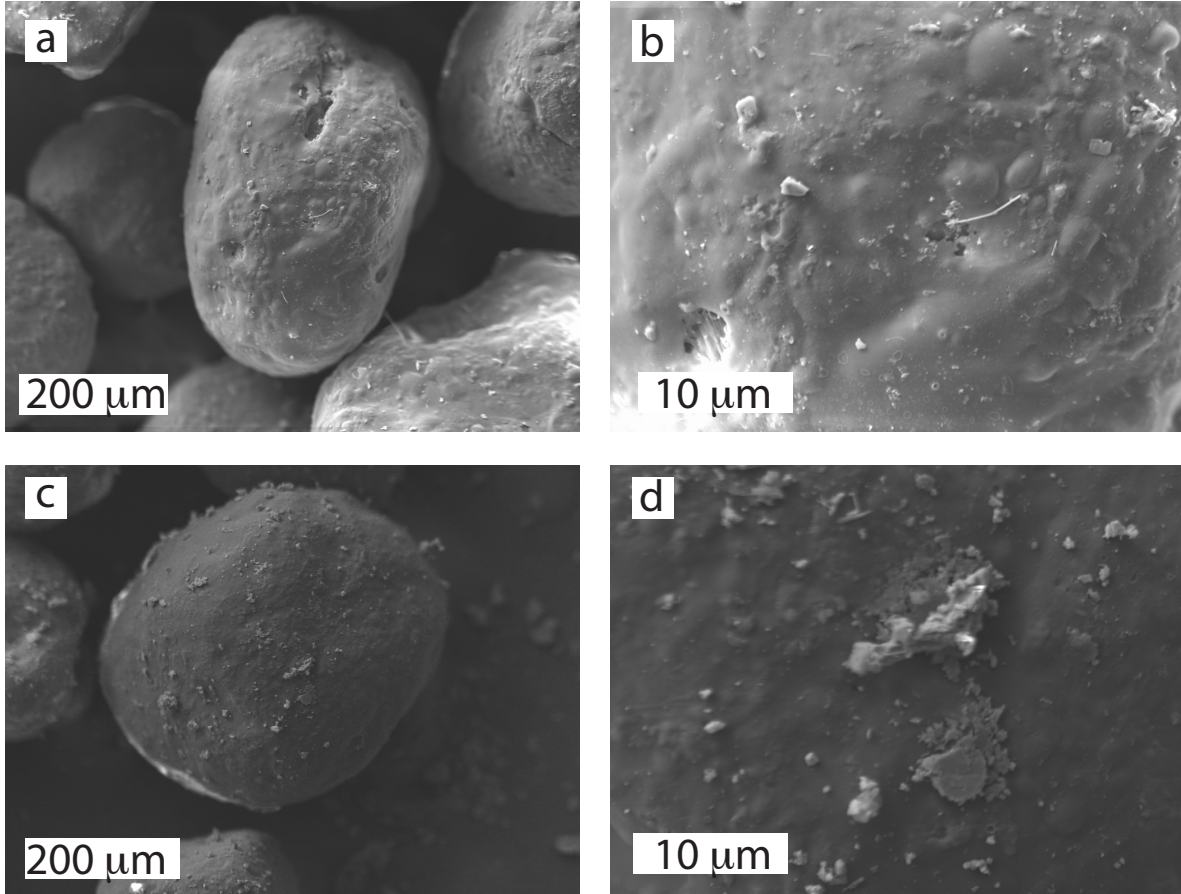
The cured, resin-coated proppant does not appear to be significantly affected by the 63-day reaction. The sample reacted with phyllite shows small pocks as a result of degassing of solvent from resin and some deposition of secondary minerals on grain surfaces. The sample reacted with diorite looks similar to the sample reacted with phyllite with slightly more secondary minerals.

Figure 10: SEM images of cured, resin-coated proppant. a,b) Proppant reacted with phyllite powder. c,d) Proppant reacted with diorite powder.
