Examination of the platinum effect on the oxidation behavior of nickel-aluminide coatings

P. Y. Hou<sup>1</sup> and V. K. Tolpygo<sup>2\*</sup>

<sup>1</sup>Lawrence Berkeley National Laboratory, Materials Sciences Division, Berkeley, CA 94720

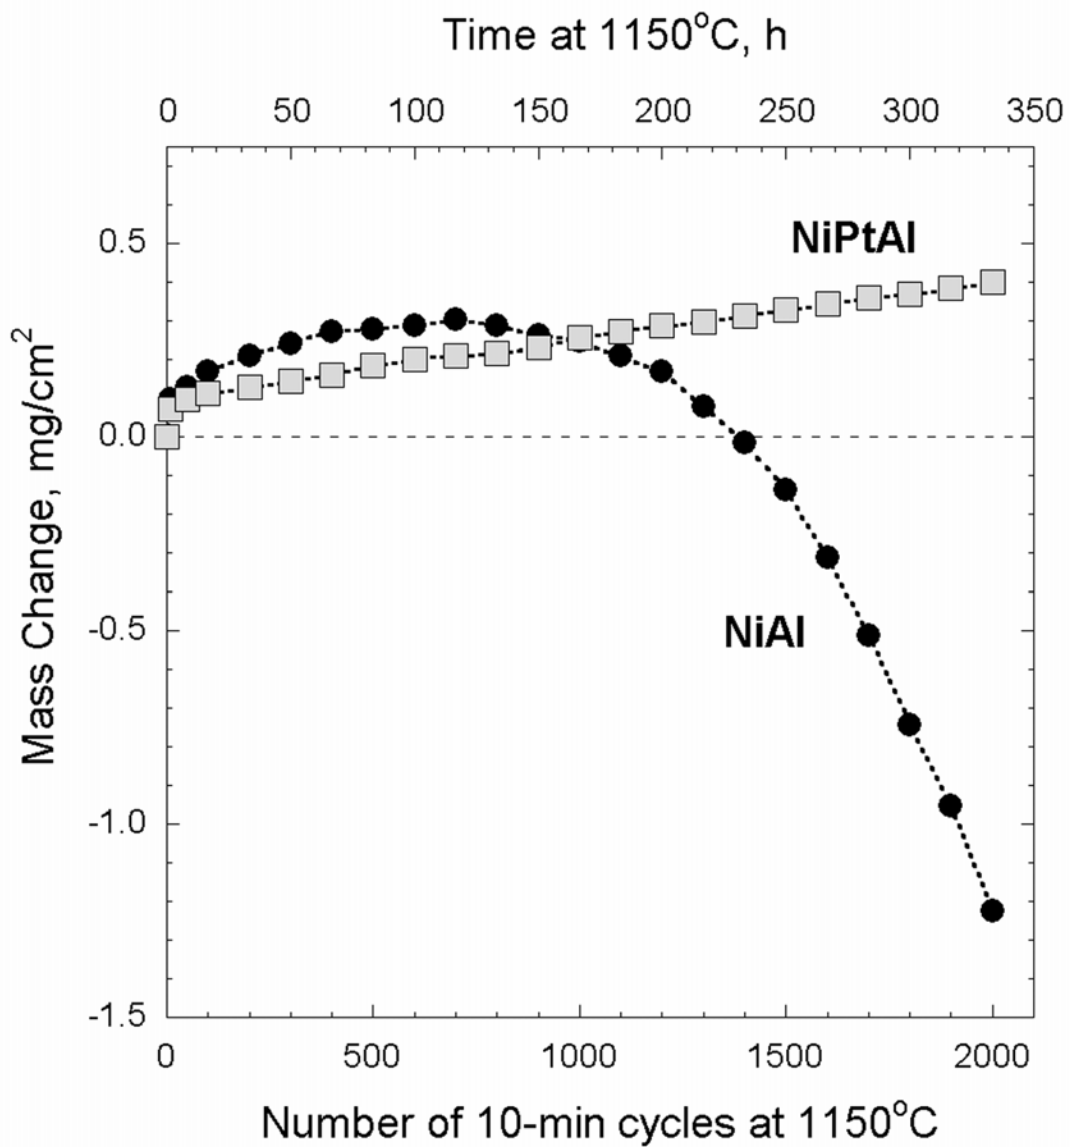
Figure 1: Cyclic oxidation behavior of NiAl and NiPtAl coatings tested in air.

Figure 1 illustrates the difference in cyclic oxidation behavior between the NiAl and NiPtAl coatings. While the NiPtAl sample displayed continuous weight gain throughout the 2000-cycle test, the NiAl started to show weight loss after 600 cycles. Visual observation revealed oxide spallation on the NiAl coating after ~200-300 cycles, but fully adherent scale on the NiPtAl coating even after 2000 cycles.

The difference in oxidation behavior of the NiAl and NiPtAl coatings, in terms of weight changes during cyclic oxidation and oxide spallation, is very similar to that reported by others [2,7]. The isothermal and cyclic oxidation experiments performed in this work demonstrate that Pt additions significantly improve Al<sub>2</sub>O<sub>3</sub> scale adhesion.

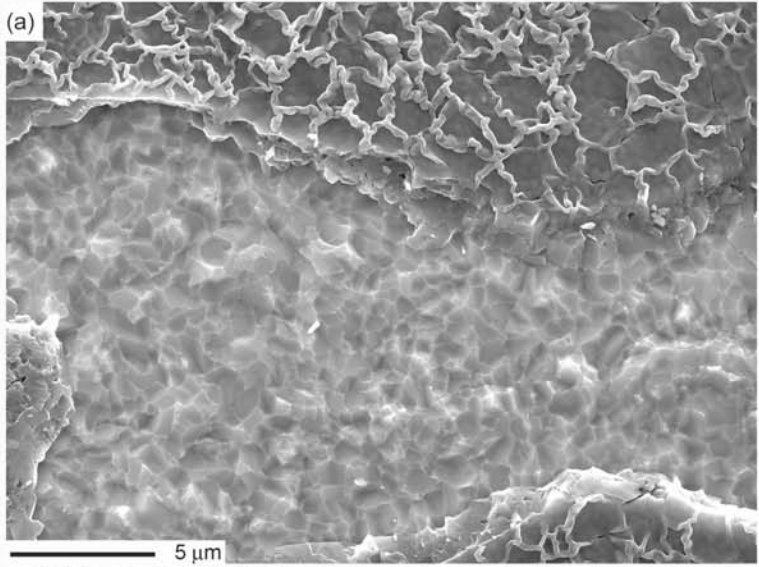
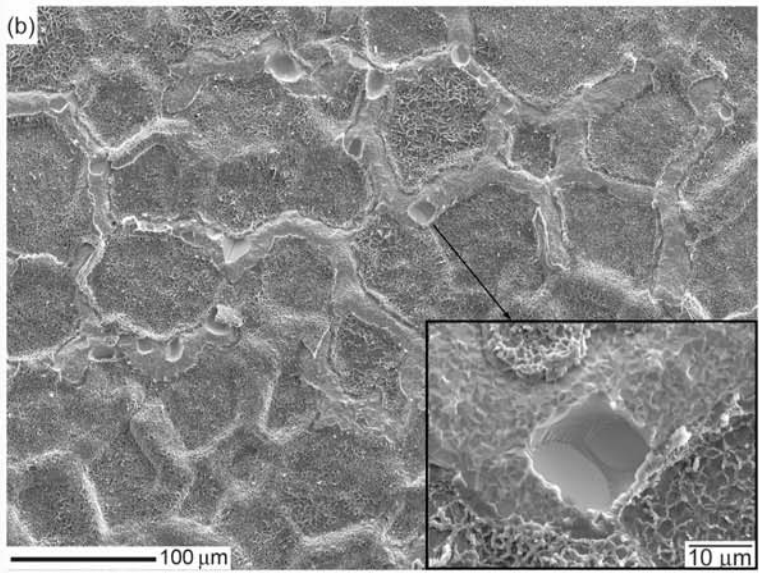
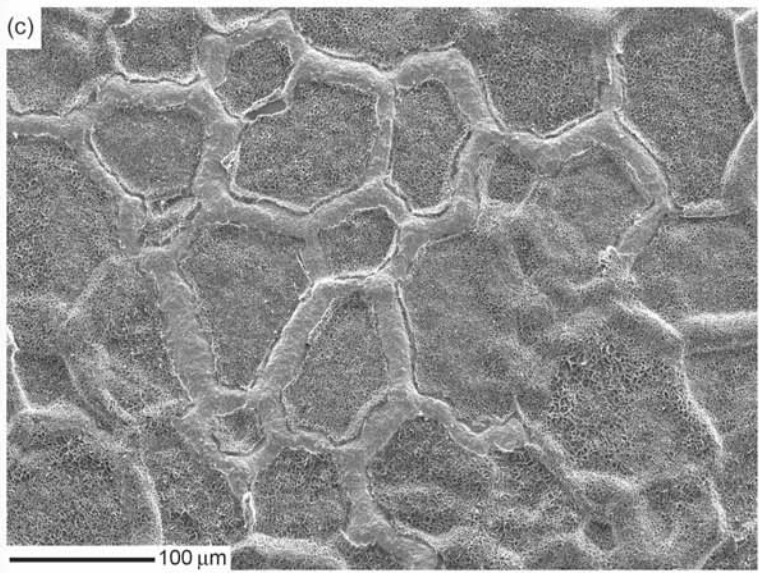
Figure 2: Surface of the NiAl coating after isothermal oxidation for 10h (a) and 250h (b),(c): after 10h, no voids are observed in the areas exposed by scratching; after 250h, spallation along grain boundary ridges exposes areas with (b) and without (c) interface voids. The insert in (b) shows a magnified view of the interface void.

No spallation was observed on the NiAl coating after isothermal oxidation at 1150°C for 10h, but the scale could be easily scratched off. Examinations of these scratch-induced spalled areas revealed fine oxide imprints with no interfacial voids, as shown in Figure 2a. After longer isothermal exposures (100 and 250 hrs), extensive scale spallation occurred on the NiAl coating (Fig. 2b,c). These spalls took place almost exclusively along grain-boundary ridges, whether or not there were interfacial voids, which formed preferentially along these ridges.

It has been suggested [2] that the improved scale adhesion on NiPtAl coatings is due to a reduction of the amount of interfacial voids; however our results indicate that voids are not necessary to cause spallation. For example, spallation during cyclic oxidation of the NiAl coating did not reveal any voids at the interface. Furthermore, the same degree of spallation was observed on regions with or without any voids on the NiAl after isothermal oxidation for 100h and 250h. The absence of interfacial voids during cyclic oxidation of the NiAl coating is quite intriguing. It suggests that some prolonged isothermal exposure is required for the voids to grow, at least the type observed here.

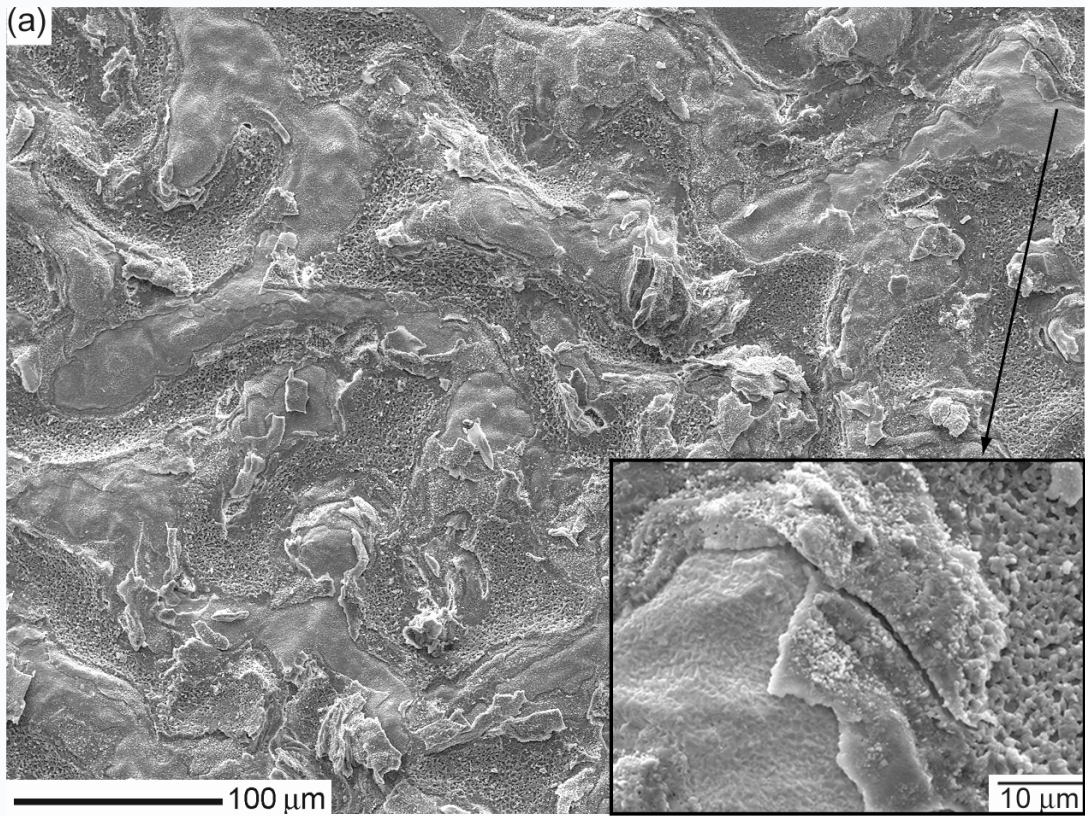
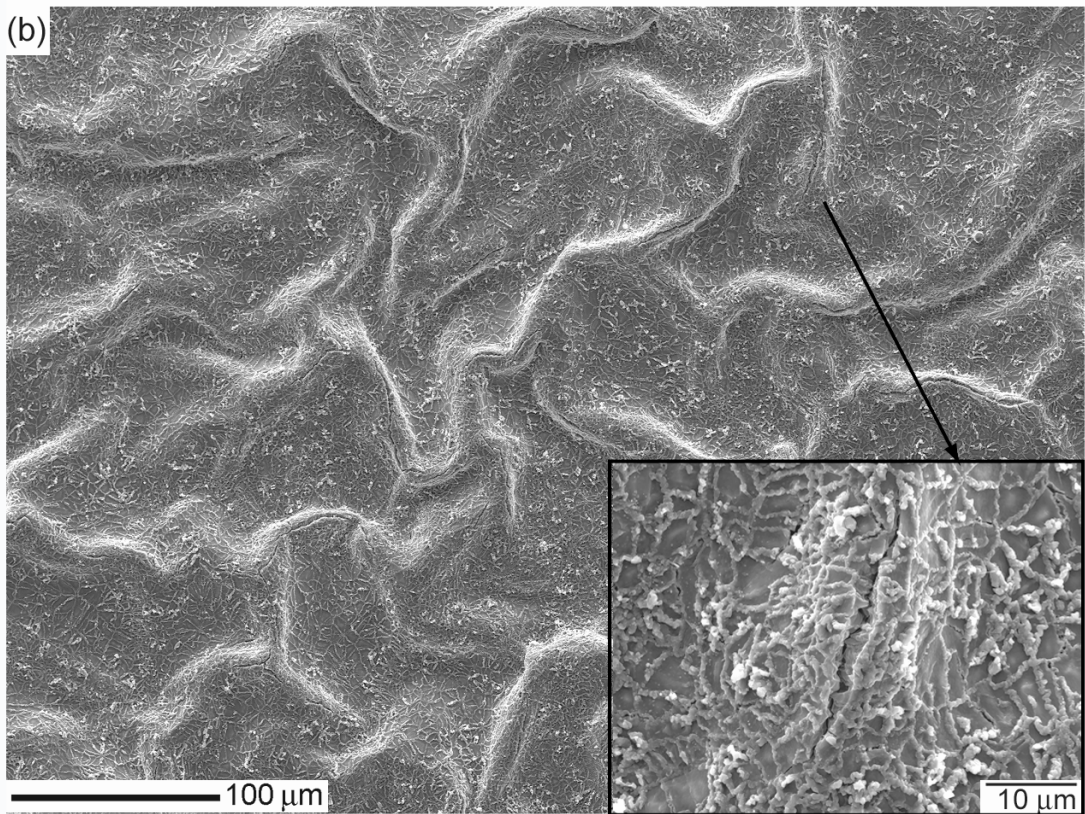
Figure 4: Surface morphology of NiAl (a) and NiPtAl (b) coatings after 2000 10-min cycles at 1150°C. Magnified views are added as inserts showing the lack of interface voids in (a) and oxide cracking along surface ridges in (b).

Significant roughening (rumpling) of both coatings occurred during cyclic oxidation (Figure 4), but it was less pronounced on the NiAl due to repeated scale spallation from ridges and peaks. Unlike under isothermal conditions, these spalled areas were free of interfacial voids. No spallation was observed on the NiPtAl coating after cyclic oxidation, even though cracks were often found in the alumina along the ridges (see inset of Fig. 4b).

On the NiPtAl coating, the interface is significantly stronger; consequently, no spallation was observed even when extensive undulations developed after prolonged cyclic oxidation (Fig. 4b). AES analysis of the interface chemistry showed no segregation of sulfur (Fig. 5b). This absence of sulfur at the oxide-metal interface appears to be the major reason of strong scale adhesion on the NiPtAl coating, although the mechanism by which platinum prevents sulfur segregation is not determined in this study. Taking into account that both coatings were deposited on the same alloy, it can be argued that the amount of sulfur in the NiPtAl should not be any smaller than in the NiAl. Also, given that no Pt enrichment was observed at the oxide-metal interface, it is unlikely that the absence of sulfur is a result of site competition with platinum (unless there is a strong repulsive interaction between S and Pt). It is possible that the presence of Pt by itself strengthens the interface. However, previous study on a similar NiPtAl coating on a different substrate showed poor scale adhesion due to S co-segregation with Cr [7], indicating that any interface strengthening effect due to Pt must be suppressed by the presence of S at the interface.

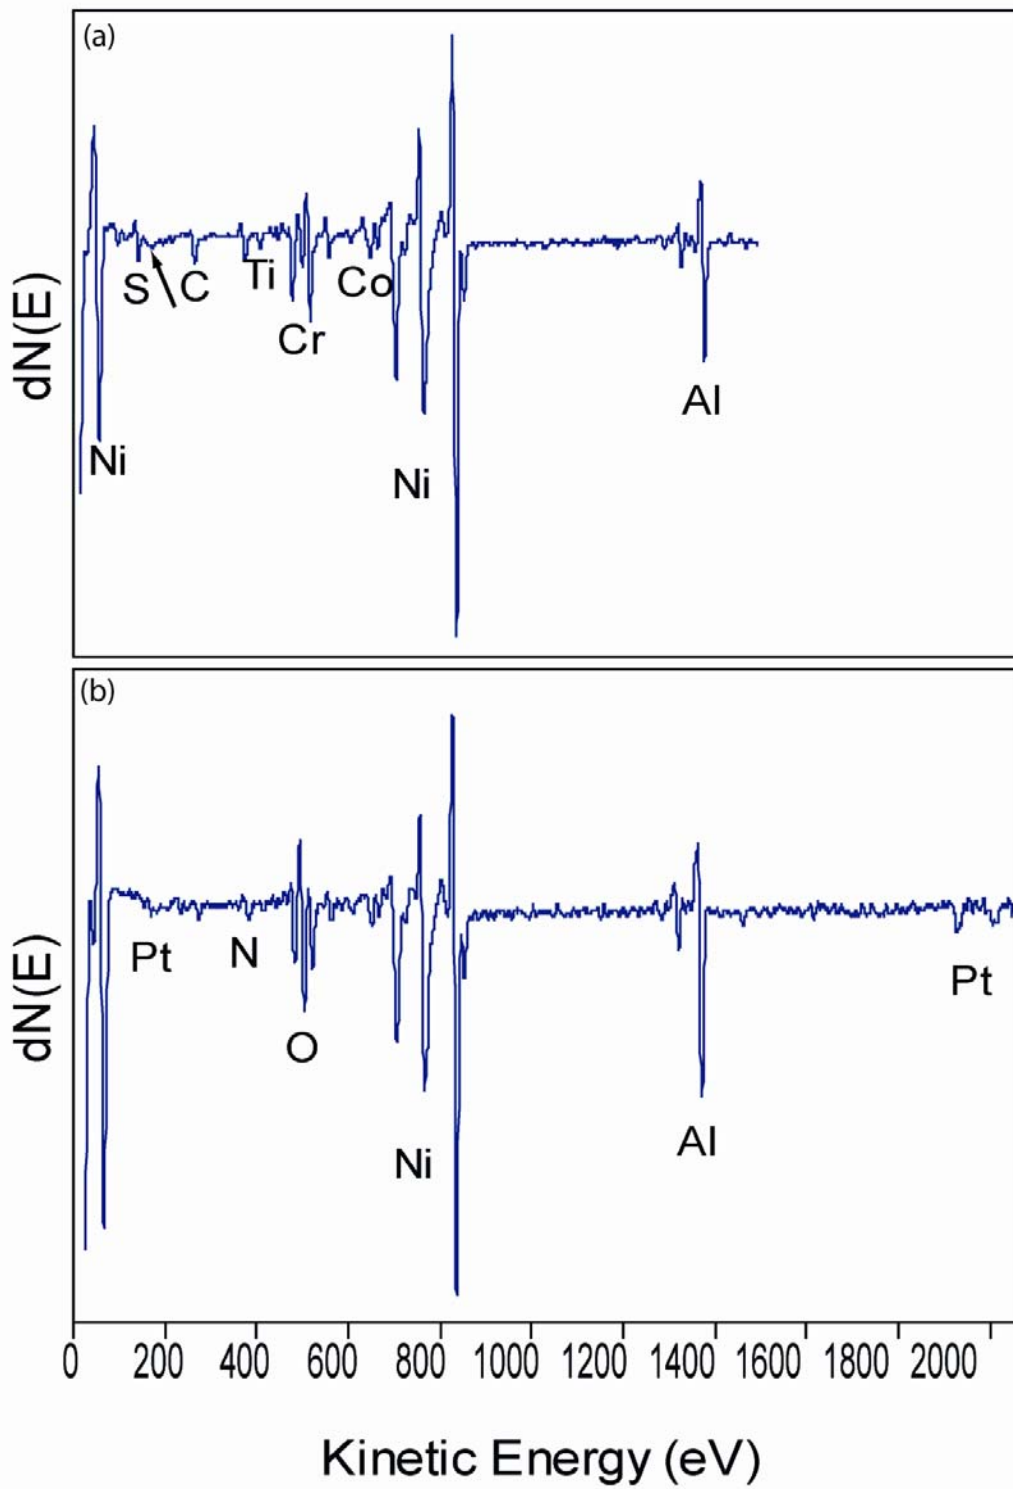
Figure 5: Typical AES spectrum found on NiAl (a) and NiPtAl (b) after Al<sub>2</sub>O<sub>3</sub> scale removal in ultra high vacuum.

Auger analysis clearly showed sulfur segregation everywhere at the  $\text{Al}_2\text{O}_3/\text{NiAl}$  interface regardless of its morphology (Fig. 5a); its surface concentration after 10h, 100h and 250h was  $0.9\pm 0.3$ ,  $1.1\pm 0.4$  and  $0.9\pm 0.3$  (at.%), respectively. These numbers indicate that the amount of interfacial sulfur has already reached a steady state level after 10 hrs. Most of the void surfaces were covered with a thin layer of oxide (due to spallation or cracking of the scale above them during cooling). Some voids that were found to be oxide-free during the AES measurements demonstrated significantly higher, up to 15 at.%, concentration of sulfur. Contrary to the NiAl coating, no sulfur was detected at the  $\text{Al}_2\text{O}_3/\text{NiPtAl}$  interface (Fig. 5b).

In addition to the major elements in the coatings (Ni, Al and Pt), both interfaces also had Cr, Co, Ti, N, O and C, as illustrated in Fig. 5. Whereas oxygen and carbon are usual UHV contaminants (their levels increased with exposure time in the AES chamber), Cr, Ti and Co were enriched at the interface relative to their concentrations in the bulk (determined by analyses made within the scratch track). On the  $\text{Al}_2\text{O}_3/\text{NiAl}$  interface, a

group of peaks (marked by the arrow in Fig. 5a) with energies close to that of Ta, W and Re are present. Closer examinations suggested that they might correspond to rhenium. Nano-sized Re [2] and Cr [2,7] particles at Al<sub>2</sub>O<sub>3</sub>/NiPtAl interfaces have been previously detected by TEM, but their effect on scale adhesion is unknown. Overlaps with low-energy Pt Auger signals prevented detection of these peaks on the NiPtAl, but high levels of Cr were found at some locations, which may be due to the presence of Cr-rich precipitates at the interface.
