What's Up With Duct Tape?

I.S. Walker and M.H. Sherman

Environmental Energy Technologies Division
Indoor Environment Department
Lawrence Berkeley National Laboratory
Berkeley, CA 94720

LBNL 56111

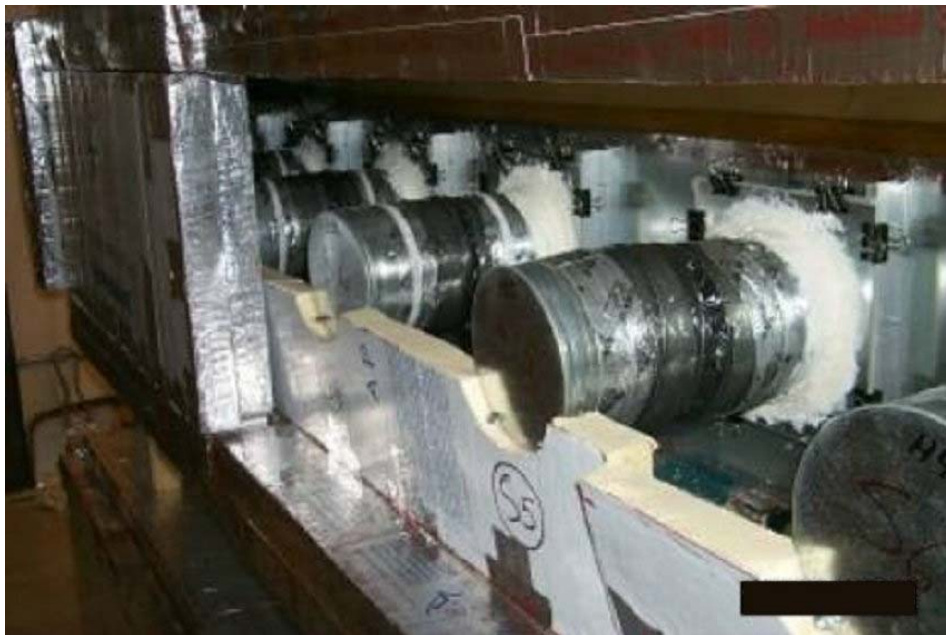
The test samples were exposed to heated air at 200 °F and were pressurized to 0.35 inches of water (85 Pa). The exact value of this pressure is not significant, we just wanted a pressure that was within a reasonable range for residential duct systems. The surface temperatures of each sample, the air temperature, and the pressure across the leaks were continuously monitored using a data acquisition system that also controlled the temperature in the apparatus. Figure 2 shows samples mounted on the test apparatus.

Figure 2. Samples mounted in the test apparatus.

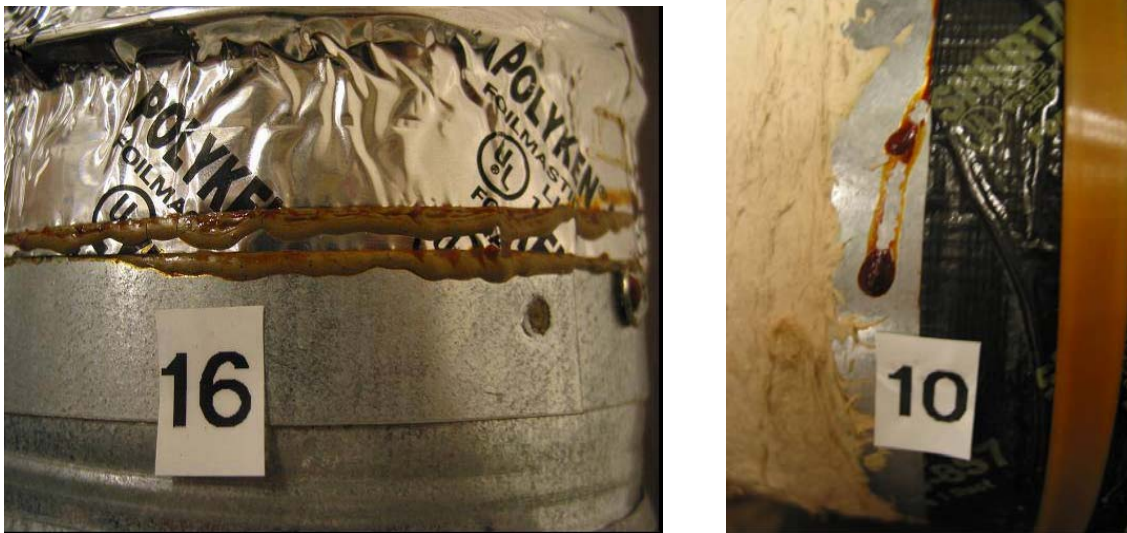
The leakage results over the two years of testing showed no systematic increases in leakage and none of the catastrophic failures seen in our previous studies. Most of the samples showed small changes in leakage (either increases or decreases) of 0.2 CFM or less. The exception was one of the foil tape samples, which showed an increase of 0.4 CFM after the first month of testing. However, this sample then stabilized at this leakage level and did not show any significant further leakage increases. Several of the samples showed leakage reductions and visual observations indicated that this is probably due to the flowing of the adhesive at high

temperatures, such that it seals more of the small cracks and leaks as it flows (see Figure 3).

Figure 3. These samples show oozing of the adhesive at the tape edges.

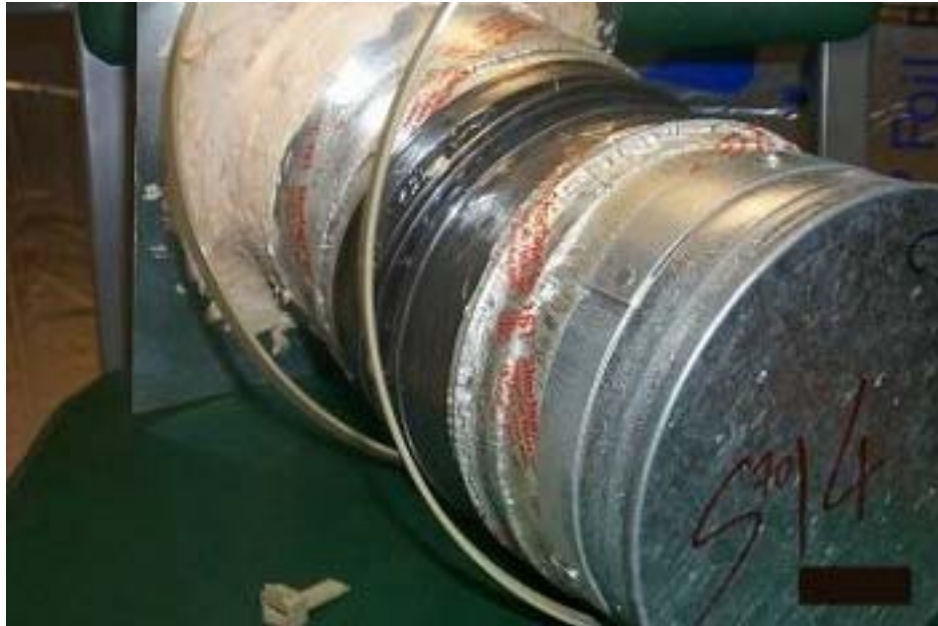
One unexpected result of the testing was the failure of the nylon straps (see Figure 6). Discoloration of the nylon strapping was observed within one month of the start of testing and the first strap broke after four months. Two different nylon strap materials were used and both showed the same brittle failure. The straps usually failed at the point where the strap passes through the ratchet of the zip-tie mechanism – where the mechanical stresses are greatest.

Figure 6. Failed plastic strapping after four months of aging.

Two straps were used—one at the cap end and one at the open end. The failure times for each end were recorded separately. The results show no significant pattern for flange or end caps failing first; the two straps on each sample generally failed within a couple of months of each other. Similarly, the failures were independent of the tape they were used with. All but two straps had failed by the end of our testing. The two remaining straps showed the same discoloration as failed straps but had not broken and fallen off. Strap failure is a major problem because mechanical attachment thereafter only is maintained by the duct sealant. If ducts are not well supported, significant mechanical stress can occur to cause the sealant to fail after the strap fails, in extreme cases, the duct connection may separate.

The materials used for the straps were typical of those used in the field, which have an unknown temperature rating. Product literature from strap manufacturers shows that there are other strap materials that have higher temperature ratings, such as Heat Stabilized Nylon 6/6 for continuous exposure above 185 °F and TEFZEL[®] for even higher temperatures, and these straps may have improved high-temperature durability. As an alternative, the authors recommend metal straps because they will not fail at even higher temperature ranges.

Until a suitable test for strap durability exists, we recommend that only high temperature nylon or metal straps be used—especially in cases where tapes may be sensitive to mechanical stresses.
