A Comparative Analysis of Pedestrian and Bicyclist Safety Around University Campuses

University of California Transportation Center
UCTC-FR-2014-03

March 2014

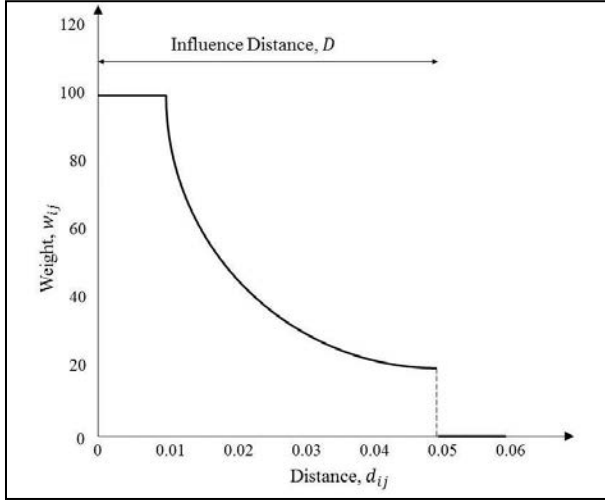
Figure 4.4 Hybrid Weighting Factor Using the Inverse Distance and Distance Metric with a 0.01 Buffer

The equation above implies that a constant weight is attributed to all crashes located within 0.01 miles of a point of measurement, exceeding which, the weight decreases inversely with the distance. Herein, 0.01 miles (~ 53 feet) represents a buffer zone around the candidate location to account for any imprecision in marking. Figure 4.4 depicts the decay in the weight as the distance increases.

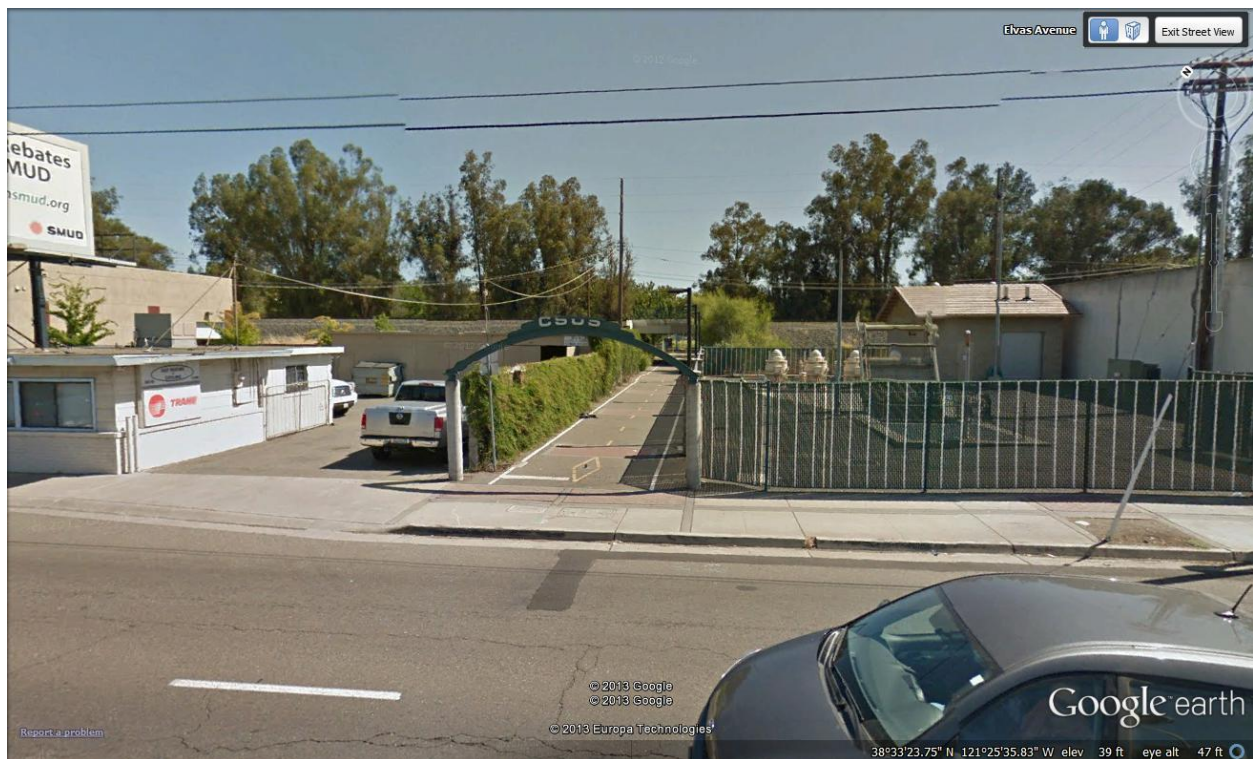
Figure 6.10 Hornet Crossing Tunnel Connection to Elvas Avenue at CSUS

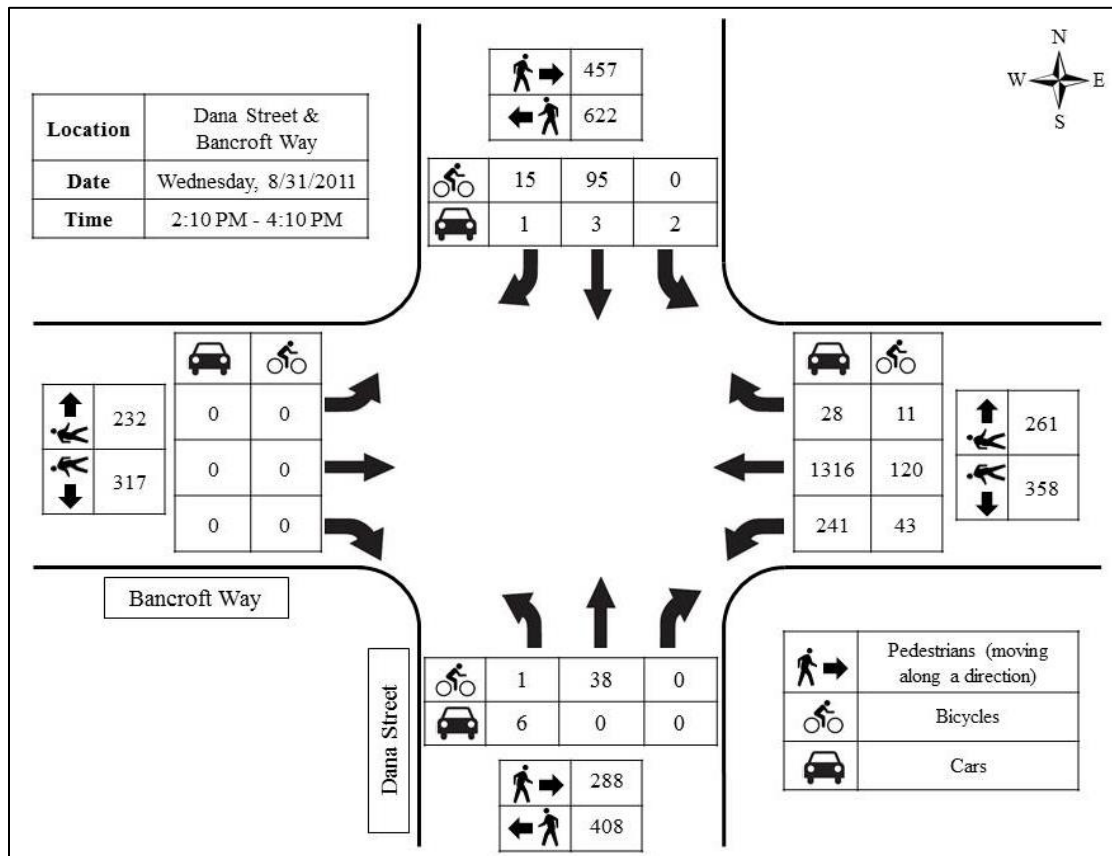
Figure 6.12 Two-Hour Manual Counts at Dana Street and Bancroft Way (8/31/2011)

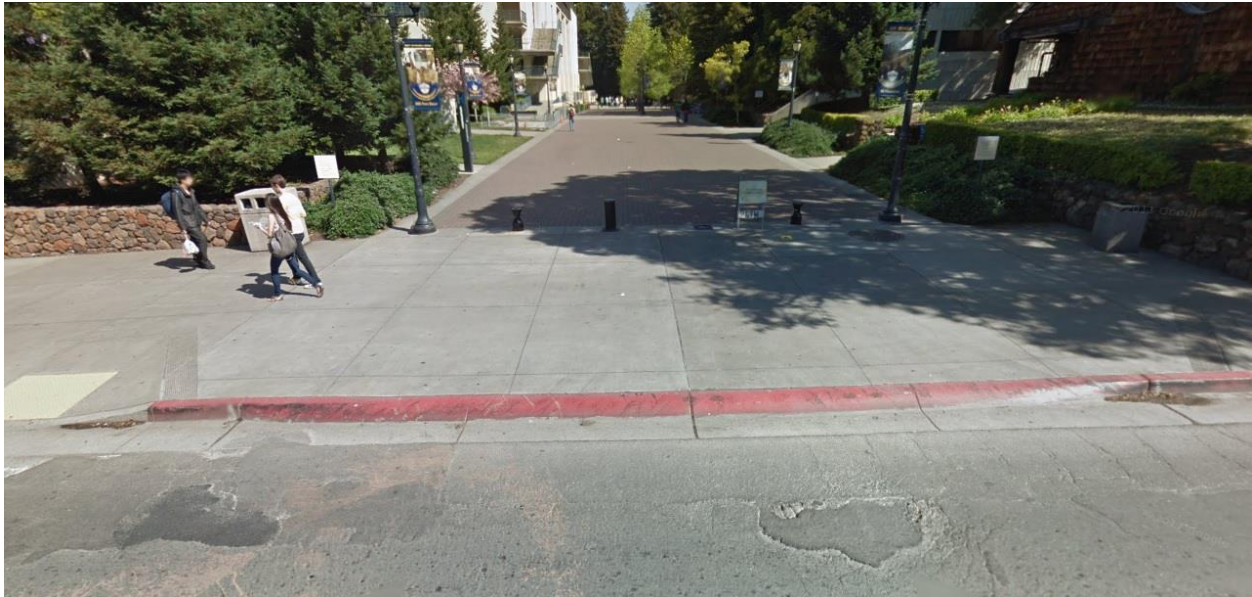
Figure 6.13 Rolled Curb along the Spieker Plaza Sidewalk to Facilitate Vehicle Access

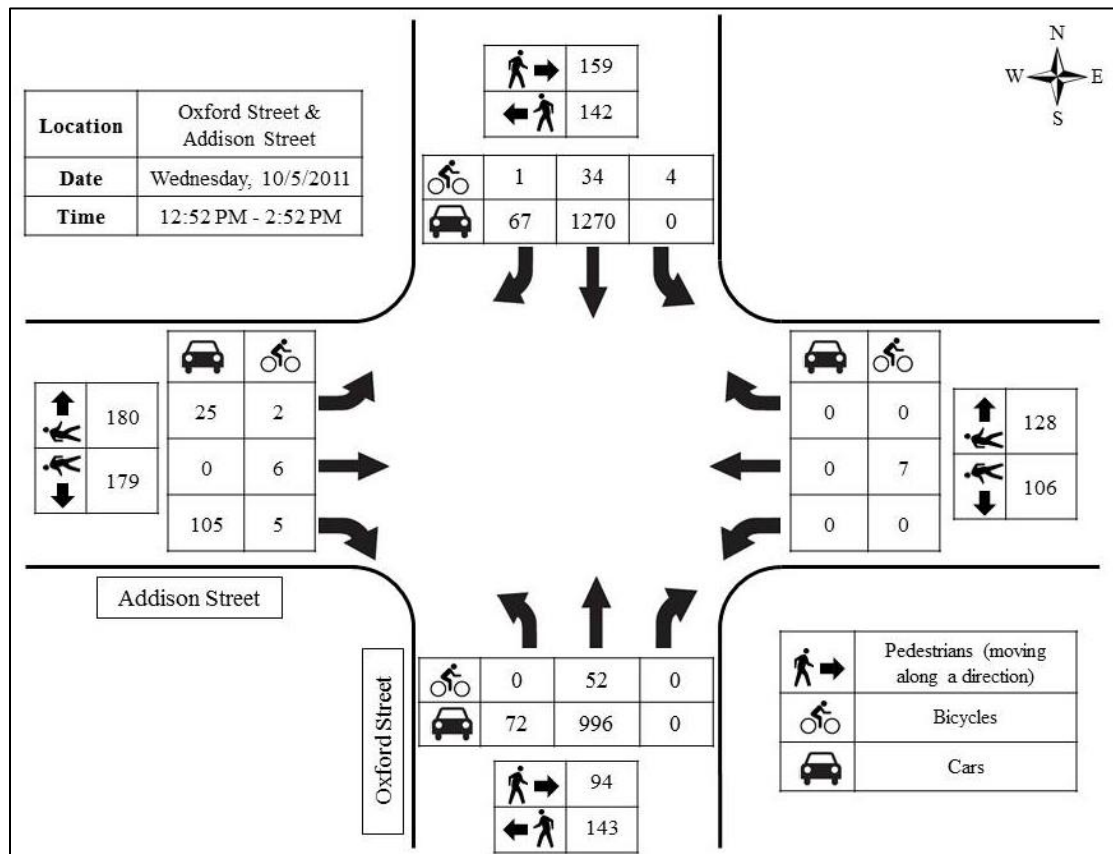
Figure 6.15 Two-Hour Manual Counts at Oxford and Addison Streets (10/5/2011)

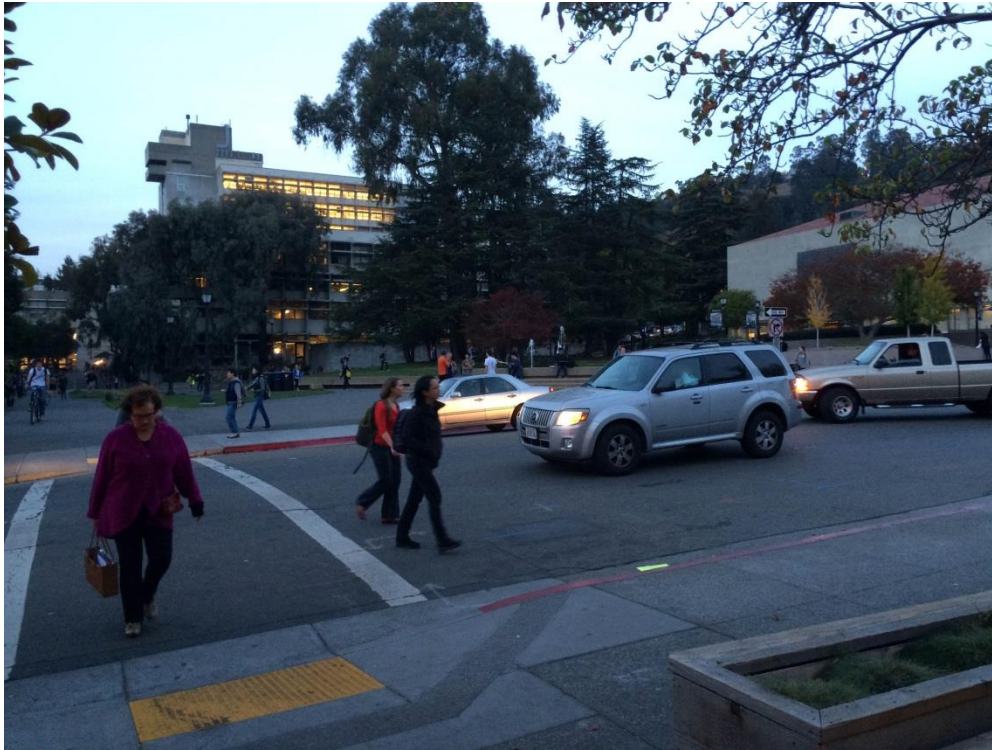
Figure 6.21 Vehicles Waiting Near the Crosswalk on Bancroft Avenue
