Development of Improved Guidelines and Designs for Thin BCOA: Summary, Conclusions, and Recommendations

Partnered Pavement Research Center (PPRC) Strategic Plan Element (SPE) 4.58B:  
Evaluate Early-Age and Premature Cracking for Pavem and LCCA (whitetopping);  
Project Task 2878: Thin Whitetopping

| 1. REPORT NUMBER<br>UCPRC-SR-2018-01 | 2. GOVERNMENT ASSOCIATION NUMBER | 3. RECIPIENT'S CATALOG NUMBER |

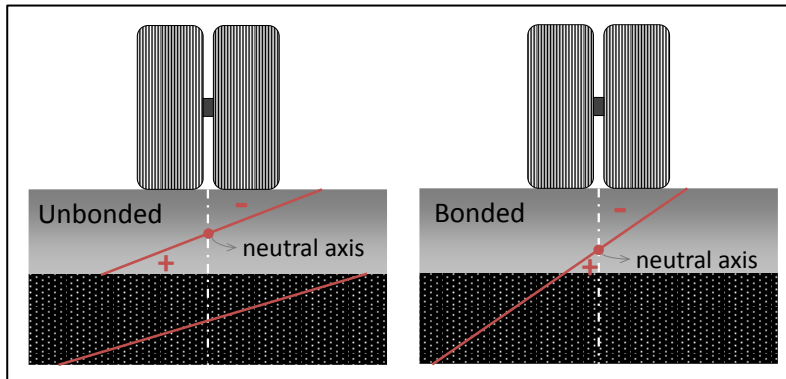
**Illustration of the Effect of Bonding on Tensile Stress in the Concrete.** The bond between the concrete and the asphalt results in a composite structure. This causes the neutral axis of the slab to shift to a lower position, closer to the bottom of the slab, thus reducing the tensile stresses that develop in the concrete slab at that location under traffic loading.

strength by bonding to the concrete to form a composite slab where both layers work together to resist bending. The bonding results in a much stronger pavement structure than if the slabs are not bonded because the bonding significantly reduces the tensile stresses in the concrete slab that cause cracking. Bonding between the concrete and asphalt therefore constitutes one of the main factors that must be considered in the design, construction, and maintenance and rehabilitation of this type of pavement.

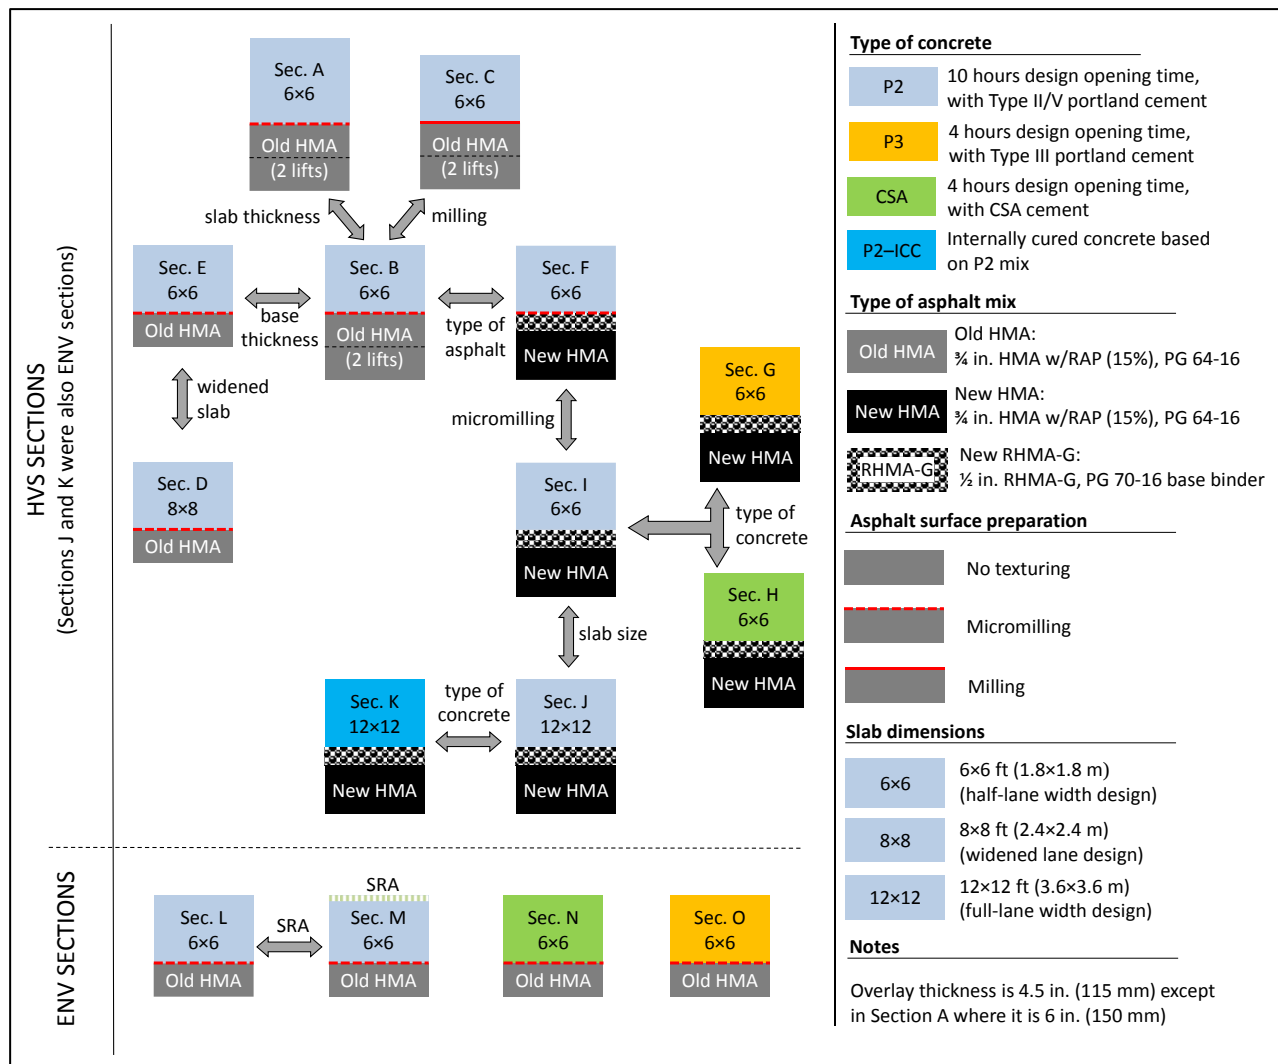
**Factorial Design for the Full-Scale Test Track.** The HVS sections were tested with the Heavy Vehicle Simulator while the environmental (ENV) sections were used to monitor the structural and hygrothermal responses to the ambient environment.

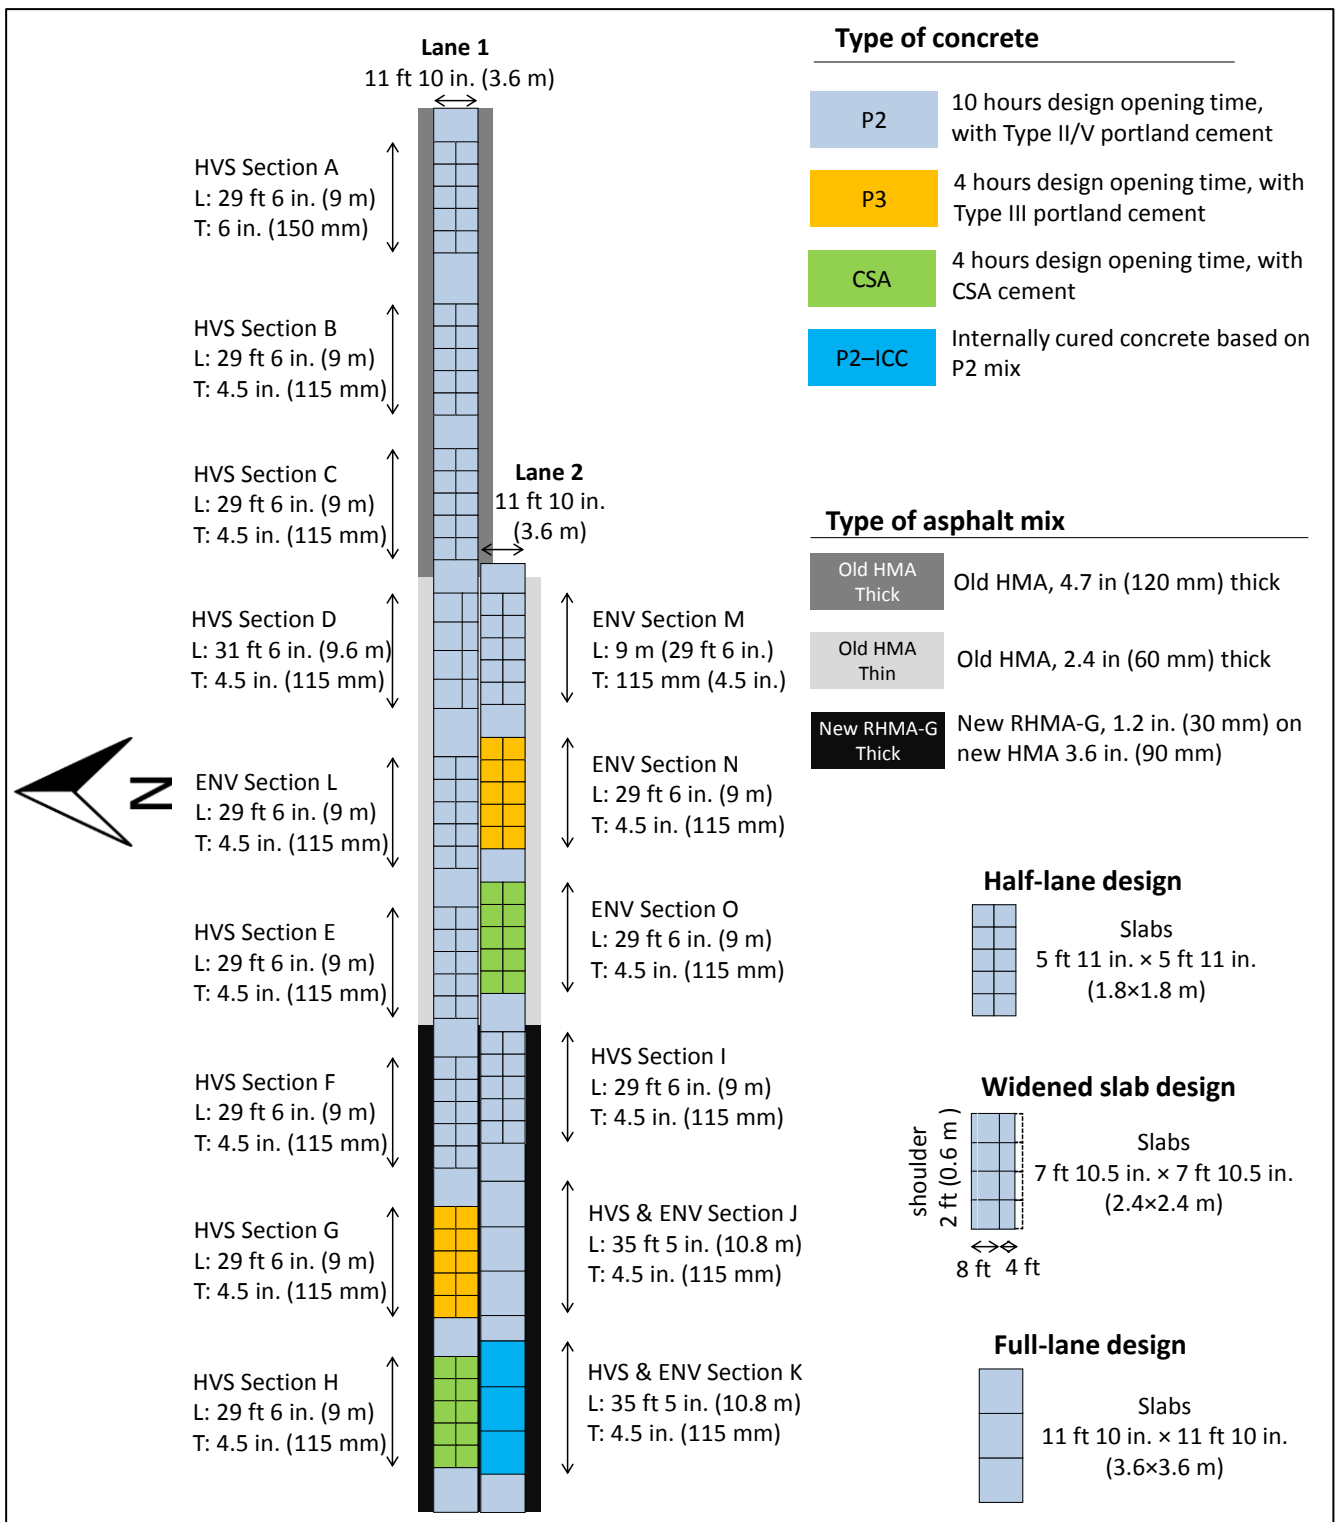
**Physical Layout of the Full-Scale Test Sections.** Nine of the sections were built on top of the old HMA that had been built and tested with the HVS for an earlier UCPRC project on full-depth reclamation. The condition of the old HMA was relatively poor, mainly due to permanent deformation caused by HVS testing. The remaining six sections were built on top of the rubberized gap-graded mix (RHMA-G) that was placed on October 2015, four months before the concrete overlay construction.

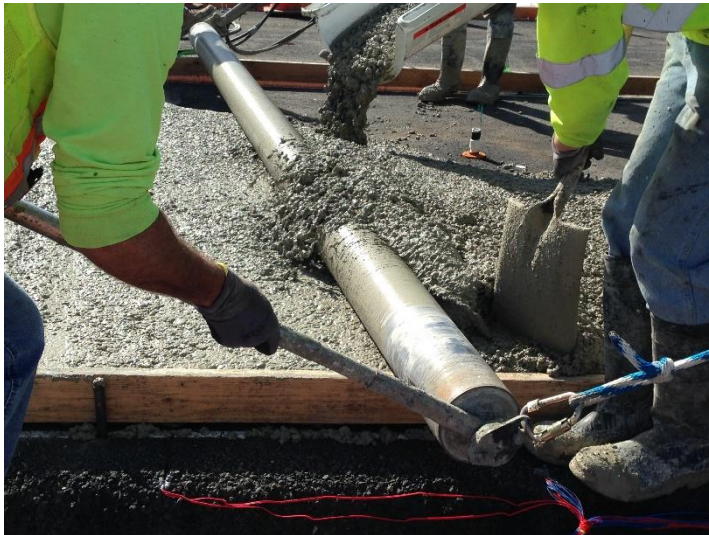
**Concrete Paving of the Full-Scale Sections.** A hand-operated roller screed was used for placement and consolidation of the concrete. This tool was selected because of the relatively small configurations of the concrete placements and the high workability of the mixes. Minimal additional vibration was required.

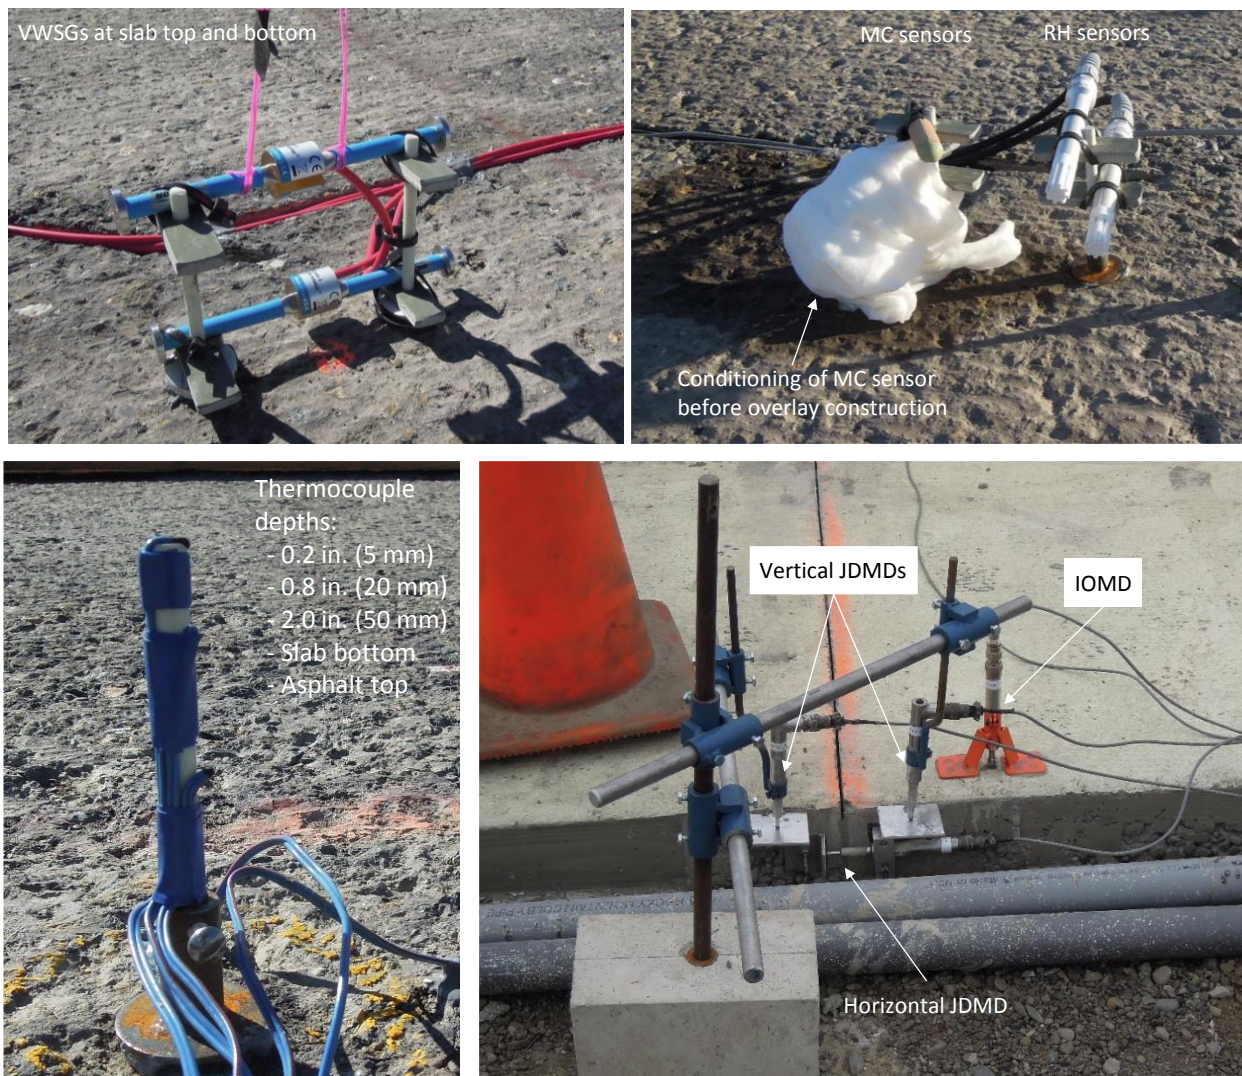
***Sensors Used for the Instrumentation of the ENV Sections.*** Three Campbell Scientific data acquisition systems were used to collect the data on the environmental sections. In the initial phase of data collection, the sampling interval was two minutes. After March 3, 2016, the sampling interval was set to five minutes, and it was set to 20 minutes after November 1, 2016.

The six environmental (ENV) sections were instrumented with 245 sensors to measure the structural and hygrothermal responses of the concrete slabs to the ambient environment and cement hydration. The structural response of the slabs was measured with vibrating wire strain gages (VWSG), vertical and horizontal joint displacement measuring devices (JDMD), and interface opening measuring devices (IOMD). The hygrothermal response was measured with thermocouples, relative humidity (RH) sensors, and moisture content (MC) sensors, all of them embedded in the concrete. Ambient conditions were measured by means of a weather station located a short distance from the test track.

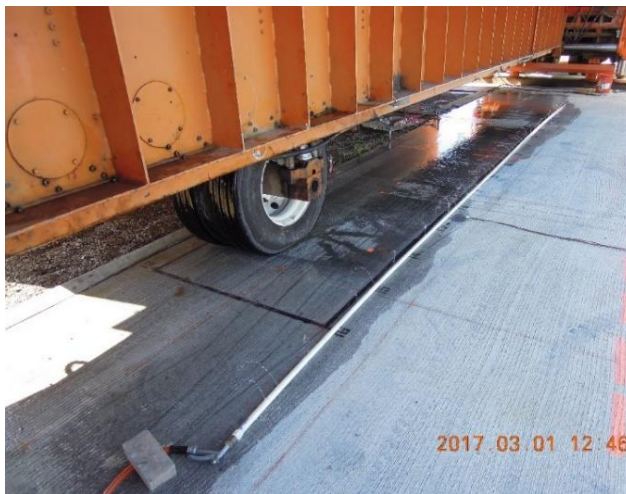
**Wet HVS Testing. “Wet” conditions represented a pessimistic field scenario where a pavement drainage system either does not exist or functions very poorly.**

Testing under “wet” conditions consisted of a ten-day pre-HVS loading period when water was ponded on the pavement surface, followed by removal of the ponding and continual application of water on the pavement during HVS loading to maintain saturated conditions at the slab/base interface. The wet loading sequence applied to five of the sections consisted of two sets of 70,000 repetitions of the HVS wheel in order of increasing load: 18 and 22.5 kip (80 and 100 kN). The wet loading included channelization (no wander) of the wheel at the shoulder edge of the slabs, which is more damaging than traffic with wander.

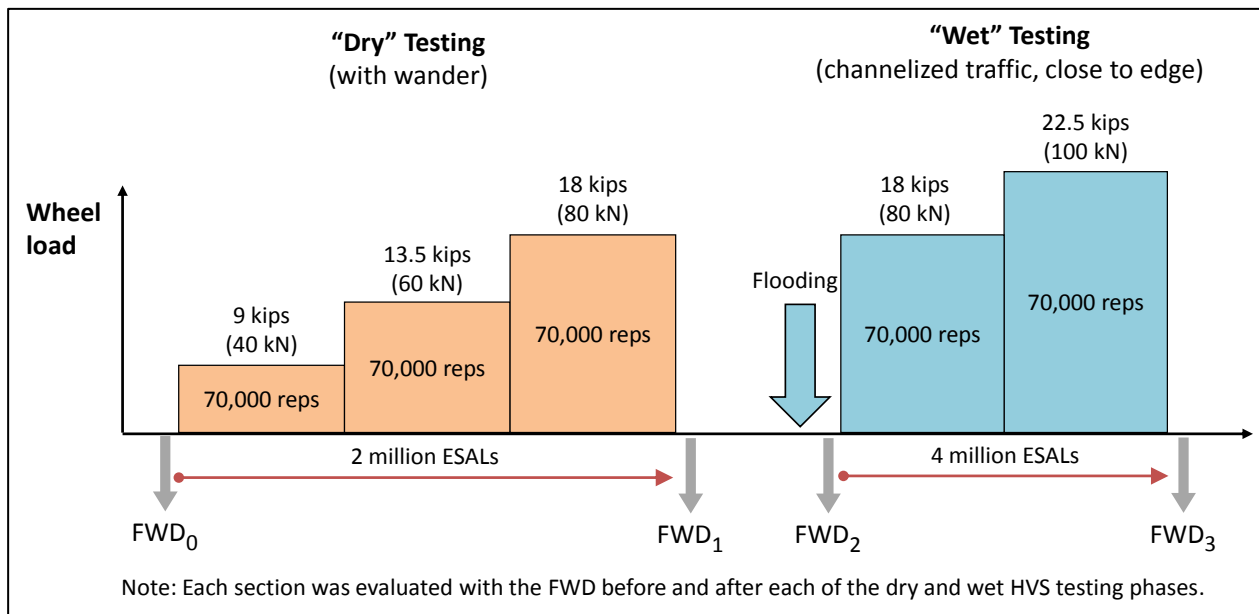
**Scheme Followed for HVS Testing of the Sections.** Using AASHTO load equivalency factors, the dry HVS testing was the equivalent of 2 million ESALs. Similarly, the wet HVS testing was equivalent to 4 million ESALs, even without taking into consideration the channelized traffic at the edge of the slabs and the artificial flooding of the section. Consequently, 6 million ESALs (2 million dry + 4 million wet) is a lower-bound estimation of the equivalent traffic supported by the five sections tested in wet conditions after the dry HVS test.

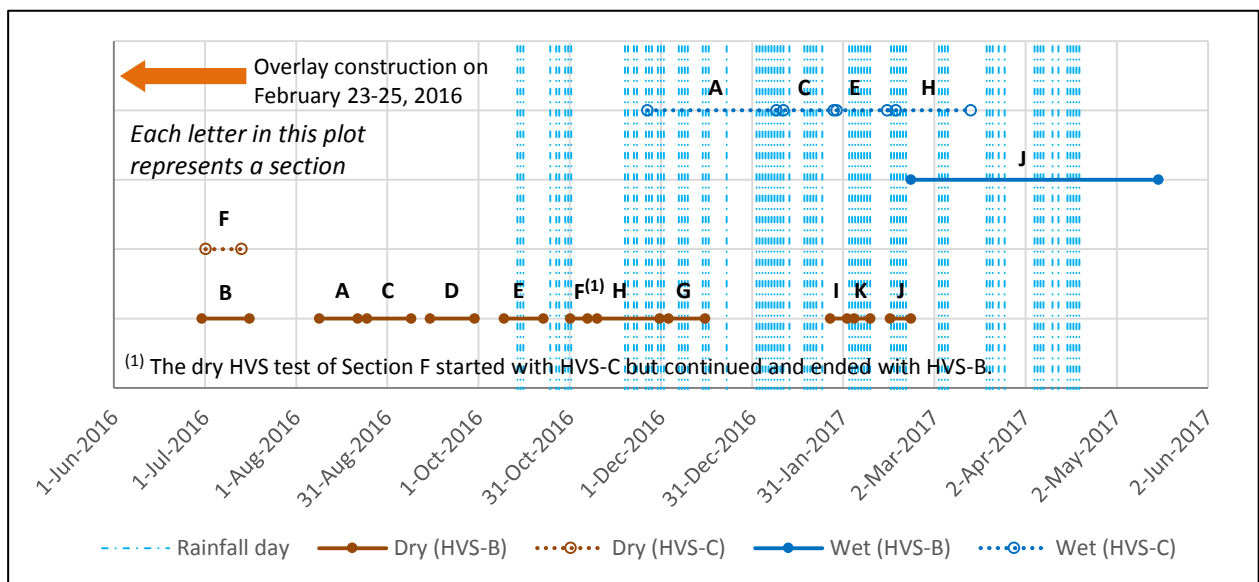
**HVS Testing Schedule.** The two HVS Units (HVS-B and HVS-C) worked together to accomplish the HVS testing of the eleven sections in around one year.

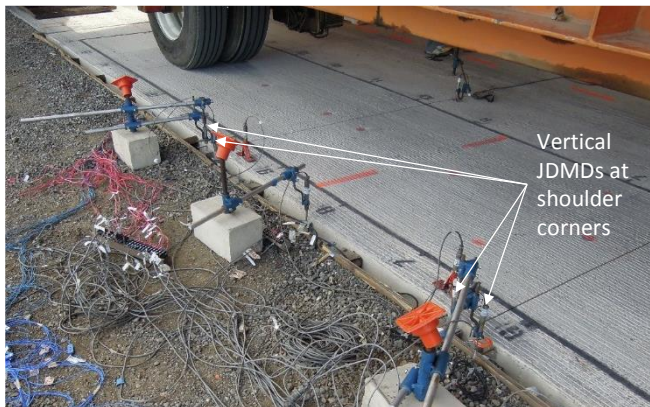
**HVS Testing.** The structural response under the HVS wheel was measured with dynamic strain gages and JDMDs. In addition to measuring corner deflection, the JDMD readings were used to determine the load transfer efficiency (LTE) of the transverse joints under the passing HVS wheel.

strain gages and JDMDs under the moving HVS wheel. The strains and deflections were also measured under the load of the Falling Weight Deflectometer (FWD) before and after the HVS testing for both the dry and wet testing. The load transfer efficiency (LTE) was measured in the mean wheelpath under the load of the FWD and in the outermost wheelpath under the load of the HVS wheel. In the latter case, the deflections were measured at the corners of the slabs next to the shoulder using JDMDs. The distresses monitored included cracking, faulting, and permanent vertical displacement of the slabs. No faulting developed in any of the sections since the HVS testing was conducted with bidirectional traffic and slow speeds.

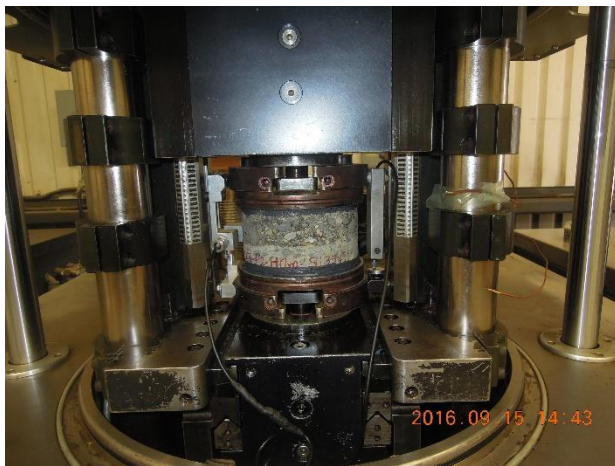
**Shear Testing of Composite Specimen.** The shear performance of concrete-asphalt interface was tested with the Simple Shear Tester.

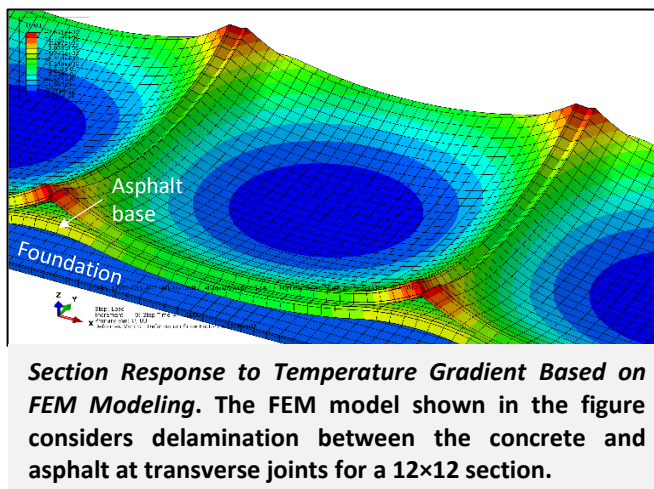
As a tool to develop the mechanistic part of the faulting model, the FEM was used to determine the deflections under single and tandem axles located at the transverse joints (8). The computed deflections in the approach and leave slabs were used to determine the differential deflection energy, which was regarded as the critical response variable that determines the development of faulting.

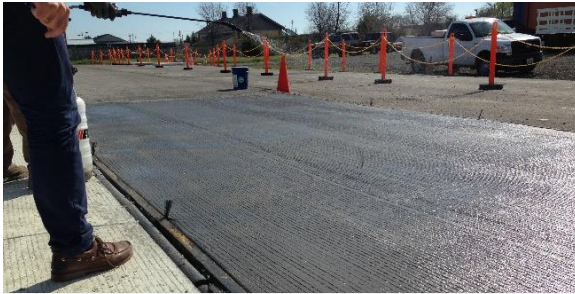
**Application of topical SRA Spray.** SRA was applied right after the “shine” on the concrete surface disappeared. The timing matches that for the application of standard curing compound.

- No major incidents occurred during the construction of the thin BCOA test tack.
- The topical use of a shrinkage-reducing admixture (SRA), 7.8 oz/yd<sup>2</sup> (275 ml/m<sup>2</sup>), prior to the application of the curing compound, reduced the drying shrinkage of the Type II/V portland cement mix considerably.

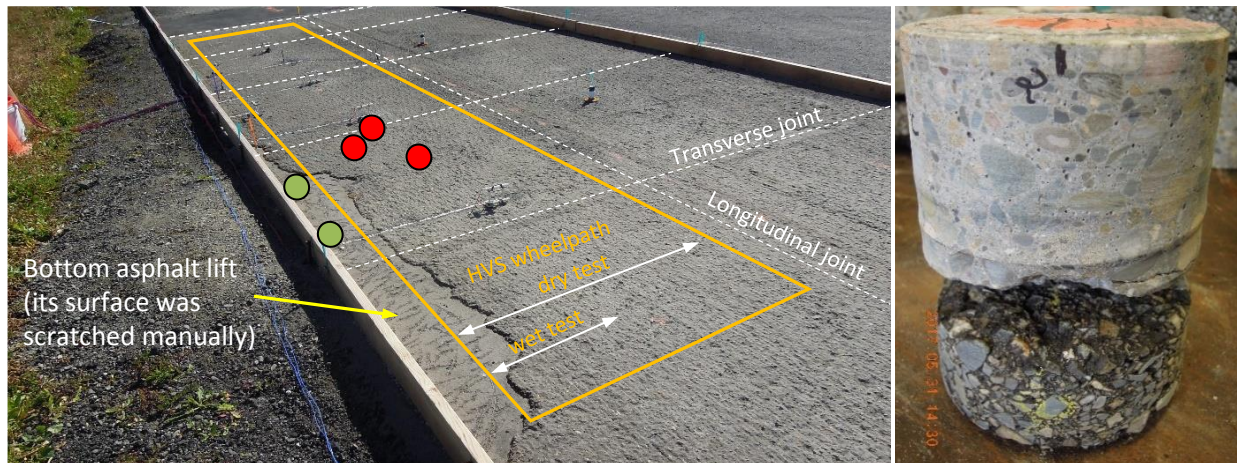
**Evaluation of Bonding from Forensic Cores.** Seven of the ten forensic cores extracted from Section C, where milling was used, showed either concrete-asphalt debonding or failure in the asphalt just below the interface. This occurred even with cores extracted far from the corners of the slabs (indicated above in red). At those locations, no damage could be seen in the sections with micromilled old HMA. Two of the three cores where the asphalt and the interface were in good condition (green cores in the picture) corresponded to asphalt with almost no texturing at all.

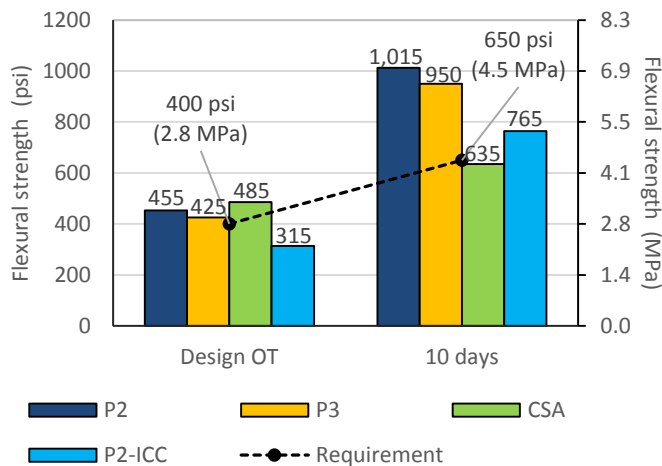
**Concrete Flexural Strengths at Opening Times and at 10 Days.** Flexural strength values in the figure are the average of the two construction days, compared with OT and 10-day specifications. On each construction day, three beams per mix type were tested following ASTM C78-10. Note design opening times (OT): 4 hours for P3 and CSA mixes; 10 hours for P2 and P2-ICC mixes.

- The increase in flexural strength from design opening time to 10 days was much smaller in the CSA-based concrete than in the mixes with portland cement. The 10 day flexural strength of the CSA-based concrete placed the first construction day was slightly below 650 psi (4.5 MPa), the Caltrans minimum requirement.

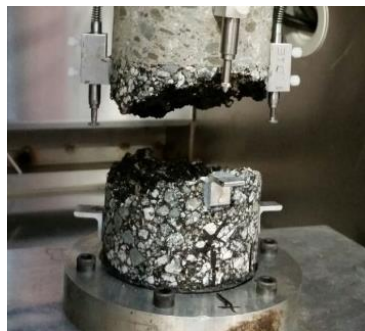
**Tensile Testing of Composite Specimen.** The composite specimens with new RHMA-G tended to fail in the asphalt rather than at the interface.

- Experimental results from this study show that concrete bonds well to new asphalt.
  - The interface between the concrete and new rubberized gap-graded asphalt (RHMA-G) had similar tensile and shear strengths to those of the new RHMA-G itself.
  - The fatigue damage of the concrete-new RHMA-G composite specimens tested in the laboratory under repeated shear loading primarily occurred in the asphalt, and not in the interface.
  - The performance of all the 6×6 thin BCOA sections with new RHMA-G was excellent, and in some ways the new RHMA-G improved the performance of the 6×6 thin BCOA sections on milled or micromilled old HMA.

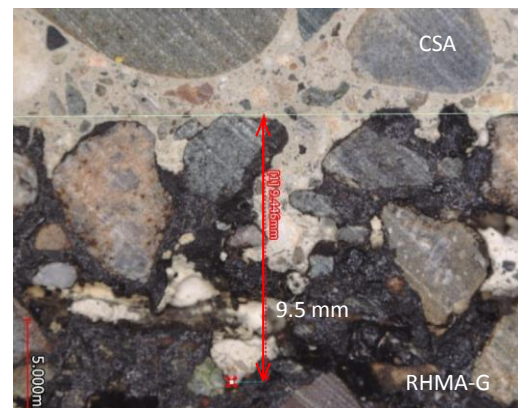
**Concrete-Asphalt Interface.** Note the penetration up to 10 mm of the cement paste into the RHMA-G voids.

- Based on the laboratory testing results, it was concluded that the mechanical nature and properties of the concrete-asphalt interface were strongly related to those of the asphalt. Two facts support this conclusion: first, the stiffnesses of the tested interfaces clearly showed temperature- and time-dependence, as do viscoelastic asphalt bases; and second, the interfaces softened significantly under wet conditions, as can occur with asphalt mixes.
- The cement paste penetrated up to 0.4 in. (10 mm) into the RHMA-G voids, thus creating a mechanical bond. The maximum penetration of the cement paste was much smaller, less than 0.1 in. (2 mm), in the micromilled old HMA. The mechanical bond includes a reinforcing effect in the volume of the asphalt base that has been penetrated by the cement, particularly the

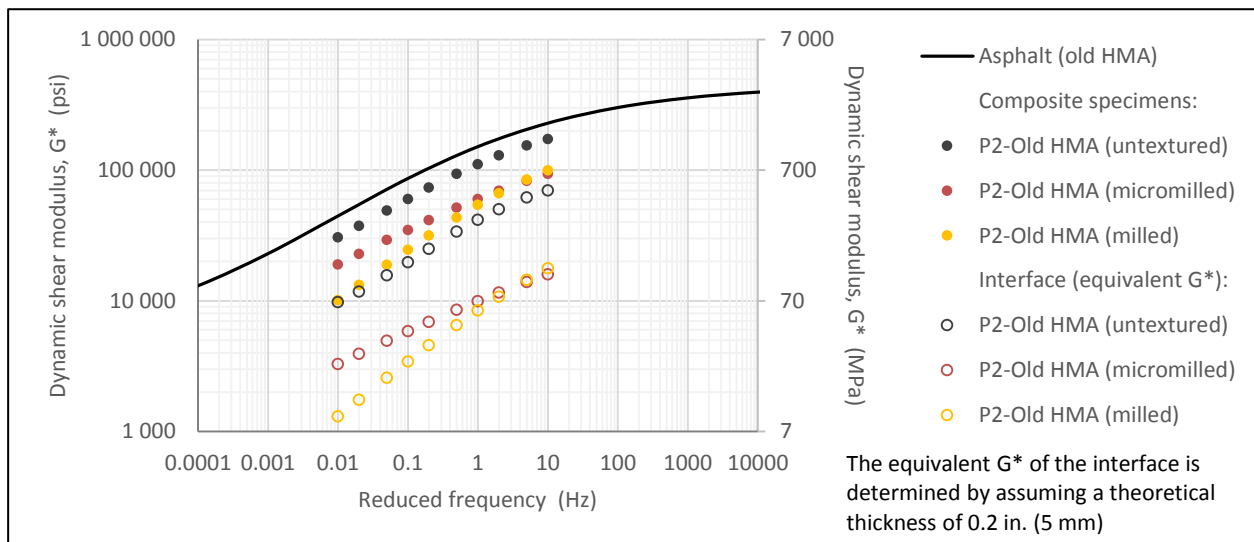
**Master Curve of Interface Stiffness as a Function of Frequency of Loading.** The stiffness of the interface was determined from the stiffness of asphalt and composite specimens. The “equivalent” stiffness of the interface (shown in the figure) is backcalculated by assigning a theoretical thickness of 0.2 in. (5 mm) to the interface, the maximum depth of penetration of cement into the old HMA. Higher frequency equals faster loading, which results in higher interface stiffness, like an asphalt mix.

- The shear stiffness of the interface between the concrete and untextured old HMA, based on frequency sweep testing at 77°F (25°C), dropped around 75 percent when the old HMA surface was either milled or micromilled. The lower the shear stiffness of the interface, the more the concrete-and-asphalt composite system will act as two completely debonded layers.

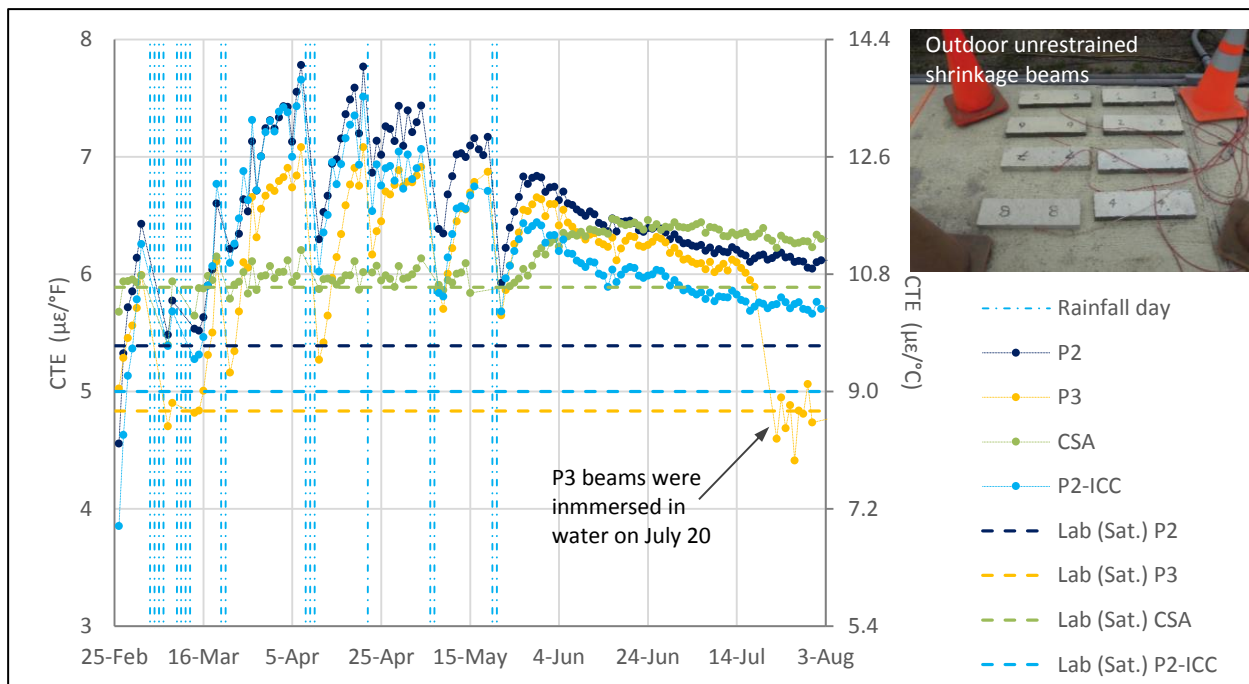
**Effect of the Ambient Environment on Concrete CTE.** The CTE of the mixes with portland cement (P2, P3, P2-ICC) tended to increase during periods without rainfall and dropped rapidly after each rainfall event (the series “Rainfall day” indicates days when rainfall took place). Note how the CTE reached maximum values around May to June while, with further drying, the CTE decreased below that maximum. Actual CTE of the beams reached maximum values that were much larger than the value determined in the laboratory following AASHTO T 336-15 (under saturated conditions).

- The changes in equivalent CTE of the concrete slabs were directly related to weather conditions.
  - The equivalent CTE tended to increase during periods without rainfall.

- Rainfall events produced an immediate reduction of the equivalent CTE, provided that the concrete was not already saturated.
  - A clear link was observed between equivalent CTE of the slabs determined from their bending and RH measured in the concrete at 0.8 in. (20 mm) depth: the equivalent CTE increased when RH decreased and vice versa.

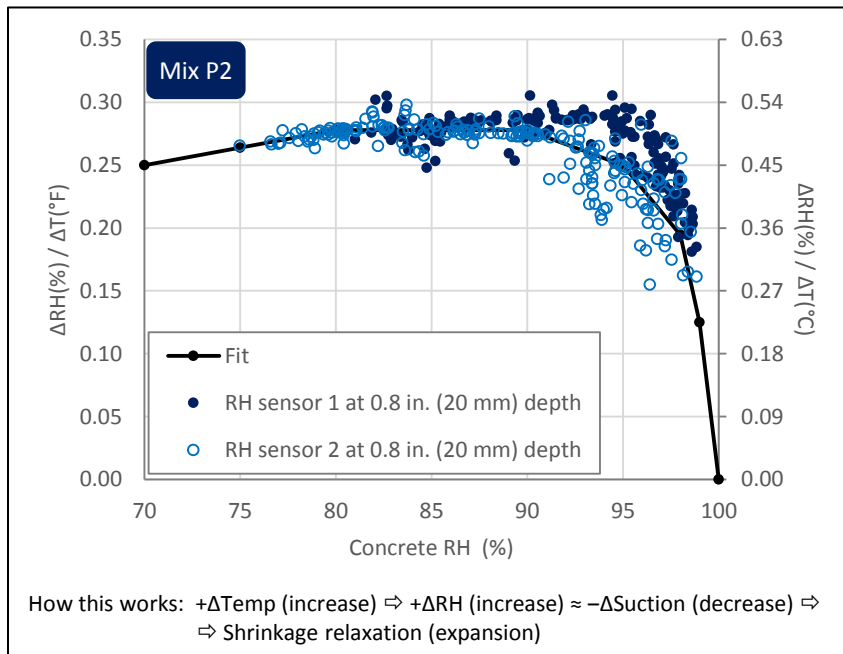
**Change in Relative Humidity in the Air Pores with Change in Temperature.** Because of the suction-temperature mechanisms, the RH in the air pores in the concrete increased as temperature increased and vice versa even though the water content was essentially constant. That is the opposite of what happens in the open air when the amount of water vapor in the air is constant and RH decreases as temperature increases. For example, based on the figure, the P2 concrete RH would have increased from 85 to 85.27% when the temperature increased 1°F and would have decreased to 84.73 when the temperature decreased 1°F.

- The temperature-related changes in the concrete’s degree of capillary saturation and capillary water suction resulted in intensification or relaxation—depending on direction of the temperature change—of the moisture-related shrinkage (i.e., they resulted in concrete contraction/expansion). Since this deformation takes place as the temperature changes, it is interpreted as thermal deformation. In fact, however, it is temperature-dependent moisture-related shrinkage.

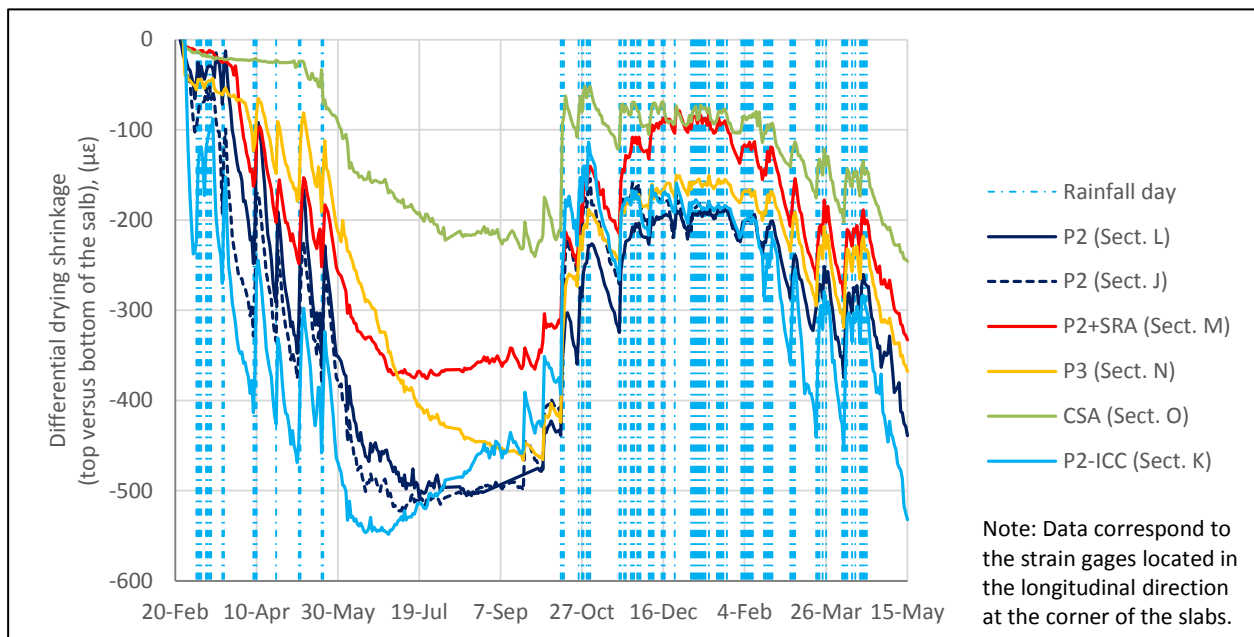
**Difference in Drying Shrinkage between Top and Bottom of Slab.** This figure shows the differential drying shrinkage between the top and bottom of the slab, with negative values indicating that the top has more shrinkage than the bottom. It can also be seen that drying shrinkage is partially reversed by rainfall events. These data were backcalculated from strain gage measurements in the slabs. Details of the calculations are in Reference (5).

- Rainfall events produced an almost immediate decrease in the magnitude of the differential drying shrinkage in the slabs except, as expected, when the concrete surface was already saturated. This occurred with both the portland cement and CSA mixes.
- The evolution of mean and differential drying shrinkage in the slabs indicated that drying affected the bottom half of the slabs considerably during summer. This conclusion was supported by moisture content measurements at 2 in. (50 mm) depth in the concrete. Since the slabs were 4.5 in. (115 mm) thick, this outcome questions the *Mechanistic-Empirical Design Guide's* (MEPDG) hypothesis that drying does not take place below 2 in. (50 mm).

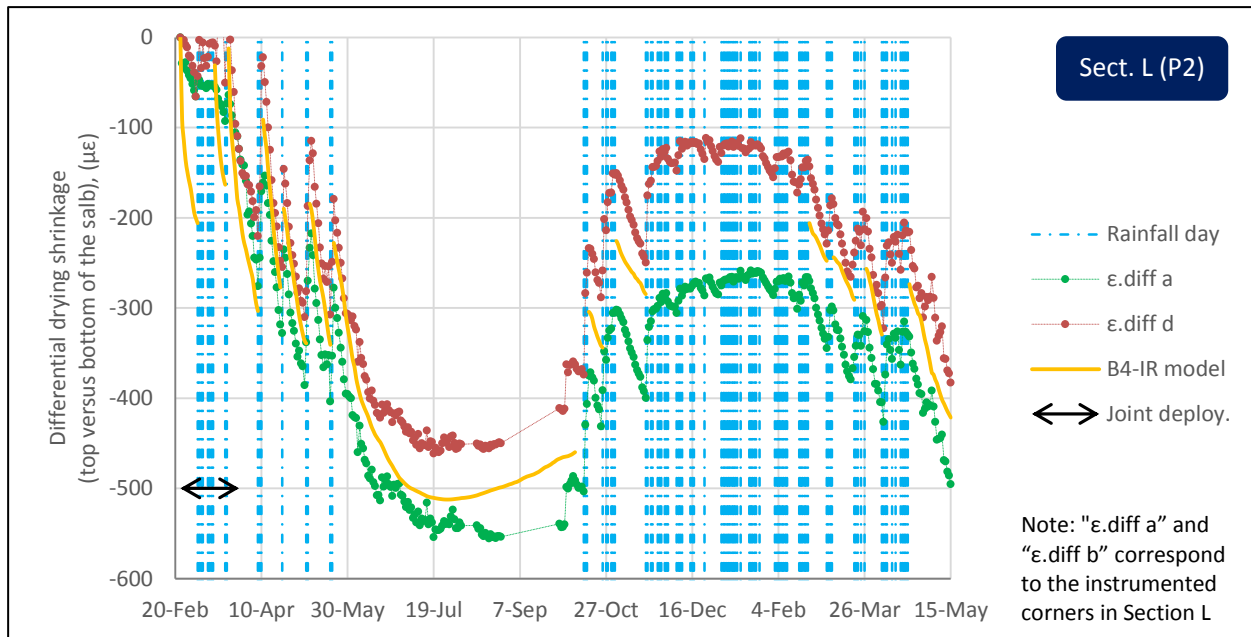
**Prediction of Drying Shrinkage with the B4-IR Model.** The B4-IR model almost exactly reproduced the backcalculated differential drying shrinkage of the slabs. The main limitation of B4-IR currently is that it cannot model shrinkage reversal after rainfall events (model predictions were forced to fit actual measured strain after each of the rainfall events).

- Shrinkage reversals due to rainfall events were not modeled in this research. This topic should be investigated in the future since experimental data show shrinkage in the concrete slabs cannot be predicted based on air RH exclusively.

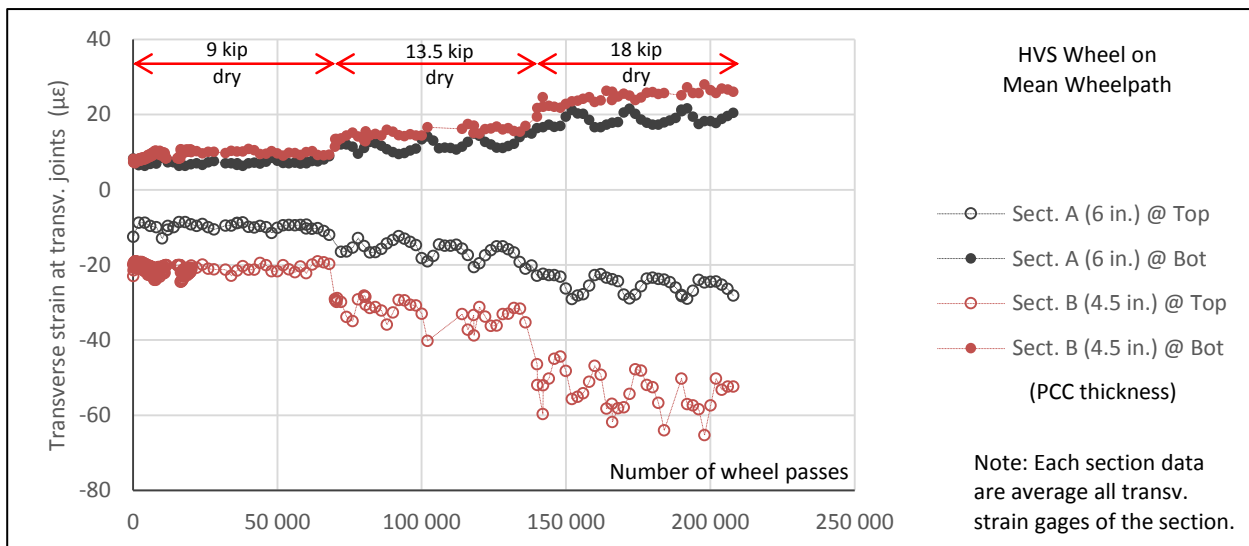
**Influence of Slab Thickness on Concrete Strains.** Based on the HVS testing results, it appears that increasing the thickness of the slab does not extend the fatigue cracking life of thin BCOA since the increased thickness did not reduce the tensile stresses induced by traffic at the bottom of the slabs. This outcome was related to the fact that the asphalt and concrete remained bonded during the HVS testing. However, in the field, the concrete and asphalt will debond over the long term. Once debonding (full or partial) occurs, the additional thickness does result in lower tensile stresses at the bottom of the slabs under traffic loading, which would provide extended cracking fatigue life.

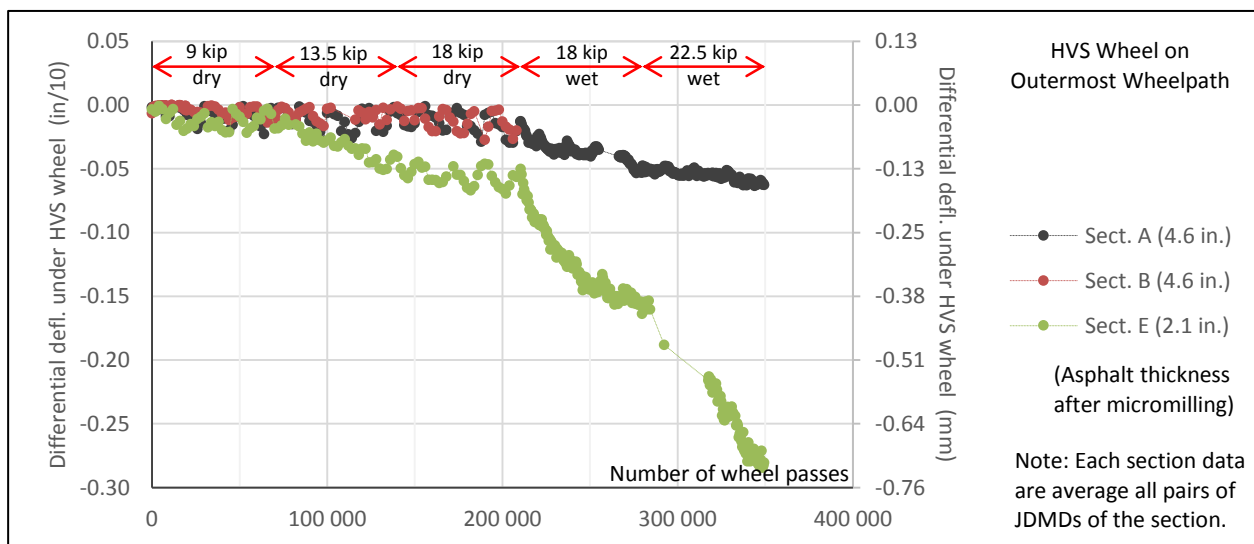
**Influence of Asphalt Base Thickness on Joint Differential Deflection.** The common practice for using thin BCOA includes a recommended minimum asphalt base thickness of 3 inches (75 mm) after milling. Based on the poor LTE performance of Section E—compared to Sections A and B—it seems that the 3-inch recommendation is reasonable although it might be somewhat unsafe when asphalt thickness variability is high or the asphalt is not in fair or good condition.

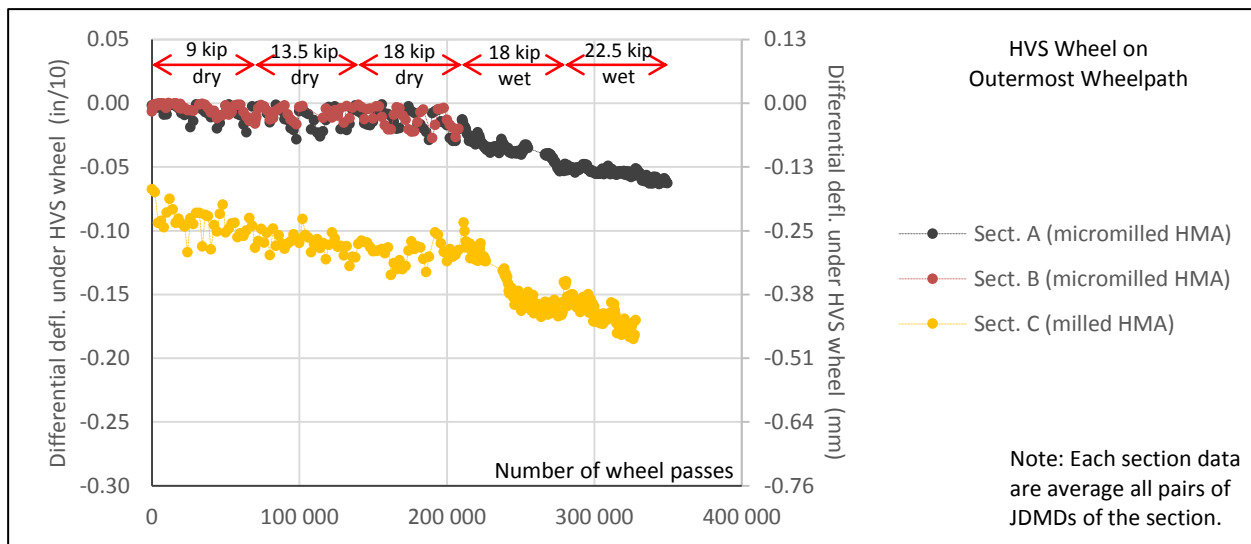
**Influence of Surface Texturing of the Asphalt Base on Joint Differential Deflection for Old HMA.** Milling is the technique that has typically been used in other states to texture the pavement surface before construction of BCOA. However, one advantage of using micromilling rather than milling is greater precision in the texturing operation. This increased precision can be useful for avoiding the delamination between asphalt lifts, as occurred in Section C. Additionally, it is believed that the micromilling process is less aggressive to the asphalt than the milling process, although further experimental data are needed to fully verify this belief.

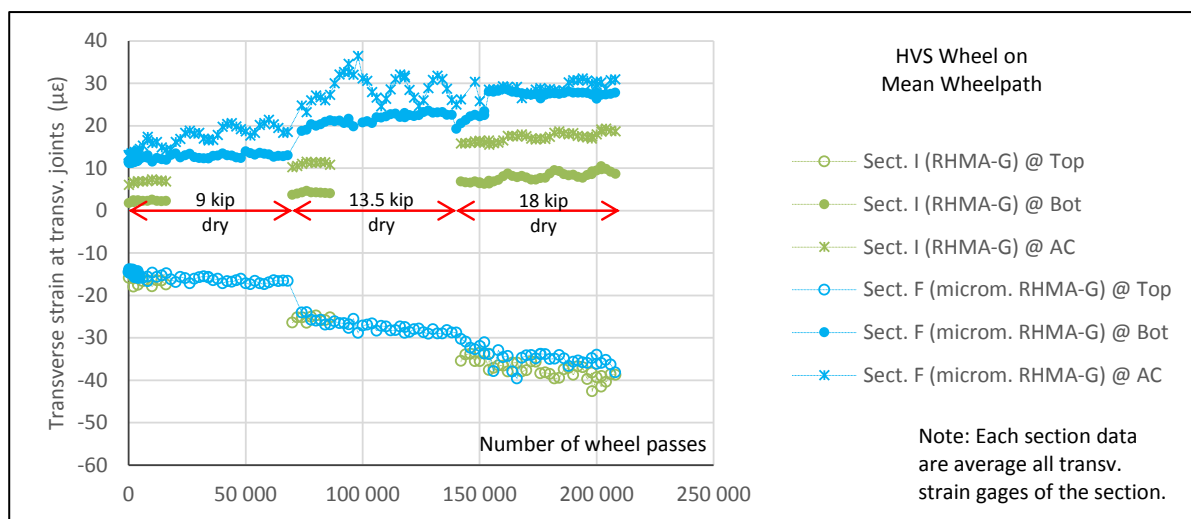
**Influence of Surface Texturing of the Asphalt Base on Transverse Strain for New RHMA-G.** The good bond between the concrete and the new RHMA-G base is apparent in Section I, as evidenced by the fact that the strain measured (in the asphalt) 1.2 in. (30 mm) below the concrete-asphalt interface is considerably larger than the strain measured at the bottom of the slab, 0.8 in. (20 mm) above the concrete-asphalt interface. However, evidence of that good bonding is not that clear in Section F, since the strain in the asphalt is similar to the strain at the bottom of the slab. This outcome indicates that the micromilling process either resulted in a surface where the concrete could not bond well or, more likely, it damaged the top part of the RHMA-G.

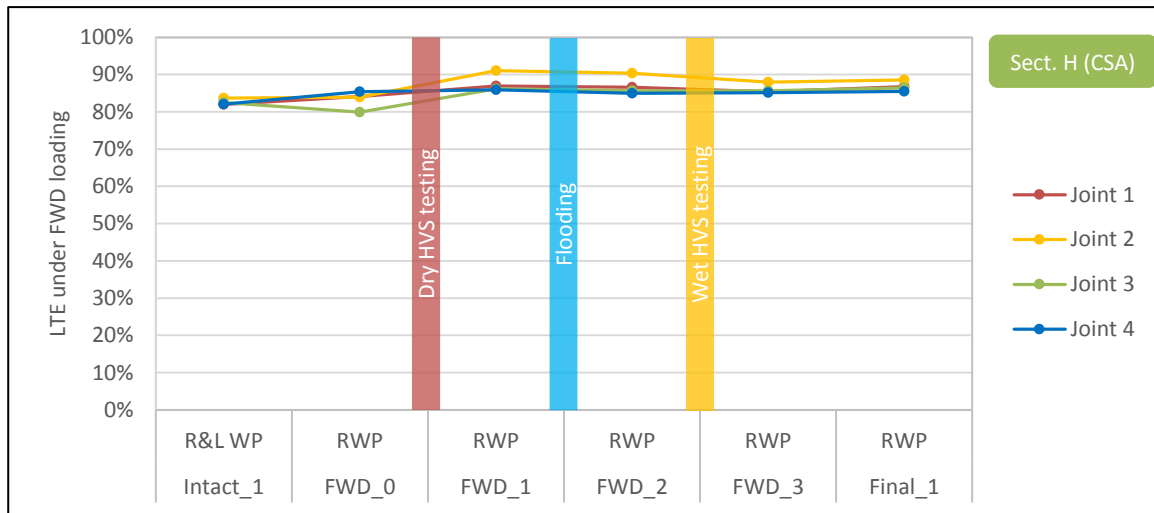
**Influence of Asphalt Mix Type on Load Transfer Performance.** All the 6×6 sections with new RHMA-G showed excellent performance during the HVS testing. As an example, this figure shows the LTE measured with the FWD in the mean wheelpath of Section H. The LTE was very uniform from one joint to another and barely changed after the HVS loading.

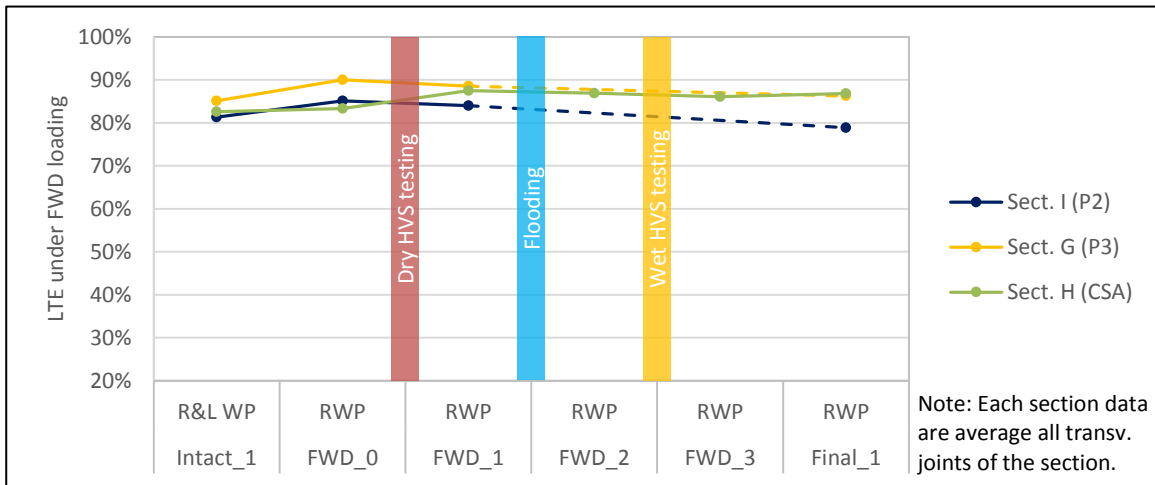
**Influence of Concrete Mix Type on Load Transfer Performance.** The three 6×6 sections with different concrete types and new RHMA-G base showed excellent performance during the HVS testing, although Section H was the only one tested in wet conditions. The only observed difference between the performance of the three sections was related to asphalt/concrete-asphalt interface damage at the corners that the forensic coring revealed. That damage was somewhat smaller in Section H than in the other two sections, an outcome that was likely related to the lower levels of moisture-related shrinkage of the CSA mix compared to the portland cement mixes.
