Development of Improved Guidelines and Designs for Thin BCOA: Summary, Conclusions, and Recommendations

Partnered Pavement Research Center (PPRC) Strategic Plan Element (SPE) 4.58B:  
Evaluate Early-Age and Premature Cracking for Pavem and LCCA (whitetopping);  
Project Task 2878: Thin Whitetopping

| 1. REPORT NUMBER<br>UCPRC-SR-2018-01 | 2. GOVERNMENT ASSOCIATION NUMBER | 3. RECIPIENT'S CATALOG NUMBER |

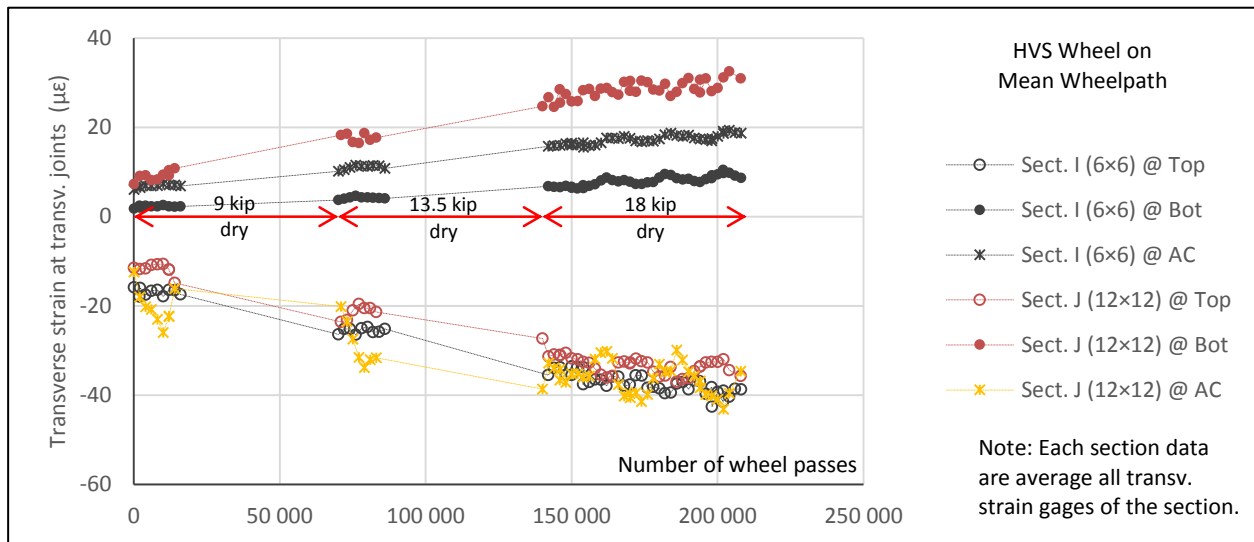
**Influence of Slab Size on Tensile Strains.** The compressive strains measured in the asphalt in Section J indicated that the concrete and asphalt layers were working independently of each other. The result was that there was no composite structure but instead a concrete overlay resting on top of—but not bonded to—an asphalt layer. The lack of concrete-asphalt composite action together with the low transverse joint LTE were the reasons why the strain at the bottom of the slabs was much larger in Section J than in its 6×6 counterpart, Section I. At the same time, the low LTE was attributed to 1) the wider transverse joint width in Section J than in Section I (due to the larger transverse joint spacing), and 2) the lack of asphalt base contribution to LTE (because the concrete and asphalt layers were not bonded at the transverse joints).

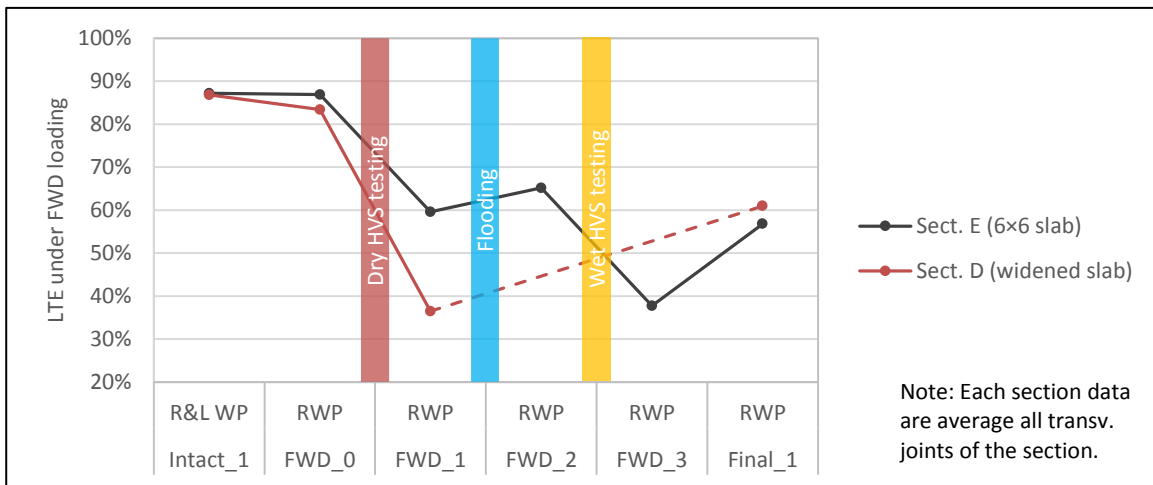
**Influence of Widened Slab on Load Transfer Efficiency.** Although the 8×8 slabs of Section D were effective in reducing the strain that develops at the shoulder edge of the slabs under traffic loading, they also resulted in worse transverse joint LTE performance than the 6×6 Section E. The poor LTE performance of Section D was attributed to its longer transverse joint spacing, compared to that of the 6×6 sections. Fortunately, the slabs can be widened while maintaining the same transverse joint spacing using 6×8 slabs (length×width). That slab size is expected to provide the benefit of reduced strain at the shoulder edge without compromising LTE.

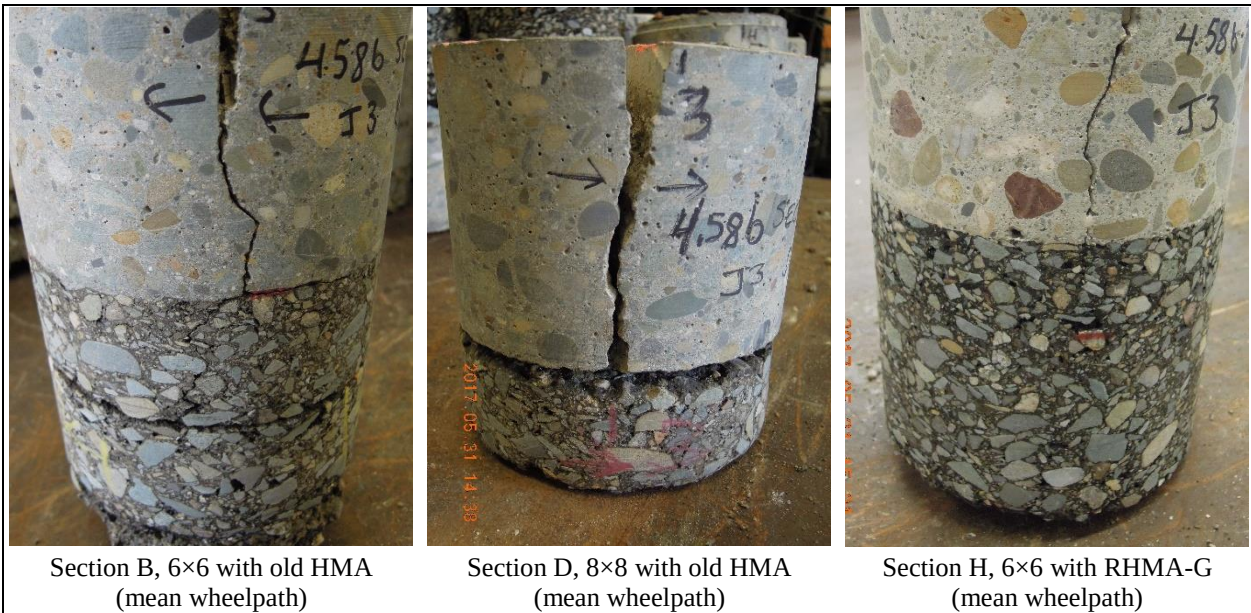
***Propagation of Transverse Joints through the Asphalt Base.*** All the transverse joints of the 6×6 HVS sections propagated into the old HMA base while none of them propagated into the new RHMA-G. In Section D, with 8×8 slabs, debonding between the concrete and the asphalt took place at the transverse joints. It is very likely that the debonding prevented the transverse joints from propagating into the old HMA base during the HVS testing.

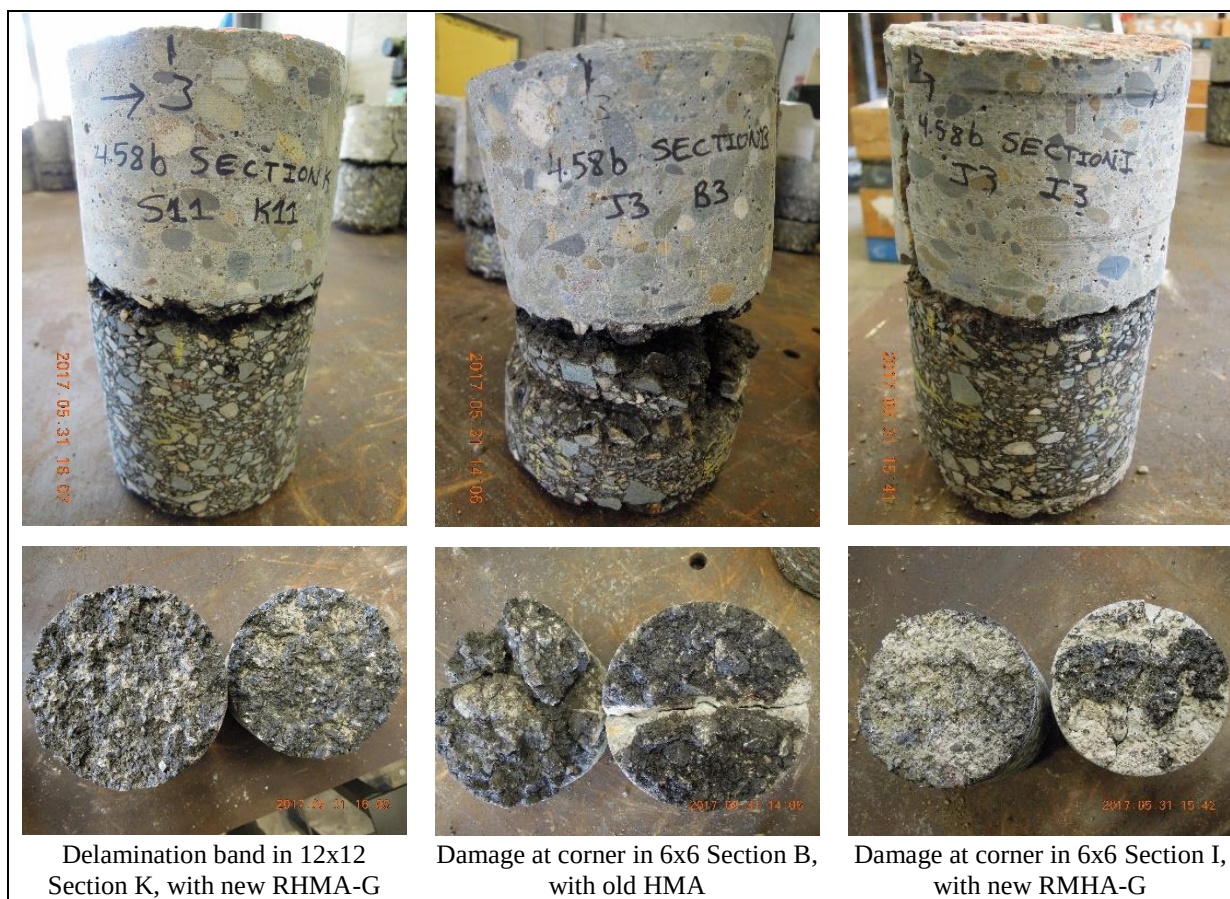
**Ambient Environment-Related Damage to Asphalt and Concrete-Asphalt Interface.** Neither the delamination band in the 12×12 sections nor the damage at the corners in the 6×6 sections were related to the HVS loading, but to the hygrothermal deformations of the slabs. The delamination band was believed to be the main reason for the poor HVS performance of the 12×12 sections. On the other hand, the damage at the corners did not have a considerable impact on the HVS performance of the 6×6 sections because of the small extent of the damage. Nonetheless, the long-term evolution of that damage remains known.

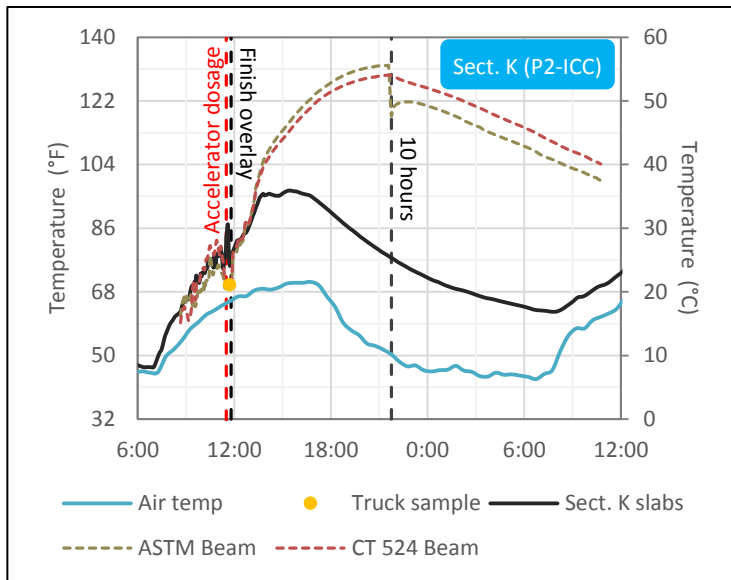
**Comparison of Temperature in Slabs and Flexural Beams per CT 524 and ASTM C78-10.** Temperature in the beams (ASTM C78-10 and CT 524) matched the temperature in the slabs for a very short period of time after concrete placement. After that short period, the temperature in the slabs was much lower than in the beams, an outcome related to the high ratio of exposed surface versus volume of the thin BCOA slabs.
