**Diagnostic Structural Health Assessment Through Layered  
Integration of Non-destructive Imaging Data**

A dissertation submitted in partial satisfaction of the  
requirements for the degree  
Doctor of Philosophy

Structural Engineering

Michael Robert Hess

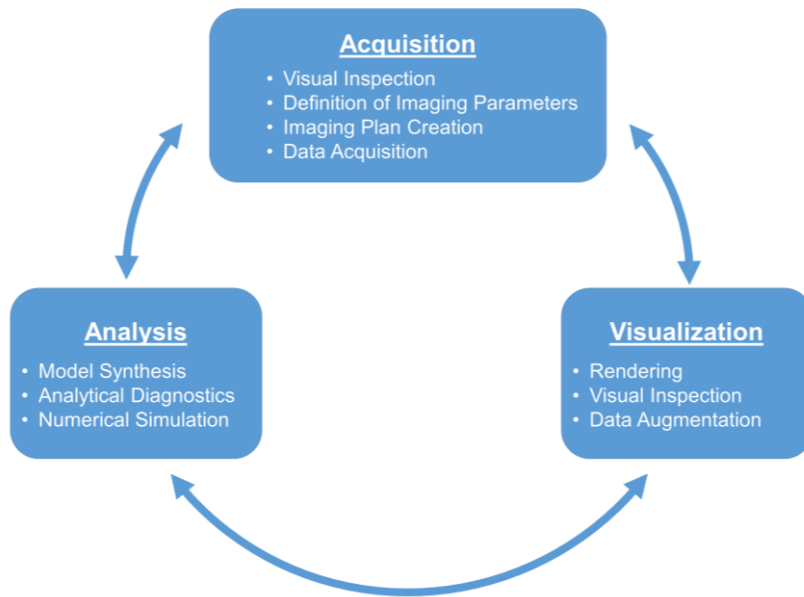
**Figure 1.1 Integrative diagnostics methodology for acquisition, visualization and analysis of non-destructive imaging data (Hess, Petrovic, Yeager, & Kuester, 2017).**

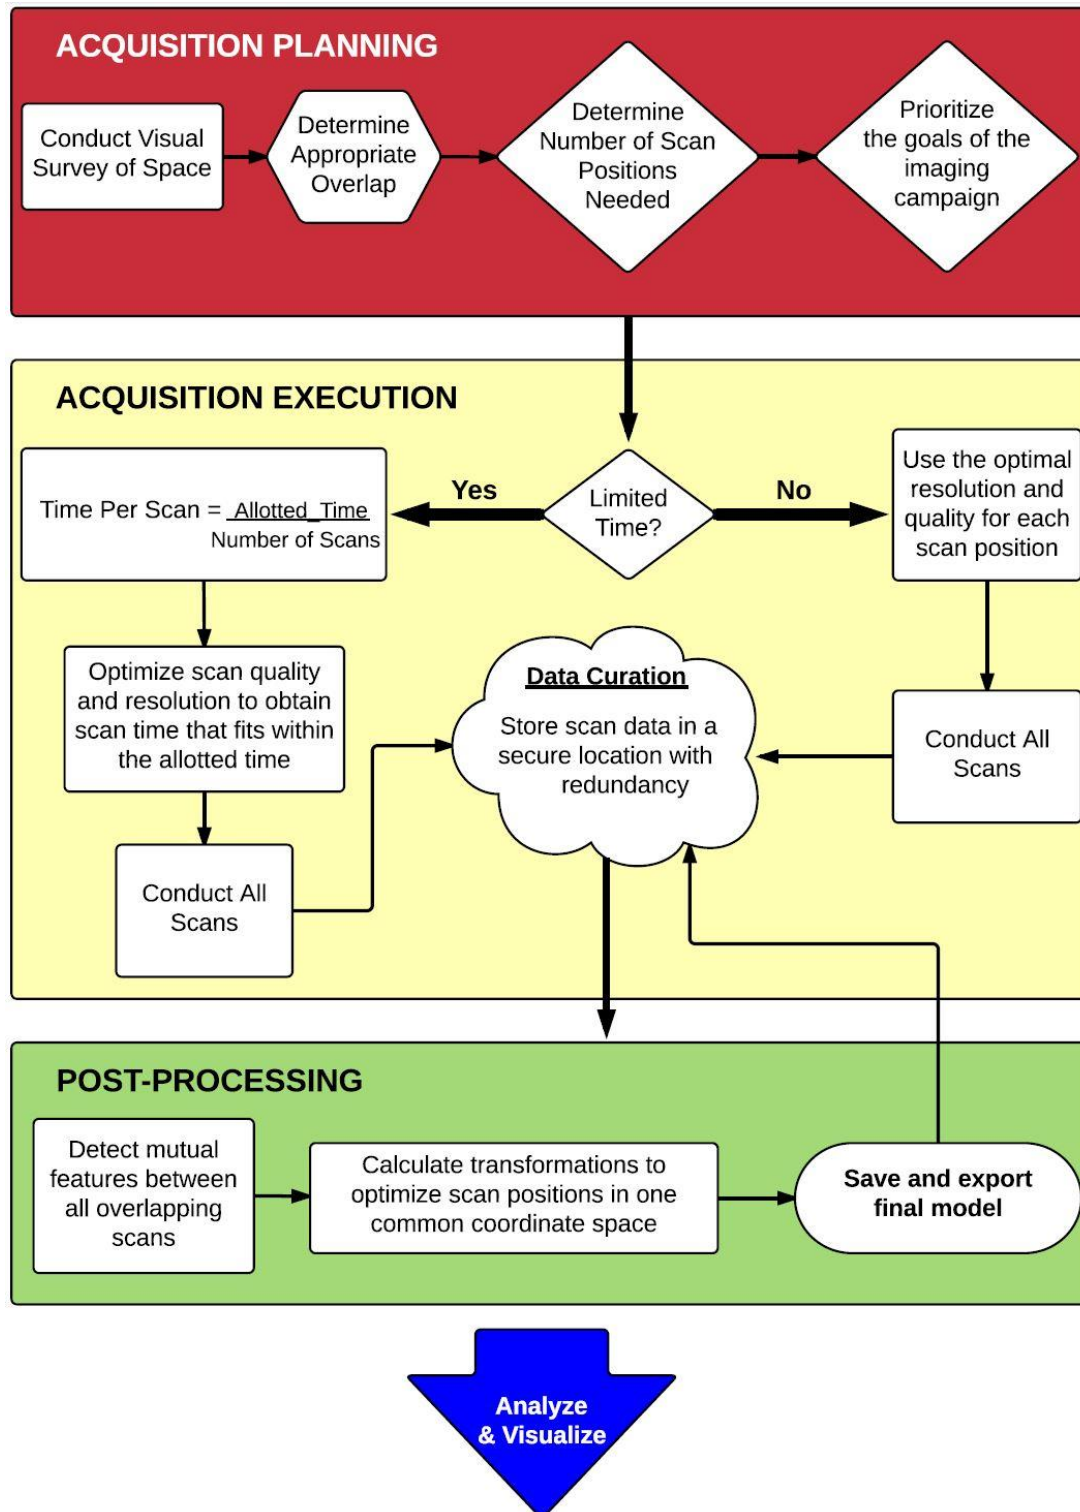
Figure 3.3 Proposed methodology for the acquisition of TLS data.

This section details the acquisition workflow (outlined in Figure 3.3) for comprehensive TLS documentation of a structure. The most difficult challenges with the data acquisition at the Baptistery was access to the building and the total amount of time on-site allotted to the study. Preliminary walkthroughs of the exterior as well as the publicly accessible portion of the Baptistery were conducted in order to formulate imaging plans for the spaces. The primary decision to be made was how many scans were required to acquire data from the proper viewpoints on all visible surfaces. In order to make this decision, any occlusions, physical constraints, range and sufficient overlap needed to be taken into account in a systematic scanning plan. The presence of line-of-sight occlusions, where one surface prevents data collection on another surface beyond it, necessitate additional scans from alternate angles in order to realize a comprehensive model of the space. Furthermore, the scans cannot simply capture each surface exclusively, but must also have sufficient overlap with adjacent scans to enable accurate alignment of the scans during data post-processing. Often, physical 2D and 3D targets, such as checkerboard placards and spheres, are placed in the target space to aid in co-locating overlapping datasets, but the targets must ideally remain stationary for the entirety of the scanning survey. Due to the abundance of surface details present on the stone surfaces and mosaics and without the ability to leave physical targets in the space between access windows, it was decided that physical targets were not needed to register the scans to each other.

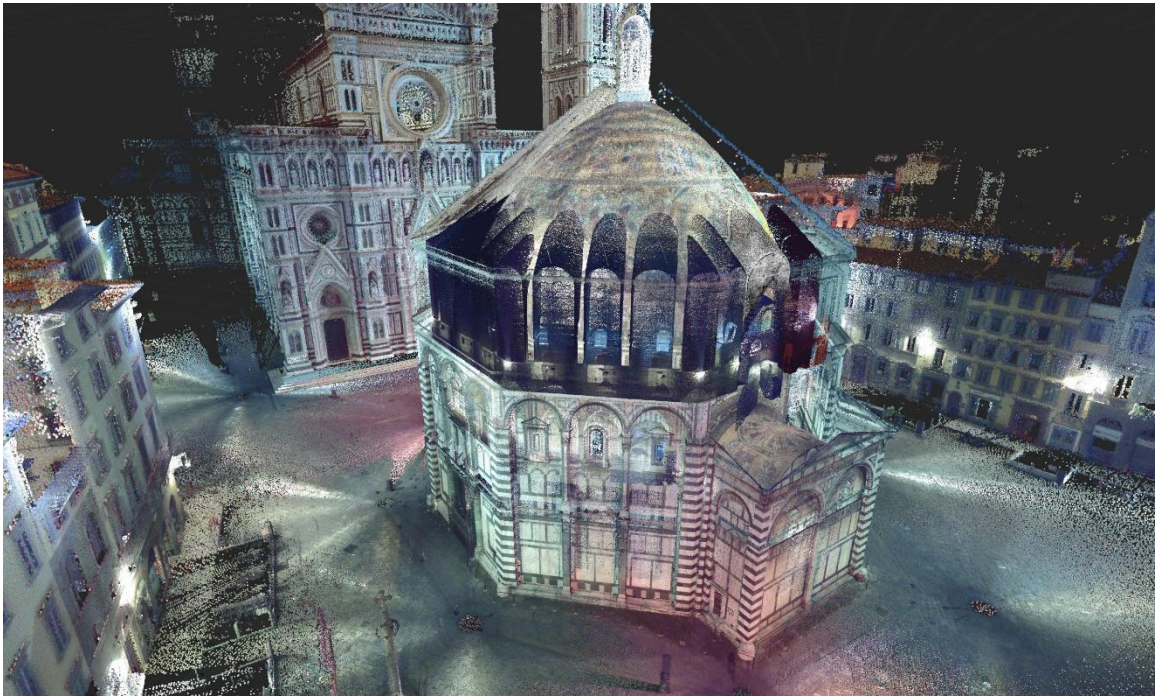
**Figure 3.5 TLS data set for the Baptistery di San Giovanni showing the surrounding structures as well as the internal dual shell construction.**

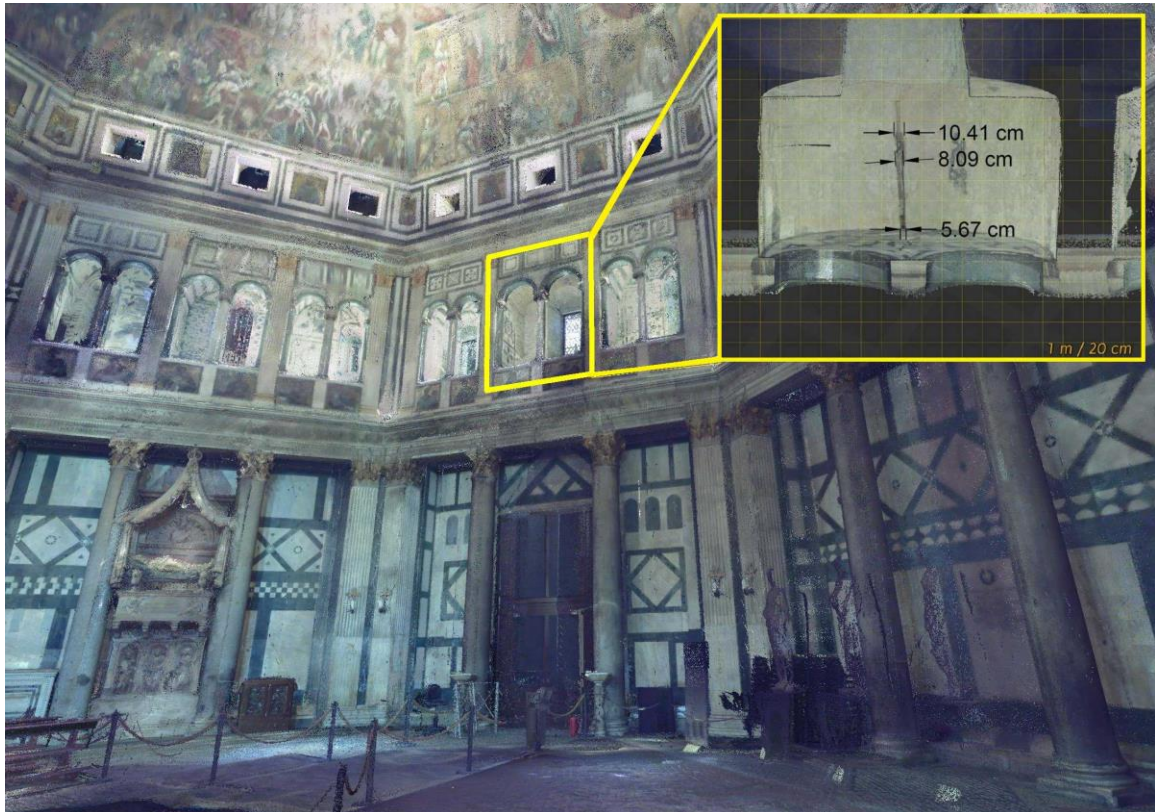
**Figure 3.11 Scanning data highlighting the dimensions of a crack above the North door.**

through a floor slab and through the archway shown. These precise measurements are important to document the existing damages in the structure. Now that this digital documentation record exists, these cracks can be monitored over time by completing subsequent laser scanning surveys of the balcony.

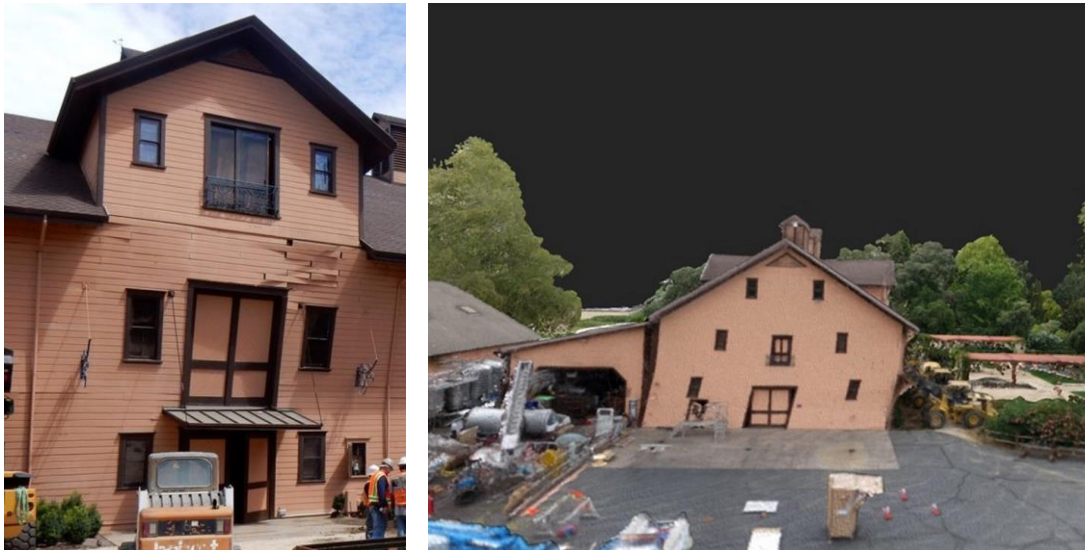
**Figure 3.16 Photograph (left) and SfM point cloud (right) of the damaged vineyard structure.**

The latter is of interest here because the photogrammetry results provide geometric snapshots in time for areas that are rapidly changing as responders work to clean, demolish and rebuild after a disaster. One example from the South Napa Valley earthquake in 2014, shown in Figure 3.16 depicts a historical family vineyard that was damaged (Wittich, Hutchinson, Lo, Meyer, & Kuester, 2014). This is an excellent example of acquiring perishable data; due to large non-structural stainless-steel tanks that had fallen and were now leaning on the interior wall, the building was deforming more and more every day. Captured in the point cloud of the damaged building are the construction loader vehicles that were used to reinforce the right side of the structure which was deforming at a rapid pace.

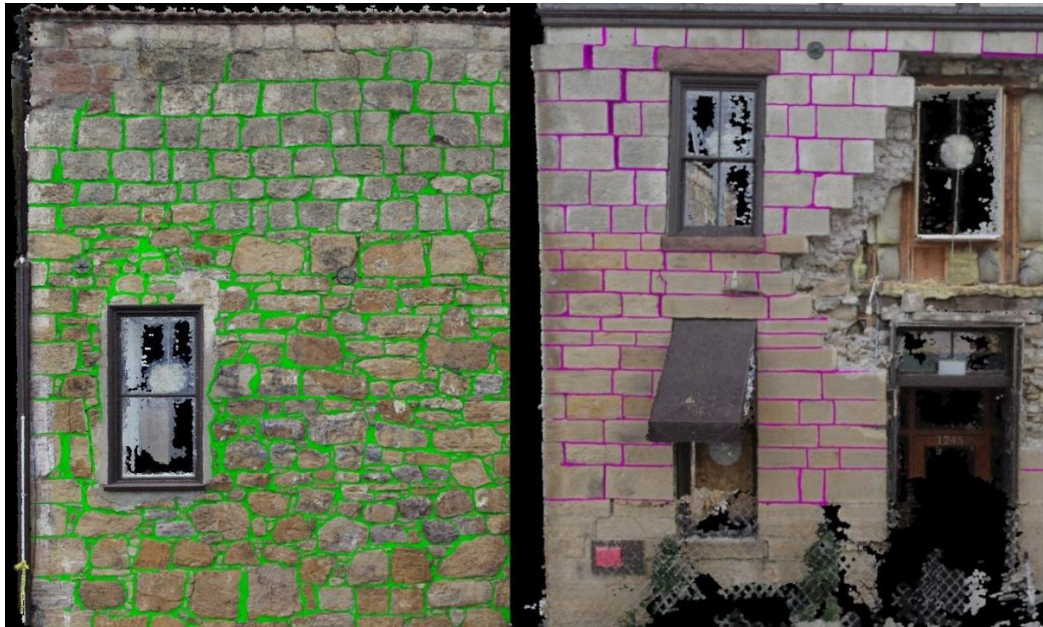
**Figure 3.20 Manual ground truth annotation of mortar joints.**

the mortar in the upper portion of the side wall is also reasonably well defined, but the colors of the stone and mortar are very similar. As for the front of the building, the construction is very regular with small mortar joints that are similar in color and do not have a very pronounced geometric pattern. Even though this ground truth creation required two and a half hours, the interactive manipulation of the point cloud made it extremely easy to select neighborhoods of points corresponding to mortar. The resulting annotation is an extremely accurate classification of the existing mortar pattern and 3D geometry. Although this initial process was completely manual, when compared to traditional drafting techniques, the time spent was not significant and the accuracy achieved is much greater.

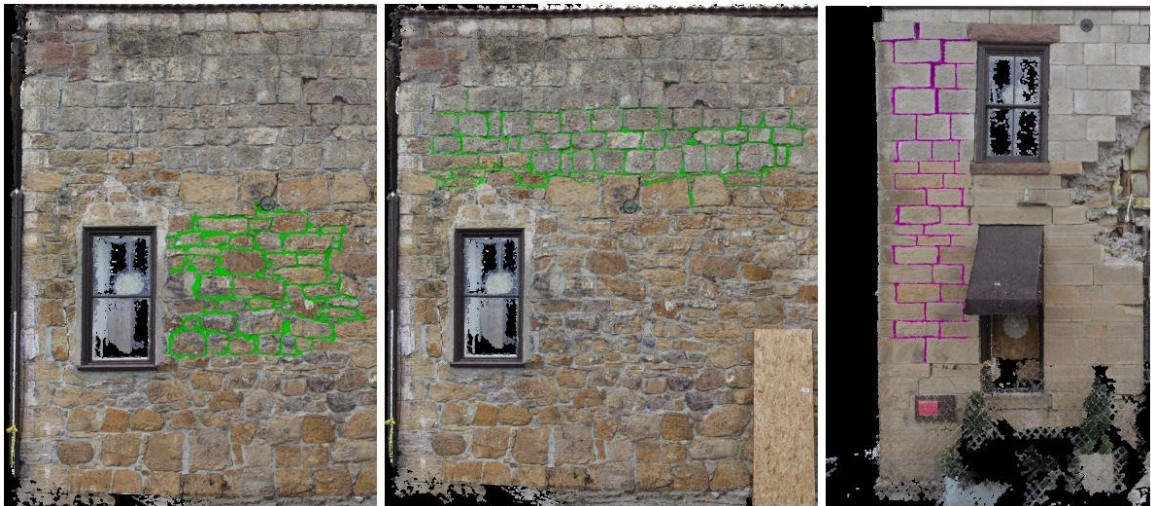
**Figure 3.21 Semi-automated annotation of mortar joints.**

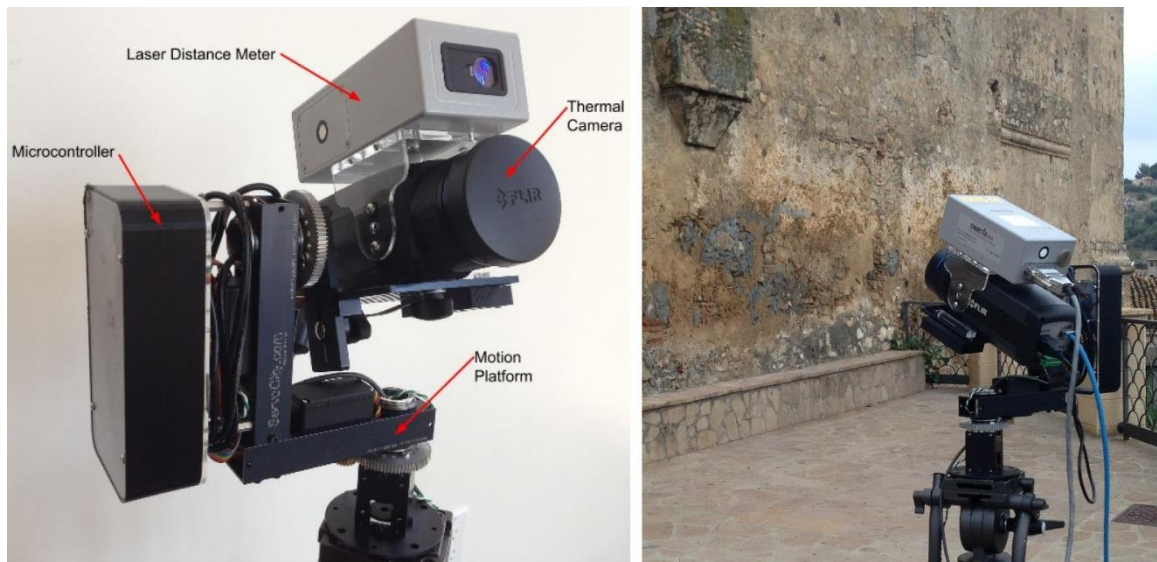
**Figure 4.2 Annotated APT instrument (left) and the APT instrument deployed in the field (right).**

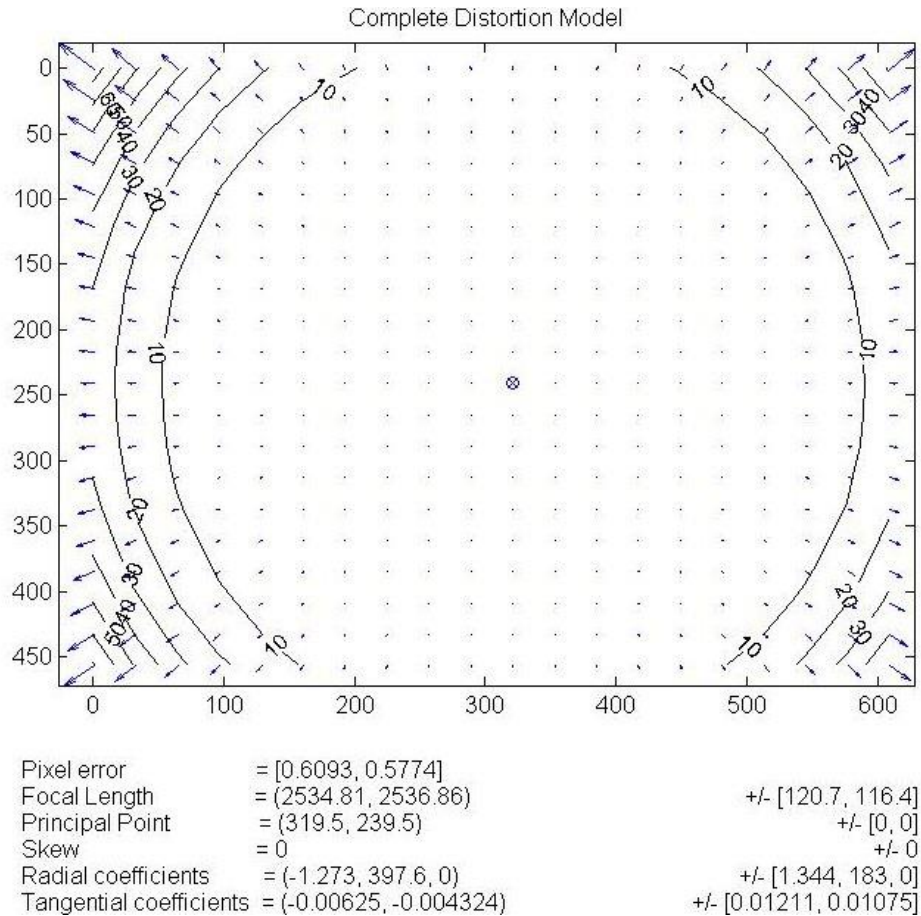
**Figure 4.4 Complete distortion model calculated in MATLAB (Bouquet, 2004).**

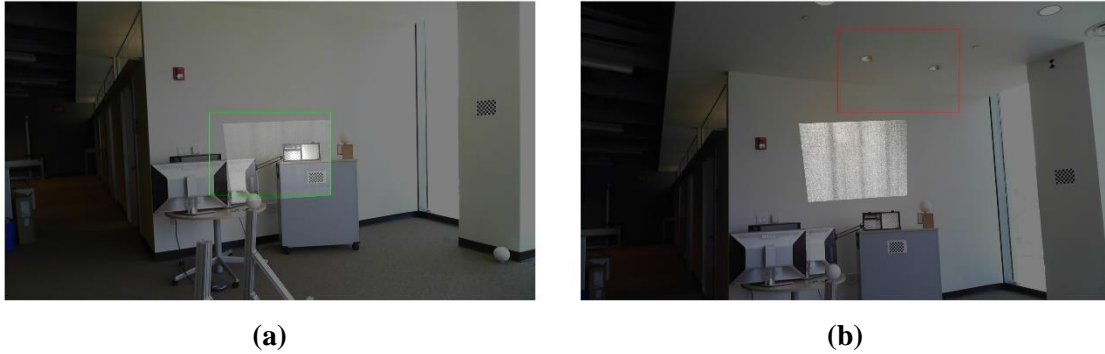
**Figure 5.6 Multimodal registration attempts using mutual information (a) Success with features and (b) Failure with no common features.**

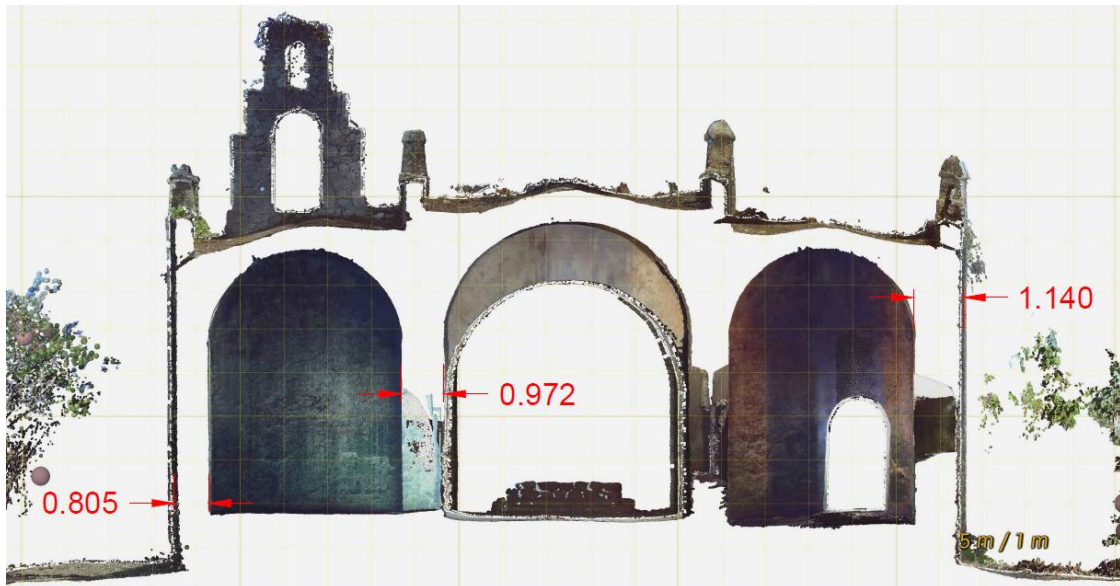
**Figure 6.3 Section cut of the church data: Example dimensions are shown to illustrate the precision and utility of TLS.**

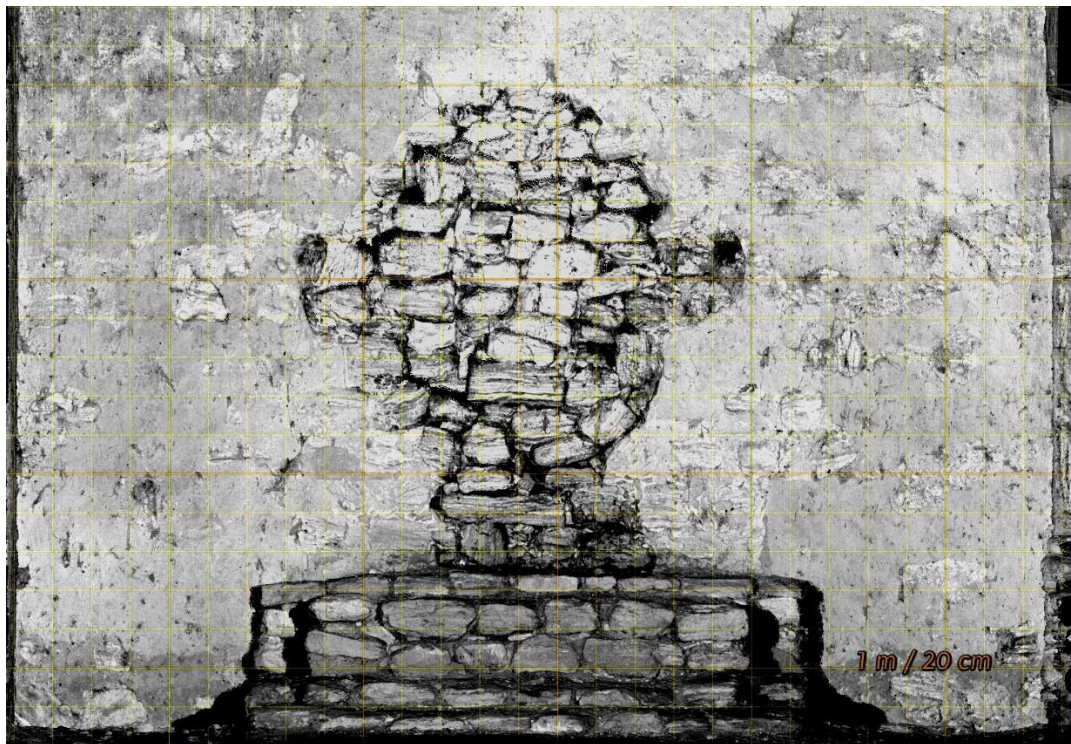
**Figure 6.4** Orthogonal image from the grayscale laser scanning point cloud outlining the vandalism of the church's altar.

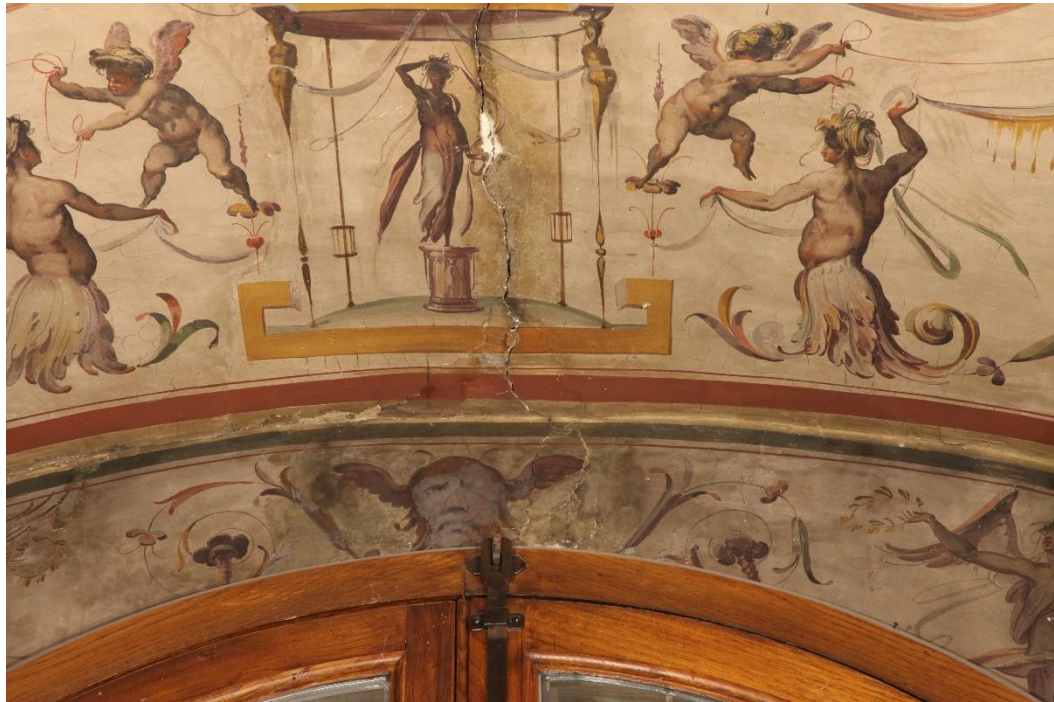
**Figure 7.1 Image showing an example of the observed cracking in the Room of the Elements.**

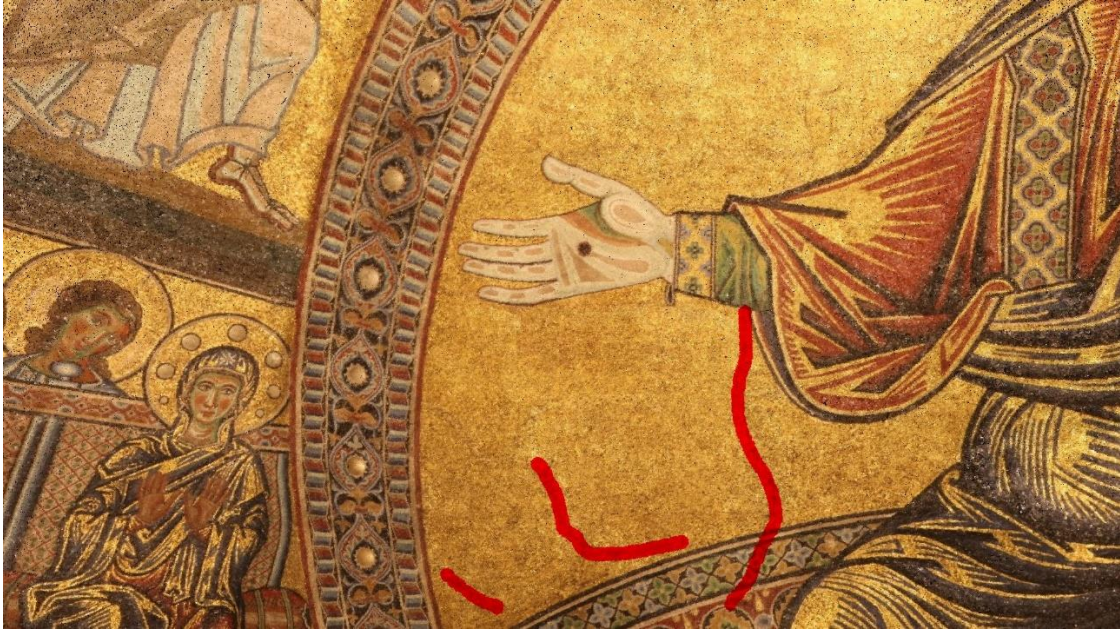
**Figure 7.9** High-resolution SfM point cloud used to map the cracks in the dome through interactive annotation which highlights the cracked areas in red.

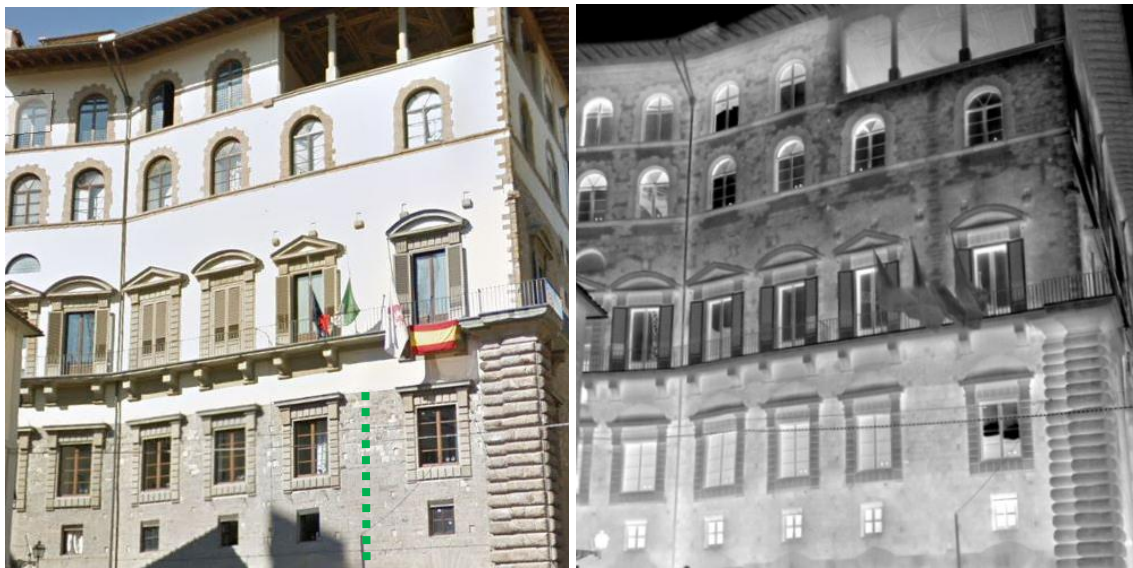
Figure 7.13 Visible and thermal layers of the South wall revealing construction details below the plaster on higher floors.

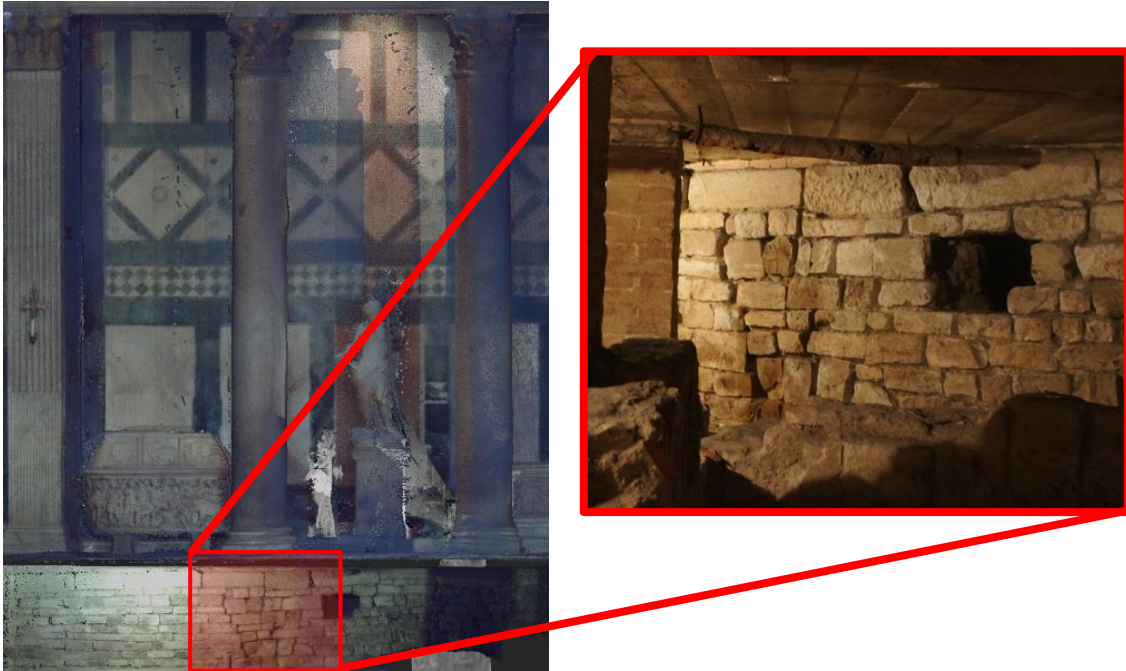
**Figure 7.14** View of the foundation wall in its context with the information model (left) and an image from the excavated area showing a view of the cracked wall.

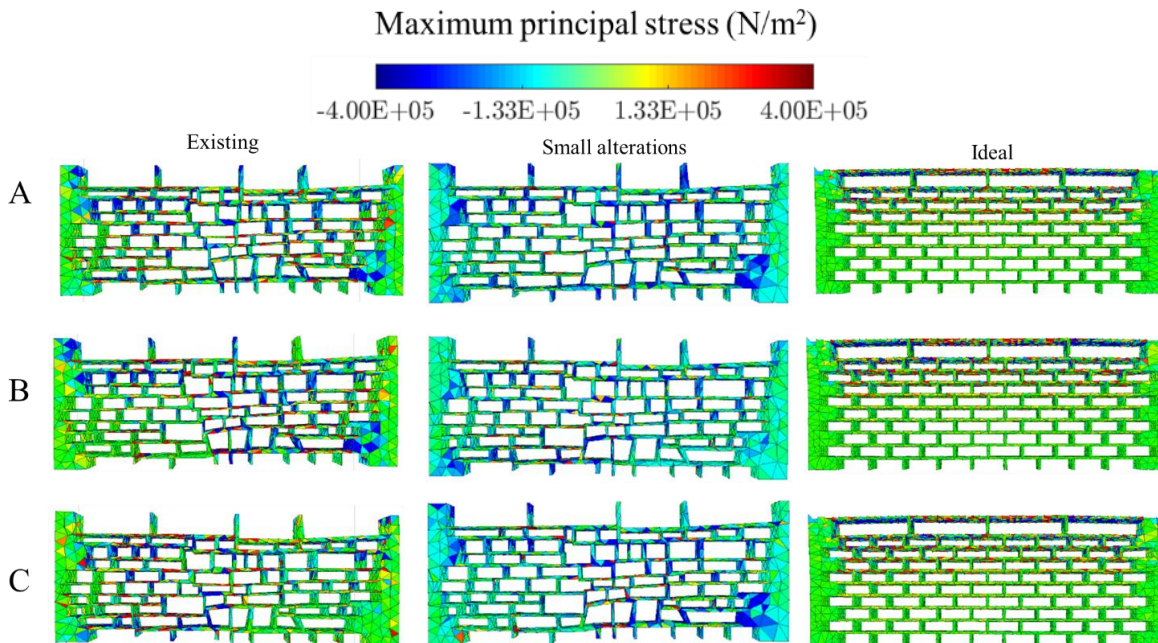
**Figure 7.18** Simulated maximum principal stress for the each of the geometries and each of loading scenario A) No settlement, B) Left settled 0.05 meters, C) Right settled 0.05 meters.

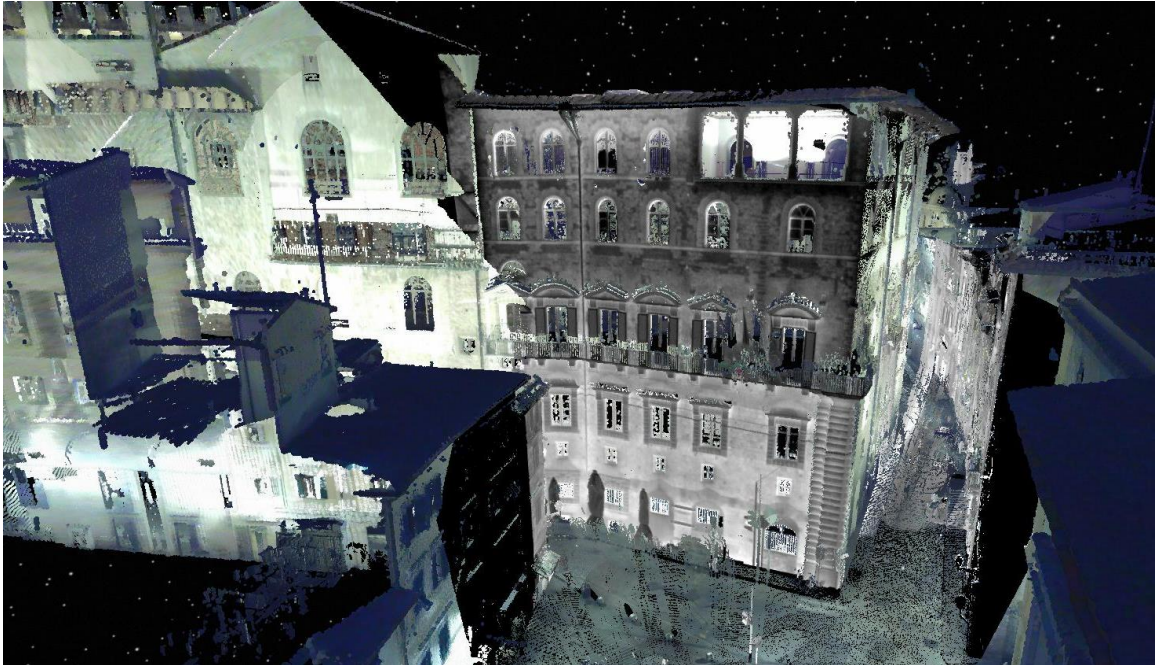
**Figure A.4 Thermal image projected onto the geometry of Palazzo Vecchio to enable inspection and measurement.**
