Vacuum compatibility of 3D-printed materials

Journal of Vacuum Science & Technology A Vacuum Surfaces and Films, 32(3)

Vacuum Compatibility of 3D-Printed Materials

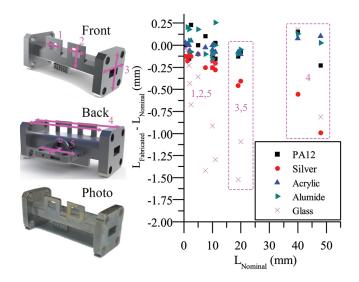
FIG. 1. (Color online) CAD renditions ($top\ left)$ of a modified waveguide used as an sample 3D printed part compared a photograph ($bottom\ left)$ of the actual waveguide printed in sterling silver. The lengths of particular features of this waveguide, highlighted in the CAD renders, are compared to printed versions of waveguide in different materials. The difference of the measured length of each waveguide to the nominal length in the CAD submission is shown for these features in the graph. (right) The waveguide has dimensions $48\text{mm}\times20\text{mm}\times19\text{mm}$. Measurements were made to 0.01mm accuracy and precision.

waveguides. Glass was found to be unsuitable for fine detail, as it warped significantly such that surfaces designed to be flat became noticeably concave (> 0.5mm deflection), even with sufficient support during printing. Common failure modes in others materials included minor distortions in thickness or breaks, especially in a thin tab (0.65mm) designed to test fabrication of small features. At the present, fractures and poor resolution in thin features is a known issue with printing fine-detailed objects fabricated by a laser sintering process.⁵ The thin acrylic tab broke off at the base during shipping and the silver tab, while solidly attached, had a small fracture running through the material. The adjacent, thicker tab (1.29mm) did not have these defects in either the silver or acrylic. The printed silver and acrylic were found to have excellent machinability, so some small features may

The accuracy and precision of printed part dimensions was measured by comparing the lengths of features on the waveguide to the nominal specifications in the CAD model. The difference between the nominal and measured lengths are compared in Fig. 1. Note that the silver part was found to be scaled down by $\sim 1.6\%$ relative to the CAD model; this was confirmed by the printing service to be a miscalibration of the scaling in the printer. In order to compensate for this, we measured accuracy as the variance from the residual sum of squares assuming a linear offset. The accuracy was found to be $\pm 0.072 \mathrm{mm}$ and $\pm 0.138 \mathrm{mm}$ for silver and polyamide respectively.

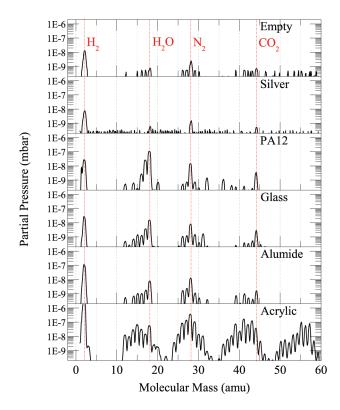
FIG. 2. Residual gas analysis of materials in a vacuum system 24 hours after cleaning and bakeout processes. The top curve is the residual gas of an empty chamber.

The residual gas analysis was performed using a SRS RGA100 mass spectrometer 24 hours after the bakeout was completed. The spectrometer filament was placed out of line of sight of the test piece to avoid excess heating; results are shown in Fig. 2. The silver piece had outgassing rates below $1 \times 10^{-10} \text{mbar L/cm}^2$ s, the detection limit of our analyzer. The polyamide and alumide had outgassing rates of $\sim 3 \times 10^{-8} - 4 \times 10^{-7} \text{mbar L/cm}^2 \text{s fol}$ lowing baking, comparable to teflon and viton materials.⁸ The residual gases present were atmospheric, suggesting that air was trapped in the material. Alumide, although part polyamide, appears to have adsorpted less water from the cleaning process. To avoid sublimation of polyamide material itself, the polyamide based materials must be baked at a low temperature (65°C). When attempts were made to bake at 100°C, the vacuum became very poor ($\sim 10^{-6}$ mbar) and a residue was found on the vacuum chamber walls near the piece. Glass had outgassing performance comparable with the polyamide materials, but could be baked at higher temperatures.

Acrylic was not able to be pumped to ultrahigh vacuum pressure levels. The mass spectrum for acrylic appears to have a hydrocarbon chain contamination, shown as the 13amu repeating feature in the mass spectrum, leading to the conclusion the acrylic material was sublimating into vacuum, even at low $(55^{\circ}\mathrm{C})$ baking temperatures.
