RESEARCH ON THE MECHANISM OF THERMAL FATIGUE IN NEAR-EUTECTIC PB-SN , SOLDERS

Presented at the Department of Navy 13th Annual
Electronics Manufacturing Seminar, China Lake, CA,
March 2, 1989, and to be published in the Proceedings

LBL-26565
e.2

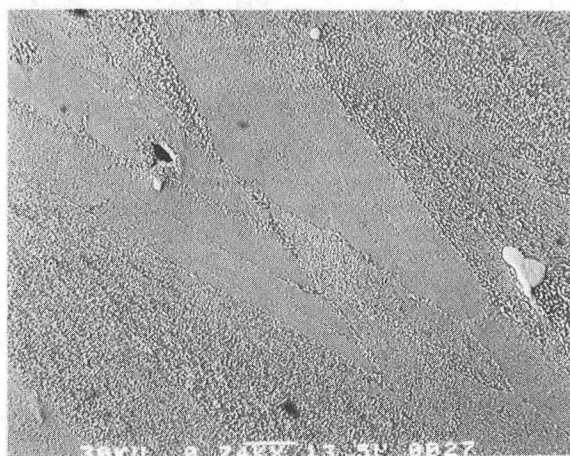
As the solder is made to solidify at increasingly high cooling rates the microstructure of the solder changes in that the Pb-rich regions of eutectic become more rod-like and closely spaced and the colony size becomes smaller, as shown in Figure 11. At very high cooling rates the Pb-rich phase may appear in the form of small, equiaxed particles.
