Concrete Pavement Tire Noise: Third-Year Results

Authors:
A. Rezaei and J. Harvey

Version 1
Work Conducted as Part of Partnered Pavement Research Center Strategic Plan Element No. 4.29:
Quiet Concrete Pavement Research

University of California
Pavement Research Center
Davis and Berkeley

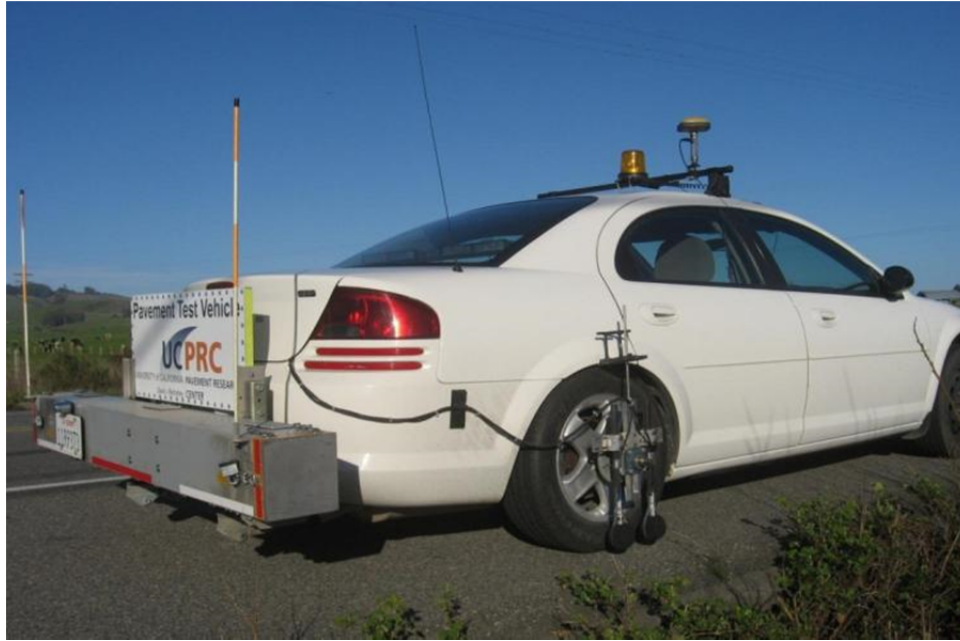
Figure 2.1: Instrumented vehicle with on-board sound intensity probes and an inertial profilometer.

In addition to the use of the OBSI method to measure tire/pavement noise, an inertial profilometer was used to measure International Roughness Index (IRI) and Mean Profile Depth (MPD), and visual observations were made of the surface texture type and condition of each test section. The measured IRI values and texture observations were collected at the same fixed short intervals used for OBSI measurement. The instrumented vehicle used in this project is shown in Figure 2.1.

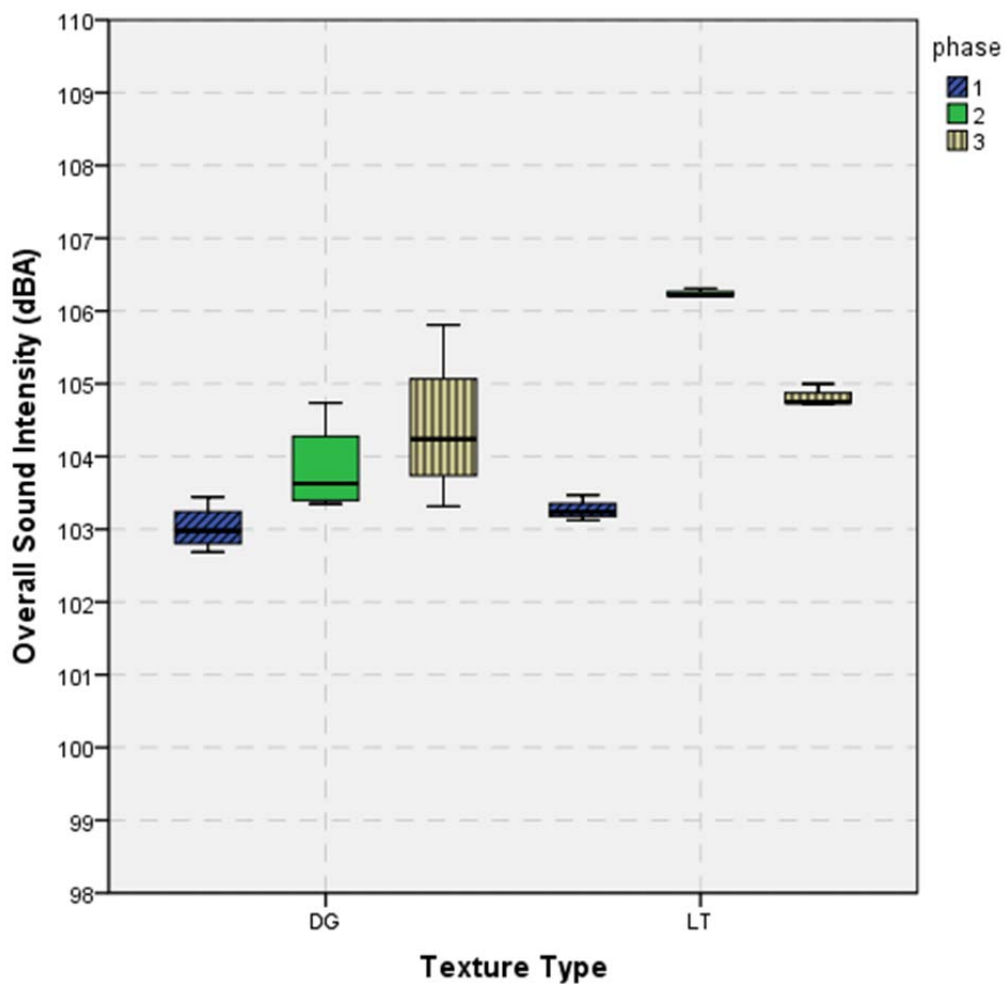
Figure 3.18: Box plots of OBSI results by texture type, all measurements from Years 1, 2, and 3, with *new* condition. (Notes: DG = diamond ground, LT = longitudinally tined.)

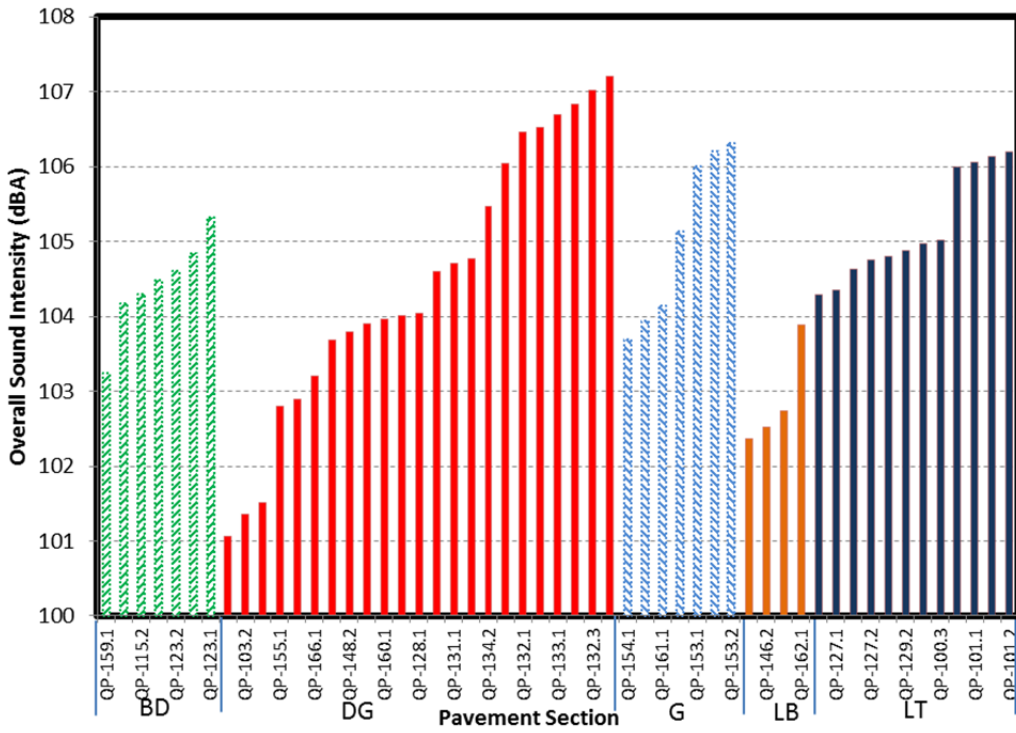
Figure 3.20: Averaged Year 1, 2, and 3 results for the *aged* texture condition for all texture types. (Note: BD = burlap drag, DG = diamond ground, Gr = diamond grooved, LB = longitudinally broomed, LT = longitudinally tined.)

Based on the results shown in Table 3.4 and Figure 3.20 and Figure 3.21, which contain averaged data from all three years and consider the mean OBSI results for all sections that have the same nominal surface type with *new* and *aged* texture conditions, the quietest texture type was found to be the longitudinally broomed (LB).

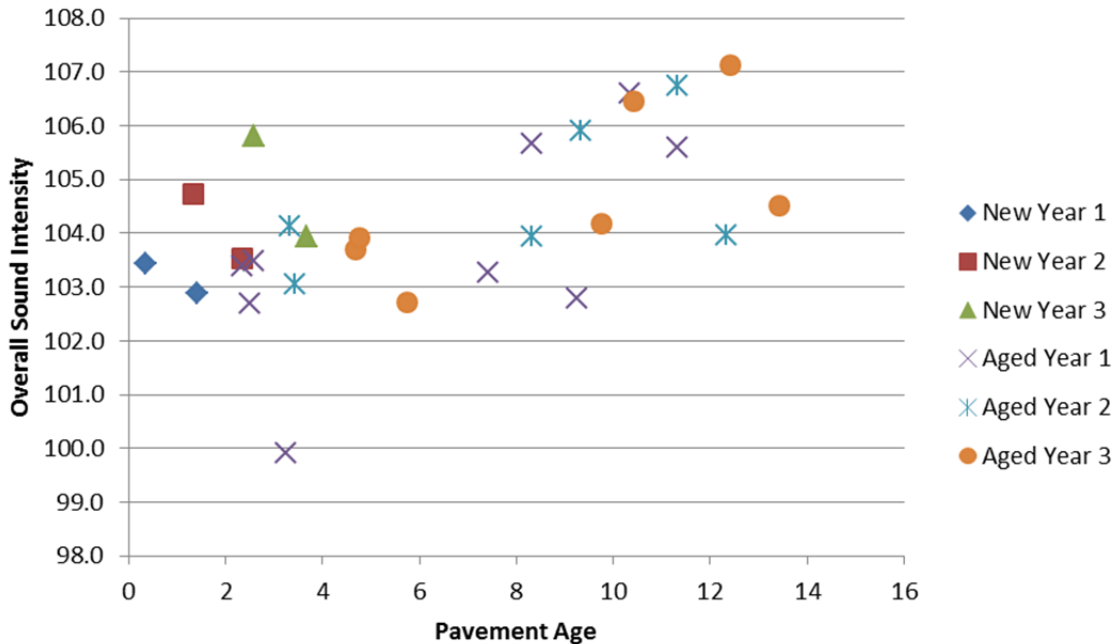
Figure 3.27: Diamond-ground Year 1, 2 and 3 OBSI results for *new* and *aged* texture sections (no worn out condition sections measured) versus years since last surfacing.

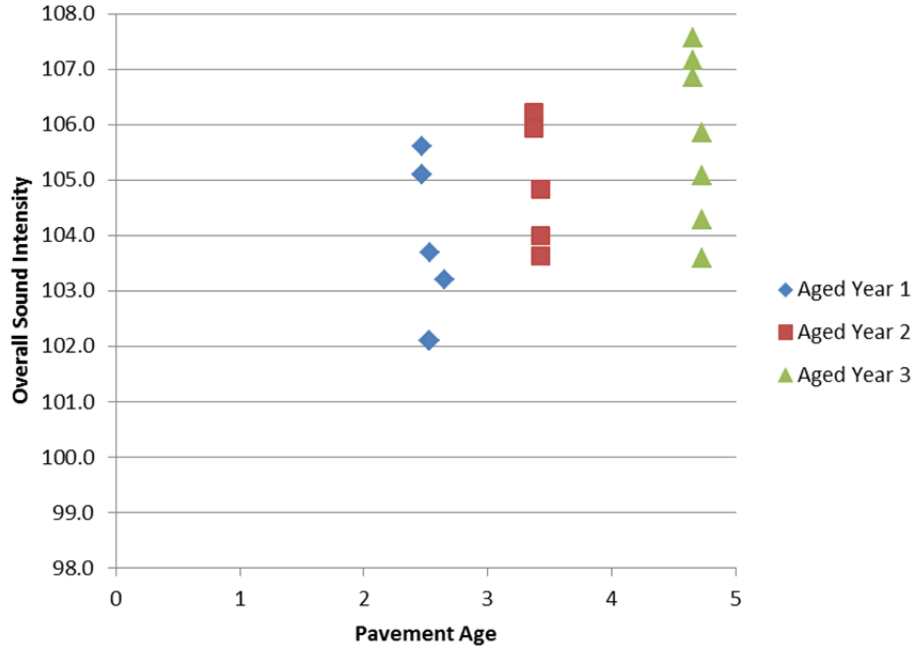
Figure 3.30: Diamond-grooved Year 1, 2, and 3 OBSI results for *aged* texture sections (no *new* or *worn out* condition sections measured) versus years since last surfacing.
 (Note: the number of data points shown for each year in the figure varies because some subsections had identical values in some years.)

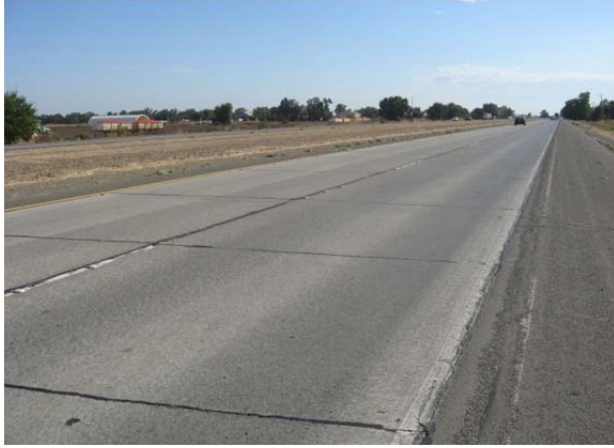
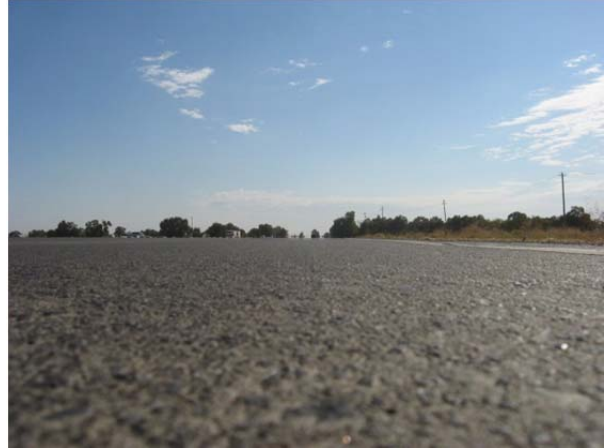
(a) QP-102.3 (102.3 dBA)

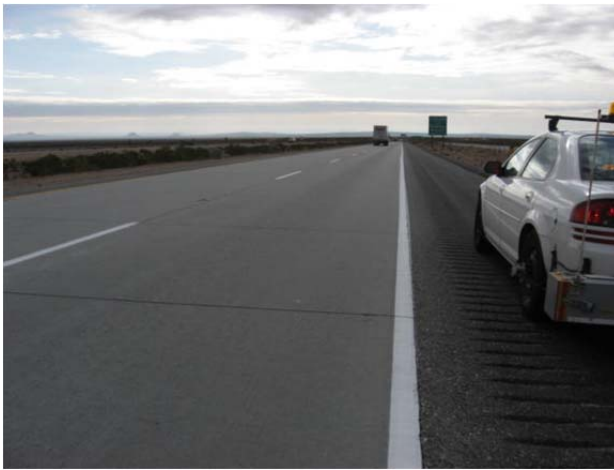
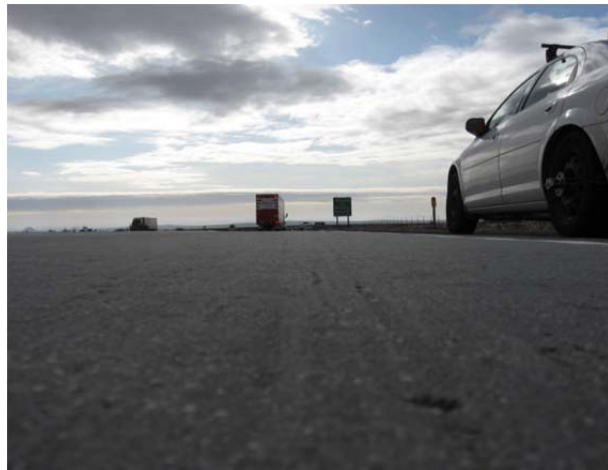
(b) Mojave burlap drag section (QP-159, 102.7 dBA)

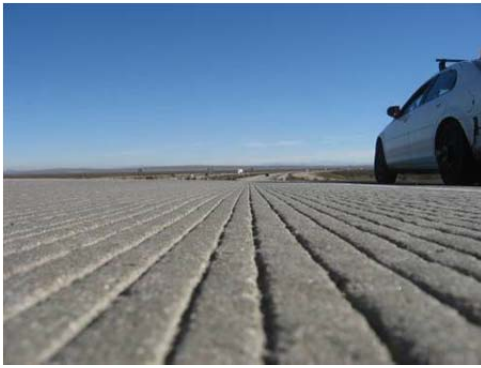
QP-158.1 (105.0 dBA)

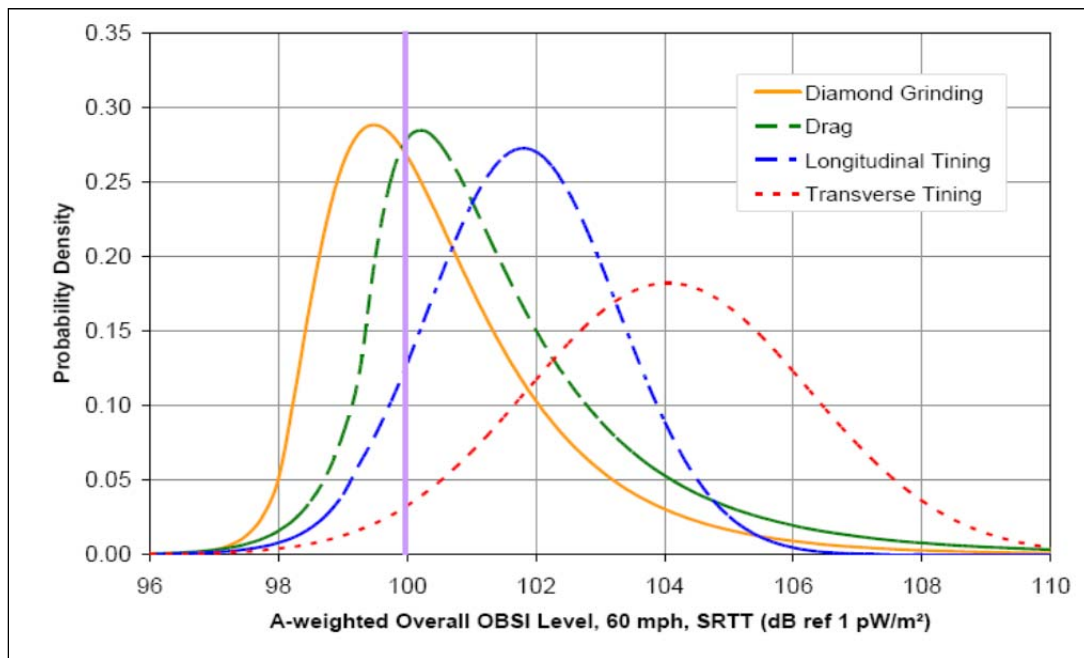
Figure 4.8: Probability distributions of OBSI noise levels for concrete pavement textures as reported by the National Concrete Pavement Technology Center (9).

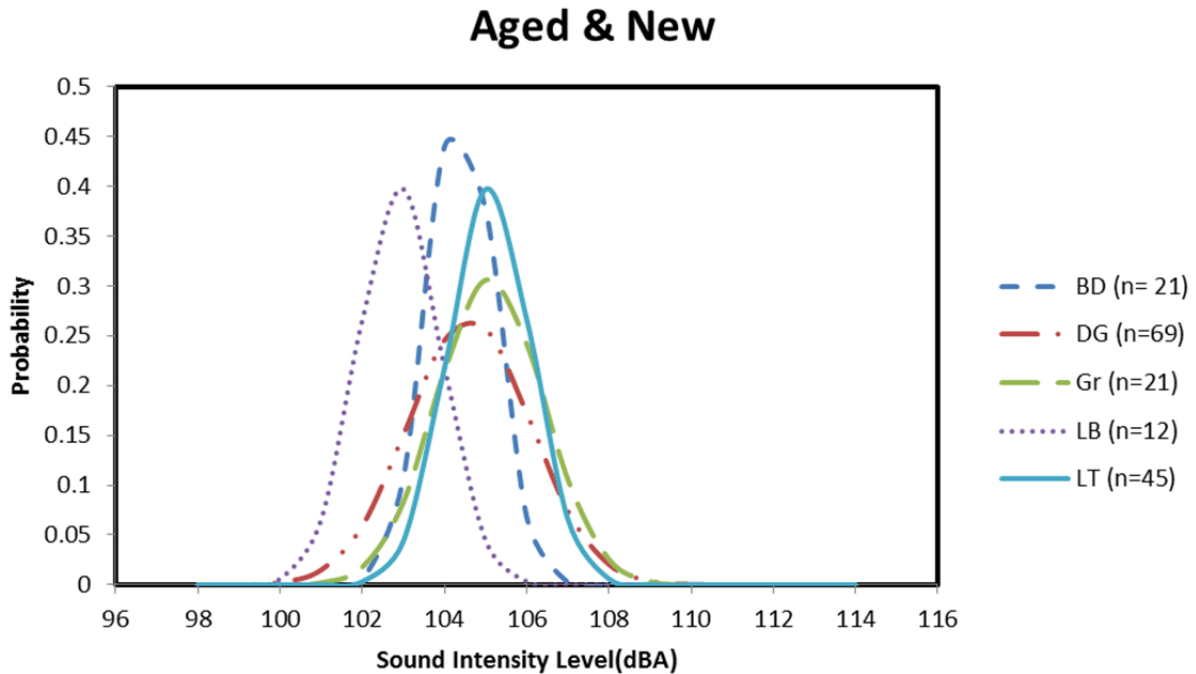
Figure 4.9: Distributions of OBSI noise levels in this study for all sections with *new* and *aged* textures.
 (Note: BD = burlap drag, DG = diamond ground, Gr = diamond grooved, LB = longitudinally broomed, LT = longitudinally tined.)

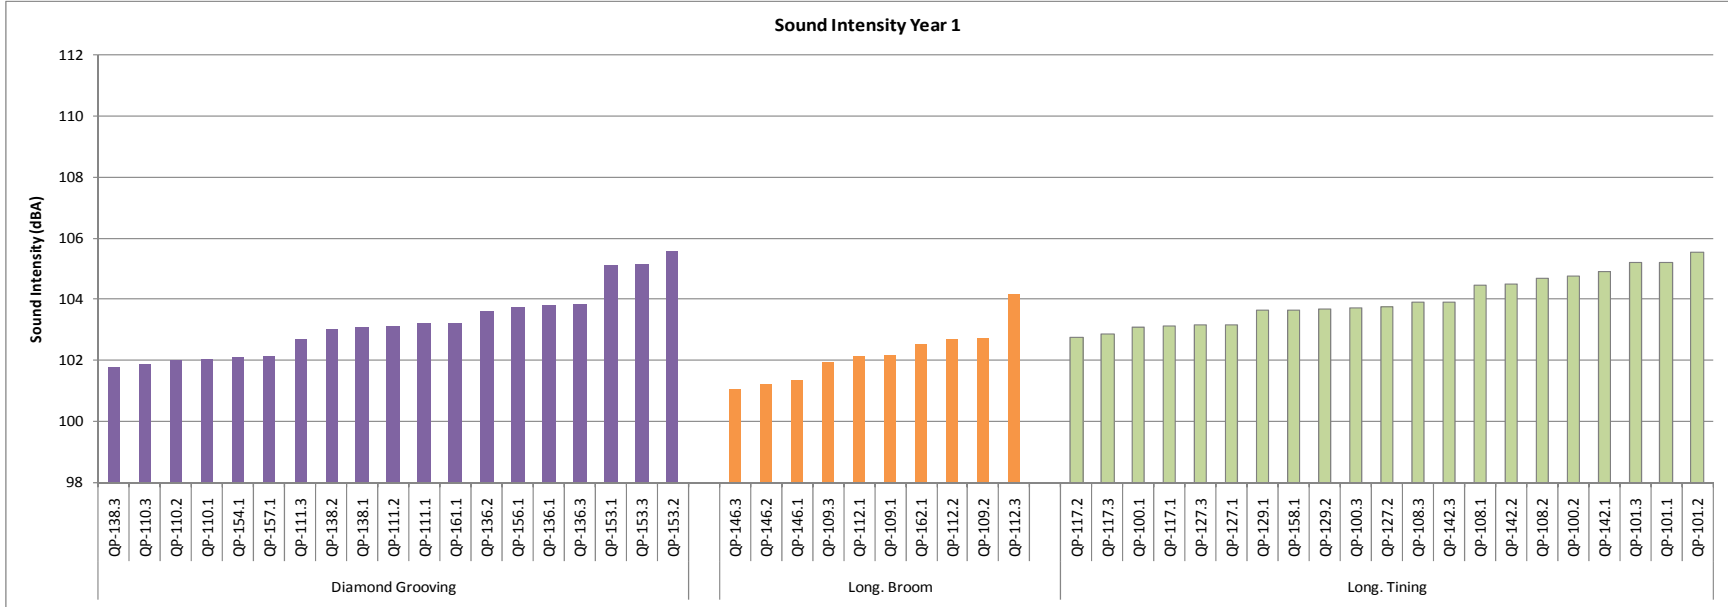
Figure A.1: On-board Sound Intensity levels of all sections as measured in Year 1.

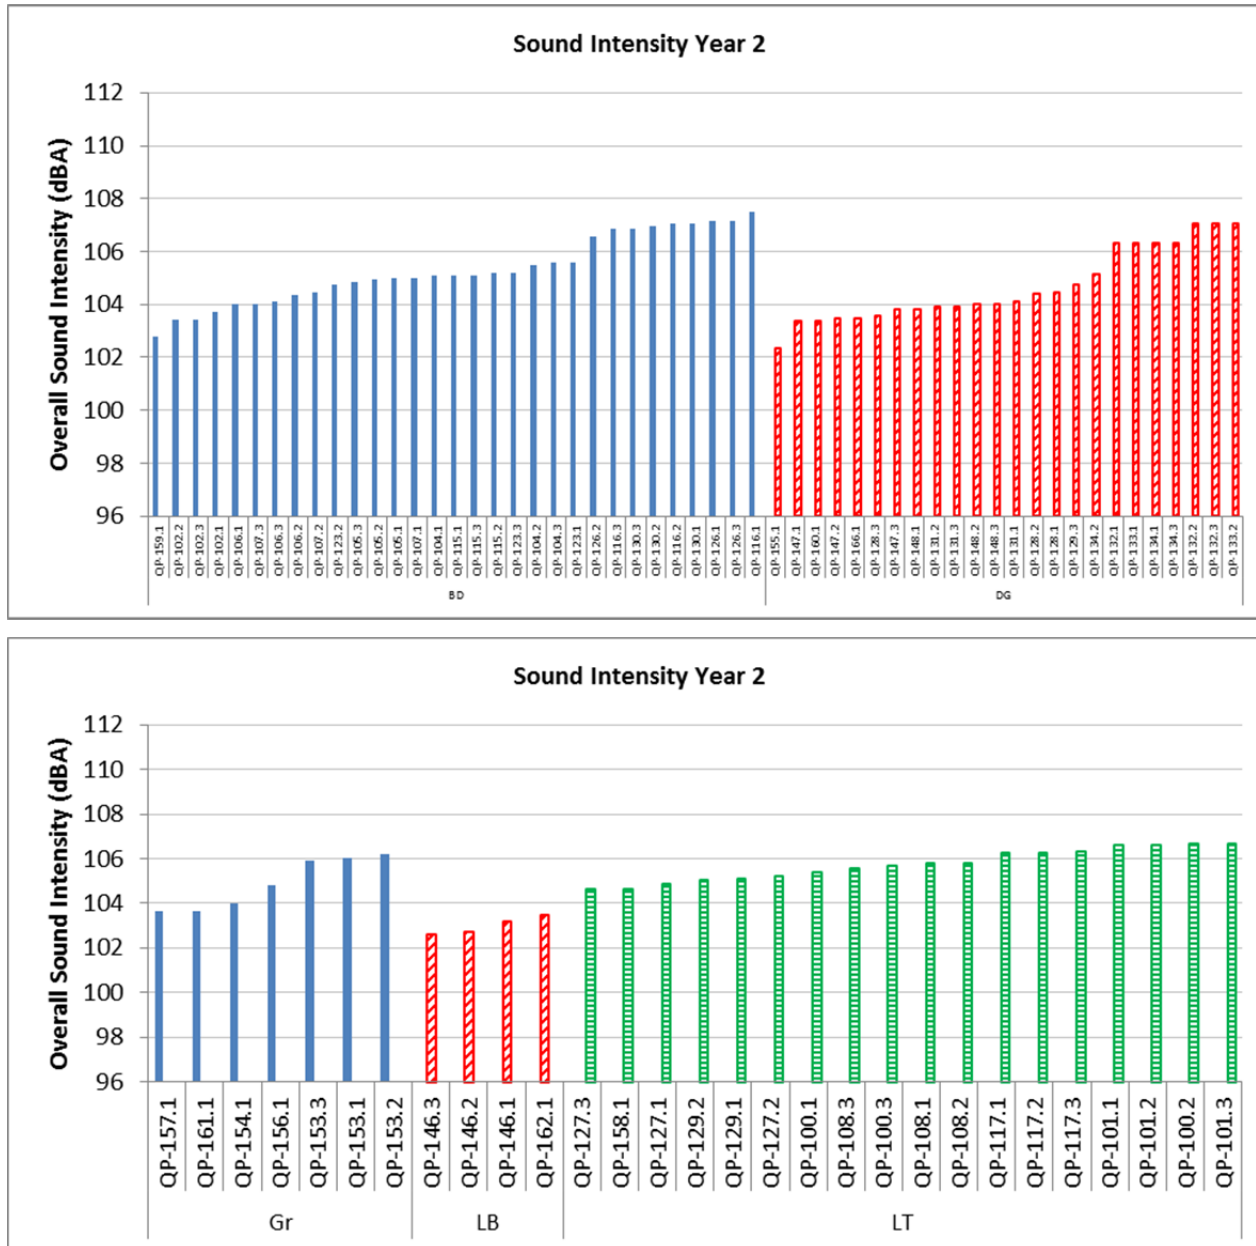
Figure A.2: On-board Sound Intensity levels of all sections as measured in Year 2.

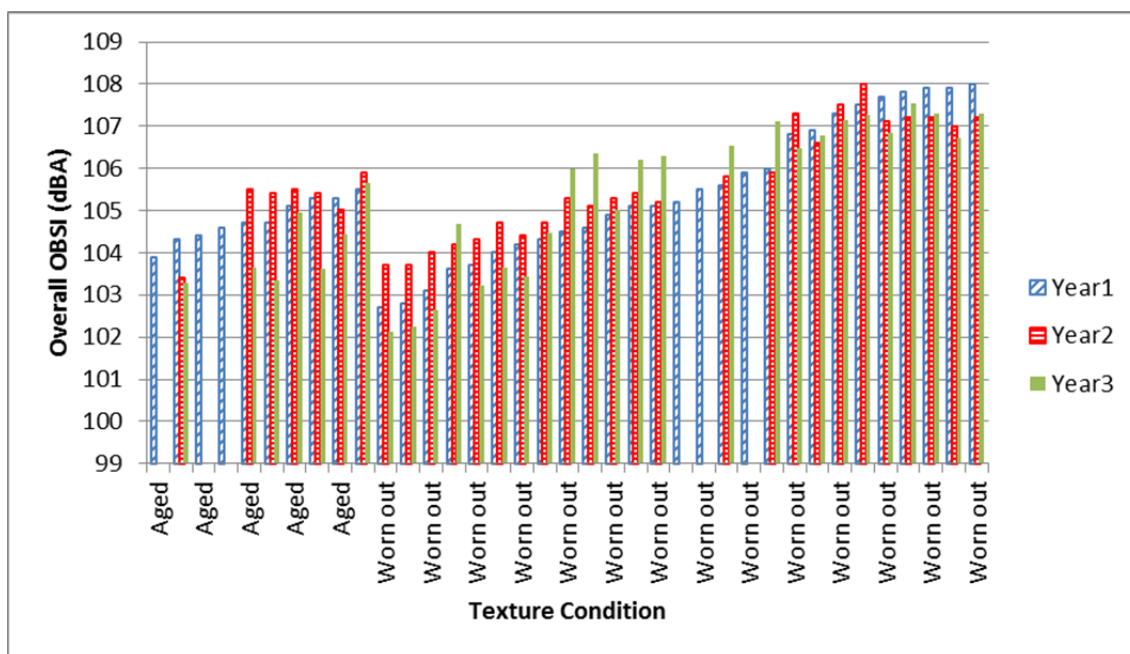
Figure C.1: Compare with Figure 3.23: Burlap drag Year 1, 2 and 3 OBSI results for *aged* and *worn out* texture sections (no *new* condition sections measured).

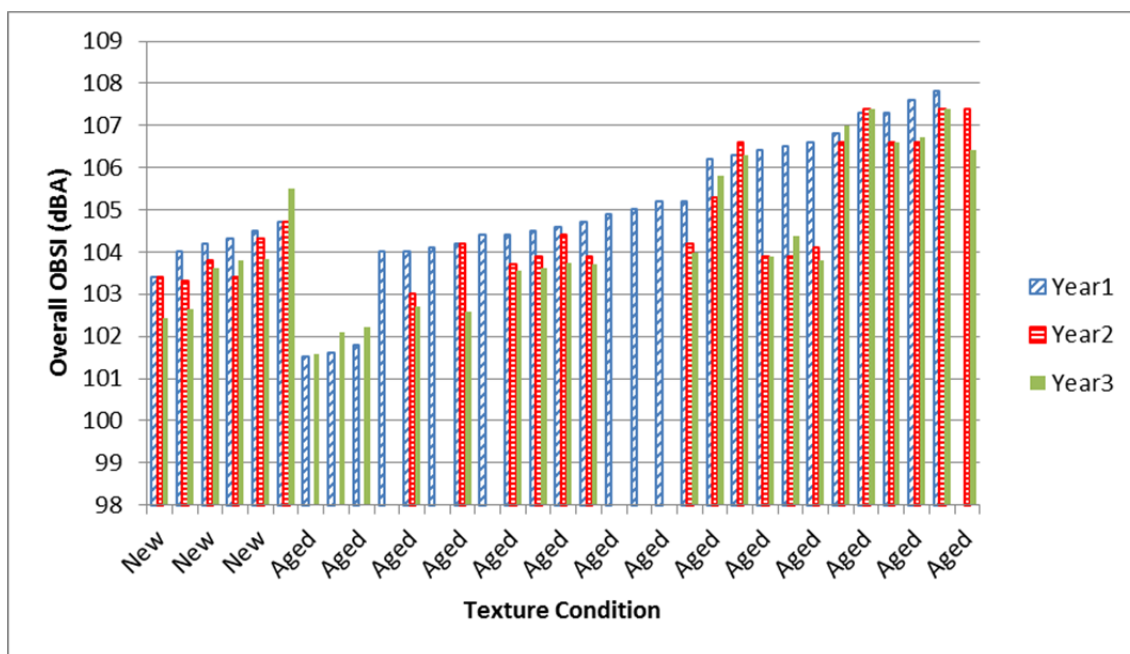
Figure C.2: Compare with Figure 3.26: Diamond-ground Year 1, 2, and 3 OBSI results for *new* and *aged* texture sections (no *worn out* condition sections measured).

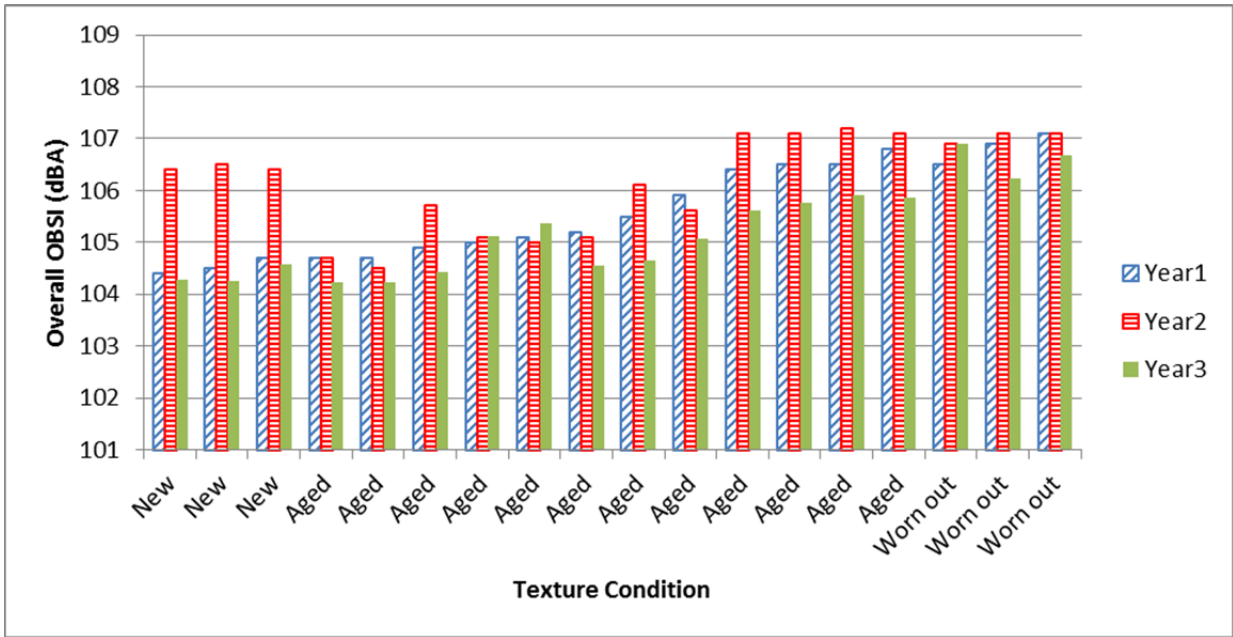
Figure C.5: Compare with Figure 3.33: Longitudinally timed Year 1, 2, and 3 OBSI results for all texture conditions (new, aged, and worn out).

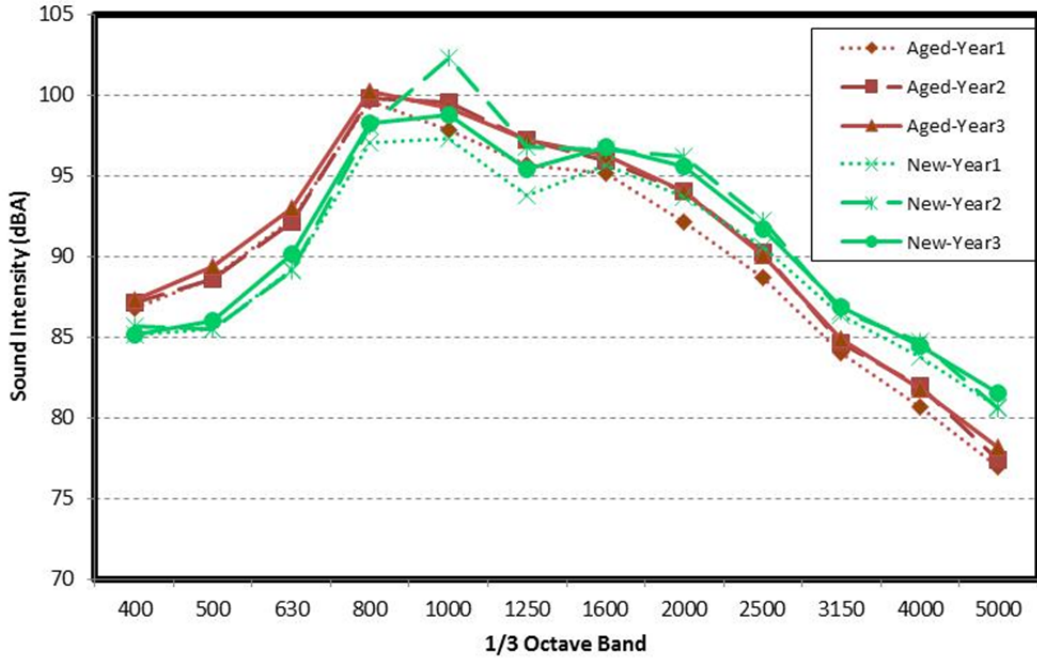
Figure D.5: Averaged OBSI spectral content of *new* and *aged* sections with longitudinally tined surface texture for three years of measurement.

Average noise spectra for the *aged* and *new* conditions for each texture type across the three years of measurement are shown in Appendix D. Overall, small incremental increases in noise levels were seen across nearly all textures and frequencies.
