Final Report: Mobile Surveillance and Wireless Communication Systems Field Operational Test; Volume 1: Executive Summary

**California PATH Research Report  
UCB-ITS-PRR-99-6**

# **Final Report: Mobile Surveillance and Wireless Communication Systems Field Operational Test**

## **Volume 1: Executive Summary**

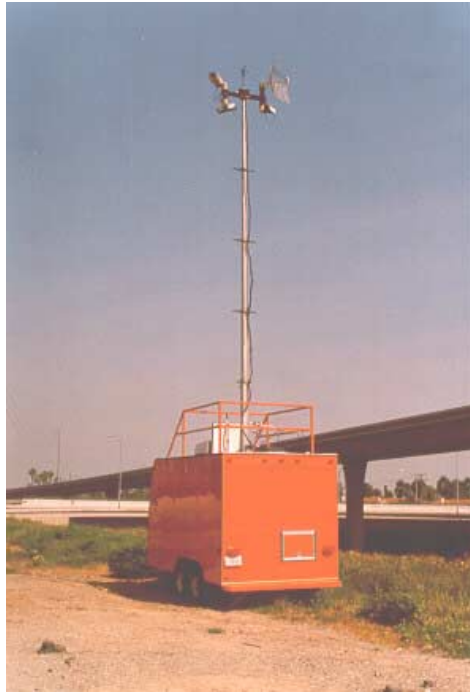
and three ramp meter trailers were assembled as part of the FOT. Figure 1-2 shows a surveillance trailer. Its major components are a video image processor; two pan and tilt black-and-white cameras; one pan, tilt, and zoom color camera; one fixed black-and-white security camera; a 170 controller; wide and narrow bandwidth spread spectrum radios for video and data transmission; a telescoping 30-foot (9.1-meter) mast; a security system; and a propane-powered electrical generator and power supply system.

**Figure 1-2. Surveillance trailer at First Street overlooking I-5 Freeway**

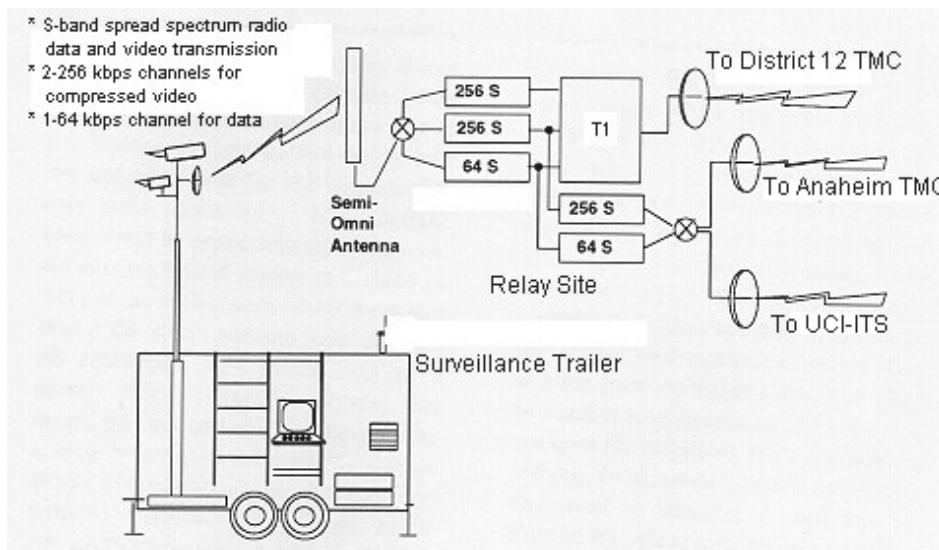
**Figure 1-6. Selection of video images for transmission from surveillance trailers to TMCs and UCI.** Video images from two cameras on any of the six surveillance trailers reach the District 12 TMC, while one camera image is transmitted to the Anaheim TMC and UCI.

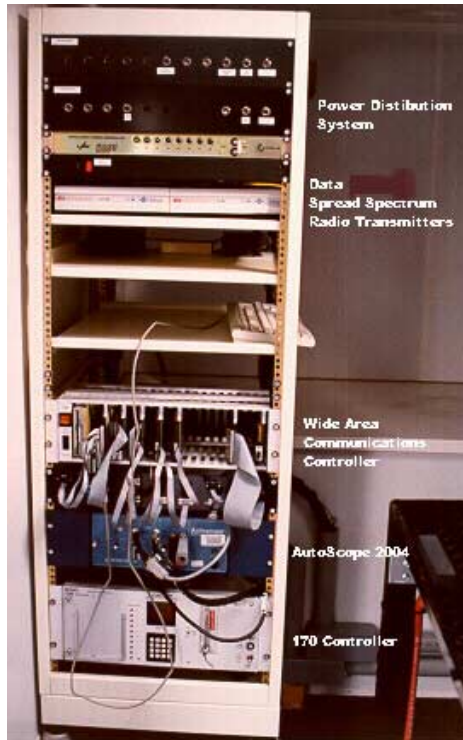
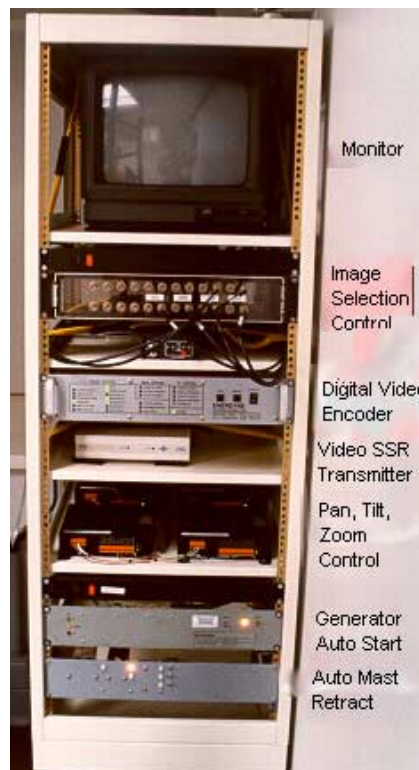
Figure 1-7. Surveillance trailer equipment racks

Figure 1-7 contains photographs of the two racks of equipment found in each of the surveillance trailers. The rack on the left contains the power distribution system, spread spectrum radios that transmit data to the ramp meter trailer and relay site, wide-area communications controller, AutoScope 2004 VIP, and the 170 controller that processes the VIP data. The rack on the right contains a monitor, controls for selectively displaying the imagery from the color surveillance camera or the black and white VIP cameras on the monitor, digital video encoder, spread spectrum radio that transmits compressed video imagery to the relay site, pan-tilt-zoom camera controls, generator auto start/battery recharge system, and the automatic mast retraction circuit.

(a) Left equipment rack

(b) Right equipment rack

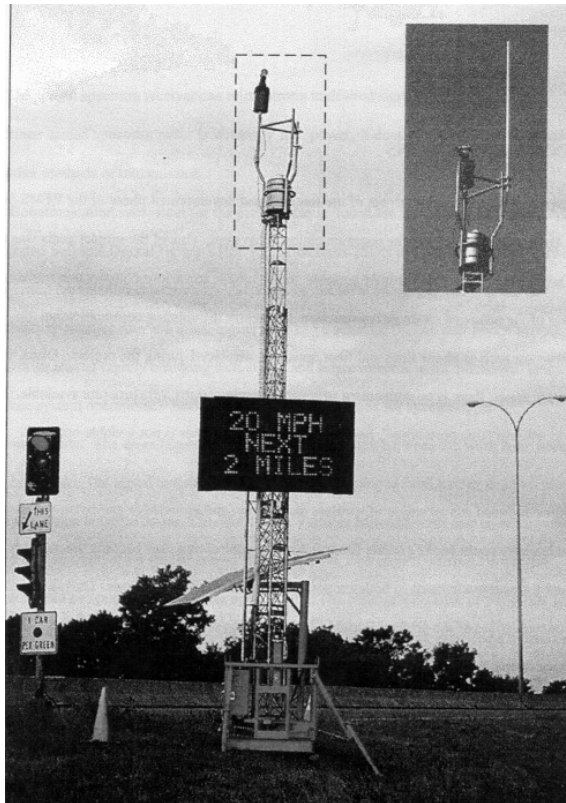
**Figure 1-8. PTMS deployed on a skid**

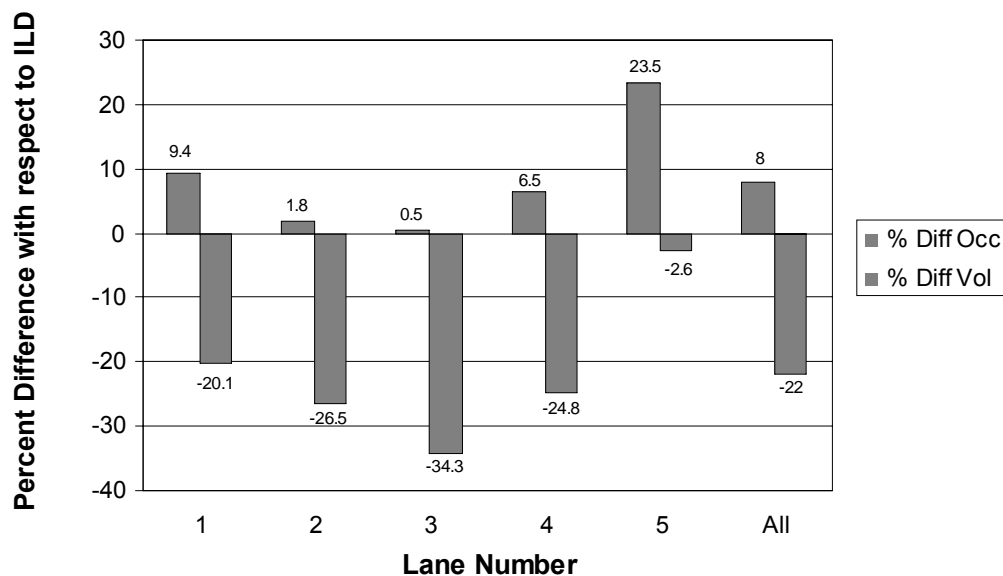
Lane 5, the lane closest to the shoulder, had the smallest percent difference in measured volume equal to -2.6 percent. The negative sign indicates that the VIP counted more vehicles than the ILD. Lane 3 had the smallest difference in occupancy measurement equal to 0.5 percent. The average percent differences in total volume and average occupancy over all lanes reporting good data were -22 and 8, respectively.

Two effects contribute to the less than optimal performance of the VIP compared with the inductive loops, especially in lanes further from the trailer location. Both effects are caused by the relatively low operational height of the VIP cameras above the road surface [approximately 32 ft (9.8 m)] as constrained by the height of the fully extended mast on the surveillance trailer. Tall vehicles, such as large commercial trucks, that project their image into adjacent lanes produce the first effect. The VIP detector zones in the adjacent lanes detect the truck as if it was actually traveling in those lanes. Depending on the location of the surveillance trailer with respect to the roadway, the tall vehicle can project its image into 1, 2, or 3 adjacent lanes. Thus, the VIP will overcount vehicles if this effect is present. The second factor that degrades VIP performance is blockage of shorter vehicles, such as passenger cars, in the lanes further from the camera by taller vehicles traveling in the lanes closer to the camera. This effect appears to be less prevalent than the detection of a tall vehicle in more than one lane.

**Figure 2-1. Average of the percent difference between average occupancies and total volumes over all I-5 Test runs as measured by the ILDs and VIP**

Because of these two effects, it was anticipated that the vehicle counts and lane occupancies calculated by the VIP would be closest to the values calculated from the inductive loops in the lane nearest the surveillance trailer, i.e., the rightmost lane. In this lane, there would be no false images of tall vehicles or blockage of short vehicles by the taller ones. This premise is generally substantiated by the data in Figure 2-1.

When examining the data in Figures 2-1 and 2-2, a goal of the mobile surveillance and wireless communication system design should be recalled, namely that the surveillance trailers and mast height were not designed to maximize the accuracy of VIP data, but rather to acquire data that were accurate enough to support the ramp-metering function. The accuracy of the VIP data appears adequate for the rush-hour ramp-metering application. However, this conclusion must be verified with additional testing because only a limited amount of data were collected during periods when TOD metering did not override local-responsive metering.

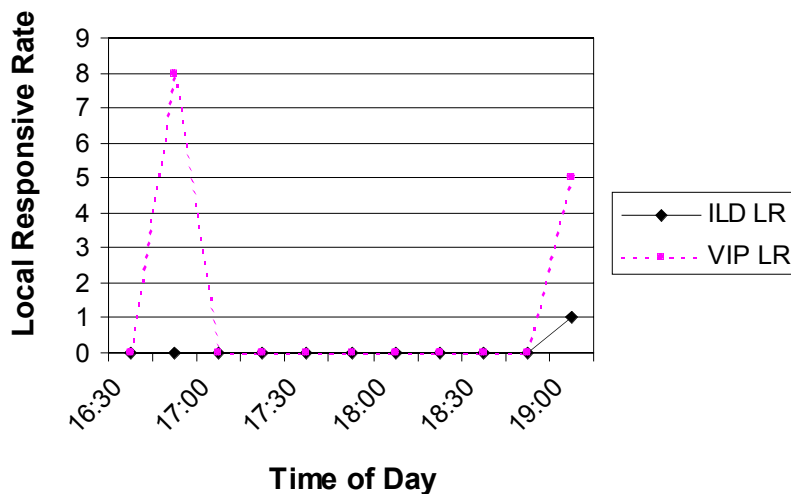
Figure 2-2 compares the local-responsive meter rate computed from the ILD and VIP measurement data acquired at the Grand Avenue site during the afternoon rush hour interval on April 16, 1998. The ILD and VIP local-responsive rates are identical in the middle of the run. This is because a more restrictive metering rate (namely zero) than the prestored time-of-day (TOD) rate was calculated by the algorithm from the ILD and VIP real-time data. Therefore, the algorithm reverted to the less restrictive TOD rate for both sets of data. The differences in meter rates at the beginning and end of the data-recording period are attributable to initialization and data interruptions that occur during the start and end of a run.

**Figure 2-2. Local-responsive ramp meter rate (vehicles/minute) computed from ILD and VIP data at Grand Avenue during afternoon rush hours on 4/16/98**

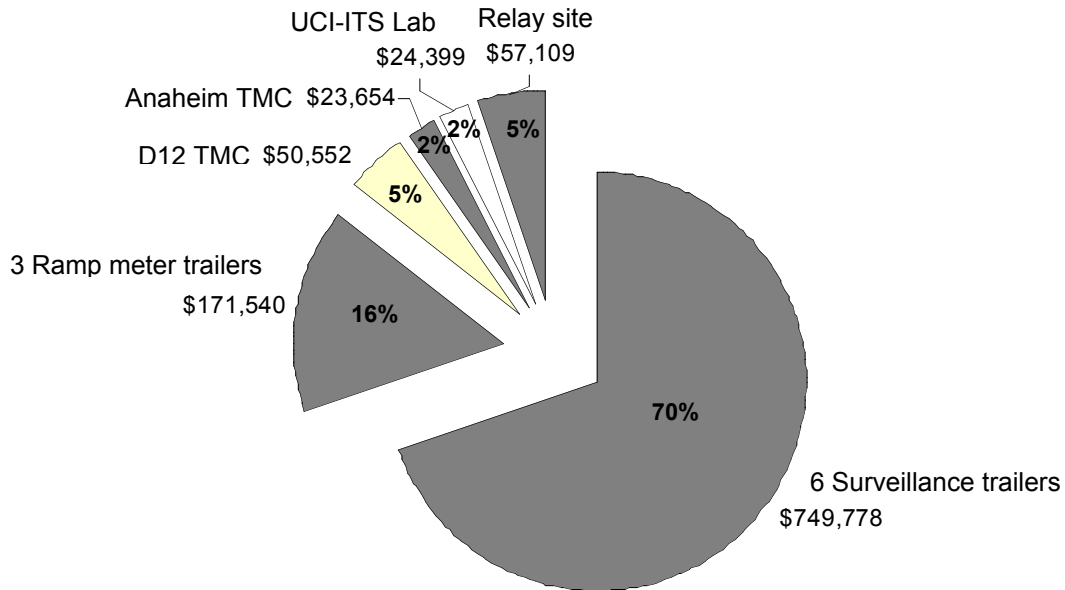
**Figure 3-1. Relative contributions of the six surveillance trailers, three ramp meter trailers, District 12 and Anaheim TMCs, UCI-ITS Laboratory, and relay site to total equipment expenditure**
